Report on
Stage 1 Contamination Assessment

Proposed West Keira Project Access Ramp
71 Market Street, Wollongong

Prepared for
Hansen Yuncken Pty Ltd

Project 40596.08
January 2012

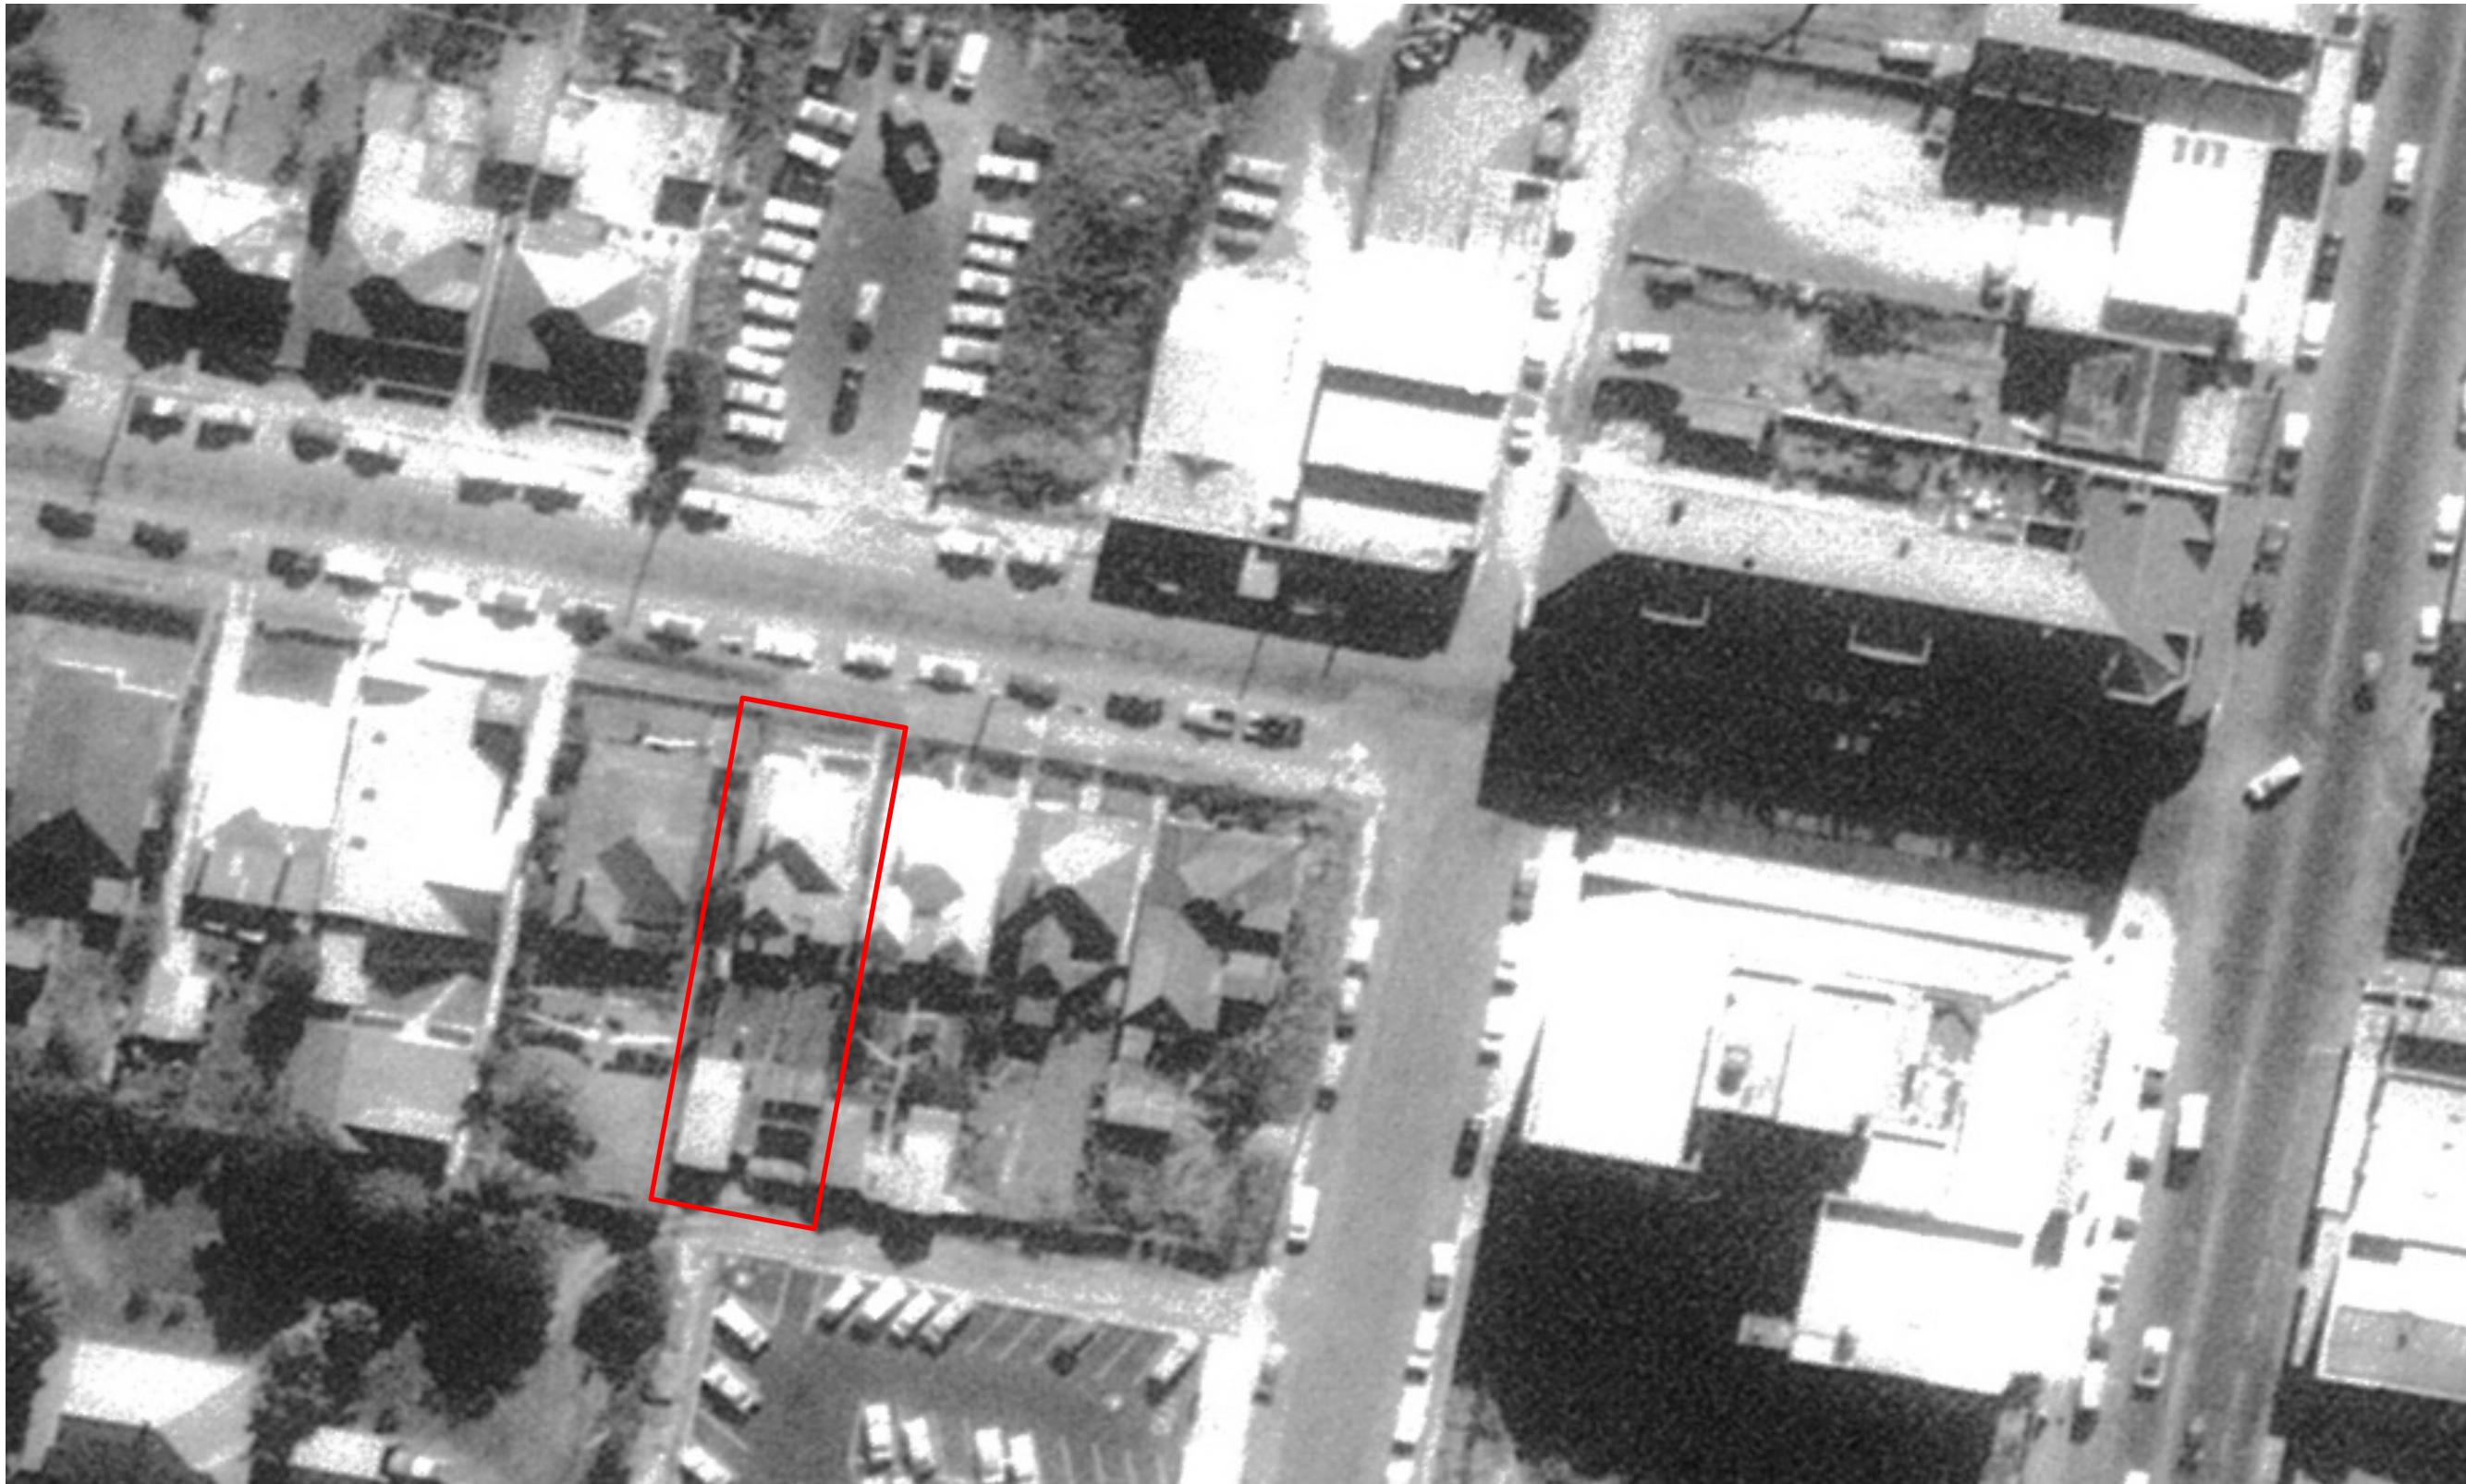
Client: Hansen Yuncken Pty Ltd		Aerial Photograph 1961 Proposed West Keira Project Access Ramp 71 Market Street, Wollongong	Project No. 40596.08
Office: Wollongong	Drawn by: KGH		Plate no 2
Scale: NTS	Date: Dec-11		Revision: A

1961: The photograph shows three structures were present on the site with the northern and south western structures appearing unchanged. The structure adjacent to the eastern boundary was no longer visible and another structure had appeared in the southern eastern corner. The structure in the north was most likely a dwelling, with three sites to the east of the site with similar rooflines visible. The southern structures were most likely garages/storage sheds. The area in the centre of the site appear to be overlain with grass with a footpath running between the north and south structures visible. The site remains bounded by residential properties in the east and west however car parks have replaced buildings in the north and south.

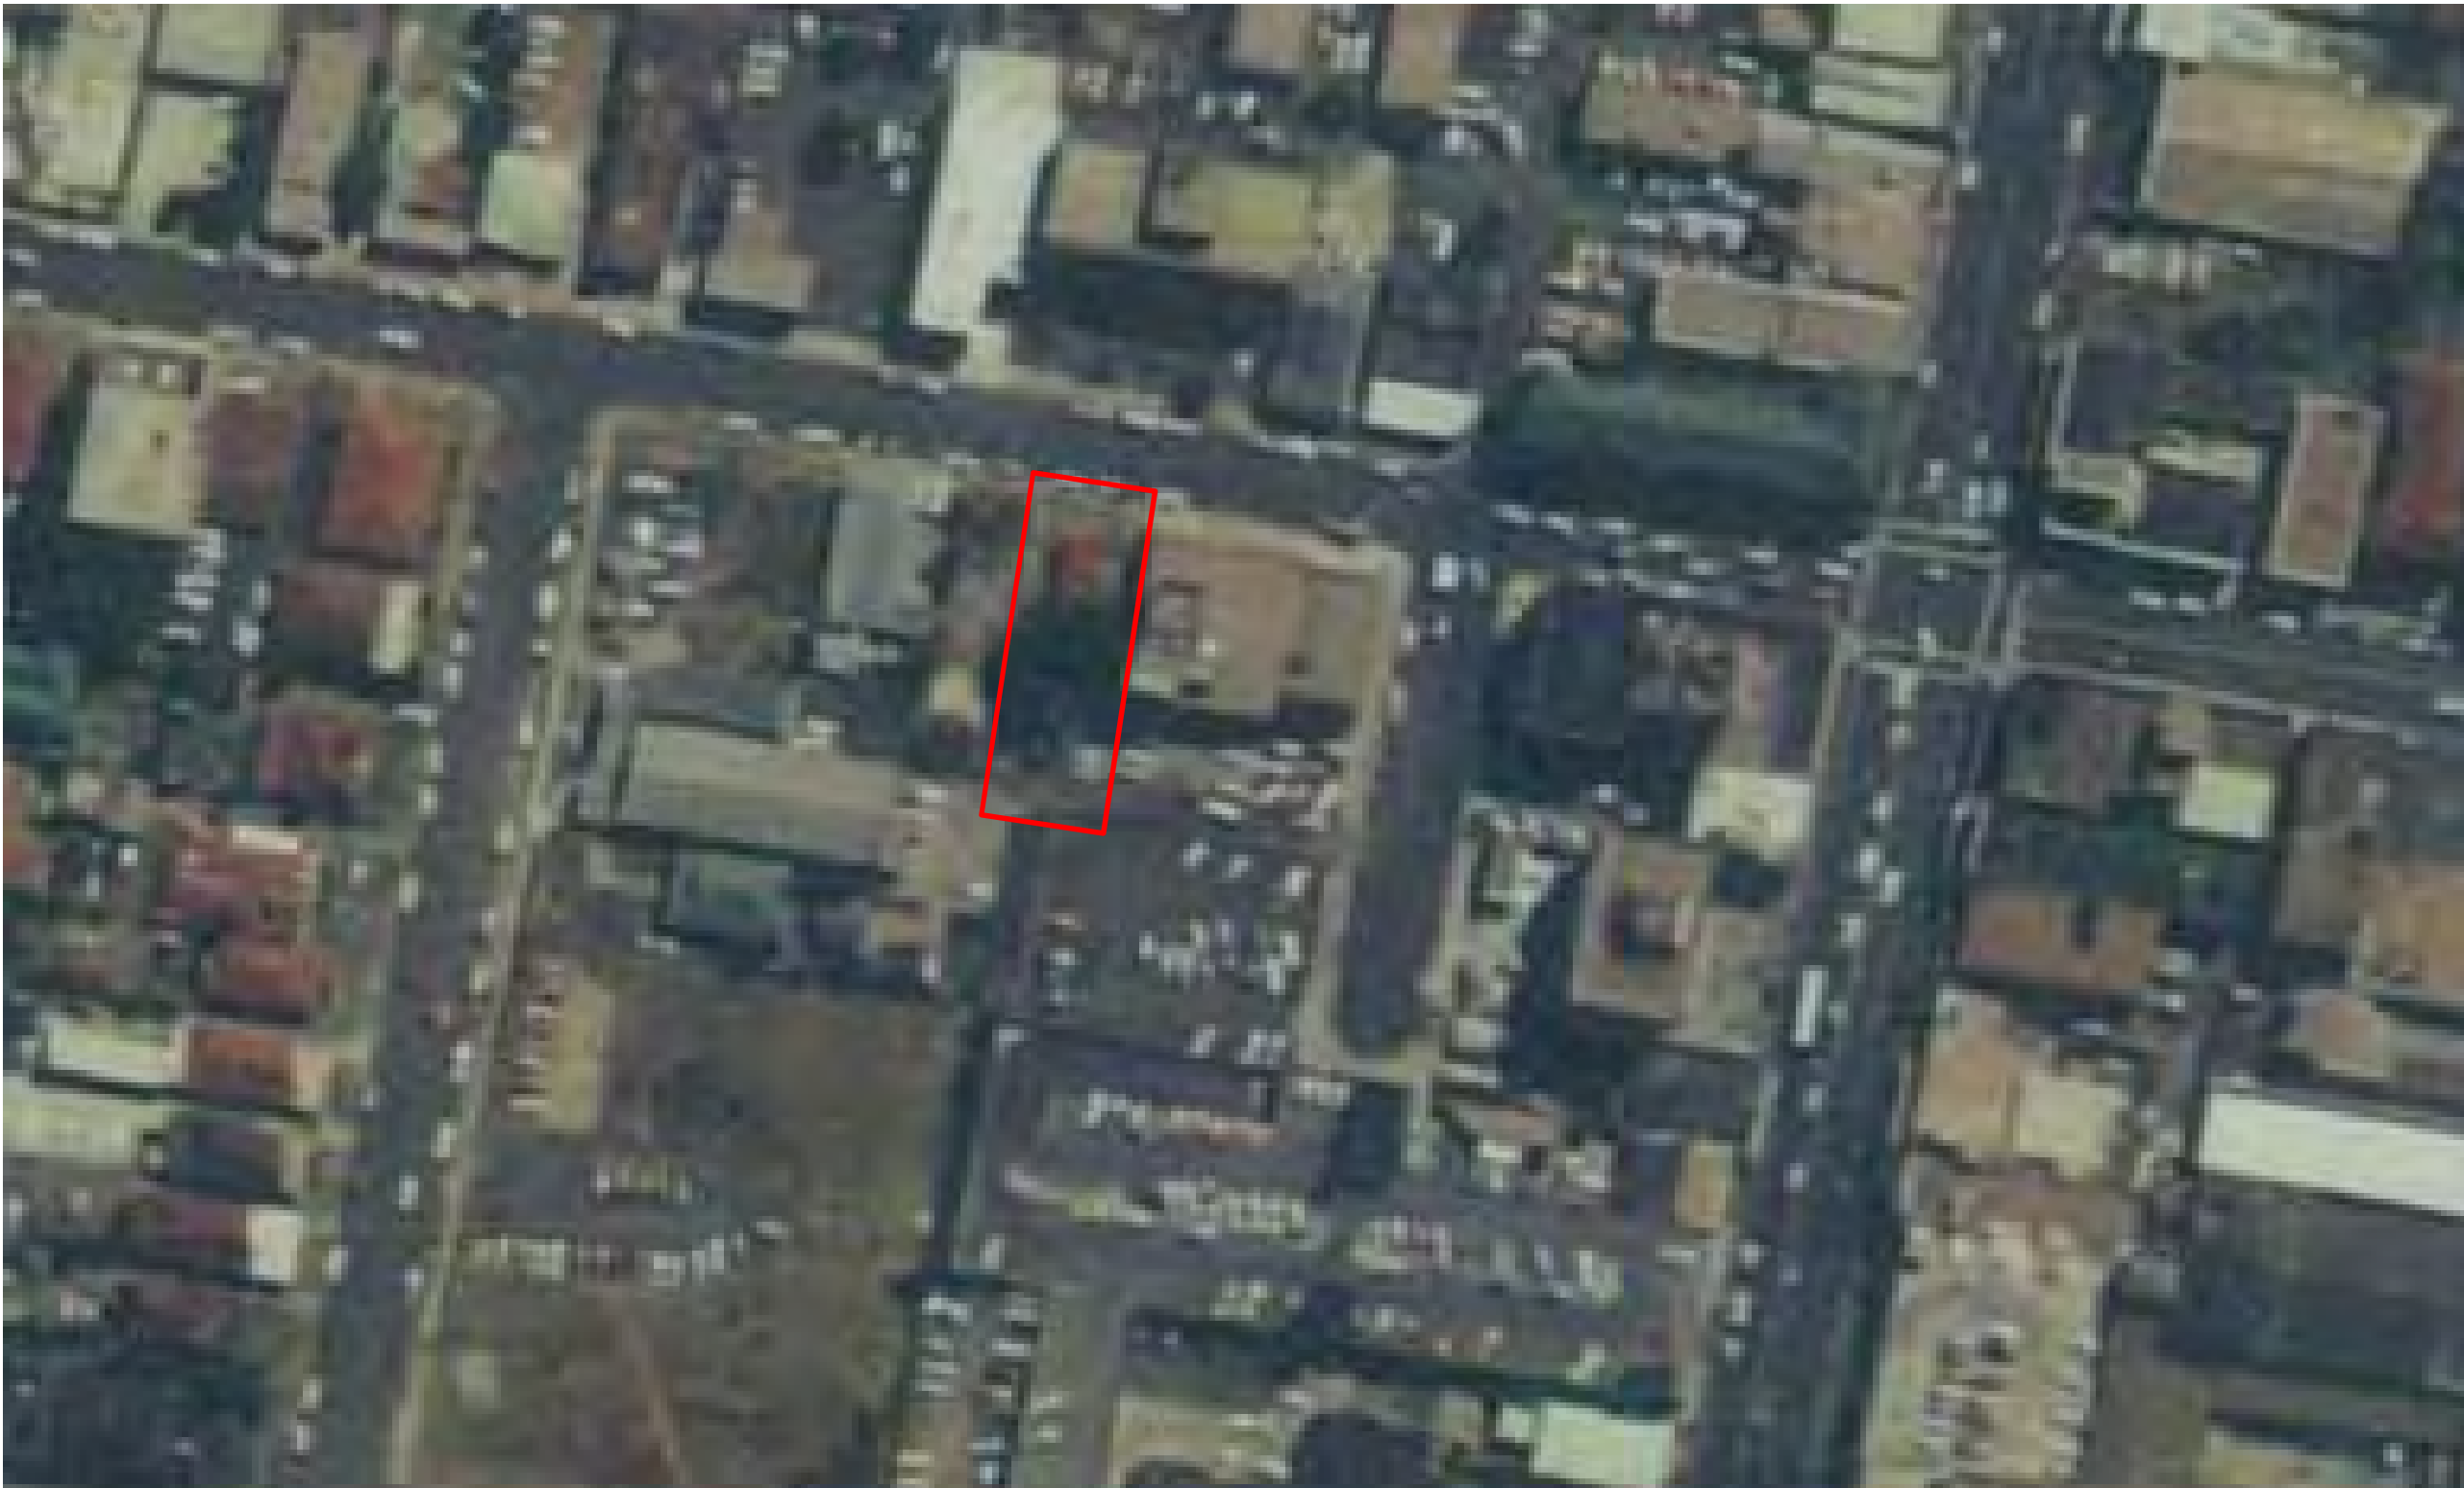
Client: Hansen Yuncken Pty Ltd		Aerial Photograph 1984 Proposed West Keira Project Access Ramp 71 Market Street, Wollongong	Project No.	40596.08
Office: Wollongong	Drawn by: KGH		Plate no	4
Scale: NTS	Date: Dec-11		Revision:	A

1984: The structure in the south western part of the site was no longer visible and the area appeared to be overlain with bitumen. Also, an area adjacent to the eastern boundary appeared to be overlain with bitumen. The remainder of the site appeared unchanged. The property to the west of the site has been demolished and the area cleared.

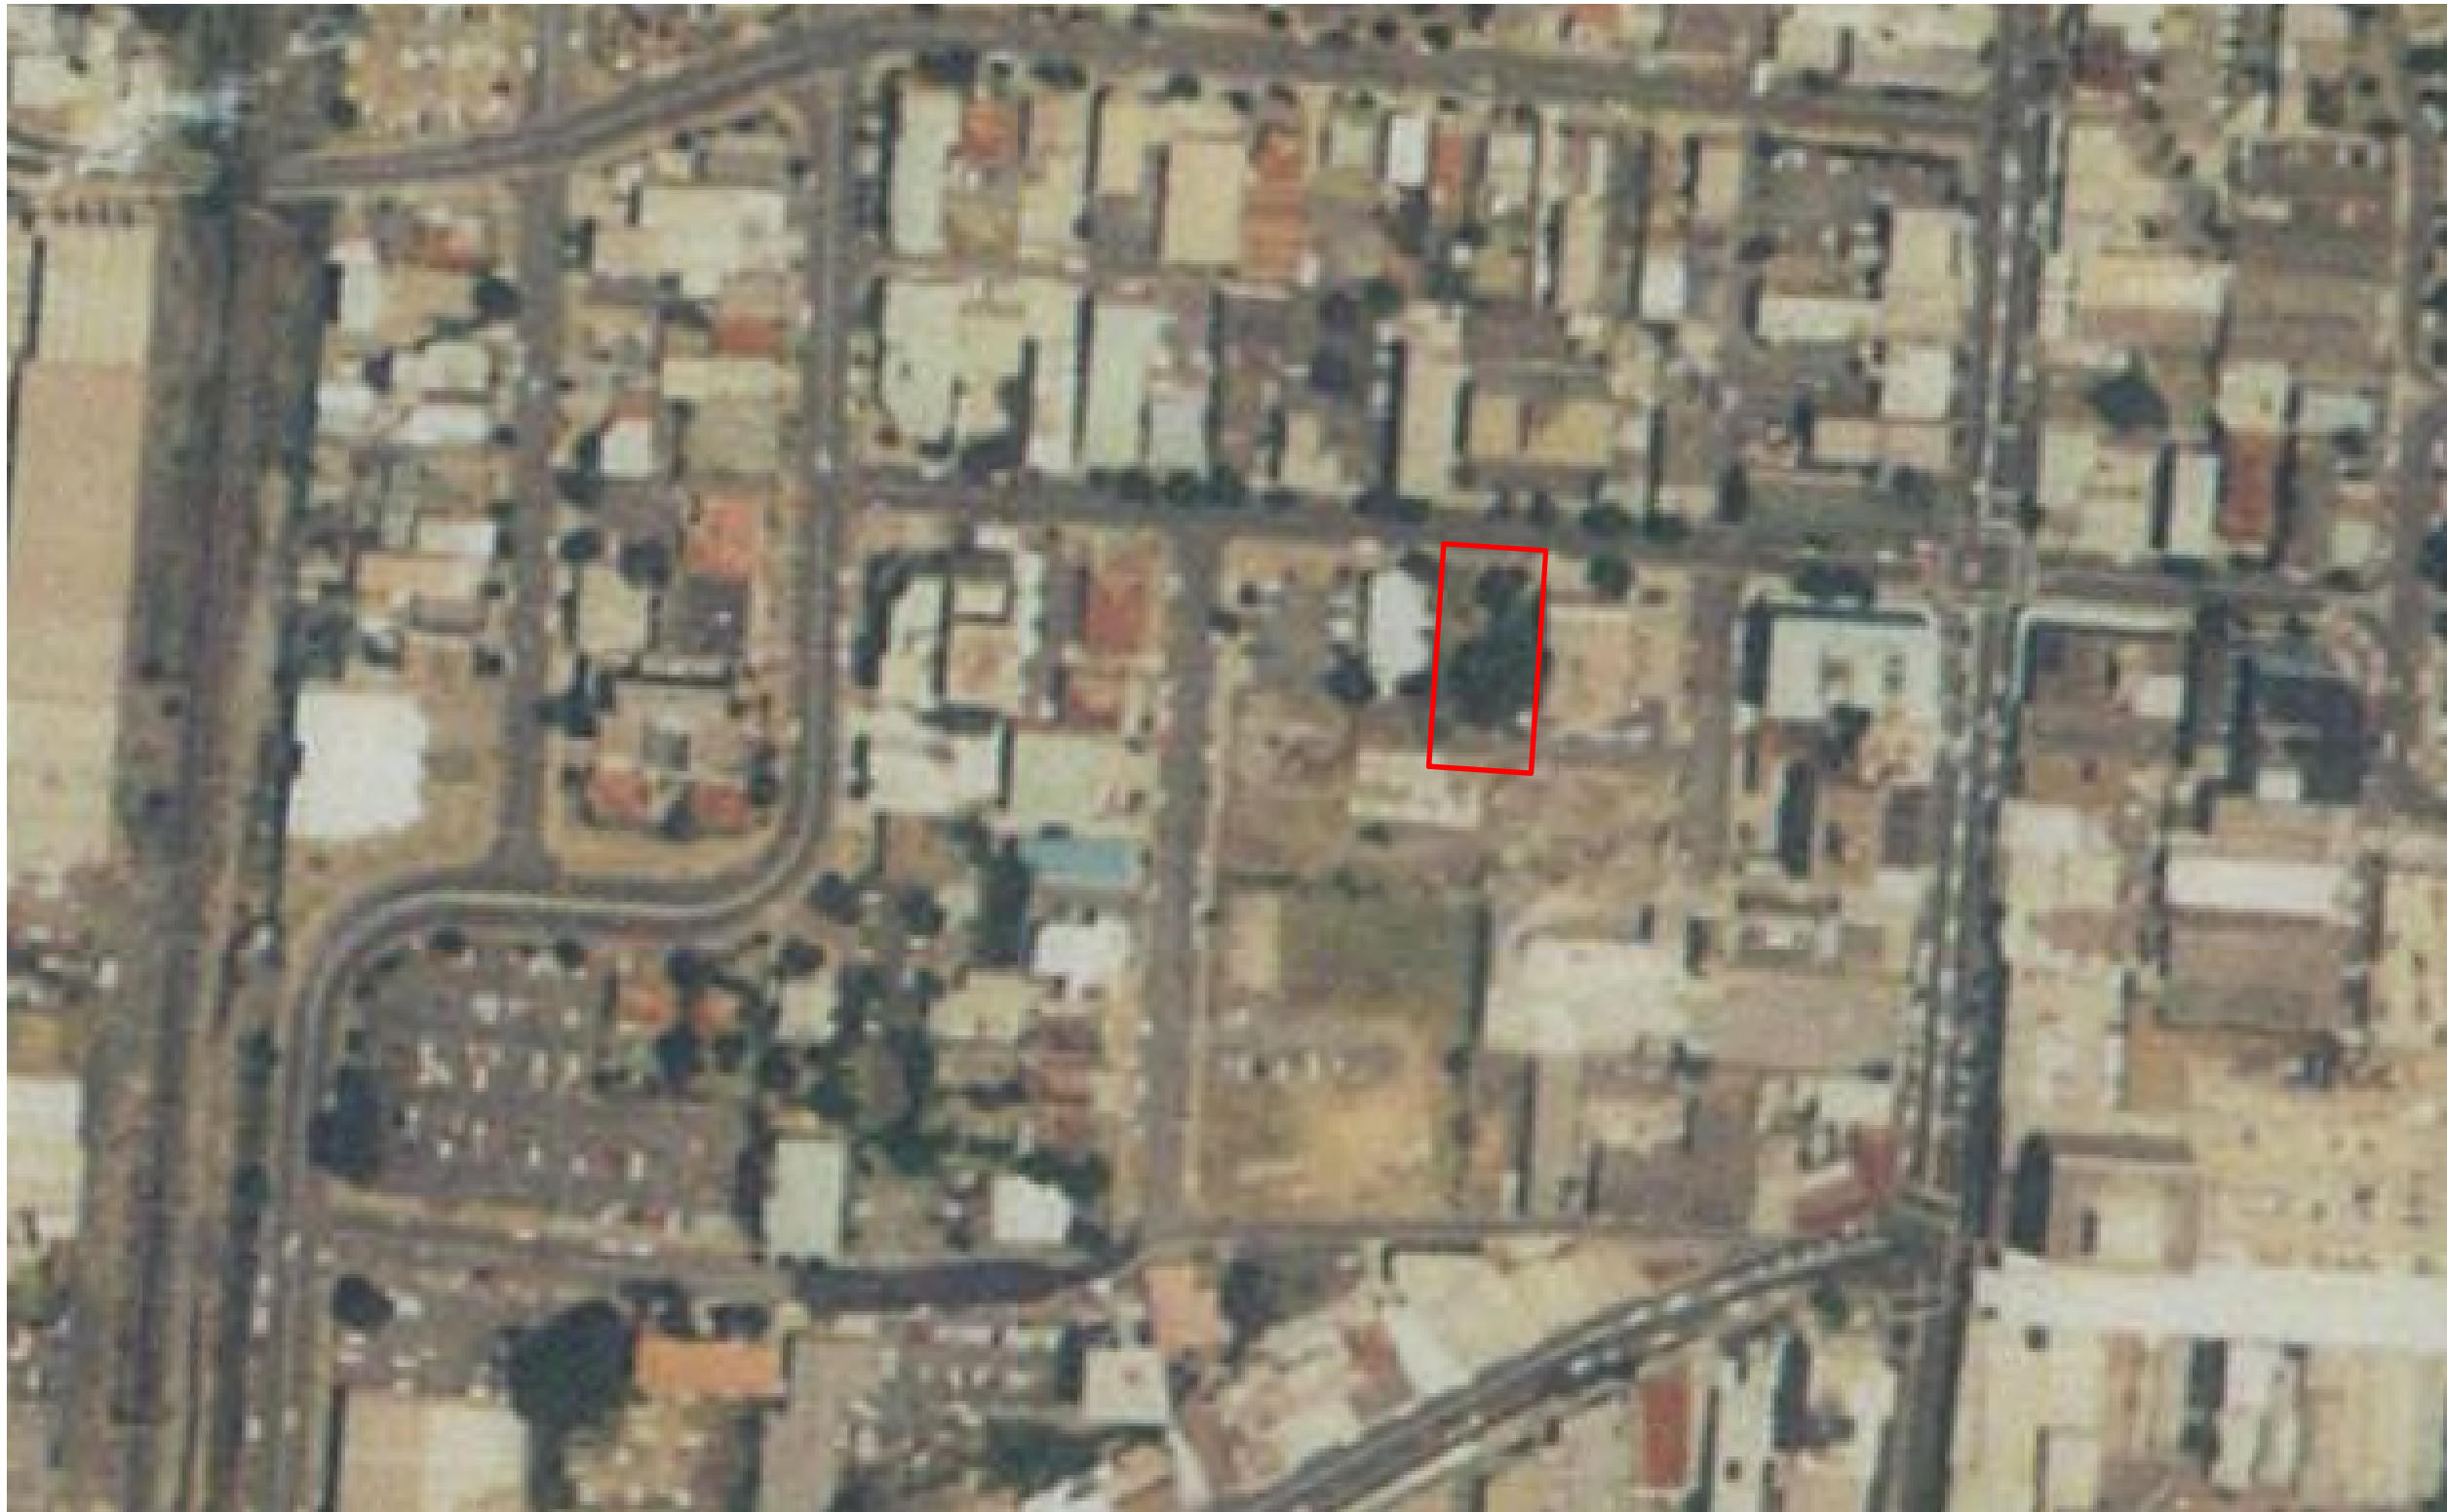
Douglas Partners <i>Geotechnics Environment Groundwater</i>	Client: Hansen Yuncken Pty Ltd		Aerial Photograph 1994 Proposed West Keira Project Access Ramp 71 Market Street, Wollongong	Project No.	40596.08
	Office: Wollongong	Drawn by: KGH		Plate no	5
	Scale: NTS	Date: Dec-11		Revision:	A

1994: The majority of the site was covered by trees however the structure in the north remained visible and the area in the south appeared overlain by bitumen. A large commercial building has been constructed to the west of the site and the car park to the south of the site appeared cleared.

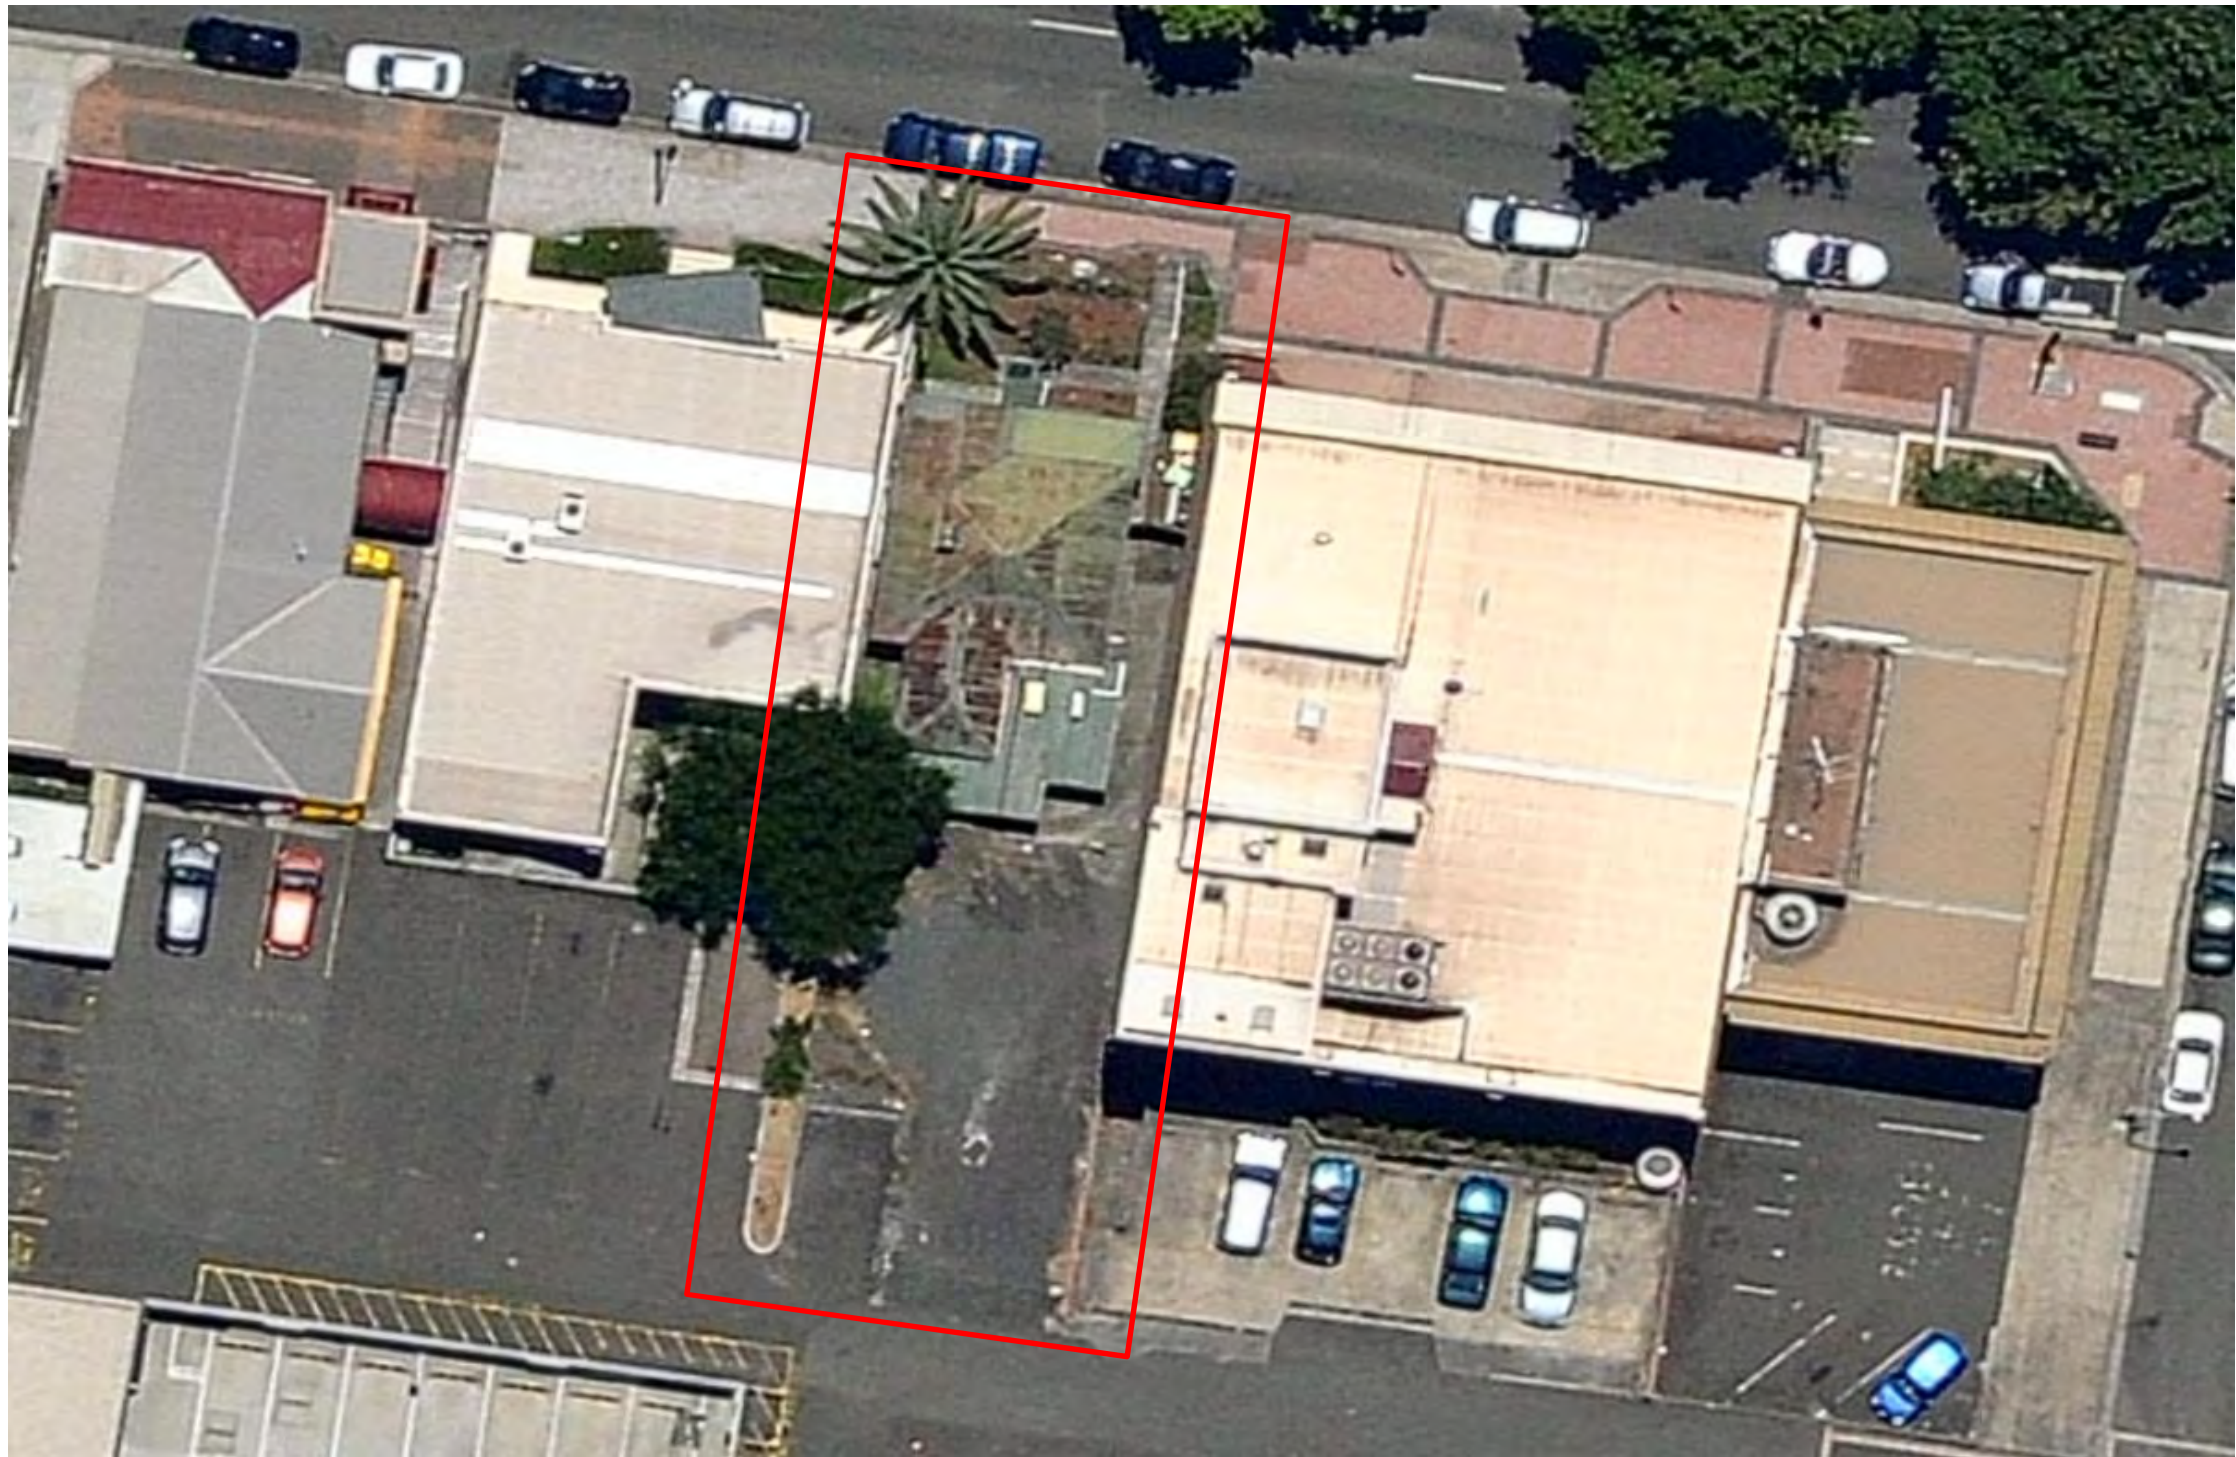
2011: The photograph clearly shows the structure in the north of the site. The area between the structure and Market Street appeared to be paved and a large palm tree was visible in the north west corner. A concrete footpath and a garden bed was visible adjacent to the eastern boundary and the structure. The large tree adjacent to the western boundary was visible. The majority of the remainder of the site appeared to be overlain with bitumen with a long narrow and a triangular garden bed visible adjacent to the western boundary.

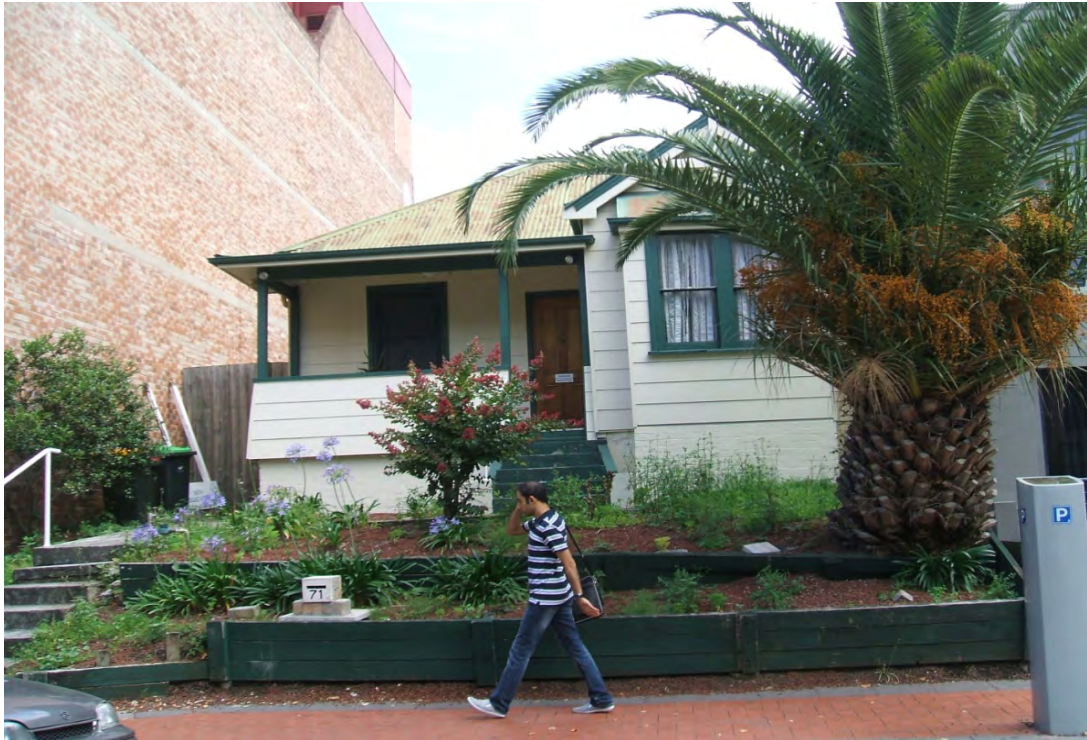
Photo 1: View from Market Street looking south

- The northern part of the site was occupied by the brick and clad dwelling, refer to photos 1 and 2. The dwelling appeared to be in good condition with no flaking paint visible. The awnings appeared to be fibre-cement sheeting however in good condition.

- The area between the northern boundary and the dwelling was occupied by tiered garden beds, refer to photo 3. The garden beds were weed covered, however, some agapanthus, two shrubs and a large palm tree were present, refer to photos 1 and 2.

- A pathway was observed on the eastern side of the dwelling and garbage bins had been placed adjacent to the eastern boundary, refer to photo 1.
- The southern part of the site was occupied by a vacant area overlain with gravel and bitumen and appeared to have been used as a car park, refer to photo 4.
