6. Appendices

Appendix A. Geotechnical Soil Profile Logs – Bore Holes

Client: Maunsell Australia		Job No: 20969	
Project: Armidale Dumaresq Council Proposed Landfill		Date: 13-Sep-05	
Location: Waterfall Way		Logged by: Robert Cork	
Excavation Method: Light Drill Rig		Bore Hole No: BH1	
Groundwater Struck: No		Groundwater Stands:	
Surface slope: 2%		Current land use: Grazing	
Vegetation: Grazed pasture and sedge		Parent material:	
Surface drainage: Toe of slope		Aspect: Northwest

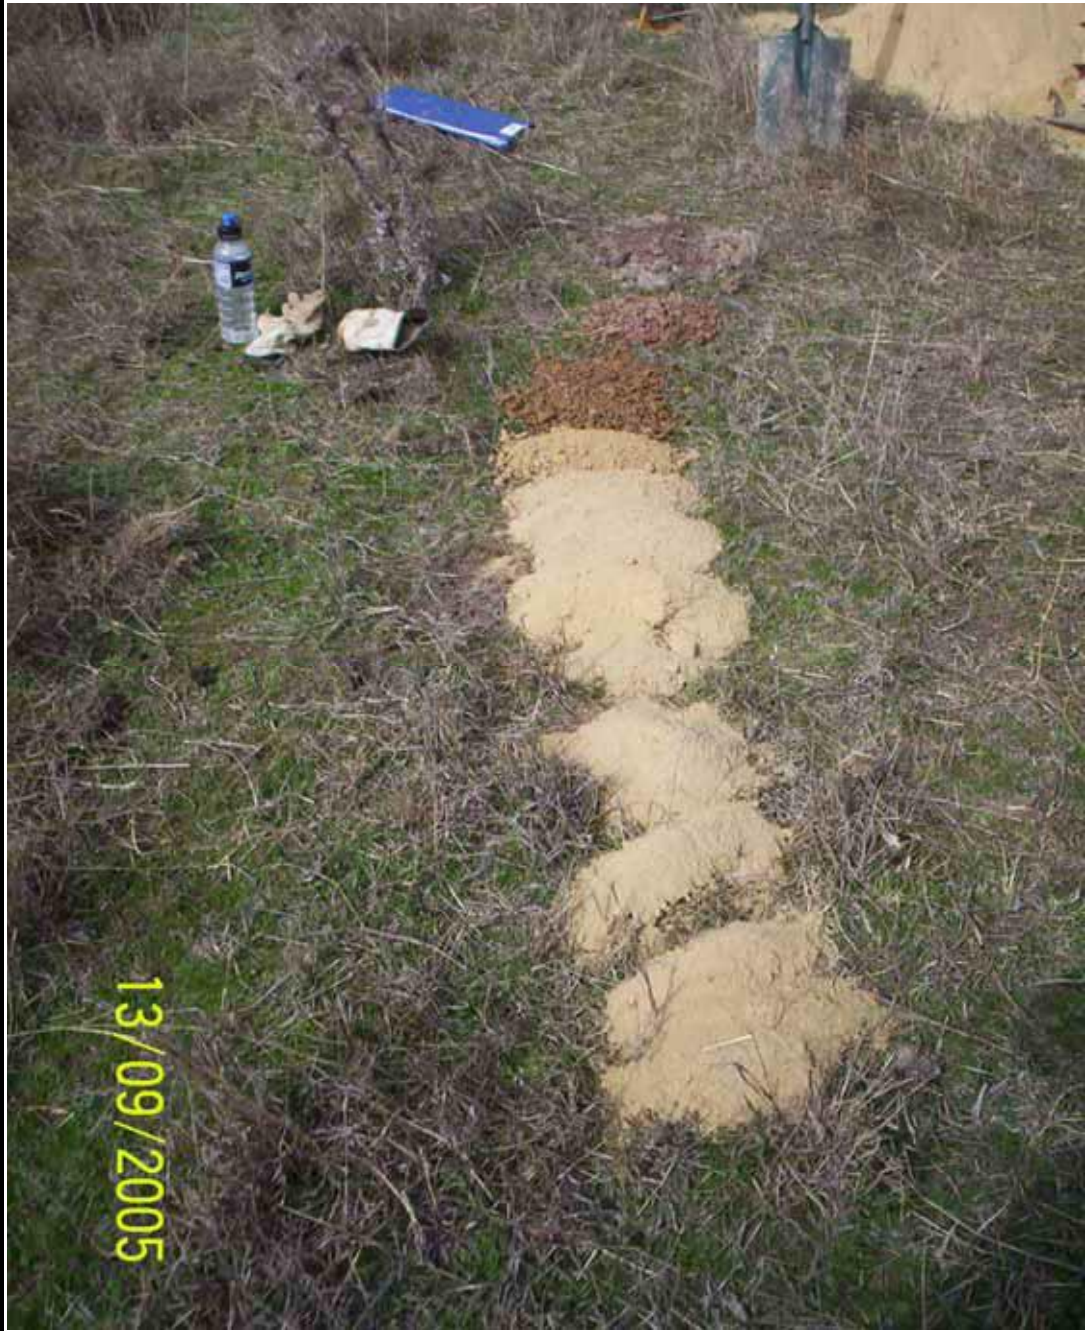
Client:	Maunsell Australia	Job No:	20969
Project:	Armidale Dumaresq Council Proposed Landfill	Date:	13-Sep-05
Location:	Waterfall Way	Logged by:	Robert Cork
Excavation Method:	Light Drill Rig	Bore Hole No:	BH1
Groundwater Struck:	No	Groundwater Stands:	
Surface Slope/Aspect:	2% Northwest	Current land use:	Grazing
Vegetation:	Grazed pasture and sedge	Parent material:	
Surface drainage:	Toe of slope	Coordinates (GDA94):	383236 E, 6619482 N MGA Zone 56

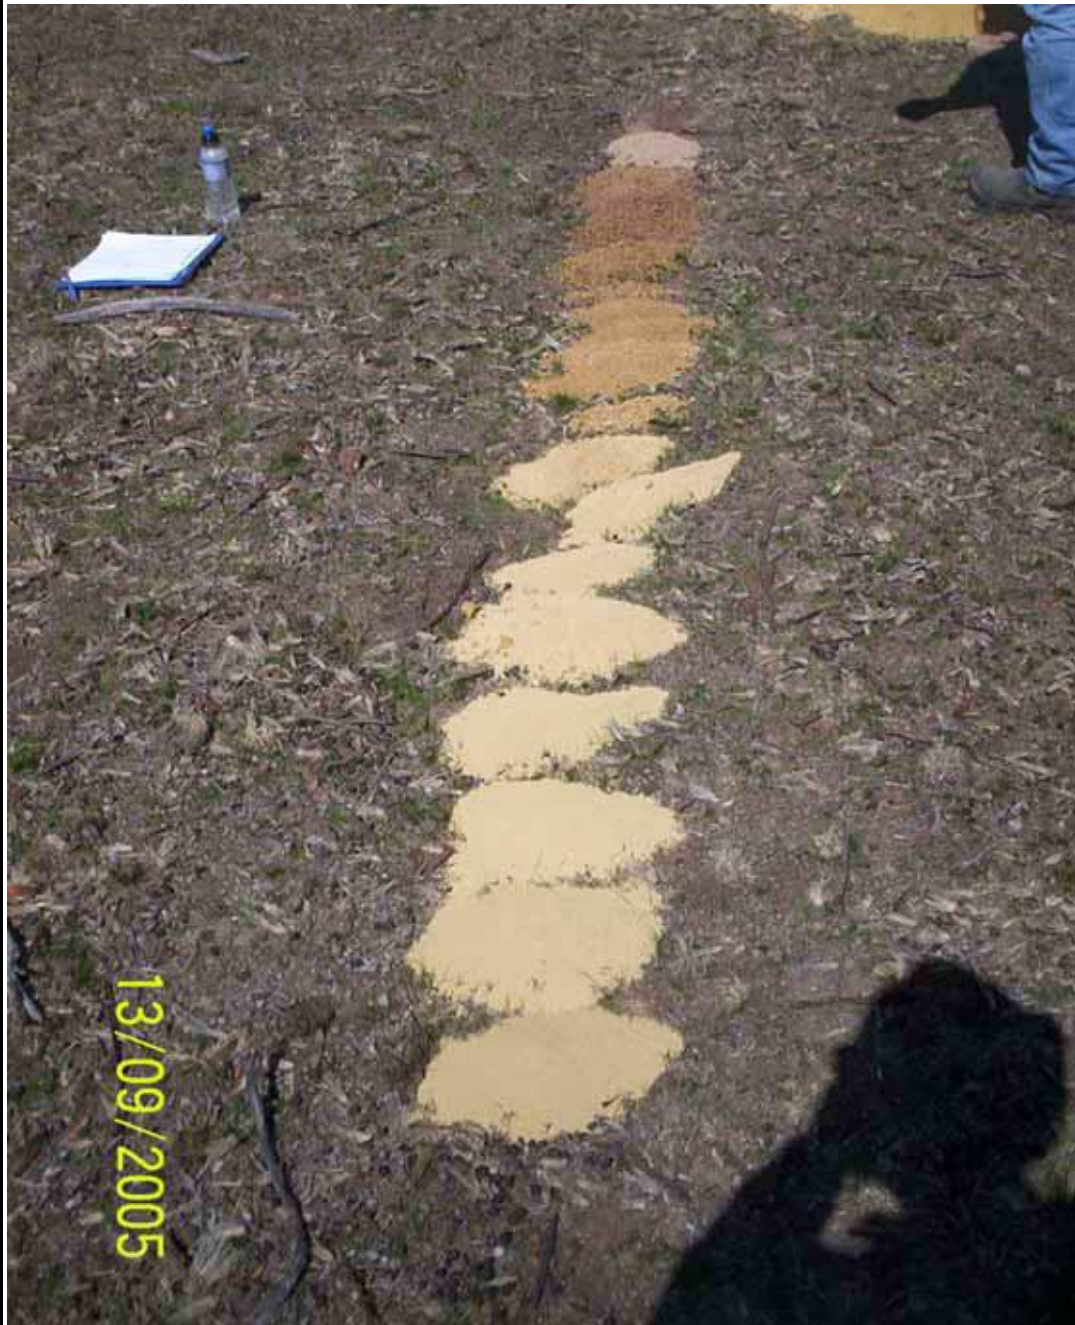
Client:	Maunsell Australia	Job No:	20969
Project:	Armidale Dumaresq Council Proposed Landfill	Date:	13-Sep-05
Location:	Waterfall Way	Logged by:	Robert Cork
Excavation Method:	Light Drill Rig	Bore Hole No:	BH 2
Groundwater Struck:	No	Groundwater Stands:	
Surface Slope/Aspect:	3% Northeast	Current land use:	Grazing
Vegetation:	Stringy barks. Cleared open woodland	Parent material:	Variable, some sediments and colluvium
Surface drainage:	Slight ridge between 2 slight depressions	Coordinates (GDA94):	383207 E, 6619280 N MGA Zone 56

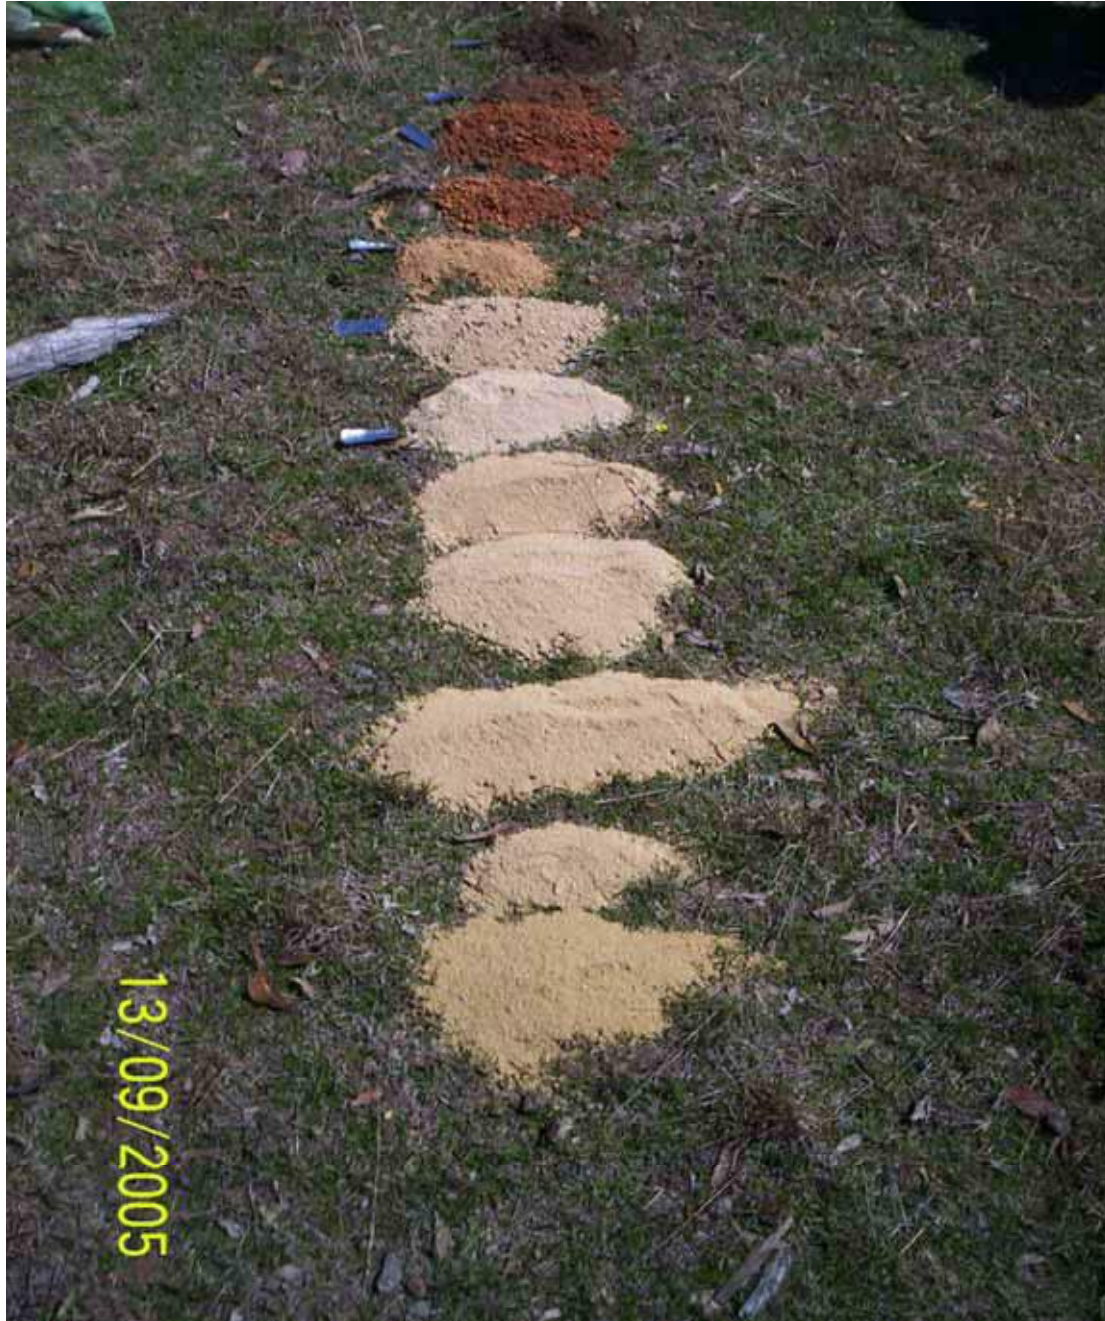
Client:	Maunsell Australia	Job No:	20969
Project:	Armidale Dumaresq Council Proposed Landfill	Date:	13-Sep-05
Location:	Waterfall Way	Logged by:	Robert Cork
Excavation Method:	Light Drill Rig	Bore Hole No:	BH 3
Groundwater Struck:	No	Groundwater Stands:	
Surface Slope/Aspect:	5% - 6% East	Current land use:	Grazing
Vegetation:	Open woodland, grazed	Parent material:	Variable, some sediments and colluvium
Surface drainage:	Open slope	Coordinates (GDA94):	383177 E, 6619088 N MGA Zone 56

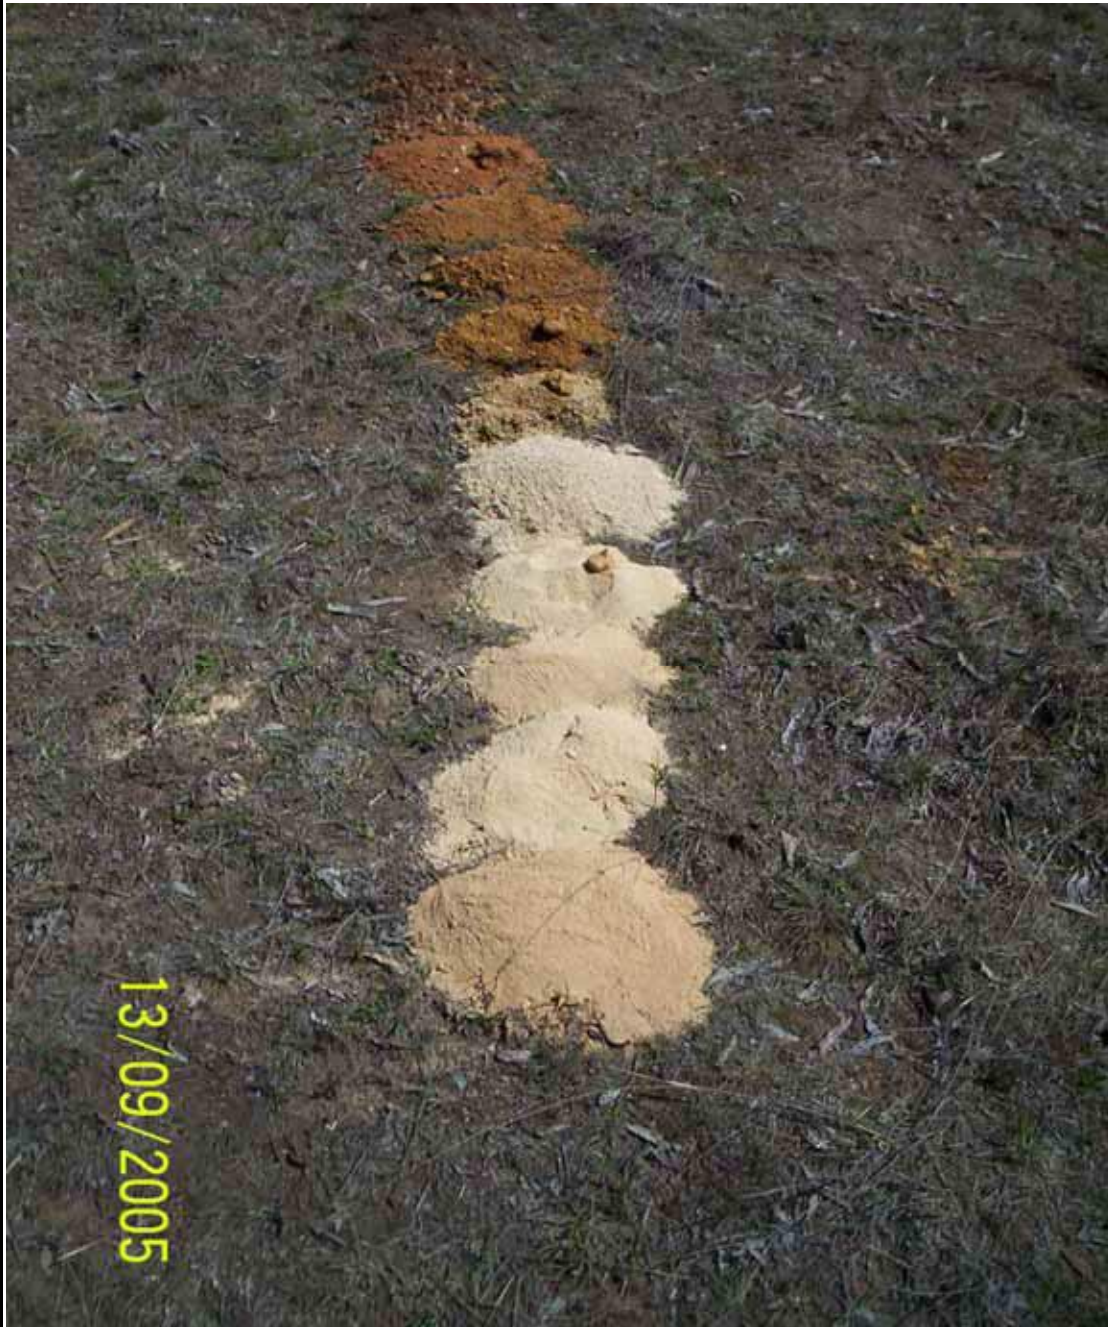
Client:	Maunsell Australia	Job No:	20969
Project:	Armidale Dumaresq Council Proposed Landfill	Date:	13-Sep-05
Location:	Waterfall Way	Logged by:	Robert Cork
Excavation Method:	Light Drill Rig	Bore Hole No:	BH 4
Groundwater Struck:	No	Groundwater Stands:	
Surface Slope/Aspect:	8% - 10% East	Current land use:	Grazing
Vegetation:	Open stringy bark woodland	Parent material:	Variable, some sediments and colluvium
Surface drainage:	Open slope with some surface rocks	Coordinates (GDA94):	383144 E, 6618879 N MGA Zone 56

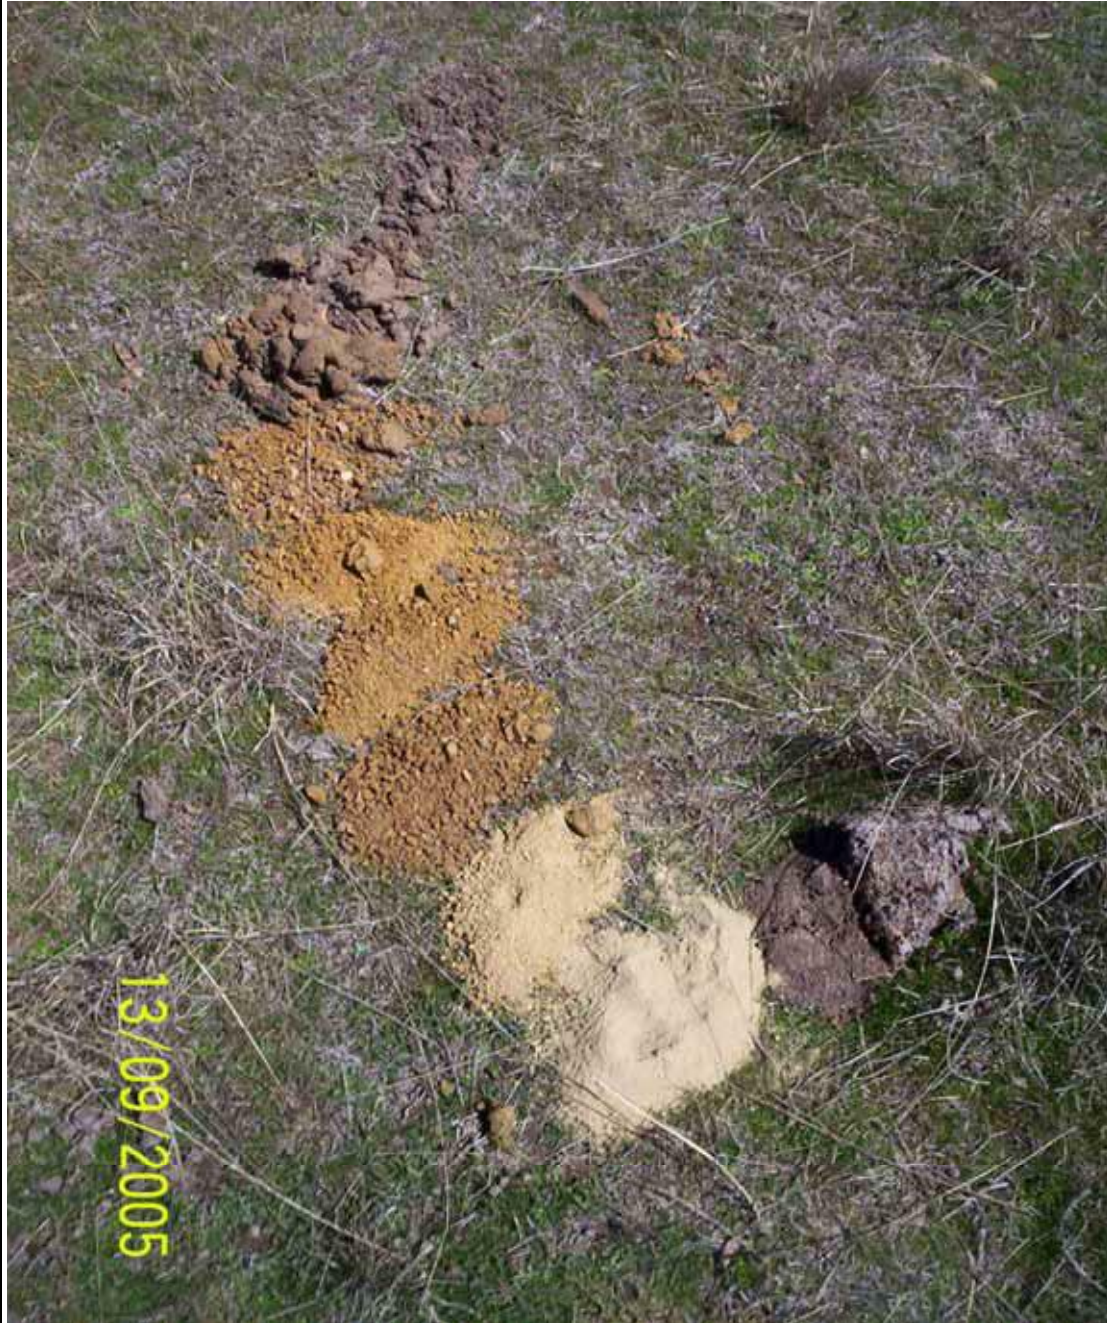
Client:	Maunsell Australia	Job No:	20969
Project:	Armidale Dumaresq Council Proposed Landfill	Date:	13-Sep-05
Location:	Waterfall Way	Logged by:	Robert Cork
Excavation Method:	Light Drill Rig	Bore Hole No:	BH 5
Groundwater Struck:	No	Groundwater Stands:	
Surface Slope/Aspect:	10% North northeast	Current land use:	Grazing
Vegetation:	Depression vegetation	Parent material:	Variable, some sediments and colluvium
Surface drainage:	Main drainage line about 50m below top dam	Coordinates (GDA94):	383389 E, 6619055 N MGA Zone 56

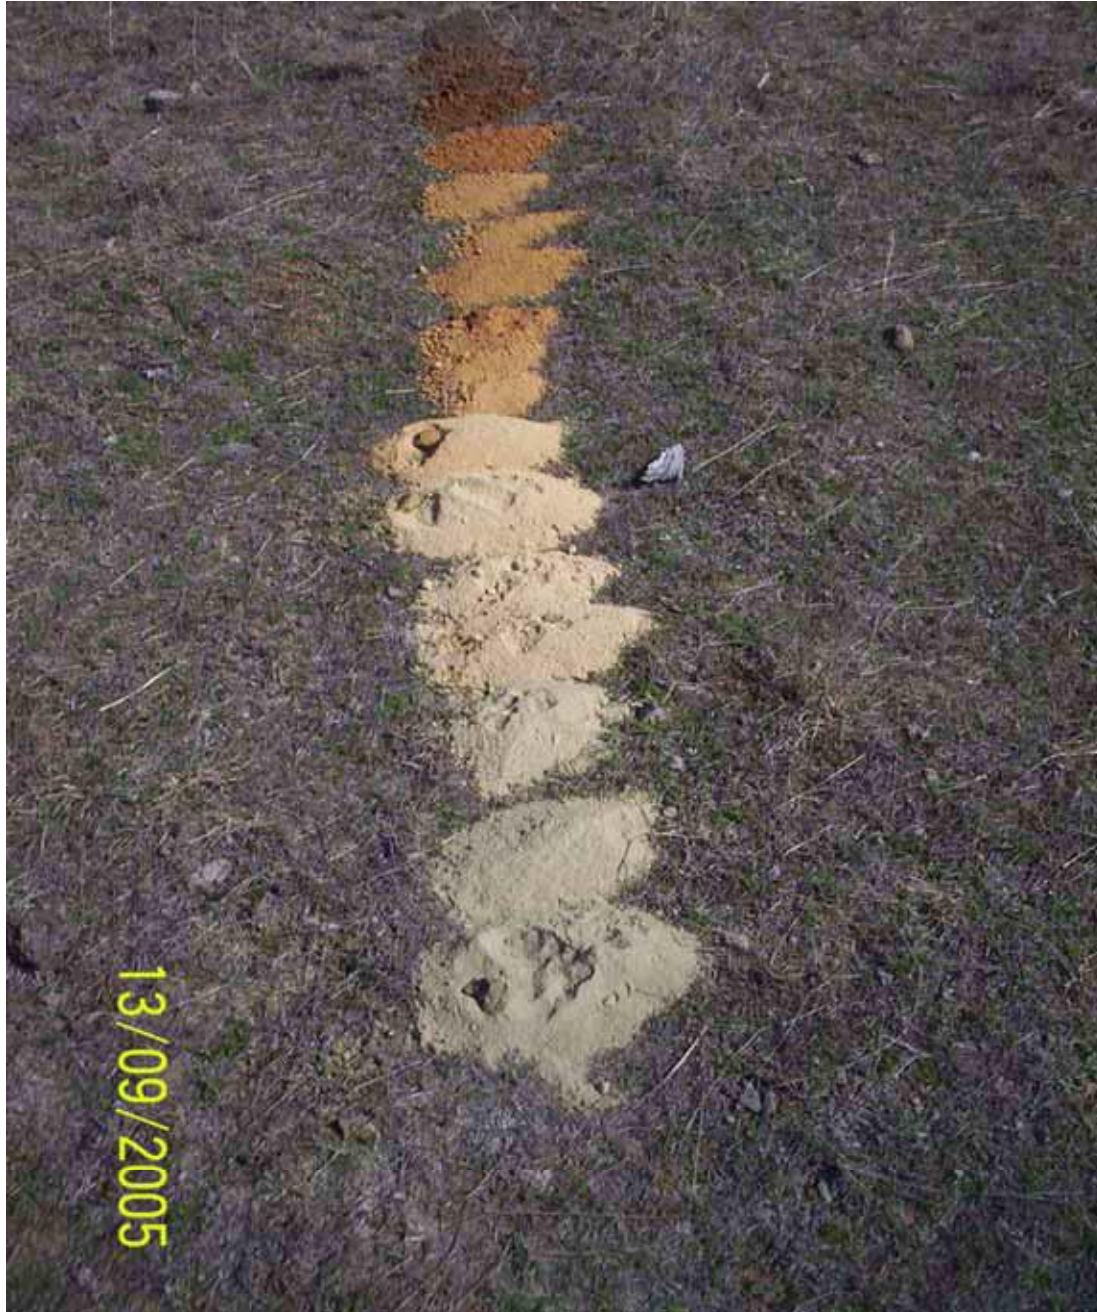
Client:	Maunsell Australia	Job No:	20969
Project:	Armidale Dumaresq Council Proposed Landfill	Date:	13-Sep-05
Location:	Waterfall Way	Logged by:	Robert Cork
Excavation Method:	Light Drill Rig	Bore Hole No:	6
Groundwater Struck:	No	Groundwater Stands:	
Surface Slope/Aspect:	1% - 2% Northeast	Current land use:	Grazing
Vegetation:	Open woodland	Parent material:	Variable, some sediments and colluvium
Surface drainage:	Drainage line approx. 100m above top dam	Coordinates (GDA94):	383353 E, 6618860 N MGA Zone 56

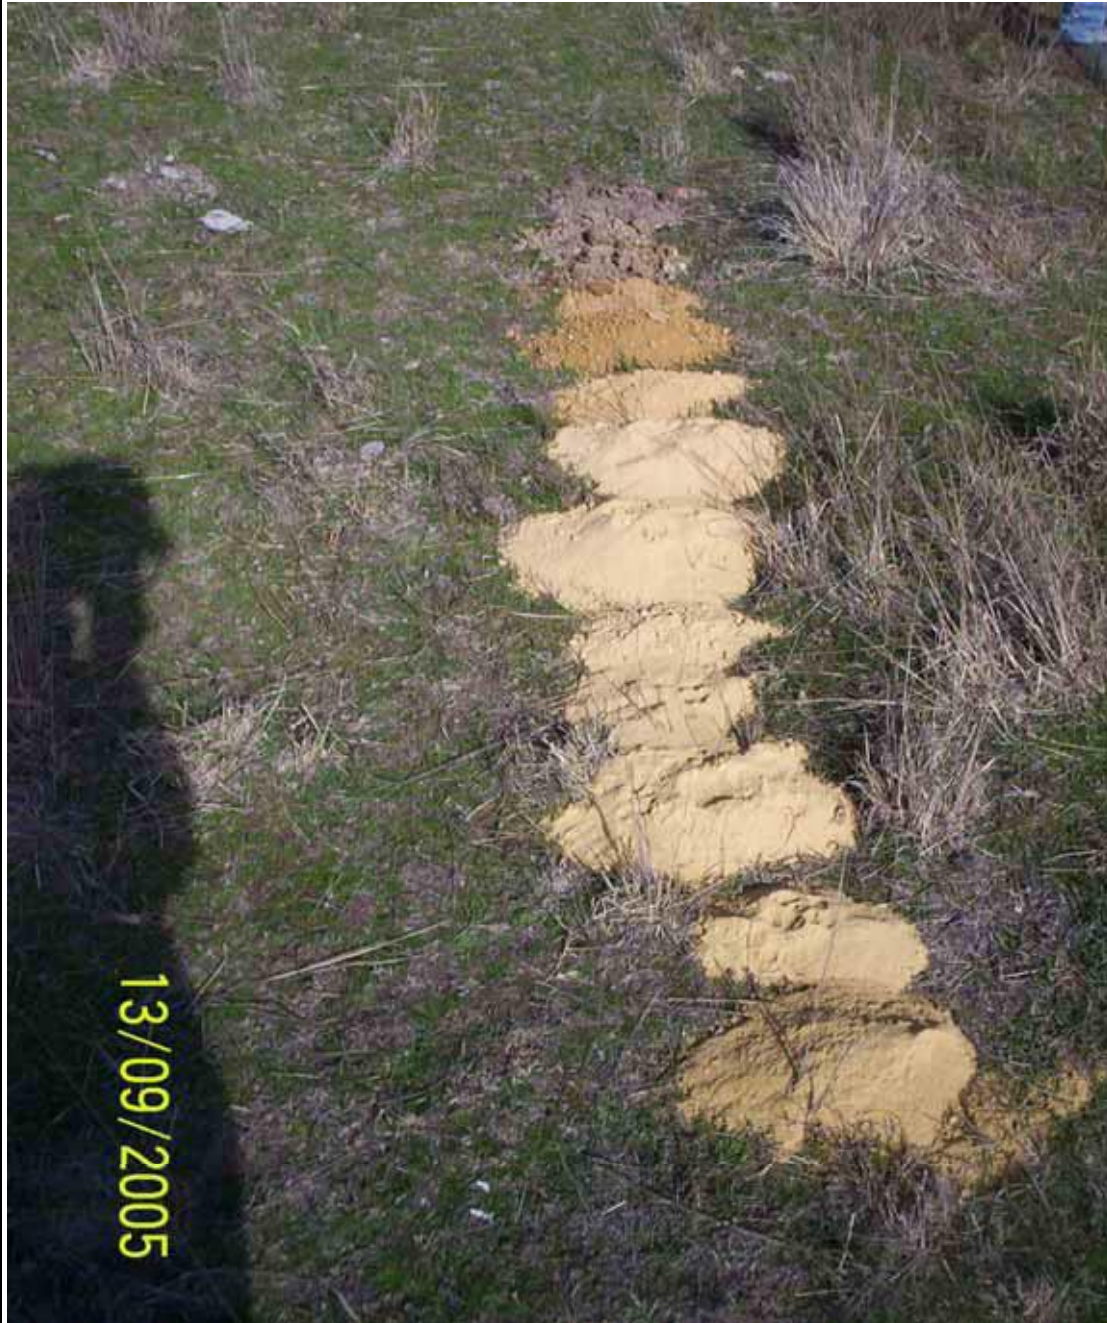
Client:	Maunsell Australia	Job No:	20969
Project:	Armidale Dumaresq Council Proposed Landfill	Date:	13-Sep-05
Location:	Waterfall Way	Logged by:	Robert Cork
Excavation Method:	Light Drill Rig	Bore Hole No:	7
Groundwater Struck:	No	Groundwater Stands:	
Surface Slope/Aspect:	0 - 1% Northeast	Current land use:	Grazing
Vegetation:	Pasture Sedges	Parent material:	Variable, some sediments and colluvium
Surface drainage:	Main drainage line approx. 50m below bottom of Dam	Coordinates (GDA94):	383511 E, 6619250 N MGA Zone 56

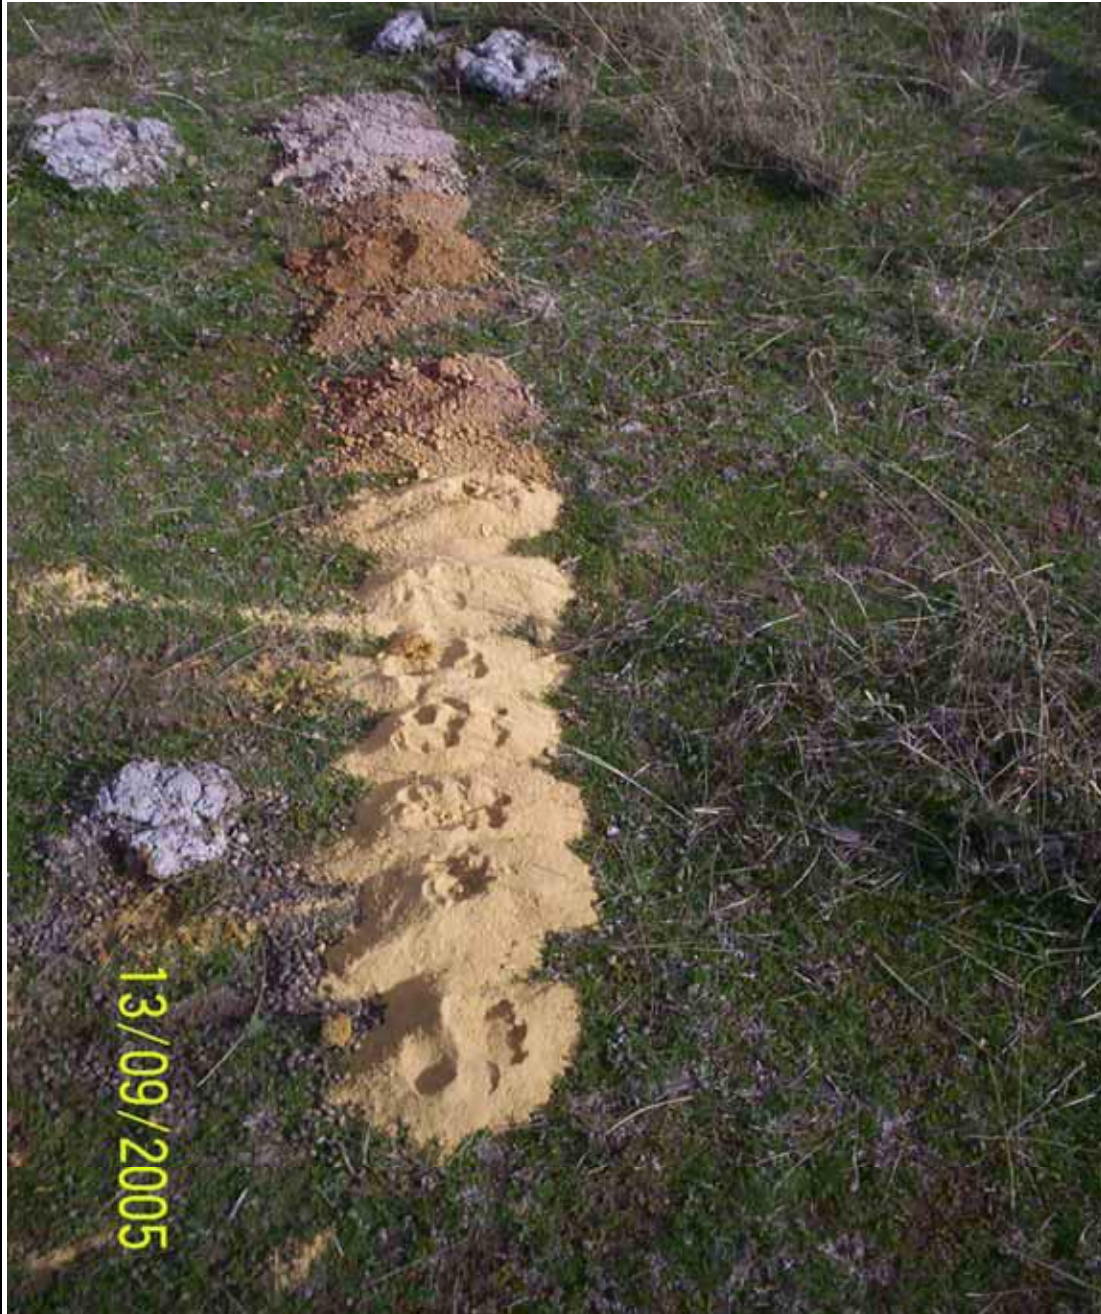
Client:	Maunsell Australia	Job No:	20969
Project:	Armidale Dumaresq Council Proposed Landfill	Date:	13-Sep-05
Location:	Waterfall Way	Logged by:	Robert Cork
Excavation Method:	Light Drill Rig	Bore Hole No:	8
Groundwater Struck:	No	Groundwater Stands:	
Surface Slope/Aspect:	1% - 2% North northeast	Current land use:	
Vegetation:		Parent material:	Variable, some sediments and colluvium
Surface drainage:	Drainage line is E of main line	Coordinates (GDA94):	383590 E, 6619247 N MGA Zone 56

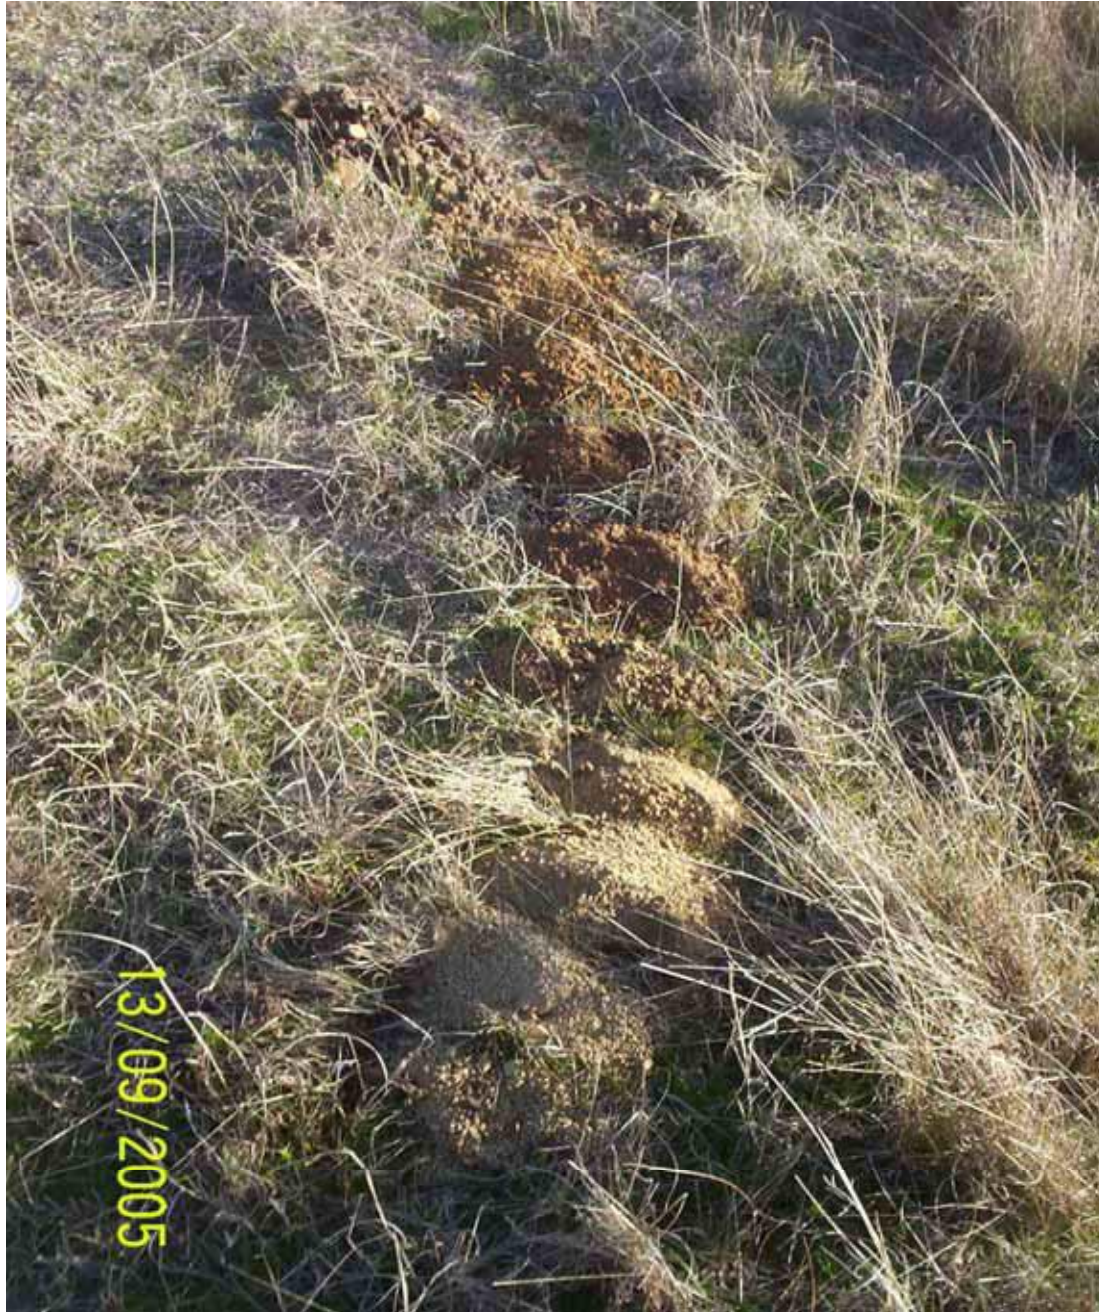
Client:	Maunsell Australia	Job No:	20969
Project:	Armidale Dumaresq Council Proposed Landfill	Date:	13-Sep-05
Location:	Waterfall Way	Logged by:	Robert Cork
Excavation Method:	Light Drill Rig	Bore Hole No:	9
Groundwater Struck:	No	Groundwater Stands:	
Surface Slope/Aspect:	1% North northeast	Current land use:	
Vegetation:		Parent material:	Variable, some sediments and colluvium
Surface drainage:	Drainage line is close to junction	Coordinates (GDA94):	383634 E, 6619435 N MGA Zone 56

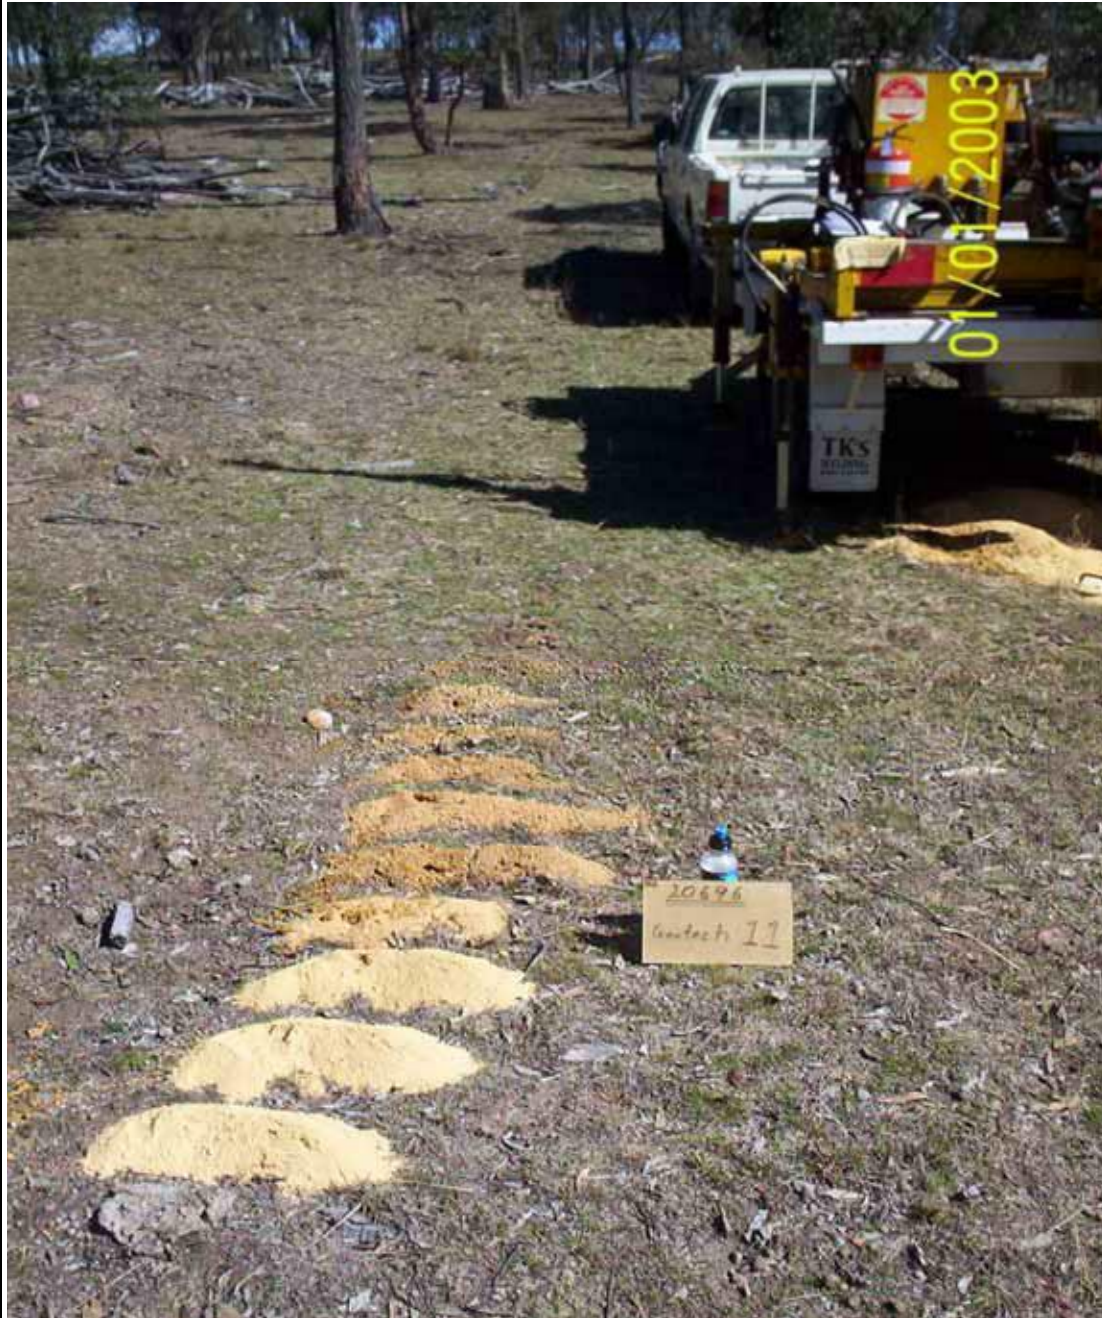
Client:	Maunsell Australia	Job No:	20969
Project:	Armidale Dumaresq Council Proposed Landfill	Date:	13-Sep-05
Location:	Waterfall Way	Logged by:	Robert Cork
Excavation Method:	Light Drill Rig	Bore Hole No:	11
Groundwater Struck:	No	Groundwater Stands:	
Surface Slope/Aspect:	15% Southeast	Current land use:	Grazing
Vegetation:	Cleared open stringy bark woodland	Parent material:	Variable, some sediments and colluvium
Surface drainage:	Slight drainage line - reasonable slope	Coordinates (GDA94):	383270 E, 6618977 N MGA Zone 56

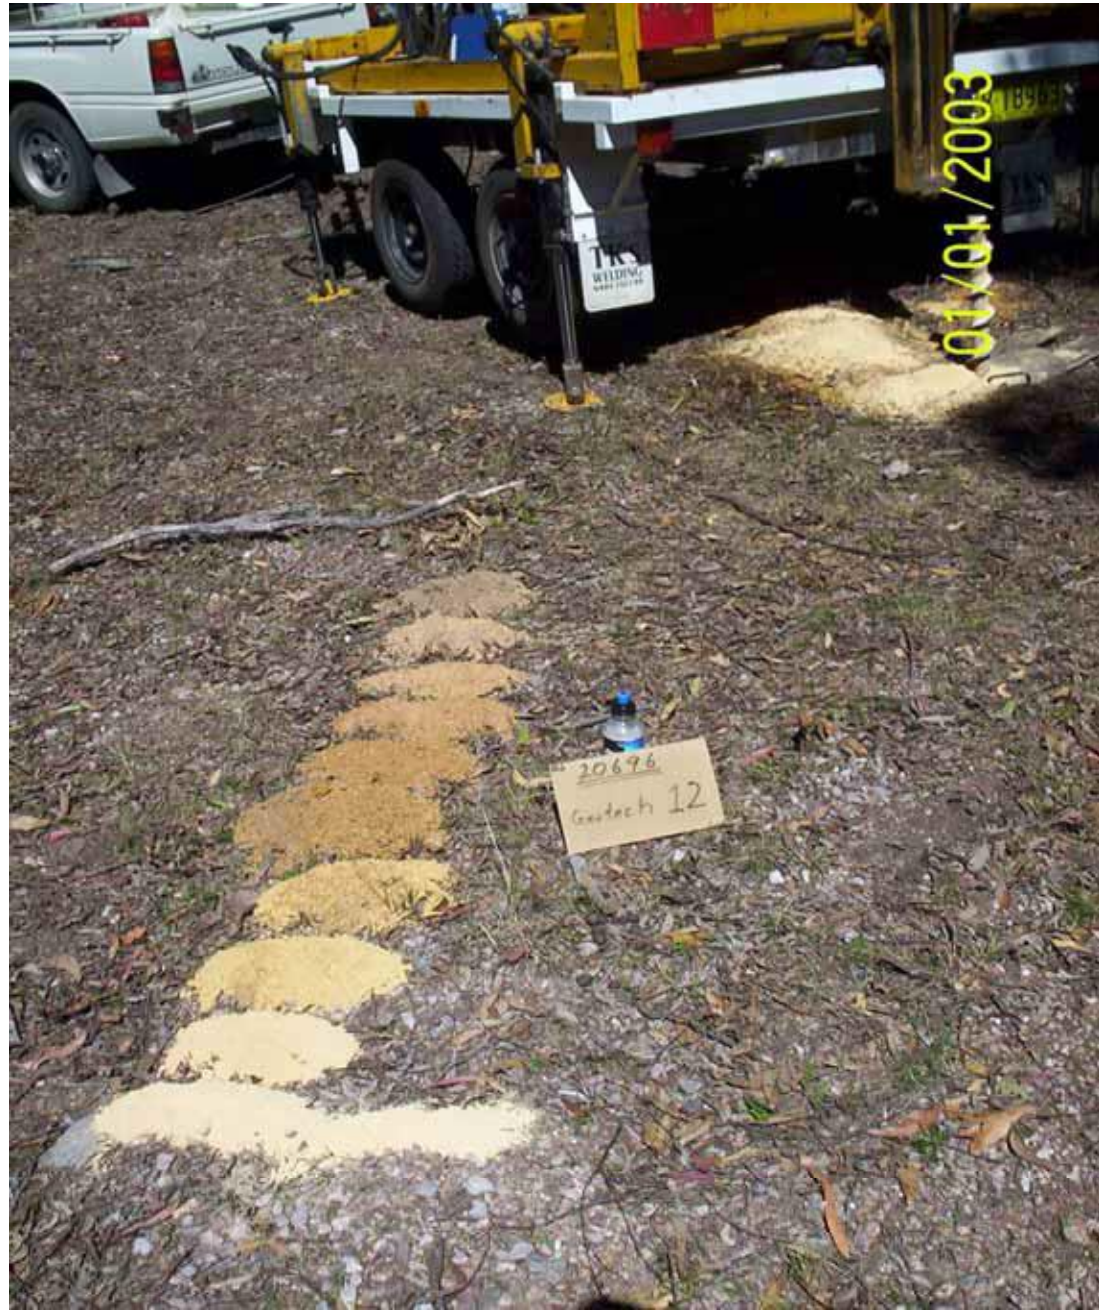
Client:	Maunsell Australia	Job No:	20969
Project:	Armidale Dumaresq Council Proposed Landfill	Date:	13-Sep-05
Location:	Waterfall Way	Logged by:	Robert Cork
Excavation Method:	Light Drill Rig	Bore Hole No:	12
Groundwater Struck:	No	Groundwater Stands:	
Surface Slope/Aspect:	15% Southeast	Current land use:	Grazing
Vegetation:	Cleared stringy bark woodland	Parent material:	Variable, some sediments and colluvium
Surface drainage:	Ridge down slope	Coordinates (GDA94):	383228 E, 6618769 N MGA Zone 56

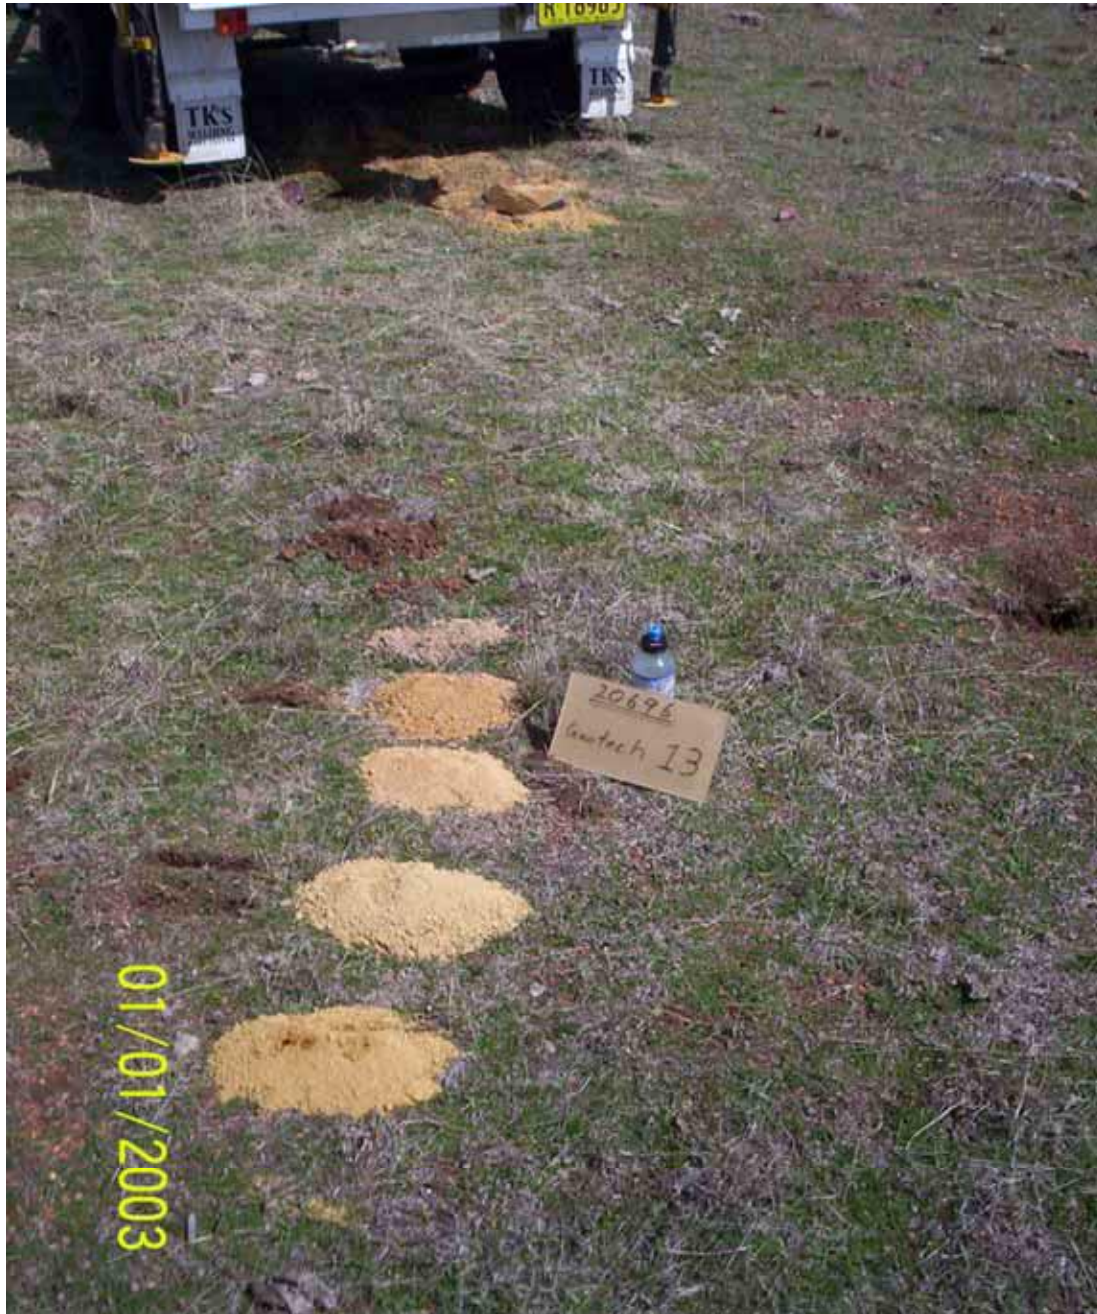
Client:	Maunsell Australia	Job No:	20969
Project:	Armistale Dumaresq Council Proposed Landfill	Date:	13-Sep-05
Location:	Waterfall Way	Logged by:	Robert Cork
Excavation Method:	Light Drill Rig	Bore Hole No:	13
Groundwater Struck:	No	Groundwater Stands:	
Surface Slope/Aspect:	3% Southeast	Current land use:	Grazing
Vegetation:	Light grass	Parent material:	Variable, some sediments and colluvium
Surface drainage:	Top of Ridge	Coordinates (GDA94):	383126 E, 6618687 N MGA Zone 56

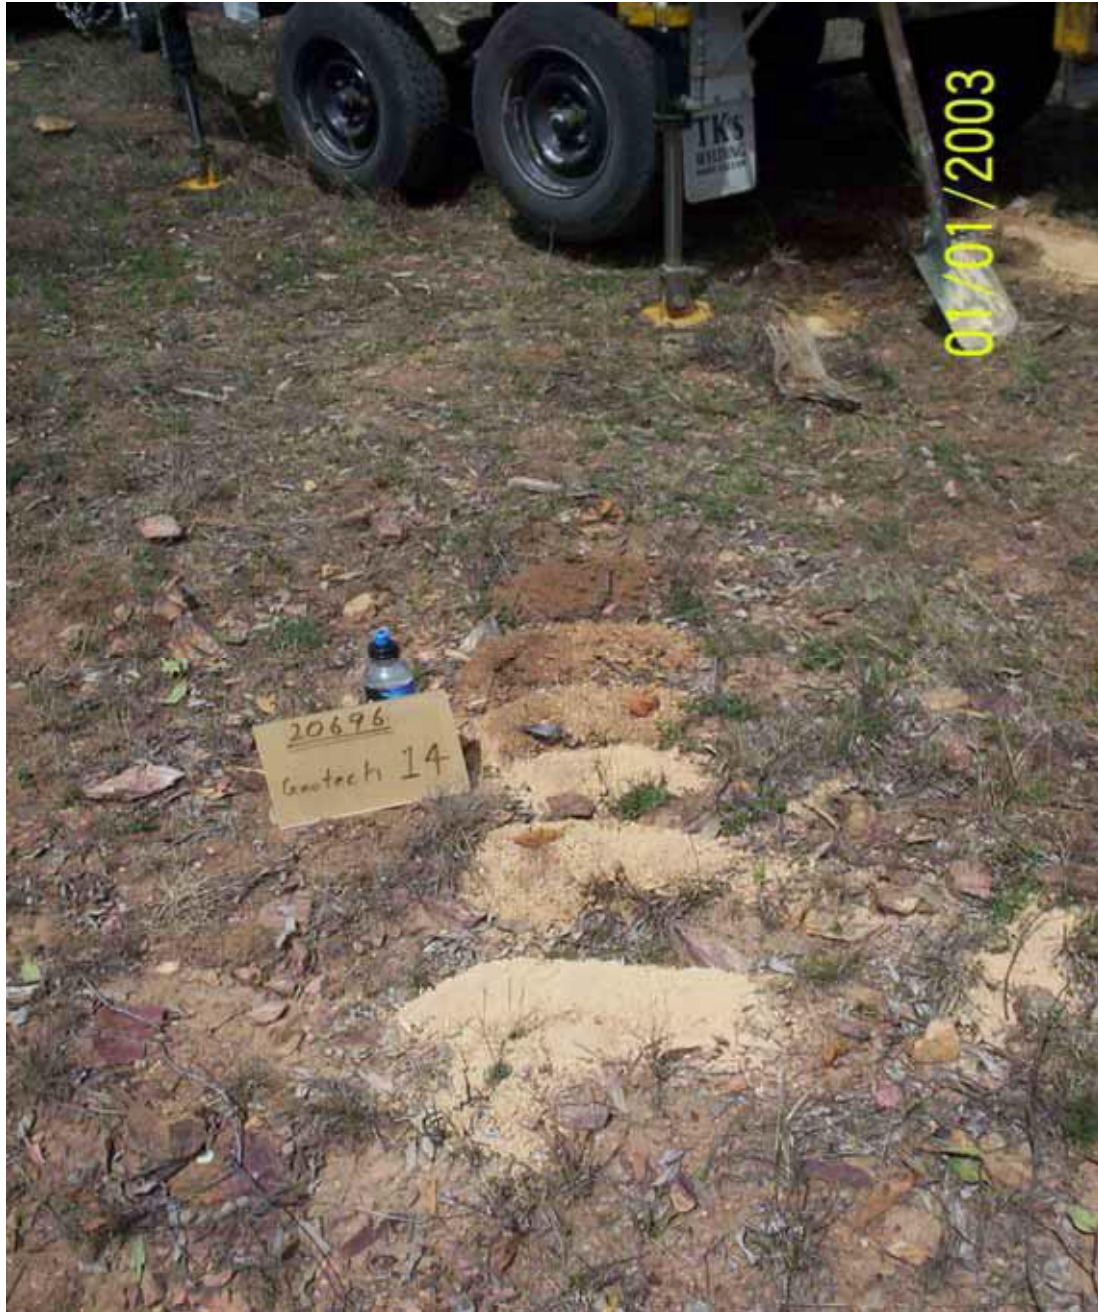
Client:	Maunsell Australia	Job No:	20969
Project:	Armistale Dumaresq Council Proposed Landfill	Date:	13-Sep-05
Location:	Waterfall Way	Logged by:	Robert Cork
Excavation Method:	Light Drill Rig	Bore Hole No:	14
Groundwater Struck:	No	Groundwater Stands:	
Surface Slope/Aspect:	15% Southeast	Current land use:	Grazing
Vegetation:	Semi cleared Stringy Bark	Parent material:	Variable, some sediments and colluvium
Surface drainage:		Coordinates (GDA94):	383535 E, 6618839 N MGA Zone 56

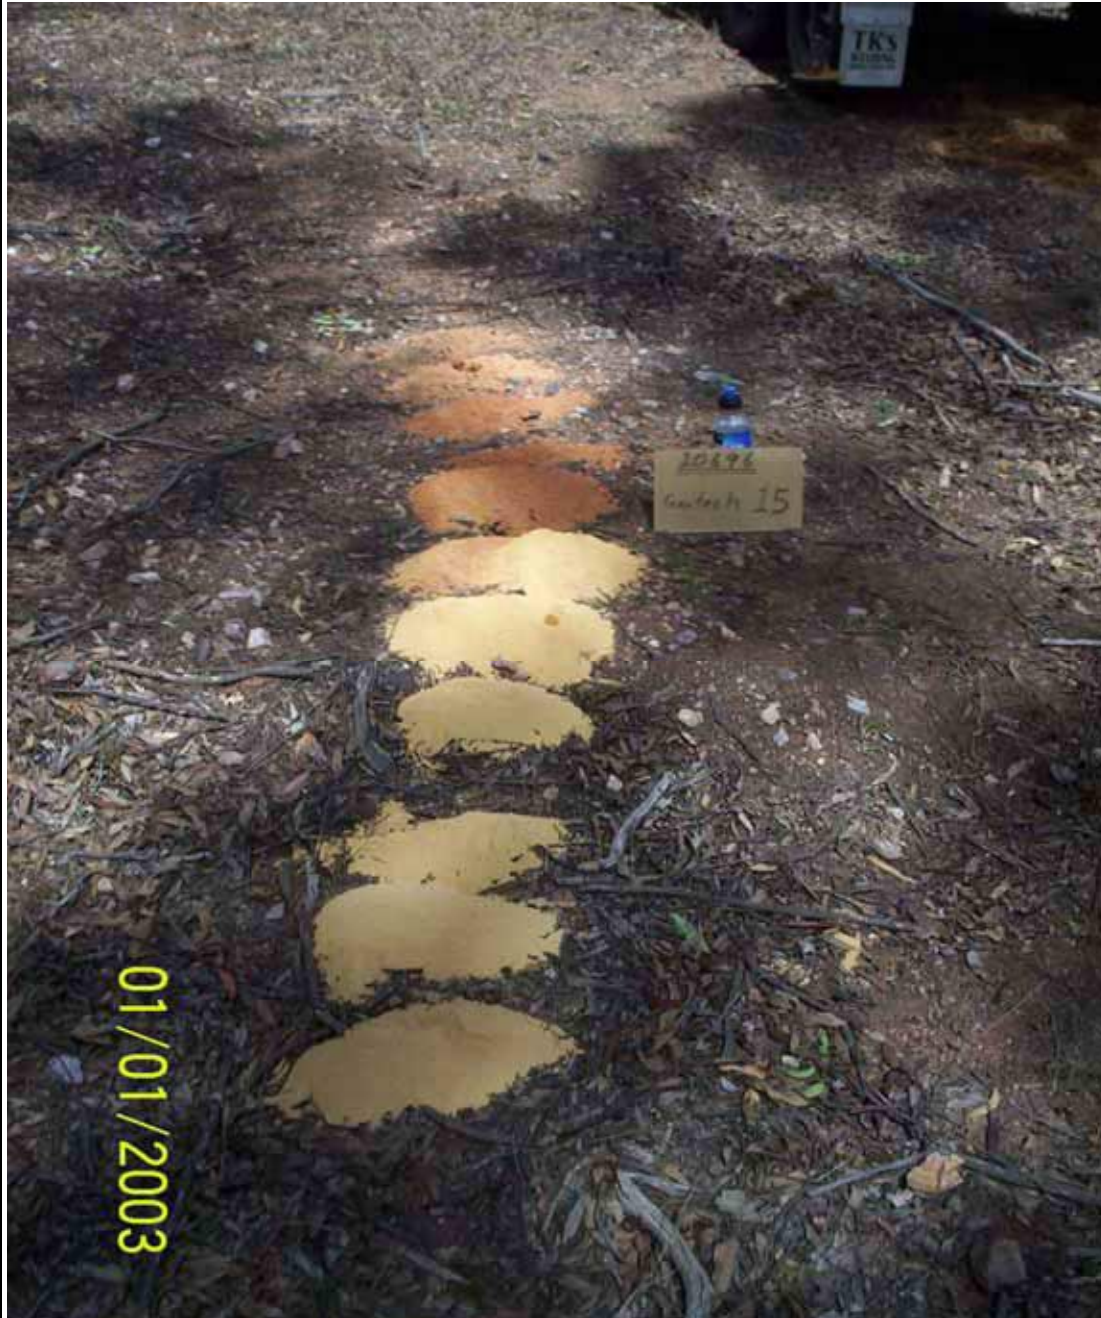
Client:	Maunsell Australia	Job No:	20969
Project:	Armidale Dumaresq Council Proposed Landfill	Date:	13-Sep-05
Location:	Waterfall Way	Logged by:	Robert Cork
Excavation Method:	Light Drill Rig	Bore Hole No:	15
Groundwater Struck:	No	Groundwater Stands:	
Surface Slope/Aspect:	8% Southeast	Current land use:	Grazing
Vegetation:	Semi cleared Stringy bark	Parent material:	Variable, some sediments and colluvium
Surface drainage:		Coordinates (GDA94):	383428 E, 6618747 N MGA Zone 56
