6. Appendices

Appendix A. Geotechnical Soil Profile Logs – Bore Holes

Client: Maunsell Australia		Job No: 20969	
Project: Armidale Dumaresq Council Proposed Landfill		Date: 13-Sep-05	
Location: Waterfall Way		Logged by: Robert Cork	
Excavation Method: Light Drill Rig		Bore Hole No: BH1	
Groundwater Struck: No		Groundwater Stands:	
Surface slope: 2%		Current land use: Grazing	
Vegetation: Grazed pasture and sedge		Parent material:	
Surface drainage: Toe of slope		Aspect: Northwest

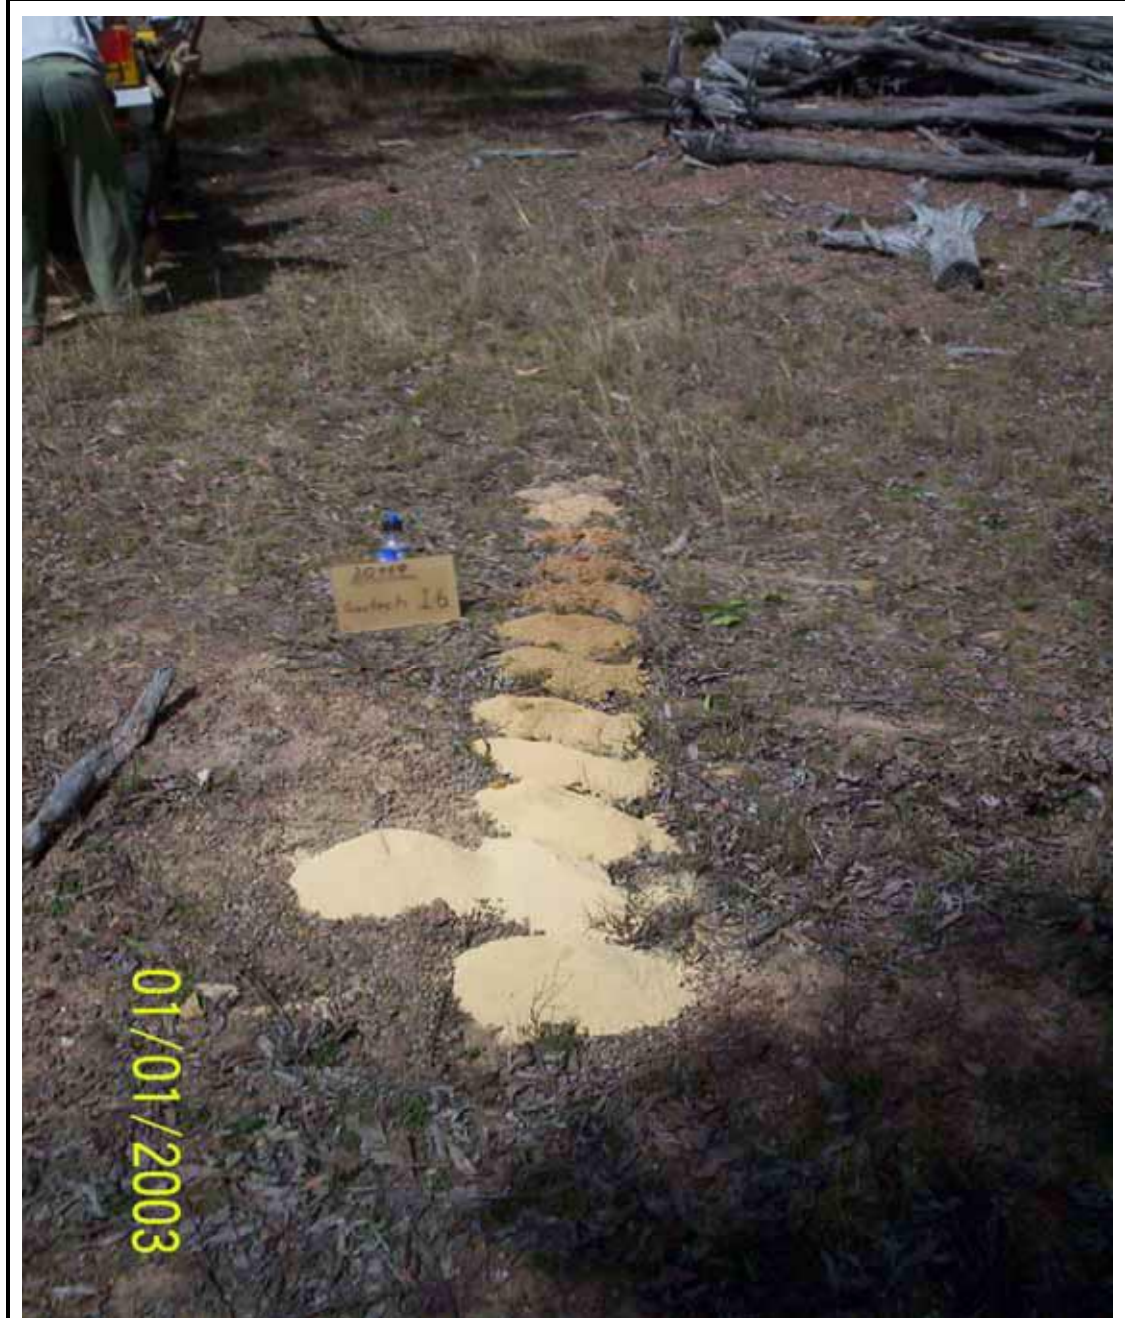
Client:	Maunsell Australia	Job No:	20969
Project:	Armidale Dumaresq Council Proposed Landfill	Date:	13-Sep-05
Location:	Waterfall Way	Logged by:	Robert Cork
Excavation Method:	Light Drill Rig	Bore Hole No:	16
Groundwater Struck:	No	Groundwater Stands:	
Surface Slope/Aspect:	5% West southwest	Current land use:	Grazing
Vegetation:	Semi cleared Stringy bark	Parent material:	Variable, some sediments and colluvium
Surface drainage:		Coordinates (GDA94):	383469 E, 6618953 N MGA Zone 56

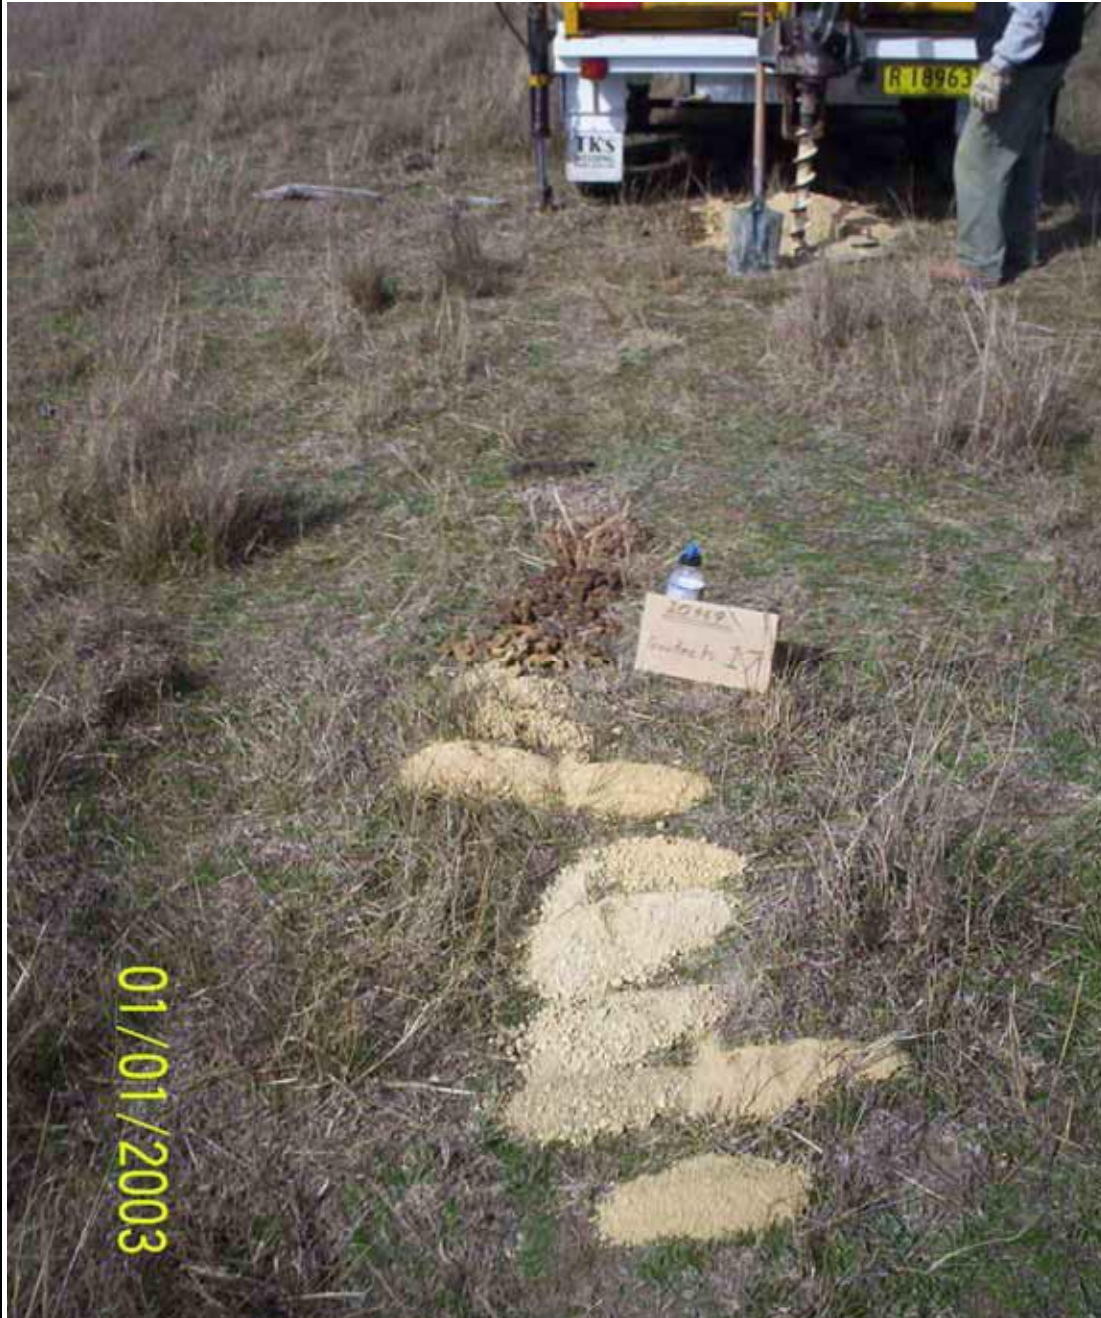
Client:	Maunsell Australia	Job No:	20969
Project:	Armidale Dumaresq Council Proposed Landfill	Date:	13-Sep-05
Location:	Waterfall Way	Logged by:	Robert Cork
Excavation Method:	Light Drill Rig	Bore Hole No:	17
Groundwater Struck:	No	Groundwater Stands:	
Surface Slope/Aspect:	2% West southwest	Current land use:	Grazing
Vegetation:	Grass	Parent material:	Variable, some sediments and colluvium
Surface drainage:	Toe of slope	Coordinates (GDA94):	383590 E, 6619122 N MGA Zone 56

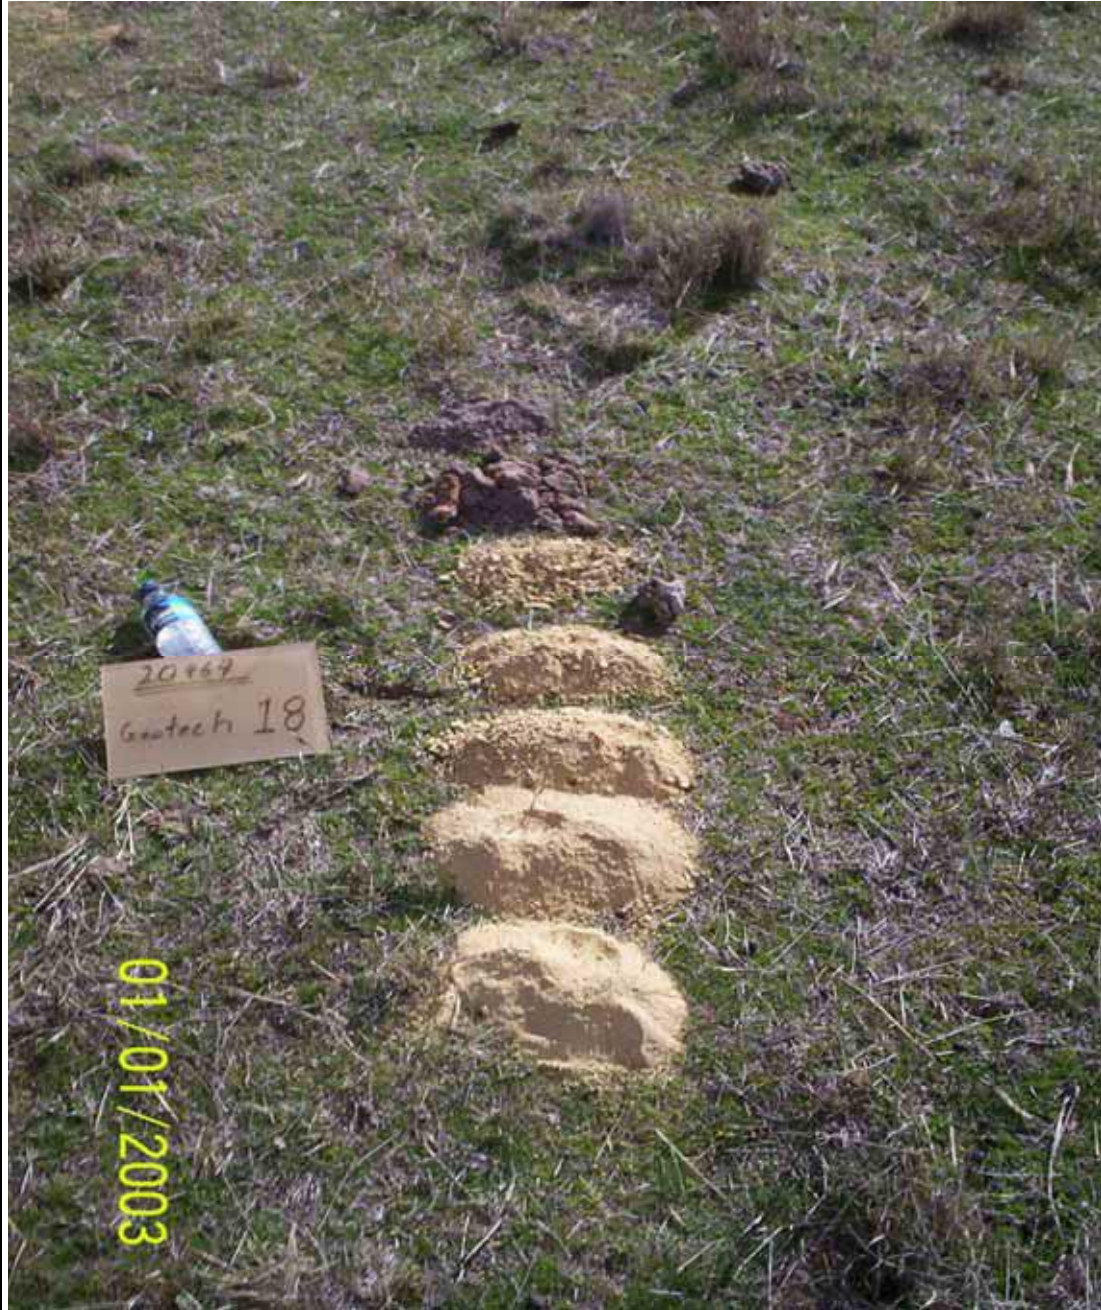
Client:	Maunsell Australia	Job No:	20969
Project:	Armidale Dumaresq Council Proposed Landfill	Date:	13-Sep-05
Location:	Waterfall Way	Logged by:	Robert Cork
Excavation Method:	Light Drill Rig	Bore Hole No:	18
Groundwater Struck:	No	Groundwater Stands:	
Surface Slope/Aspect:	2% East	Current land use:	Grazing
Vegetation:	Grass	Parent material:	Variable, some sediments and colluvium
Surface drainage:	Flat	Coordinates (GDA94):	383431 E, 6619449 N MGA Zone 56

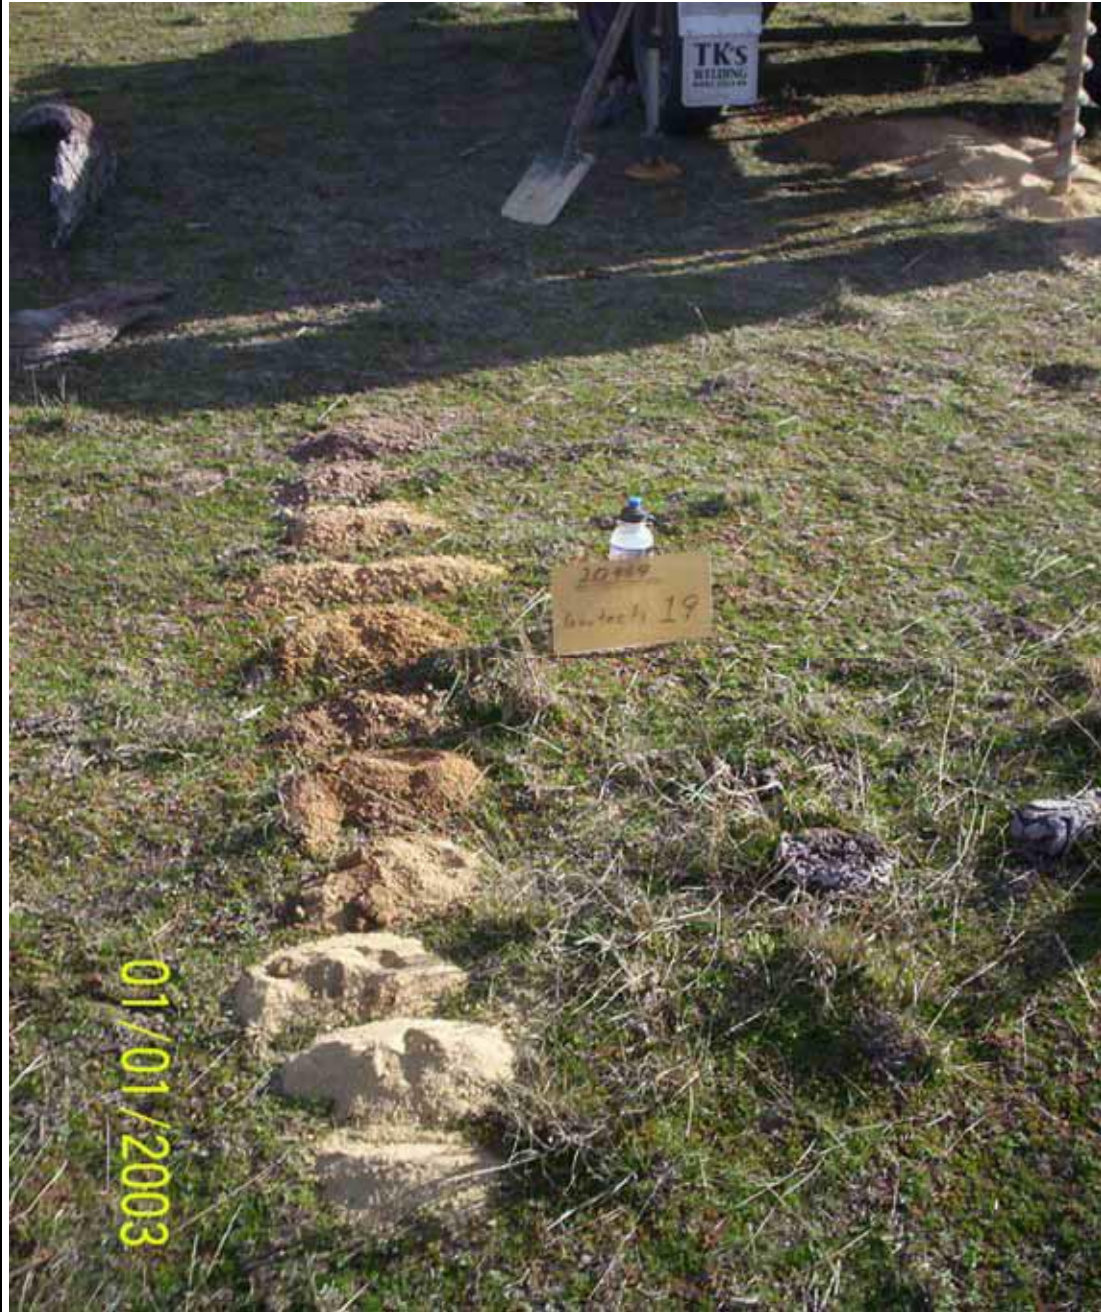
Client:	Maunsell Australia	Job No:	20969
Project:	Armidale Dumaresq Council Proposed Landfill	Date:	13-Sep-05
Location:	Waterfall Way	Logged by:	Robert Cork
Excavation Method:	Light Drill Rig	Bore Hole No:	19
Groundwater Struck:	No	Groundwater Stands:	
Surface Slope/Aspect:	2% South	Current land use:	Grazing
Vegetation:	Grass	Parent material:	Variable, some sediments and colluvium
Surface drainage:		Coordinates (GDA94):	383462 E, 6619652 N MGA Zone 56

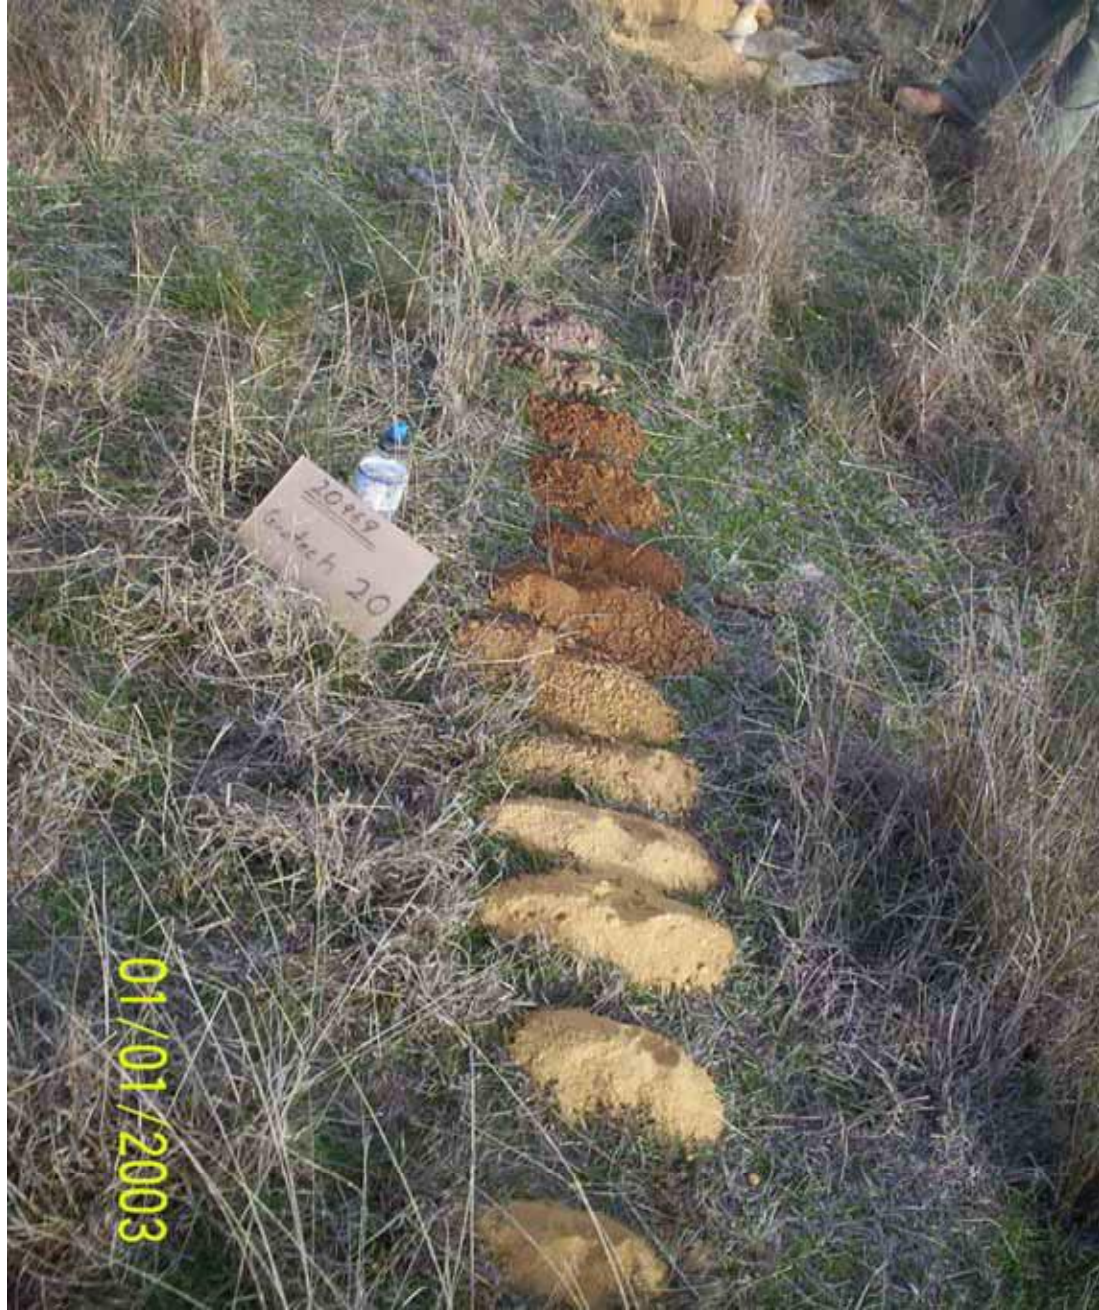
Client:	Maunsell Australia	Job No:	20969
Project:	Armidale Dumaresq Council Proposed Landfill	Date:	13-Sep-05
Location:	Waterfall Way	Logged by:	Robert Cork
Excavation Method:	Light Drill Rig	Bore Hole No:	20
Groundwater Struck:	No	Groundwater Stands:	
Surface Slope/Aspect:	2% South	Current land use:	Grazing
Vegetation:	Grass	Parent material:	Vazriable, some sediments and colluvium
Surface drainage:		Coordinates (GDA94):	383491 E, 6619152 N MGA Zone 56

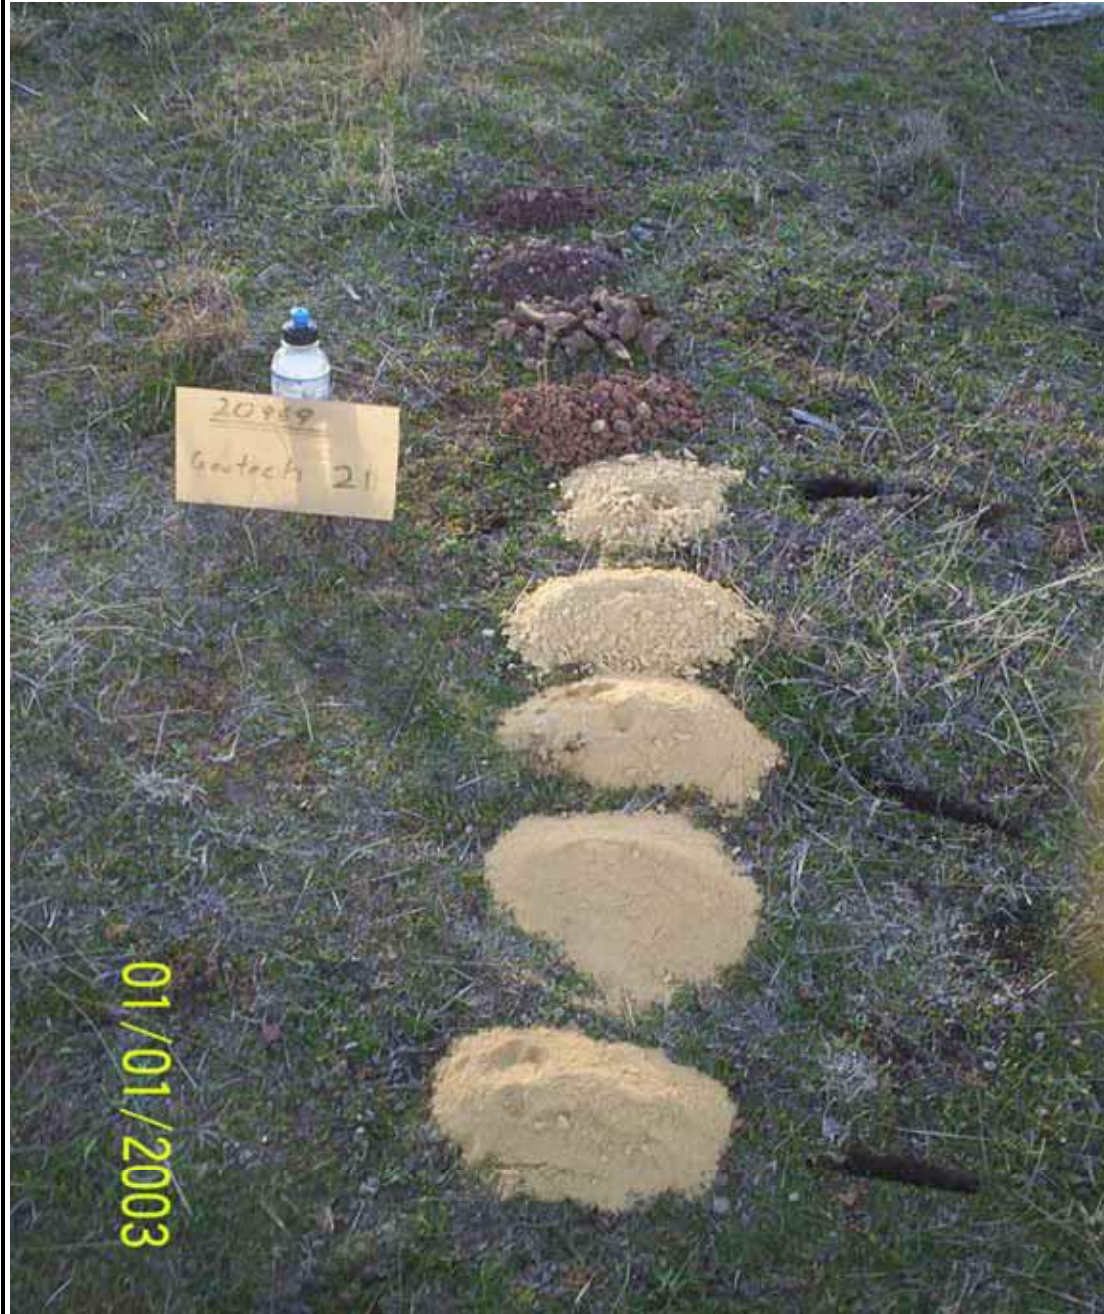
Client:	Maunsell Australia	Job No:	20969
Project:	Armidale Dumaresq Council Proposed Landfill	Date:	13-Sep-05
Location:	Waterfall Way	Logged by:	Robert Cork
Excavation Method:	Light Drill Rig	Bore Hole No:	21
Groundwater Struck:	No	Groundwater Stands:	
Surface Slope/Aspect:	4% South southeast	Current land use:	Grazing
Vegetation:	Grass	Parent material:	Variable, some sediments and colluvium
Surface drainage:		Coordinates (GDA94):	383391 E, 6619167 N MGA Zone 56

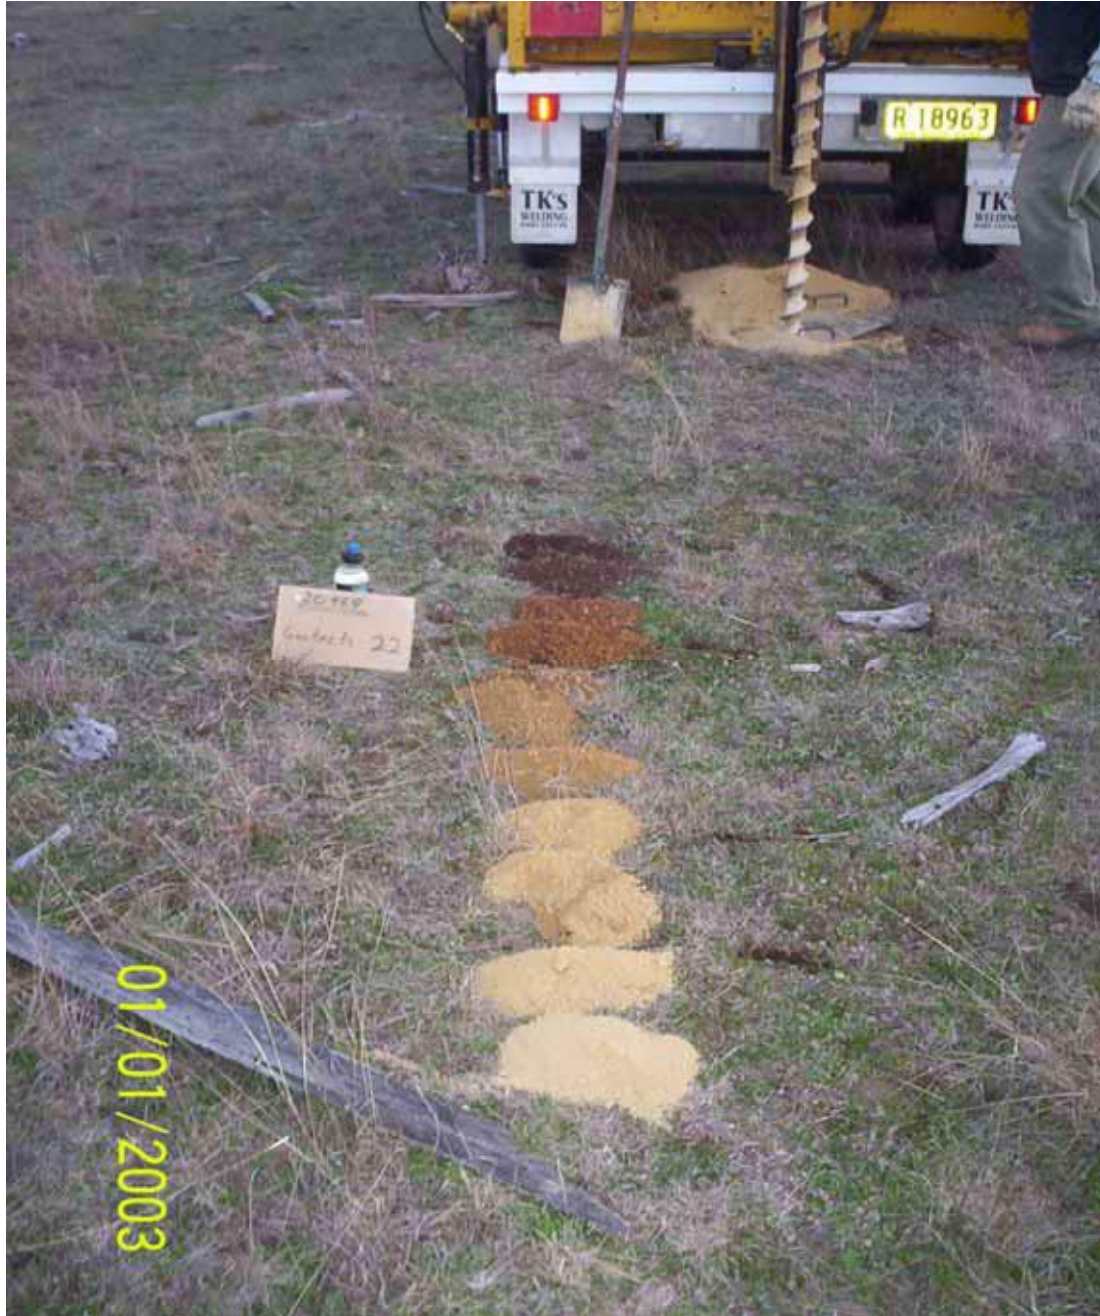
Client:	Maunsell Australia	Job No:	20969
Project:	Armidale Dumaresq Council Proposed Landfill	Date:	13-Sep-05
Location:	Waterfall Way	Logged by:	Robert Cork
Excavation Method:	Light Drill Rig	Bore Hole No:	22
Groundwater Struck:	No	Groundwater Stands:	
Surface Slope/Aspect:	5% South	Current land use:	Grazing
Vegetation:	Grass	Parent material:	Variable, some sediments and colluvium
Surface drainage:		Coordinates (GDA94):	383503 E, 6619065 N MGA Zone 56
