Appendix B. Geotechnical Soil Profile Logs – Backhoe Test Pits

Geotechnical Soil Profile Log

Client: Maunsell Australia		Job No: 20969	
Project: ADC Proposed Landfill		Date: 13-Sep-06	
Location: Waterfall Way		Logged by: Robert Cork	
Excavation Method: Backhoe		Bore Hole No: Test pit 1	
Groundwater Struck: No		Groundwater Stands:	
Surface slope: 1%		Current land use: Grazing pastures	
Vegetation:		Parent material:	
Surface drainage: 20-40m above drainage line on slight drainage		Coordinates (GDA 1994): 383405 E, 6619103 N MGA Zone 56

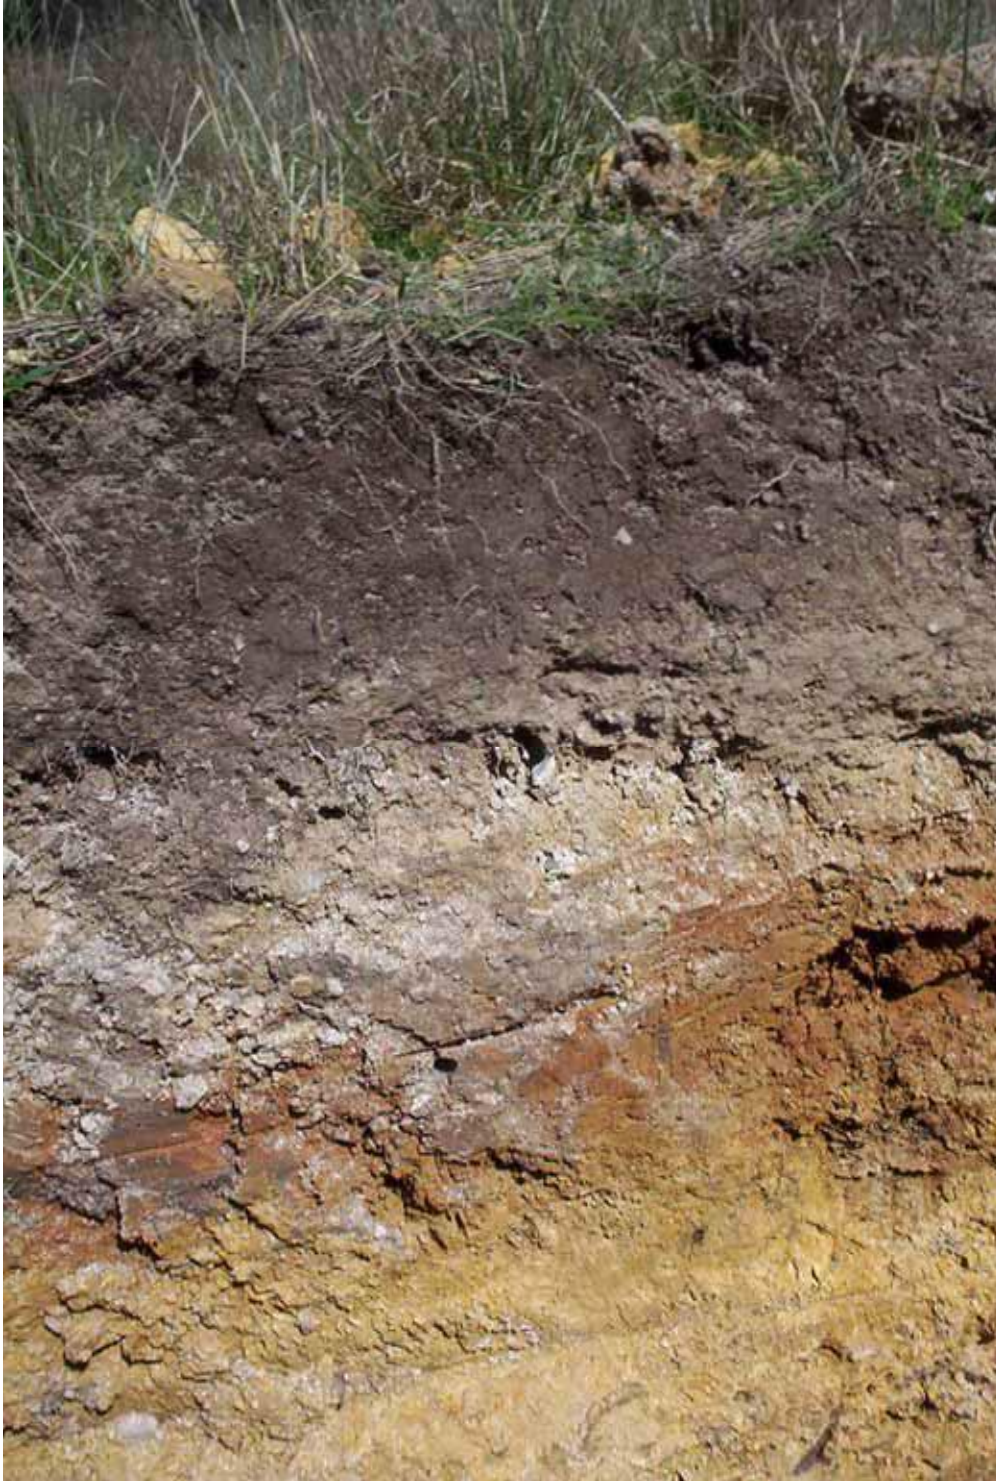
Depth (metres)	Soil Description	Sample No.	Group Symbol - AS 1726	Moisture Content	Consistency	Plasticity
	0.0-0.20 Topsoil: dark brown loam		SC-CI	D	Non-cohesive	
	0.20-0.35 Bleach A2 horizon; sandy clay with gravel up to 10mm (sub-rounded)		CI	D	F-St	
	0.35-0.55 Heavy clay, mottles present and roots		CI-CH	D	F-St	
	0.55-0.85 Gravelley clay (gravel seam - sub-rounded,)	155345	GC	D	St	M
	0.85-1.20 Extremely weathered rock		-	D	-	-
	1.20 Refusal

Client:	Maunsell Australia	Job No:	20969
Project:	ADC Proposed Landfill	Date:	13-Sep-06
Location:	Waterfall Way	Logged by:	Robert Cork
Excavation Method:	Backhoe	Bore Hole No:	Test pit 1
Groundwater Struck:	No	Groundwater Stands:	
Surface slope:	1%	Current land use:	Grazing pastures
Vegetation:		Parent material:	
Surface drainage:	20-40m above drainage line on slight drainage	Coordinates (GDA 1994):	383405 E, 6619103 N MGA Zone 56

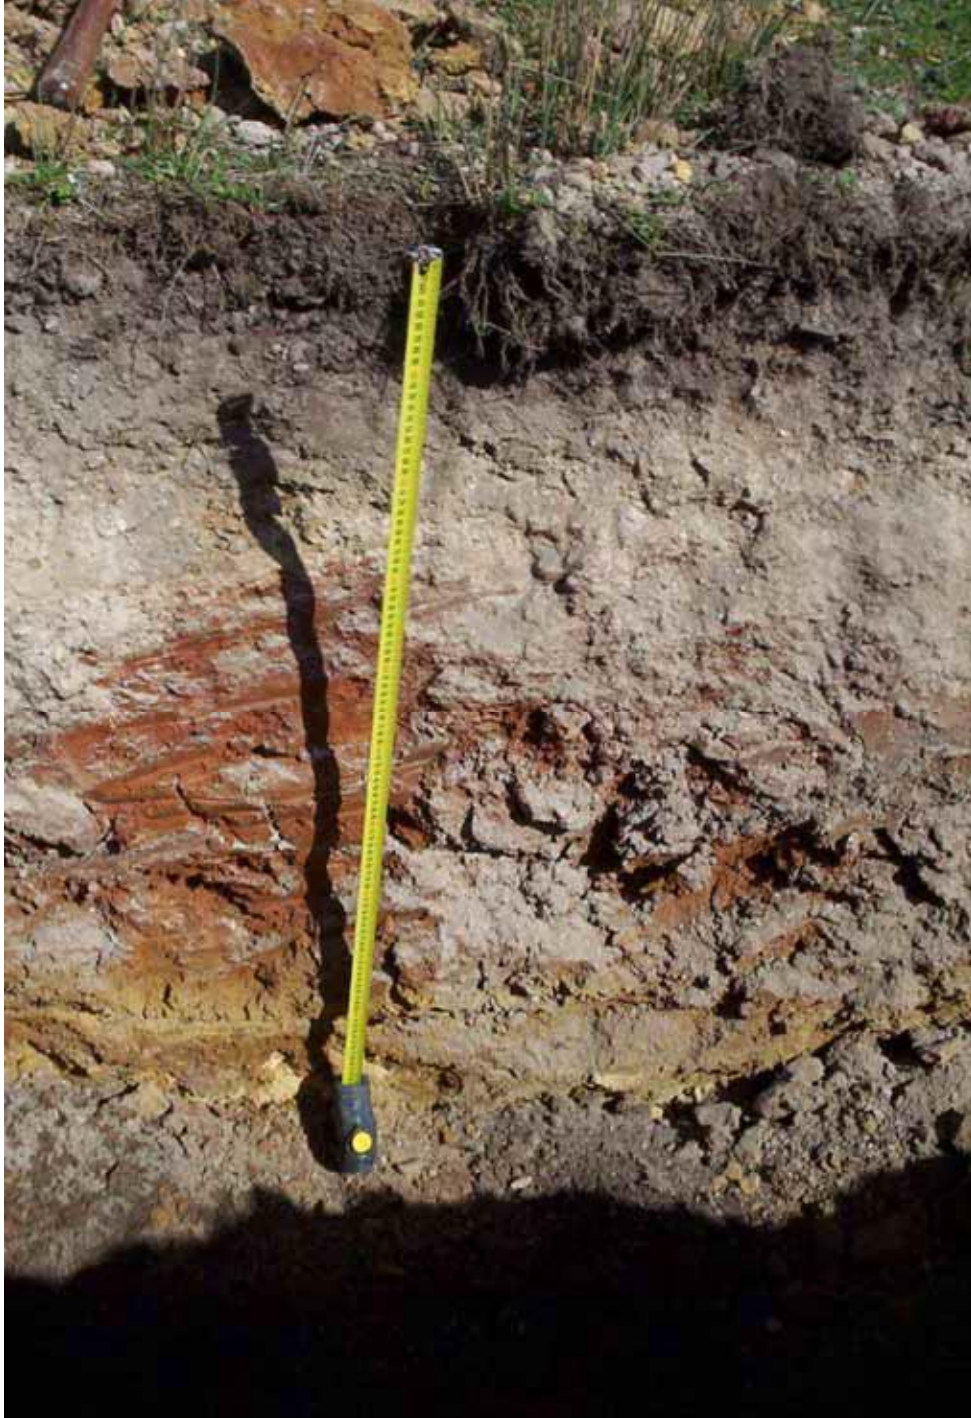
0.00-0.20 Dark grey brown topsoil, fine sandy loam, some gravel deposited on surface		SC-CI	D	Non-cohesive	-	
	0.20-0.30 Grey white clay with gravel (<5mm)		CI-CL	D	St

0.30-0.90 Orange red heavy clay	155346	CH	D	St-VSt		
1							
2	0.90-1.20 Orange silty clay, high plasticity	155346	CH	D	St-VSt		
	1.20 Refusal						
Moisture Content		Weather Rock Classification Symbols		Consistency/Density			
D	Dry	EW	Extremely Weathered	VL	Very Loose	VS	Very soft
M	Moist	HW	Highly Weathered	L	Loose	S	Sort
W	Wet	MW	Moderately Weathered	M	Medium	F	Firm
		SW	Slightly Weathered	D	Dense	St	Stiff
		F	Fresh	VD	Very Dense	VSt	Very stiff
						H	G+Hard
Plasticity		Plans/Remarks:					
NP	Non-plastic						
T	Trace						
VL	Very Low						
L	Low						
M	Medium						
H	High						
VH	Very High						
EH	Extra High

Client:	Maunsell Australia	Job No:	20969
Project:	ADC Proposed Landfill	Date:	13-Sep-06
Location:	Waterfall Way	Logged by:	Robert Cork
Excavation Method:	Backhoe	Bore Hole No:	Test pit 2
Groundwater Struck:	No	Groundwater Stands:	
Surface slope:	On knoll	Current land use:	Grazing pastures
Vegetation:		Parent material:	
Surface drainage:		Coordinates (GDA 1994):	383225 E, 6619121 N MGA Zone 56

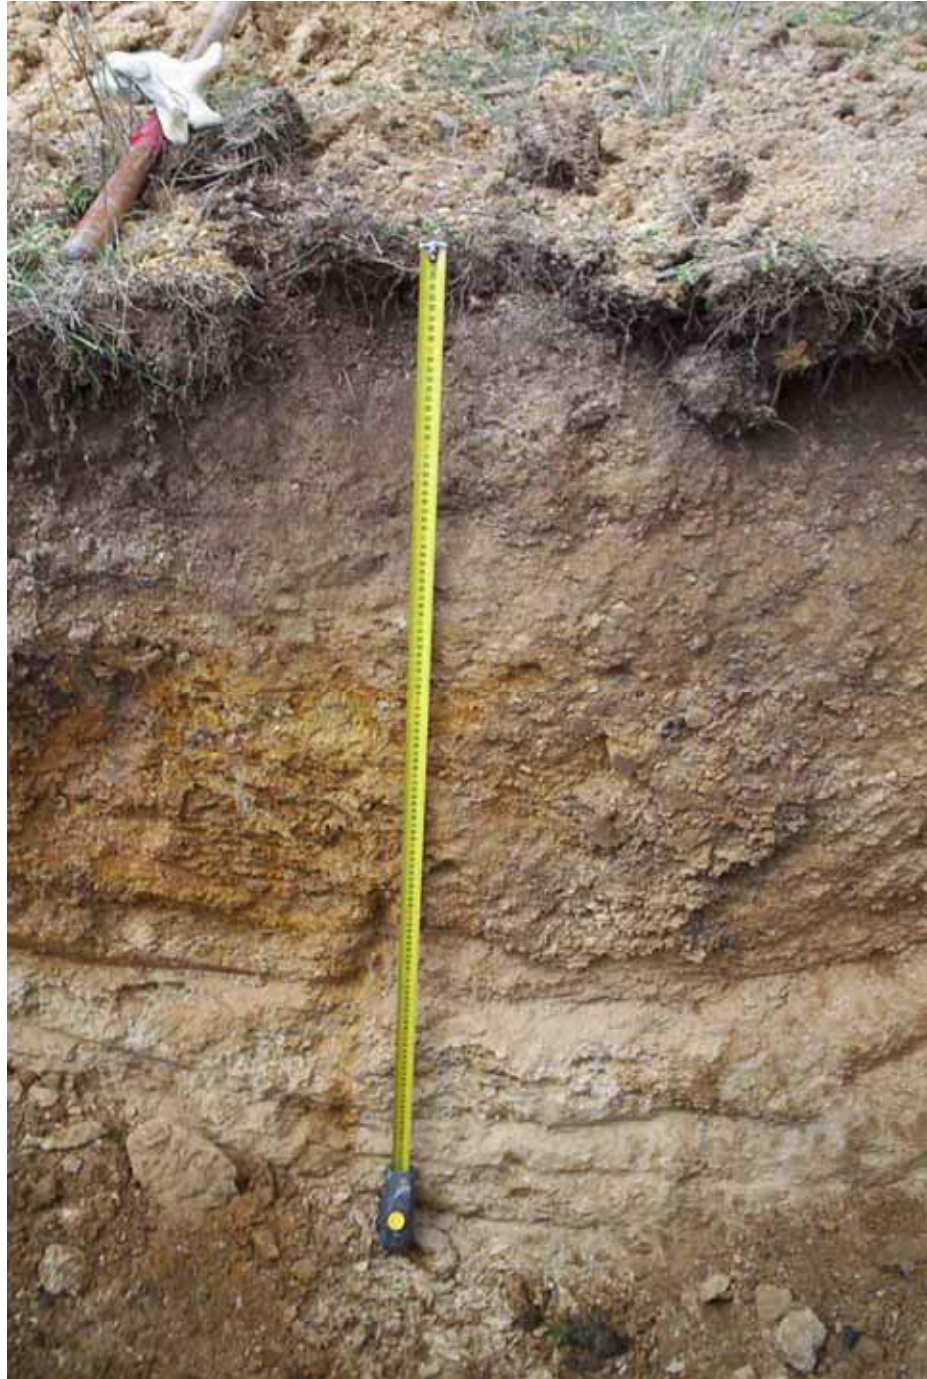
0.10-0.40 Medium clay with gravel		CL/CI	D	St-VSt		
	0.40-0.85 Orange heavy clay with gravel		CL-CH	D	St-VSt		
	0.85-1.20 Pale orange heavy clay with gravel, grey clay seams vertically and horizontally		CL-CH	D	St-VSt

Client:	Maunsell Australia	Job No:	20969
Project:	ADC Proposed Landfill	Date:	13-Sep-06
Location:	Waterfall Way	Logged by:	Robert Cork
Excavation Method:	Backhoe	Bore Hole No:	Test pit 3
Groundwater Struck:	No	Groundwater Stands:	
Surface slope:	Eastern aspect	Current land use:	Grazing pastures
Vegetation:		Parent material:	
Surface drainage:	20-40m above drainage line on slight drainage	Coordinates (GDA 1994):	383335 E, 6618989 N MGA Zone 56

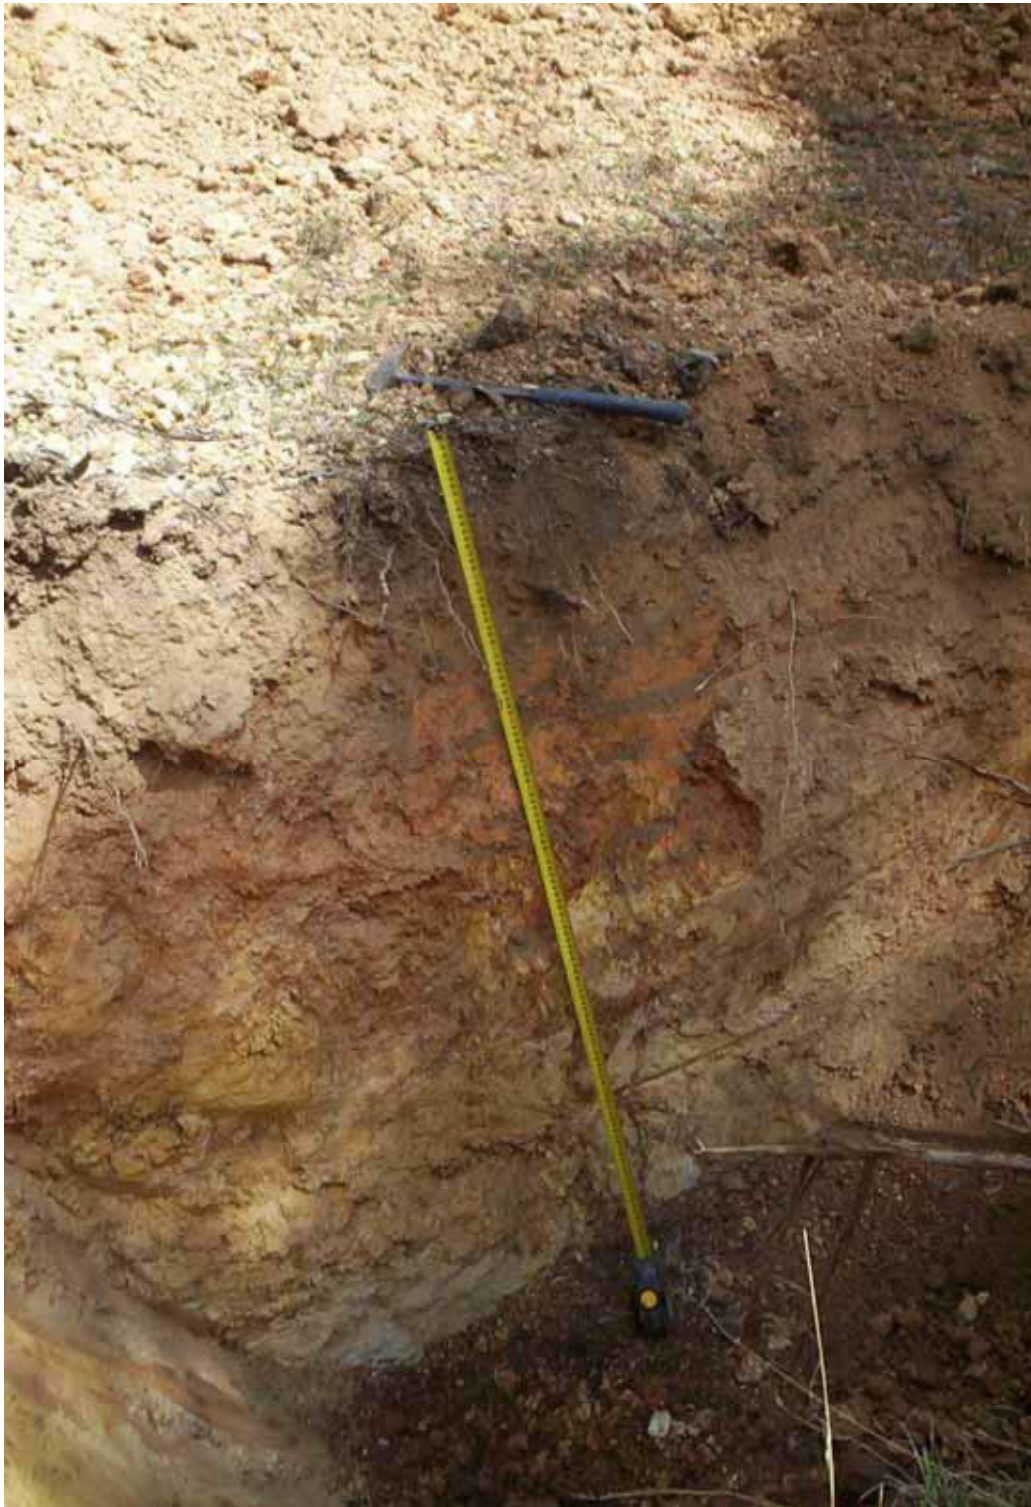
0.10-0.25 Pale orange brown medium clay loam, some gravel (<2mm)		CI,CL	D	VS-S	
	0.25-0.60 Orange red heavy clay		CI,CL	D	St	
	0.60-0.90 Red heavy clay; yellow and white envelopes	155342	CI	D	VSt	M

0.90-1.40 White heavy clay with red seams		CI	D	VSt	
2	1.40 Refusal					
Moisture Content		Weather Rock Classification Symbols		Consistency/Density		
D Dry	EW Extremely Weathered	VL Very Loose	VS Very soft			
M Moist	HW Highly Weathered	L Loose	S Sort			
W Wet	MW Moderately Weathered	M Medium	F Firm			
	SW Slightly Weathered	D Dense	St Stiff			
	F Fresh	VD Very Dense	VSt Very stiff			
			H G+Hard			
Plasticity		Plans/Remarks:				
NP Non-plastic						
T Trace						
VL Very Low						
L Low						
M Medium						
H High						
VH Very High						
EH Extra High

Client:	Maunsell Australia	Job No:	20969
Project:	ADC Proposed Landfill	Date:	13-Sep-06
Location:	Waterfall Way	Logged by:	Robert Cork
Excavation Method:	Backhoe	Bore Hole No:	Test pit 5
Groundwater Struck:	No	Groundwater Stands:	
Surface slope:		Current land use:	Grazing pastures
Vegetation:	Open woodland stringy bark	Parent material:	North-easterly aspect
Surface drainage:		Coordinates (GDA 1994):	383331 E, 6618699 N MGA Zone 56

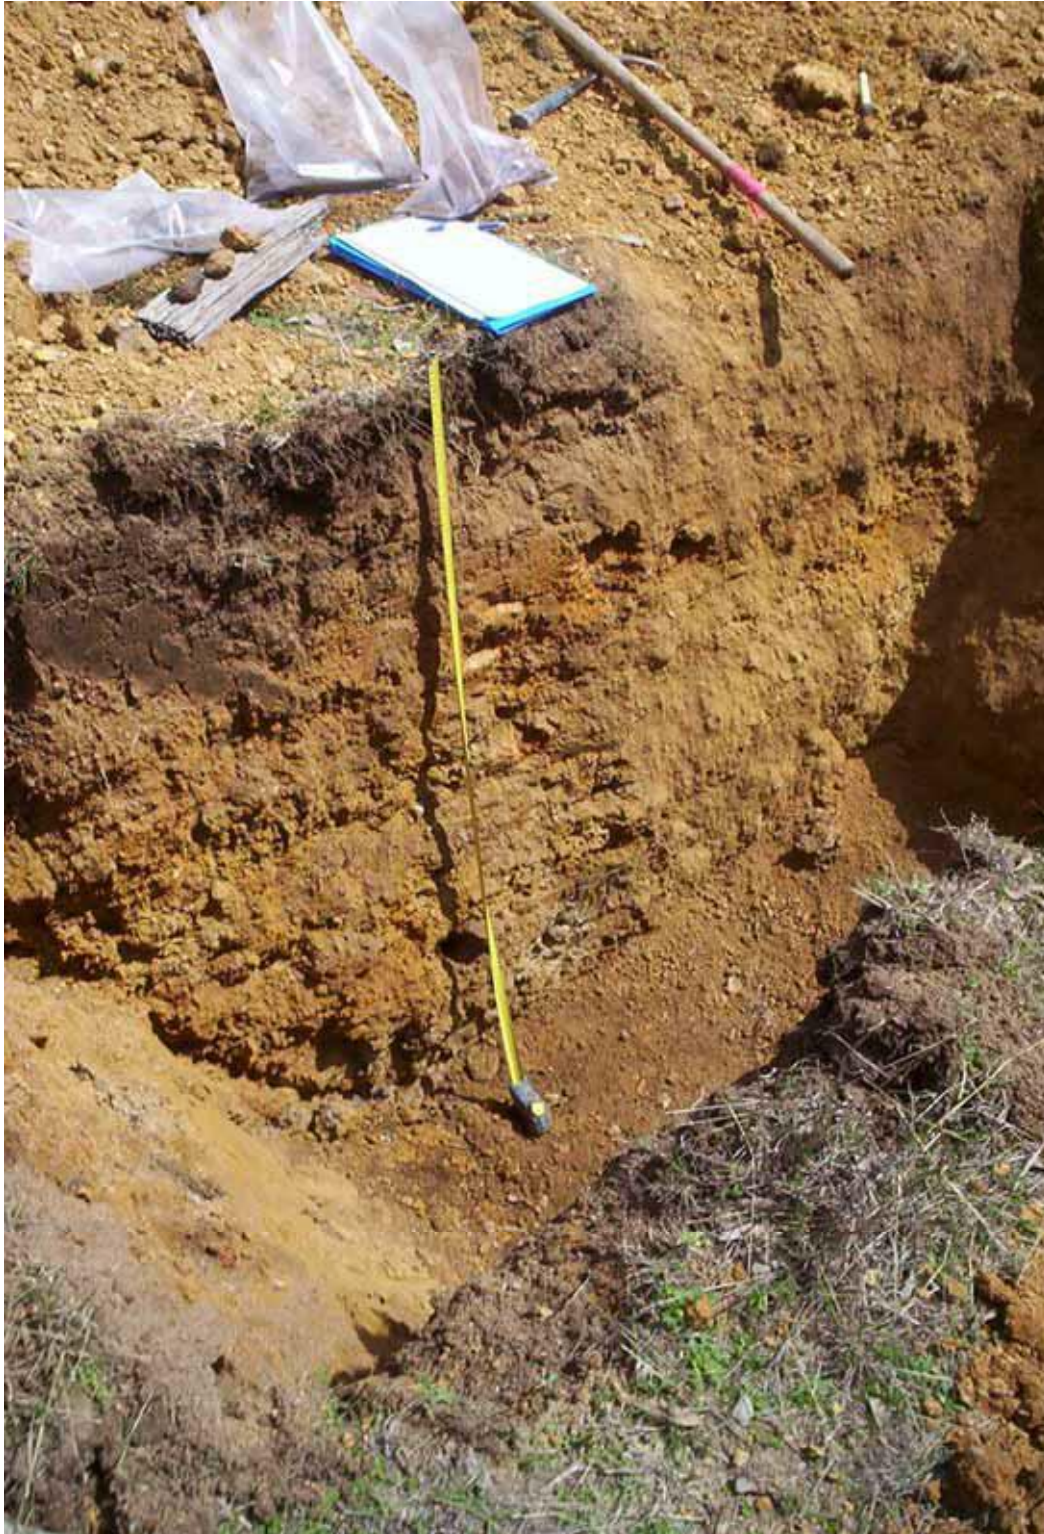
0.00-0.15	Dark brown sandy clay loam		SC-CI	D	Non-cohesive	
0.15-0.30	Brown silty clay, with some rocks and sand present		CI,CL	D	F-St	
0.30-1.10	Orange brown heavy clay, mottle grey and orange rocks and gravel		CI-CH	D	St

1.10-1.40	Grey orange heavy clay, mottling		CI-CH	D	VS-t-H	
1.40	Refusal					
Moisture Content		Weather Rock Classification Symbols		Consistency/Density		
D Dry	EW Extremely Weathered	VL Very Loose	VS Very soft			
M Moist	HW Highly Weathered	L Loose	S Sort			
W Wet	MW Moderately Weathered	M Medium	F Firm			
	SW Slightly Weathered	D Dense	St Stiff			
	F Fresh	VD Very Dense	VSt Very stiff			
			H G+Hard			
Plasticity		Plans/Remarks:				
NP Non-plastic						
T Trace						
VL Very Low						
L Low						
M Medium						
H High						
VH Very High						
EH Extra High

Client:	Maunsell Australia	Job No:	20969
Project:	ADC Proposed Landfill	Date:	13-Sep-06
Location:	Waterfall Way	Logged by:	Robert Cork
Excavation Method:	Backhoe	Bore Hole No:	Test pit 6
Groundwater Struck:	No	Groundwater Stands:	
Surface slope:		Current land use:	Grazing pastures
Vegetation:		Parent material:	
Surface drainage:		Coordinates (GDA 1994):	383288 E, 6618773 N MGA Zone 56

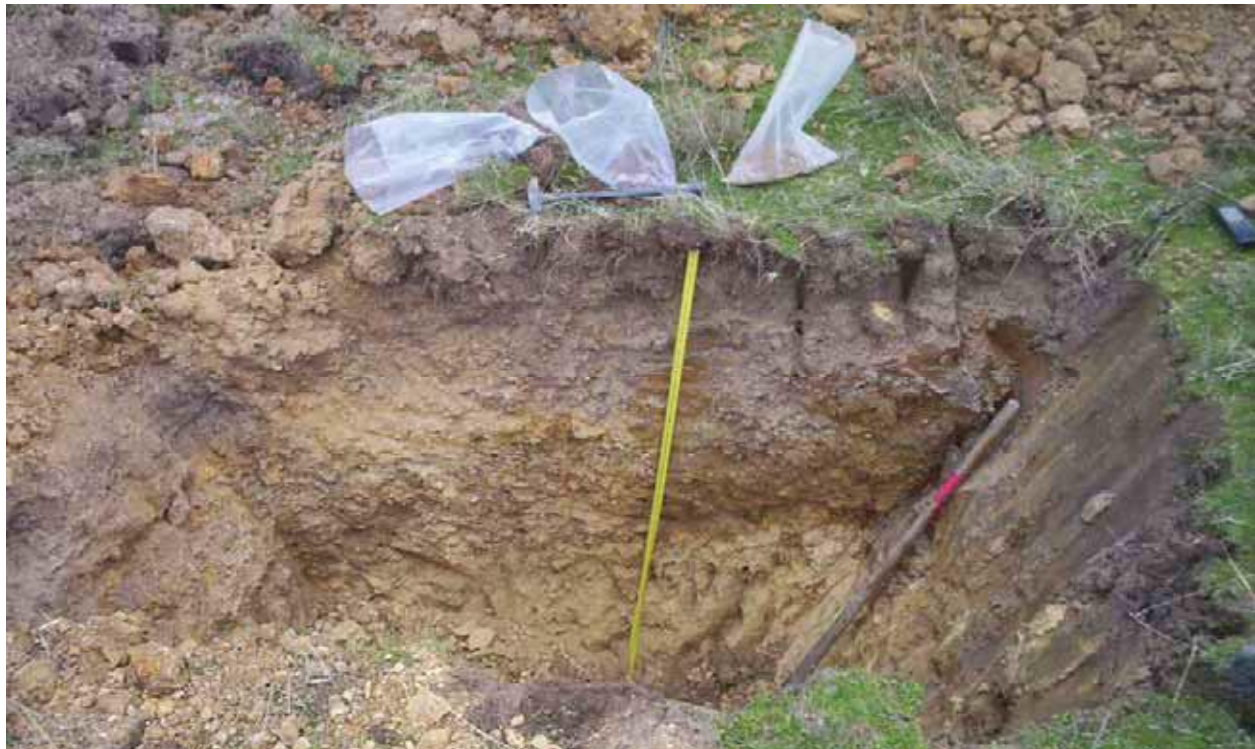
0.10-.30 Grey slightly bleached clay, loamy clay				SC-CI	W	S	
	0.30-0.60 Brown red medium clay				CL-CH	W	St	
	0.60-0.95 Orange red gravelly clay				CL-CH	W	VSt

0.95-1.35 Yellow white, sandy clay (extremely weathered rock)				SC-CL	D	VS	
2	1.35 Refusal							
Moisture Content		Weather Rock Classification Symbols			Consistency/Density			
D Dry		EW Extremely Weathered			VL Very Loose		VS Very soft	
M Moist		HW Highly Weathered			L Loose		S Sort	
W Wet		MW Moderately Weathered			M Medium		F Firm	
		SW Slightly Weathered			D Dense		St Stiff	
		F Fresh			VD Very Dense		VSt Very stiff	
							H G+Hard	
Plasticity		Plans/Remarks:						
NP Non-plastic								
T Trace								
VL Very Low								
L Low								
M Medium								
H High								
VH Very High								
EH Extra High

Client:	Maunsell Australia	Job No:	20969
Project:	ADC Proposed Landfill	Date:	13-Sep-06
Location:	Waterfall Way	Logged by:	Robert Cork
Excavation Method:	Backhoe	Bore Hole No:	Test pit 7
Groundwater Struck:	No	Groundwater Stands:	
Surface slope:	1%	Current land use:	Grazing pastures
Vegetation:	Tussock	Parent material:	
Surface drainage:		Coordinates (GDA 1994):	383514 E, 6619319 N MGA Zone 56

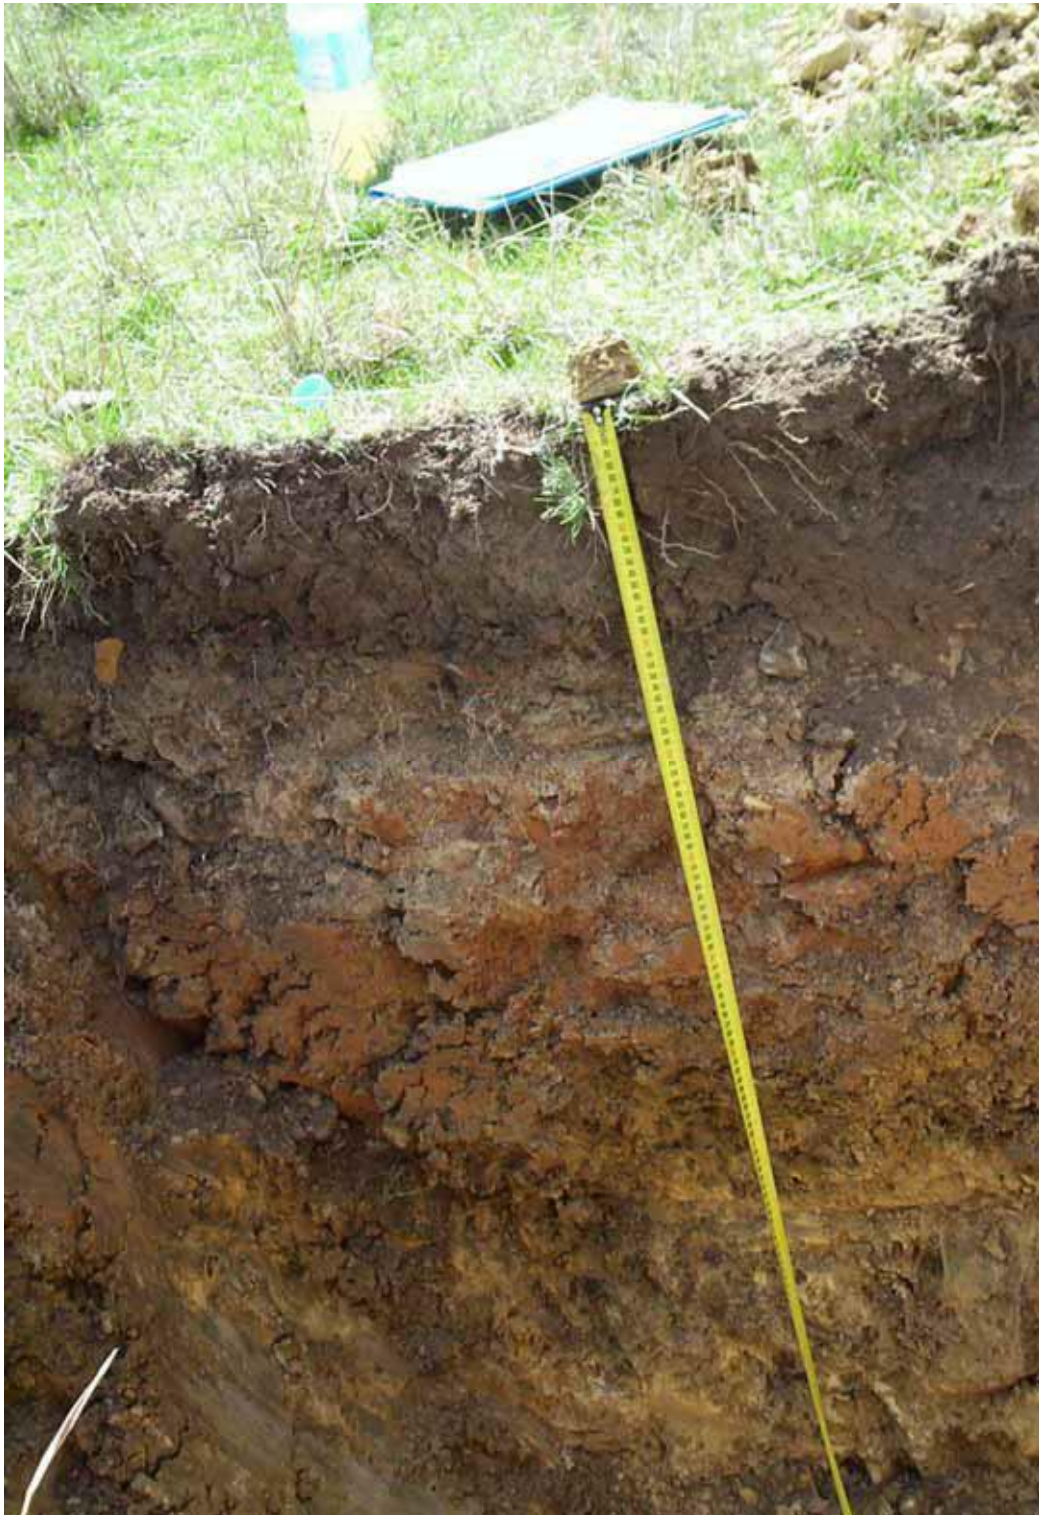
0.15-0.30 Beached grey sandy clay/clayey sand		SC-CI	D	S-F	
	0.30-0.70 Heavy clay (orange) with mottling (grey)		CL-CH	D	VSt	
	0.70-1.20 Light brown heavy clay with black mottles (precipates) with gravel		CL-CH	D	VSt-H

Client:	Maunsell Australia	Job No:	20969
Project:	ADC Proposed Landfill	Date:	13-Sep-06
Location:	Waterfall Way	Logged by:	Robert Cork
Excavation Method:	Backhoe	Bore Hole No:	Test pit 8
Groundwater Struck:	No	Groundwater Stands:	
Surface slope:	2-3%	Current land use:	Grazing pastures
Vegetation:		Parent material:	
Surface drainage:		Coordinates (GDA 1994):	383609 E, 6619714 N MGA Zone 56

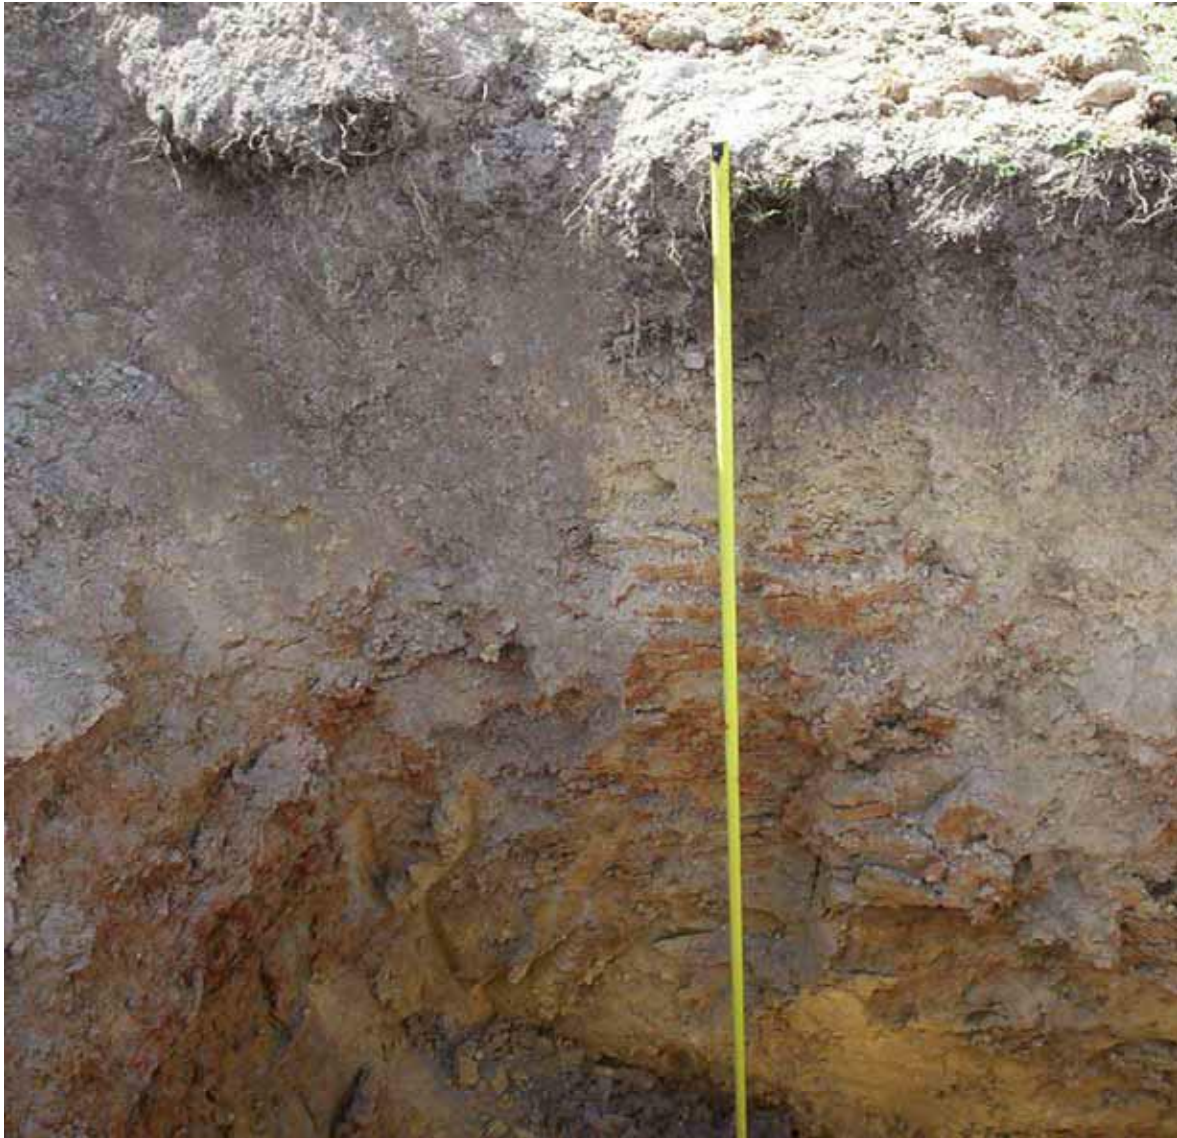
0.00-0.25	Dark brown sandy loam		SC-CL	D	VS-S	
0.20-0.45	56 Grey brown loamy sand with gravel		SM-SC-CL	M	S-F	
0.45-0.90	Orange medium clay, very sticky		CL-CH	M	VSt

0.90-1.30	Orange grey heavy clay with mottling (white)		CL-CH	D	VSt-H	
1.30	Refusal					
Moisture Content		Weather Rock Classification Symbols		Consistency/Density		
D Dry	EW Extremely Weathered	VL Very Loose	VS Very soft			
M Moist	HW Highly Weathered	L Loose	S Sort			
W Wet	MW Moderately Weathered	M Medium	F Firm			
	SW Slightly Weathered	D Dense	St Stiff			
	F Fresh	VD Very Dense	VSt Very stiff			
			H G+Hard			
Plasticity		Plans/Remarks:				
NP Non-plastic						
T Trace						
VL Very Low						
L Low						
M Medium						
H High						
VH Very High						
EH Extra High

Client:	Maunsell Australia	Job No:	20969
Project:	ADC Proposed Landfill	Date:	13-Sep-06
Location:	Waterfall Way	Logged by:	Robert Cork
Excavation Method:	Backhoe	Bore Hole No:	Test pit 9
Groundwater Struck:	No	Groundwater Stands:	
Surface slope:	4-5%	Current land use:	Grazing pastures
Vegetation:		Parent material:	
Surface drainage:		Coordinates (GDA 1994):	383315 E, 6619174 N MGA Zone 56
