ARMIDALE REGIONAL LANDFILL

Preliminary Contaminated Site Investigation

Lot 1 DP 253346 and 2 DP 253346 and (County of Sandon, Parish of Gara) located on Gara Road, Armidale, NSW

Report Number 20971.13871

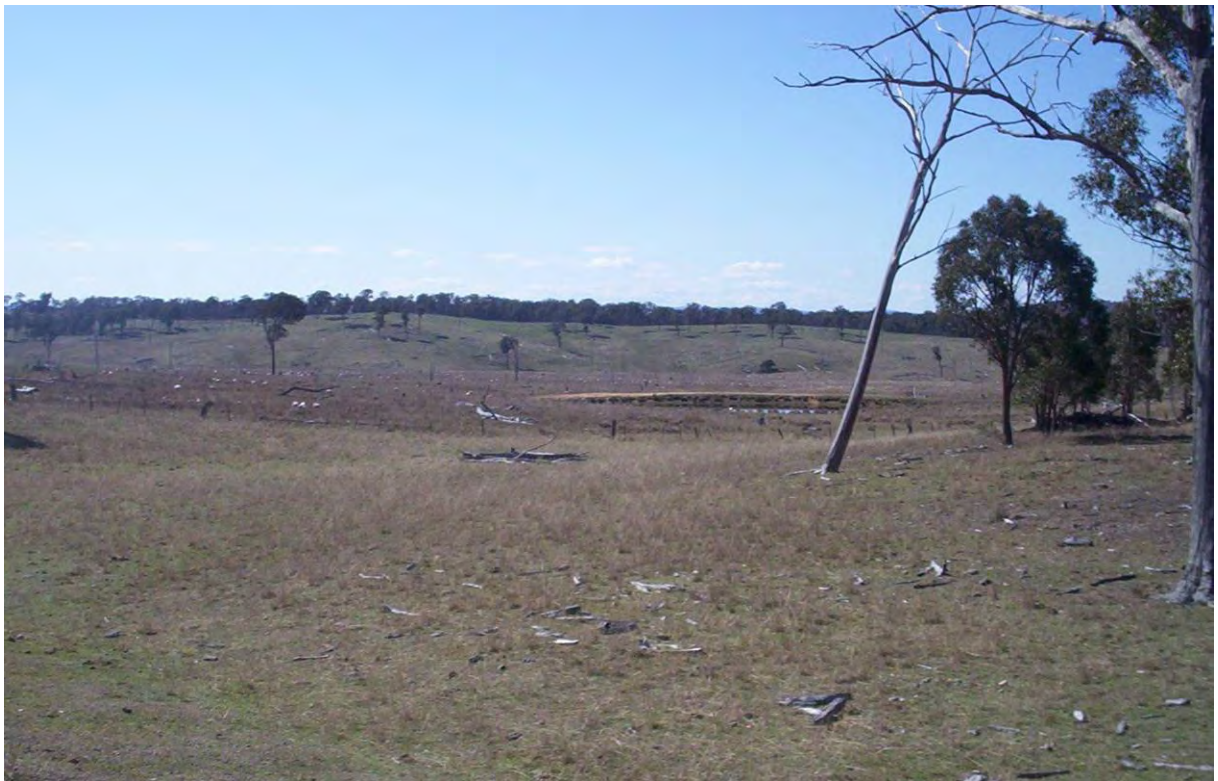
Plate 1. Small Paddocks have sparse ground cover and are used for livestock grazing

- The primary land use of the subject lots has been livestock grazing (Plates 1 and 2).
- A small quarry was in operation in Lot 2 DP 253346, this quarry has been used for extracting gravel (Plates 3 to 5).
- Sheep yards were located in Lot 1 DP 253346 (Plate 6).
- Two empty 200 litre (44 gallon) drums and discarded empty vaccination packs were observed on the ground beside the sheep yards (Plate 7). The tops of the drums were intact, indicating that the drums had not been used for mixing of chemicals.
- There was no evidence of earth fill material (acquired from another site) present on the site.

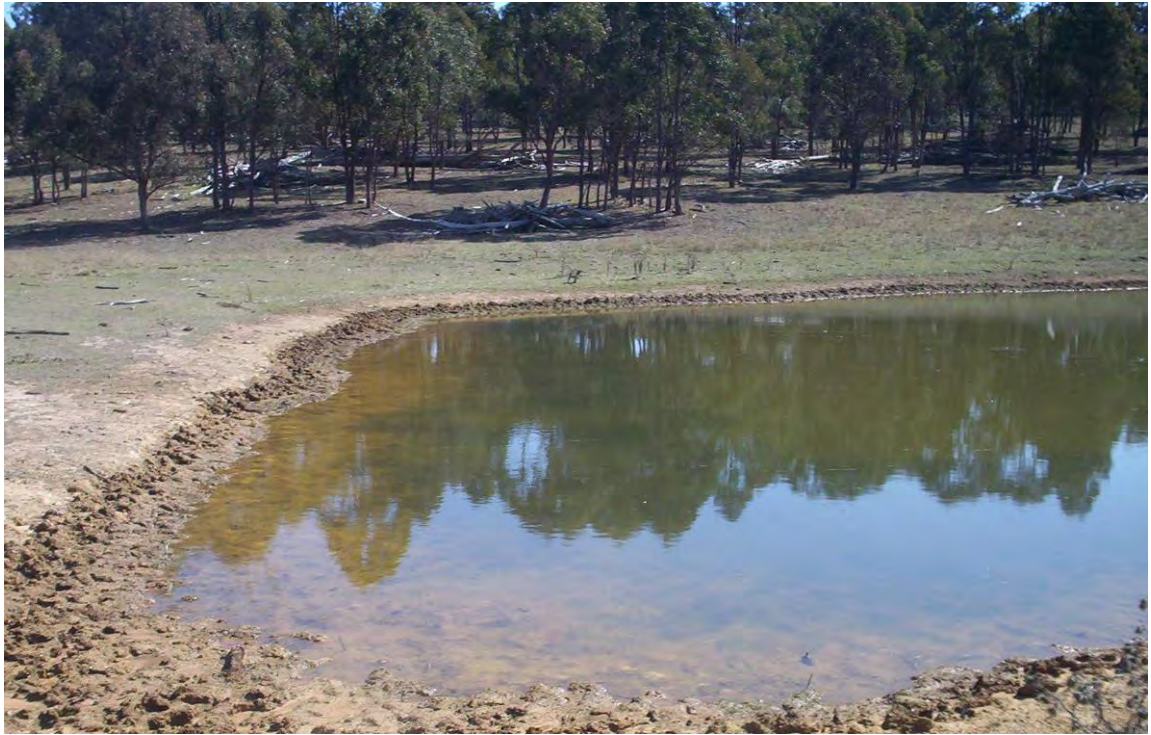
Plate 2. One of the two dams located on Lot 1 in DP 253346

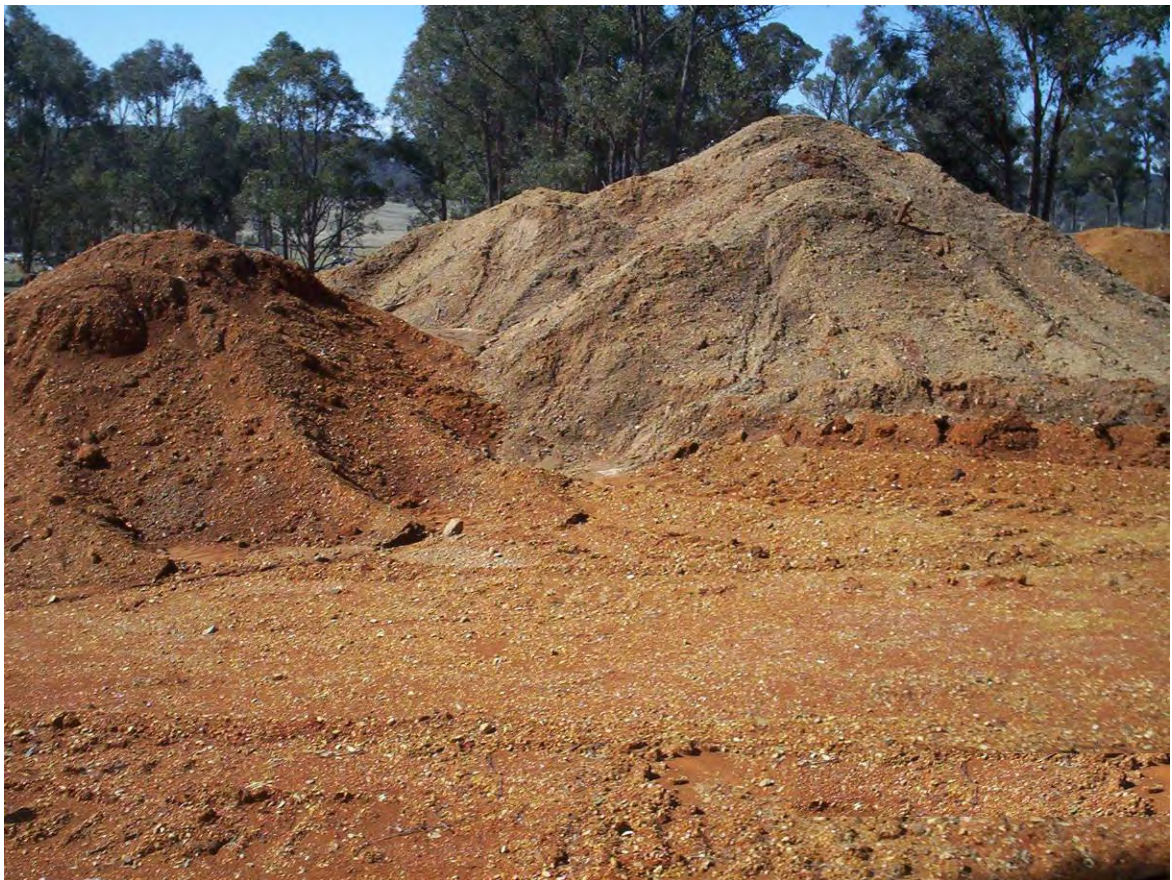
Plate 3. Small quarry located in the north eastern corner of Lot 2 in DP 253346

- There is no evidence of oil spills or stains from the use of heavy vehicles in the quarry area.
- No dangerous goods or explosives were used in the quarry.

- No chemicals of concern have been used for gravel extraction.
- There is no evidence of either contaminated or clean earth fill material (acquired from another site) present on the site.

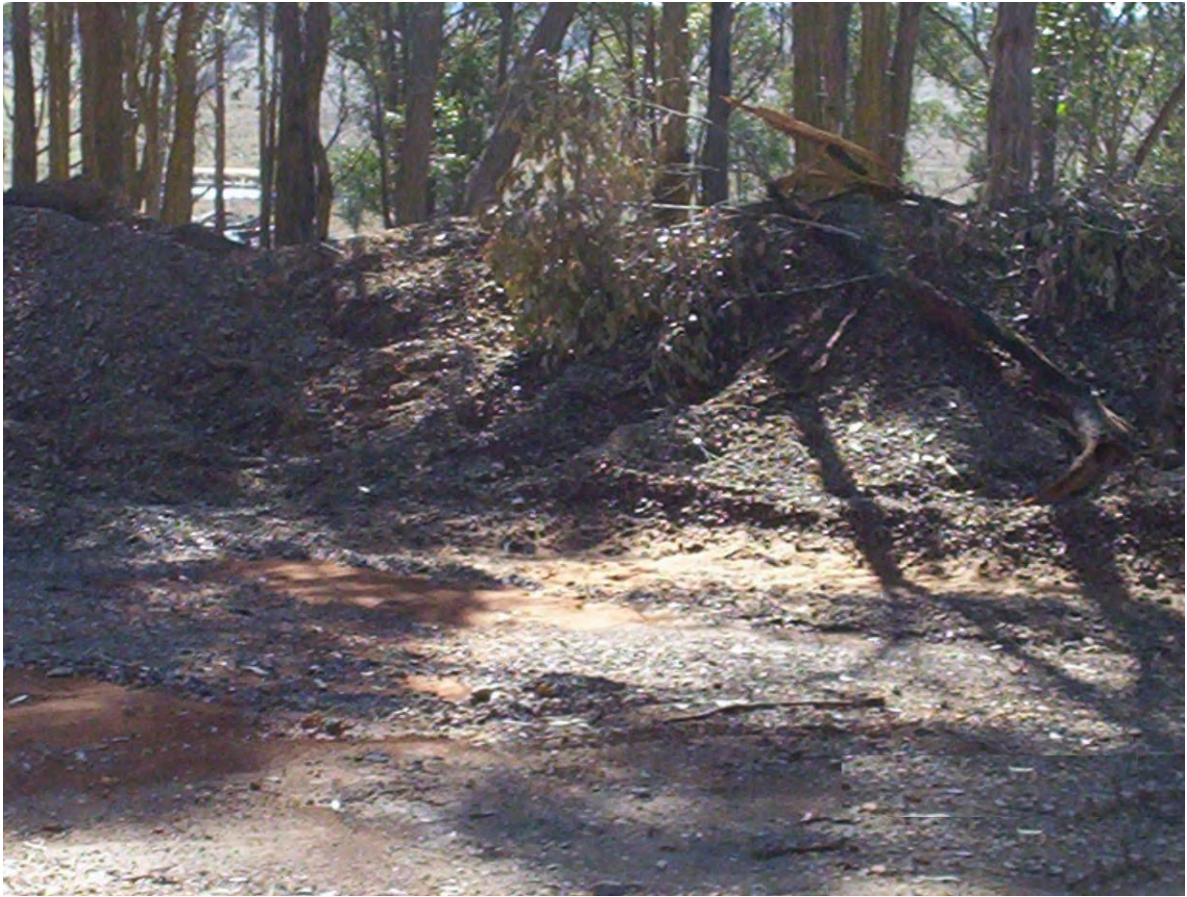
Plate 4. The boundary of the small quarry located in the north eastern corner of Lot 2 in DP 253346

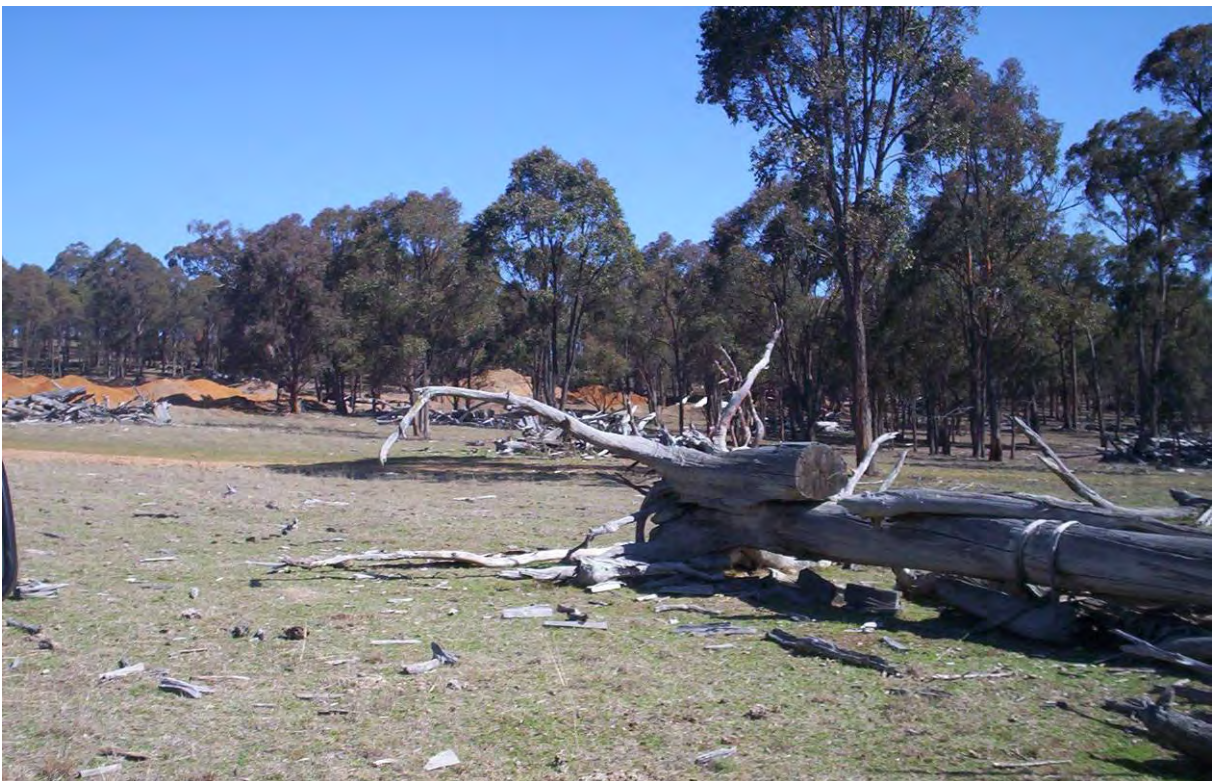
Plate 5. Small quarry in the background of Lot 2 in DP 253346

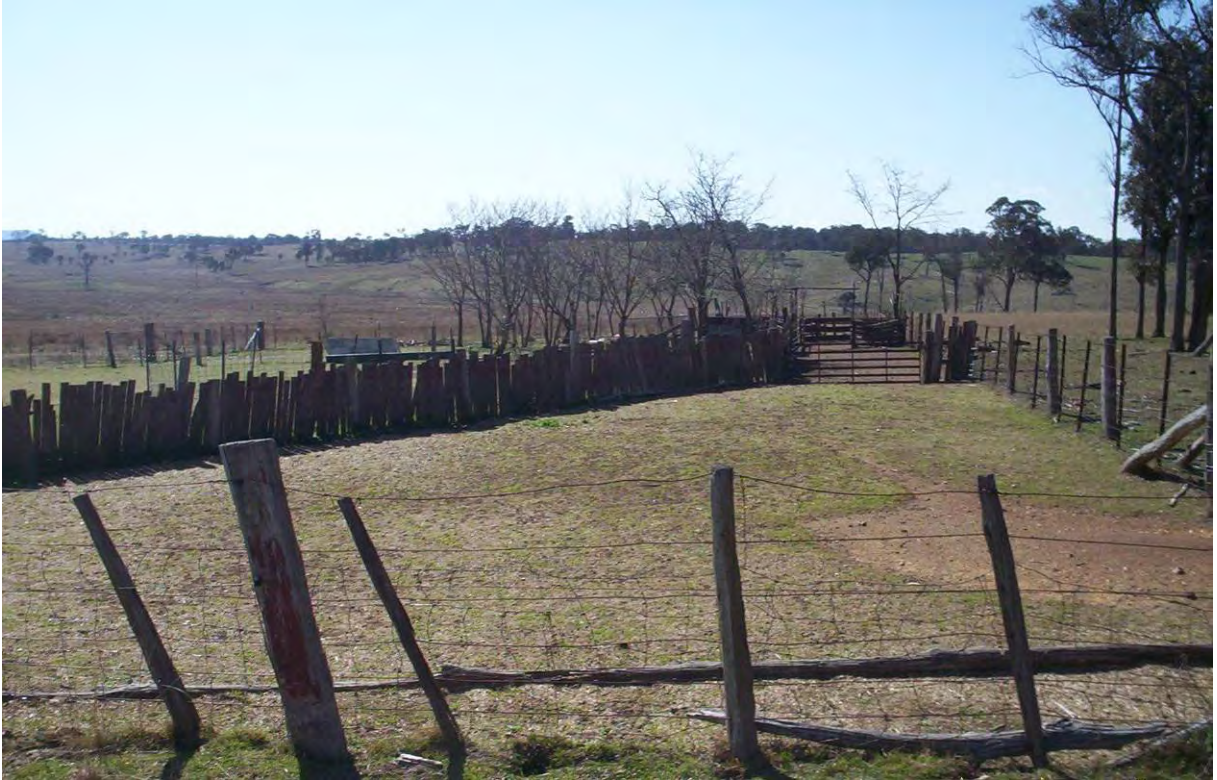
Plate 6. Sheep yards located in the centre corner of Lot 1 in DP 253346. The yards include pens and a race that are likely to have been used for drenching, jetting and vaccinating sheep

- There may be areas in and around the sheep yards that have been exposed to chemicals associated with routine sheep drenching, jetting and vaccination. However there is no permanent infrastructure present that would have allowed dipping or fixed hose jetting, therefore any contamination would be low and limited to localised surface stains.

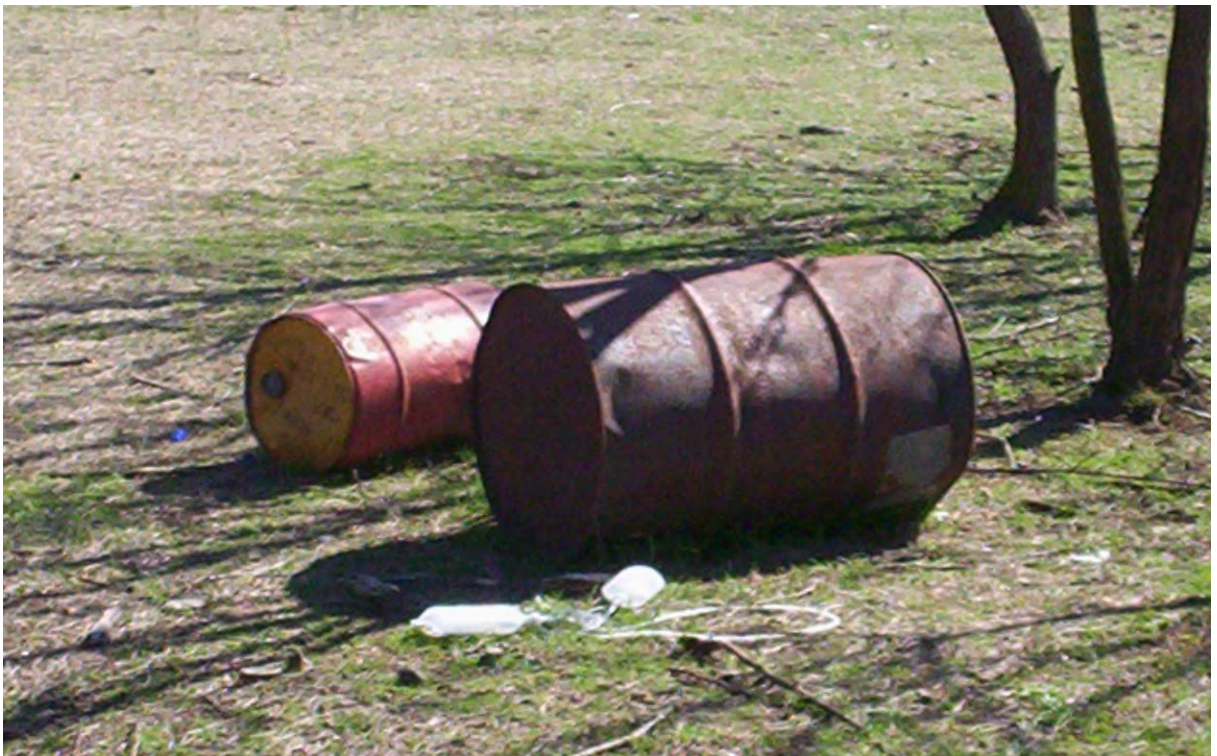
Plate 7. Empty vaccination packs (foreground) and empty 44 gallon drums (background) beside the sheep yards located Lot 1 in DP 253346
