ARMIDALE REGIONAL LANDFILL

Salinity Assessment

Armidale Dumaresq Council Landfill Facility Salinity Assessment

Report Number 20969. 13866

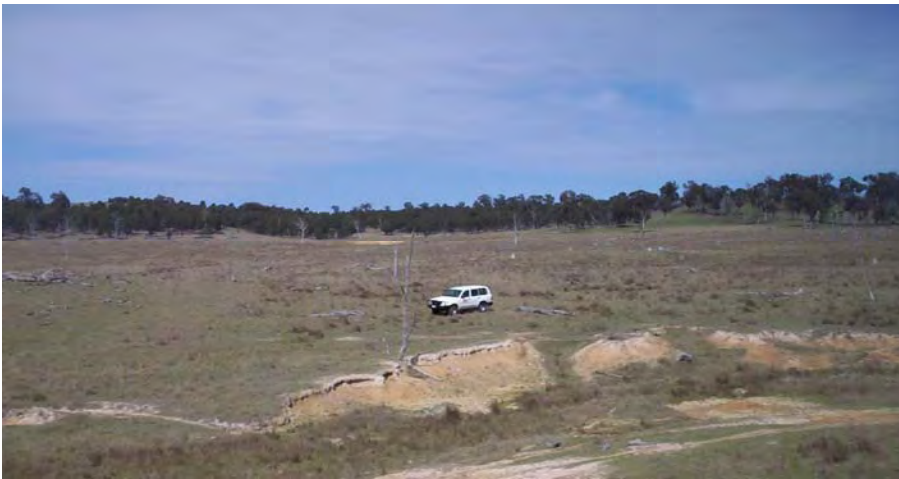
Plate 1. The 'flats running down to the creek line (photo taken from across the main drainage line looking south up towards the proposed landfill.

The investigation site can be broadly broken down into three geomorphological areas; the 'flats' running out to the creek line (See Plate 1 below), the wooded mid-slope(See Plate 2 below) area and the rocky crests of the hills. These areas, and the locations of the excavated test pits on the study site are presented in Figure 4. With the exception of the hill crests where the profile was generally shallower and contained more rock, the soils were relatively uniform across the site. The general soil profile also reflected those described by King, P, D (in prep) in the soil landscape group classifications.

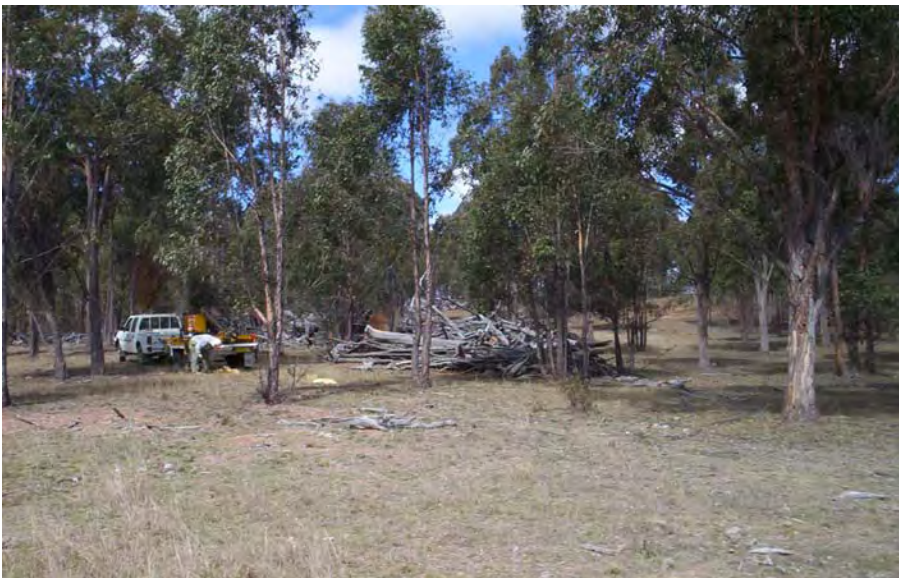
Plate 2. Typical area of the wooded midslope area.
