Phase 1 Contamination Assessment, Acid Sulfate Soils Investigation, and Riverbank Stability Assessment

Proposed Beverage Grade Ethanol Plant, Main
Manildra Plant, Bolong Road, Bomaderry

7 November 2016

ENAUWOLL04315AA-R01 Rev 2

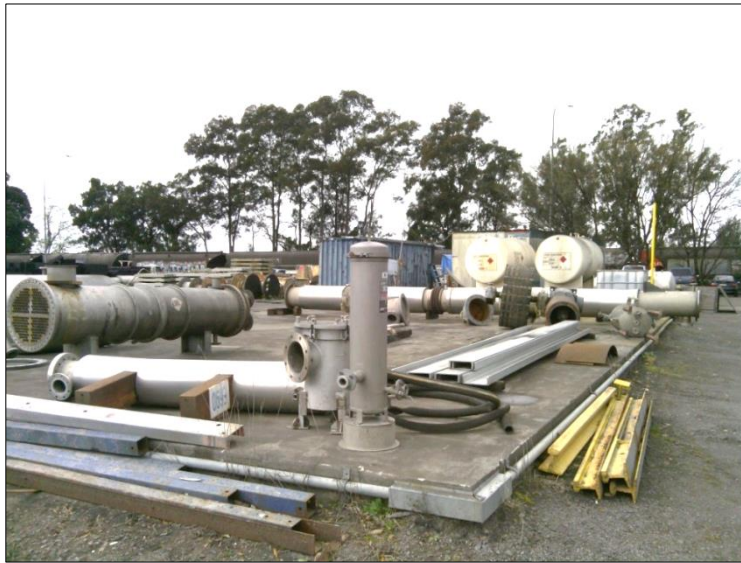
This area is situated in the eastern part of the plant. This area was generally covered by gravel fill, with a concrete pad noted in the centre of this portion. The concrete pad was constructed approximately 8 years ago and operated as a working base for the construction of ethanol tanks several years previously. During the site walkover, this pad (and immediate surrounding areas) were used for storage of miscellaneous industrial parts, such as pipework, two above ground tanks (formerly containing cyclohexane), empty pallets and wooden cable spools (Photograph 1).

Photograph 1. Looking south across the concrete pad

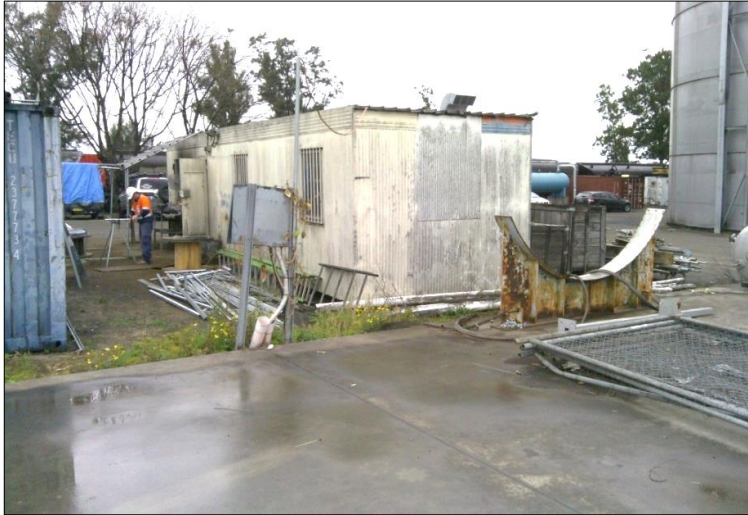
Approximately 20 IBC containers (containing various forms of acid), and a metal skip bin which appeared to be full of scrap metal, concrete sleepers, and plastic and metal formwork materials were noted to the west of the concrete slab. An open grassed area was observed in the western portion of the proposed IBC storage and loading area. To the south of the concrete pad, a metal shed and metal shipping container was observed. The shed and container appeared to be used as fitter's workshop. During the walkover, a worker was observed to be undertaking cutting work in this area (Photograph 2). Visual evidence of staining was not observed in this area.

Photograph 2. Looking southwest towards a site shed, possibly used as a workshop.

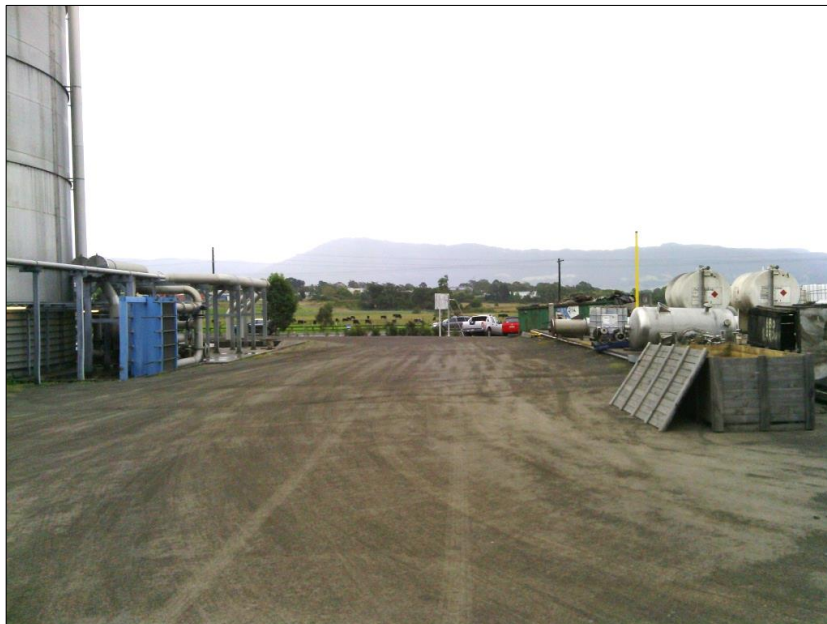
The proposed evaporator / cooling towers / substation is to be situated on a gravel access road. Visual evidence of staining was not observed in this area. A compressor shed followed by a railway line and spur was situated to the south of the proposed substation, as indicated on existing plans. The compressor is electrically powered, and situated on a platform approximately 0.8m above the ground. The base of the compressor shed is concrete. No visual evidence of leakages were noted.

Photograph 3. Looking north across the gravel access road.

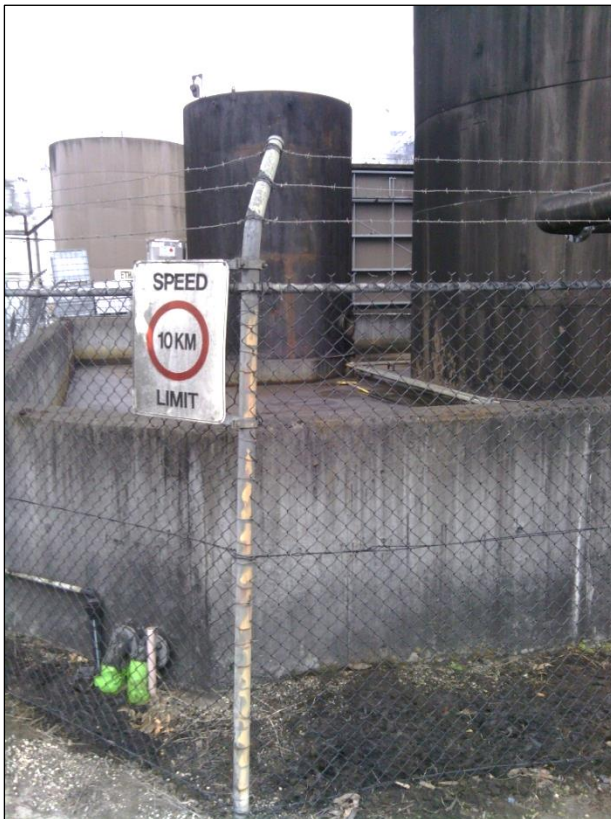
The proposed tanks 1 and 2 will be situated within the existing ethanol recovery area (Photograph 4). The ethanol recovery area is a concrete bunded area where three existing tanks (containing ethanol) are currently located. One of these tanks will be removed as part of the development. The tanks were observed to be in good condition, and there was no apparent visual evidence of leakages / staining, and the concrete bunds appeared to be in good condition.

Photograph 4. Looking west towards the existing tanks in the ethanol recovery area. The tank in the right side of the photograph will be removed.

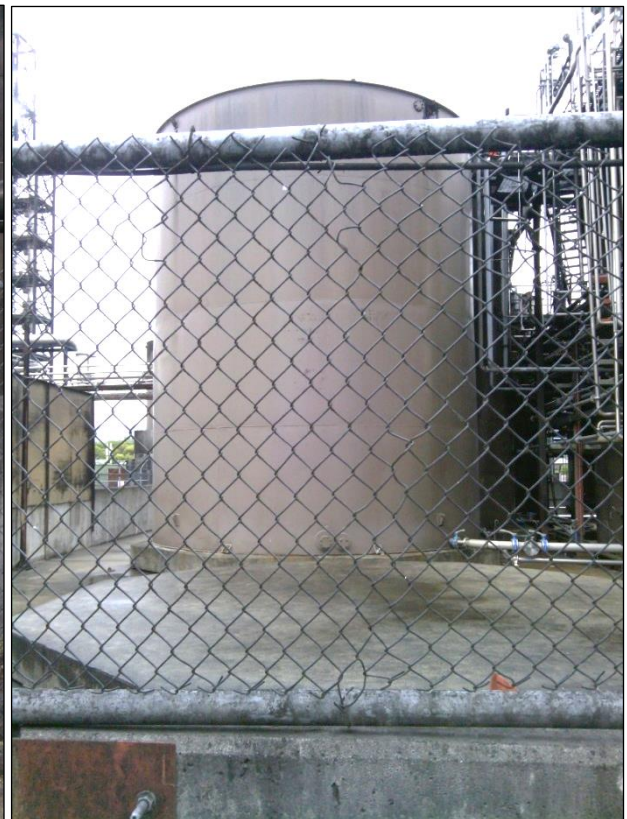
The proposed tank 8 will be situated within the existing ethanol storage area (Photograph 5). The ethanol storage area is a concrete bunded area where an existing tank and concrete plinth was observed. According to information provided by Manildra, the proposed tank 8 is likely to be situated on top of the existing concrete plinth. The tanks were observed to be in good condition, and there was no apparent visual evidence of leakages / staining, and the concrete bunds appeared to be in good condition.

Photograph 5. Looking west towards the proposed location of Tank 8 in the ethanol storage area. This tank will be situated on the existing concrete plinth

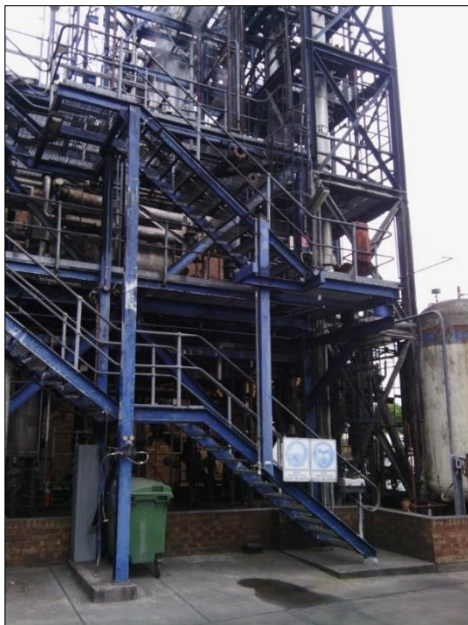
The proposed ethanol plant is to be situated to the east of the existing control room. The proposed plant footprint partially encompasses an existing gantry and chemical storage area (containing various ethanol, alcohol and ether based products), as shown in Photograph 6. Four partially filled IBC containers and two above ground tanks were observed situated over concrete pavement. There did not appear to be significant leakages or evidence of staining in the proximity of the containers and tanks.

Photograph 6. Looking west towards the existing gantry, to be removed to make room for the proposed ethanol plant

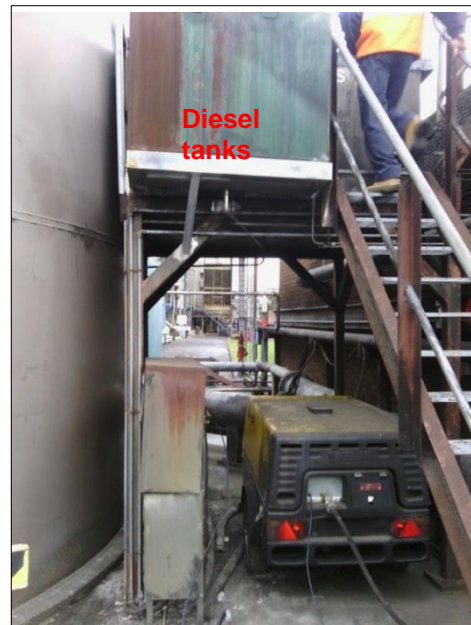
The eastern portion of the proposed ethanol plant is currently occupied by two large above ground tanks used for water storage, three 1,000L diesel above ground tanks (Photograph 7) , and a brick pump house. These structures will be demolished. The tanks are situated on an elevated gantry, in a self bunded steel holding pen. The tanks were observed to be in good condition, and visual or olfactory evidence of leakages were not observed. The purpose of these tanks is to power pumps in the adjacent pump room in emergency situations.

Photograph 7. Looking west towards the above ground diesel tank bund. This will be removed as part of the development

Above ground storage tanks containing diesel were observed near the proposed ethanol plant. Coffey understands the purposes of these tanks is to power adjacent pumps during emergency situations. The tanks are situated within a self bunded steel framework, and no visual or olfactory evidence of leakages were noted. Minor levels of chemical storage (cumulatively less than 100L) were noted in the current pump room.

All		As direct assessment of all areas was not possible during this work, we recommend that observations be made during the demolition of the any existing plant for evidence of contamination. For example during removal of the diesel Above Ground Storage Tank (AST) near the proposed ethanol plant area.

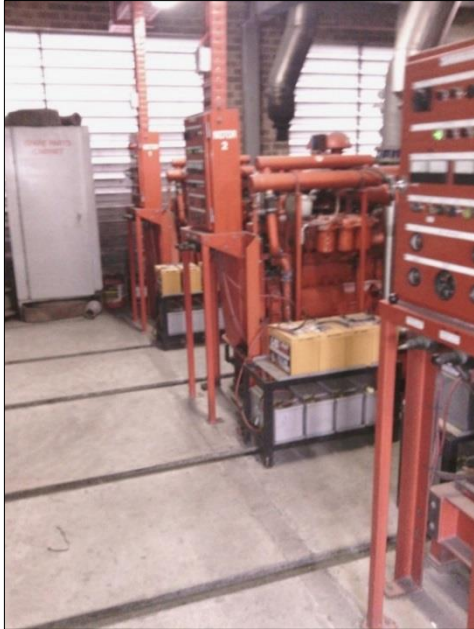
Visual observations were made of the pump room interior (Photograph 8). Four pumping motors were observed, fixed to a concrete floor slab. The pumps appeared to be in good condition, and no visual or olfactory evidence of contamination observed. Relatively minor quantities (<100L) of cleaning and maintenance chemicals were observed in the pump room. Generally, the standard of housekeeping appeared to be high.

Photograph 8. Interior of the pump room

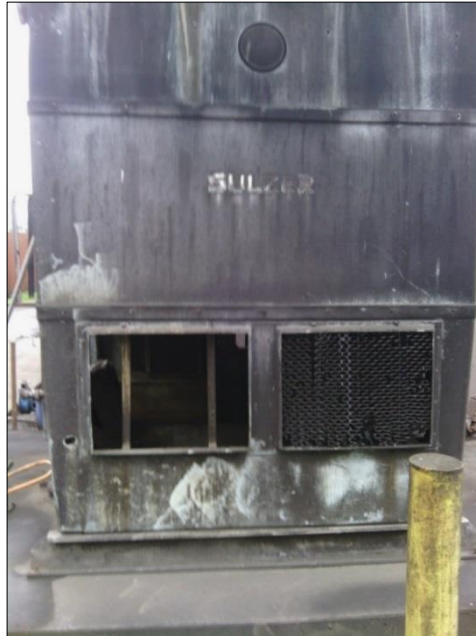
Photograph 9. Redundant structure to the south of the water tanks

A structure was observed to the south of the water tanks (Photograph 9), immediately outside the proposed ethanol plant footprint. Mr Studdert indicated that the structure was the cooling tower for the dimethyl ether (DME) plant, this structure will be removed during the development. The structure is situated on a concrete plinth. Visual evidence of fuel storage and contamination relating to this structure was not observed.

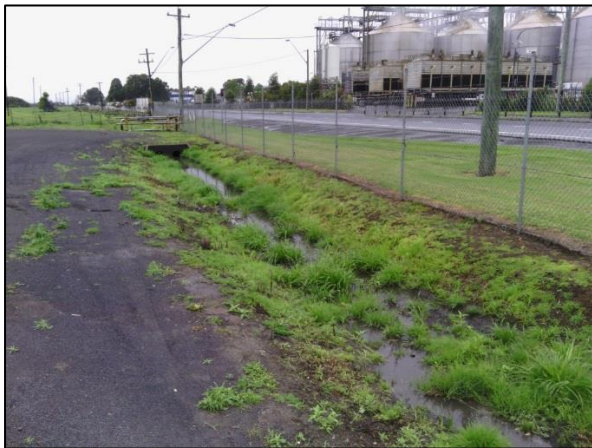
Proposed additional carpark spaces are to be situated on the north side of Bolong Road, near the BOC gas facility (see Figure 2). At present, the majority of this area comprises a gravel hardstand carpark, with an existing open drainage line and culverts along the southern and eastern perimeter (Photograph 10). Mr Studdert indicated this drainage line will be filled in and surrounding areas require some earthworks (i.e. cut to fill) to level the terrain in this area. Evidence of filling beneath the carpark has occurred in this area (Photograph 11). The drainage line discharges to Abernathys Creek further north-west.

Photograph 10. Drainage line around perimeter of carpark

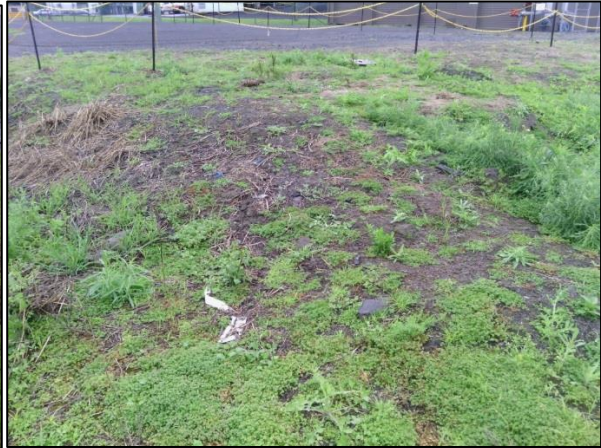
Photograph 11. Evidence of fill beneath carpark
