**Phase 1 Contamination  
and  
Acid Sulphate Soils Assessment**

**Coffey Services Australia Pty Ltd**

**Phase 1 Contamination and Acid Sulfate Soil Assessment  
Boiler House Modifications, Bolong Road, Bomaderry**

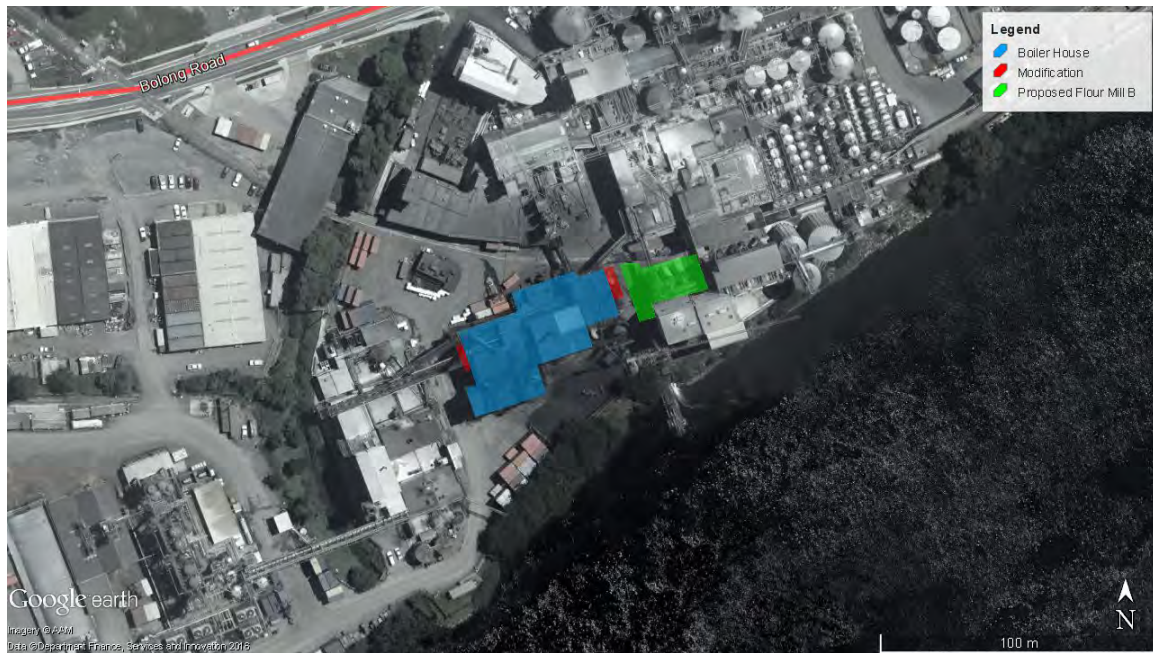
Figure 1 below shows the approximate location of the ground level Modification Sites (red) and the Boiler House building (blue). We understand that the extent of ground disturbance for these modifications is likely to be relatively small and only for some possible foundations if founding on the surface pavement is not adequate. The footprint of the proposed Flour Mill B (green) has been the subject of previous geotechnical and environmental investigations by Coffey. Other additions/modifications are proposed in the central part of the boiler house, but these are all understood to be above ground and not involve any ground disturbance

**Figure 1:** Aerial photo showing approximate location of subject site (Source: Google Earth Pro)

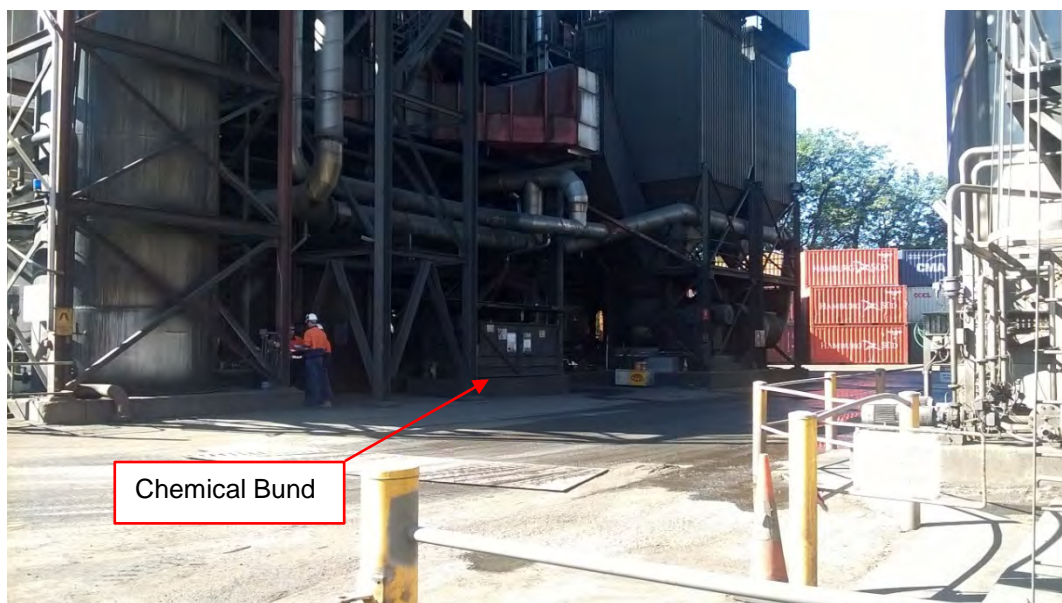
At the time of the walkover the Boiler House was in operation with active equipment observed in the eastern modification site. This equipment primarily comprised fans, ducting and exhaust stacks which are to be replaced as part of the modification works. A chemical storage bund was observed in the western modification area, this chemical storage bund was visibly in good condition with no evidence of damage or leaks and is intended to remain unmodified during the planned works. The chemicals in the bund, were identified by external labels as Nalco 780 (liquid) and NexGuard 22310 (liquid). Both products are used to dose the boiler water as a part of standard operations on the site based upon the description provided by Mr Mark West. A review of safety data sheets for these suggest that Nalco 780 contains sodium bisulfite, which can be harmful. NexGuard 22310 is not described as hazardous, but can cause irritations.

The western modification site was surrounded by the Boiler House and associated structures to the east, north and south. To the west was a road way and on the opposite side of this was a large plant structure. All ground surfaces were generally moderate to good condition hardstand particularly in areas where planned modification works will contact the surface.

Photo 1: Western modification site showing chemical storage bund and surrounding structures.

Based upon the results of the site walkover and review of previous reports we consider the potential for widespread contamination of the site to be low. Some chemical additives have been stored in the western part of the boiler house used for dosing boiler water. Some components of these can be hazardous. As the site is paved, widespread subsurface contamination is not likely in the case of incidental spillage. These are also stored in a bunded storage area.

Due to the history of industrial activities and indirect shallow investigations we recommend that precautions be taken with any subsurface penetrations, in particular if any are required in the vicinity of the chemical storage bund. Soils should be handled with caution as per requirements of handling the substances that are within the chemical bund as a precaution. If any evidence of contamination is identified during construction stages (e.g. soil discolouration, chemical odour, unusual odour, waste, asbestos containing material, staining etc), then work should cease and a suitably qualified environmental practitioner should be engaged to assess the potential for risk to human health or environment and provide advice on proper management. Soil assessment would also be required for any excess construction spoil generated requiring offsite disposal or reuse.

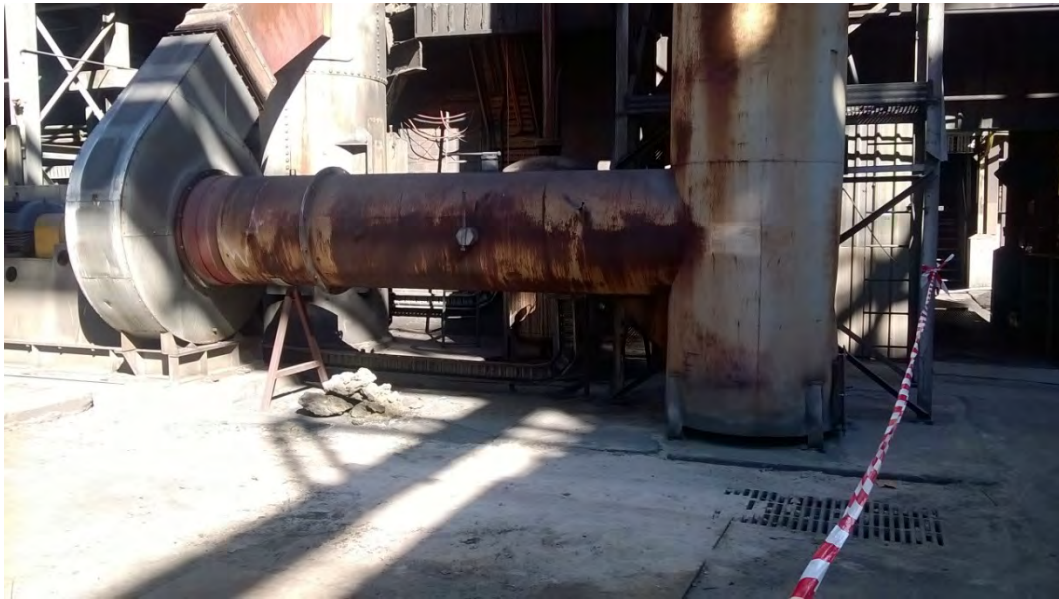
The eastern modification site was surrounded by the Boiler House and associated structures to the west and south, the train line to the north and open space followed by storage silos to the east. Ground surfaces were generally moderate to good condition hardstand with a stormwater drain identified adjacent to the modification site. This stormwater drain is connected to the sites drainage system, with stormwater transferred to Manildra's wastewater treatment plant for treatment. On the ground floor of the Boiler House building adjacent to the eastern modification site were two full pallets containing 20kg bags of Nalco 156C PULV which are used as an anti-scalant within the boilers. The bags were wrapped and did not appear they had been used. A review of safety data sheets for these suggest that this product contains hazardous substances: copper oxychloride and magnesium oxide. Also within this area were wheelbarrows being used for the collection of ash from the wood chip fired boiler no. 2.

Photo 2: Eastern modification site, showing fans and base of stacks, stormwater drain at the lower right of the photo
