**Geotechnical, Contamination and
Acid Sulphate Soils Assessment
and
Addendum Letter addressing Riverbank Stability**

**22, 24, 171 and 220
Bolong Road, Bomaderry**

Proposed Modification Application to MP06-0228,
Shoalhaven Starches Expansion Project, Proposed New
Specialty Processing Facility, New Gluten Dryer and other
associated works at 22, 24 and 171 Bolong Road,
Bomaderry.

Desktop Study - Geotechnical, Contamination and ASS

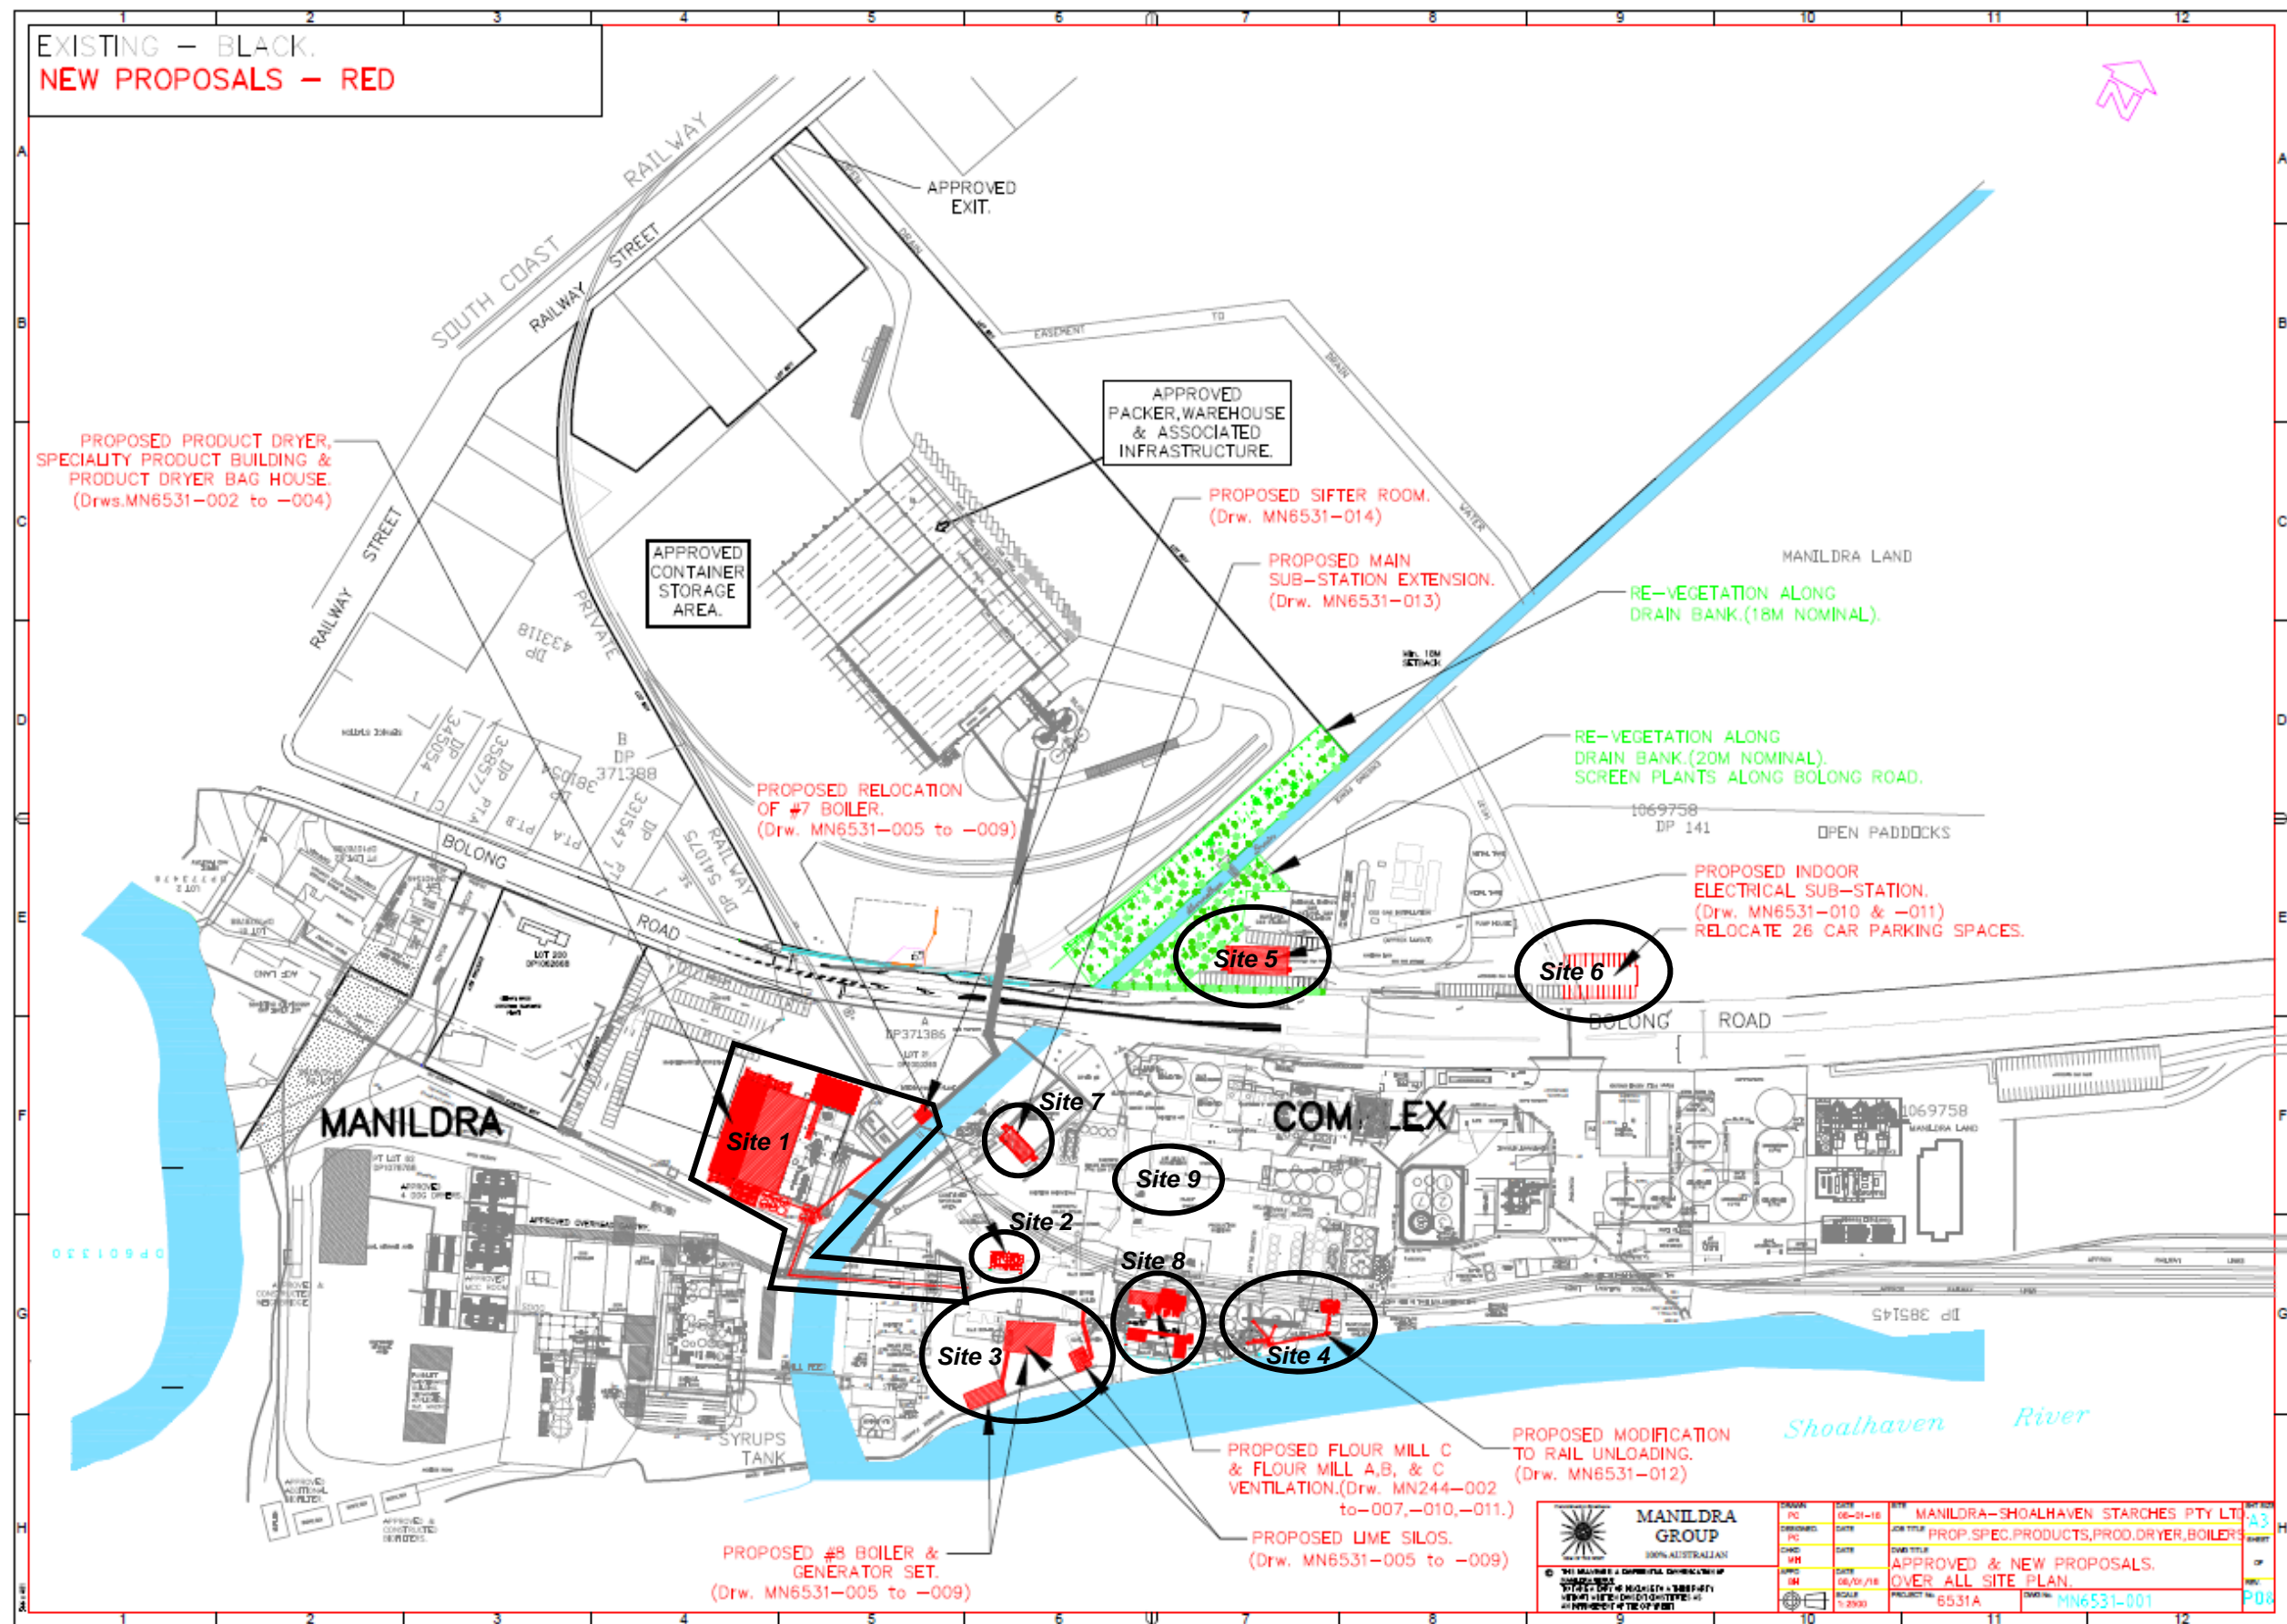
Proposed changes to the original project approval are indicated by red in the overall development plan provided by Cowman Stoddart, as shown in Figure 1 below.

Figure 1 Proposed modifications to Shoalhaven Starches expansion development approval (shown in red)

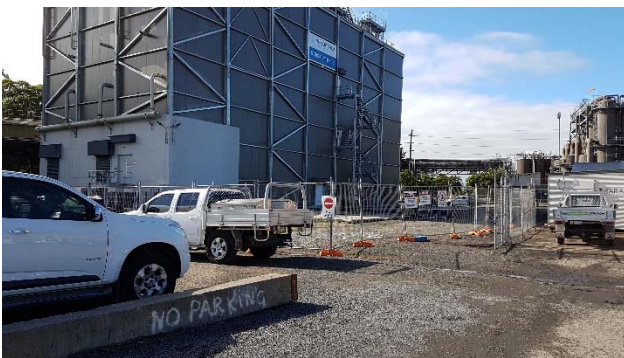
The proposed Site 1 development area is located on the northern, western and southern sides of Starch Dryer No. 5 and extends west to the maintenance workshop (Photo 1). The area was near level and occupied by concrete pavement and gravel hardstand. No evidence of contamination or contaminating activities were observed within the proposed development area.

Photo 1: Looking south towards proposed Site 1 development area

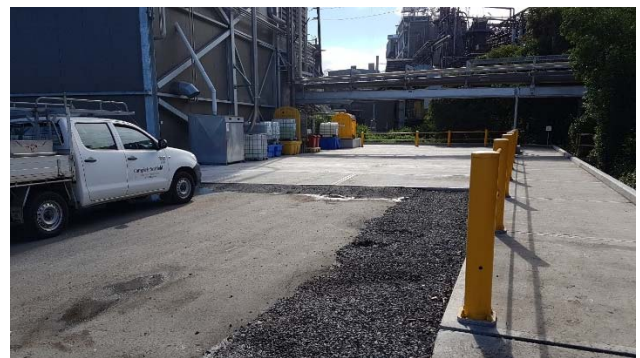
The southern area was used for storage of various acids and sodium hydroxide in IBC containers. The chemicals were stored within a concrete paved area. There was no apparent evidence of historical spillages which was consistent with anecdotal information provided by John Studdert, a Manildra employee for 17 years (Photo 2).

Photo 2: Looking east at Site 1 along the southern side of Starch Dryer No. 5.

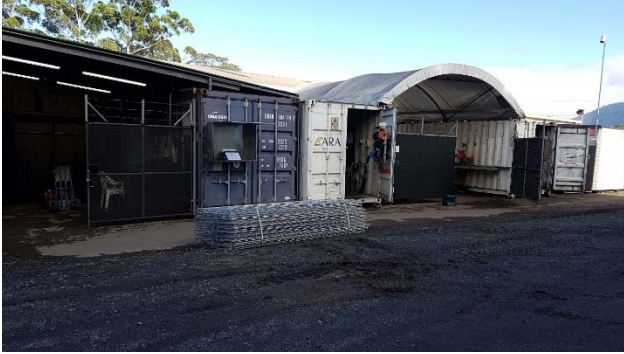
The maintenance area is located to the west of Site 1 and includes a store and contractor mechanical engineers workshop. Photo 3 shows workshop areas.

Photo 3: Looking northwest of Site 1 towards workshop areas

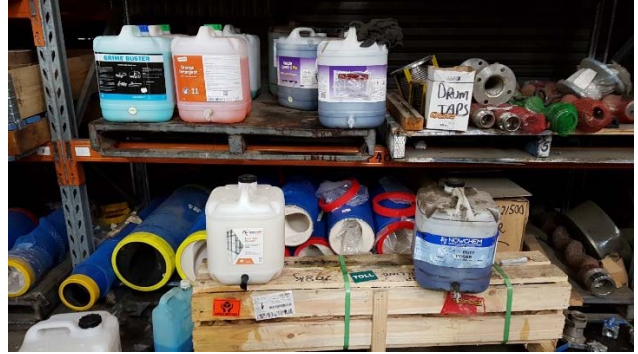
The maintenance store includes spare parts and small quantities (~20L) of oil, thinners, cleaners, detergents, grease, etc. Oil was also stored in 205L steel drums. (Photos 4 & 5).

Photo 4: Typical chemical storage

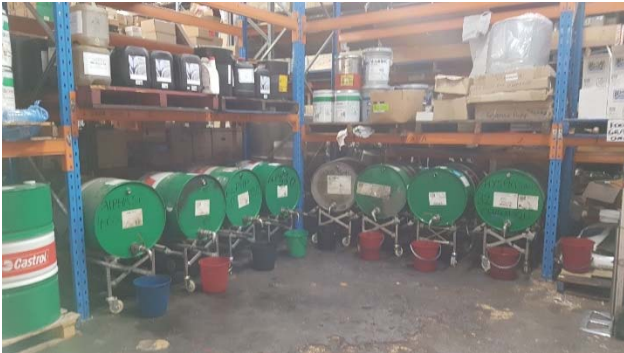
Some oil was observed on the concrete floor of the maintenance stores building. The concrete floor appeared to be in good condition, however joints between concrete slabs were up to 1cm wide, which may allow surplus spills to seep into underlying ground.

Photo 5: Oil storage area

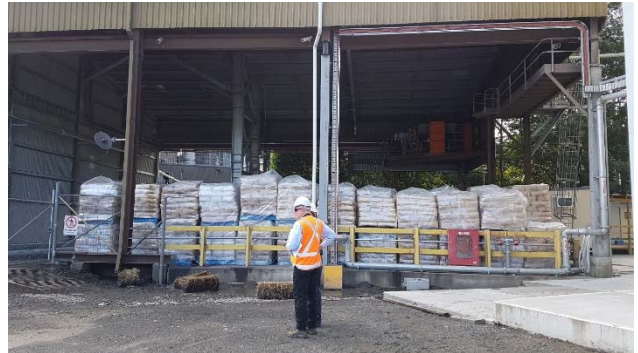
The northern development area adjoined a carpark (north) and undercover wheat starch store (Photo 6). Mr Studdert indicated that prior to ownership by Manildra, this area was a steel fabrication workshop. No other activities other than wheat starch storage had occurred in this area.

Photo 6: Undercover wheat starch storage area

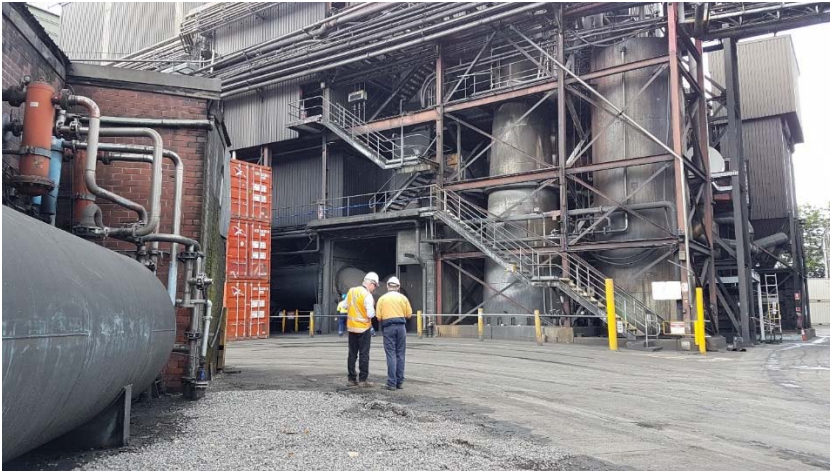
The proposed Site 2 development is located adjacent to the existing boilers, substation No. 4 and internal access road. (Photo 7 – use IMG-20180117-103018). At the time of our site visit, the site was asphalt paved and occupied by three shipping containers (Photo 8 – IMG-20180227-103227). The asphalt pavement was in fair to good condition. No apparent evidence of contamination observed.

Photo 7: Looking south towards proposed development area

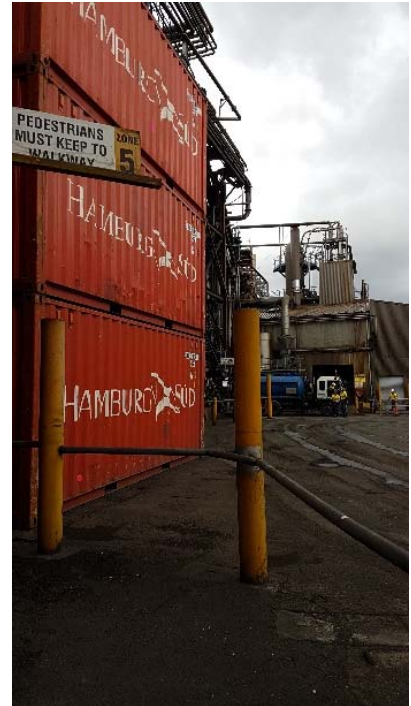
Photo 8: Looking west towards the proposed development area

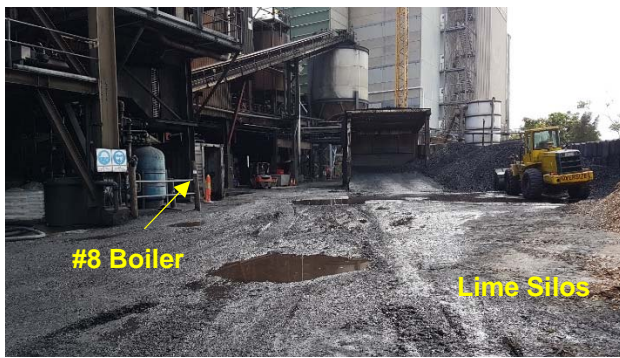
The proposed Site 3 development is located on the southern side of the existing boiler house (Photos 9 and 10). The existing boiler house forms part of the original plant structures constructed approximately 30 years ago. The boilers are coal, gas and woodchip fired. Coal and woodchip are stored in stockpiles south of the proposed development and adjacent to the Shoalhaven River (Photo 9). Mr Studdert indicated that the coal ash from the boilers was washed then transported to the farm.

At the time of our site visit, surface water was ponded due to recent rain over parts of the paved or gravel surfaces. The ground surface appeared impaired, comprising mostly woodchip and coal dust/fragments to give it its black colour (Photos 9 & 11). Some fill may exist below the woodchip.

Photo 9: Looking east towards proposed Site 3 development area

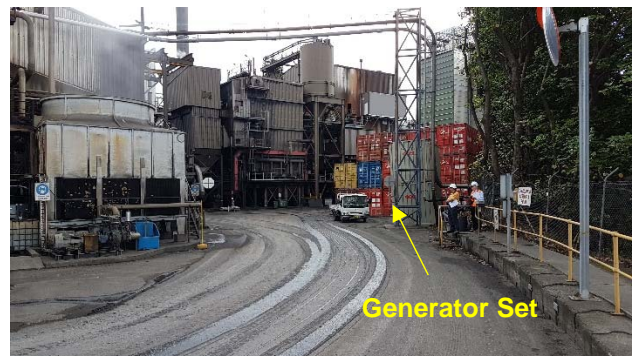
Photo 10: Looking northeast towards proposed generator set location

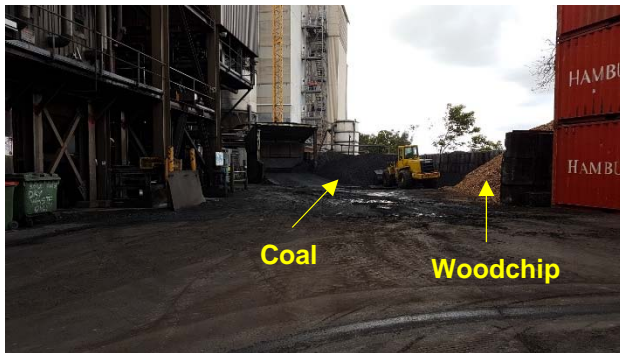
Photo 11: Looking east towards woodchip and coal stockpiles

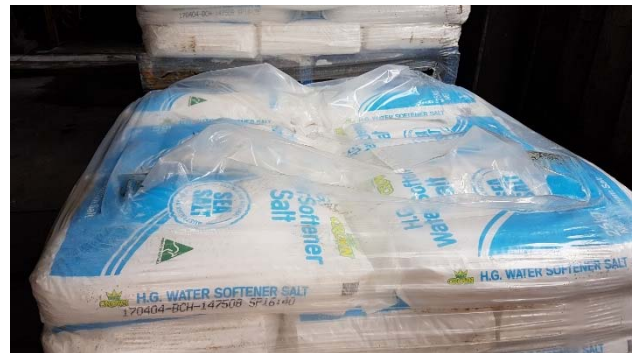
No chemical storage was observed in the general vicinity of Site 3, however 25kg bags of water softener salt were noted (Photo 12). Mr Studdert indicated that the softener is a form of sea salt and used in the boiler water. No apparent evidence of contamination was observed.

Photo 12: 25kg salt bags stored adjacent to proposed #8 Boiler.

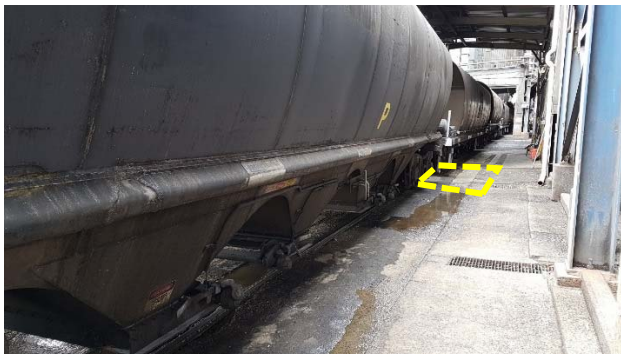
The proposed development of the extension to the grain unloading pit will require excavations for the unloading pit and foundations for the conveyor bucket elevator. The proposed intake pit will be positioned on the eastern side of the existing intake pit, within the rail corridor (Photo 13). The railway infrastructure forms part of the original plant and is used to transport flour, wheat and millfeed. The trains are pulled by diesel locomotives. Mr Studdert indicated that there have not been any reported diesel spills associated with the locomotives. The rail corridor comprised a single operational track. Within Site 4, the 4 foot section of shoulders were asphalt paved. Photo 14 shows an example of pavement condition within Site 4.

Photo 13: Looking west towards proposed unloading pit extension (Site 4 development area), as shown in yellow.

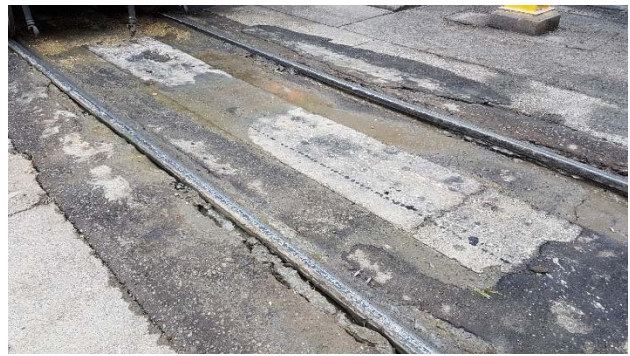
Photo 14: Typical condition of the rail track near grain unloading pit.

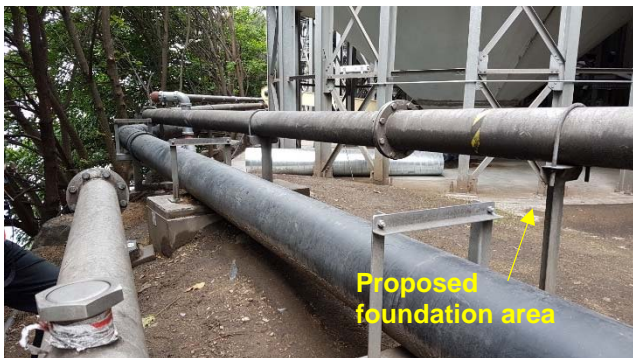
The proposed foundation area for the conveyor bucket occupies a relatively small area adjacent to the existing grain silo (north and west) and Shoalhaven River (south) (Photo 15). Photo 16 shows the general foundation area which appears to have been filled. The fill may have been generated during the construction of adjoining silos.

Photo 15: Looking west towards area for conveyor bucket foundations. Note proximity to Shoalhaven River immediately to left of photo.

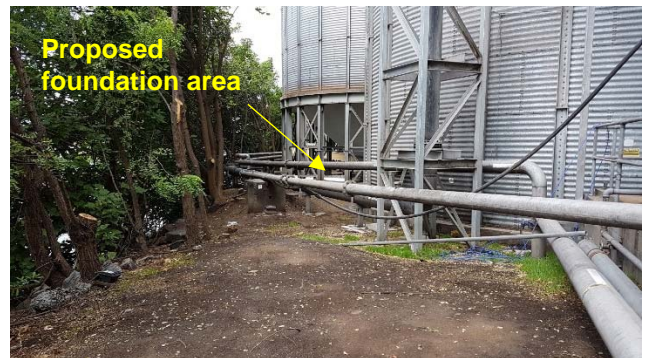
Photo 16: Looking west towards area for conveyor bucket foundations. Note potential fill within foreground of photo.

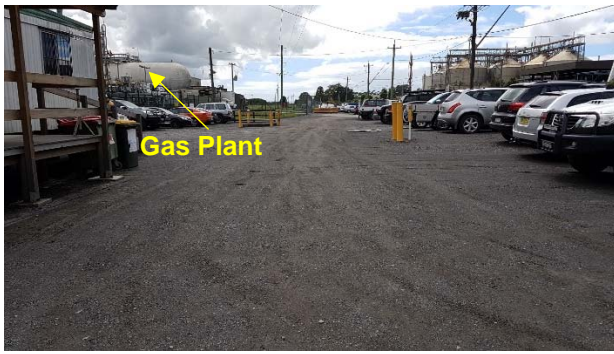
This site is currently used as a gravel hardstand carpark and demountable office building (Photos 17 & 18). The gravel hardstand comprised crushed rock sourced from a local quarry. Apart from the gravel, we understand no other fill has been placed at this site. North and east of the site there is a gas plant which was built over 20 years ago. Mr Studdert indicated that no other activities have been undertaken at the site, and prior to being developed was used as farming land.

Photo 17: Looking east at the proposed Site 5 development area.

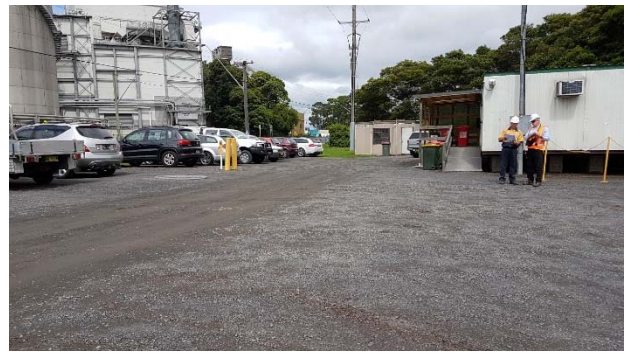
Photo 18: Looking west at the proposed Site 5 development area.

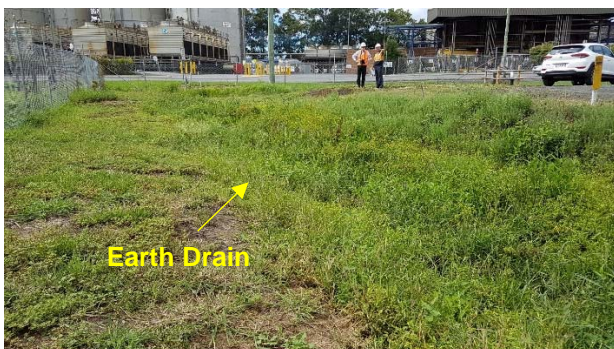
The proposed carpark area will be located east of an earthen drain within an open paddock area. The site divided by a chain wire fence, which is orientated north-south (Photo 19).

Photo 19: Looking south towards an earth drain that receives runoff from Bolong Road.

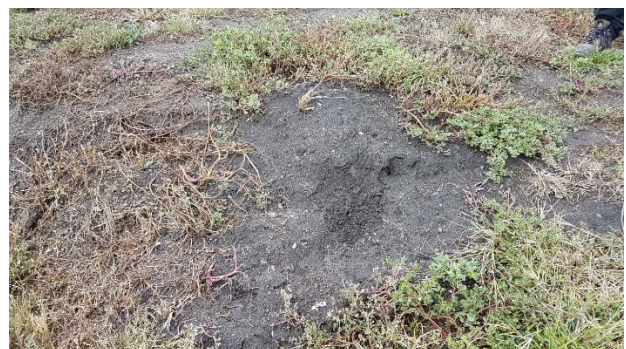
The western bank of the drain appeared to have been filled with concrete and topsoil evident (Photo 20). Ash may have also been placed in the vicinity of the drain, however no evidence of ash was observed. The drain receives stormwater from Bolong Road. A drainage valve and temporary bunded area within the adjacent farmland allows containment of process water overflows from the main plant area.

Photo 20: Looking at the southern section of the western bank of drain indicating topsoil fill.

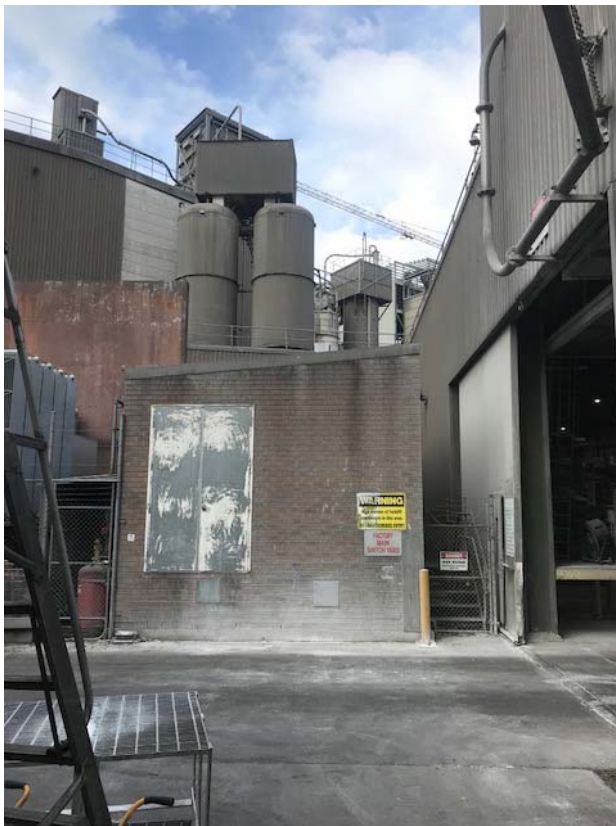
The area of the proposed substation extension is shown in Photos 21 and 22. The site adjoins an asphalt paved access way and appeared to be in relatively good condition. The current substation footprint comprises coarse grained gravel. We note transformers are present and can contain PCB oil. Mr Studdert confirmed that one transformer was replaced in 2007 and the other in 2011. At the time of replacement, the oil was tested and did not contain PCB's. No information was available regarding PCBs in oil prior to this time. No oil releases from transformers have occurred onsite.

Photo 21: View of brick building at existing substation area

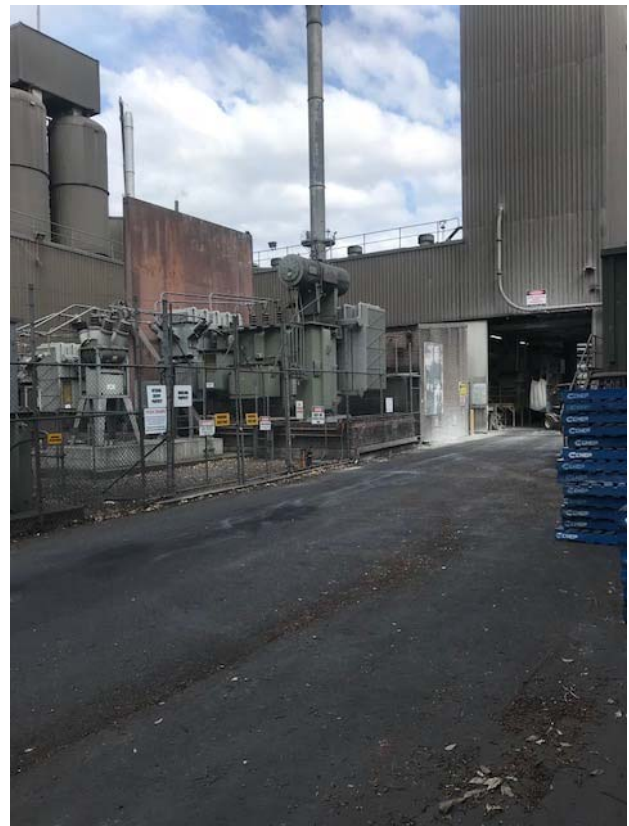
Photo 22: View of existing substation

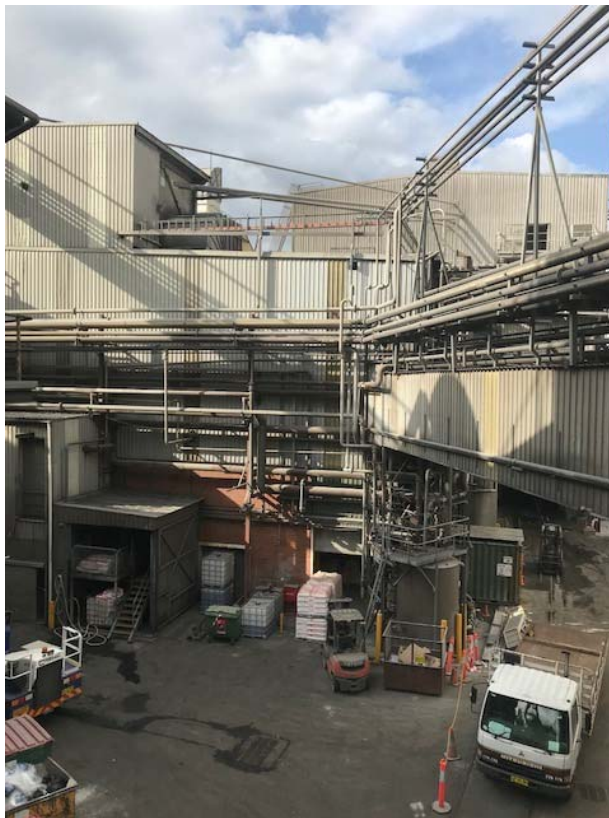
This will involve the conversion of two existing Gluten Dryers (Nos. 1 and 2) to starch dryers, within the existing starch plant production building. No ground penetration anticipated. The site for these proposed works is sufficiently remote from the Shoalhaven River bank and the eastern bank of Abernethy's Creek not to influence the stability of the river or creek banks. Photo 23 shows the general area of the proposed development.

Photo 23: View of proposed Starch Plant Building
