From Sections N1 to N4 Quarry Resources Investigation Report Doc No: GEOTLCOV23007AC-BP 27th August 2007 HUME HIGHWAY DUPLICATION STURT HIGHWAY TO HOLBROOK NORTHERN HUME ALLIANCE

## 3.0 BLYTH MERINO QUARRY (N1)

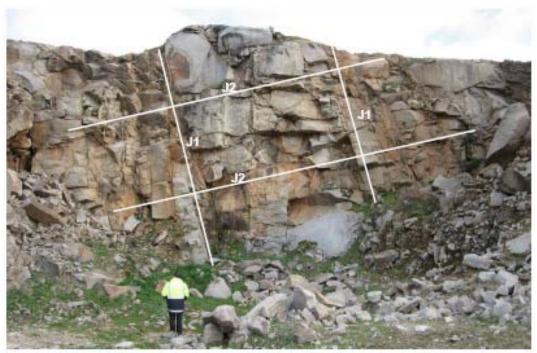
**Plate BM1:** Locality 1, Looking west at quarry face exposed at Blyth Merino Quarry showing the slightly weathered and fresh nature of the rock mass at this locality. The dominant joint sets are highlighted.

Joint Set 3 strikes sub-parallel to the quarry face and creates the flat surface of many of the blocks.

There appear to be three dominant joint sets plus one random joint set within the rock exposed at Blyth Merino Quarry. The first, Joint Set 1, trends WNW-ESE and dips steeply north at around 85 degrees. Joint Set 2 dips shallowly at around 20-30 degrees, trending NNW-SSE. Joint Set 3 trends roughly north-south and dips subvertically at around 87 degrees to the east. These joints sets are highlighted on Plate BM1 which shows the main quarry face.

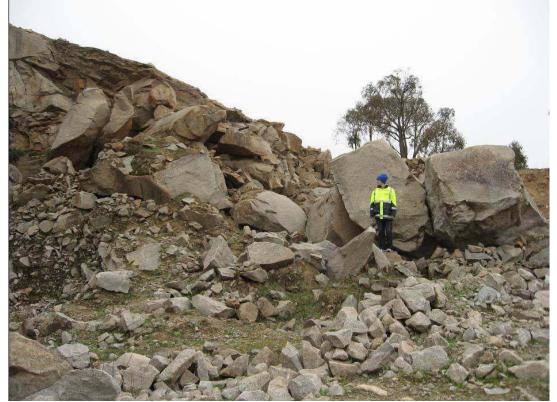
**Plate BM2**: Locality 1, Photo looking north at variation in block size and oblique-shaped (rhomboidal) equidimensional rock blocks.

The joint sets identified were noted to be medium to very widely spaced (600mm to >2000mm) giving rise to medium to very large (200mm to >2000mm) rock blocks (refer to Plate BM2). The three dominant sets of discontinuities are mutually oblique with occasional irregular joints, this gives rise to oblique-shaped (rhomboidal) equidimensional rock blocks (refer to Plates BM2 and BM3).

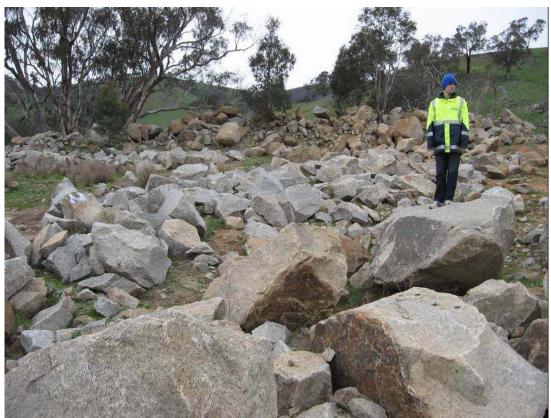
Plate BM3: Locality 2, Photo looking south-east at both fresh and slightly weathered granodiorite blocks, note equidimensional, oblique-shaped nature of the rock blocks. These rocks were sampled and crushed for material testing.

The rock in close proximity to the existing quarry face is predominantly slightly weathered to fresh, as witnessed by the numerous loose rocks in the vicinity (refer to Plate BM3). The degree of weathering would appear to increase as one moves westward, this was evident within the boreholes that were carried out as part of this investigation and is substantiated by the topography of the area which slopes away suddenly to the west with no visible rock outcrops. Elsewhere in the vicinity of the quarry, granite can be seen to be very close or at ground surface (refer to Plate BM4). This is suggestive either of a change in rock type or an increase in weathering of the rocks in this area.

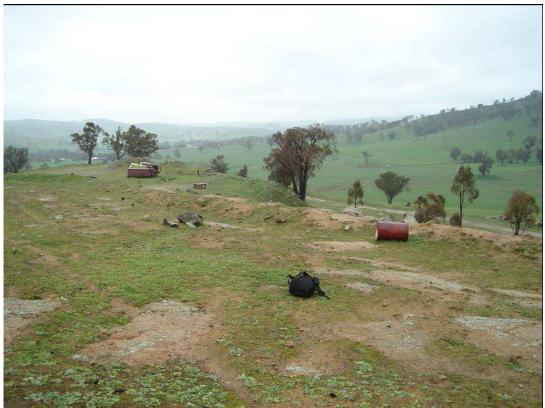
**Plate BM4:** Locality 3, Photo looking north-east at upper plateau above quarry face and working area. Note granodiorite outcrops at or very close to ground surface.

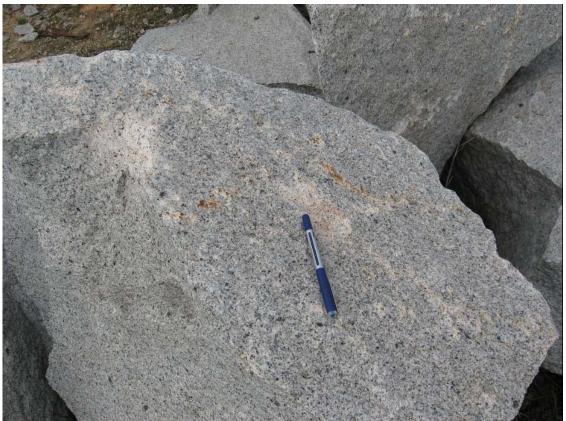
**Plate BM5:** Locality 2, Close up detail of ex-situ block of fresh granodiorite showing pale grey, evengrained and isotropic nature of the rock mass. The white and pale grey minerals are plagioclase feldspar and quartz and the black flecks are biotite.

indicates the mineralogy is dominated by quartz, plagioclase and orthoclase feldspars with subordinate biotite and muscovite mica (refer to Plate BM5). The quartz and feldspar crystals are 1mm to 4mm in size. No fabric was observed within the rock and it may therefore be described as massive or isotropic. However, the petrographic analysis identified significant microfractures within the quartz crystals and extending to some feldspar crystals. These microfractures are postulated as a result of earthquake damage (this could be possibly related to quarry blasting) and are inferred to reduce the strength of the rock, increase water absorption and produce more sands during crushing.
