Fern Bay Seaside Village
Offset Package:
Worimi Regional Park
Vegetation Management Plan

Aspen Group Pty Ltd

0065580VMP Final 1

February 2009

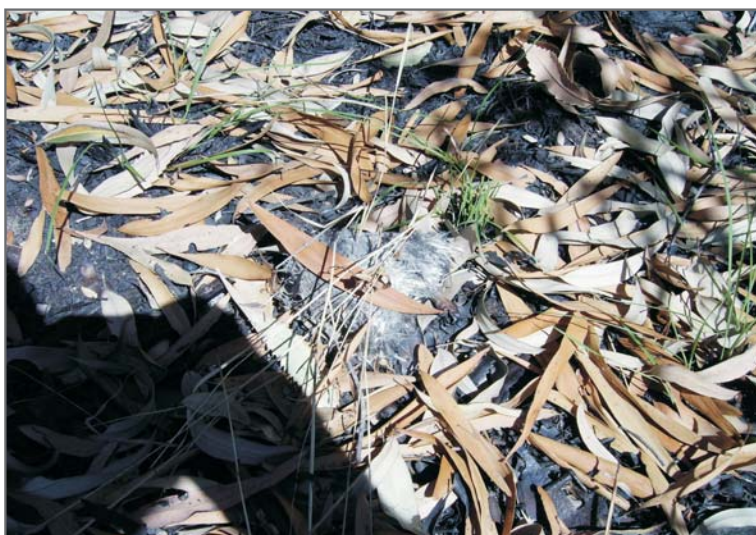
Photograph 2

Fragments of glass-fibre type material (potential asbestos containing material). Corresponds to Mark 1.

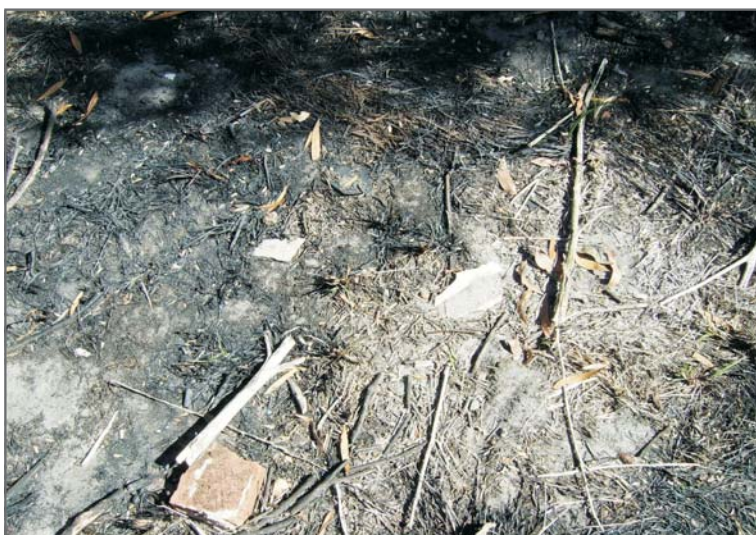
Photograph 5

Fragments of cement fibre sheeting (potential asbestos containing material). Corresponds to Mark 4.

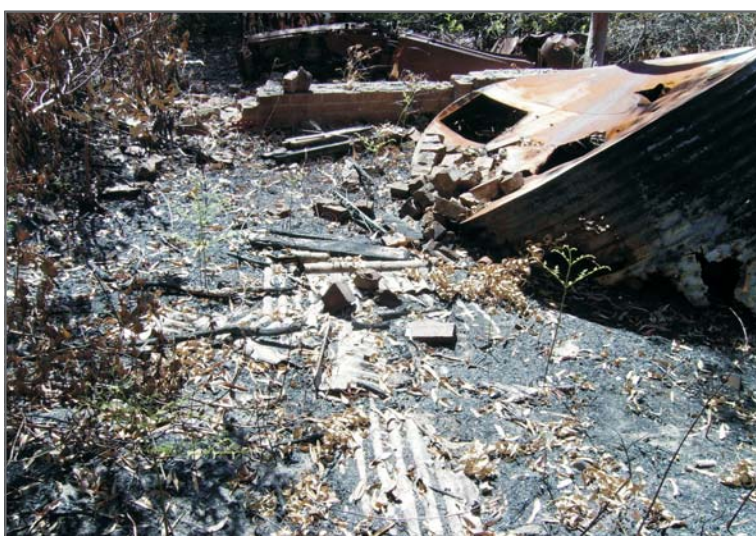
Photograph 9

Burnt out car and fragments of cement fibre sheeting (potential asbestos containing material), building rubble, corrugated metal water tank. Corresponds to Mark 10.

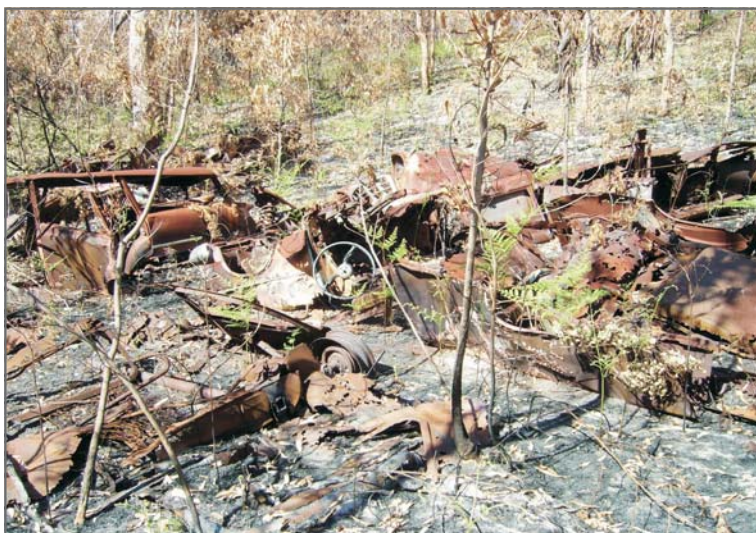
Photograph 34

Burnt out cars, piles of rusted barbed wire. Corresponds to Mark 20.

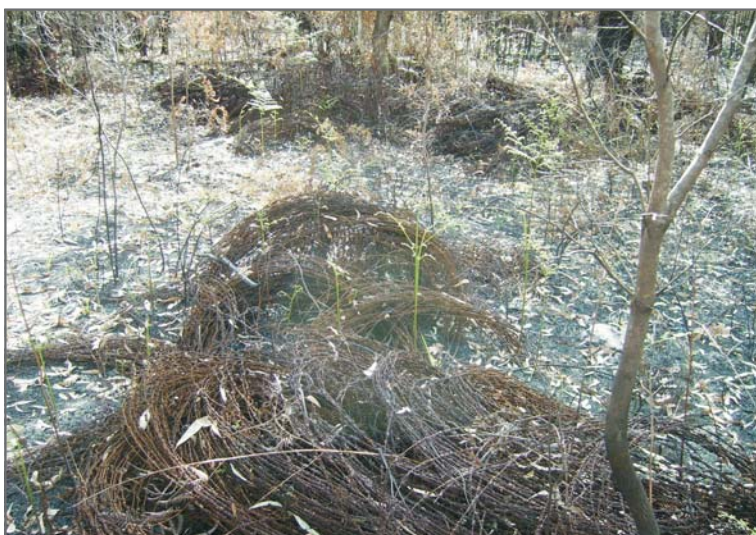
Photograph 35

Area with coils of old rusted barbed wire. Corresponds to Mark 25.
