Appendix L
Soils management

REPORT 10-5693mrc01-emp

General Soil Management Assessment Queensland Hunter Gas Pipeline (QHGP)

1 SEPTEMBER 2008

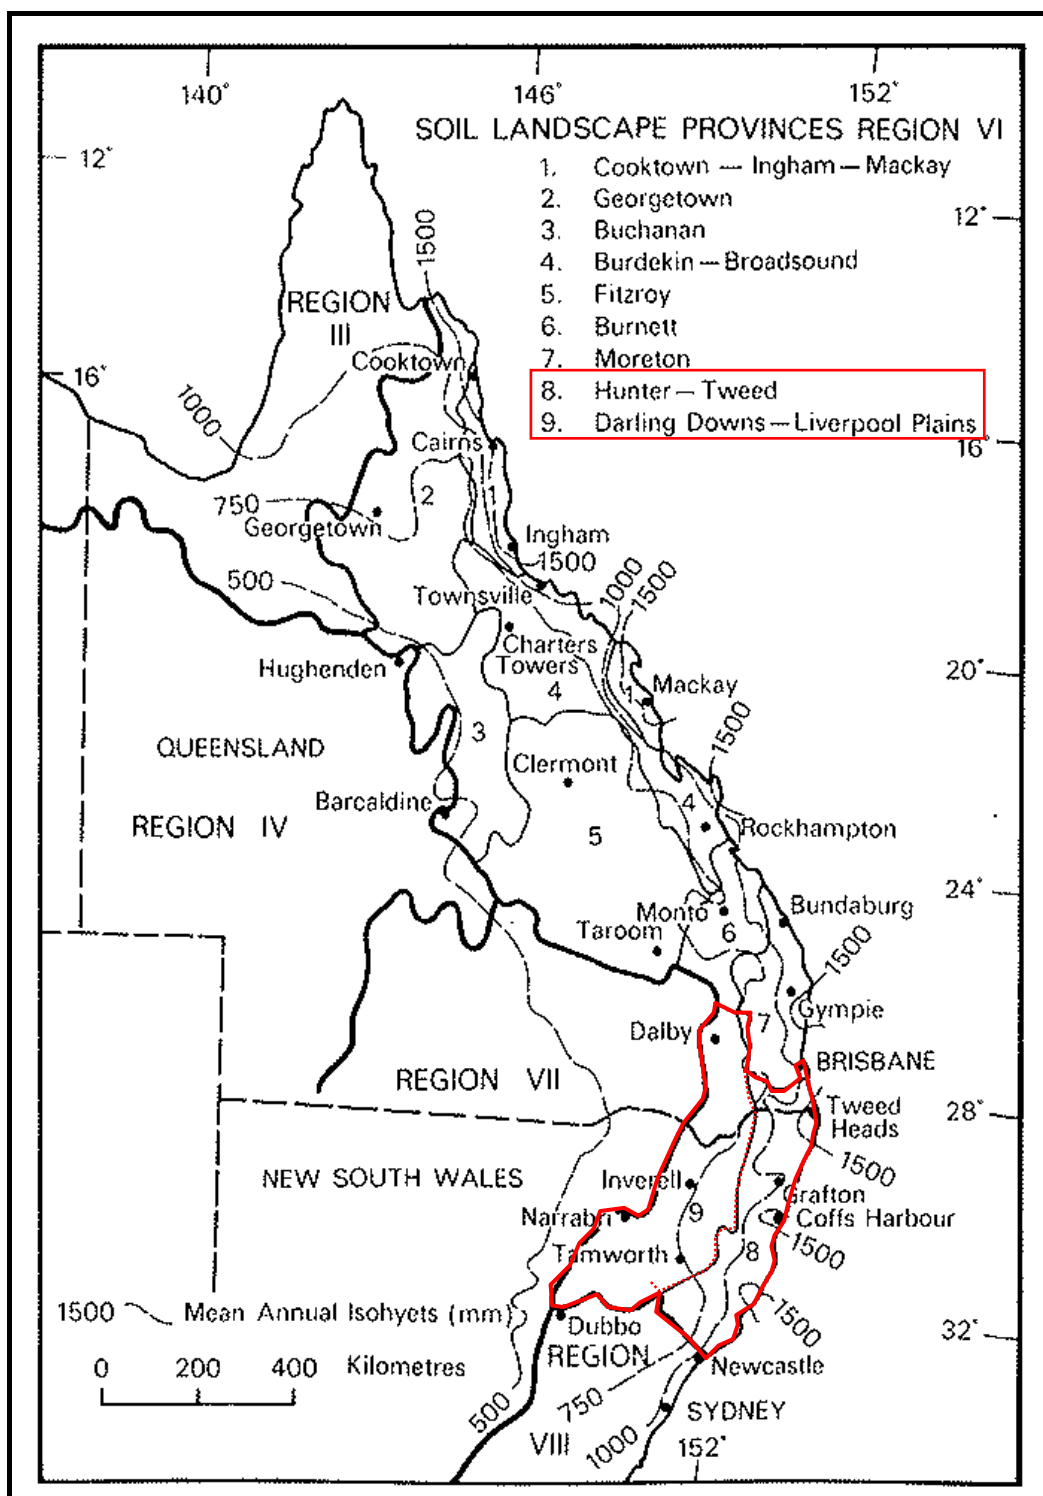
Figure 3a – Soil Landscape Region VI Eastern Highlands (Hubble and Isbell, 1983)

- Region VI Eastern Highlands (**Figure 3a**); and
- Region VII Murray – Darling Plains (**Figure 3b**).

Hubble and Isbell (1983) described this region as *having a dominantly erosional terrain and embraces all of the hilly to mountainous and undulating lands of eastern Australia*. Because of the Great Dividing Range traversing its length, the elevation reaches 1,600 m near coastal areas in the extreme north and south. The land relief is moderate and is influenced by valleys and ranges which are juxtaposed to the coast with crest heights of up to a range between 600 m and 900 m (e.g. the Liverpool Range in the vicinity of Ardglen, Murrurundi Section KP627 to KP629 in **Figure 2i** in **Appendix B**). The region consists of 9 soil landscape provinces, of which 2 landscape provinces are related to the Study Area (**Figure 3a**):

- Hunter – Tweed (Approx KP628 to KP819); and
- Darling Downs – Liverpool Plains (approx. KP 428 to approx. KP628).

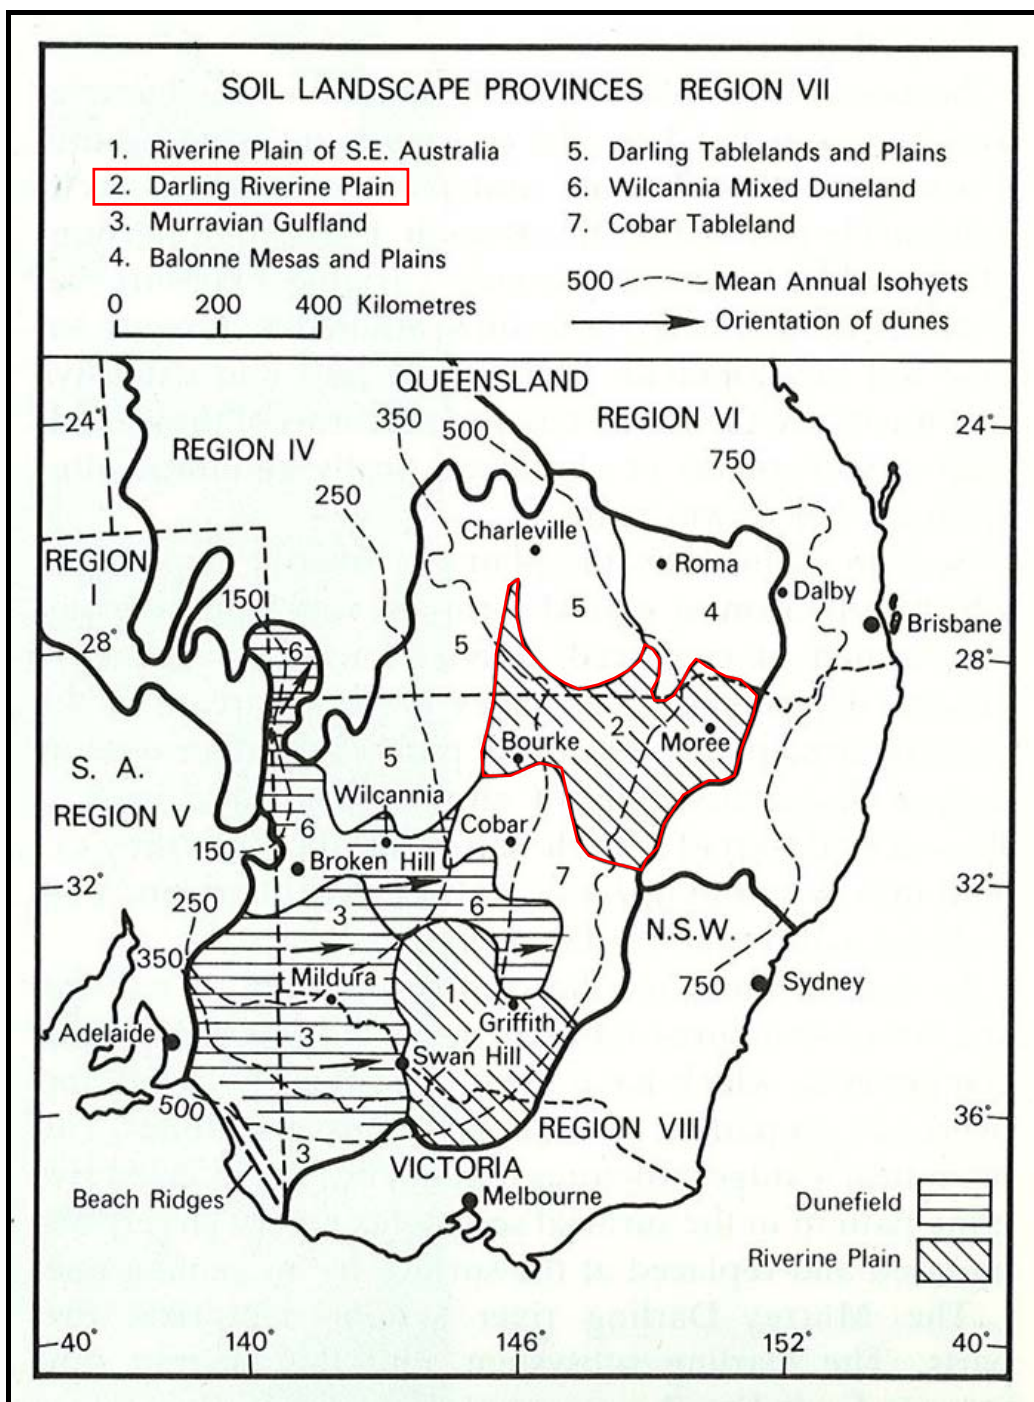
Figure 3b – Soil Landscape Region VI Murray-Darling Basins (Butler et al., 1983)

Of 9 landscape provinces forming the region, the Darling Riverine Plain Province (**Figure 3b**) covers a study area between KP 222 to approx. KP 428. This province comprises the alluvial plains of the following rivers:

Plains of riverine deposition, inlier hills and liner dunes are typically found in the province. Alluvial deposits and mantles of ancient weathering are often observed. The general pattern of soils in the province is based on coalescent alluvial fans of river ridges and clay flood plains, resulting in grey, brown and red clays being predominant. The concentration of soluble salts increases towards the southwest. Solodized solonetz occurs on the levees in the northern tributaries. Red brown earth also occurs on these levees towards the southeast. Black earths are associated with plains of basaltic alluvium.

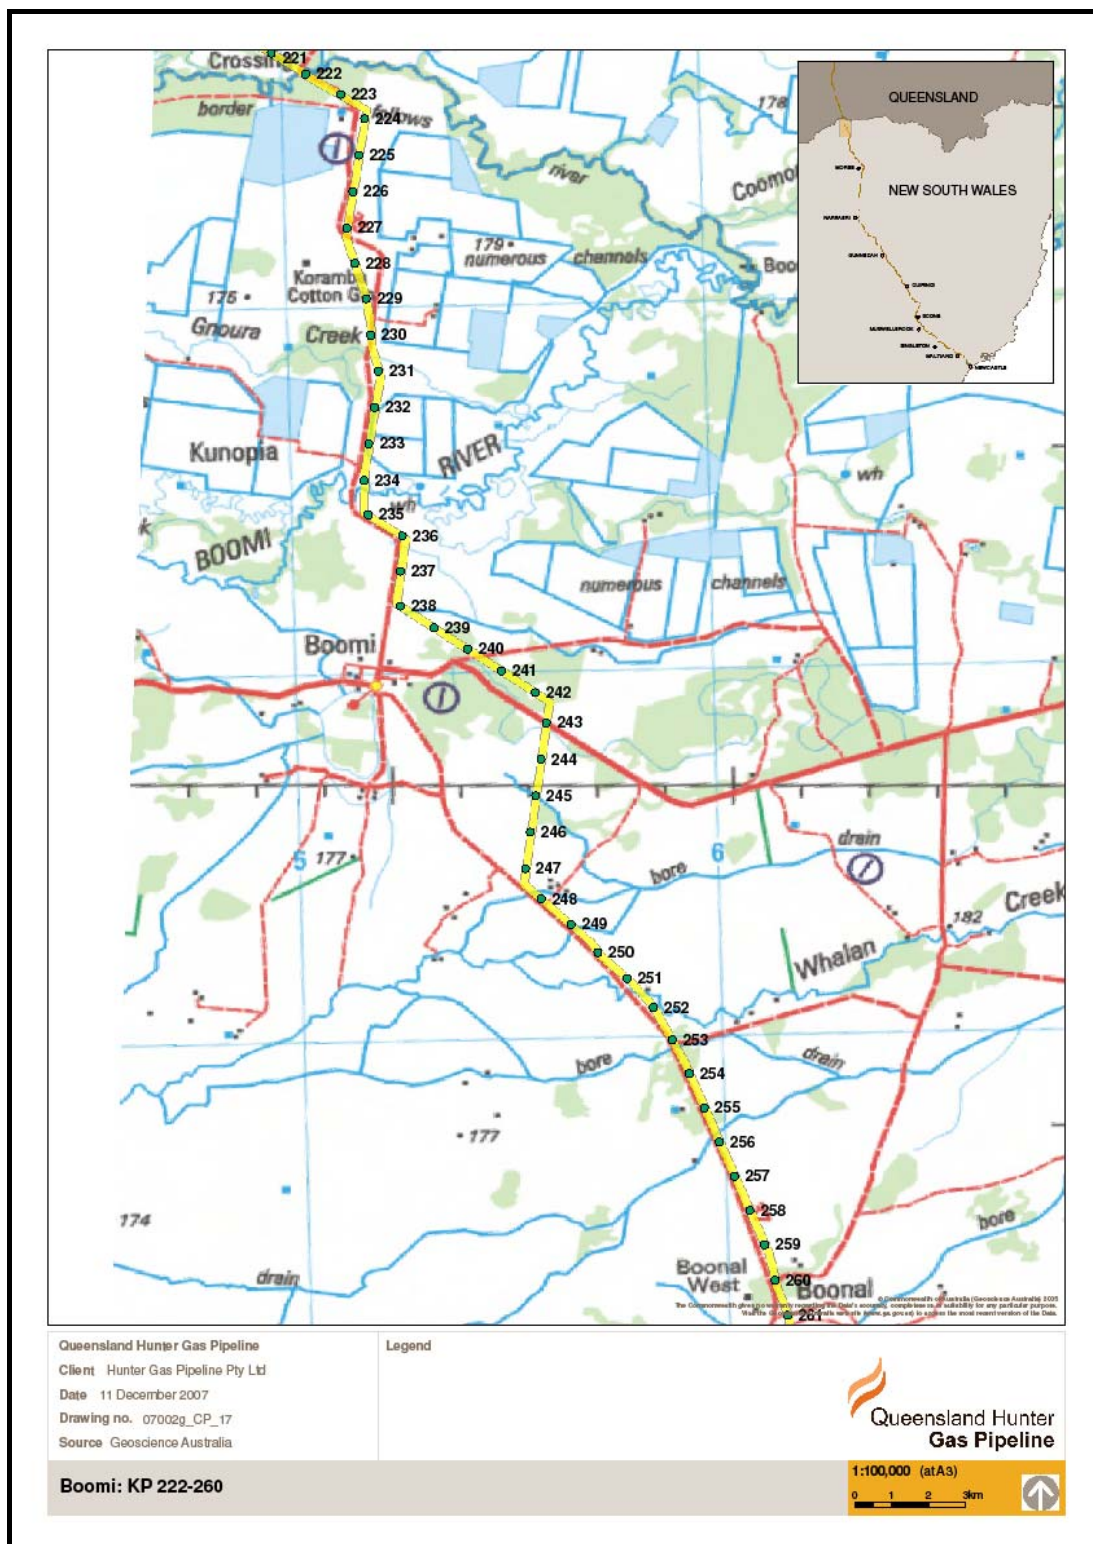
Figure 2a – Study Area in Boomi (KP222-260)
 (Original plan supplied by the Client on 17 December 2007)

- Boomi, Kilometre Point (KP) 222 – 260 (**Figure 2a in Appendix B**);
- Garah, KP 260 - 295 (**Figure 2b in Appendix B**);
- Ashley, KP 295 - 333 (**Figure 2c in Appendix B**);

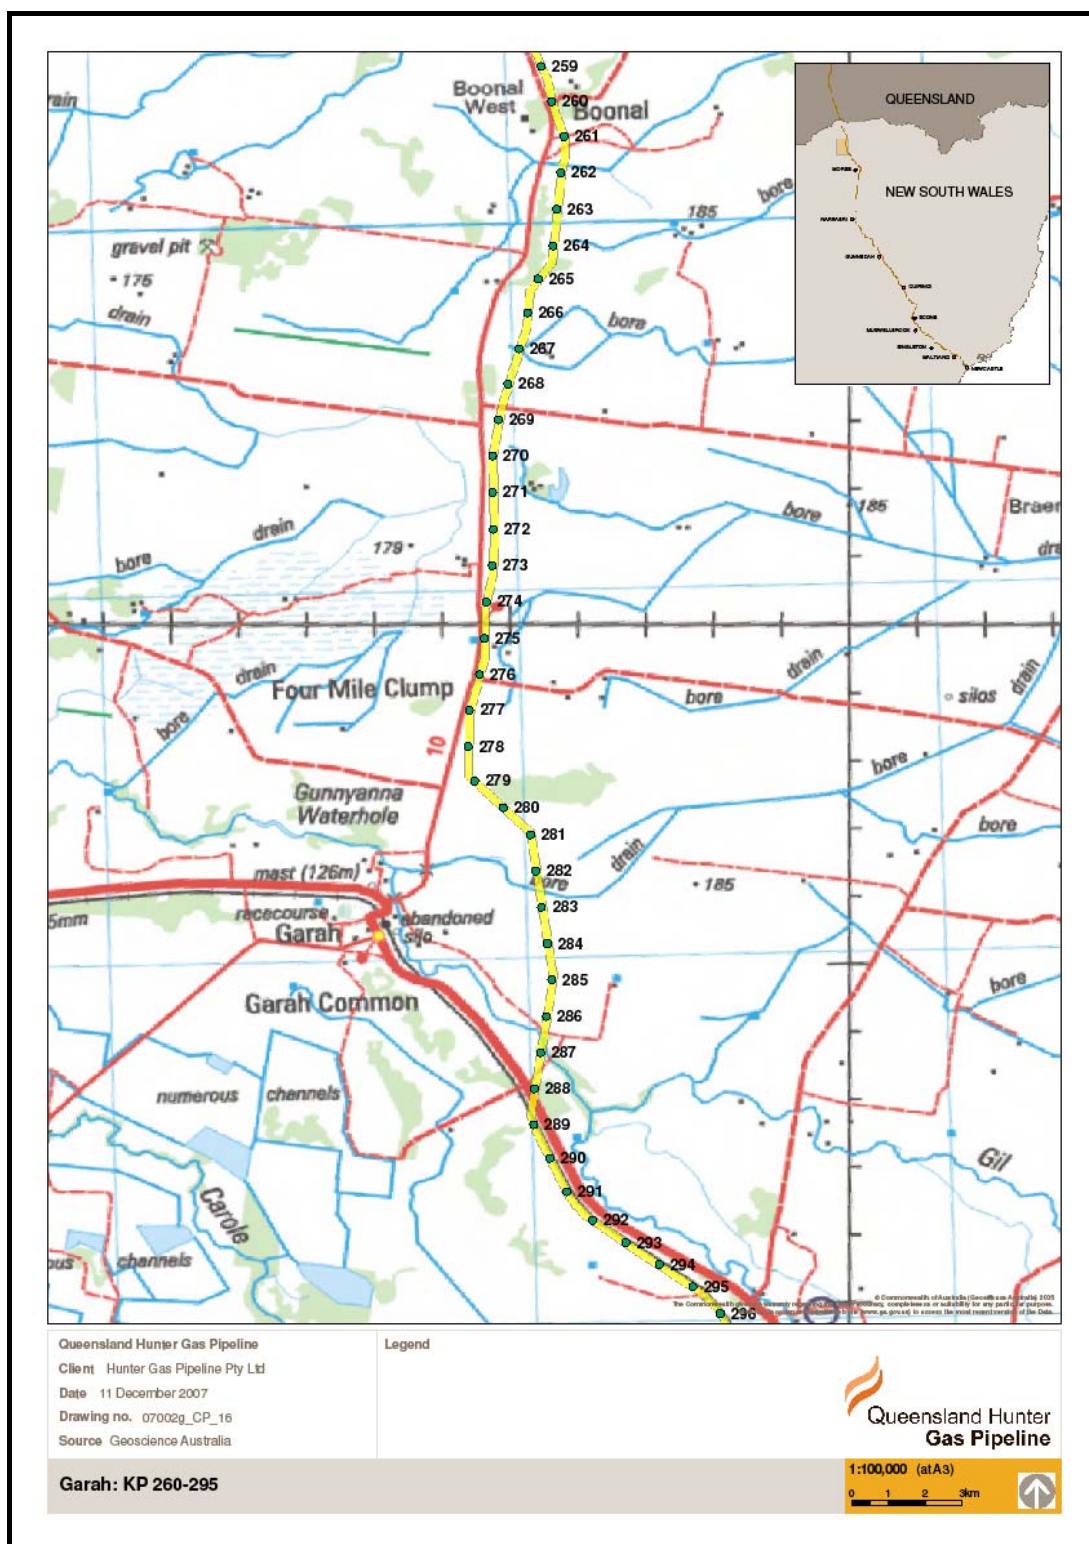
Figure 2b – Study Area in Garah (KP260-295)
(Original plan supplied by the Client on 17 December 2007)

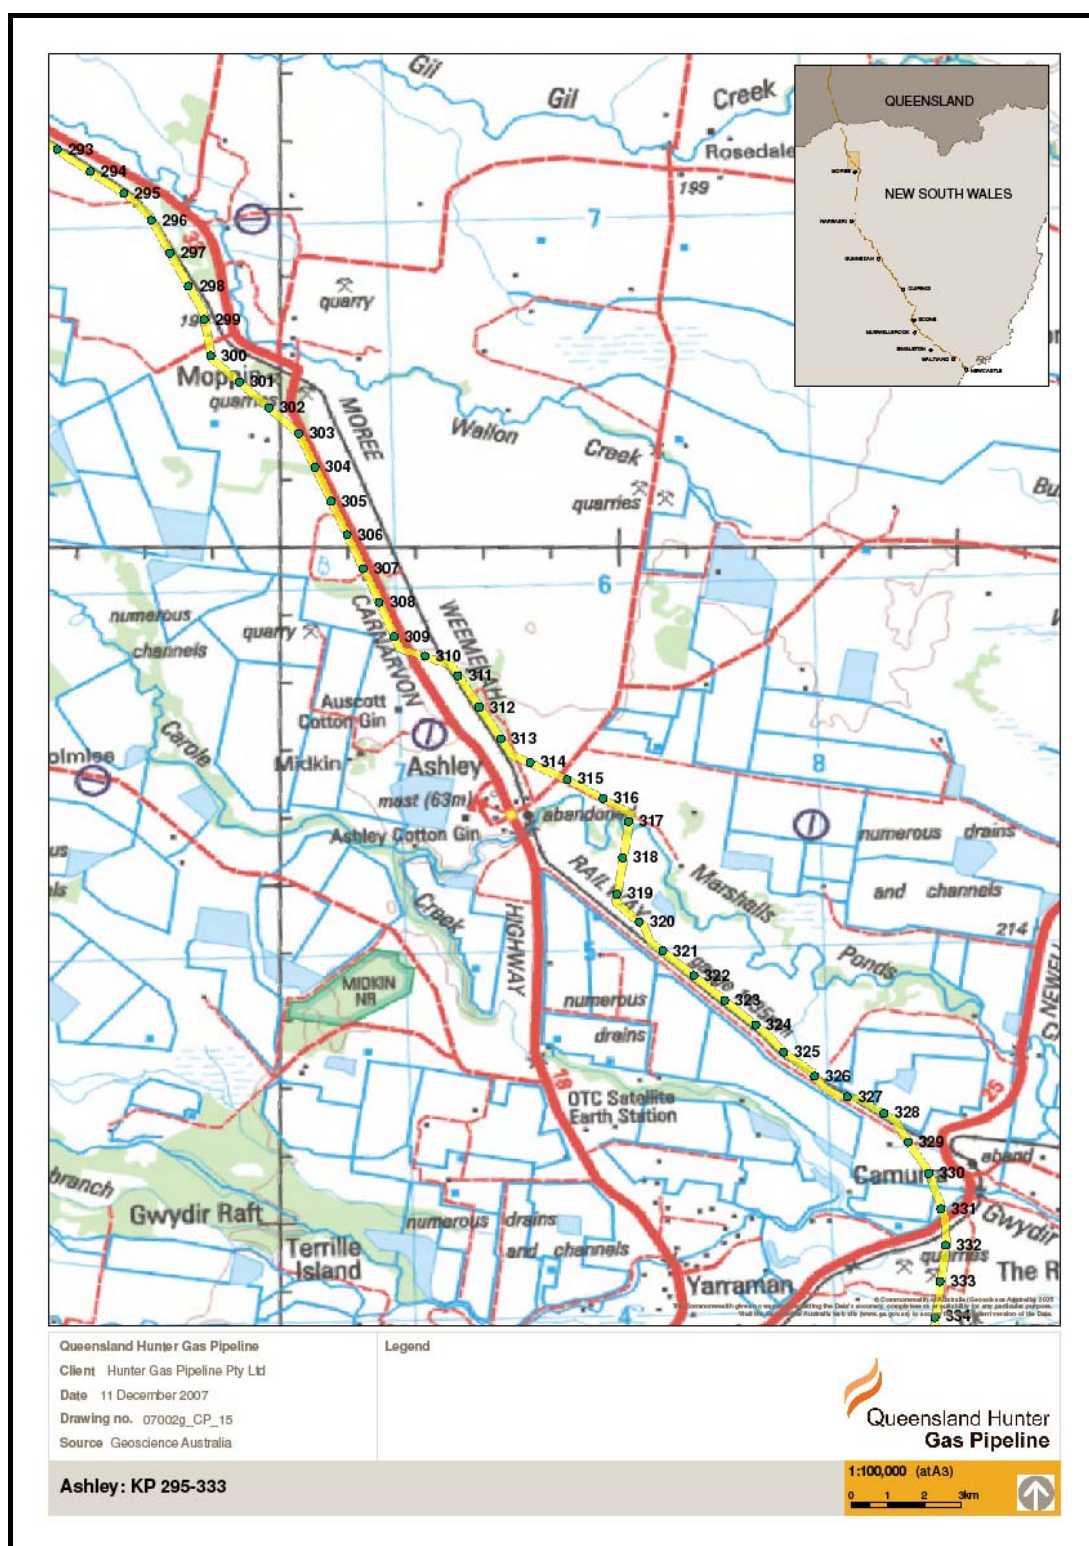
Figure 2c – Study Area in Ashley (KP295-333)
 (Original plan supplied by the Client on 17 December 2007)

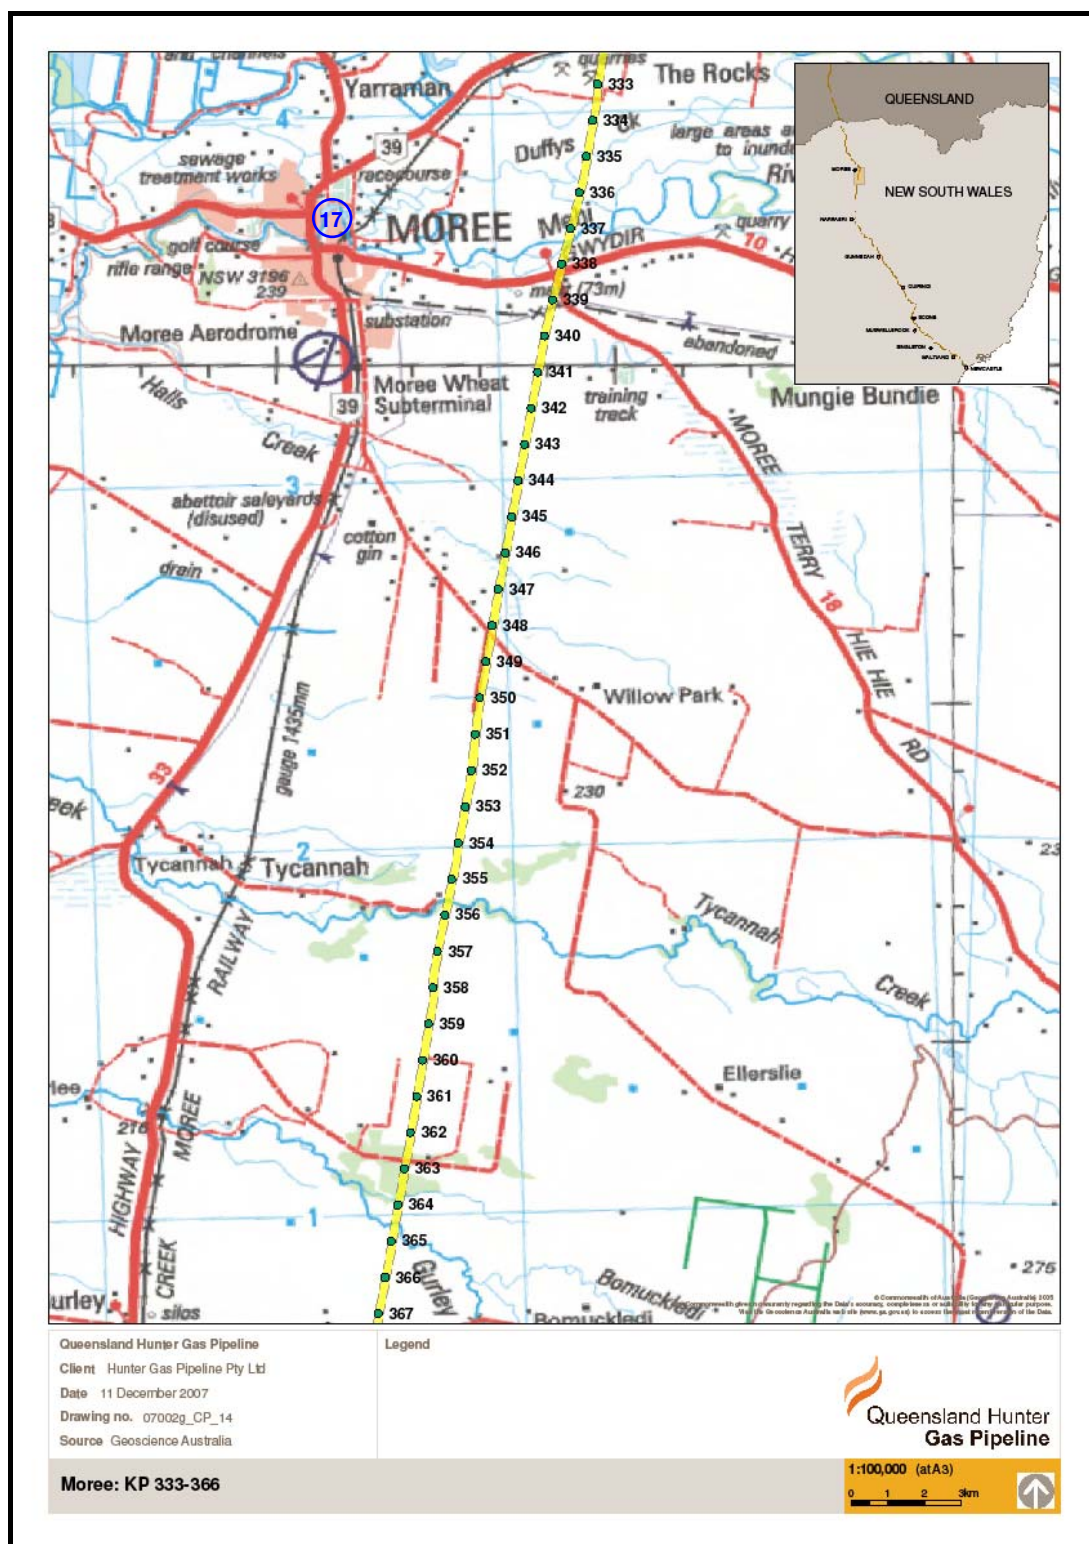
Figure 2d – Study Area in Moree (KP333-366)
 (Original plan supplied by the Client on 17 December 2007)

- Moree, KP 333 - 366 (**Figure 2d in Appendix B**);
- Bellata, KP 366 - 399 (**Figure 2e in Appendix B**);
- Narrabri North, KP 399 - 432 (**Figure 2f in Appendix B**);

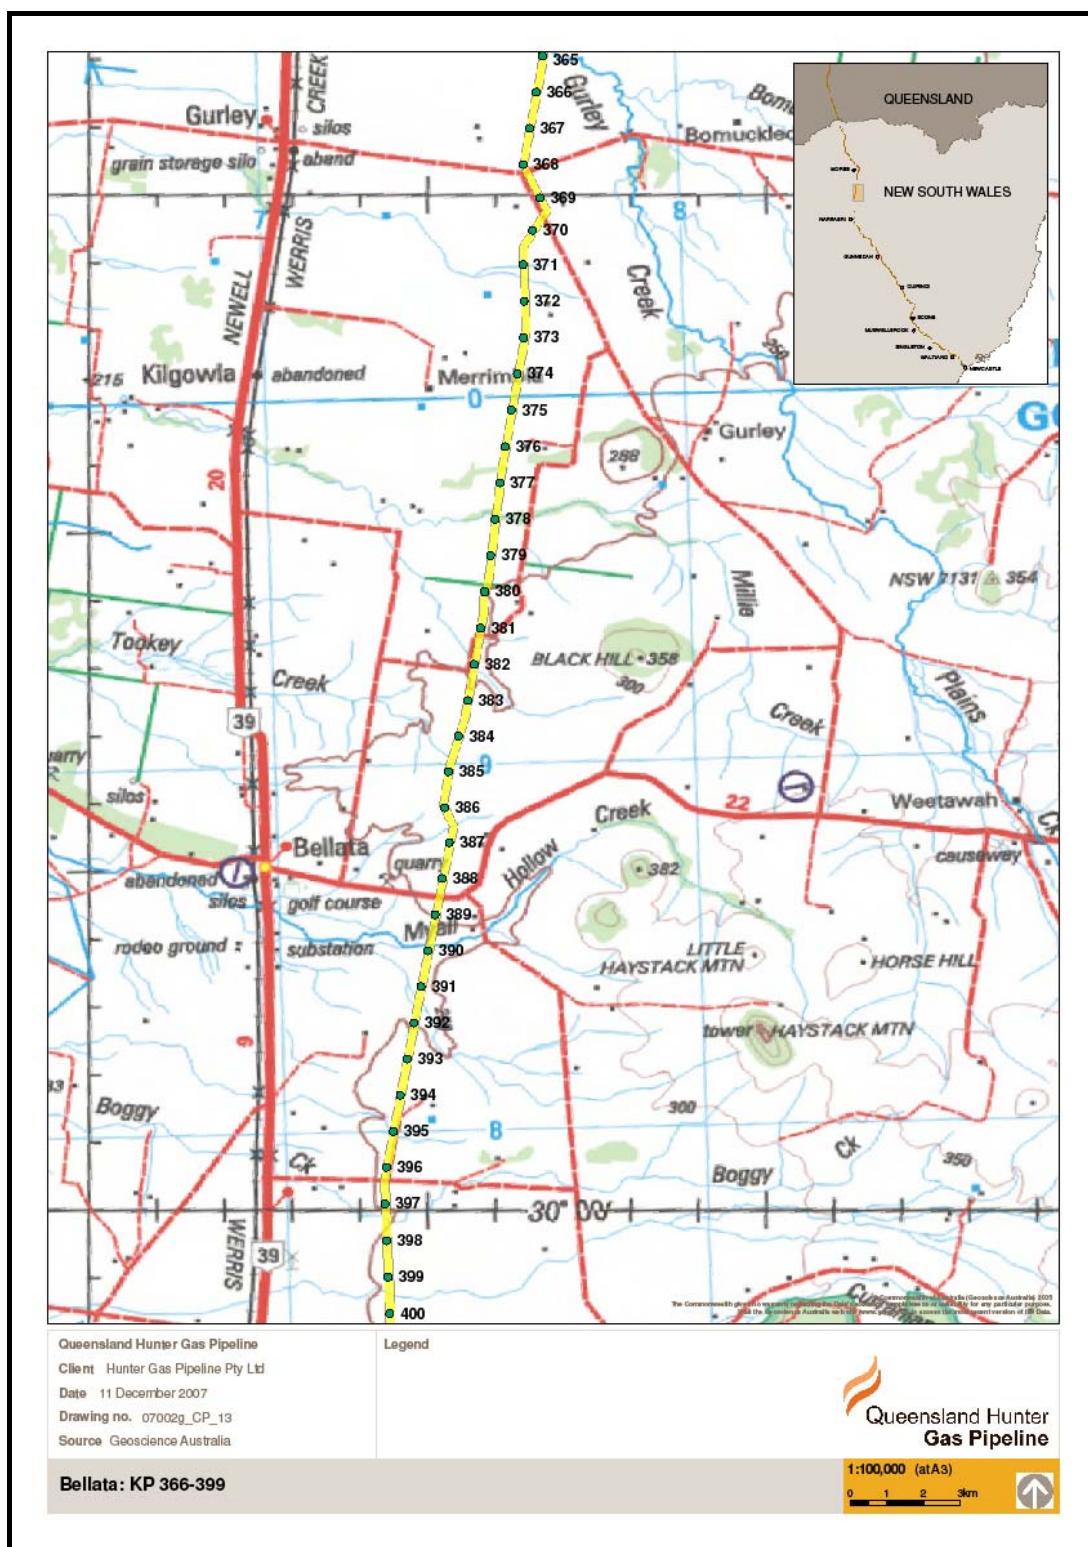
Figure 2e – Study Area in Bellata (KP366-399)
(Original plan supplied by the Client on 17 December 2007)

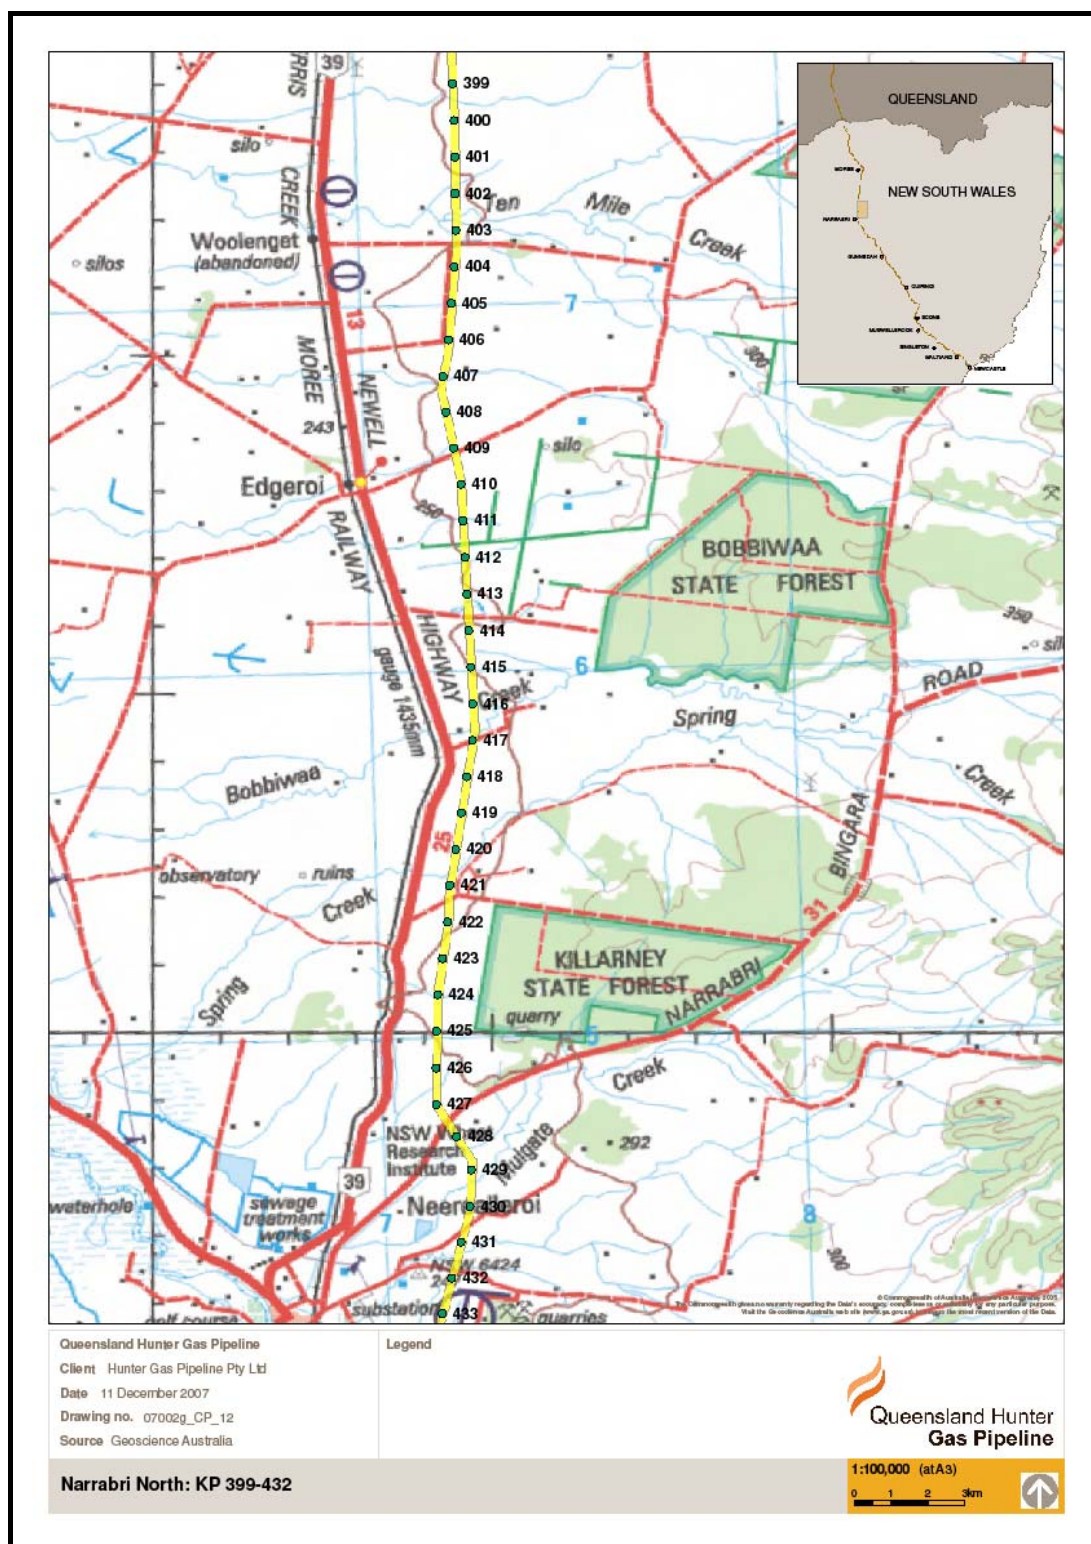
Figure 2f – Study Area in Narrabri North (KP399-432)
 (Original plan supplied by the Client on 17 December 2007)

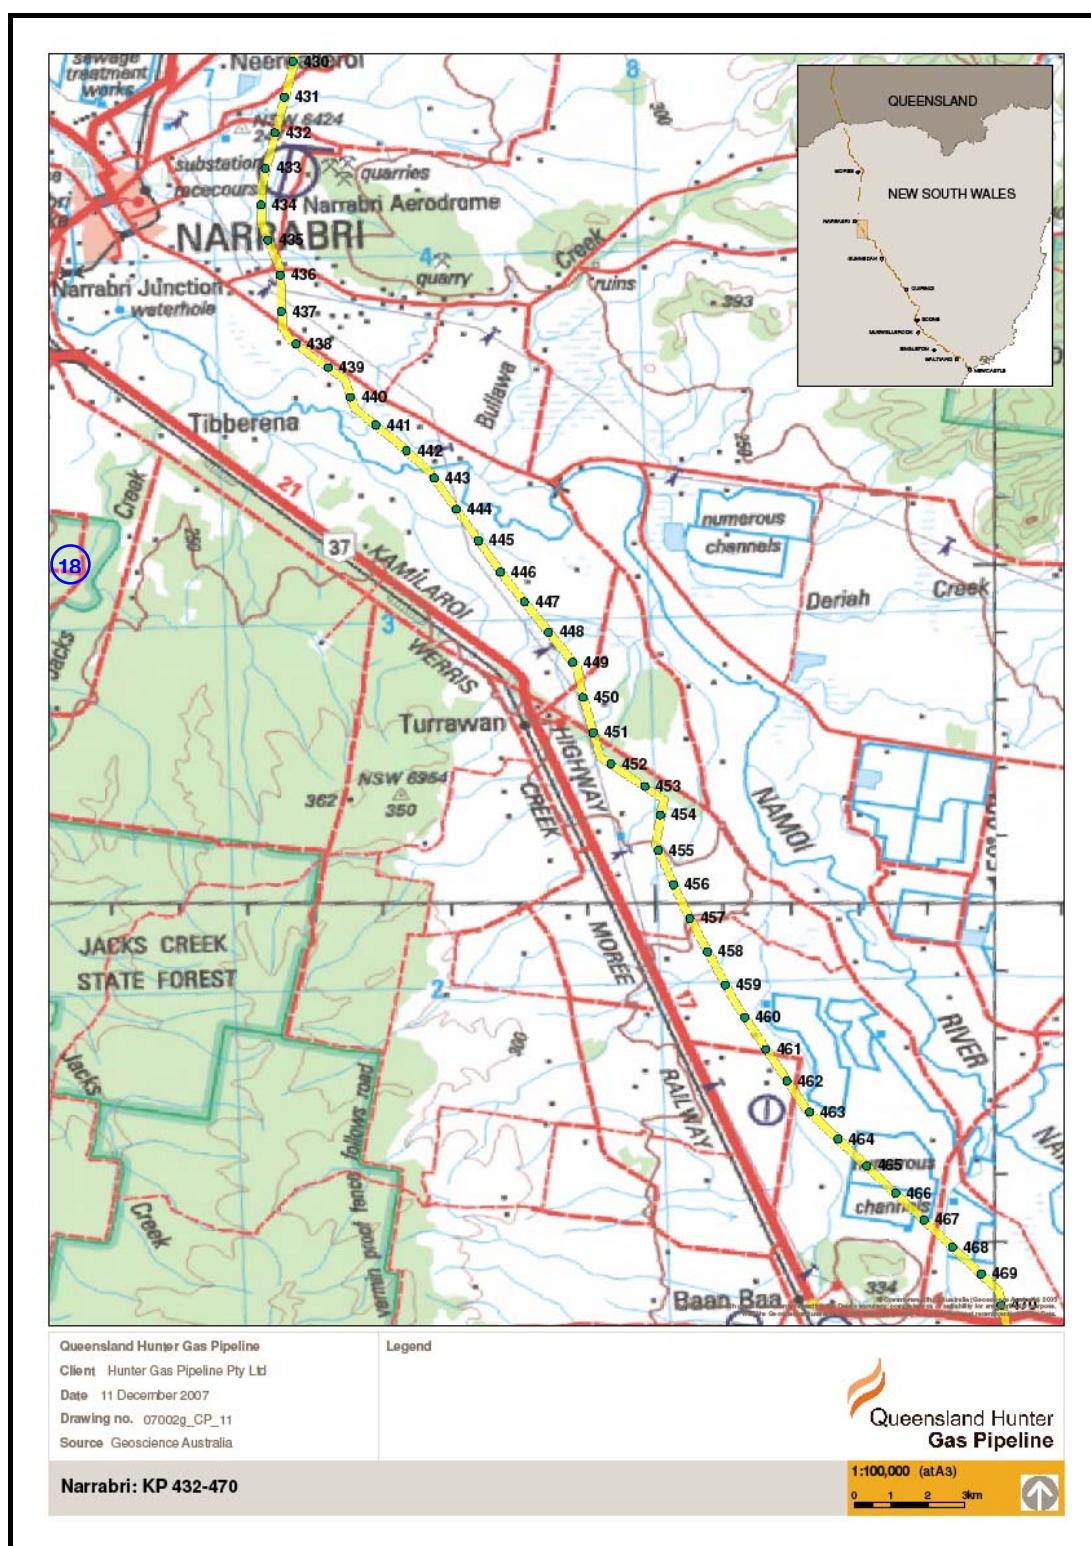
Figure 2g – Study Area in Narrabri (KP432-470)
 (Original plan supplied by the Client on 17 December 2007)

- Narrabri, KP 432 - 470 (**Figure 2g in Appendix B**);
- Boggabri, KP 470 - 505 (**Figure 2h in Appendix B**);
- Gunnedah, KP 505 - 544 (**Figure 2i in Appendix B**);

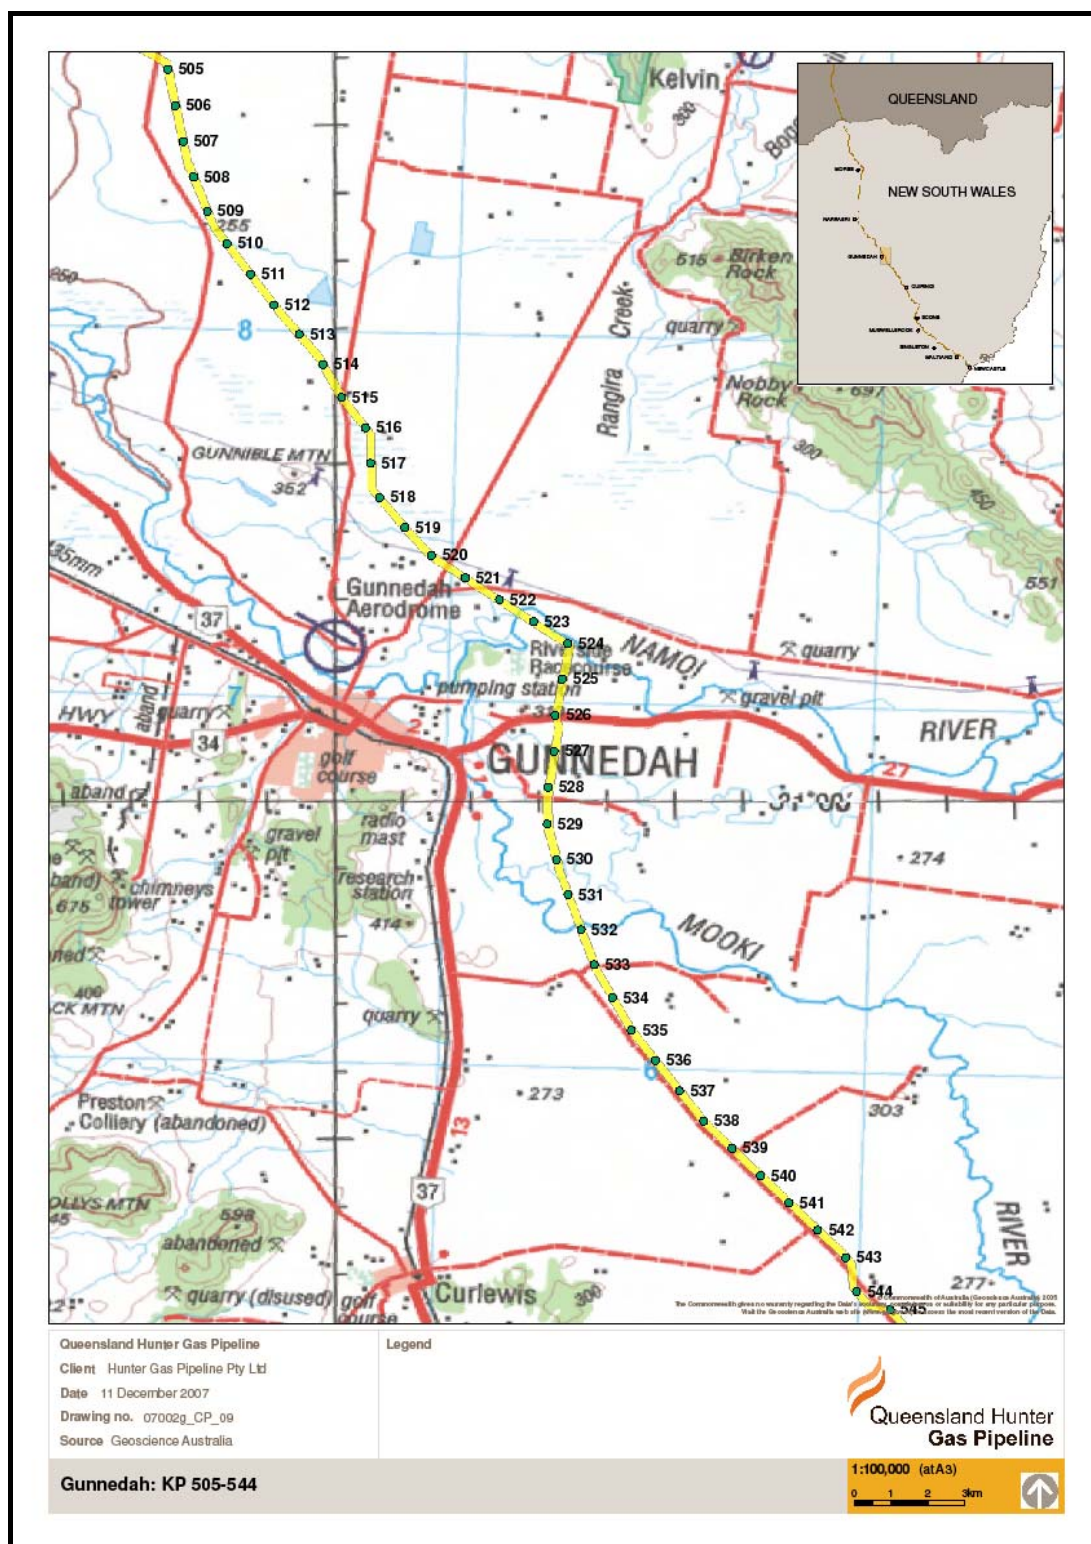
Figure 2i – Study Area in Gunnedah (KP505-544)
(Original plan supplied by the Client on 17 December 2007)

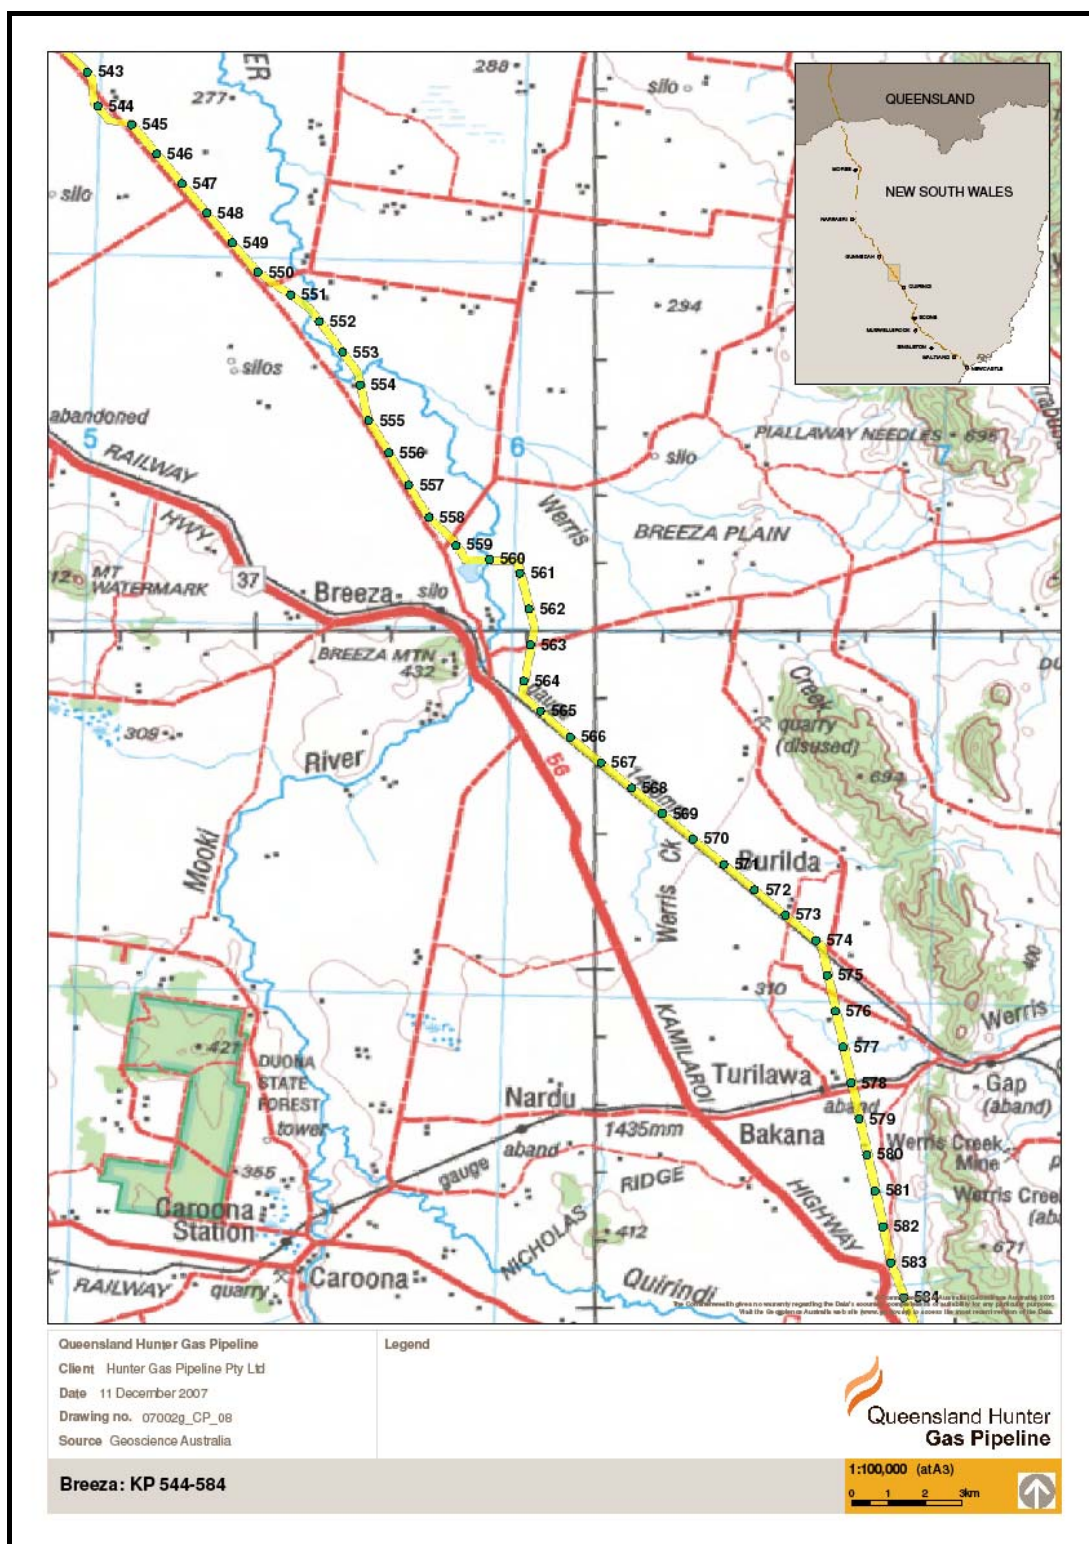
Figure 2j – Study Area in Breeza (KP544-584)
 (Original plan supplied by the Client on 17 December 2007)

- Breeza, KP 544 - 584 (**Figure 2j in Appendix B**);
- Quirindi, KP 584 - 622 (**Figure 2k in Appendix B**);
- Murrurundi, KP 622 - 665 (**Figure 2l in Appendix B**);

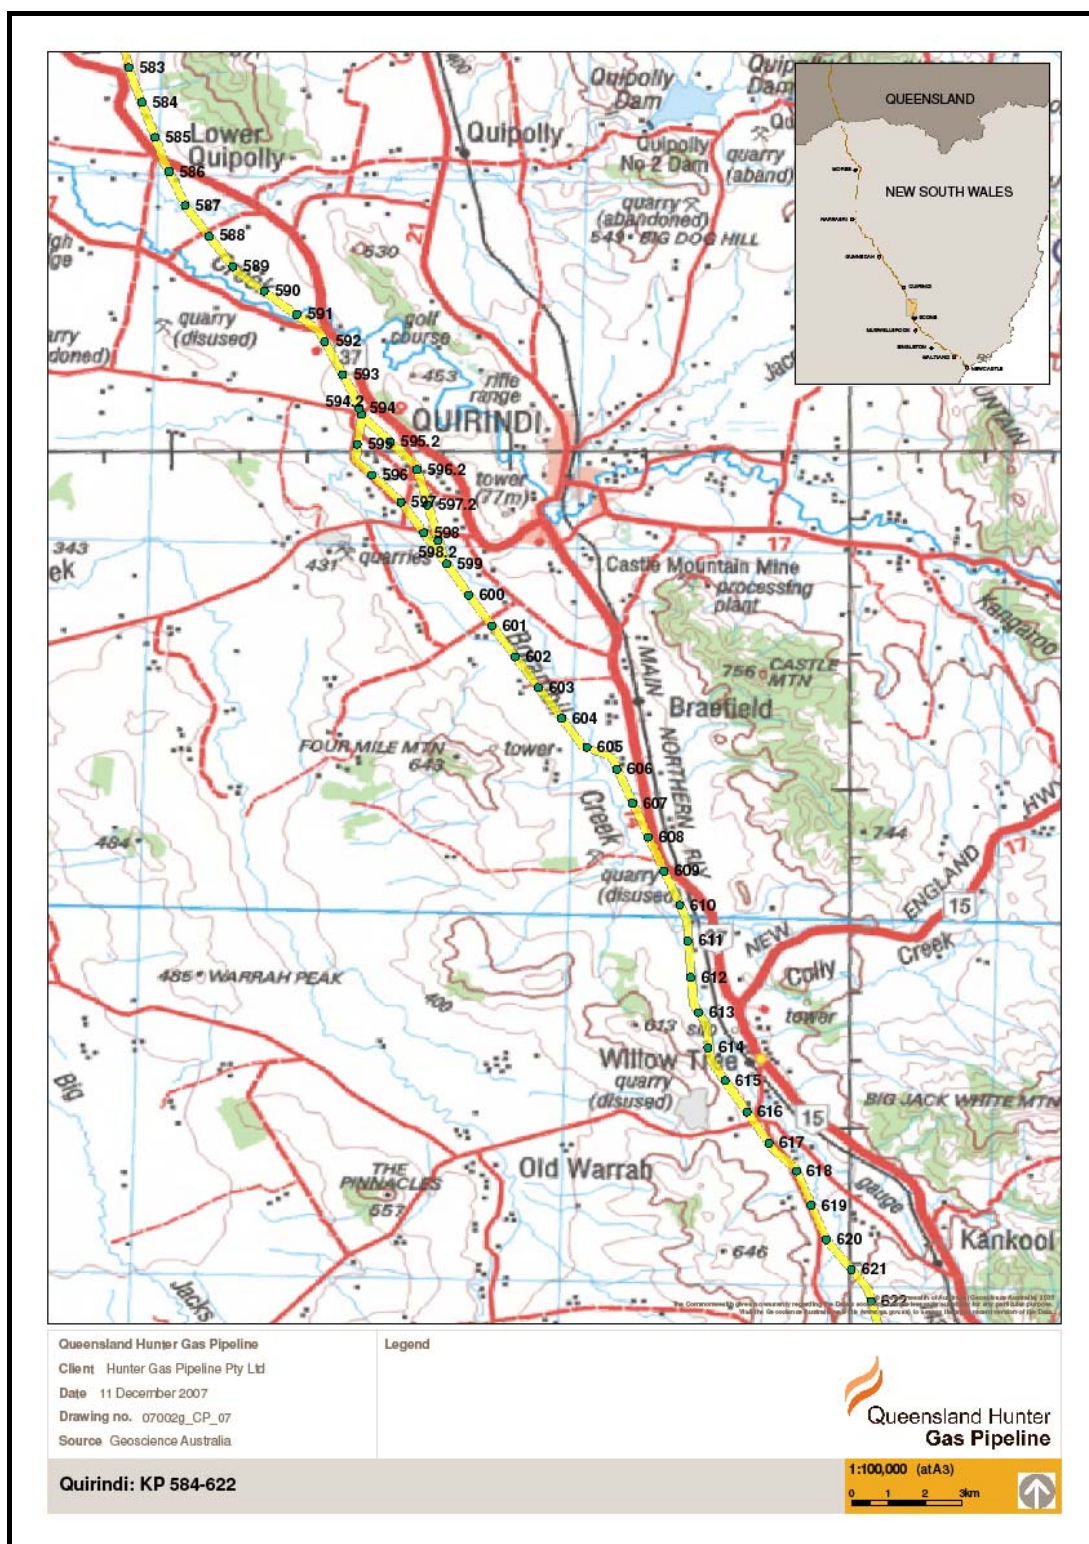
Figure 2k – Study Area in Quirindi (KP584-622)
 (Original plan supplied by the Client on 17 December 2007)

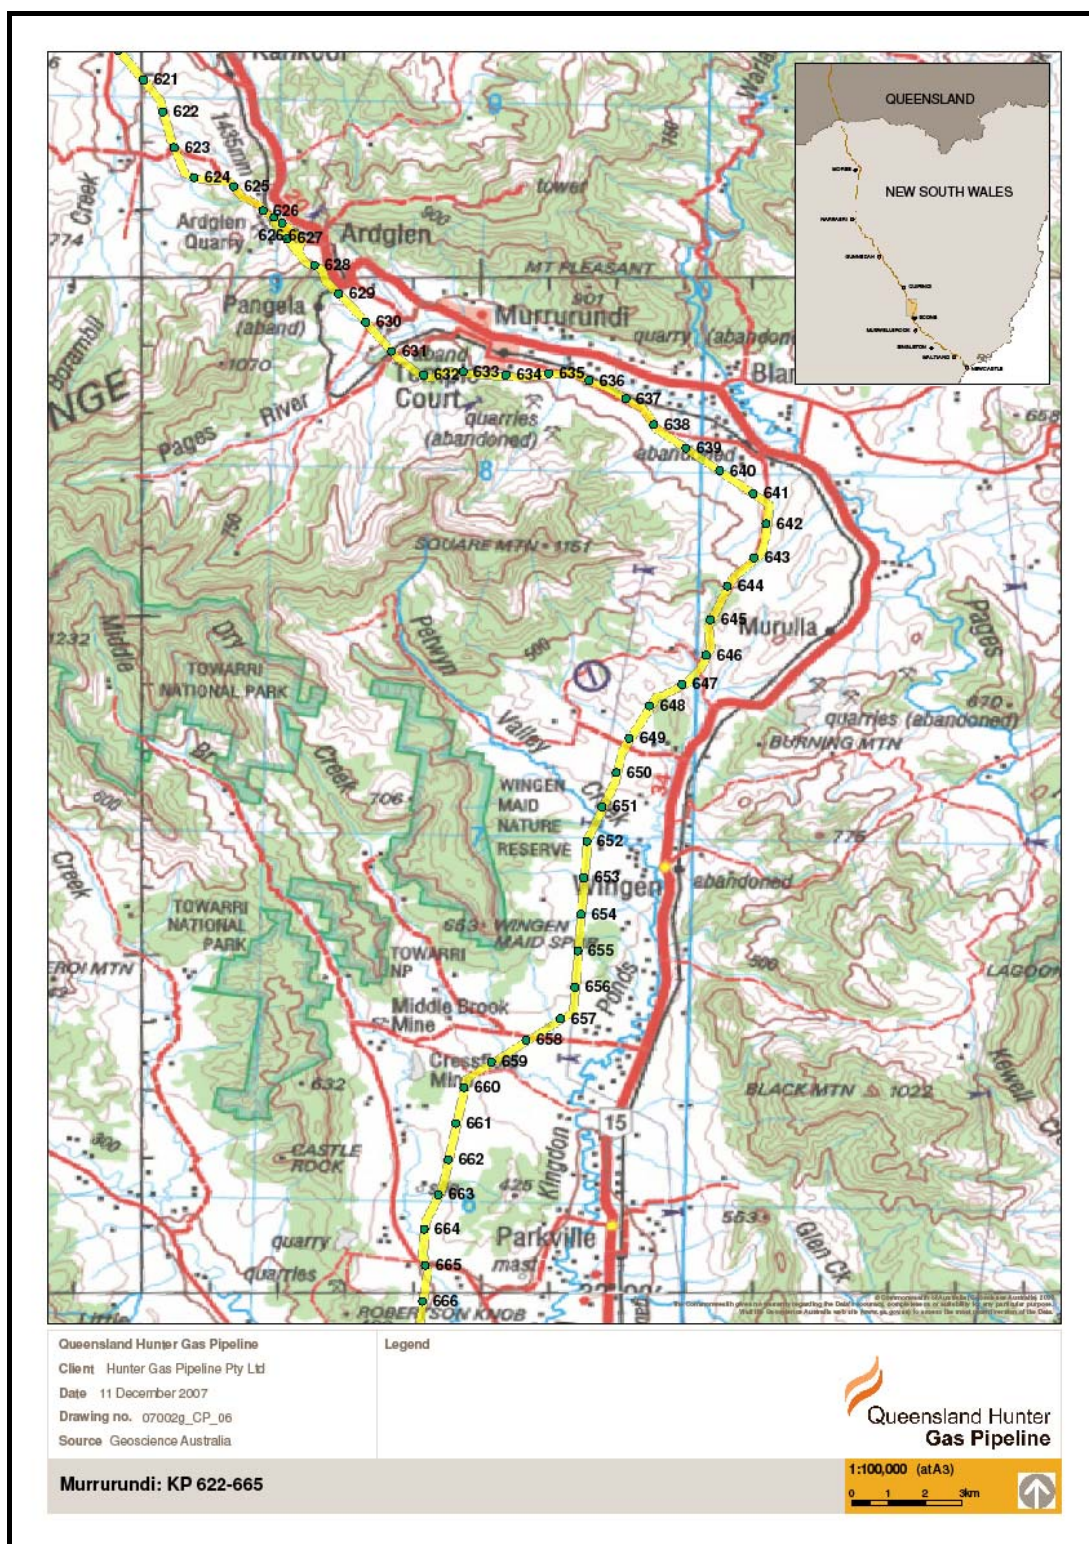
Figure 2I – Study Area in Murrurundi (KP622-665)
 (Original plan supplied by the Client on 17 December 2007)
