Appendix L
Soils management

REPORT 10-5693mrc01-emp

General Soil Management Assessment Queensland Hunter Gas Pipeline (QHGP)

1 SEPTEMBER 2008

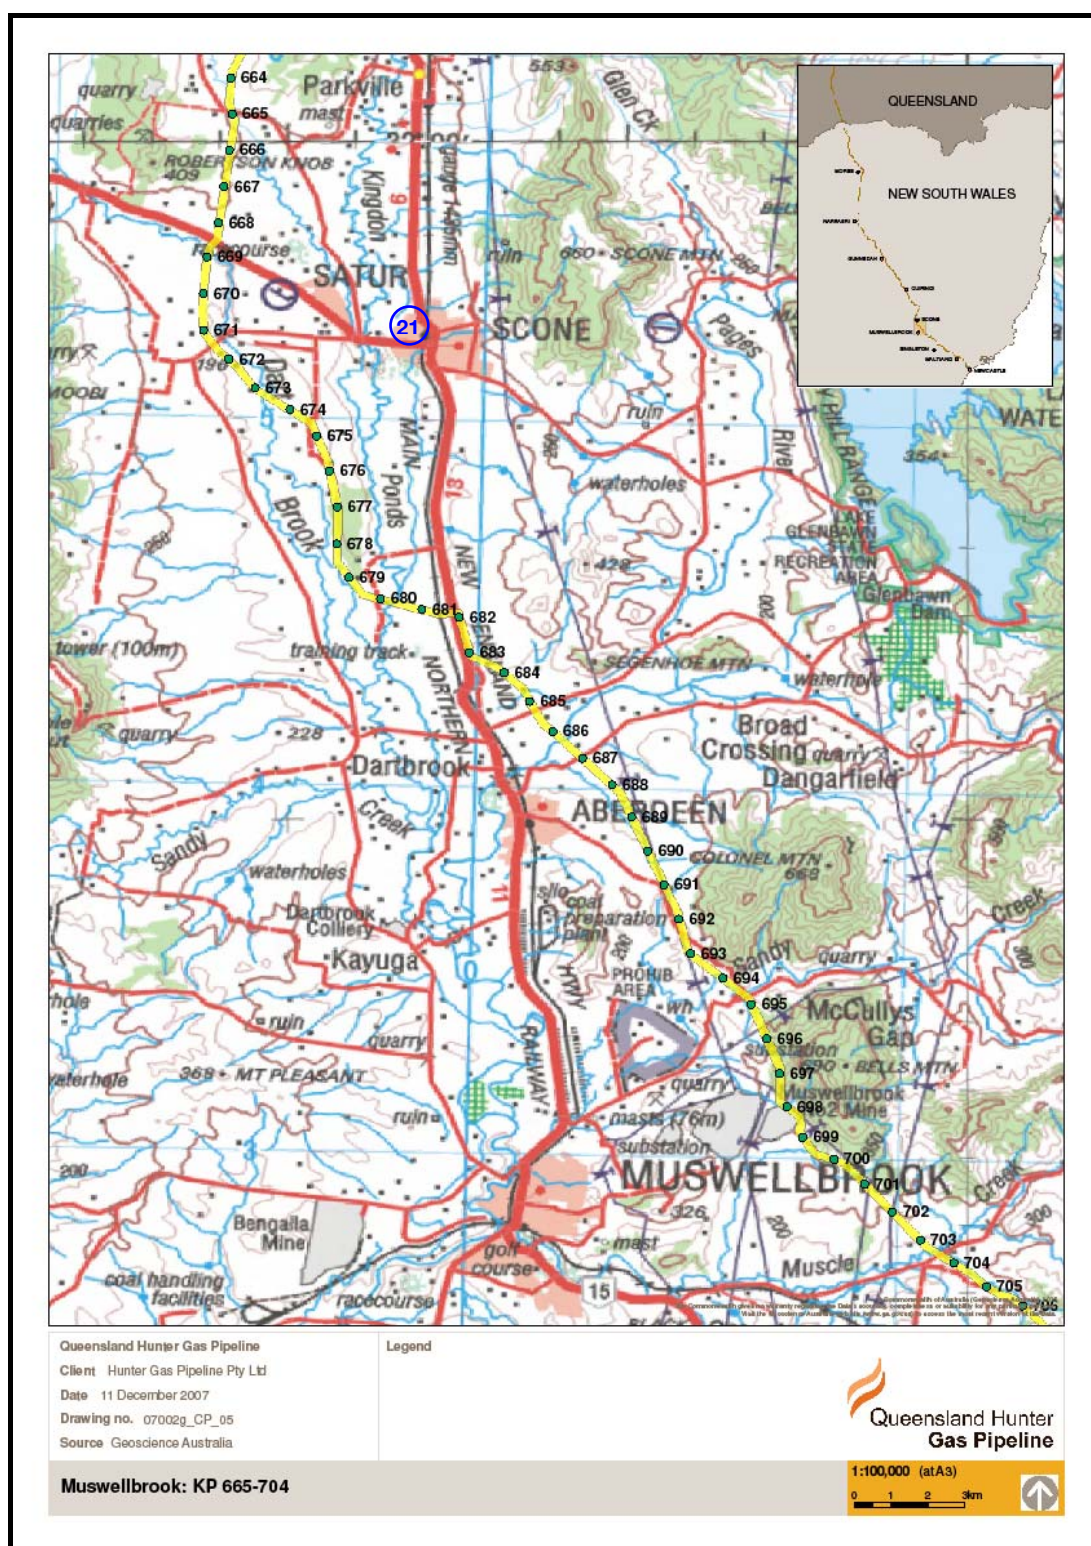
Figure 2m – Study Area in Muswellbrook (KP665-704)
 (Original plan supplied by the Client on 17 December 2007)

- Muswellbrook, KP 665 - 704 (**Figure 2m in Appendix B**);
- Singleton North, KP 704 - 734 (**Figure 2n in Appendix B**);
- Singleton East, KP 734 - 761 (**Figure 2o in Appendix B**);

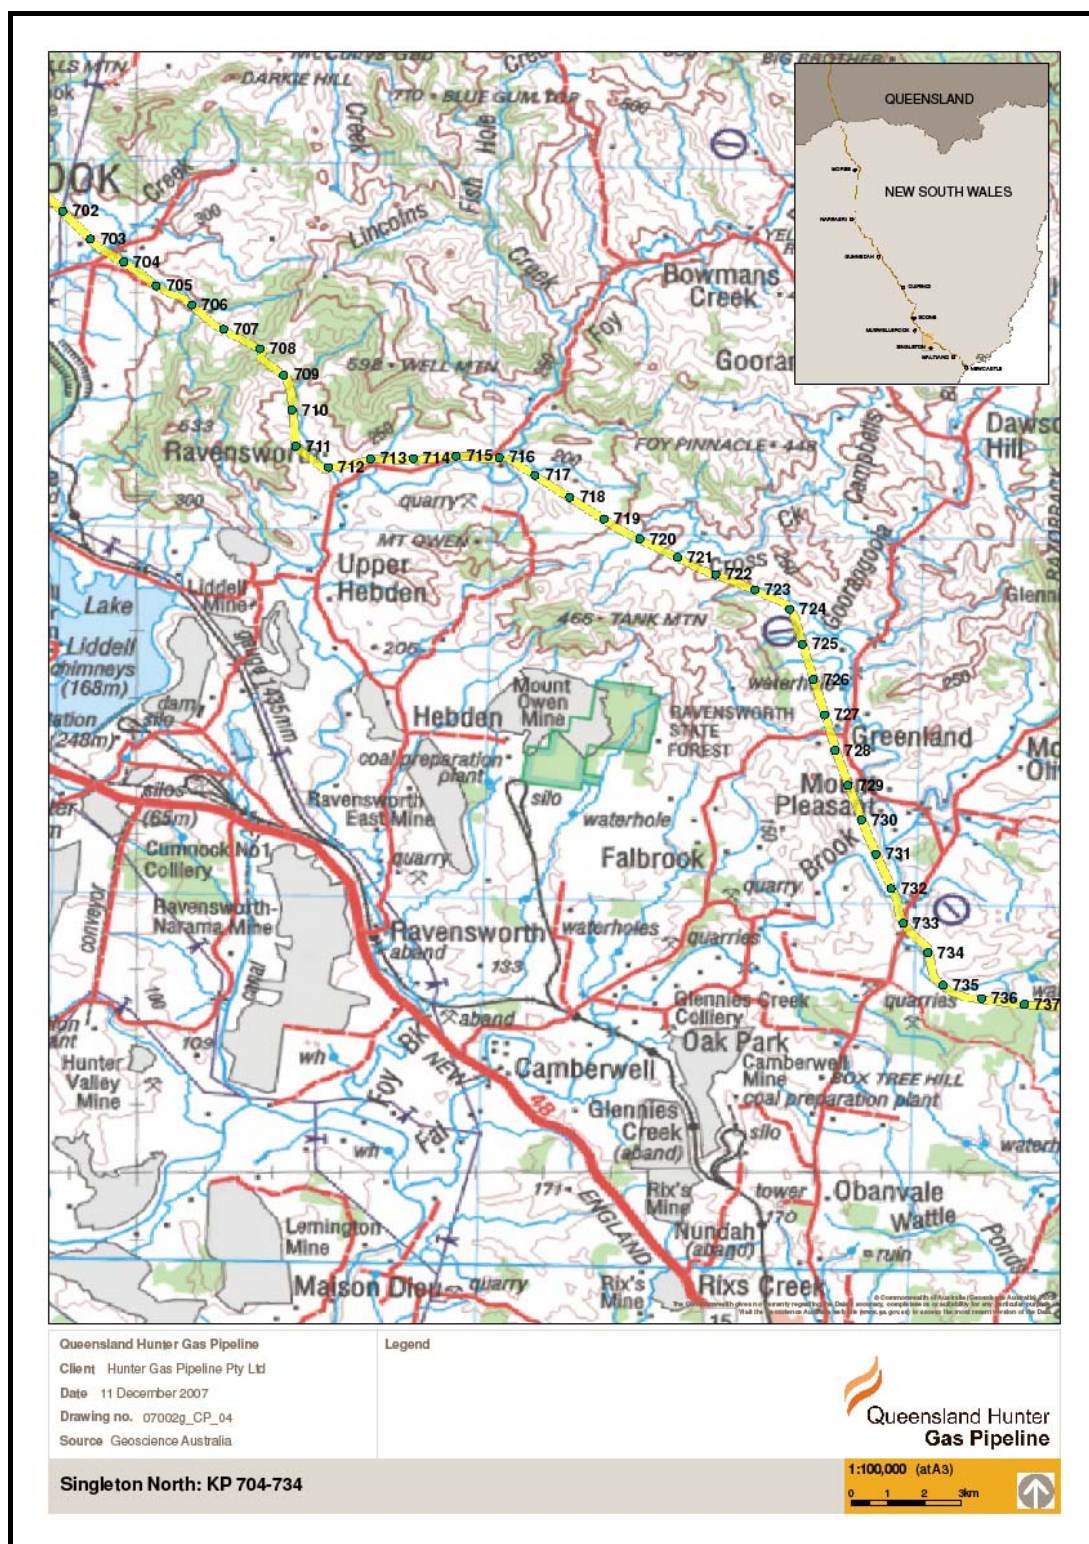
Figure 2n – Study Area in Singleton North (KP704-734)
 (Original plan supplied by the Client on 17 December 2007)

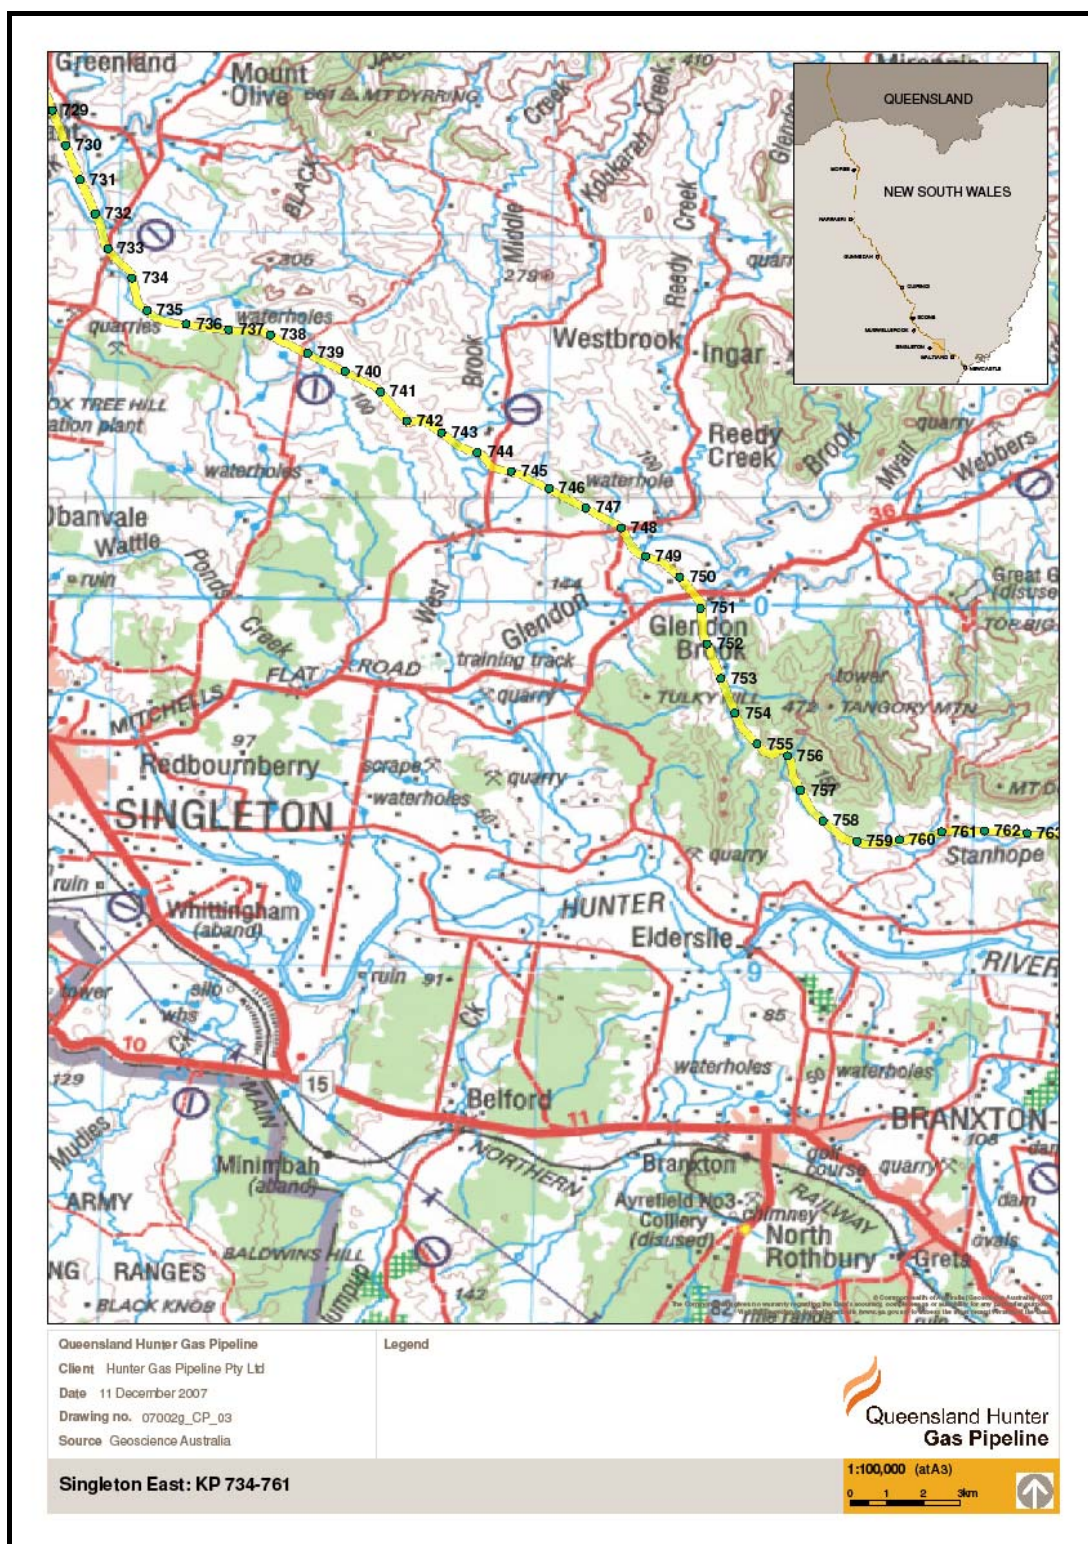
Figure 2o – Study Area in Singleton East (KP734-761)
 (Original plan supplied by the Client on 17 December 2007)

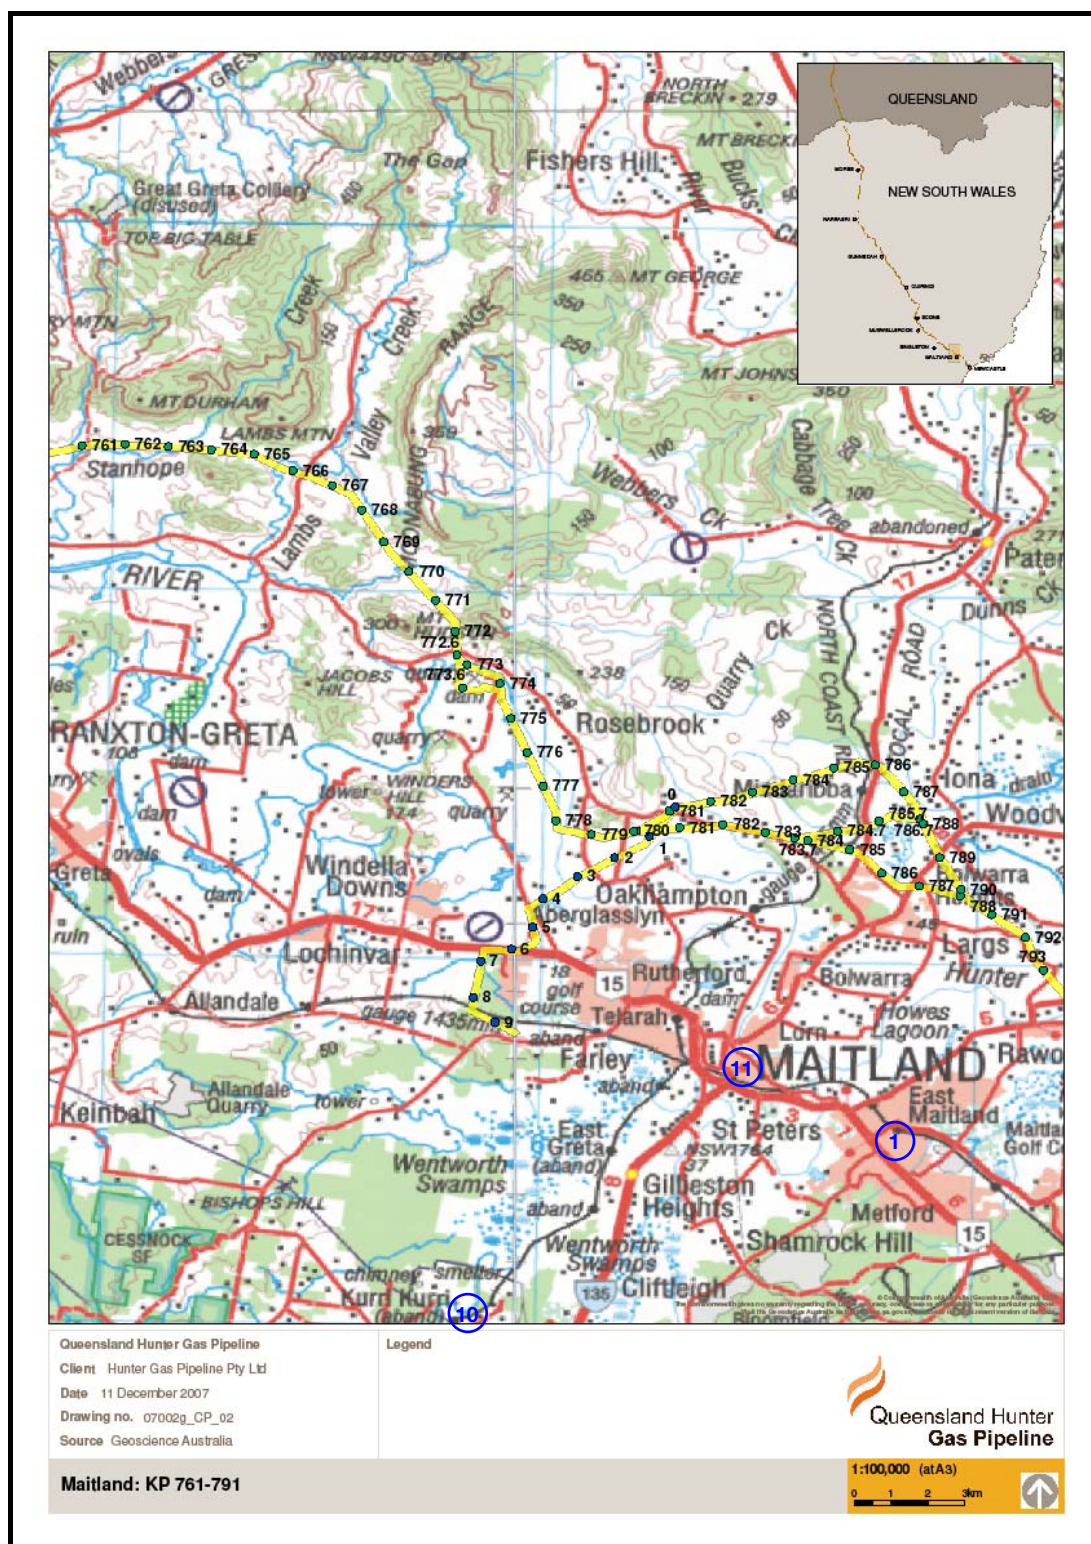
Figure 2p – Study Area in for Maitland (KP761-791)
(Original plan supplied by the Client on 17 December 2007)

- Maitland, KP 761 - 791 (**Figure 2p in Appendix B**); and
- Newcastle, KP 791 - 819 (**Figure 2q in Appendix B**).

A lateral of approximately 10.5 km is understood to extend from the main pipeline to the Maitland area (**Figure 2p in Appendix B**).

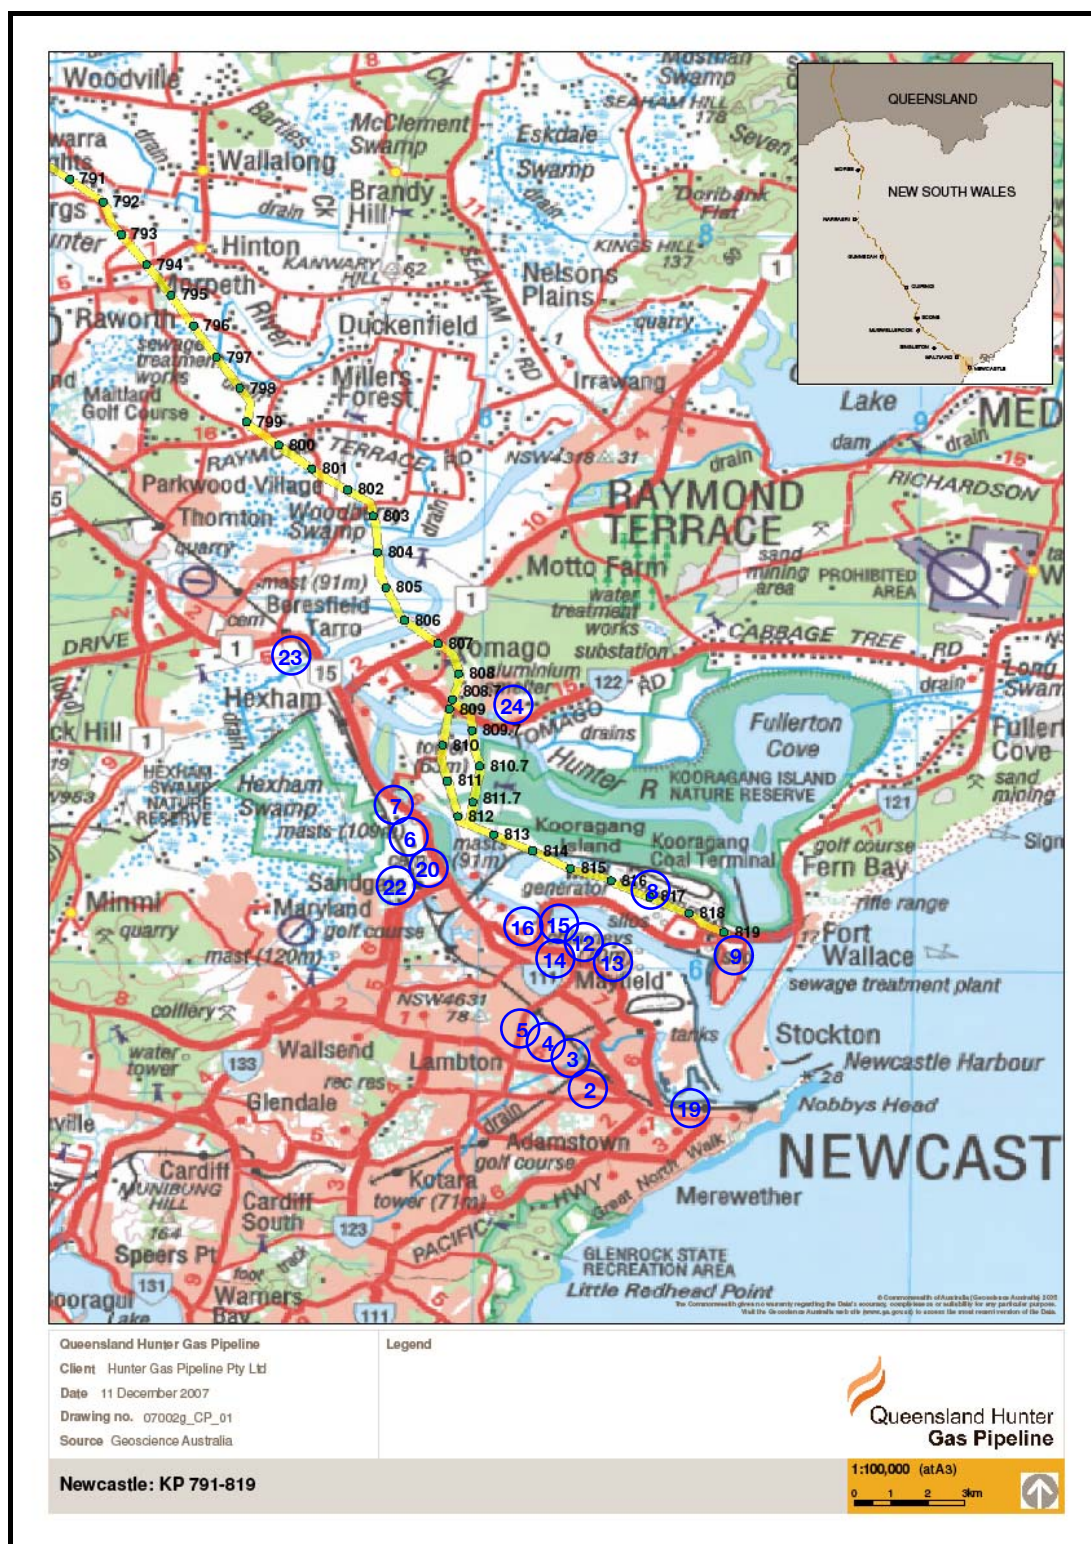
Figure 2q – Study Area in Newcastle (KP791-819)
 (Original plan supplied by the Client on 17 December 2007)

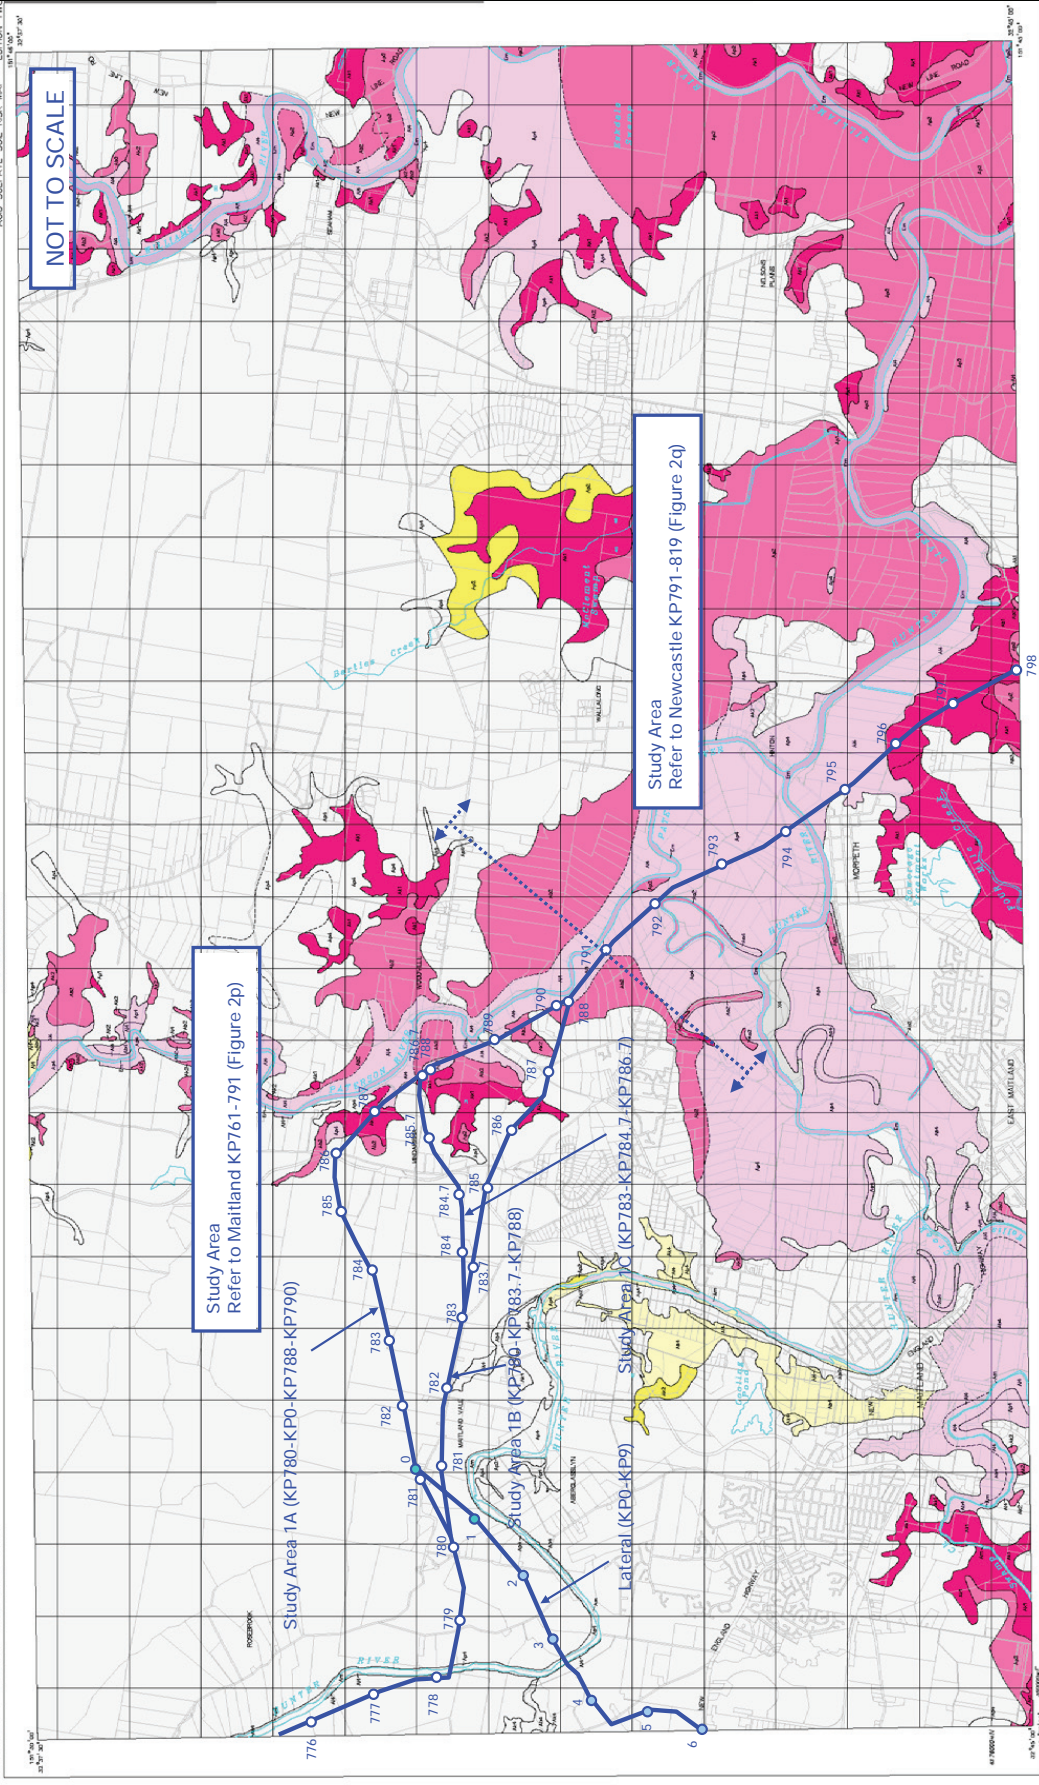
Figure 4d – Acid Sulphate Soil Risk Map for Williamtown (The original plan prepared by NSW Department of Natural Resources)

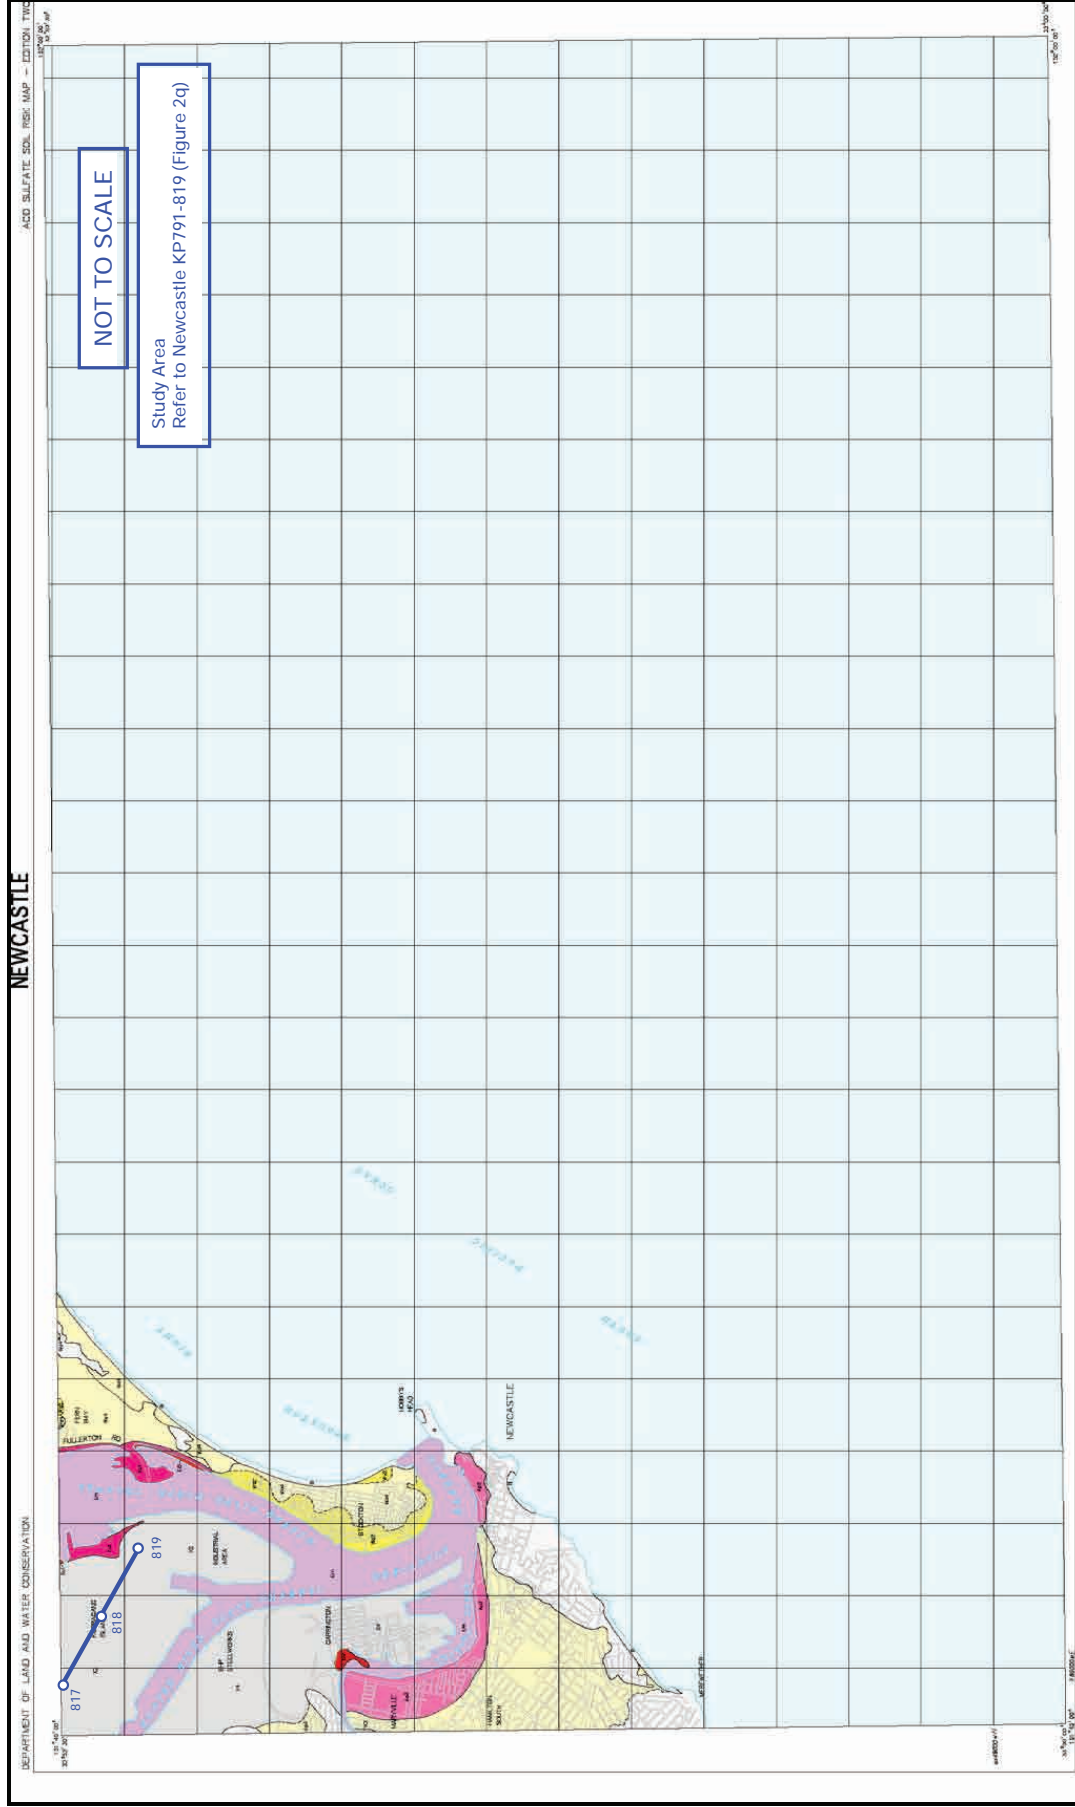
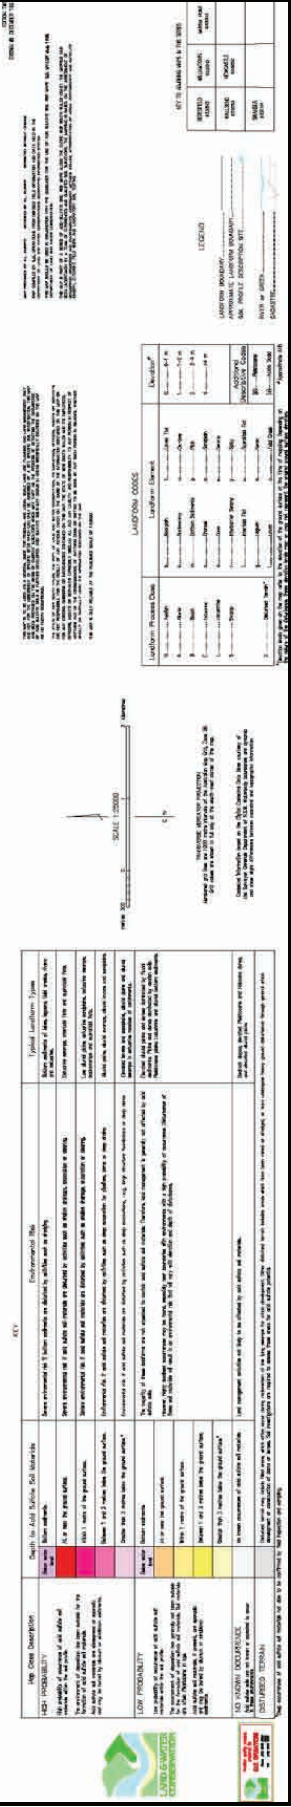
Figure 4e – Acid Sulphate Soil Risk Map for Newcastle (The original plan prepared by NSW Department of Natural Resources)
