Cadia Valley Operations

Riparian Release Ecology Assessment

August 2020

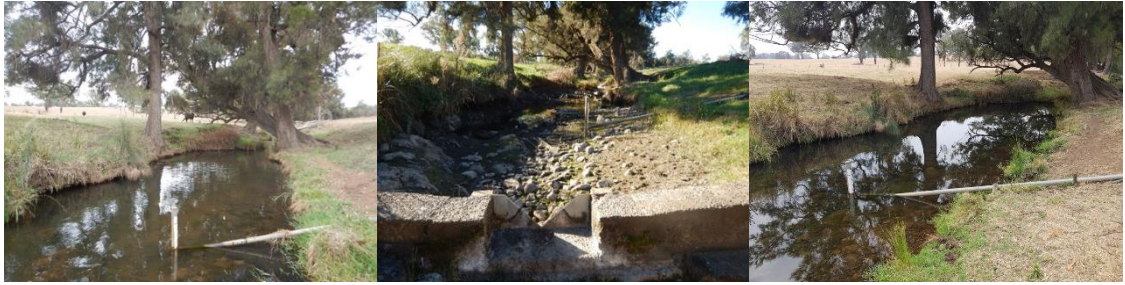
Figure 3 Pool 11 (Gauging Station 412161) during riparian releases in March, while releases were ceased on 23 May, and following the reintroduction of releases in December 2019

The cessation of releases had a noticeable effect on surface water connectivity along Cadiangullong Creek and water levels in the pools (see Figure 3). However, data from gauge 412161 indicate that water levels increased at Pool 11 while no releases were occurring and in the absence of significant rainfall events (Figure 4). Given there are no major tributaries upstream of Pool 11, it is likely that groundwater contributes a greater proportion to baseflow in lower reaches of Cadiangullong Creek during cease-to-flow events (Figure 4). There was an increase in water levels in all pools following the trial pulse release in late July. The cease-to-flow event from December 2019 until March 2020 is evidenced by the drying out of the pool (gauge 412168) upstream from Cadiangullong Dam during this period. Pool depths at locations downstream from the Cadiangullong Dam were maintained during this period.

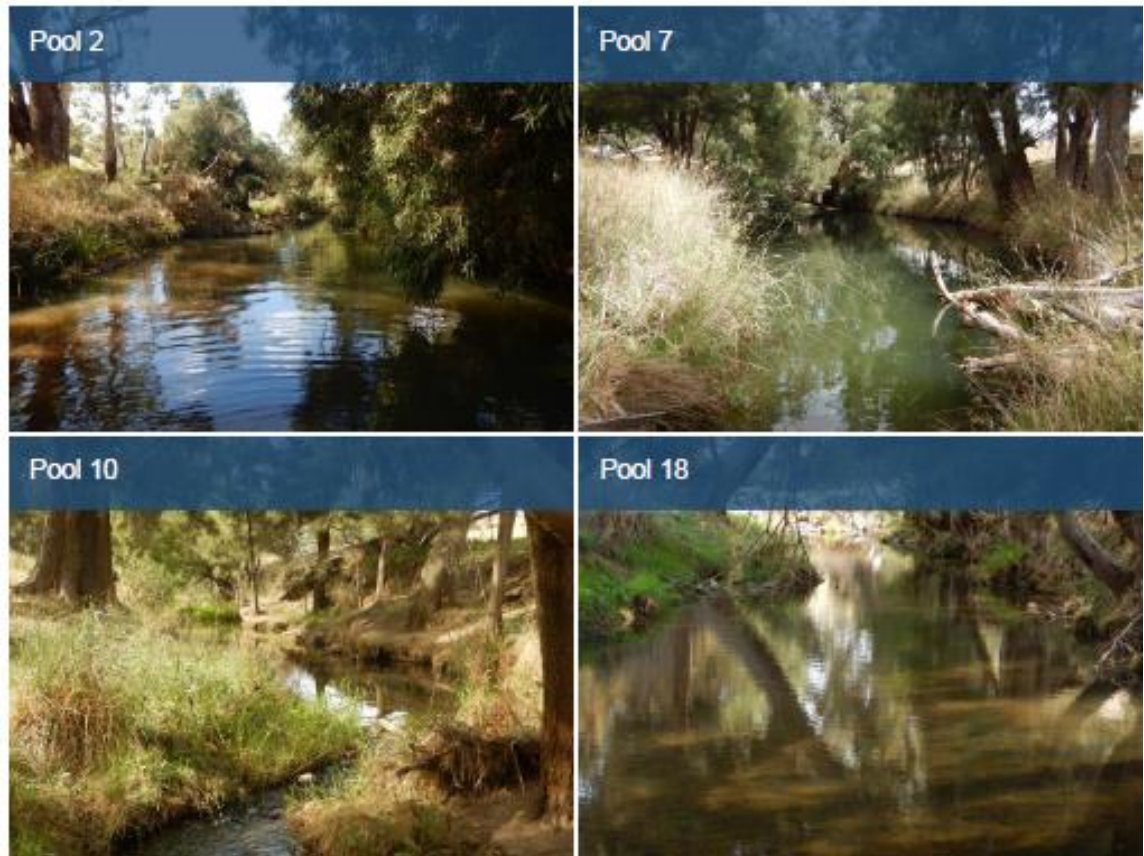
Figure 5 Cadiangullong pools with high habitat value

Based on the habitat suitability index derived from the initial survey of Cadiangullong Creek during March 2019, the pools considered to have the most diverse and highest quality habitat features were Pools 1, 2, 7, 10, 11, 15 and 18. These had significant logjams, consolidated banks and overhanging vegetation, and were considered likely to persist and provide refuge habitat during periods of low flow for platypus. Example photographs of selected pools are included in Figure 5.

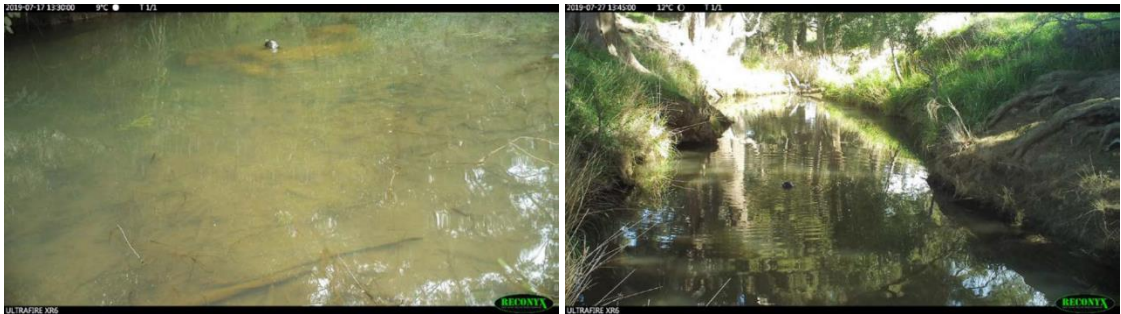
Figure 7 Photographs of platypus in Pool 2 on 17 July 2019 (left) and Pool 10 on 27 July 2019 (right)

On several occasions, the eDNA results for platypus were confirmed by video footage and/or photographs captured by field cameras deployed in multiple pools of Cadiangullong Creek (Figure 7). Importantly, the results suggest that Platypus remained within the Creek prior to and following the cessation of the riparian releases. Results also indicate that conditions during the natural cease-to-flow event from late February to late March 2020 also provided suitable water quality and habitat conditions without flow inputs – evidenced by their presence during the cease-to-flow event and following resumption of flows.
