**Aquatic Flora & Fauna Survey**  
**Rainbow Beach, Bonny Hills – St Vincents Foundation**

# **Aquatic Flora & Fauna Survey**

## **Rainbow Beach, Bonny Hills – St Vincents Foundation Pty Ltd**

Report Number – 41/0708A

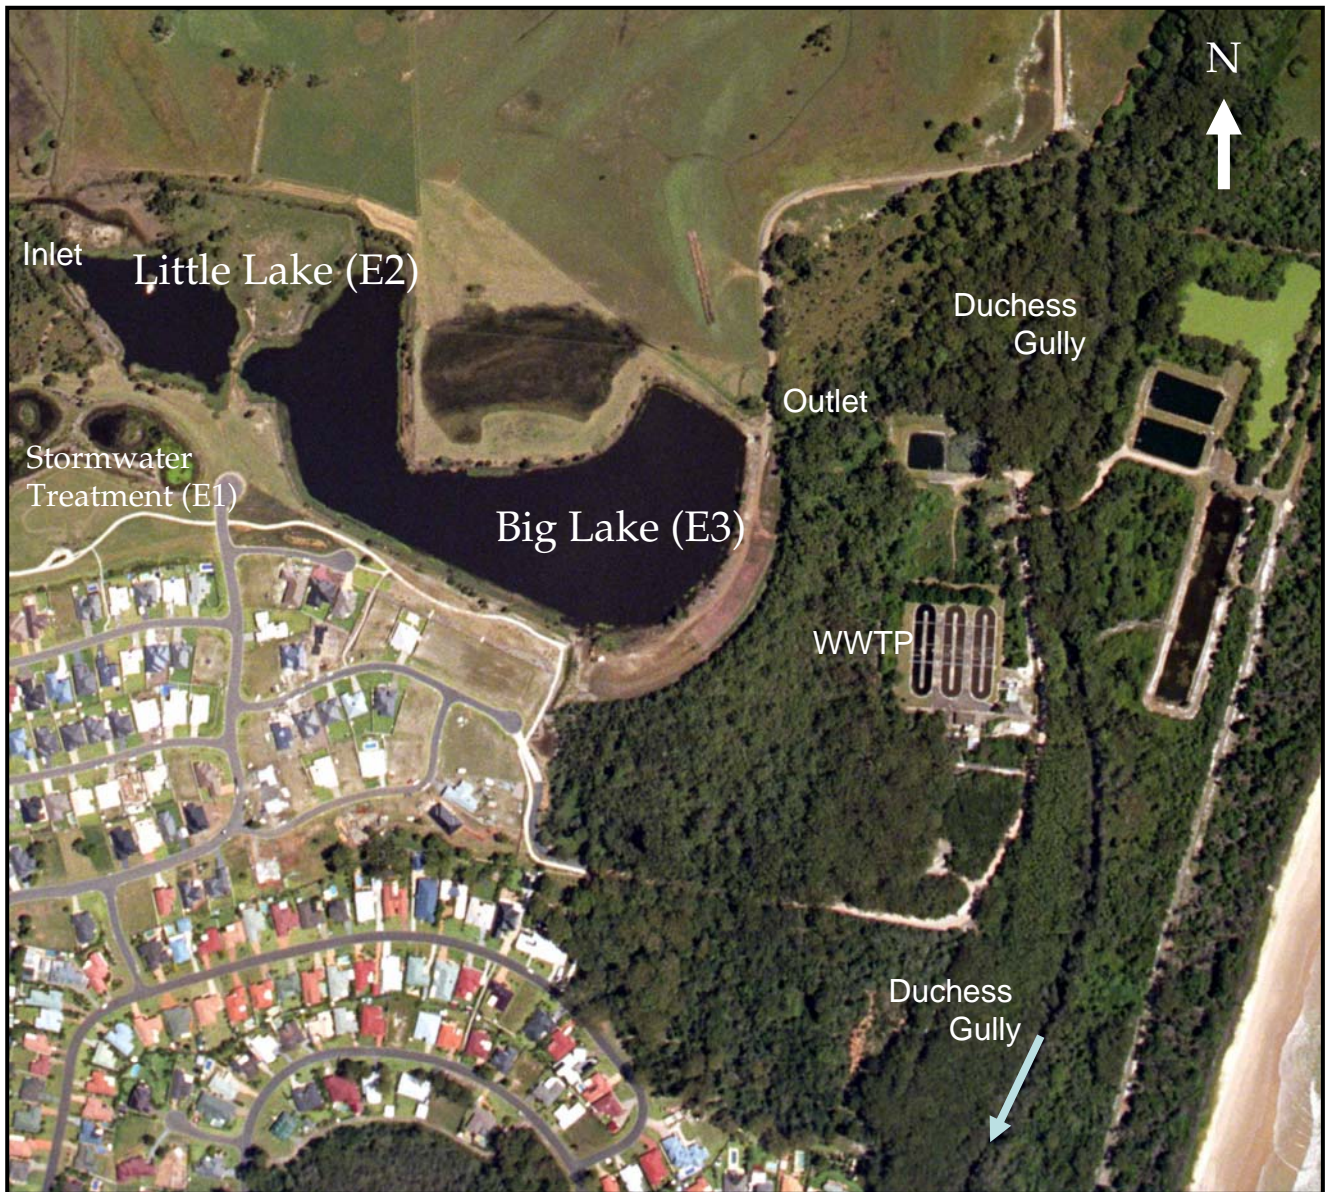
**Figure 1.** Aerial photograph showing subject site and surrounding features. WWTP = Waste Water Treatment Plant. Blue arrow shows direction of flow of water in Duchess Gully towards the sea. Source of Photo – Tierney Property Services (January 2008).

The subject water body comprises two lakes (Figure 1). The larger lake (E2) is on the eastern side and contains the outlet to Duchess Gully. The outlet passes through a small culvert comprising a small pipe encased in concrete, which forms a low weir (Plate 1a - c). The water level of the water body can be regulated somewhat by a swivelling pvc pipe which can be adjusted in relation to the water levels of the water body (Plate 1b). This configuration, which is temporary, would allow passage of small fish and invertebrates from the water body into Duchess Gully. It would, however, limit upstream movement unless the weir is overtopping, which does occur from time to time (Tierney Property Services, personal communication). Below the outlet there is a relatively broad channel (4 – 6 m wide) flowing to Duchess Gully (Plates 1 d, e,; and 2a). Between the two lakes of the water body is a small channel (< 0.5 m wide) fringed by a dense growth of torpedo grass (Plate 1f). During the visit water was flowing from the small lake (E2) into E3. A stormwater treatment area (E1) treats some, but not all, stormwater entering the water bodies.

following rainfall. A waste water treatment plant (WWTP) occurs to the east of the subject water body and adjacent to Duchess Gully (Figure 1). There are ponds associated with the WWTP; these appear to be “downhill” of the water body.

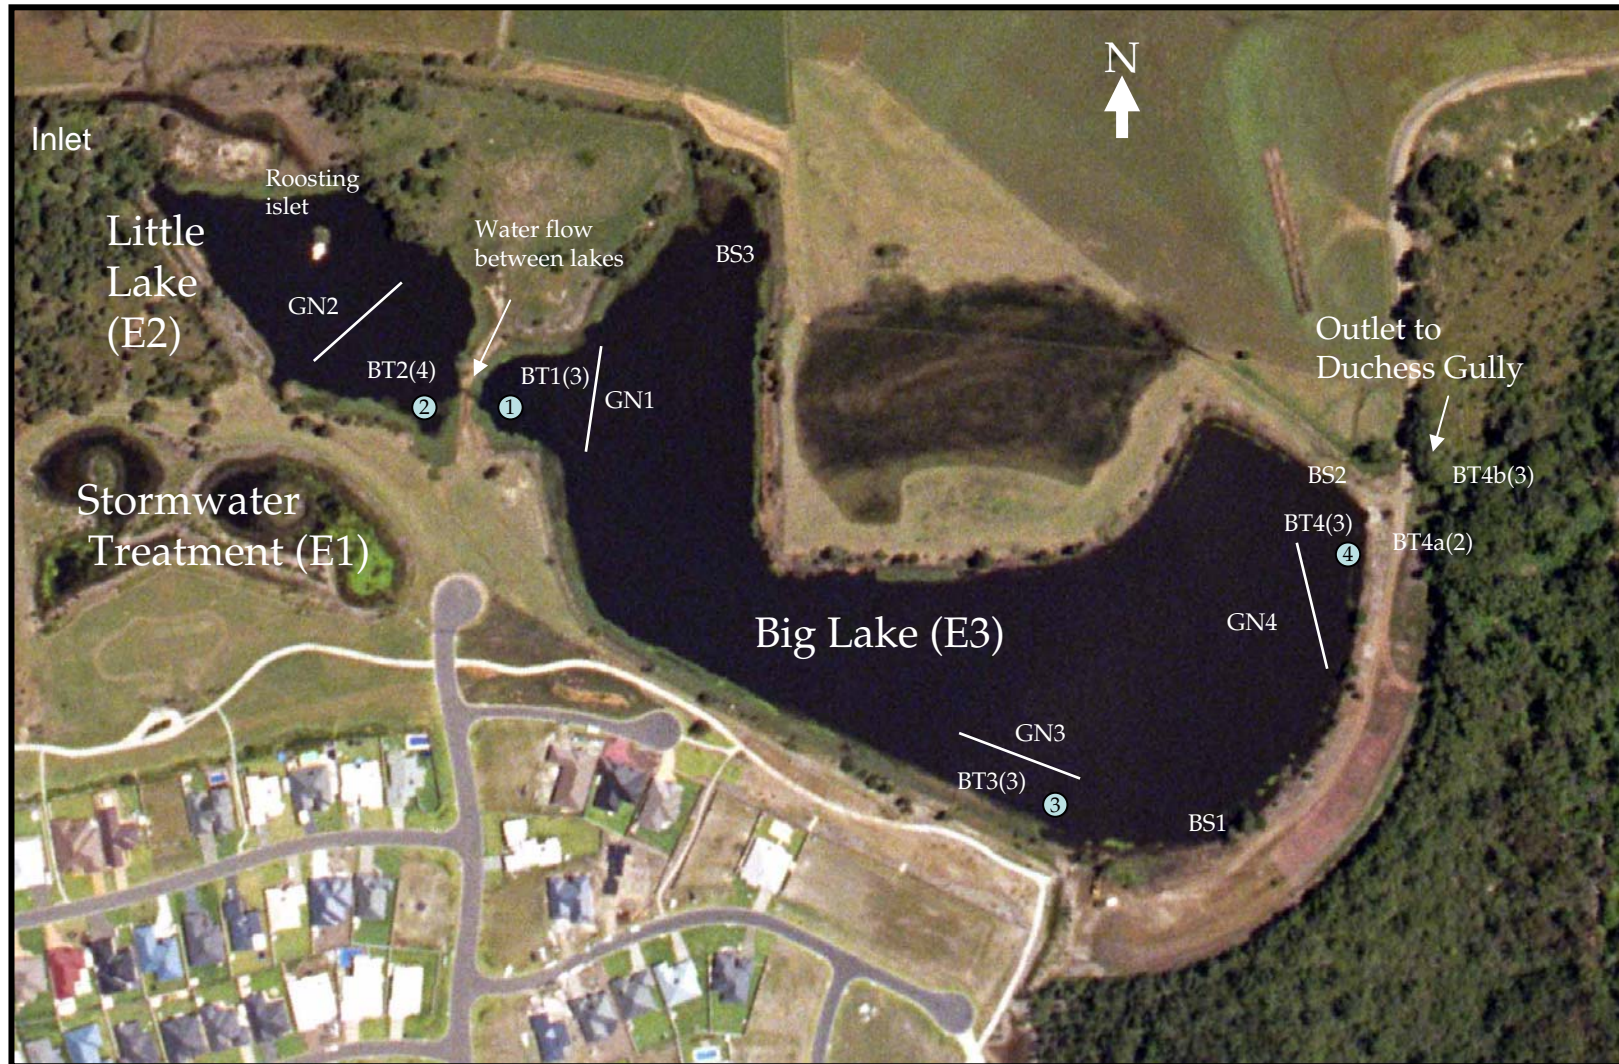
**Figure 2.** Aerial photograph showing sampling sites in January 2008. Blue circles with numbers = sites of benthic cores (2 cores per site); BT = Bait Trap sites (brackets show number of traps deployed); BS = Beach Seine sites; GN = Gill net sites. Source of Photo – Tierney Property Services (January 2008).

Finally, gill nets were set at four sites around the water body, including three nets in the big lake and one in the small lake (Figure 2). Each net was 60 m long and comprised two, 30 m lengths of 100 mm and 50 mm monofilament mesh, approximately 1.5 m deep. The nets were set for approximately three hours, but were checked approximately every 30 to 40 minutes. Fish were removed from the net, identified, counted and measured to fork length (LCF, mm) and released.

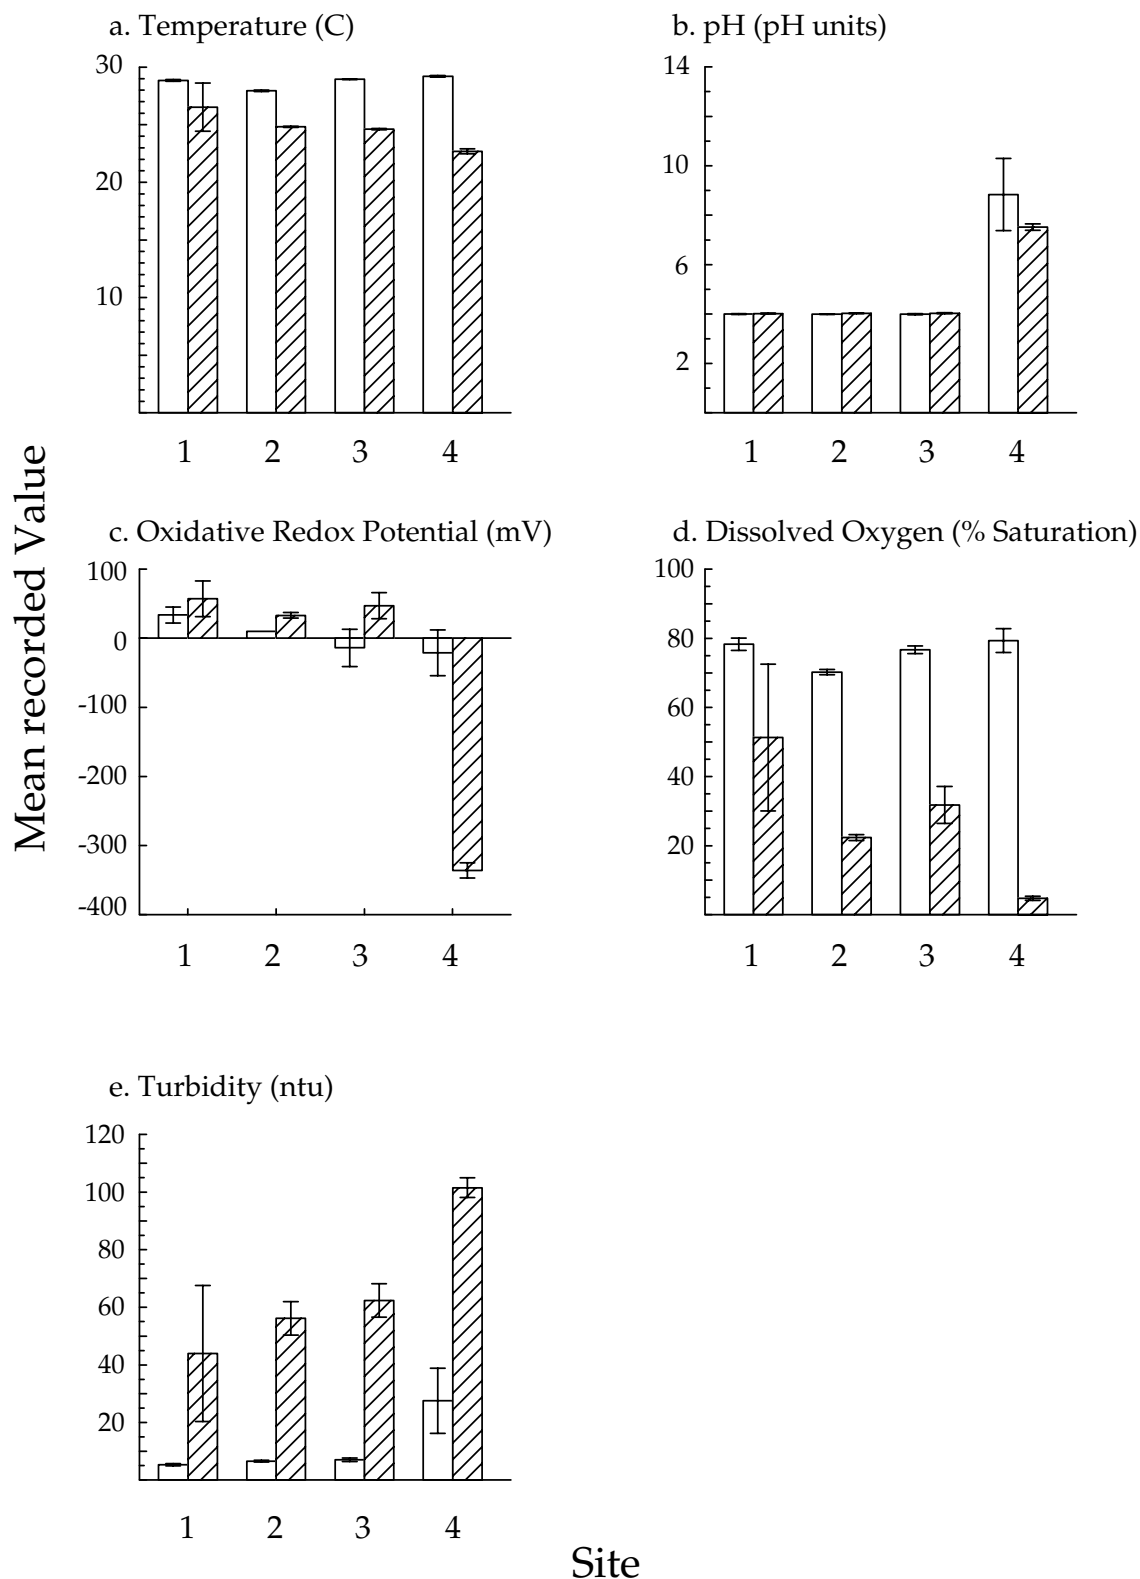
**Figure 3.** Mean and Standard error ( $n = 2$ ) for water quality indicators measured at four sites at the surface (open bars) and bottom (hatched bars) of the subject water body.

Data collected using the probe are presented in Table 1 and Figure 3. The data indicate variability among sites within the water body and with depth. Temperature was always slightly less at the bottom than the surface (Figure 3a). Conductivities (not graphed) were around 0.2 mS/cm, which is consistent with earlier studies (Appendix 1). pH was generally low, with higher values at Site 4 (Figure 3b). As noted above, results for pH may be unreliable due to a faulty sensor. ORP was generally relatively low and positive at sites 1 – 3, but strongly negative at Site 4, indicating a reducing environment (Figure 3c). Concentrations of dissolved oxygen were generally low, and always less at the bottom than the surface (Figure 3d). Finally, turbidity was always substantially greater at the lake bottom than the surface (Figure 3e).

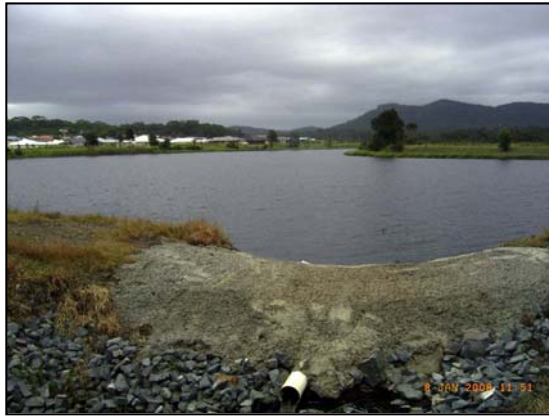
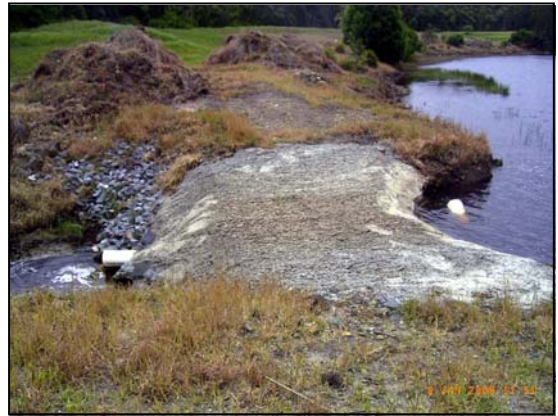
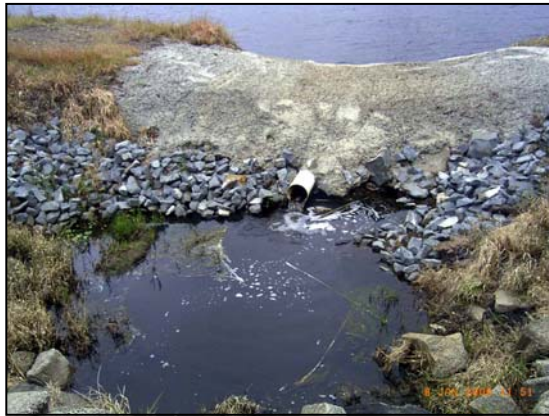
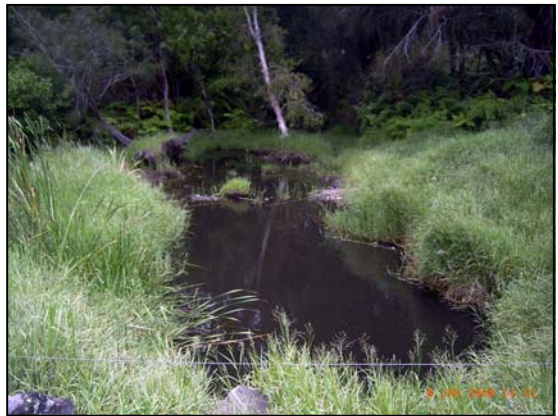
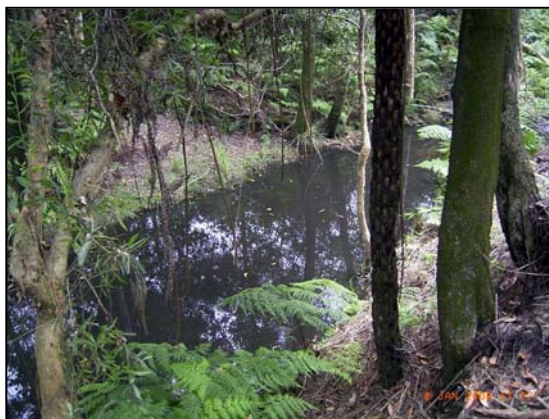
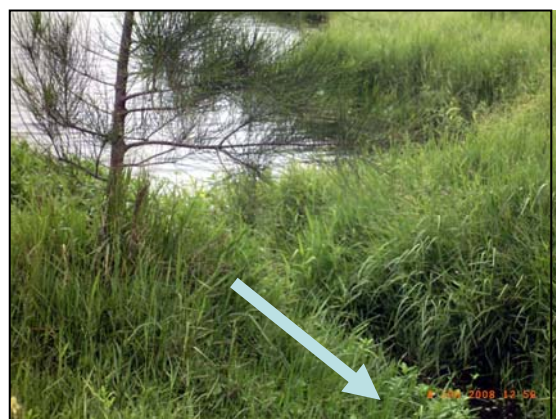
**Plate 1.** Photographs of the temporary outlet of the subject waterbody and the channel between the Big (E3) and Little (E2) lakes. a) Culvert and upstream view to Big Lake; b) Culvert – Temporary weir structure showing in- and outflow; c) Pool below temporary weir structure; d) outlet downstream of culvert; e) main channel downstream of culvert (upstream of confluence with Duchess Gully; f) narrow channel between Big and Little lakes – arrow shows direction of flow out from Little Lake during the site visit. Plate 1f also shows dense growth of torpedo grass along shore.

5. Redesign the existing, temporary outlet to Duchess Gully to facilitate fish passage between the water bodies and the gully. Similarly, design the outlet of the proposed new water bodies to optimise fish passage.

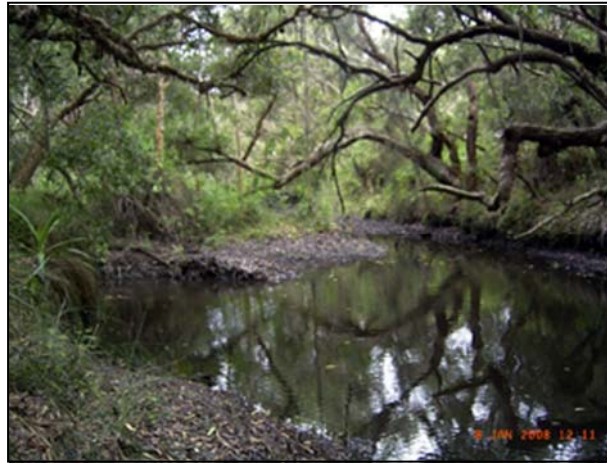
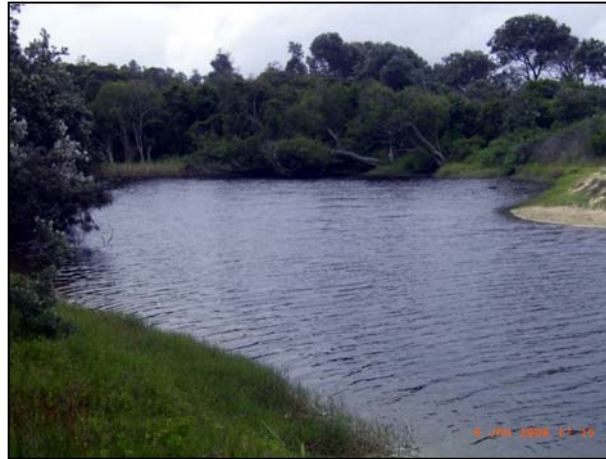
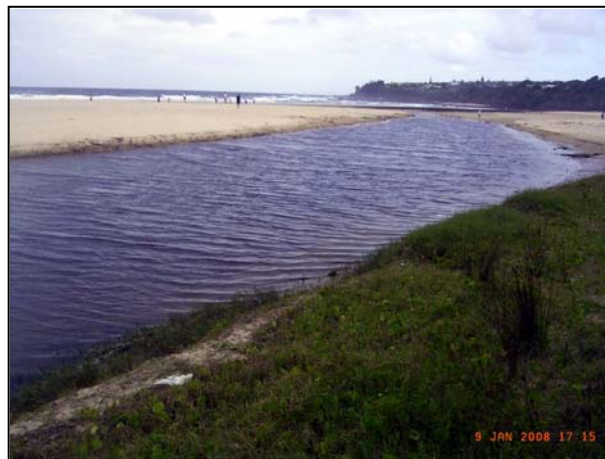
**Plate 2.** Photographs of Duchess Gully a) Confluence of Duchess Gully with the outlet of the outlet of the subject waterbody; b) Duchess Gully looking upstream from rainbow Beach; c) Duchess Gully looking downstream across Rainbow Beach towards its opening to the sea.

Duchess Gully flows over a wide beach berm at Rainbow Beach (Plate 2b, c). Water throughout the system was dark brown during the visit, possibly reflecting tea-tree staining

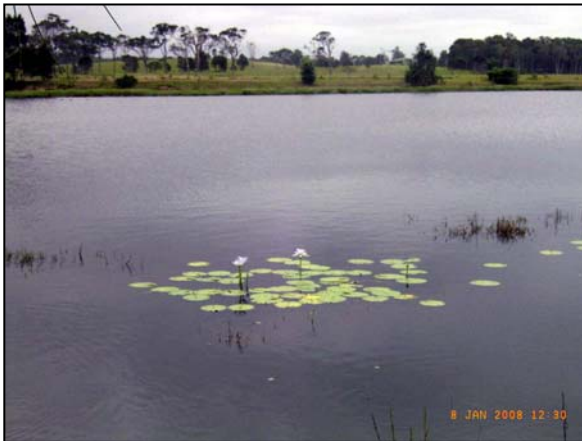
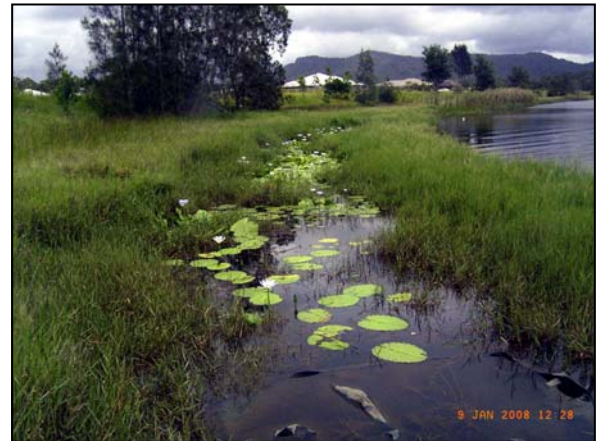
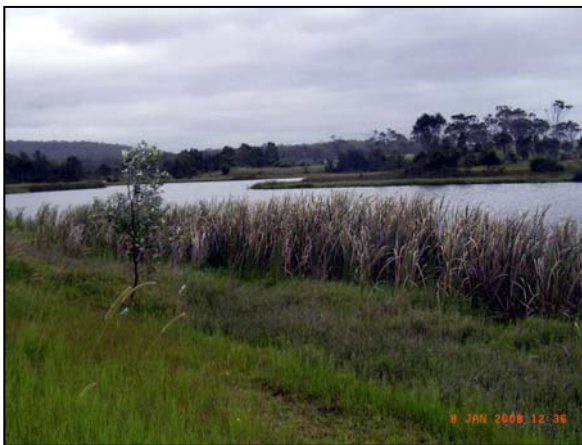
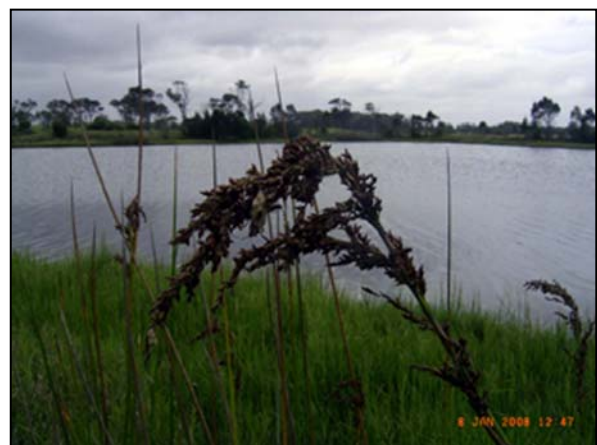
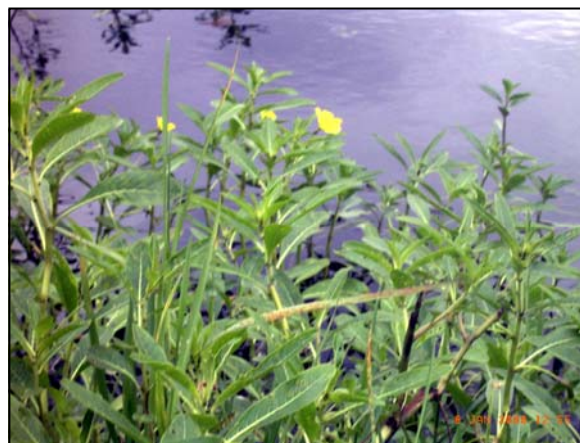
**Plate 3.** Photographs of various macrophytes on and around the subject water body. a) Cape waterlily (*Nymphaea caerulea*, syn: *N. capensis*) and unidentified emergent plant; b) Cape waterlily and Florida torpedo grass (*Panicum repens*); c) Cumbungi (field identified as *Typha orientalis*); d) Torpedo grass with jointed twigrush (*Baumea articulata*) in foreground; and e) Water primrose (*Ludwigia peploides*).

As noted previously, the water body was fringed by dense growth of aquatic plants, primarily torpedo grass. Notwithstanding the dominance of this species, there were numerous other species recorded at the site, both during the site visit and by other workers (Table 2, Plate 3). During the visit we observed areas of dense growth of a submerged plant, identified as *Vallisneria nana*, which was prevalent at the western end of E3 and in parts of E2.

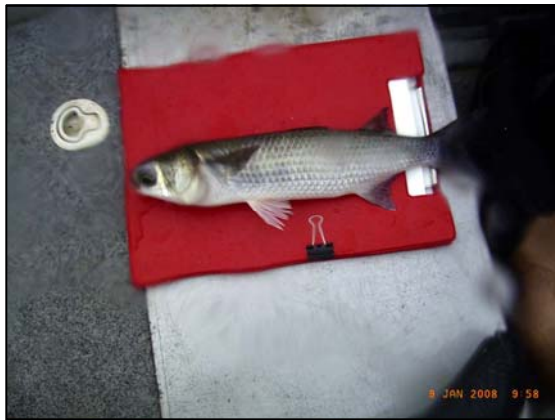
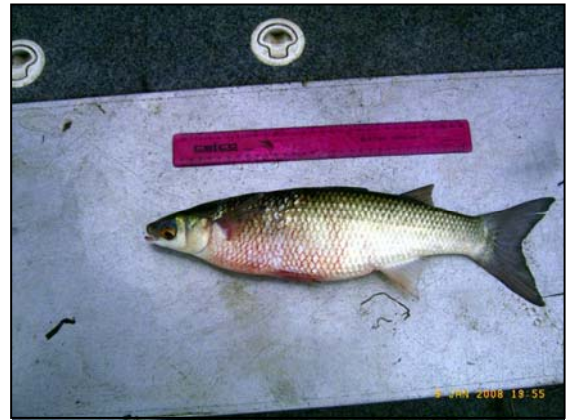
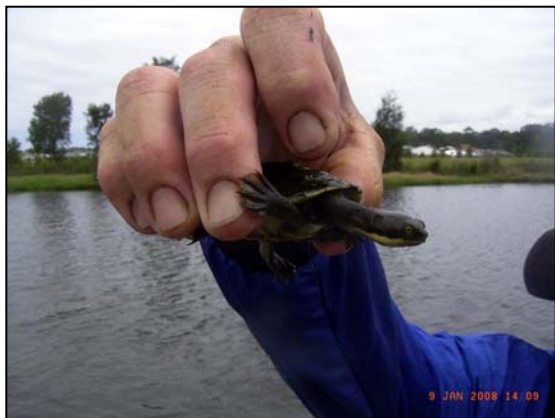
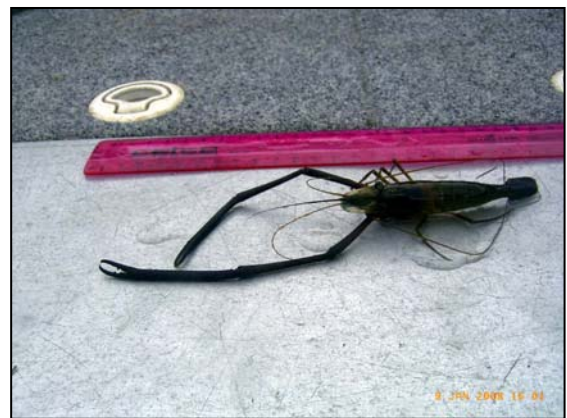
**Plate 4.** Fauna collected during the site visit, January 2008. a) Sea mullet (*Mugil cephalus*); b) Freshwater mullet (*Myxus petardi*); c) Juvenile snake-necked turtle (*Chelodina longicollis*); d) Palaemonid shrimp (*Macrobrachium* sp.)

Bait traps collected mosquito fish (introduced), three species of gudgeons (native) and at least two species of freshwater shrimps (Table 4). Seining yielded similar species to the bait traps, plus two juvenile short finned eels. Large numbers of freshwater shrimps were also caught in the seine, often where the seine passed through fringing water plants (Table 4, Plate 4). Gill nets collected two species of fish – sea mullet and freshwater mullet – and one turtle (Table 4, Plate 4). No Oxleyan pygmy perch were recorded.
