Assessment of the supporting hydrology of the Wallum Froglet Marshland at Rainbow Beach

Project	Rainbow Beach	
Project No.	06503266.03	
Report Title	Assessment of the supporting hydrology of the Wallum Froglet Marshland at Rainbow Beach	
Location	Rainbow Beach, Bonny Hills, NSW,	
Prepared for	St Vincent's Foundation	
Revision	C	
Author(s)	Dr Courtney Henderson and Dr Peter Breen	
Approved by	Dr Peter Breen	
Date	6 July 2010	
File Location	P:\0650 PROJECTS\06502366 Rainbow Beach\2366.03 3A Application\03WRKG_DOCS_REFS\3.2Environ\Draft_Docs	
Distribution	Electronic Copies to: James Dunn	TPS

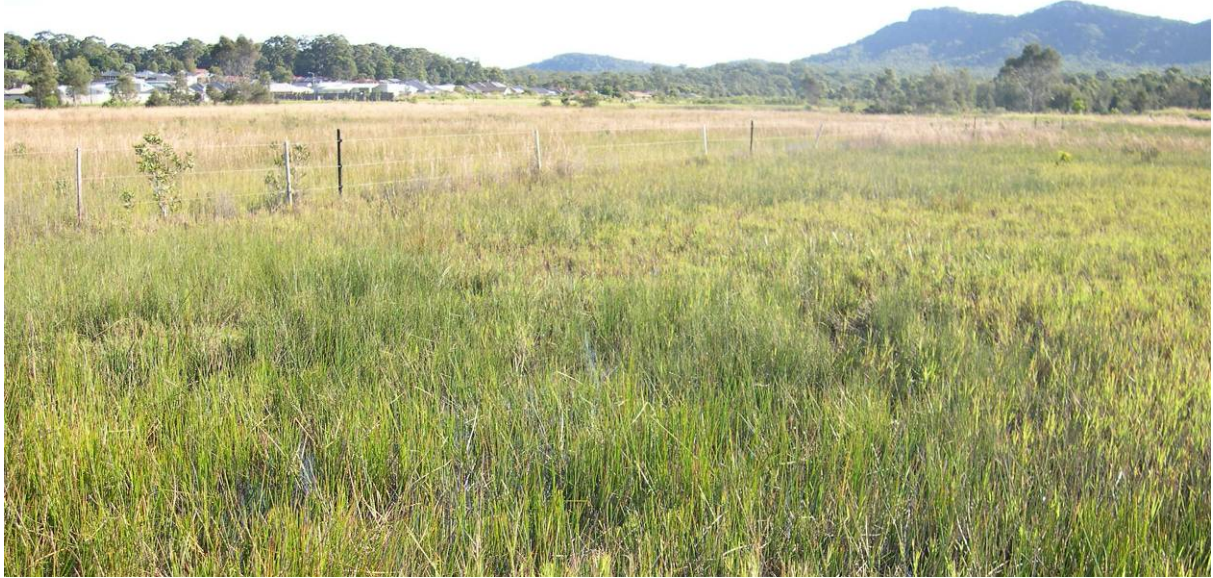
Figure 1 Wallum Froglet Marshland circa 2006. The Marshland is heavily infested with Torpedo Grass (Torpedo Grass has a light green colour with broader leaves than dark, grey-green sedges).

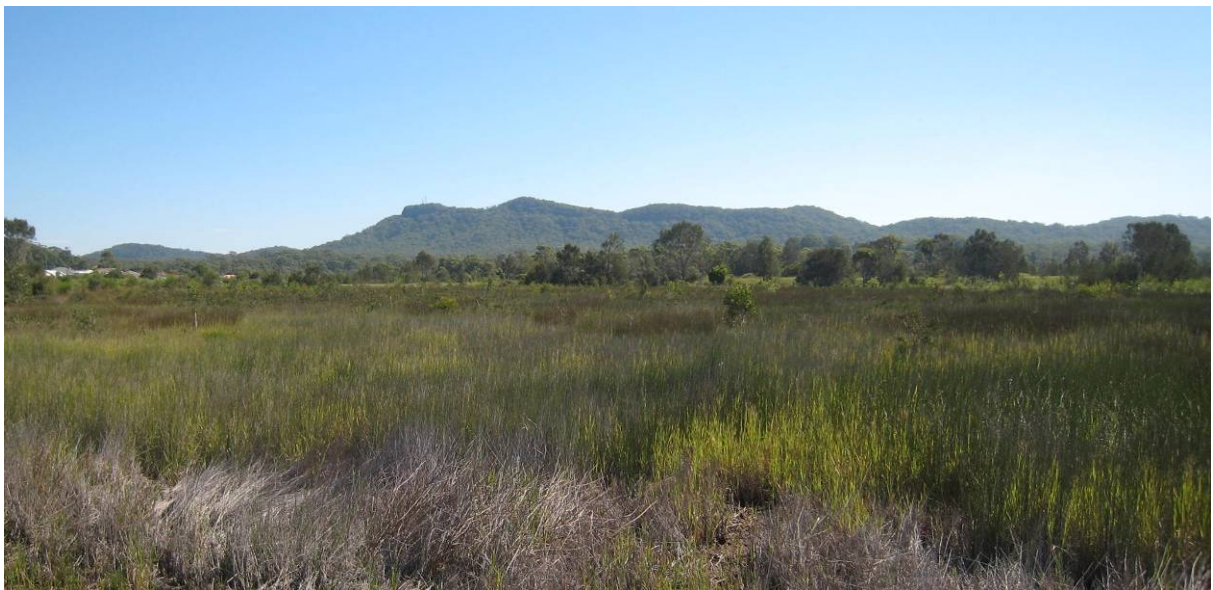
Figure 2 Wallum Froglet Marshland circa 2009. Note that Torpedo Grass is decreasingly visible (light green) and the dark grey-green sedges are increasingly dominant

appears to be increasing with time (*pers.comm.* Wild Things Native Gardens (June 2010), the bush regenerator responsible for bush regeneration of the site) (refer to Figure 2, Figure 3, and Figure 4).

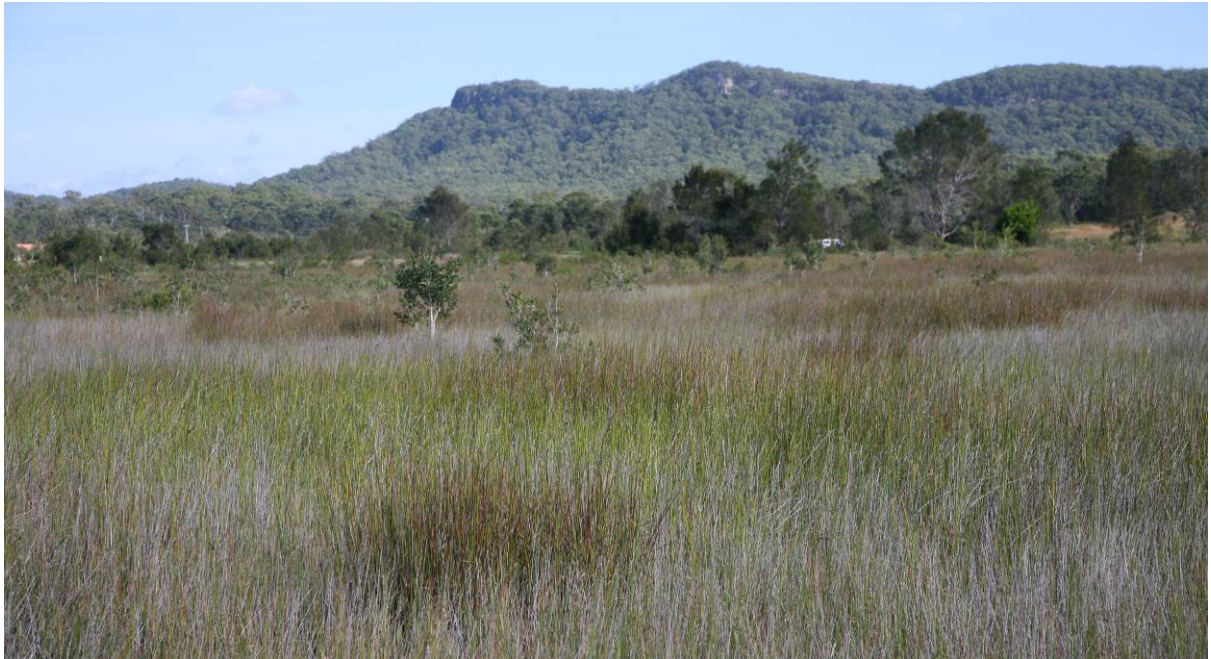
Figure 3 Wallum Froglet Marshland June 2010. Note the increasing dominance of dark grey-green sedges, and the decreasing prevalence of light-green Torpedo Grass.

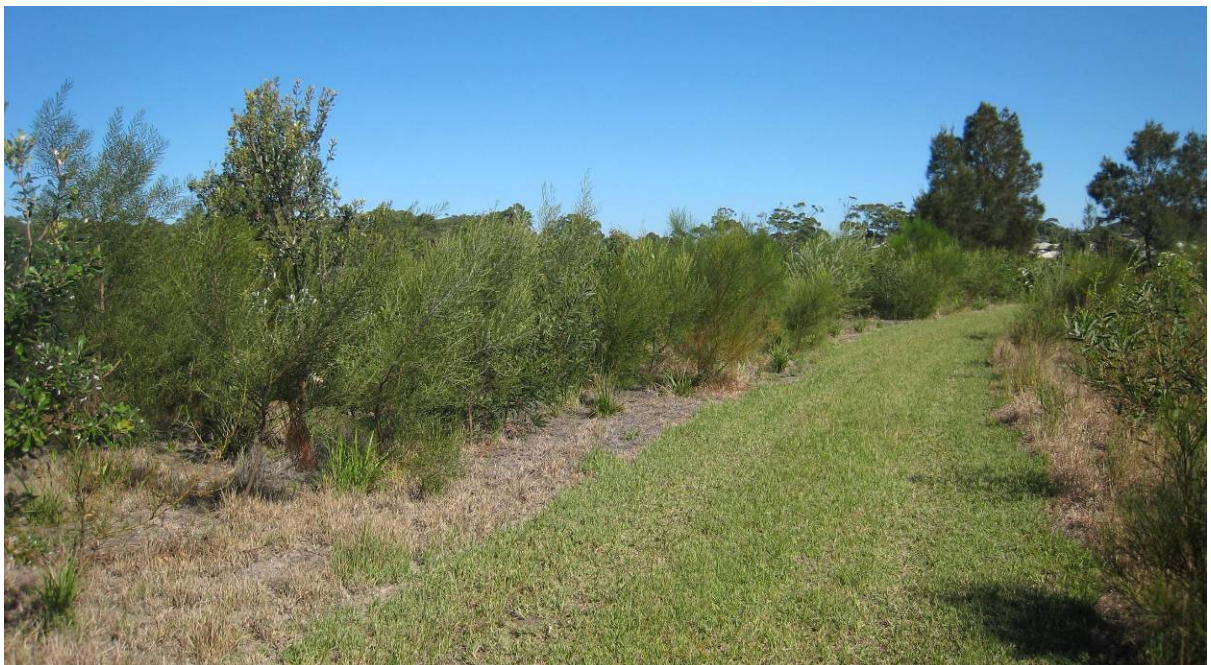
Figure 4 Regeneration adjacent to Wallum Area (to left of photo). This boundary planting is designed to exclude adventitious shoots of Torpedo grass.

The exclusion of Torpedo grass from the Wallum Froglet area should be facilitated by encouraging a shaded perimeter around the Wallum Froglet Marshland habitat. The shade can be provided by combinations of groundcovers, grasses, shrub and small trees. This approach has already been adopted for parts of the Marshland perimeter.

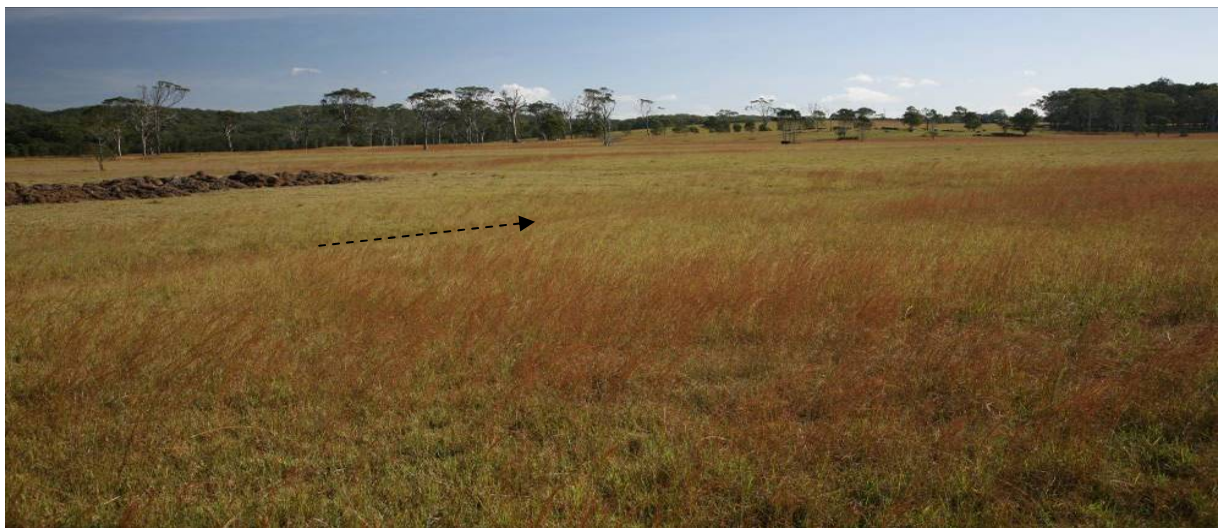
- The existing surface drain network intercepts and directs surface runoff from the upper catchment away from the rehabilitating Wallum Marshland area towards Duchess Creek (refer Figure 5).

Figure 5 A channel or drain upstream of the Marshland that intercepts runoff from the upper catchment (location and direction of flow indicated by dashed line). Marshland lies off to the left of the photo. The mound on the left is decomposing Torpedo grass that was removed from the existing lagoon last year.

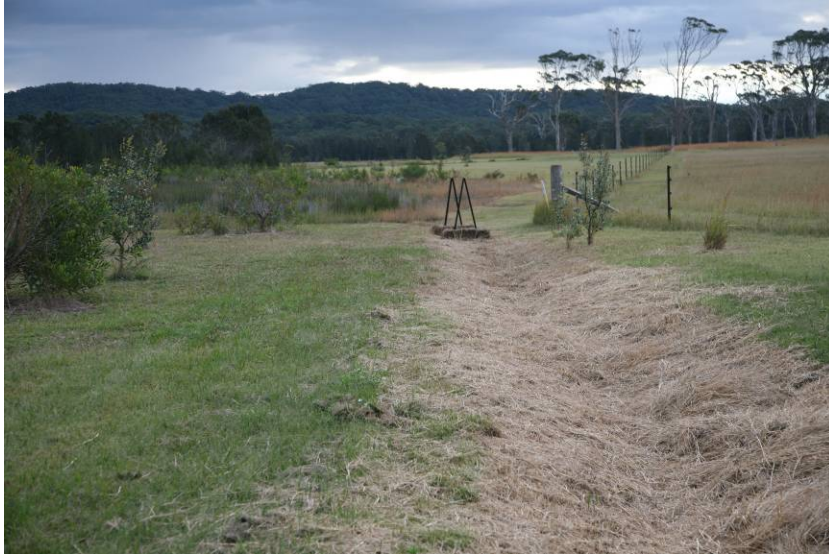
- Water levels within the Marshland are controlled by a surface drain that drains the Marshland basin. This drain controls the maximum depth of inundation and volume of runoff that is retained (refer Figure 6).

Figure 6 The surface drain that controls inundation depth and runoff from the Marshland (looking upstream). Note the Marshland in the background. Hay bales have been placed in the drain to compensate for the flow control that would have been provided by the grass prior to slashing.

The cut drain that controls the discharge of runoff from the Marshland should be surveyed to within 50mm accuracy in order to determine its height.

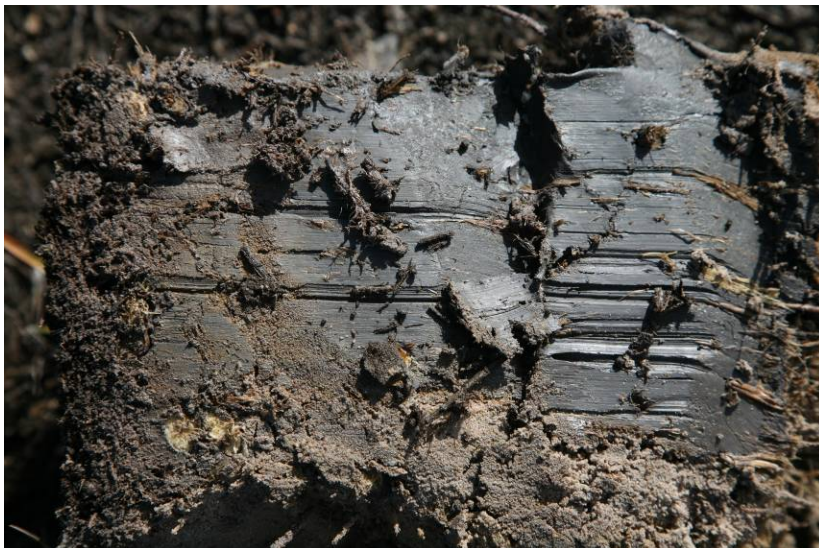
- There was no evidence of groundwater expression in the vicinity of the Marshland.
- The plasticity of the clays that line the Marshland was investigated by hand excavation of several shallow pits. These revealed the occurrence of heavy plastic clays at the surface (refer Figure 7). These pits confirmed the description of soil parameters reported by WRL (in their Section 7.2), and the bore log data sheets of Holmes and Holmes (2002).

Figure 7 Heavy plastic clay dug from the surface of the Marshland. The low permeability of this soil is thought to be responsible for the impeded drainage of the Marshland.

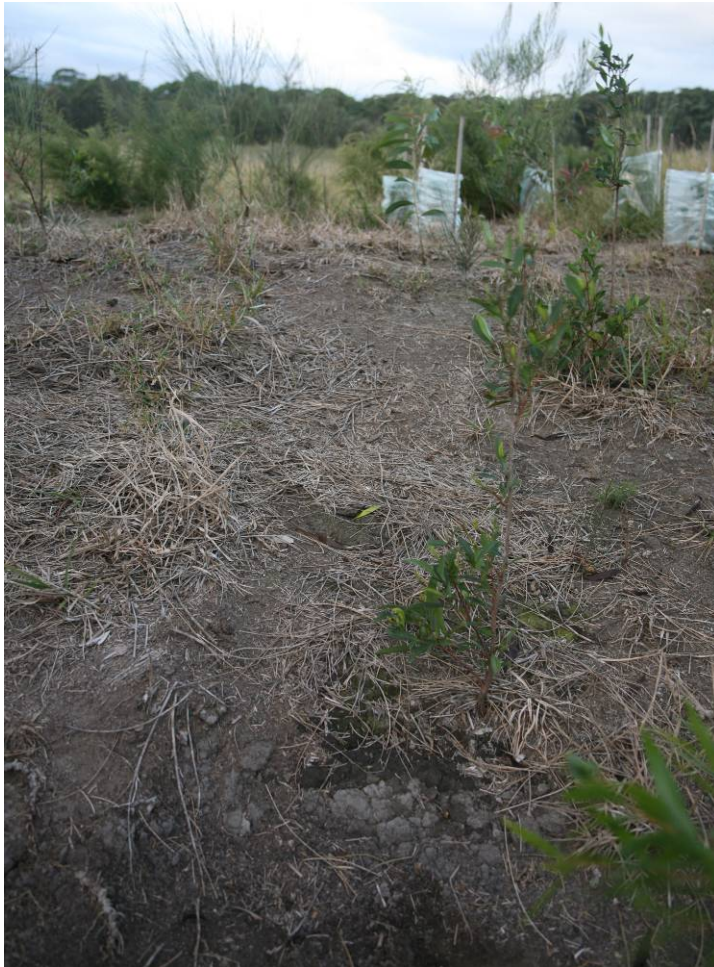
- The Marshland area is set approximately 1.6 metres above the surface of the adjacent lake (WRL 2010). At this location the groundwater is known to occur at a depth approximately level with the height of the water in the lake. If the Marshland was supported by a more extensive local or regional aquifer, the steep cut of the lake batter would have drained the water down below the soil surface to near the lake surface. Since this has not occurred, it is thought that the high plasticity of the clays that make up the surface soil of the Marshland area are sufficiently impervious that rainfall that falls on the catchment is retained on or close to the soil surface and does not infiltrate into the soil (refer Figure 8).

Figure 8 Heavy clays exposed high on the batter from the Marshland to the lagoon. These soils would prevent surface drainage from infiltrating to the groundwater below, approximately 1.6m below the surface.

If it is determined that water is being lost from the Marshland due to erosion of the lagoon batters at any location other than the identified primary exiting drainage outlet, a spoon drain should be built in the unstable area to capture and re-direct water into the Marshland.

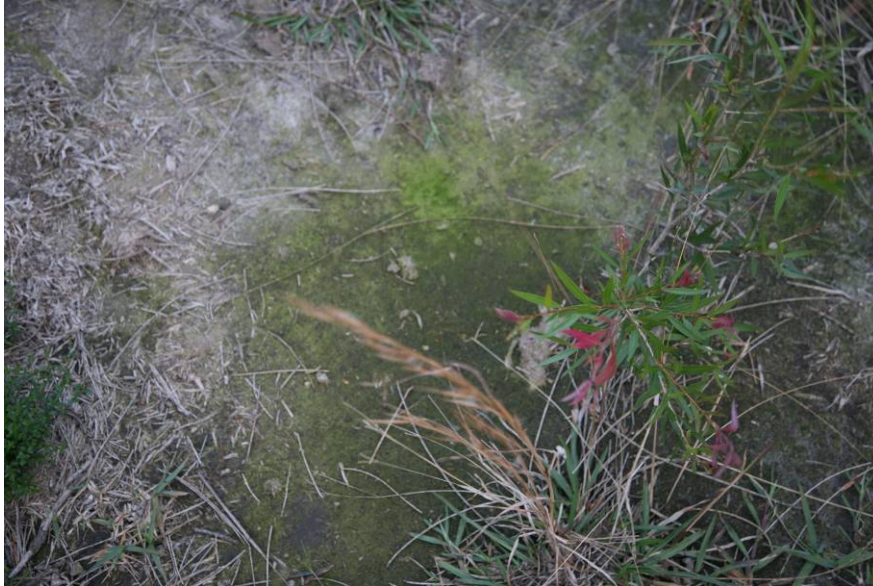
- The presence of algae growing on the soil surface in bare patches amongst the Marshland vegetation, indicates that water ponds on the soil surface, and persists long enough to support the growth of algae (refer Figure 9). This supports the proposition that the Marshland is supported by impeded drainage at the soil surface.

Figure 9 Green algae growing on the soil surface in exposed areas of the Marshland, indicating that water is retained on the soil surface

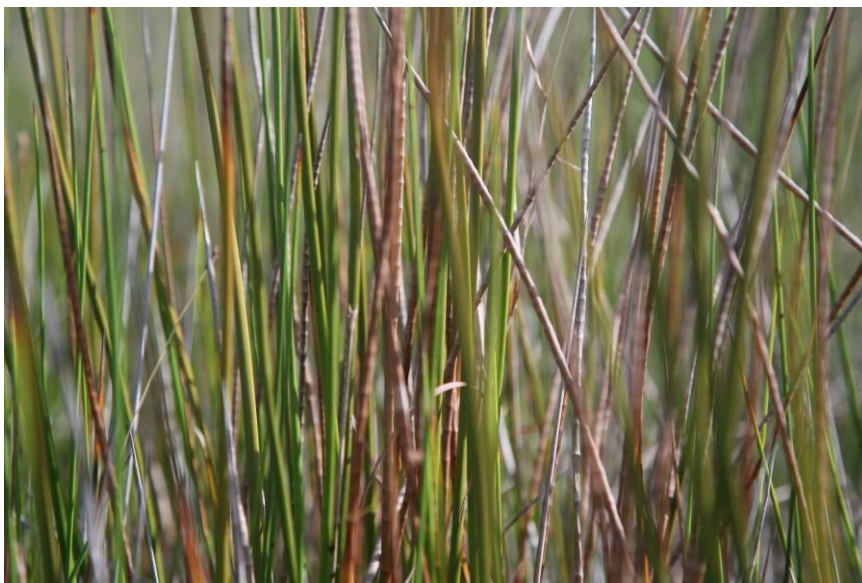
- The plant species found in the Wallum Froglet Marshland are indicative of impeded drainage and saturated conditions. These species included sedges such as *Baumea articulata*, *Eleocharis acuta*, *Juncus spp.*, *Cyperus polystachyos*, *Carex apressa*, *Fimbristylis dichotoma*, *Restio tetraphyllus* (refer Figure 10). Many of these species could not persist in this location if they were dependent on the groundwater 1.6 m below the surface.

Figure 10 Sedges including *Baumea articulata* and *Juncus usitatus* growing in the Marshland
