Incitec Fertilizers Limited Cockle Creek

Heritage Assessment

for Manidis Roberts Pty Ltd

October 2008

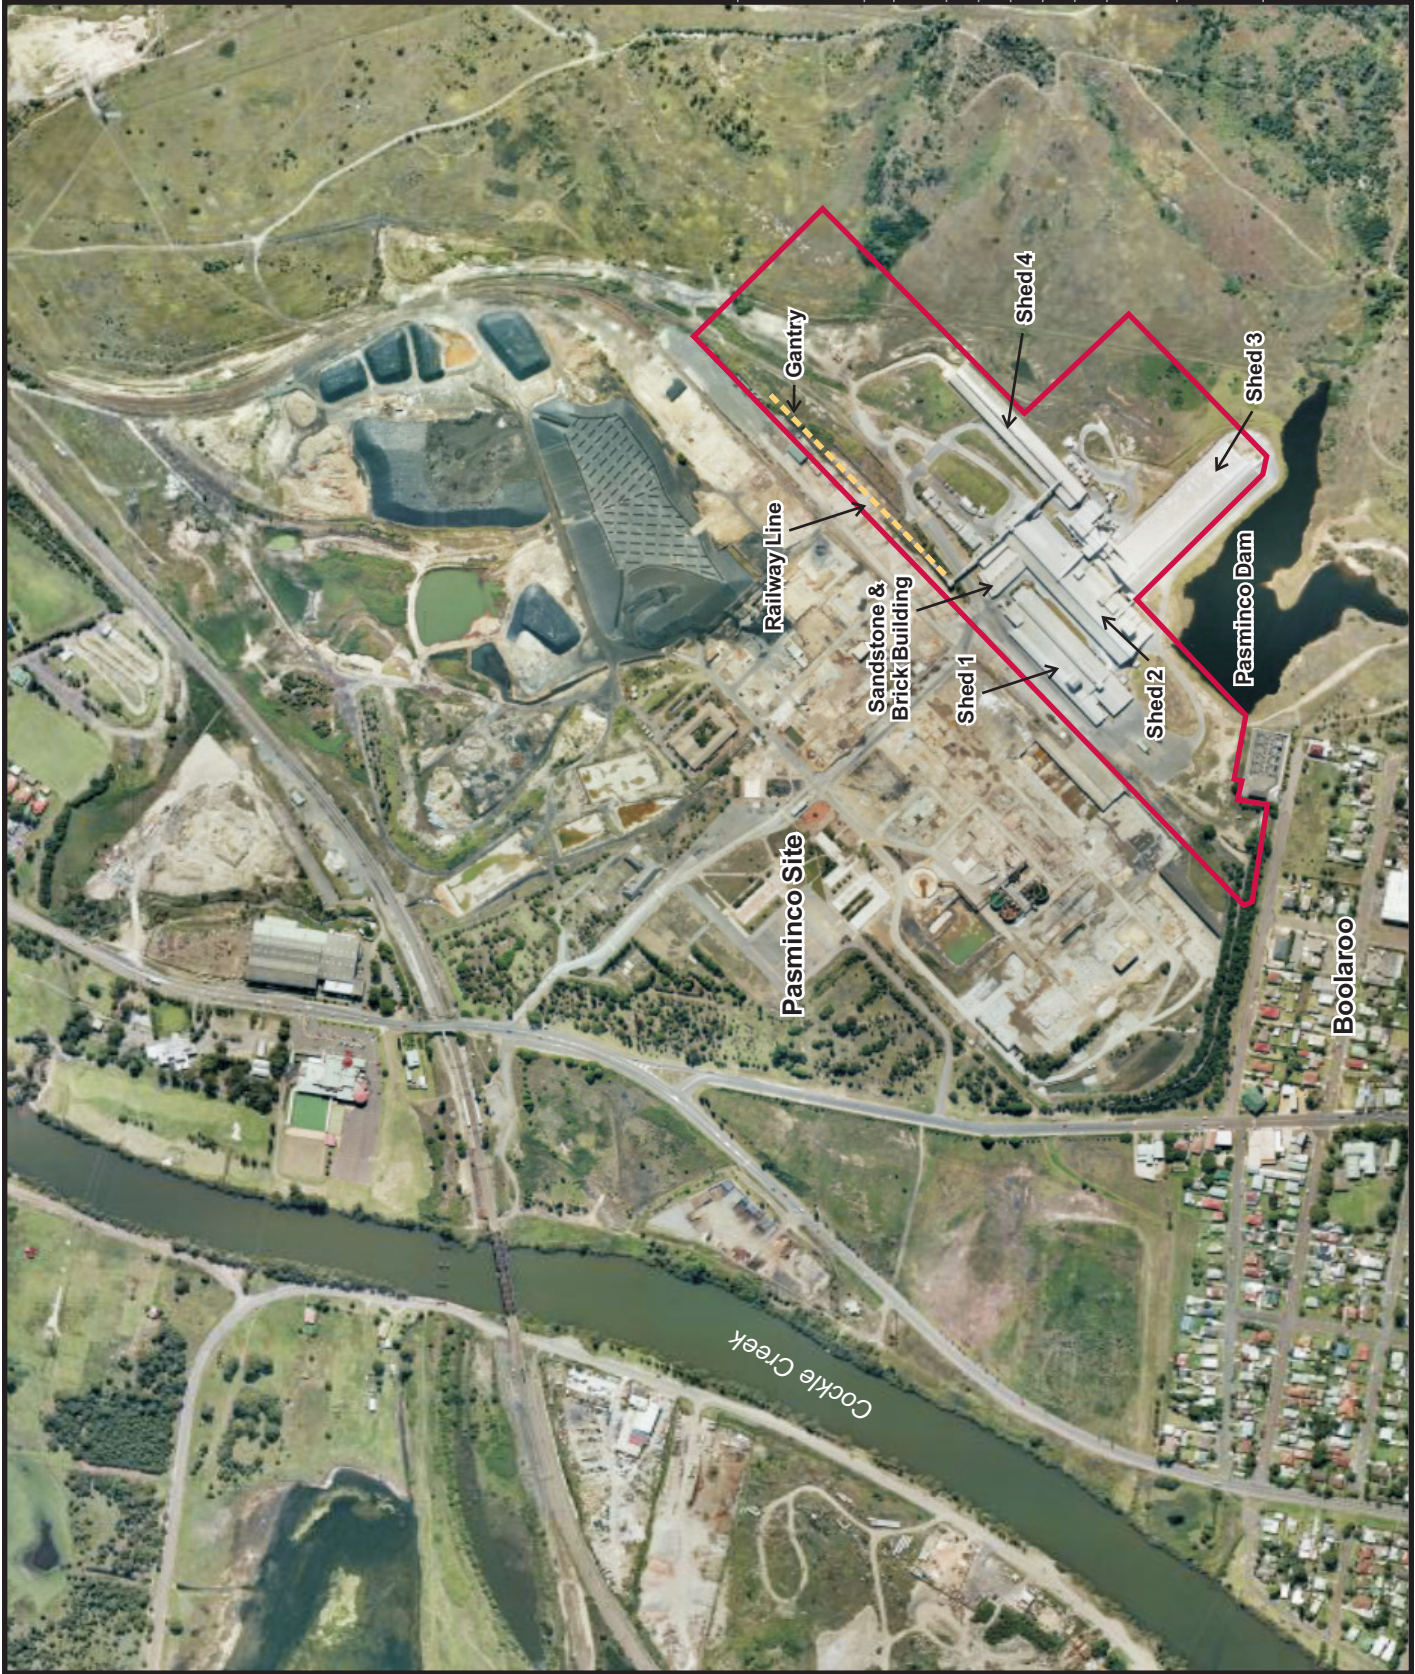
Figure 3.1

Annotated Site Features Plan

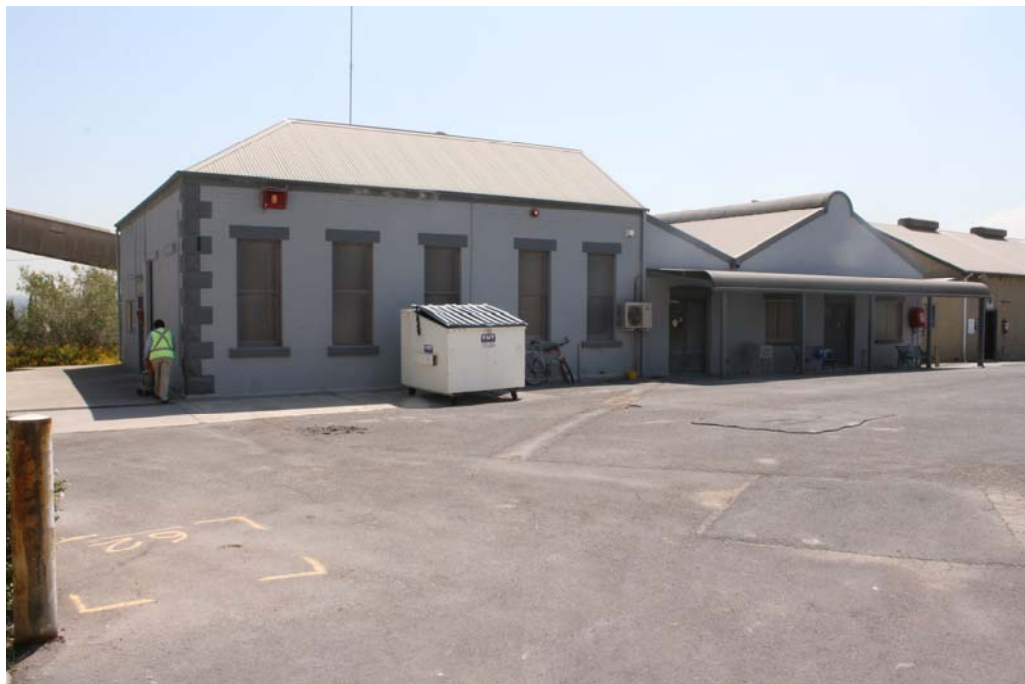
This building stands at the centre of the study area and currently houses several offices of IFL staff. It is made of machine made bricks with sandstone foundations, corners (Quoins), and double sash windows with sandstone lintels. There is a newer add on building with a wide sloping veranda on the northern half of the building. It is suggested that this building was originally an office, with the assay lab attached, constructed c. late 1890s. It was the first item constructed on the IFL site.

The external condition of the building is fair but has clearly been modified for current use. The interior of this building retains little of its original design, with a modern fit out for offices. The primary evidence for modifications are at the southern and eastern ends of the building.

Photograph 3.1 Eastern façade of sandstone and brick building

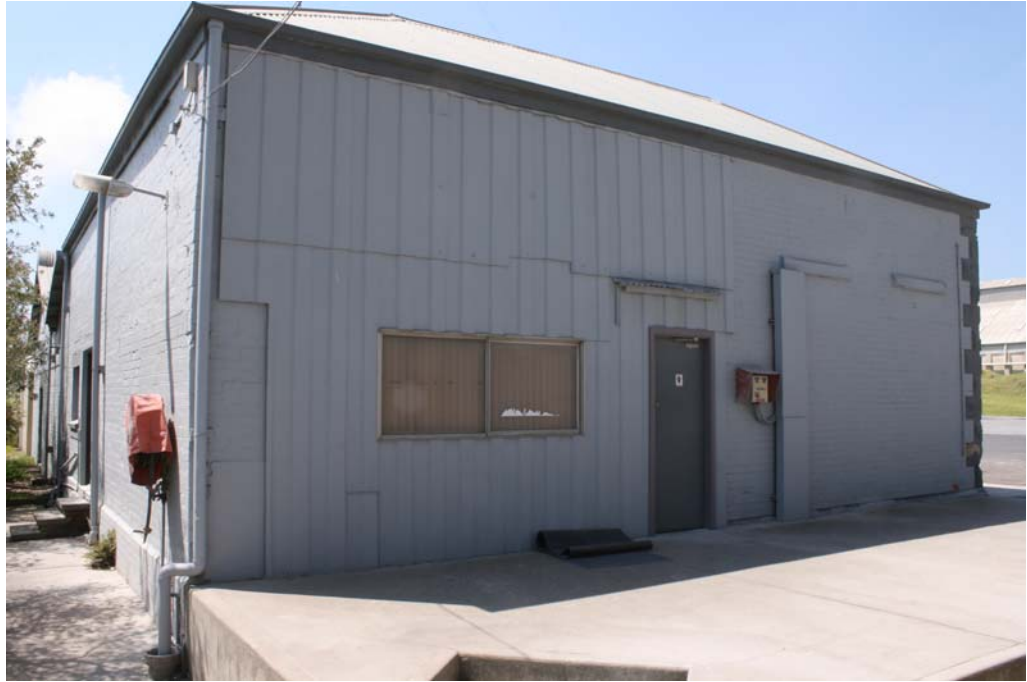
On the southern side of the house is a corrugated iron addition, several bricked up windows with sandstone lintels and a couple of holes are cut into the sandstone corner blocks, possibly for some kind of support beam. The eastern end of the building may have once had a veranda but this too has been removed, evidence of which are rectangular holes cut into the sandstone corner blocks.

Photograph 3.2 Southern façade of sandstone and brick building

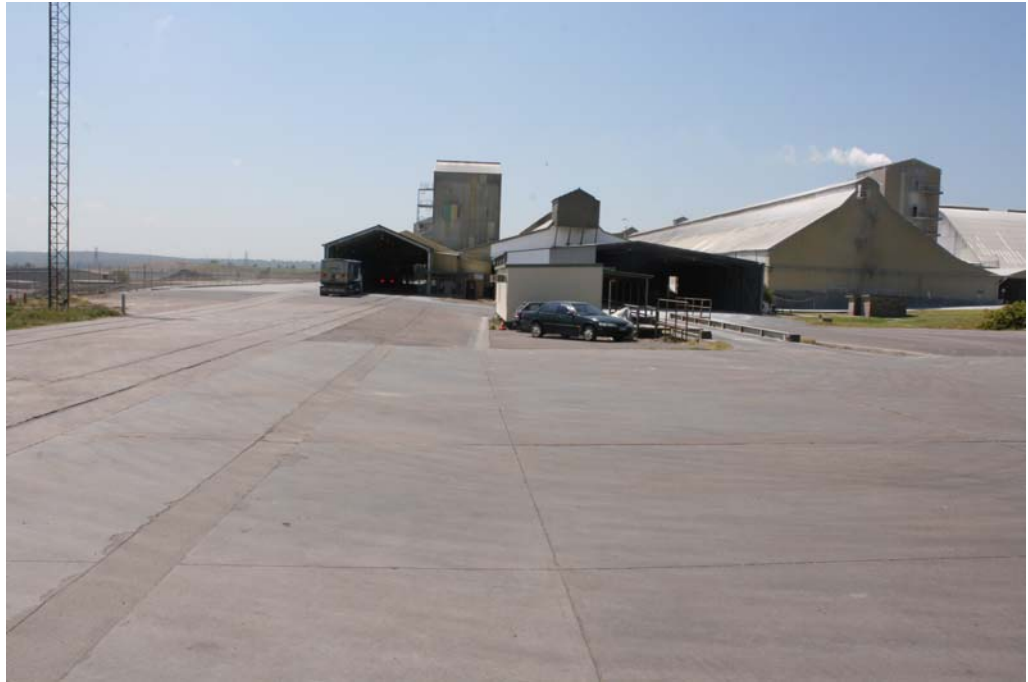
Photograph 3.3 Shed 1 (left) and Shed 2 (right) with railway line running through Shed 1.

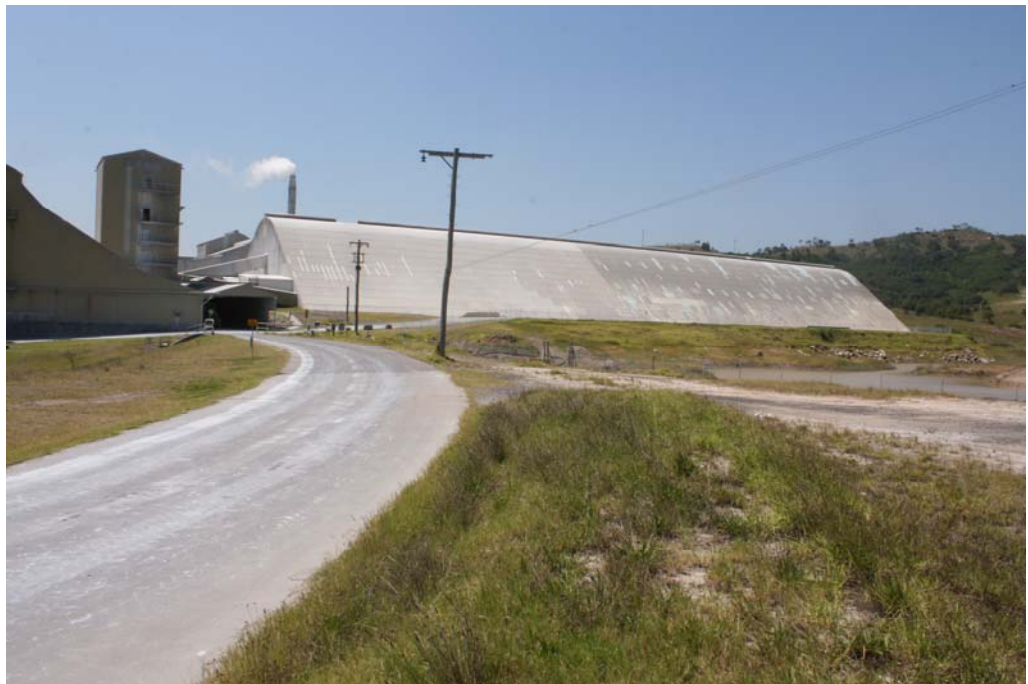
Shed 3 is an asbestos and steel structure with sloped sides and a ridge ventilator at the top. It is in a fairly poor condition with the roof appearing quite brittle and flaking.

Photograph 3.4 Shed 3 (right) with end of Shed 2 on left.

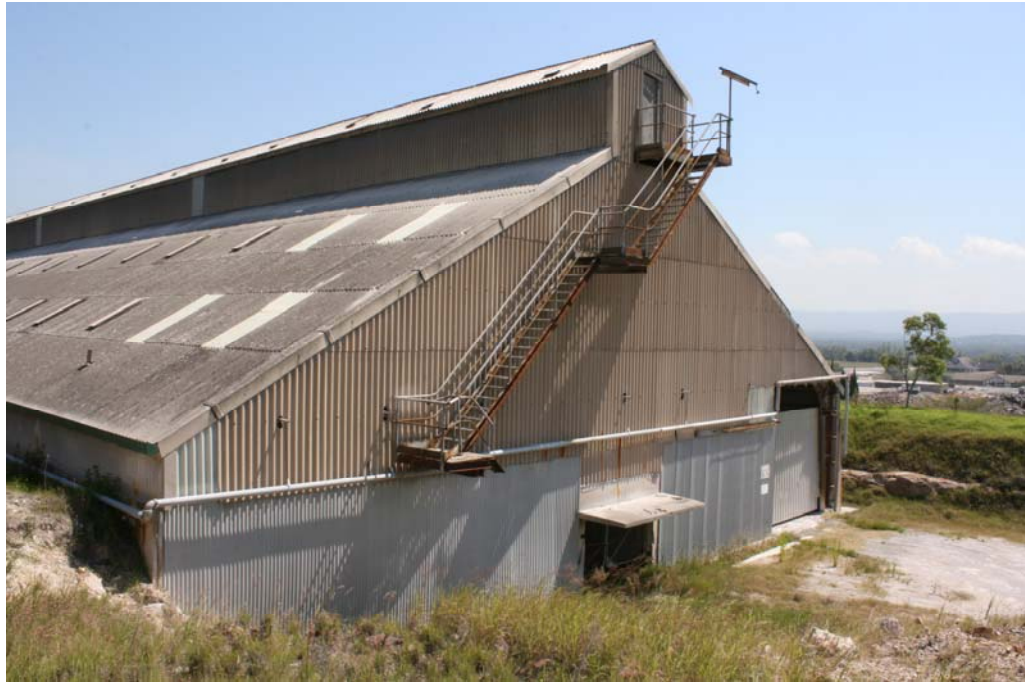
Sheds 4 is a large rectangular sheds with a sloping roof made from corrugated sheets of asbestos/fibro and steel. This shed was not accessed internally.

Photograph 3.5 Northern end of Shed 4

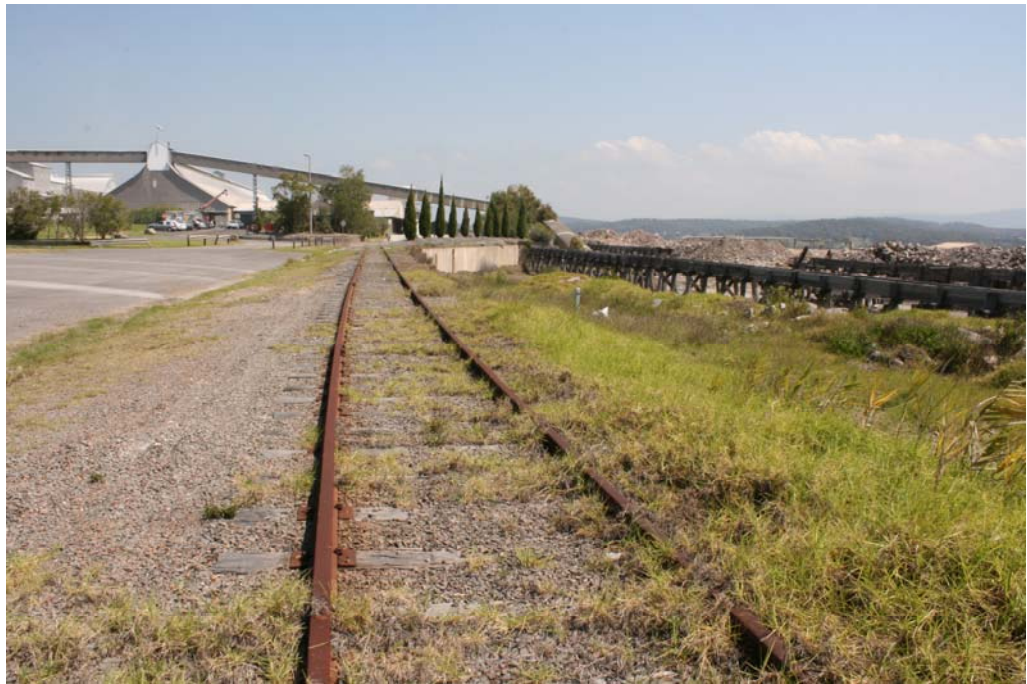
Photograph 3.6 Railway line running South West.

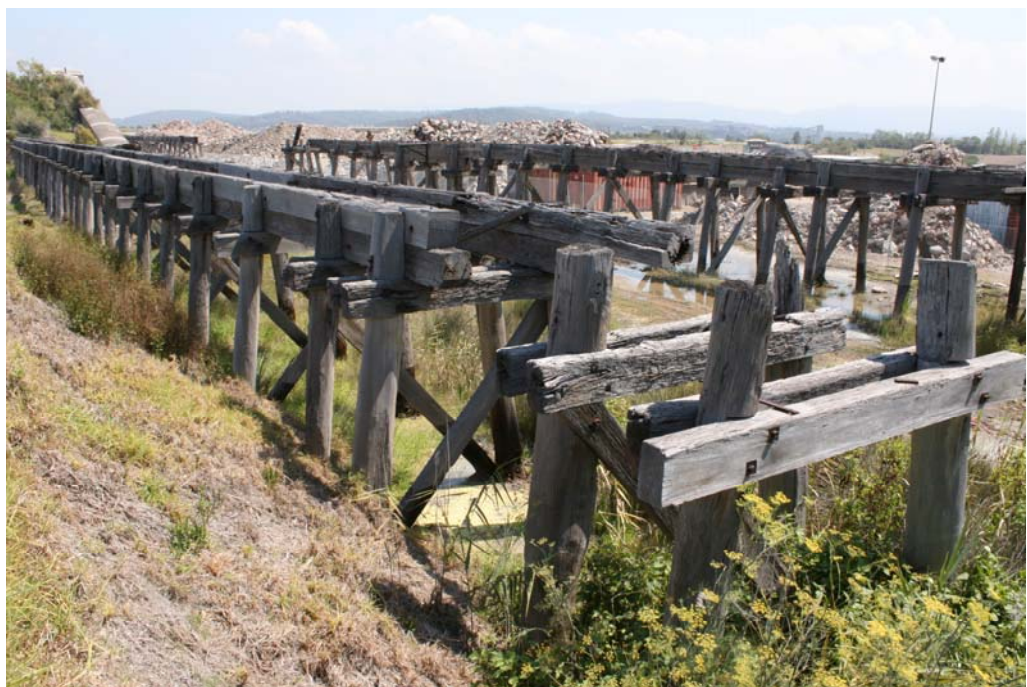
The wooden gantry runs parallel to the railway line described above and is in a dilapidated state (*Photograph 3.7*). It consists of a wooden ‘A’ frame gantry with steel pegs, support pegs and circular upright poles with rectangular horizontal beams. Railway lines run through the middle. The entire structure is elevated to approximately 2.5-3 metres in height. The design of this gantry is typical of other observed across NSW (author’s personal observations).

Photograph 3.7 Wooden Gantry

The gantry cannot be retained as it is located over one of the groundwater 'hotspots' (S&G draft 2008). S&G draft 2008 has noted that all structural members at the site (which include the gantry) contain asbestos and heavy metals. Therefore it is unfeasible, in the interests of environmental remediation and public health and safety, for the gantry to be retained, in situ or following removal/dismantling.

As noted above the gantry contains high levels of heavy metals. Retention of these elements could pose a significant risk to public health. It is therefore not recommended that they be retained.

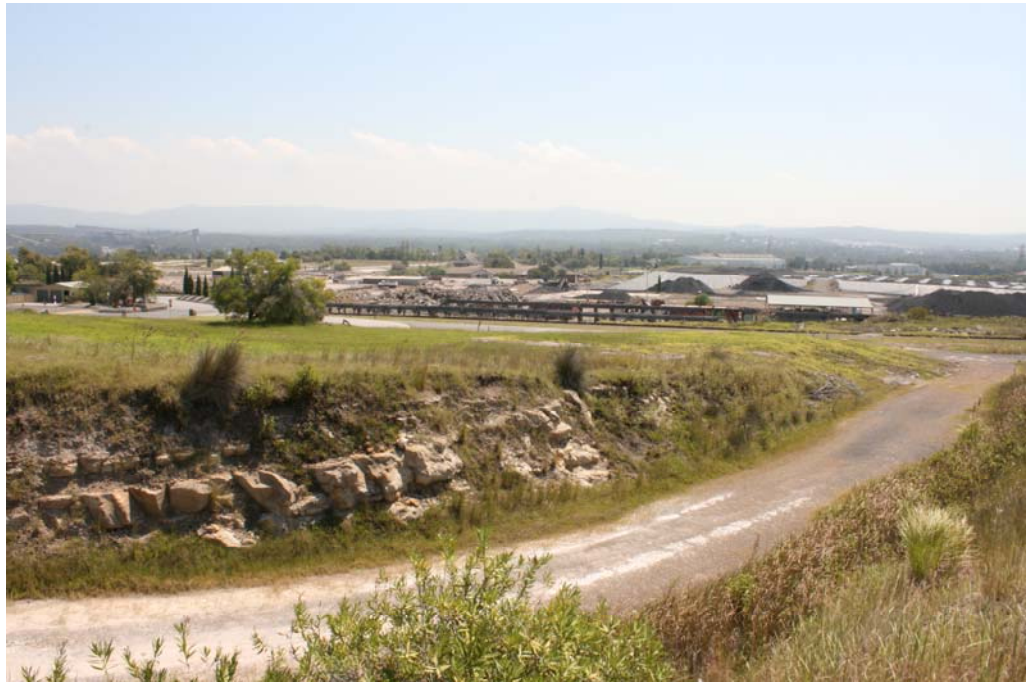
The original landscape has been modified through quarrying of stone material from the eastern rises to create a flat site; on which Sheds 3 and 4 are located. Evidence of this quarrying can be seen through cut bedrock (c.f. Photographs 3.5, 3.8 and *Annex A*).

Photograph 3.8 Elevation of IFL site is shown in relation to Pasminco site.
