BASELINE CONTAMINATION ASSESSMENT

FORMER NAPHTHA STORAGE AREA

GREENLEAF ROAD, KOORAGANG ISLAND

Project 39654

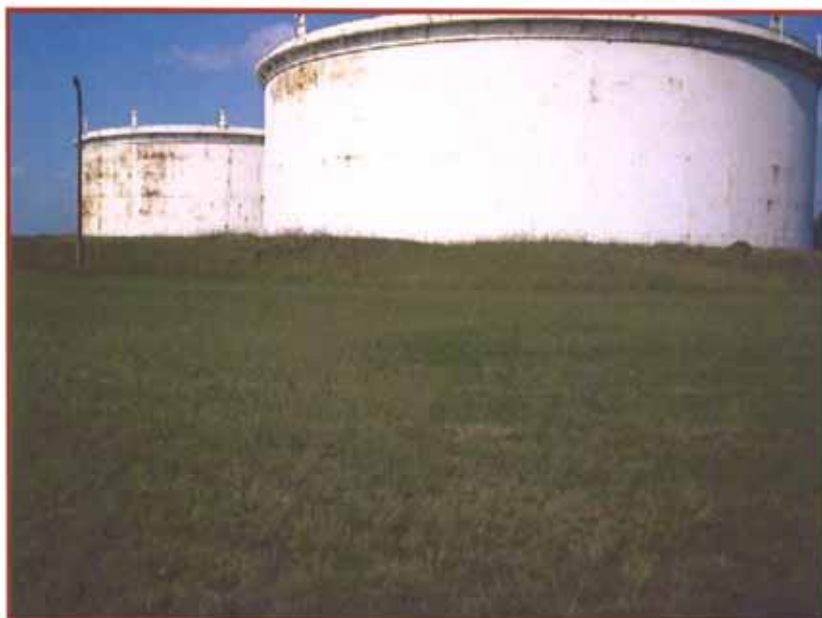
- two metal storage tanks with floating roofs located in the central and northern portions of the site (Photo 1);
- an open brick and concrete base foam station located in the southern portion of the site (Photos 2 and 3);
- A small storage building with metal roof located adjacent to the foam station (Photo 3);
- soil bunding around the storage tanks which continues to the southern portion of the site (Photo 4).

Photo 1 – metal storage tanks (looking south-west)

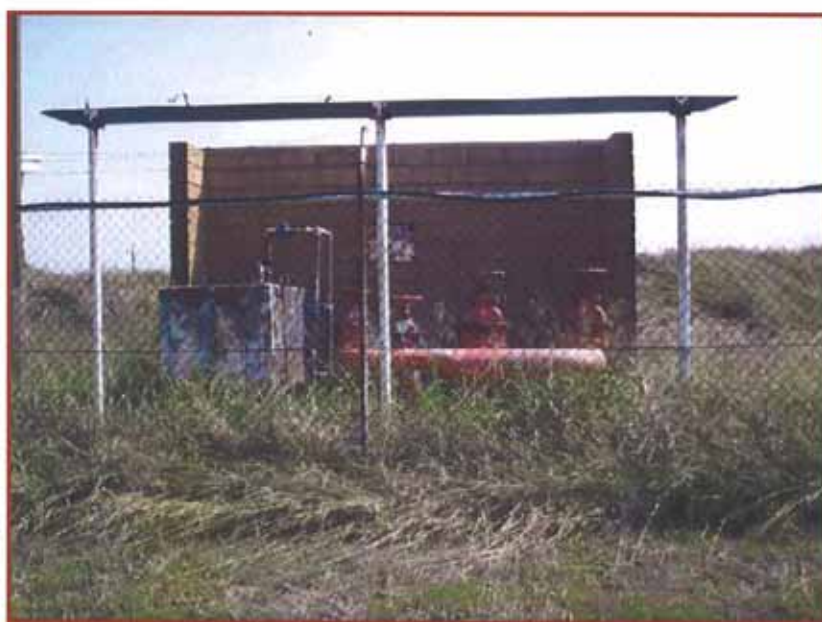
Photo 2 – foam station and associated pipelines (looking north)

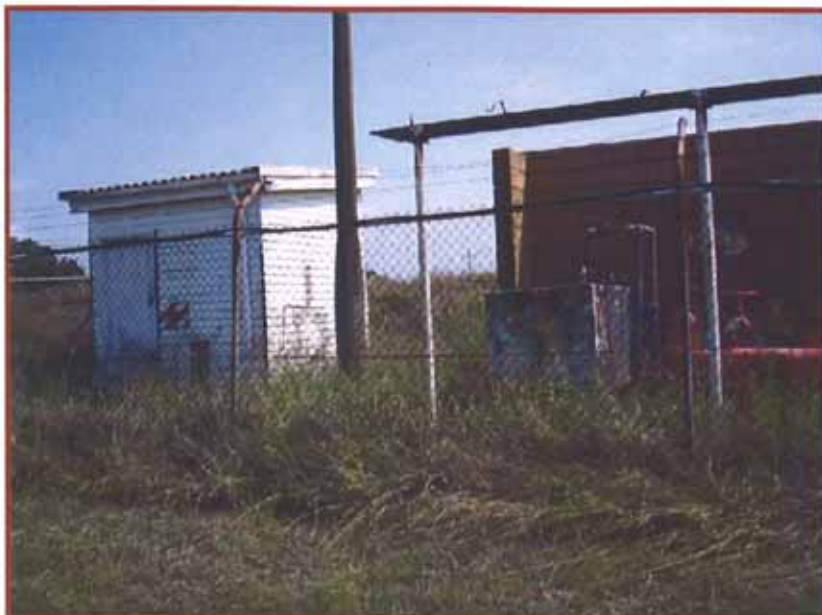
Photo 3 – storage building (left of photo) and adjacent foam station (right of photo)

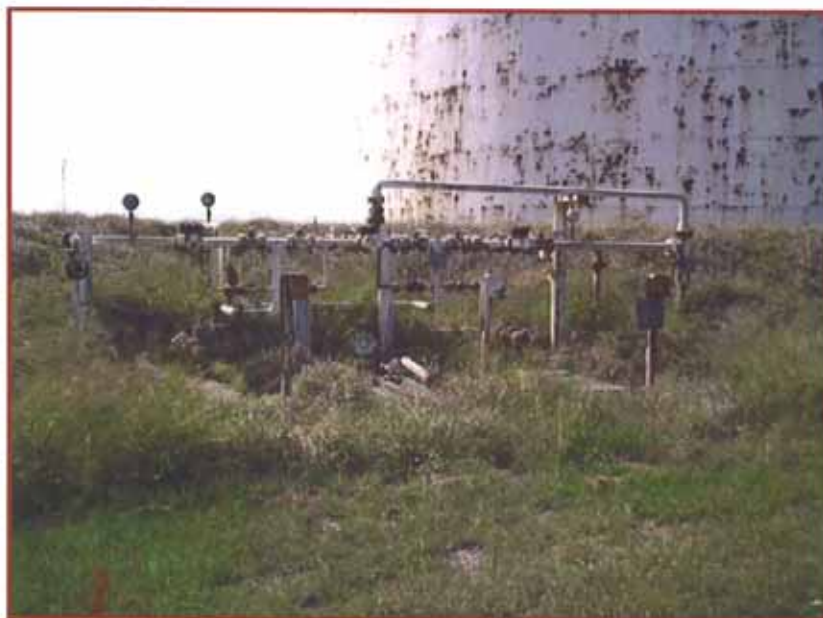
- a pumping station located in the western portion of the site between the storage tanks (Photo 5);

Photo 5 – pumping station linked to storage tanks located close to the western boundary of the site (looking east)

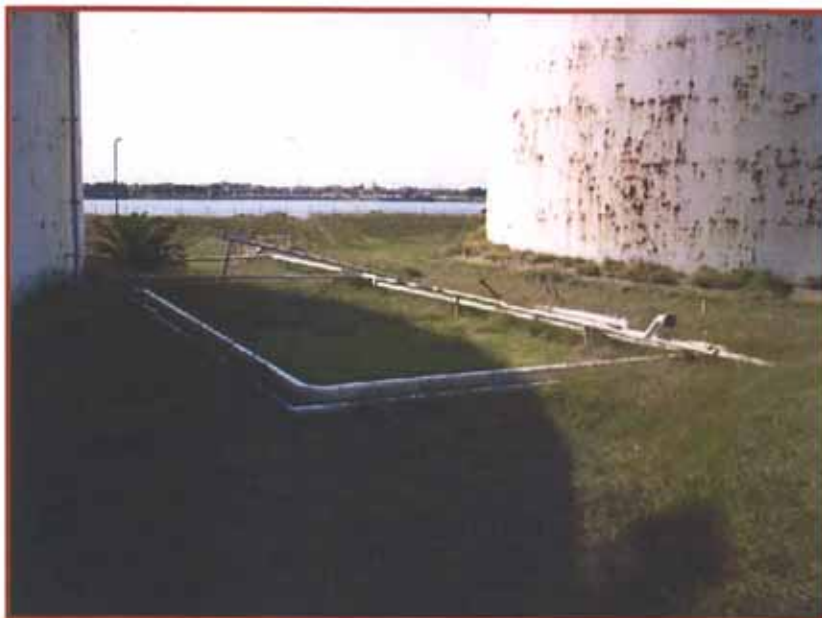
Photo 6 – pipe network linking storage tanks and pumping station situated between the storage tanks (looking east)

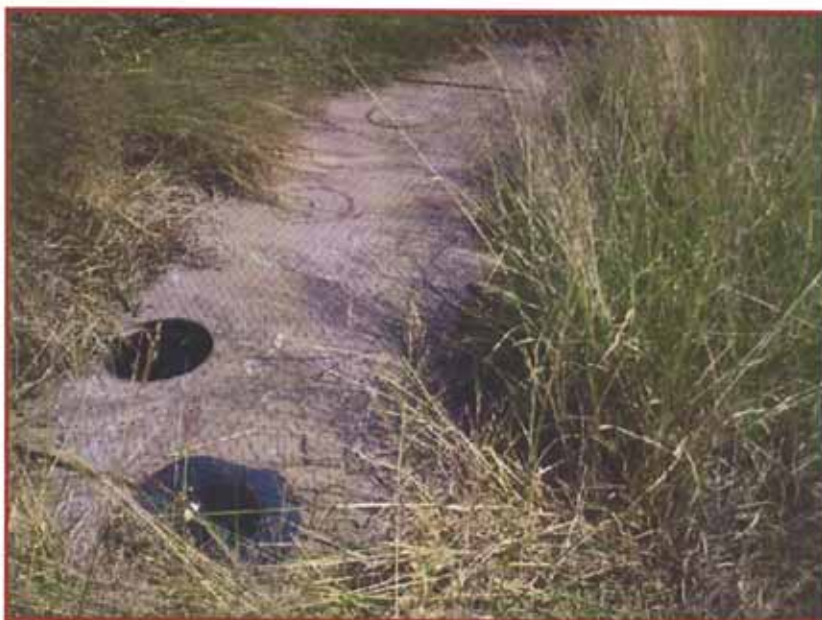
Photo 7 – oil-water separating device located in the eastern portion of the site

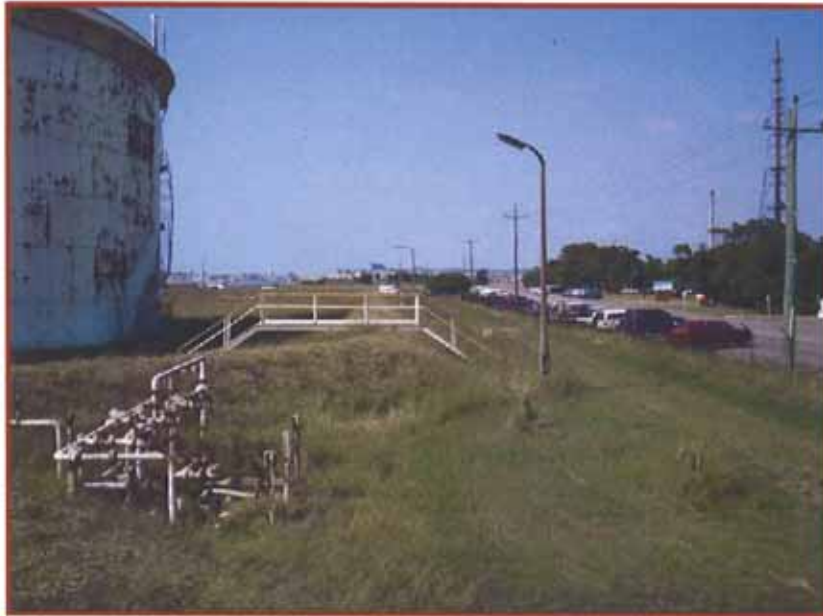
Photo 8 – step and platform structure (centre of photo for entry into the storage tank area (looking south)

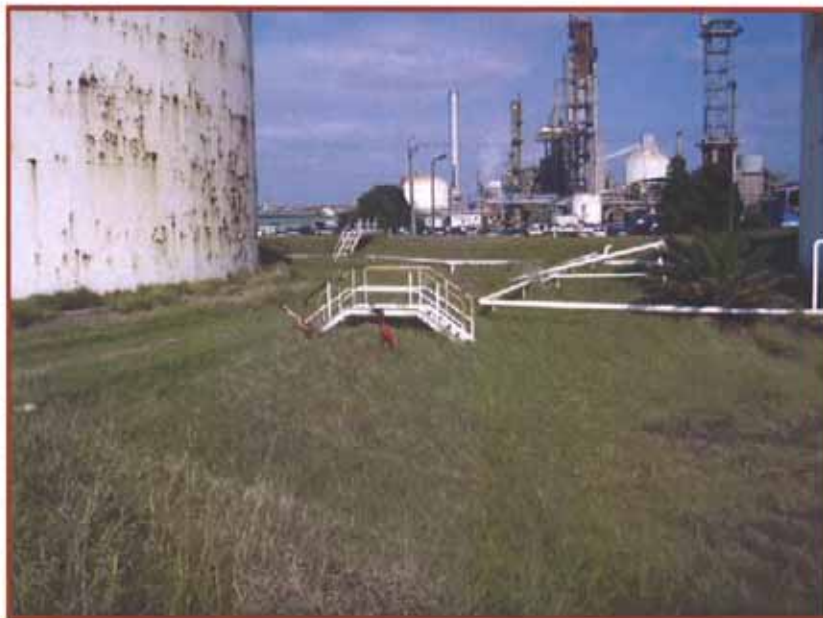
Photo 9 – hydrants and fire-fighting equipment in the central-northern portion of the site (ie. between the northern and southern tanks)

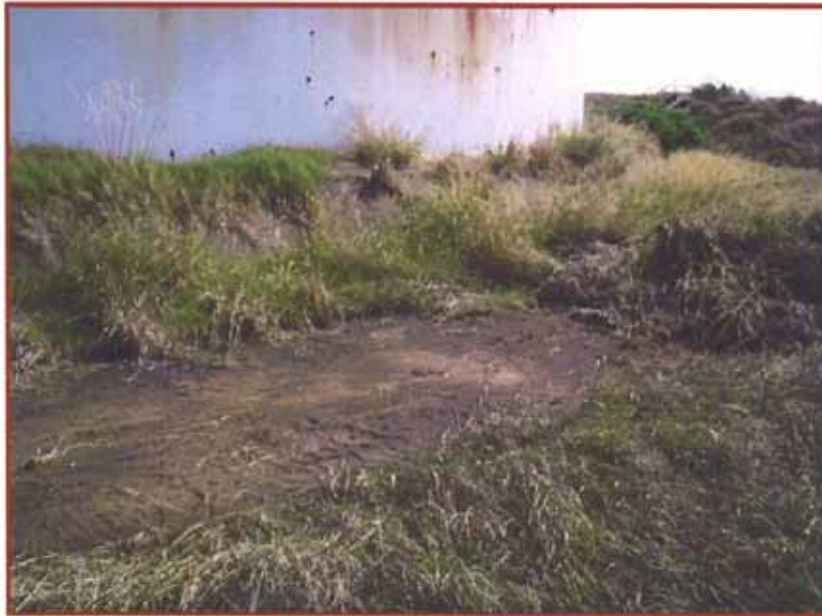
Dark grey/black sand sized granular filling (possible sandblasting material) was observed on the ground surface at the perimeter of the fuel storage tanks, as shown in Photo 10.

Photo 10 – dark grey/black granular material in the vicinity of the fuel storage tanks

- sand blasting materials, paints and particulate metals from the metal storage tanks, observed in near surface soils in the vicinity of the tanks, which may be a source of heavy metals;
- possible fill materials (source unknown) which may contain a range of contaminants including hydrocarbons, heavy metals, pesticides, PCB's etc;
- potential migration of ammonia and heavy metals from the adjacent Orica plant onto the site.

The results of chemical analysis suggest that fill materials on the site are classified between 'Solid' and 'Industrial Waste', with lead impacted soils in the vicinity of the tanks classified as 'Industrial Waste' in accordance with Ref 5. If off-site disposal of site soils is required then additional analysis is recommended to confirm disposal options.

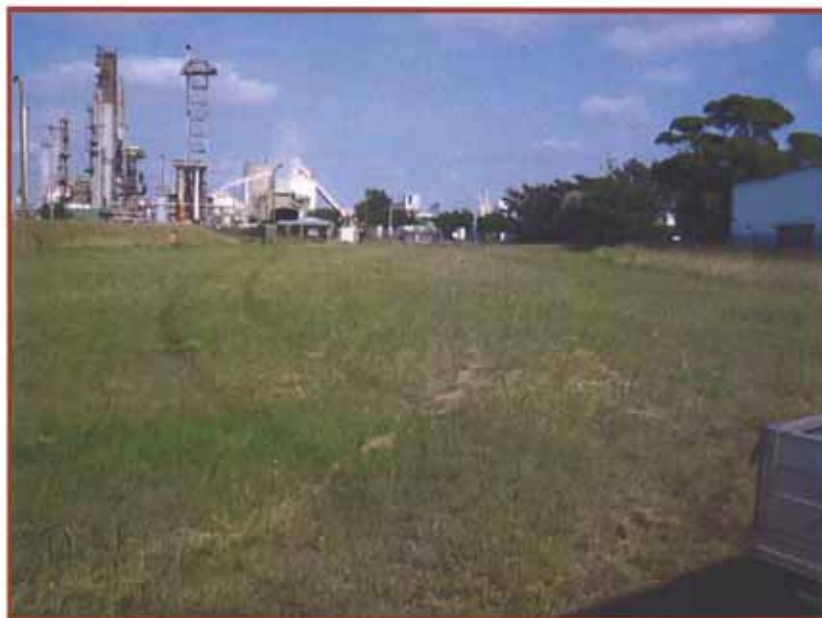
The site is generally flat. The majority of the site comprises of unsealed grassed areas. The northern region of the site includes the entry point with vegetation consisting of mostly grasses (Photo 11).

Photo 11 – northern region of the site which remains mostly cleared (looking west)

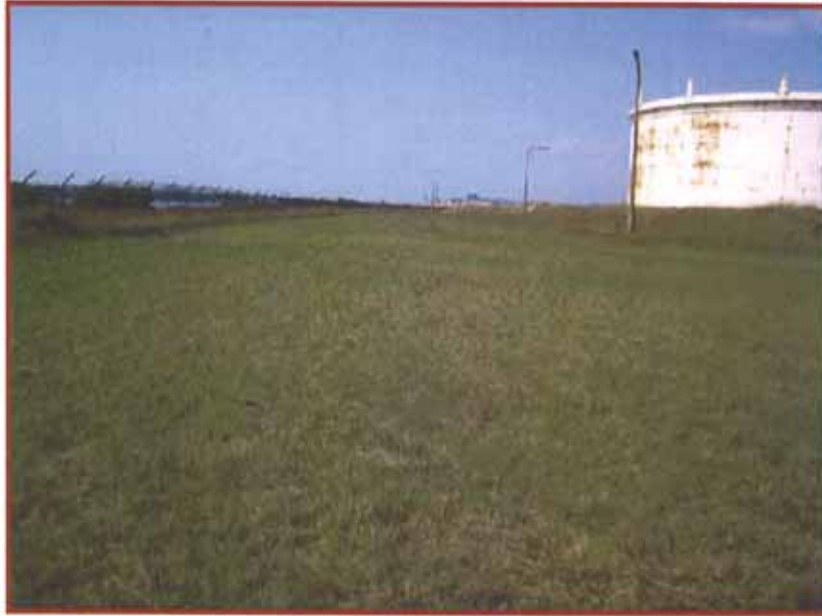
Similarly the eastern portion of the sight, adjacent to the Hunter River, remains covered in short grasses as shown in Photo 12. A single-lane gravel access track was observed to the east of the site.

Photo 12 – eastern region of the site which remains mostly cleared (looking south)

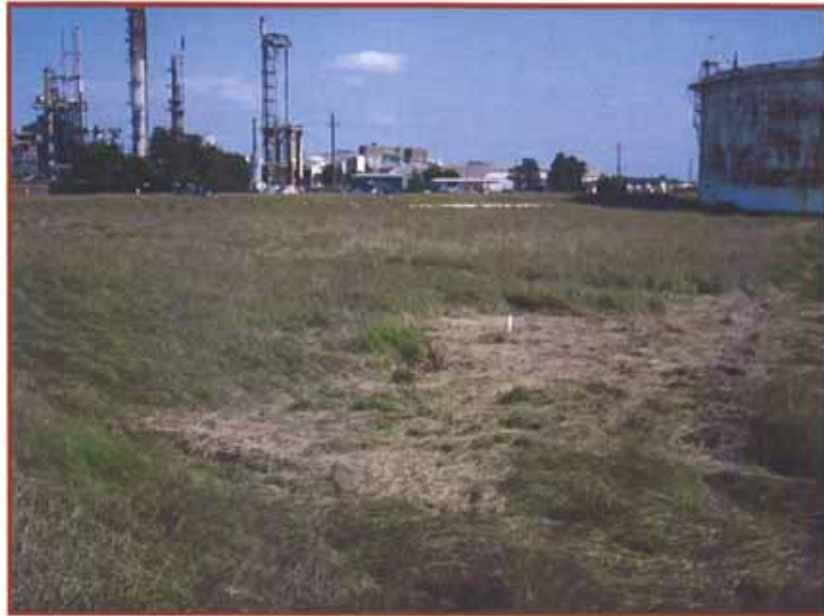
The central-southern section of the site is bounded by the soil bunds and consists of an area covered in longer grasses (Photo 13). The area was not observed to contain any surface structures.

Photo 13 – central-southern region of the site covered in longer grasses (looking north-west)
