## Ash Dam Augmentation Project

**Environmental Assessment**

Client: Origin Energy Resources Limited

15-Aug-2018

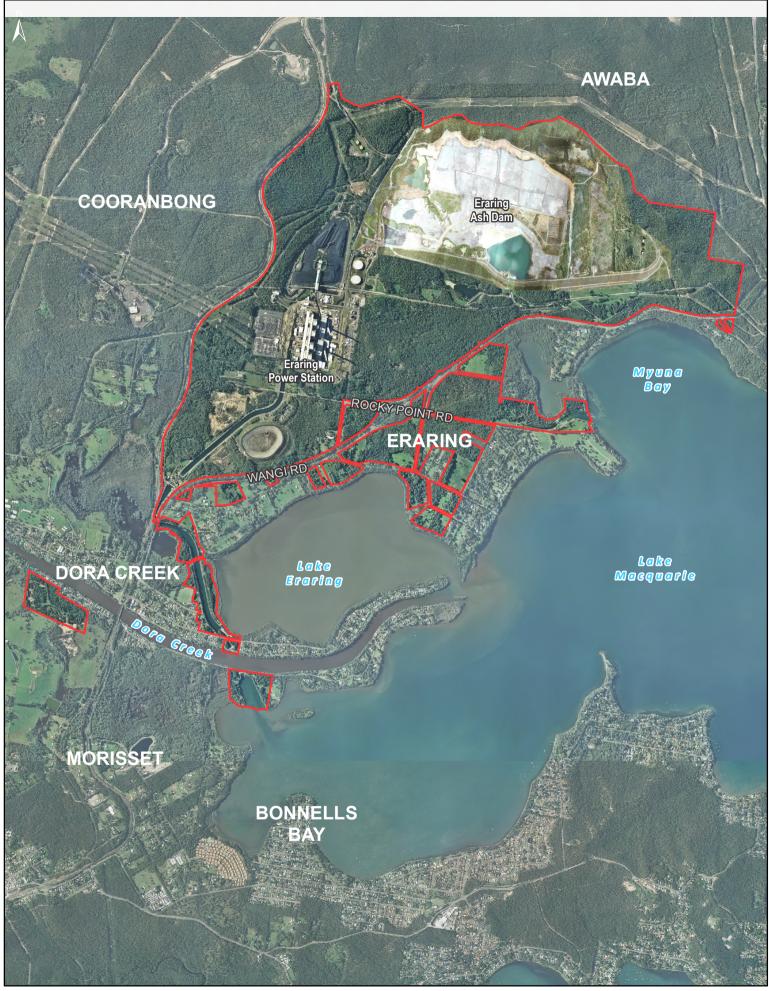
Site Overview Ash Dam Augmentation Project Source: Origin 2018, DFSI 2018 0.25 0.5

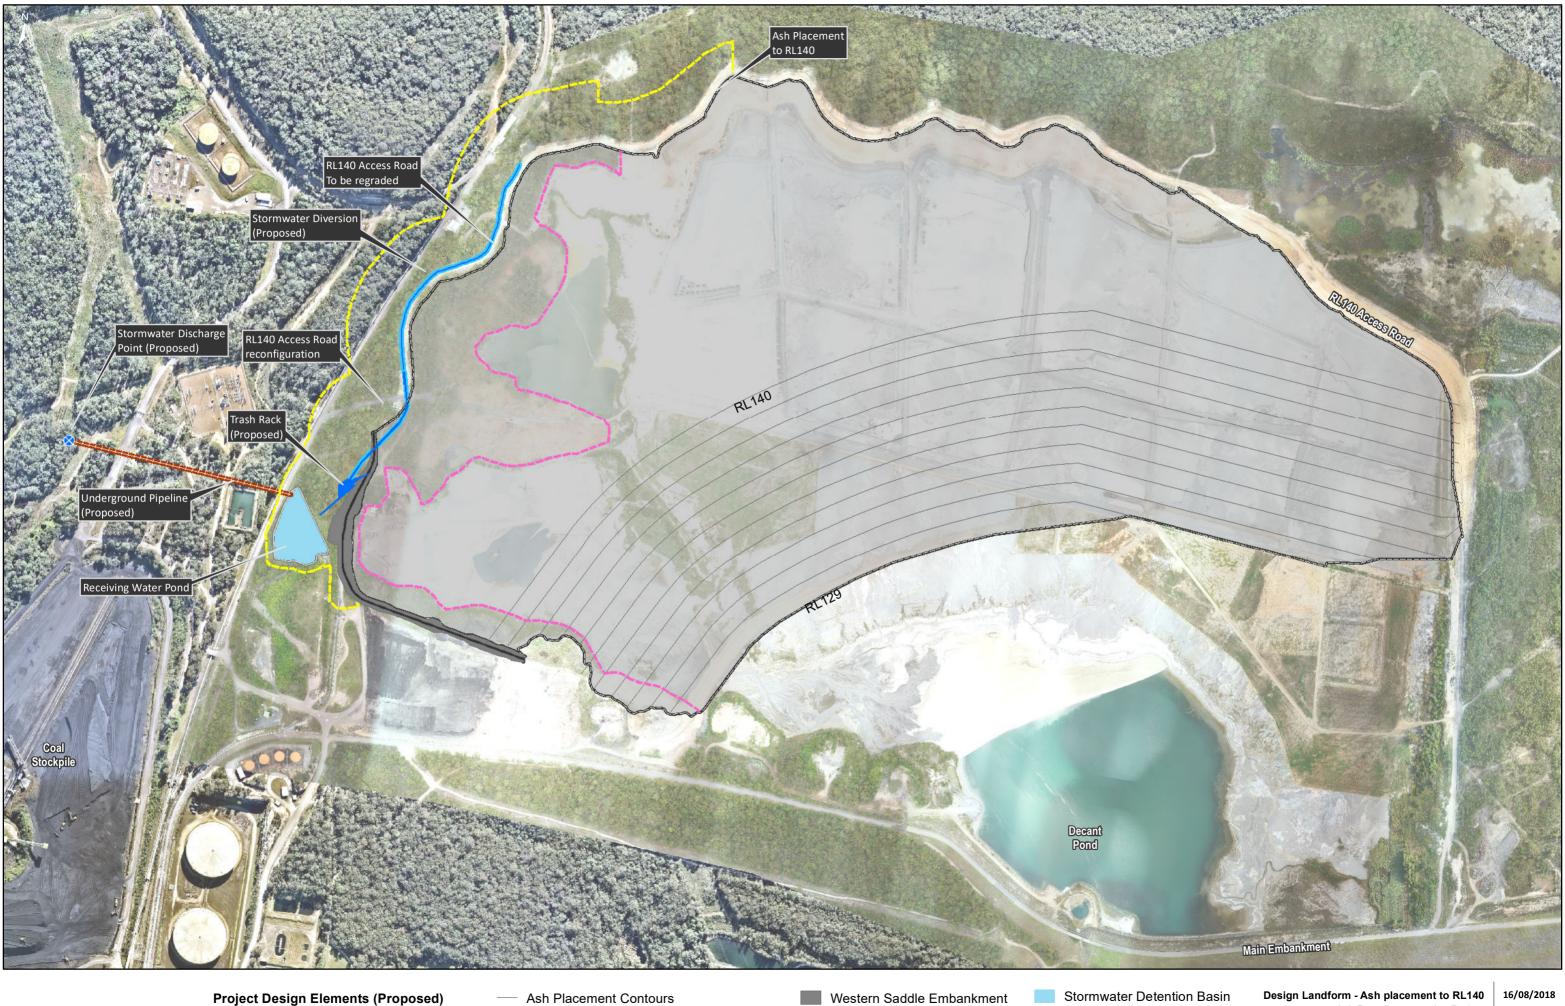
Western Extent of Ash Placement - Existing

Ash Placement to RL140

The Environmental Assessment that informed Project Approval 07\_0084 for the staged expansion of the Eraring Ash Dam in 2008 envisaged that ash placement would be limited to relative level (RL) 140metres. The project as modified would not involve ash storage above RL 140 metres and retains broadly similar landform characteristics to the original design. However, establishment of an improved stormwater diversion system and western saddle embankment are new design elements which require earthworks and clearing of additional vegetation.

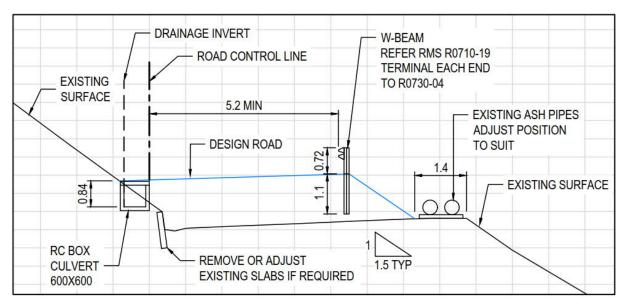
Figure 3 Road Design - Indicative Cross Section

Whilst the RL140 access road is established at a nominal height of RL 140m, actual road level is variable along the alignment. To support stormwater diversion works it would be necessary to adjust gradients by raising the road at the Rail Loop Pond location by up to 1.9m and grading the road at 0.5% in both directions back to original levels. It is anticipated that up to 500m of existing roadway may require regrading. Select fill would be used to achieve design grades. Granular materials would be imported to site. Piling, buttressing or retaining works may be required to ensure geotechnical stability and would remain within the proposed disturbance footprint.

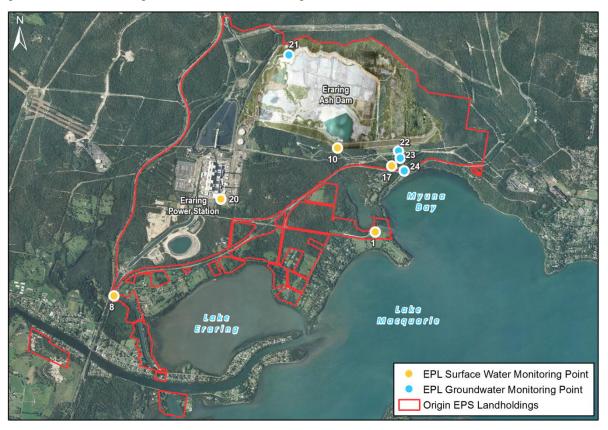
Figure 5 Surface and Groundwater Monitoring Locations

Surface water and groundwater monitoring activities are currently undertaken in accordance with the requirements of EPL 1429. EPL 1429 sets out the concentration and volume limits for discharges from the licensed discharge points as well as relevant monitoring requirements. Surface water and groundwater monitoring locations are shown in Figure 5.

Key parameters of the surface water monitoring program include metals, selenium, temperature, pH, nutrients and total suspended solids (TSS). In the event that monitoring results indicate an exceedance of specified EPL criteria for these parameters, the results are reported to the relevant government agencies and further site specific investigations are undertaken.

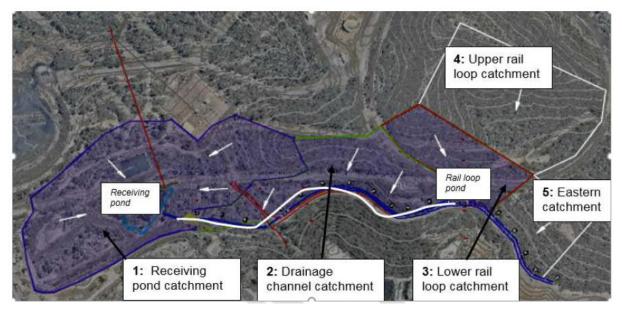
Figure 6 Local Catchments (Indicative)

Survey and site investigations were carried out as part of the Clean Water Design, Stormwater Drainage Design Report (Aurecon, 2018). Three catchments were identified that contribute to the proposed new stormwater system, being Catchments 1, 2 and 3 (refer to Figure 6). Catchments 4 and 5 divert to an existing water storage located in the north west of the Eraring Ash Dam.

The total area of Catchments 1, 2 and 3 is estimated to be 207,332m<sup>2</sup>. The surface run-off from Catchment 1 currently drains to the receiving pond whilst run off from Catchments 2 and 3 drains to the ash dam as shown in Figure 6. The catchment descriptions and catchment areas are summarised in Table 10 below.

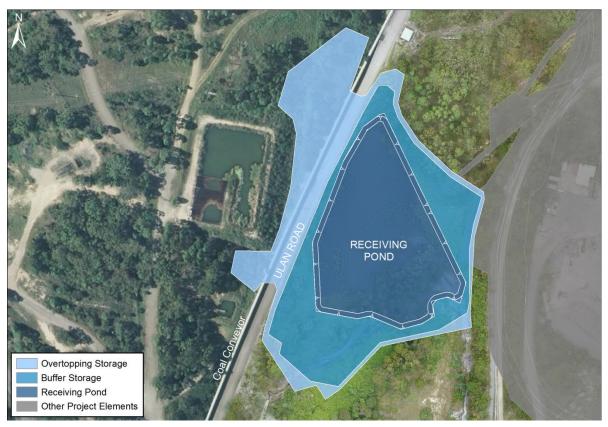
Figure 7 Receiving Pond Water Storages

| Storage element | Details | Capacity (m <sup>3</sup> ) |
|---|---|---|
| Buffer storage | Between RL 129 and RL 131 | 21,346 |
| Overtopping storage | Between 131 and RL 132 | 17,996 |

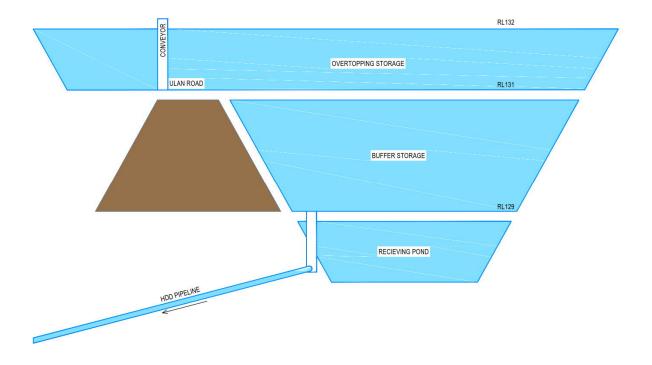
Figure 8 Receiving Pond Conceptual Arrangement in Cross Section

When the current holding capacity of the receiving water pond is exceeded, water would be discharged via an underground HDD pipeline to a new discharge point (refer Figure 9). The proposed discharge point is located approximately 360m to the west of the receiving water pond, directly north of the existing coal stockpile. The discharge point would consist of a precast headwall and rock lined channel extending for approximately 5 metres to reduce the potential for local scour or erosion to occur.

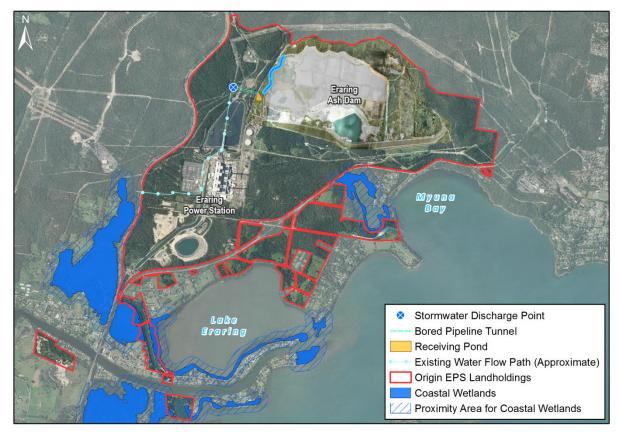
Figure 9 Proposed discharge point and Flow Path

Diverted water would only be discharged during times of sustained rainfall events when the receiving pond's estimated 10,000m<sup>3</sup> storage capacity may be exceeded (Aurecon, 2018). Flows discharged from the receiving pond would be limited to a rate of 240m<sup>3</sup>/hour by the DN300 HDD pipeline diameter and therefore water received during peak storm inflows would be discharged over a prolonged period. Storage performance during both Probable Maximum Precipitation (PMP) and 1% AEP rainfall events are summarised in Table 12.

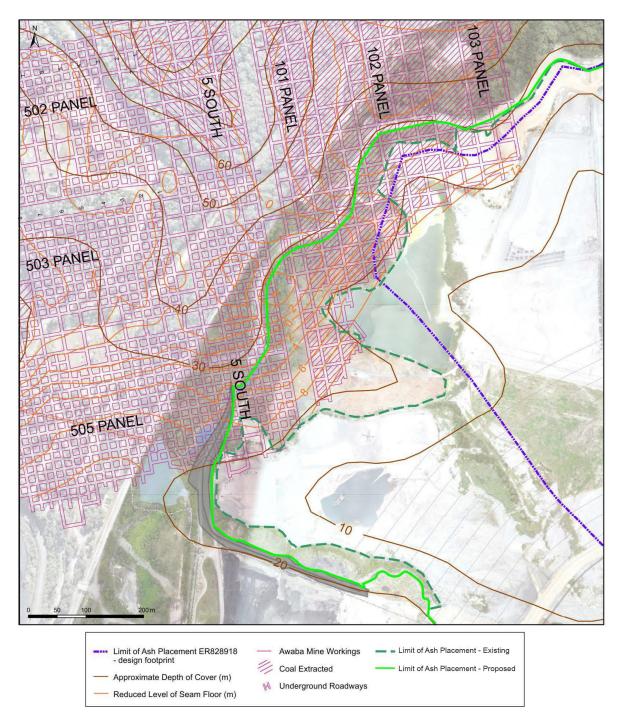
Figure 10 Overview of Awaba Colliery Workings

The mine plan (see Figure 10) presents three types of mining within the proposed ash dam:

- On the development, the system of mining involved driving roadways to form generally square
  pillars at nominally 36 metre centres. Where the overburden depth is very low, no further mining
  was conducted.
- In 101, 102 and 103 Panels, the larger square pillars formed on development were subsequently fully extracted. Extracted pillars are shown as cross-hatched (Figure 10). Pillar extraction typically allows up to approximately 85% of the coal to be safely recovered.
- In 5 South, the large square pillars were split and quartered to form smaller square pillars, nominally 11.5 – 12.5 metres wide (measured from rib-to-rib) but in practice would be 10 – 11 metres wide. The roof of these pillar splits would not be typically supported or reinforced with roof bolts.

The condition of the overburden strata within the project area is not known and therefore the potential for sinkhole subsidence cannot be accurately estimated. However a sinkhole close to the edge of the existing limit of ash placement was identified during the site visit. Sinkholes are commonly observed in the Newcastle area at shallow overburden depths ranging up to 30m and occasionally observed to overburden depths up to 50m (SCT, 2018). Further sinkholes similar to the one observed on site are considered almost certain to be present along the edges of areas of pillar extraction at shallow depths (SCT, 2018).

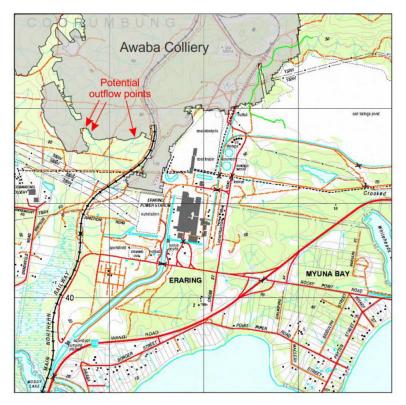
Figure 11 Potential outflow points for water from the Awaba Colliery underground workings (SCT, 2018)

Under these conditions a flow pathway may establish between surface water in the ash dam and the nearby tributaries of Dora Creek (SCT, 2018). The water level in Awaba Colliery is currently managed by pumping at a level in the range RL16 to 17 metres AHD. At this water level, artesian flow could be expected to reach tributaries of Dora Creek. Figure 11 shows where artesian flows are likely to emerge and flow into the tributaries of Dora Creek when the water level in the mine is greater than about RL16 metres AHD.

Without intervention, the cessation of pumping at the closure of Awaba and Eraring Power Station would potentially lead to the creation of an ongoing flow pathway whereby processed water from the Eraring Ash Dam flows into Awaba workings and would potentially flow into the nearby tributaries of Dora Creek. Water falling as rainfall onto the surface of the ash dam would potentially be at an elevation above RL 40 metres AHD (RL140 metres using the Eraring Datum). The water level in the mine workings would potentially be at an elevation in the range of RL17 metres to RL 20 metres depending on rainfall levels. Water would potentially continue to flow as artesian flow into waterways around the edge of Awaba at multiple low points within the topography as it does currently.

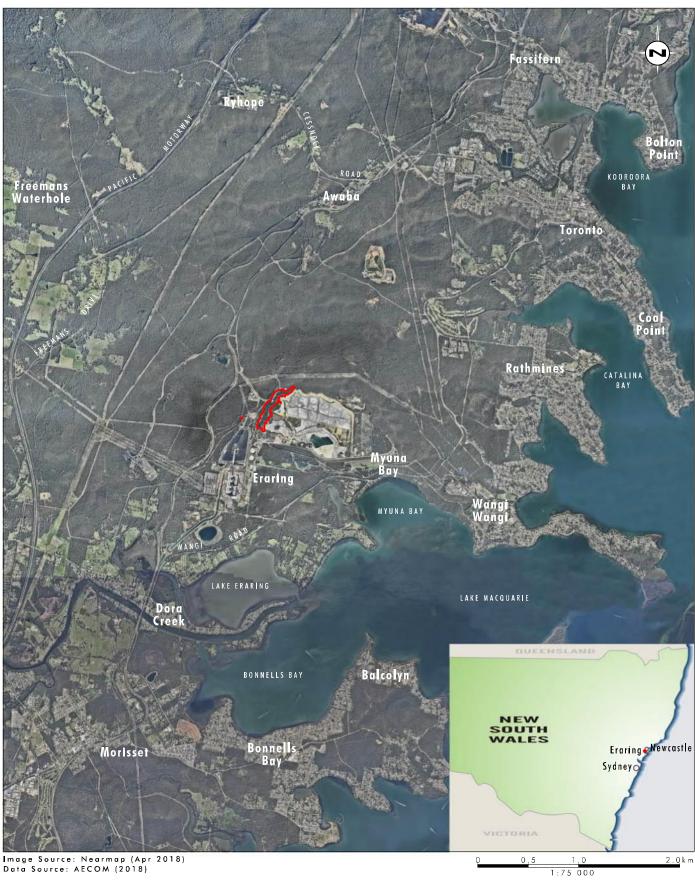
FIGURE 1.1

Development Footprint (Outside Existing Disturbed Areas)

The Development Footprint is located along Wangi Road, Eraring and Myuna Bay, NSW (refer to **Figure 1.1** and **Figure 1.2**) in the Lake Macquarie Local Government Area (LGA). The Development Footprint covers an area of approximately 15.1 hectares and is surrounded by generally intact buffer lands of the power station.

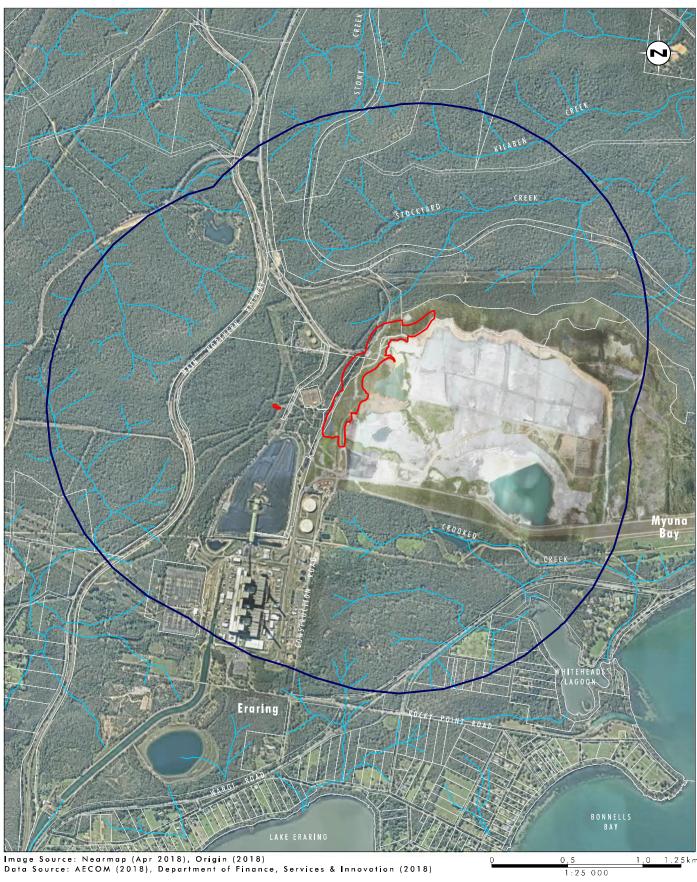
Cadastre Drainage Line FIGURE 1.3

Development Footprint (Outside Existing Disturbed Areas)

The Development Footprint is located in the west of the Lake Macquarie region (refer to **Figure 1.3** and **Figure 1.4**). The locality is occupied by rural landscapes and residential areas associated with Dora Creek, Eraring, Myuna Bay and Rathmines with substantial areas of intact vegetation associated with buffer land associated with the Eraring Power Station. Key land uses around the Development Footprint include rural and residential areas, infrastructure, transport routes and open space. The M1 Pacific Motorway and Main Northern Railway are located to the west of the Development Footprint providing public transport routes northward and southward along the NSW coast but also contributing to fragmentation and barriers to fauna movement.

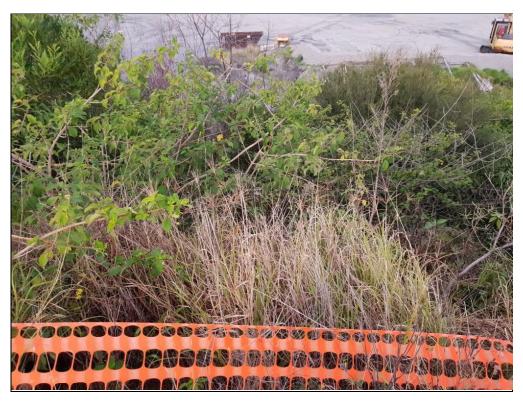
**Plate 3.1** Exotic vegetation in the Development Footprint © Umwelt, 2018

The Development Footprint contains a range of exotic vegetation, including dense monocultures of woody weeds and exotic grasses (refer to **Plate 3.1**). The most abundant exotic species present include castor oil plant (*Ricinus communis*), Rhodes grass (*Chloris gayana*), pampas grass (*Cortaderia selloana*), whisky grass (*Andropogon virginicus*) and lantana (*Lantana camara*), which dominate the native vegetation in some areas. Other exotic species present include crofton weed (*Ageratina adenophora*), fireweed (*Senecio madagascariensis*), camphor laurel (*Cinnamomum camphor*), cobbler's pegs (*Bidens pilosa*), wild tobacco bush (*Solanum mauritianum*) and Bitou (*Chrysanthemoides monilifera*). A number of weeds present in the Development Footprint are classed as High Threat Weed species under the BAM, and are identified in the flora species list in **Appendix C**.

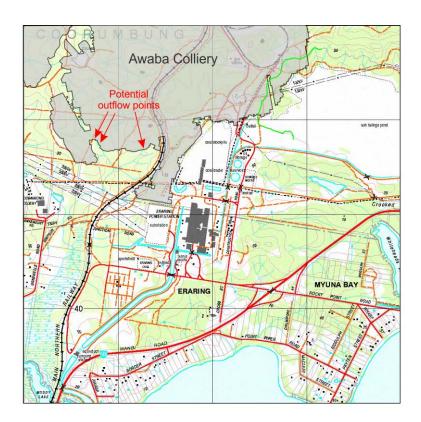
Awaba Colliery is flooded and fully connected across the footprint of the mine. Only small areas of the mine in the north and east are dry; the seam floor rises above the water level in the mine in these areas. SCT notes (based on discussions with Centennial Coal Pty Ltd) that:

- Water level within the mine is artificially maintained in the range of 16.5 metres AHD to 17 metres AHD, from pumping at two locations and by natural overflow at low points within the surface topography in the south western parts of the mine.
- One of the reasons for this pumping is to control the potential for artesian outflows at Eraring Power Station during periods of extended rainfall.
- The water level increases with increasing rainfall consistent with the inflow of water through fractured and naturally jointed overburden strata.
