# CASEY & LOWE Pty Ltd

## Results of Testing for Earlier Roadways AIPM Site, North Head

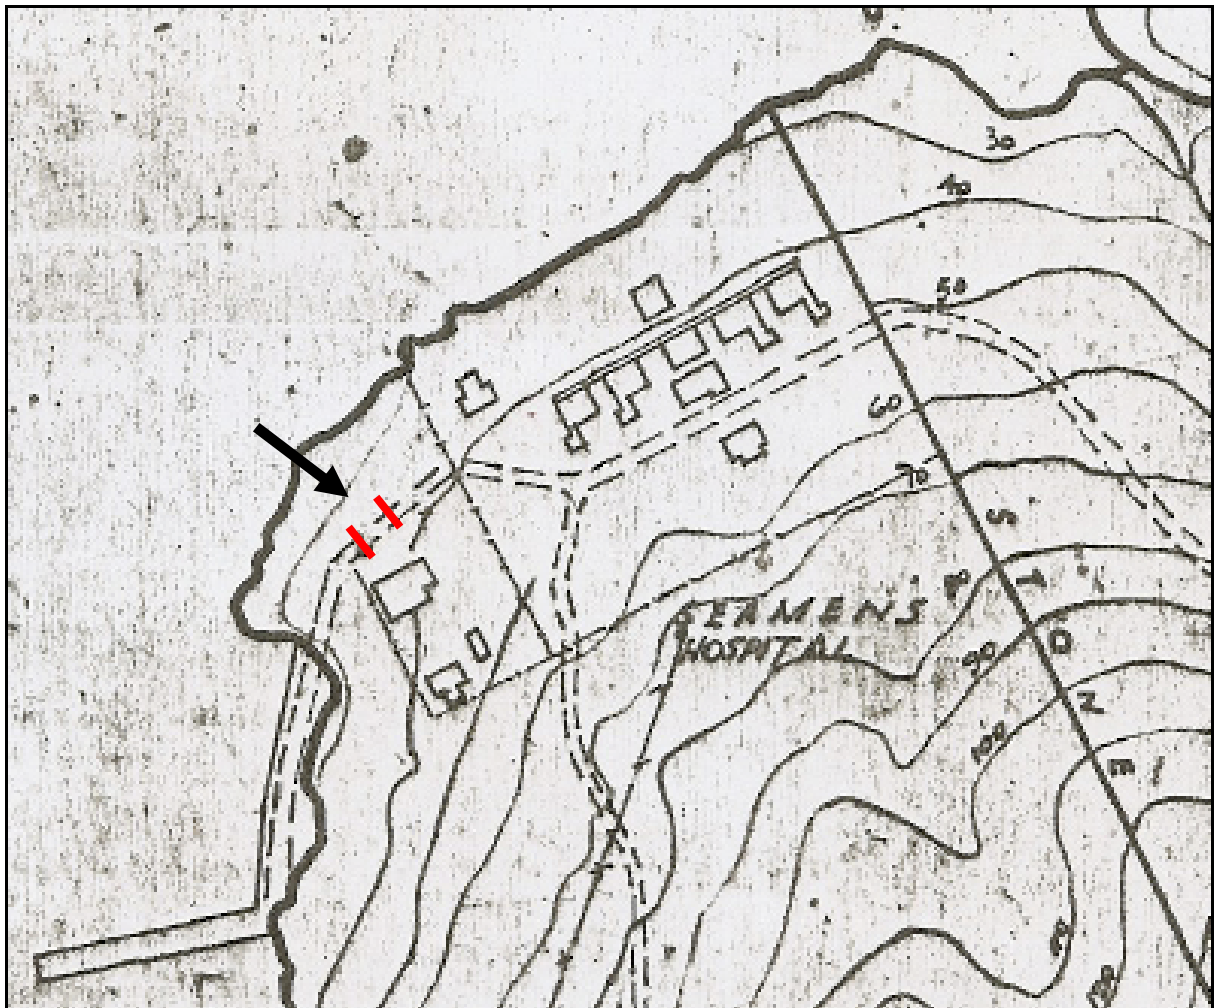
**Figure 1:** Detail of 1947 plan showing Seamen's Isolation Hospital. The test trenches are arrowed.

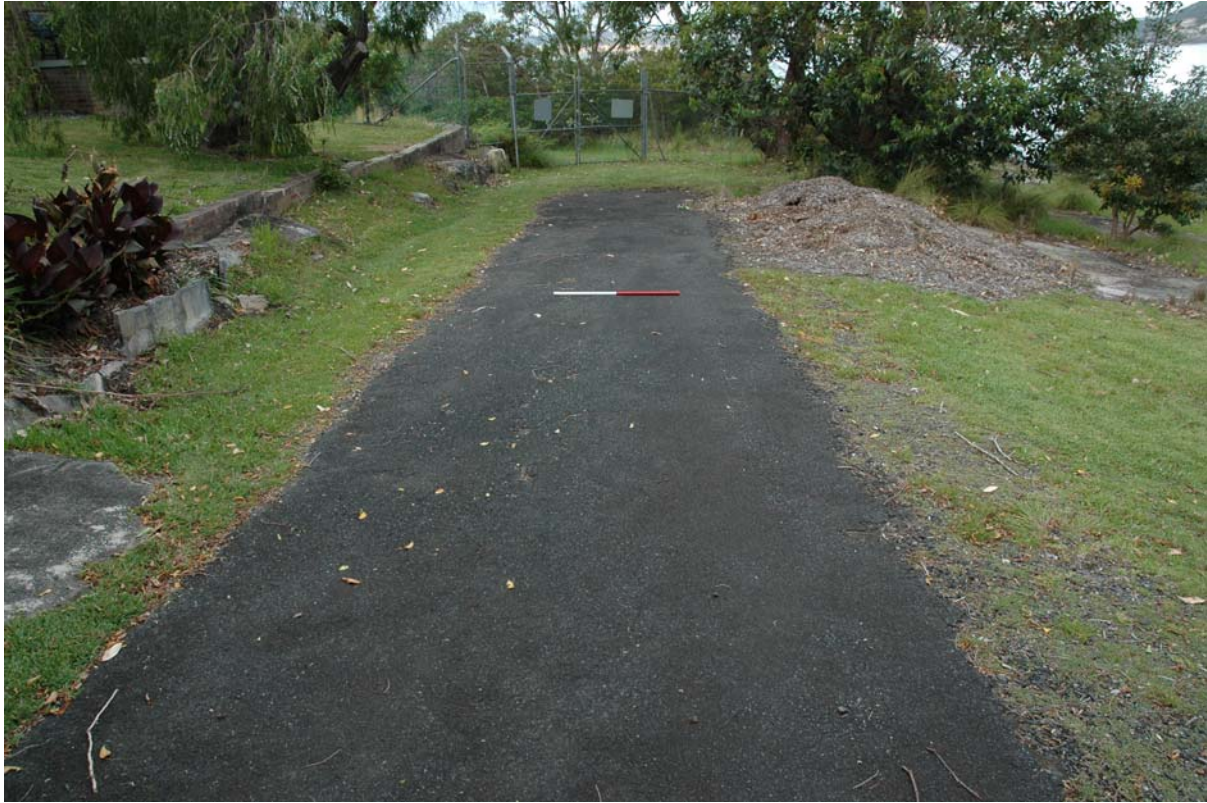
The first test trench was excavated through the bitumen roadway in front of Harbour Cottage (Fig. 1, 2). Cut bedrock outcropping was visible in the vicinity of this and the second trench on the southern side of the roadway, indicating that bedrock needed to be quarried to allow the road through (Fig. 2). It is noted that substantial areas of quarried bedrock is present to the west beyond the site fence.

**Figure 2:** Section of roadway prior to testing, looking towards site boundary. Note bedrock outcrops to left and right. Scale 1m in location of first trench.

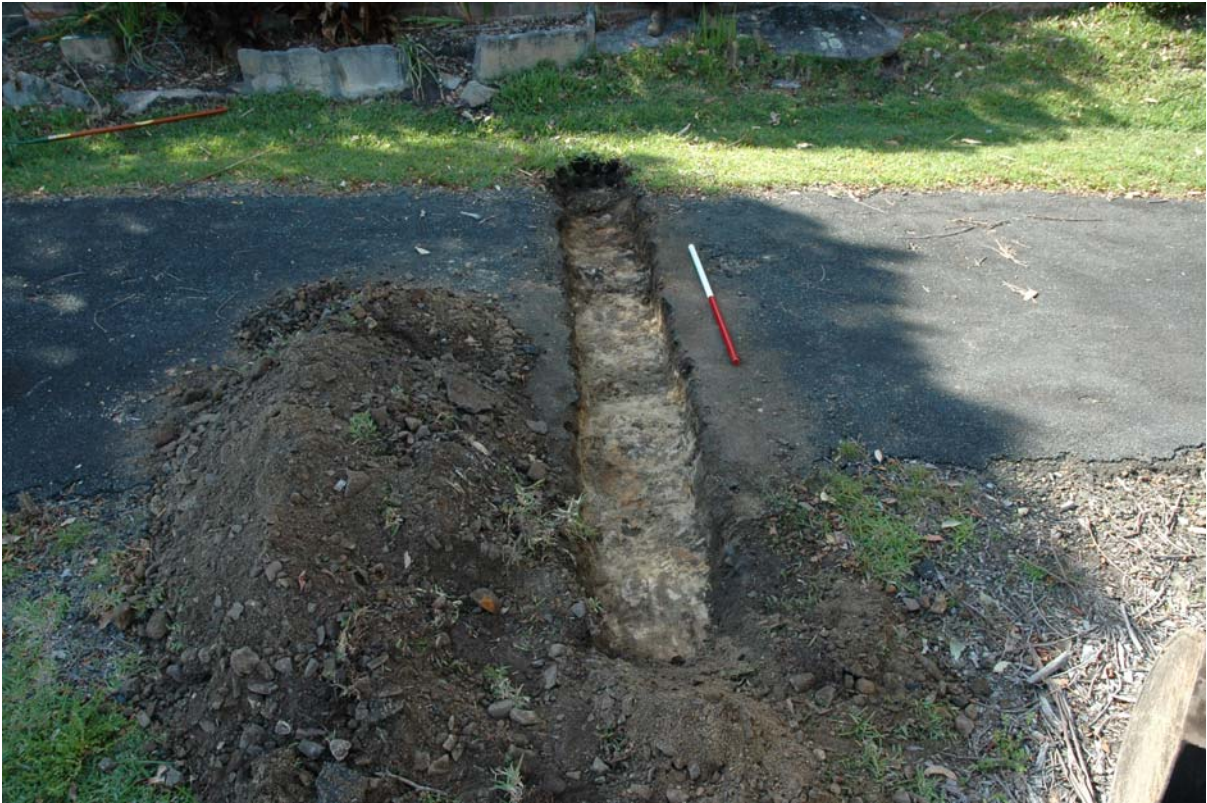
The first trench exposed loose crushed sandstone packing under the bitumen (Fig. 3, 4). This was laid onto grey sand over weathered bedrock. No evidence of road surfacing predating the present bitumen road was found.

**Figure 3:** Trench through bitumen showing sandstone packing. Scale 1m.

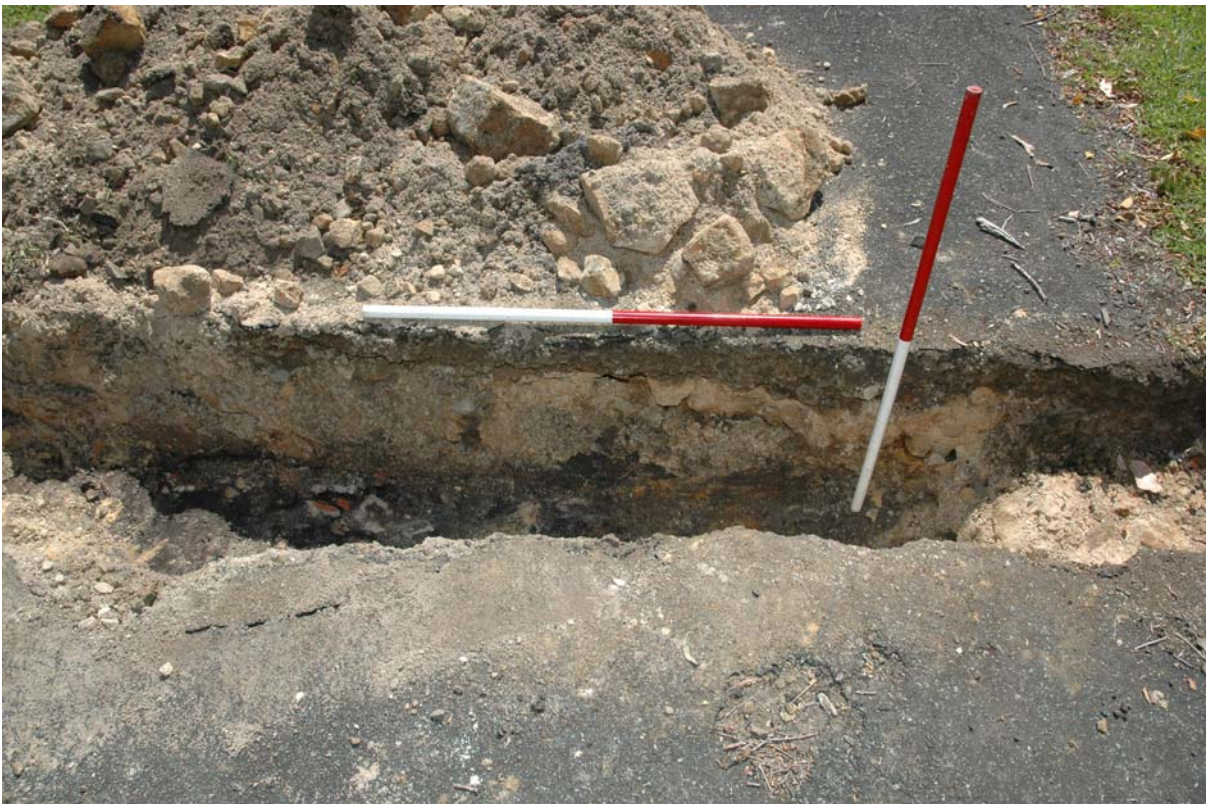
**Figure 4:** Trench through roadway showing detail of sandstone fill. Scales 1m.

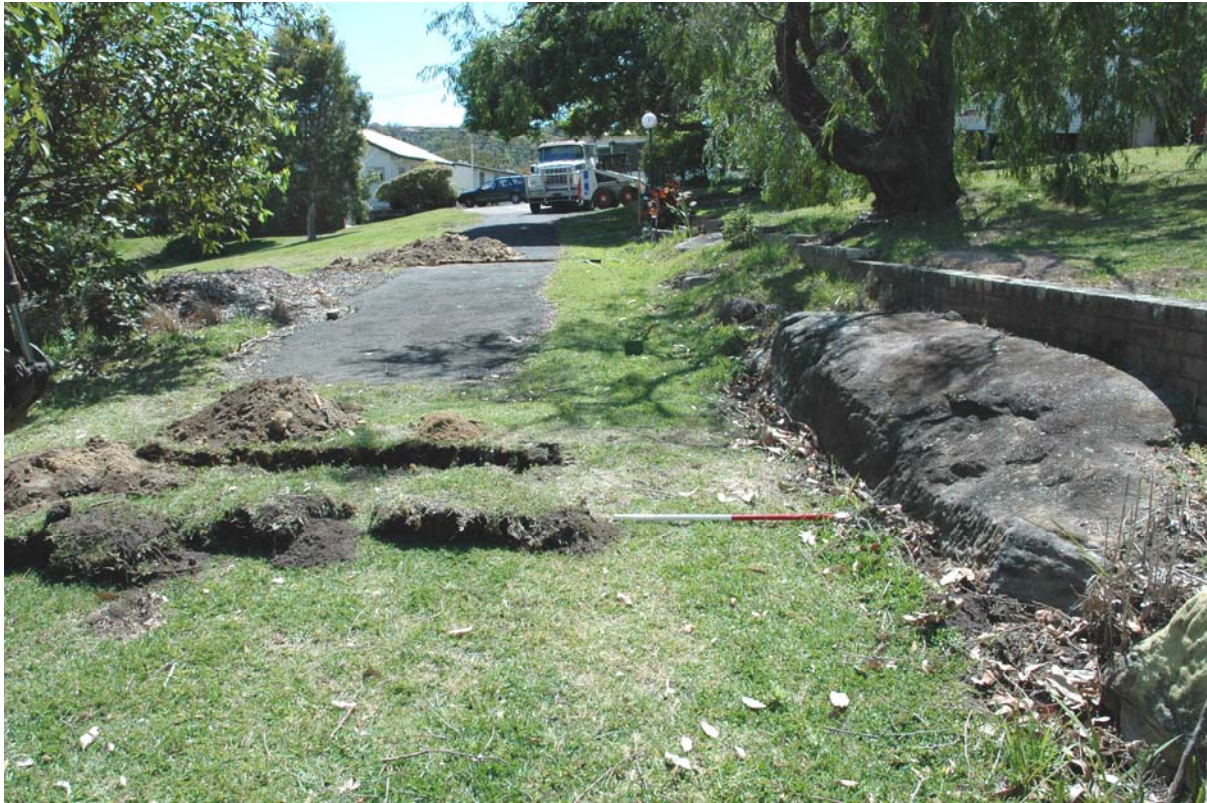
The second trench was located in the grass to the west of the first (Fig. 1).

**Figure 4:** Trench in grassed area, looking east. Note cut bedrock to right. Scale 1m.

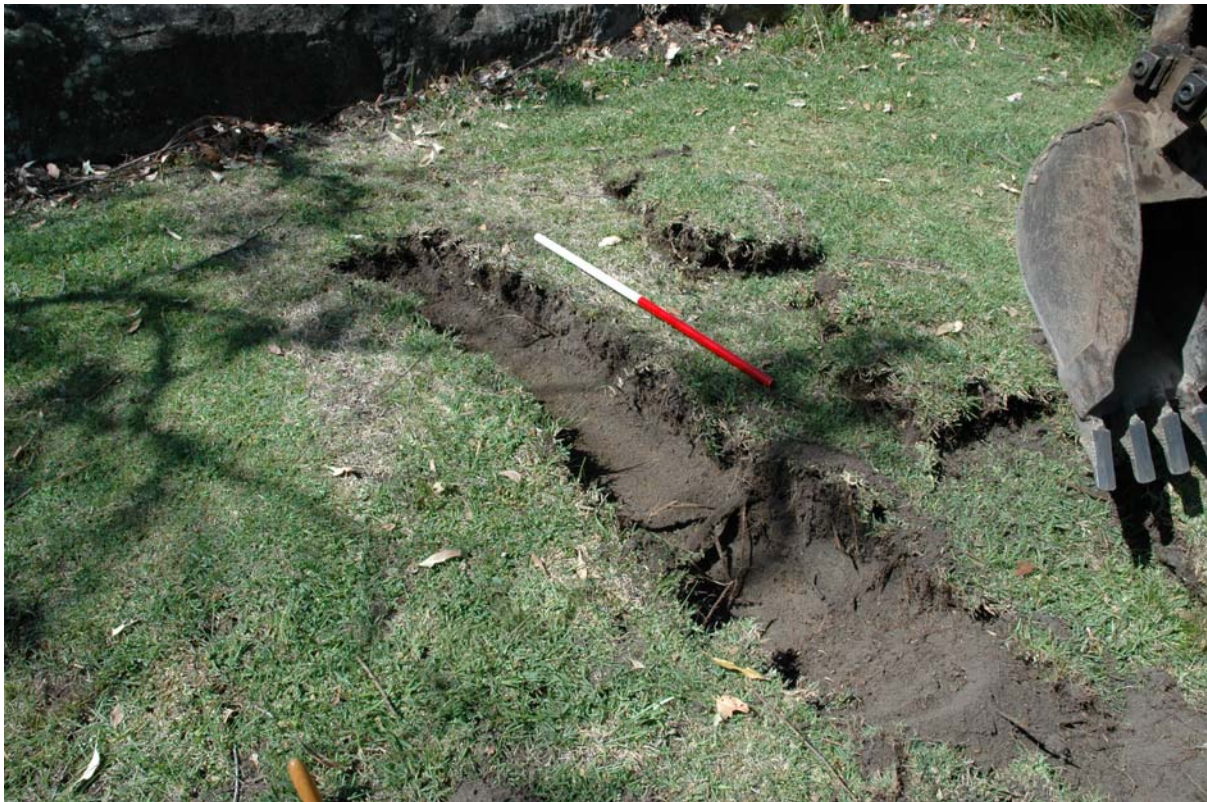
**Figure 5:** Trench in grassed area, with layer of gravel under the grass. Scale 1m.

A layer of small ironstone gravel was found beneath the bitumen in the second trench, with crushed sandstone fill beneath this. The gravel appears to be part of a gravel surfacing, perhaps representing the pre-bitumen form of the roadway.

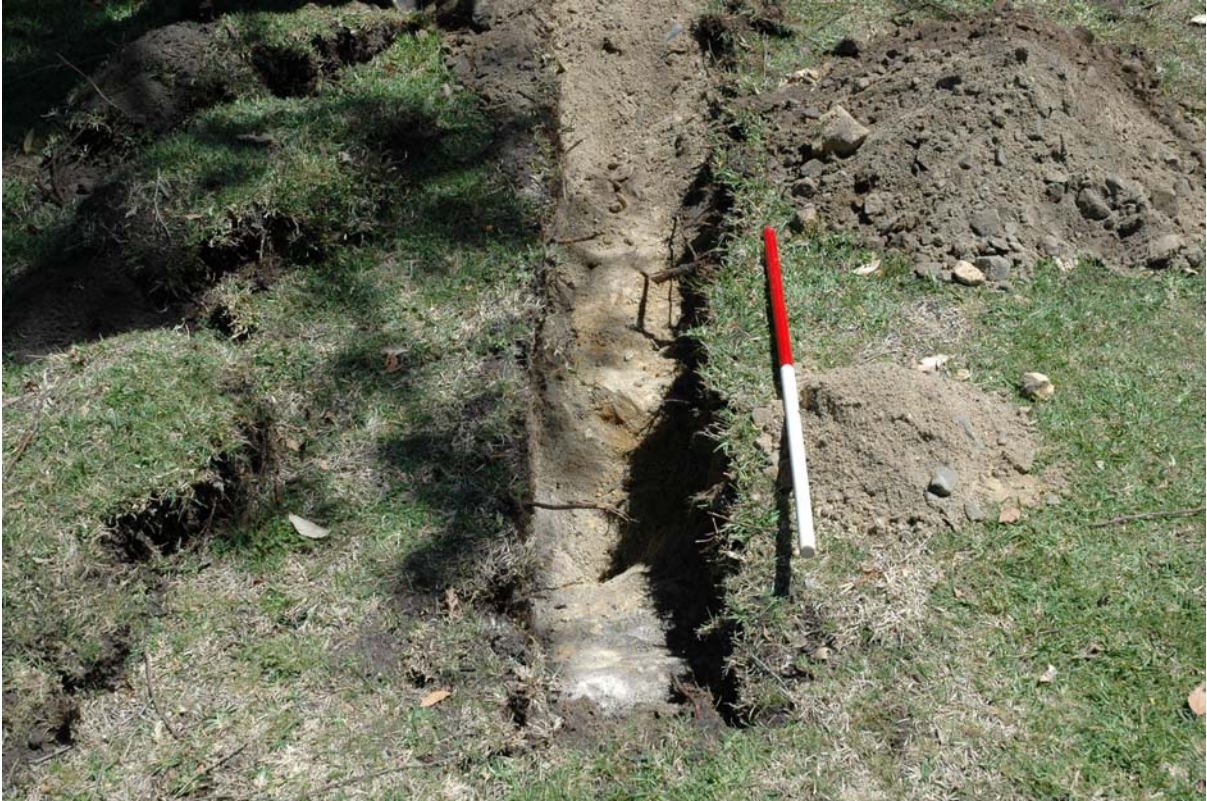
**Figure 5:** Detail of trench in grassed area, showing sandstone fill. Scale 1m.
