REPORT on GEOTECHNICAL INVESTIGATION

JUSTINIAN HOUSE REDEVELOPMENT 18-22 SINCLAIR STREET, WOLLSTONECRAFT

Prepared for ST VINCENTS & MATER HEALTH

Project 45046 September 2007

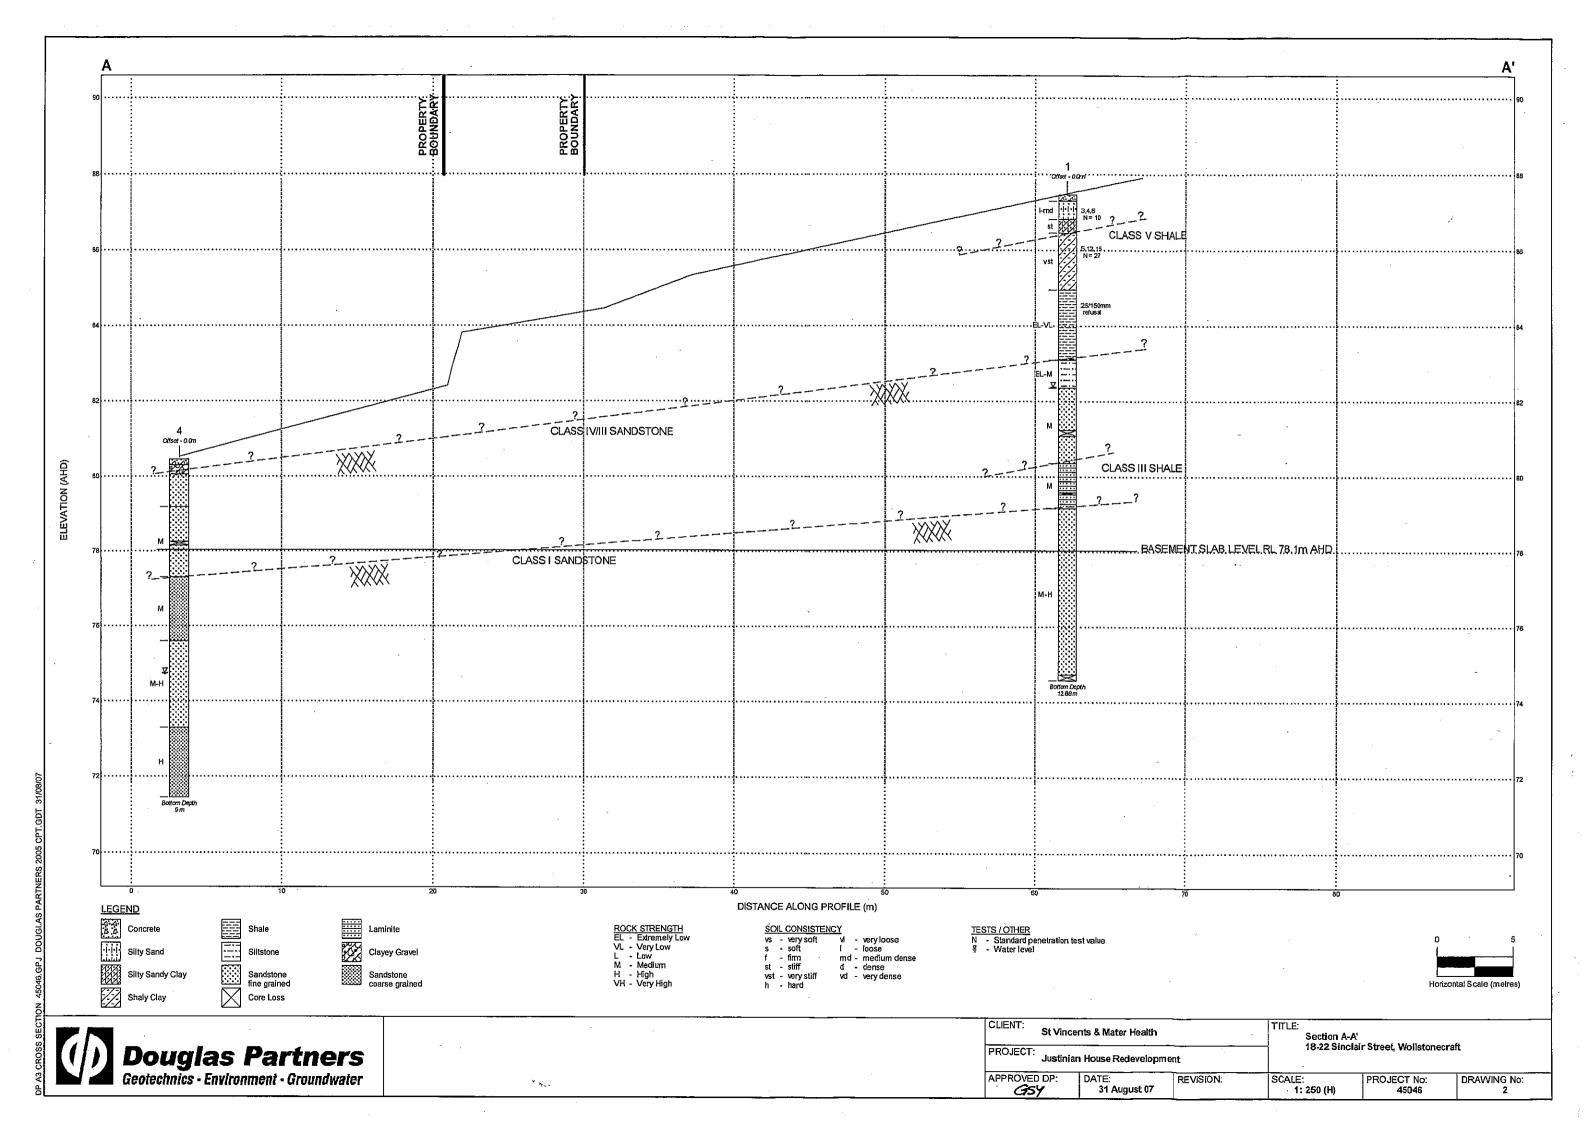
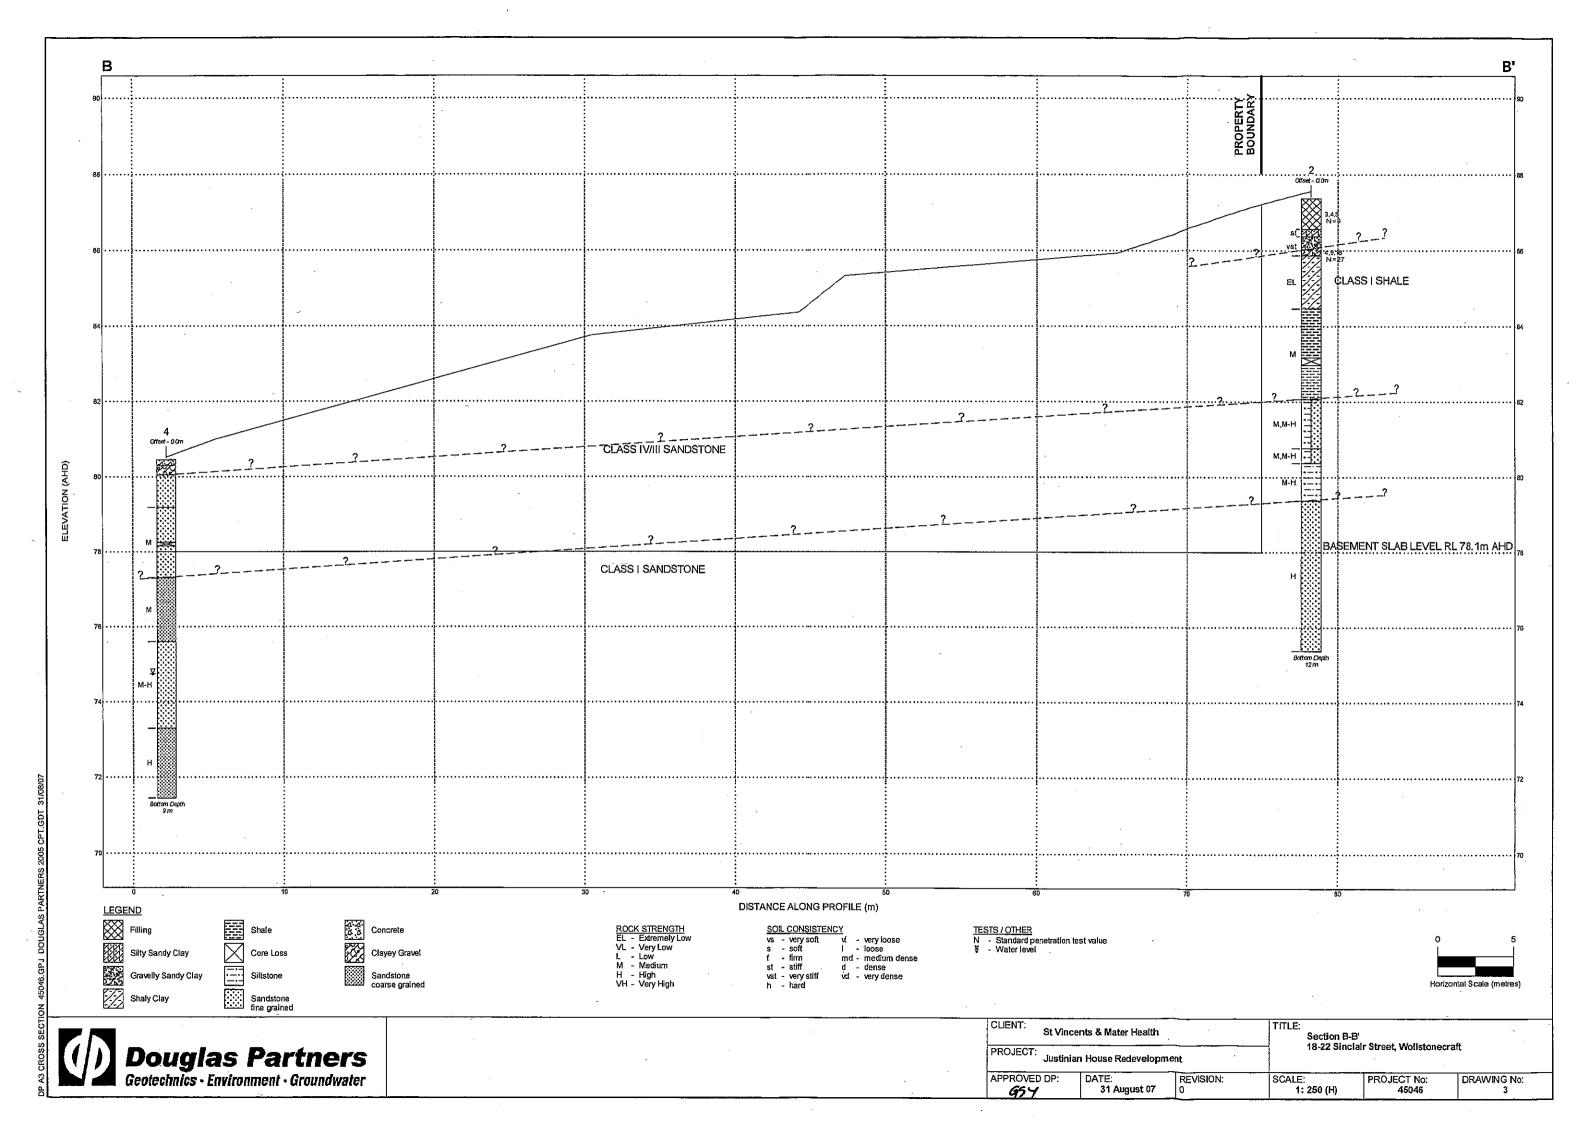
The floor of the basement excavation will be to RL 78.1 m AHD as shown on Sections A-A' and B-B' (Drawings 2 and 3, respectively). Basement excavation level intersects medium and high strength sandstone, and foundations may be supported on either of these strata. Suitable foundation types include spread footings such as pads or strip footings, and if sizing is unsuitable, piles.

Excavations braced/anchored either temporarily or permanently will be subjected to earth pressures from the ground surface down to the top of the Class III Sandstone (refer to Drawings 2 and 3). Table 4 contains active earth pressures and bulk unit weights that are recommended for the design of gravity, cantilever or single propped/anchored walls, assuming a level surface behind the wall.

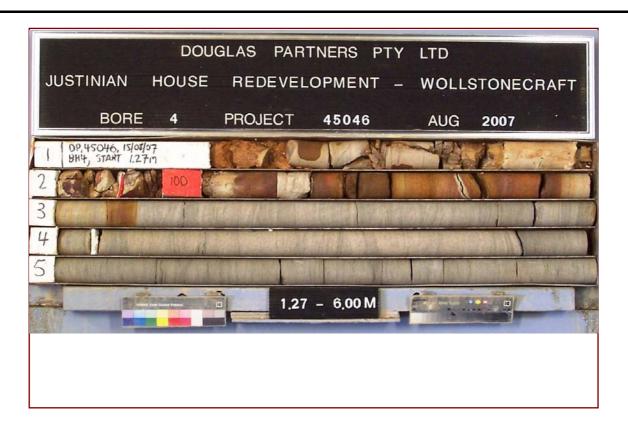
PHOTO 5: BH4, Box 1of 2

Core photographs for borehole BH4
