Seascape Grove, Belle O'Connor Street, South West Rocks

Aboriginal Heritage Assessment

WB and ME Walls

May 2007

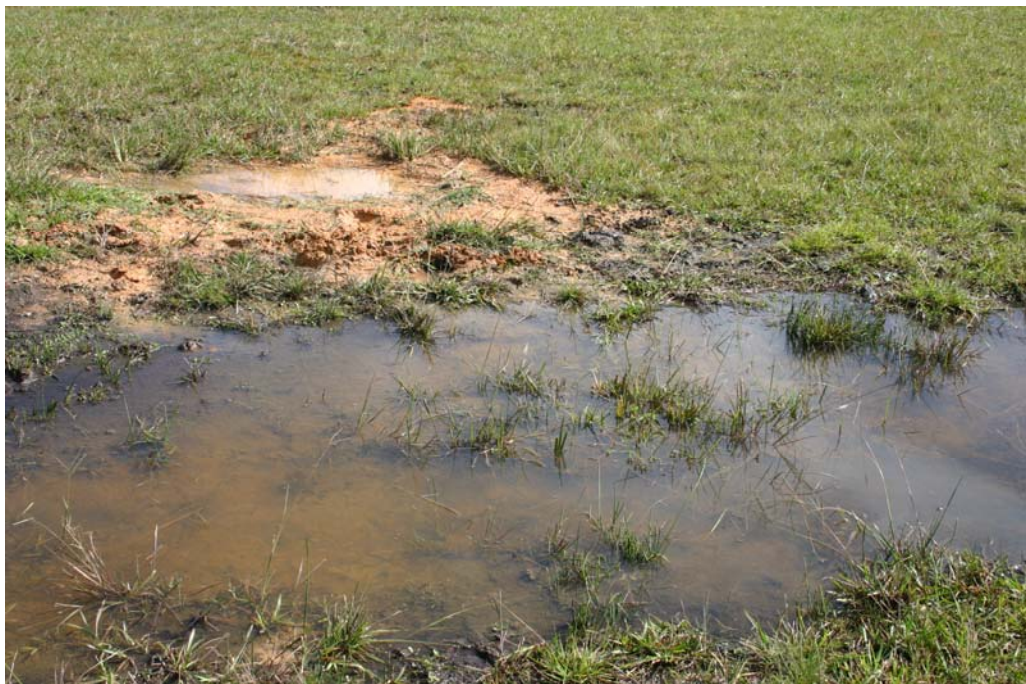
While much of the study area was covered with grass during the site visit, there were a number of areas throughout the site which had been subject to erosion and had exposed the ground surface. Patches of vehicle tracks remain in the study area, notably in the north west and north east. An area used for burning vegetative debris has exposed some of the ground, and vehicles used in transporting such debris had torn up parts of the ground, in this area. In the east of the study area, the land is subject to inundation. Parts of the ground surface had been exposed in this area, and some soil had clearly been introduced to attempt to fill some of the inundated areas (see *Photograph 2.1*).

Photograph 2.1 Example of introduced soil (orange in colour) in north east of site

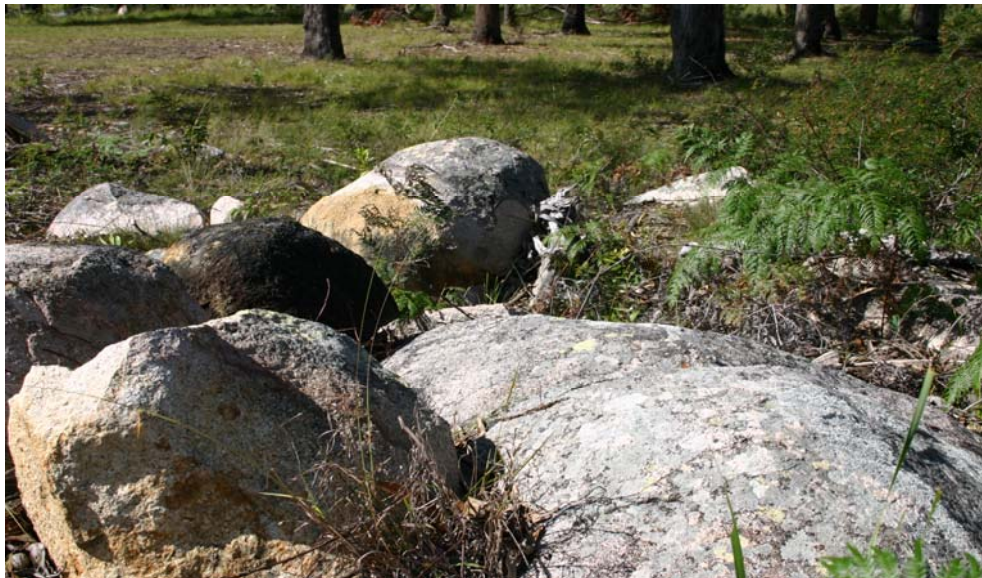
The Macleay Coast has extremely complex faulted terrain where the New England Fold belt over-thrusts the Sydney Basin. The main rocks present are Silurian and Devonian slates, quartzites and acid volcanics, Carboniferous mudstones and lithic sandstones, and less deformed Permian shales and sandstones, as well as Quaternary coastal sands (Morgan 2001). The study area itself has a number of individual stone outcrops which appear to be coarse conglomerate with large quartz inclusions (see *Photograph 2.2*). Such coarse-grained stone is generally unsuitable for stone artefact manufacture and engravings. Some small pieces of unmodified chert and quartz were noted on the property, but these appear to occur sporadically in the gravels of the region. The outcrops are not of a nature suitable for shelter sites, and no creeklines are present in the study area. Therefore, axe grinding grooves, engravings, stone quarry sites and shelter sites are not expected to occur in the study area.

Photograph 2.2 Stone outcrops seen in the study area

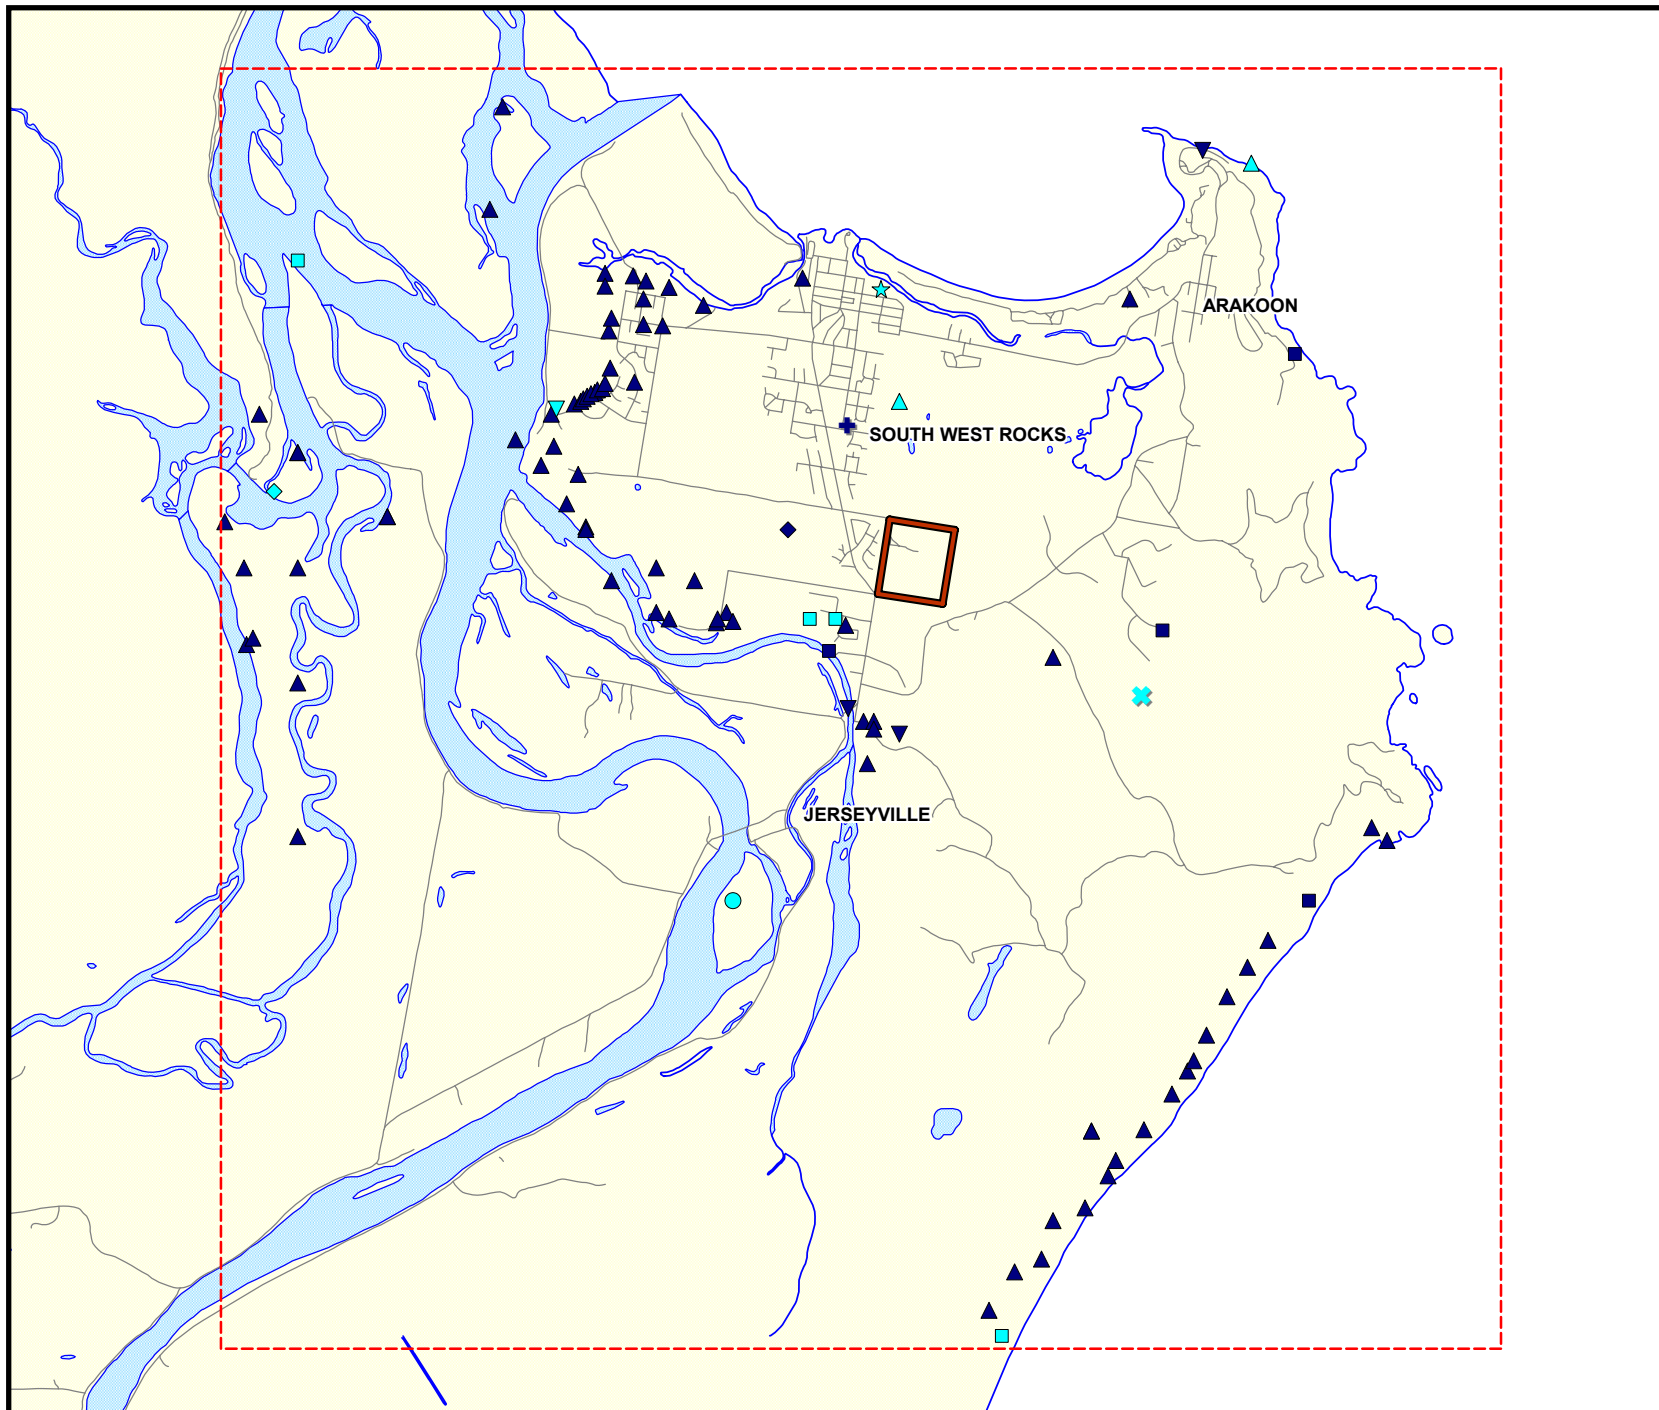
Figure 2.1

A search of the Aboriginal Heritage Information Management System (AHIMS) Aboriginal Sites Database at DEC within a 10 km x 10 km area centred on the study area was undertaken on 14 May 2007. The search identified 101 recorded sites (*Figure 2.1*), which comprised 88 middens (four of which are associated with burials, one associated with a stone artefact scatter, one associated with a burial and a stone artefact scatter, and one associated with a burial and an Aboriginal resource/gathering site), four burials, three stone artefact scatters, two natural mythological (ritual) sites, one Aboriginal resource/gathering site, one bora/ceremonial site and carved tree, one contact mission and one carved tree. Midden exposures cluster along the coast and along Spencers Creek (which passes approximately 1 km to the south west of the study area). The closest site to the study area is a midden located approximately 500 m to the south west, and a burial and midden located slightly further away.

**Location of Registered AHIMS Sites
in Relation to the Study Area**
