PRELIMINARY ENVIRONMENTAL
ASSESSMENT
1-8 NIELD AVENUE
GREENWICH

Environmental Consulting Services Pty Ltd
April 2008

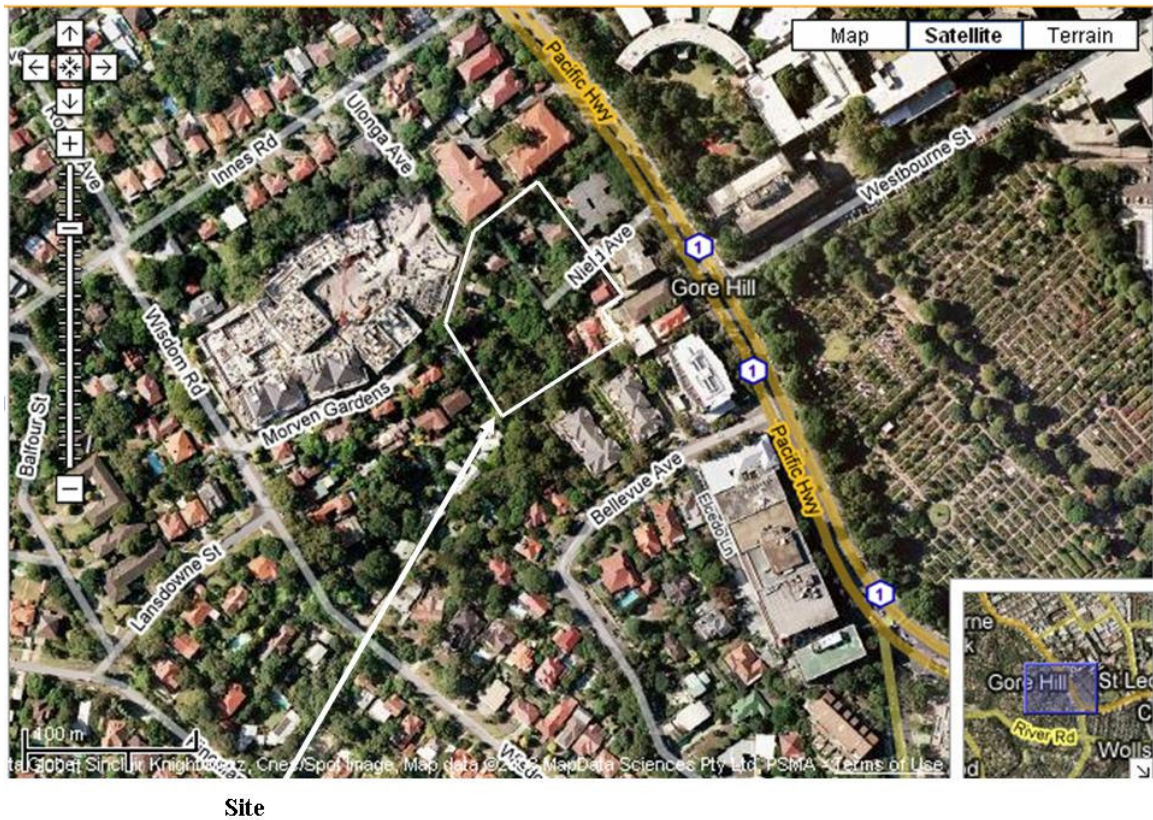
Figure 3 – Aerial Photograph

The location of this site is presented on Figure 1 – Location plan and the lots are shown on Figure 2 – Site plan. An aerial photograph of the site is shown in Figure 3 – Aerial Photo (Google).

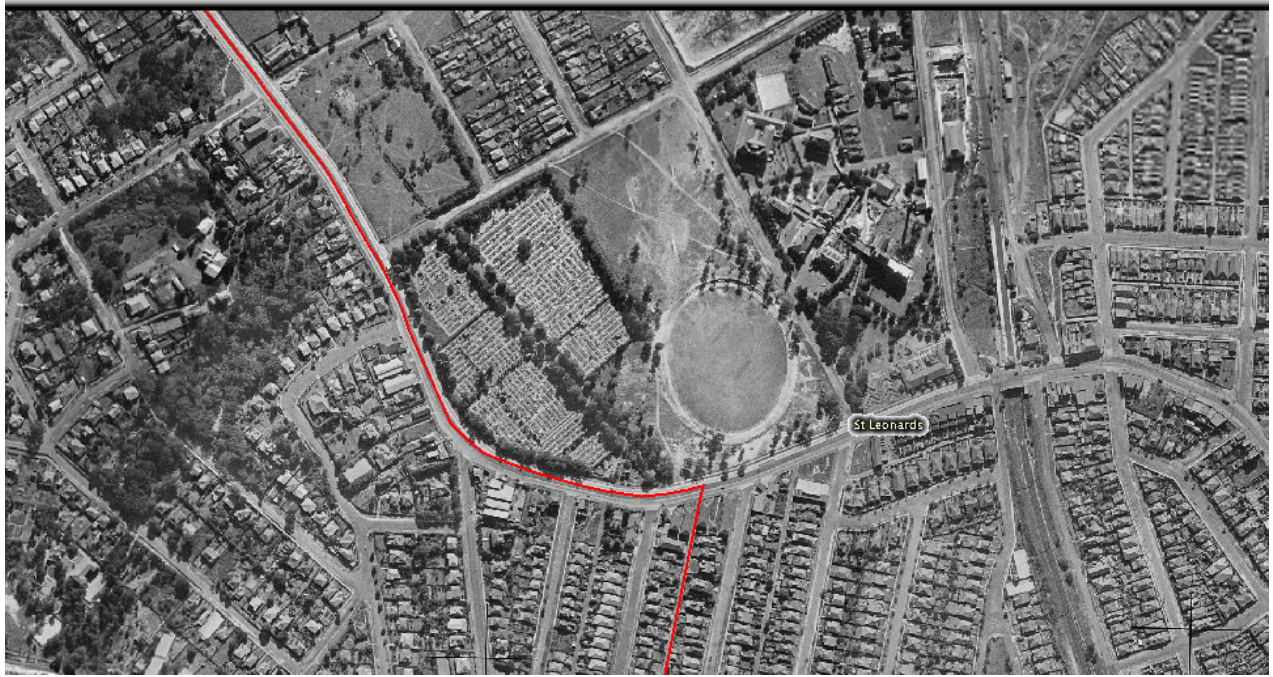
The earliest photograph reviewed was from 1943. This photograph clearly shows the land is partly undeveloped 'bush' and partly residential. Subsequent photographs show some changes to the appearance of buildings, the number of buildings and the locations of building although all photos appear to show only residential development on the site. A copy of the 1943 aerial photograph is included in Appendix 1.
