5.0 Site survey, archaeological potential and sensitivity

5.3. Site Inspection

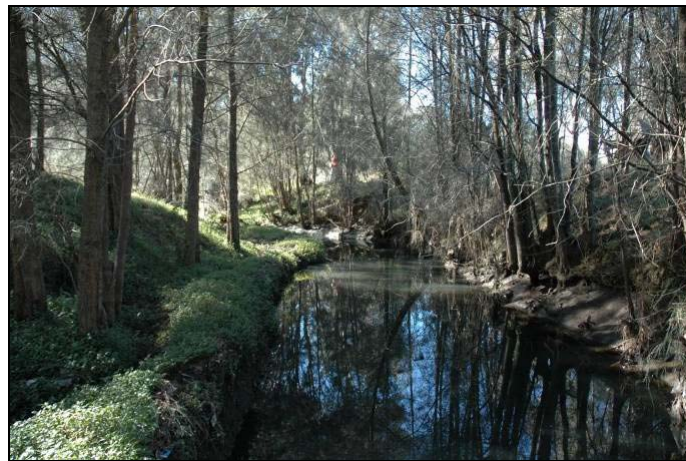
Plate 5- 1 View facing south east of tributary creek line crossing the rail corridor at Quakers Hill.

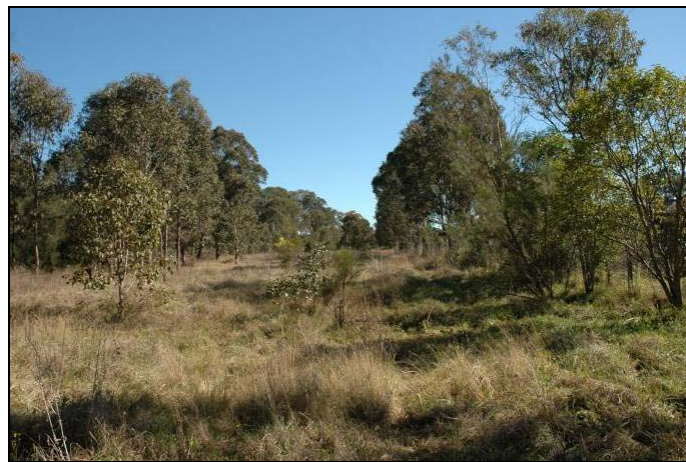
Plate 5- 2 View facing north west of flat swampy terrain along the southern end of the rail corridor in Survey Zone 1.

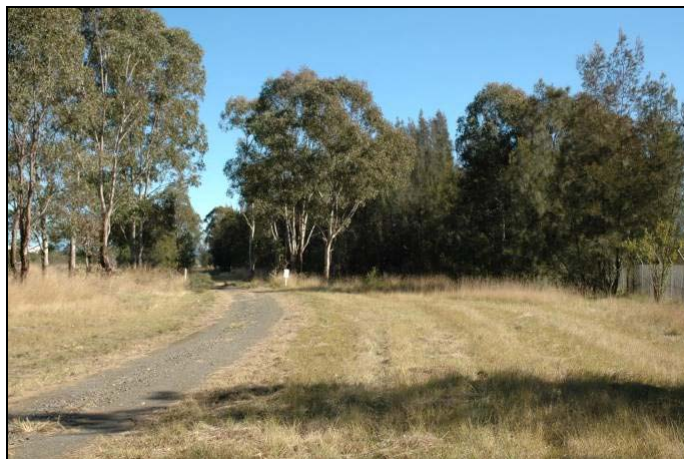
Plate 5- 3 View facing west of southern most end of Survey Zone 1. Visibility along the alluvial flats was restricted to dirt tracks.

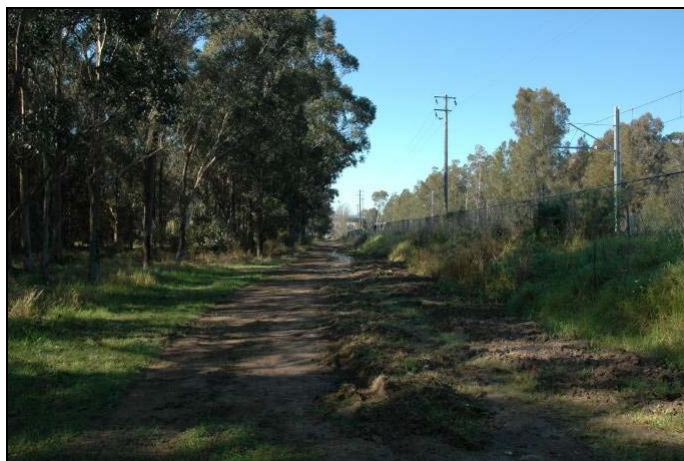
Plate 5- 4 View facing south east showing area in which archaeological testing has taken place.

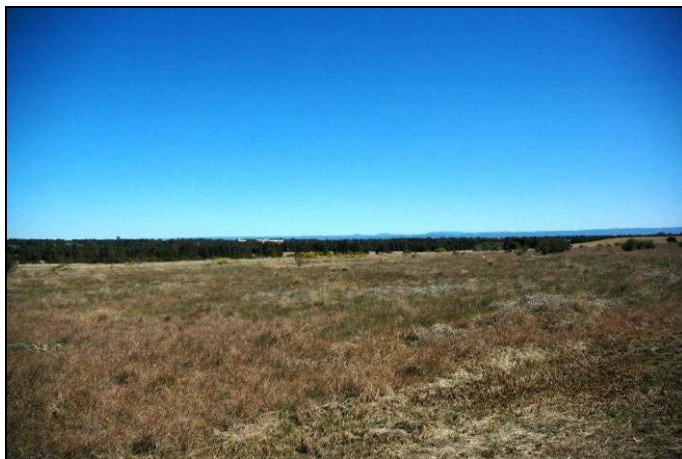
The swampy terrain of the South Creek soils gives way to higher ground of the Blacktown soil landscape further north towards Schofields Road and is characterised by gently undulating, open pasture terrain east of the valley flats along Eastern Creek (Plate 5-5). Ground surface visibility was generally poor with surface exposures limited to erosion scours and dirt tracks (Plate 5-6). Ground disturbance within this area appeared to be limited to historic tree clearance and farming practices. The soils along the western and eastern boundary of the rail corridor are predominantly comprised of the Blacktown soil landscape.

Plate 5- 5 View of gently undulating open pasture land facing west north west towards Eastern Creek.

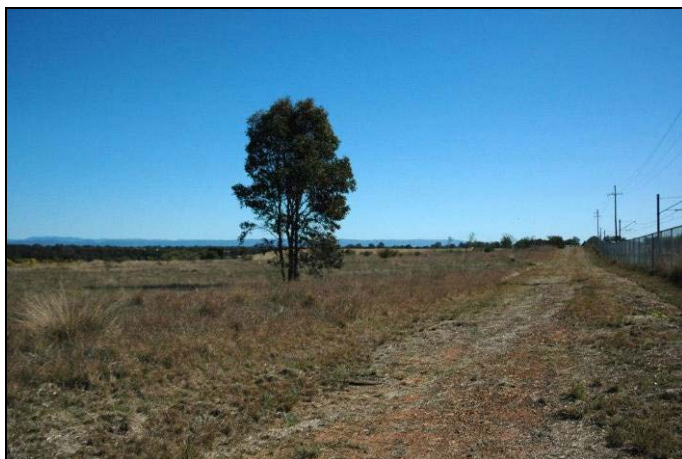
Plate 5- 6 View facing north west of ground surface exposure along the northern end of Survey Zone 1.

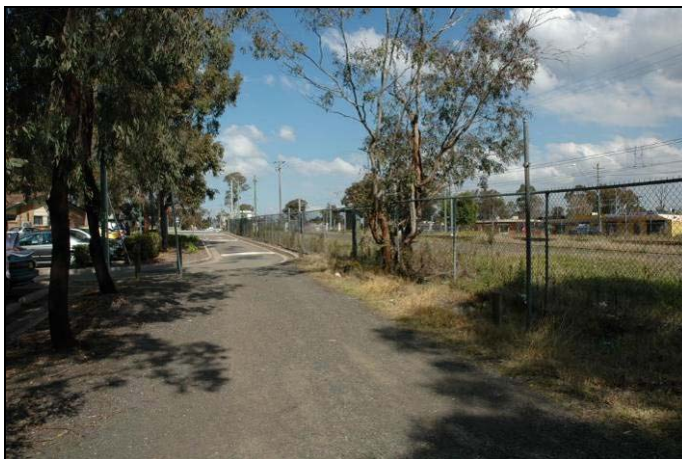
There are two areas within survey zone 1 which have undergone land use impacts which are significant enough to have either altered or removed sub surface archaeological material. These areas constitute landscapes which have undergone significant urban development, or constitute modified natural landscapes with the construction of earthen embankments. Both the western and eastern boundary of the rail corridor between Quakers Hill train station and the Parkway overpass, and between Reycroft Avenue and Burdekin Road, along the eastern side of the rail corridor, constitute such environments (Plate 5-7).

Plate 5- 7 View facing south toward Quakers Hill train station, from Parkway Overpass.

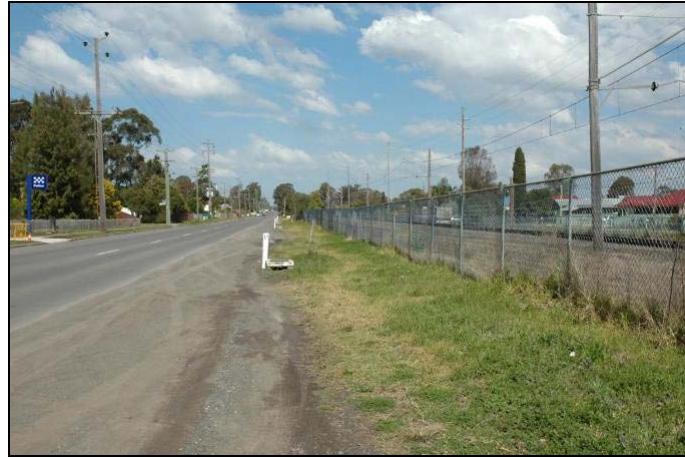
Plate 5- 8 View facing south east of Survey Zone 2; Riverstone.

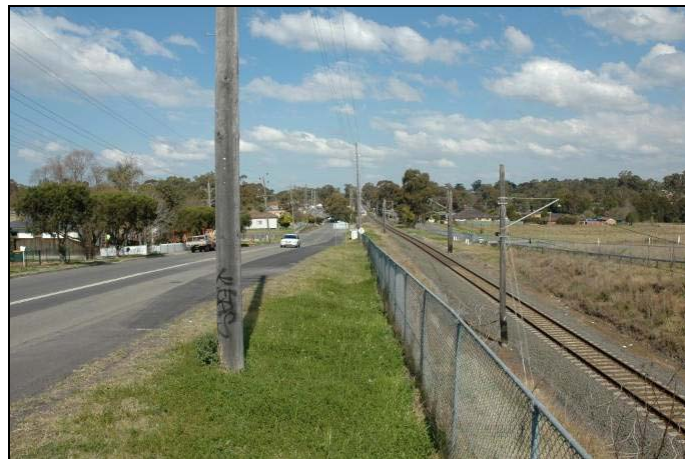
Plate 5- 9 View facing south east of Survey Zone 2; Schofields.

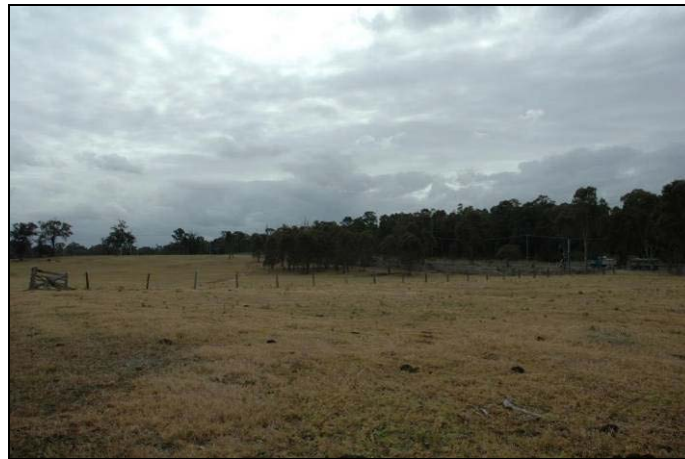
Survey zone 3 is predominantly situated along a series of north-south trending, gently undulating hills that dip down into the valley flats to the west of the rail corridor towards Eastern Creek. It predominantly comprises open pasture land with isolated patches of regrowth woodland (Plate 5-10). The survey unit essentially consists of two areas, which are defined according to land use impacts. In the northern section along the western boundary of the rail corridor from the Riverstone Meatworks to Vineyard station, existing land use impacts are limited to vegetation clearance, historic farming practices, and the establishment of dirt access roads and linear utility installations such as electricity easements (Plate 5-11 and 5-12). This section of survey unit 3 is composed of the Blacktown soil landscape with occurrences of the alluvial South Creek and Berkshire Park soil landscapes along the northern most extent of the survey zone at Vineyard.

Plate 5- 10 View facing north of gently undulating pasture land adjacent to the rail corridor.

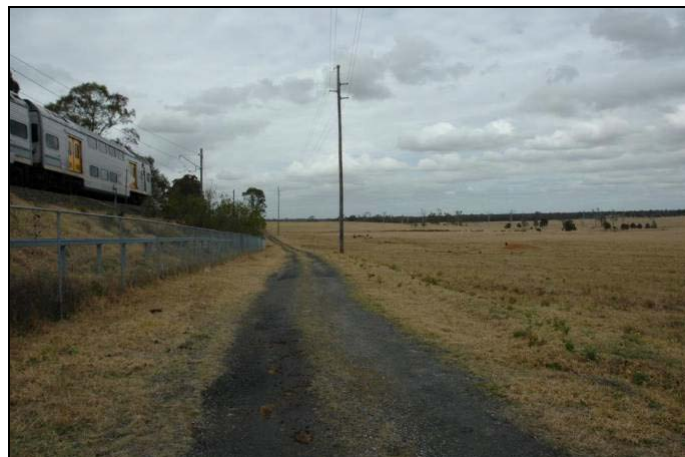
Plate 5- 11 View facing south east detailing land use impacts including vegetation clearance and the establishment of earthen tracks and power lines.

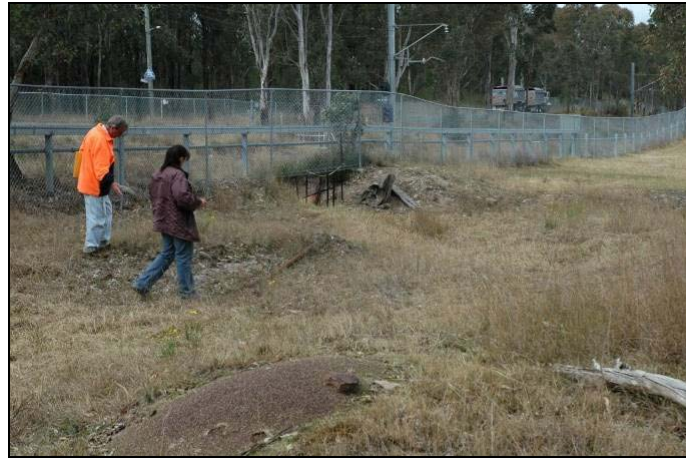
Plate 5- 12 View facing south east of localised disturbance.

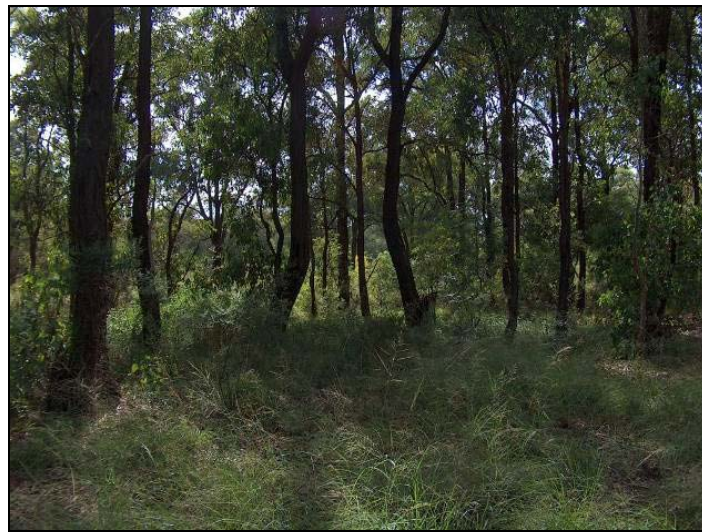
The proposed Vineyard station car park site is also located in an area of minimal land use impact. The proposed site is located in a heavily vegetated area that appears to have undergone relatively minor ground disturbance (Plate 5-13). Vegetation at this site retains structural characteristics of the pre-European equivalent and is thought to have changed little over time (Parsons Brinkerhoff 2008). The soils along the eastern boundary of the rail corridor are of the Blacktown soil landscape.

Plate 5- 13 Looking north- east through the woodland and regrowth scrubland to the north of the proposed car park.

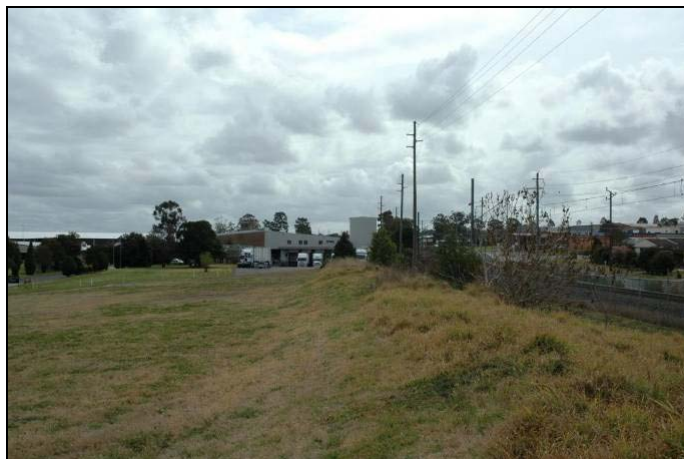
The remainder of Survey zone 3 is comprised of areas which have undergone significant land use impacts. The western boundary of the rail corridor from the Riverstone Meatworks to Riverstone Station, has been significantly altered through urban development, with the establishment of the Meatworks facility and the construction of an artificial earthen embankment adjacent to the existing rail corridor (Plate 5-14 and 5-15). Land use impacts in these areas will have served to significantly alter or remove sub surface archaeological deposits.

Plate 5- 14 View of Riverstone Meatworks facing north west.

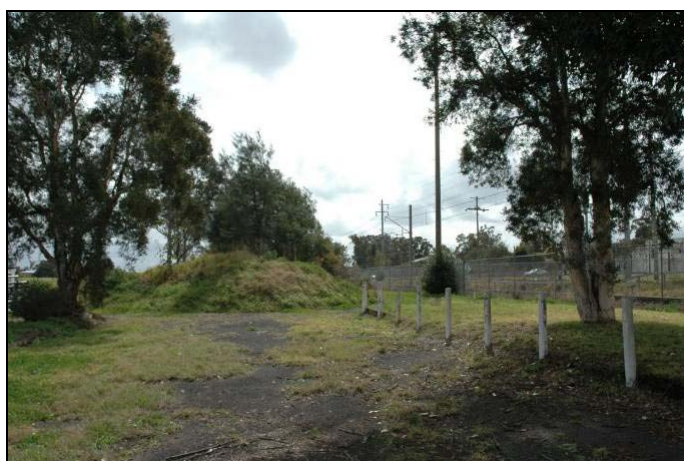
Plate 5- 15 Detail of artificial earthen embankment adjacent to the rail corridor at Riverstone.

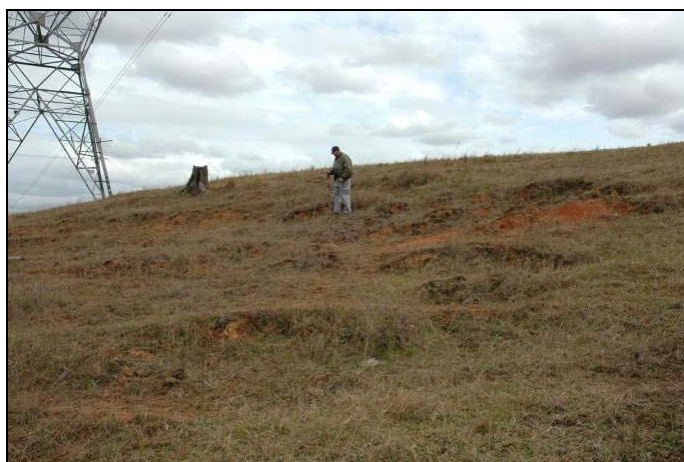
Ground surface visibility across the entire survey unit was generally poor with surface exposures confined to dirt tracks and erosion scours. Erosion across the survey unit occurs in isolated patches and is focused along the steeper slopes (5-16).

Plate 5- 16 View facing west of localised erosion scours along the steeper slopes of the study.

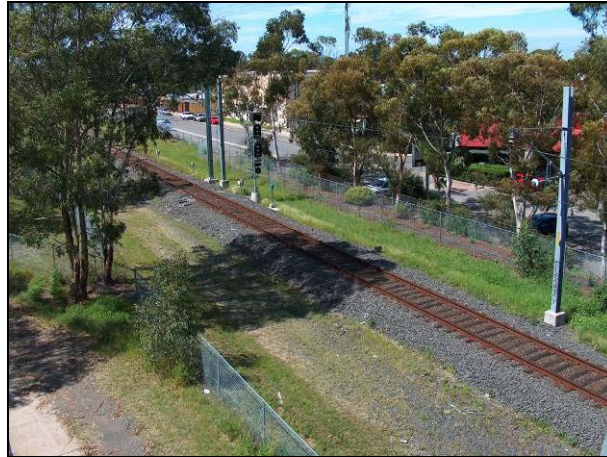
Plate 5- 17 Looking south- east towards the rail corridor from immediately north- west of Quakers Hill Station.

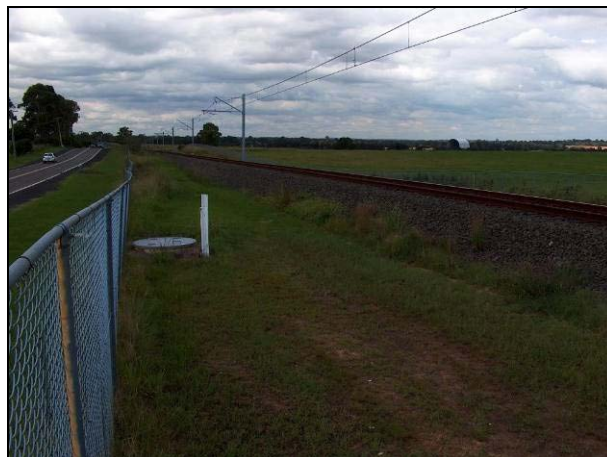
Plate 5- 18 Looking west- north- west to the rail corridor from south- east of Schofields Station.

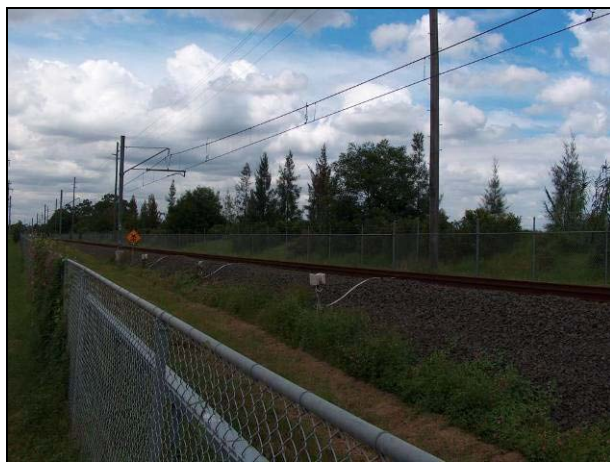
Plate 5- 20 Looking south- south- west from north of Riverstone Station.

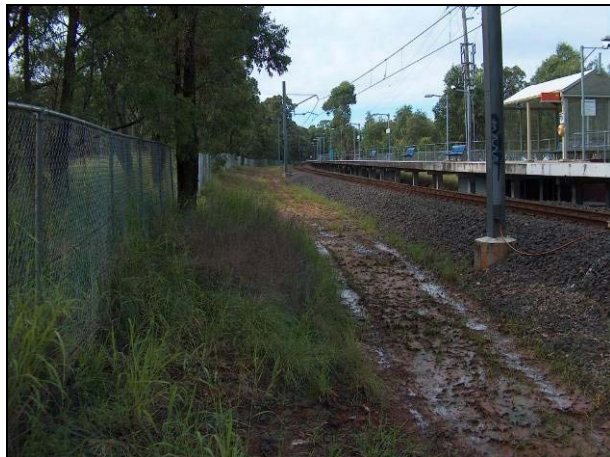
The Quakers Hill to Vineyard rail corridor runs in a north-west to south-east direction, through gently undulating terrain in a built urban and semi rural environment. The vegetation clearance and installation and on-going maintenance of the rail corridor means that any surface and/or sub-surface Aboriginal archaeological material is likely to have been severely compromised. Rail embankments have either cut into the existing ground surface or comprise built, earthen embankments (plates 5-17 to 5-20). Ground conditions comprise low grass and weed cover with evidence of erosion along maintenance tracks (Plate 5-21).

Plate 5- 21 Looking south- east towards the existing Vineyard Station; note ground conditions in the foreground.

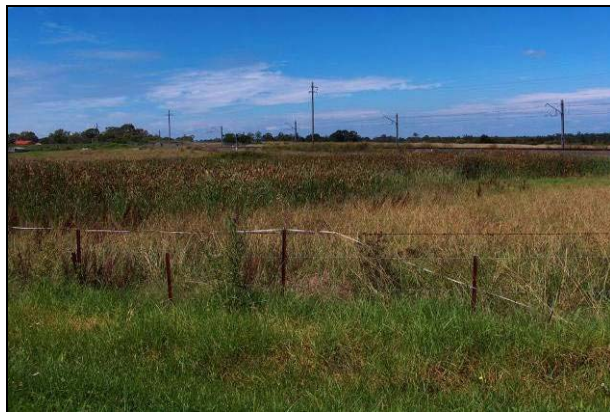
associated with the installation of the railway line and subsequent drainage control measures (Plate 5-23). The rail corridor in its entirety is considered to have low archaeological potential for both surface and sub-surface Aboriginal archaeological material due to the high level of impact associated with construction and maintenance of the railway line.

Plate 5- 23 Looking south towards a drainage depression along the eastern border of the rail corridor near the former Schofields aerodrome.

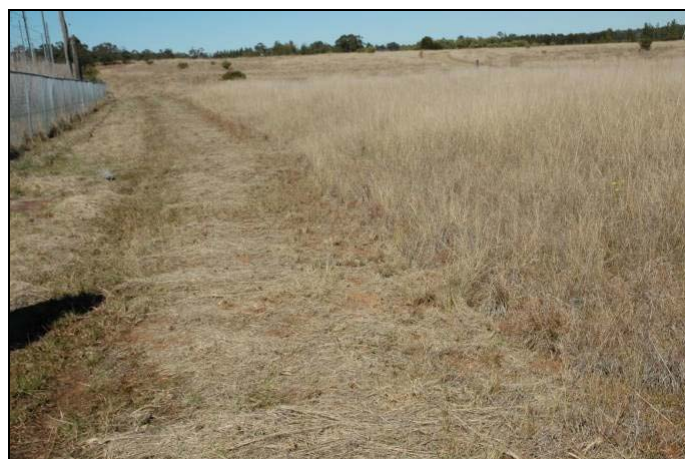
Plate 5- 25 View facing south east of location where QV1 was found.

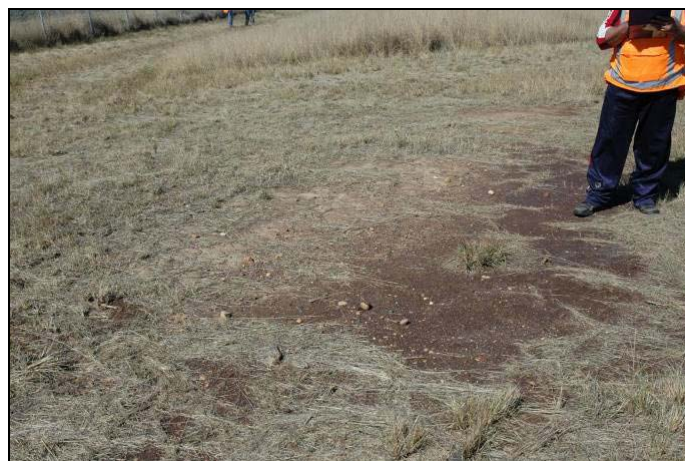
Plate 5- 27 **Detail of erosion scour along hill crest, where QV2 is located.**

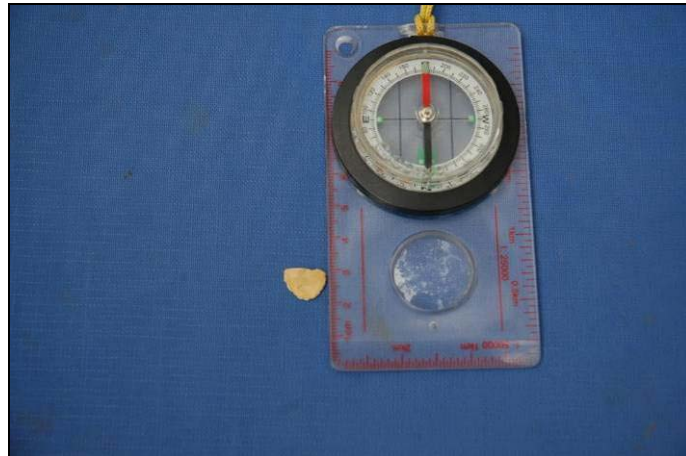
Site Name: QV3	Site Type: Isolated finds
Grid Coordinates; Datum: Aus 84	Zone 56
Easting: 303726	Northing:6266350
QV3 comprises a yellow silcrete broken retouched flake, measuring 1.8 x 1.1 x 0.1cm (Plate 5-34). This find is situated east of the rail corridor on a dirt track, along the alluvial flats of Eastern Creek. (Plate 5-35). This find is located within survey zone 1.

Plate 5- 28 **Detail of broken retouched flake, QV3.**

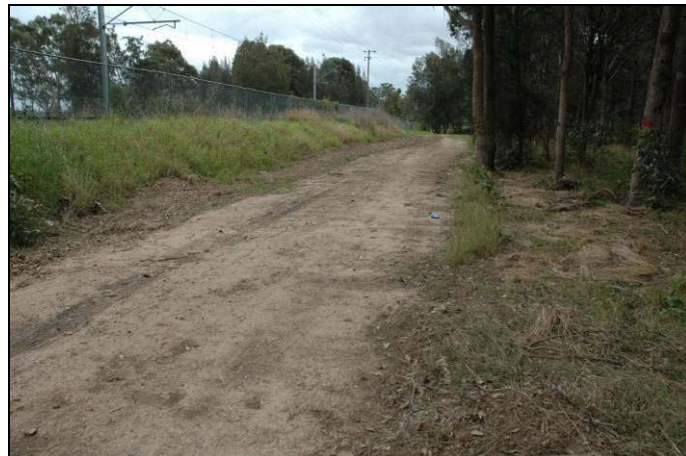
Plate 5- 29 **Location shot of QV3, facing north.**

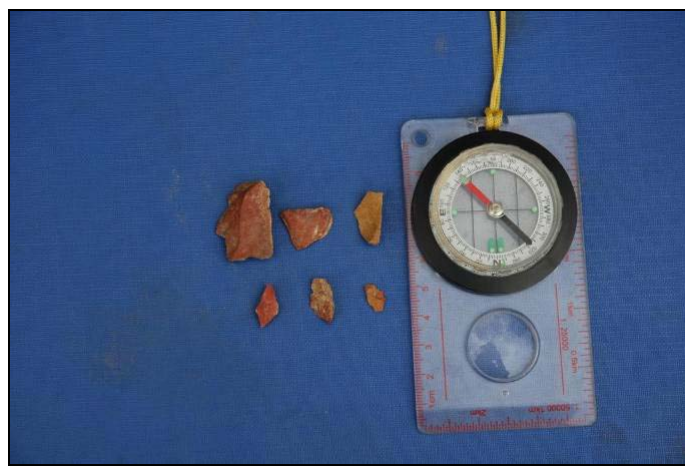
Site Name: QV4	Site Type: Artefact Scatter
Grid Coordinates; Datum: Aus 84	Zone 56
Easting: 303771	Northing:6266285
QV4 comprises three red silcrete debitage flakes, measuring 1.2 x 0.5. x 0.2cm, 1.4 x 0.6 x 0.4cm and 1.0 x 0.5 x 0.1cm, two red and brown silcrete flaked pieces measuring, 2.8 x 2.0 x 0.7cm and 1.8 x 1.1 x 0.6cm, and one red silcrete complete flake, measuring 1.7 x1.4 x 0.2cm. (Plate 5-36). These finds are situated east of the rail corridor on a dirt track, along the alluvial flats of Eastern Creek. (Plate 5-37). These finds are located within survey zone 1.

Plate 5- 30 Detail of QV4, comprising flakes, flaked pieces and debitage.

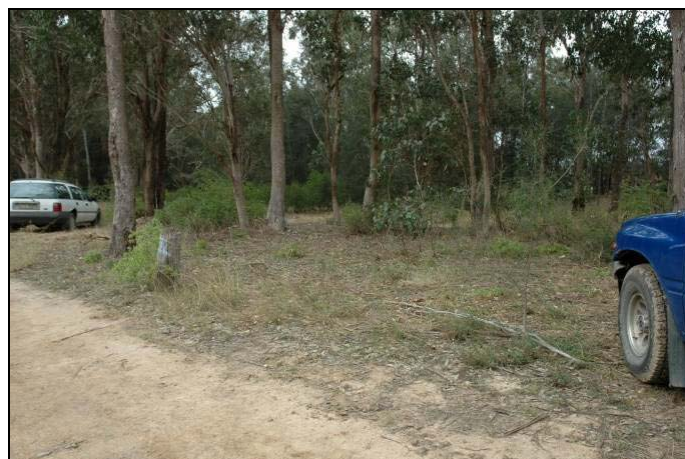
Plate 5- 31 Location shot of QV4, facing north east.

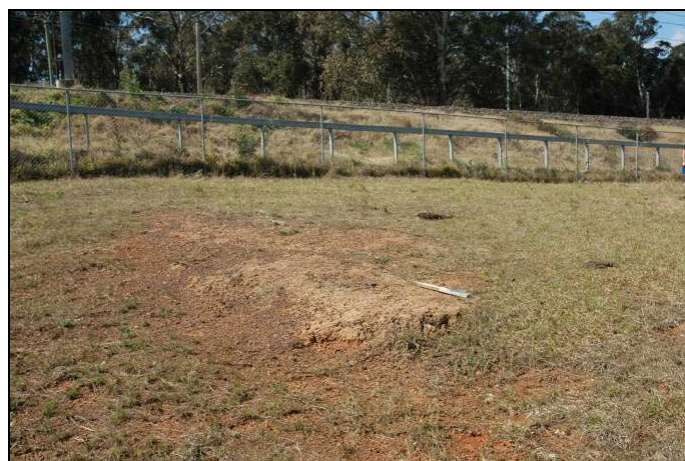
Site Name: QV5	Site Type: Isolated find
Grid Coordinates; Datum: Aus 84	Zone 56
Easting: 303732	Northing:6273274
QV5 comprises one red silcrete flaked piece, measuring 1.6 x 1.7 x 0.5cm (Plate 5-38). This find is situated west of the rail corridor within an erosion scour, along a lower slope of the alluvial flats of Eastern Creek. (Plate 5-39). This find is located within survey zone 3.

Plate 5- 33 **Context shot of QV5, facing south east.**

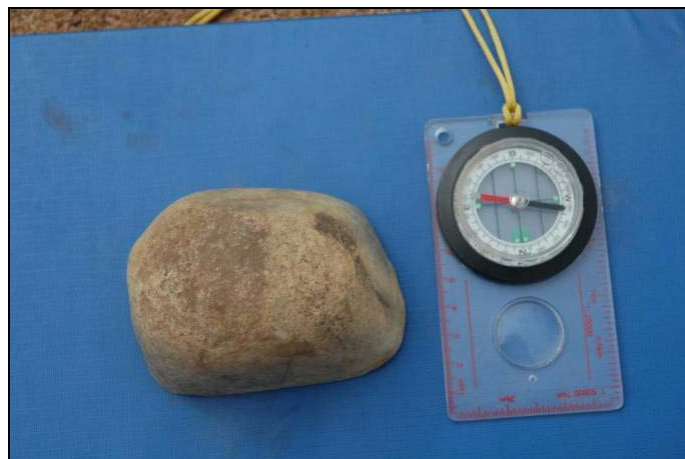
Site Name: QV6	Site Type: Isolated Find
Grid Coordinates; Datum: Aus 84	Zone 56
Easting: 300666	Northing:6274165
QV6 comprises a broken hammer stone made from a grey cryptocrystalline river cobble, measuring 9.5 x 6.0 x6.5cm (Plate 5-30). This find is situated west of the rail corridor adjacent to a dirt track, along a gentle hill crest above the Eastern Creek floodplains (Plate 5-31). This find is located within survey zone 3.

Plate 5- 34 **Detail of broken hammerstone; QV6.**

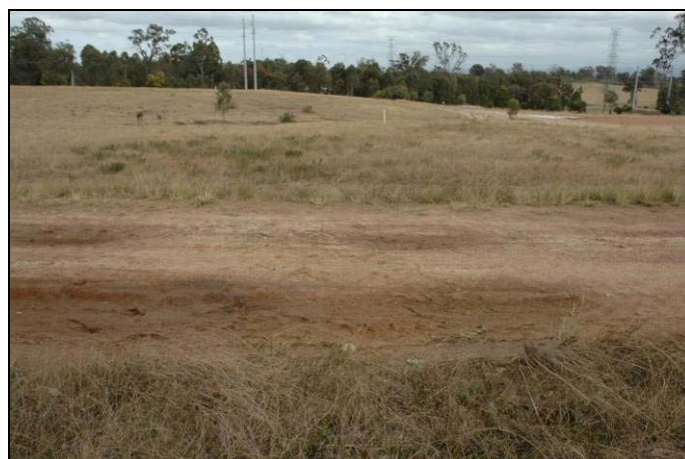
Plate 5- 35 **Location shot of QV6, facing north west.**

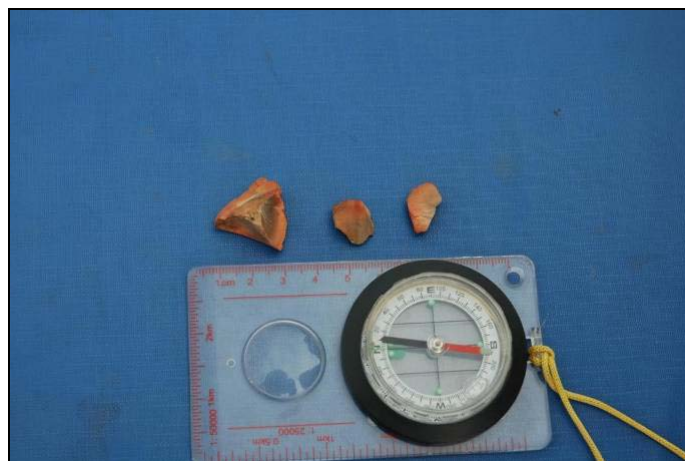
Site Name: QV7	Site Type: Three isolated finds
Grid Coordinates; Datum: Aus 84	Zone 56
Easting: 300703	Northing:6273810
QV7 comprises one orange chert flake, measuring 1.5 x 1.6 x 0.5cm, and two orange chert flaked pieces measuring, 1.7 x 1.1 x 0.4cm and 2.1 x 1.9 x 1.2cm (Plate 5-32). These finds are situated west of the rail corridor along a dirt track, situated on a gentle hill crest above the Eastern Creek floodplains (Plate 5-33). These finds are located within survey zone 3, and are potentially associated with PAD V2.

Plate 5- 36 **Detail of isolated finds QV7.**

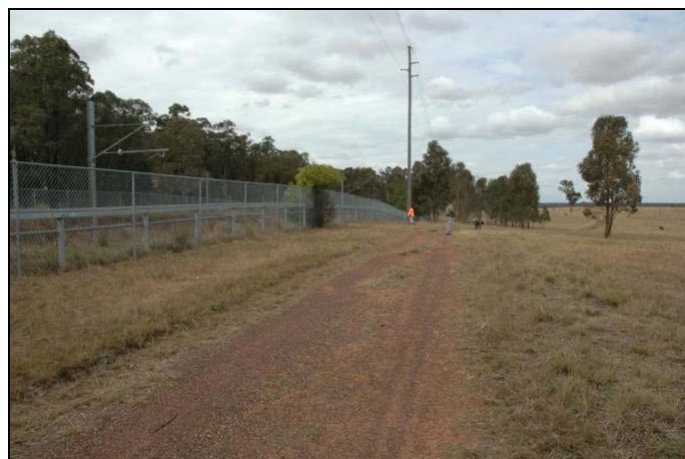
Plate 5- 37 **Context shot of QV7, facing south east.**
