ARDENT LEISURE PTY LTD

Stage 1 Contamination Assessment: The Spit Marina Mosman, NSW.

P0701675JR01_v2
May 2010

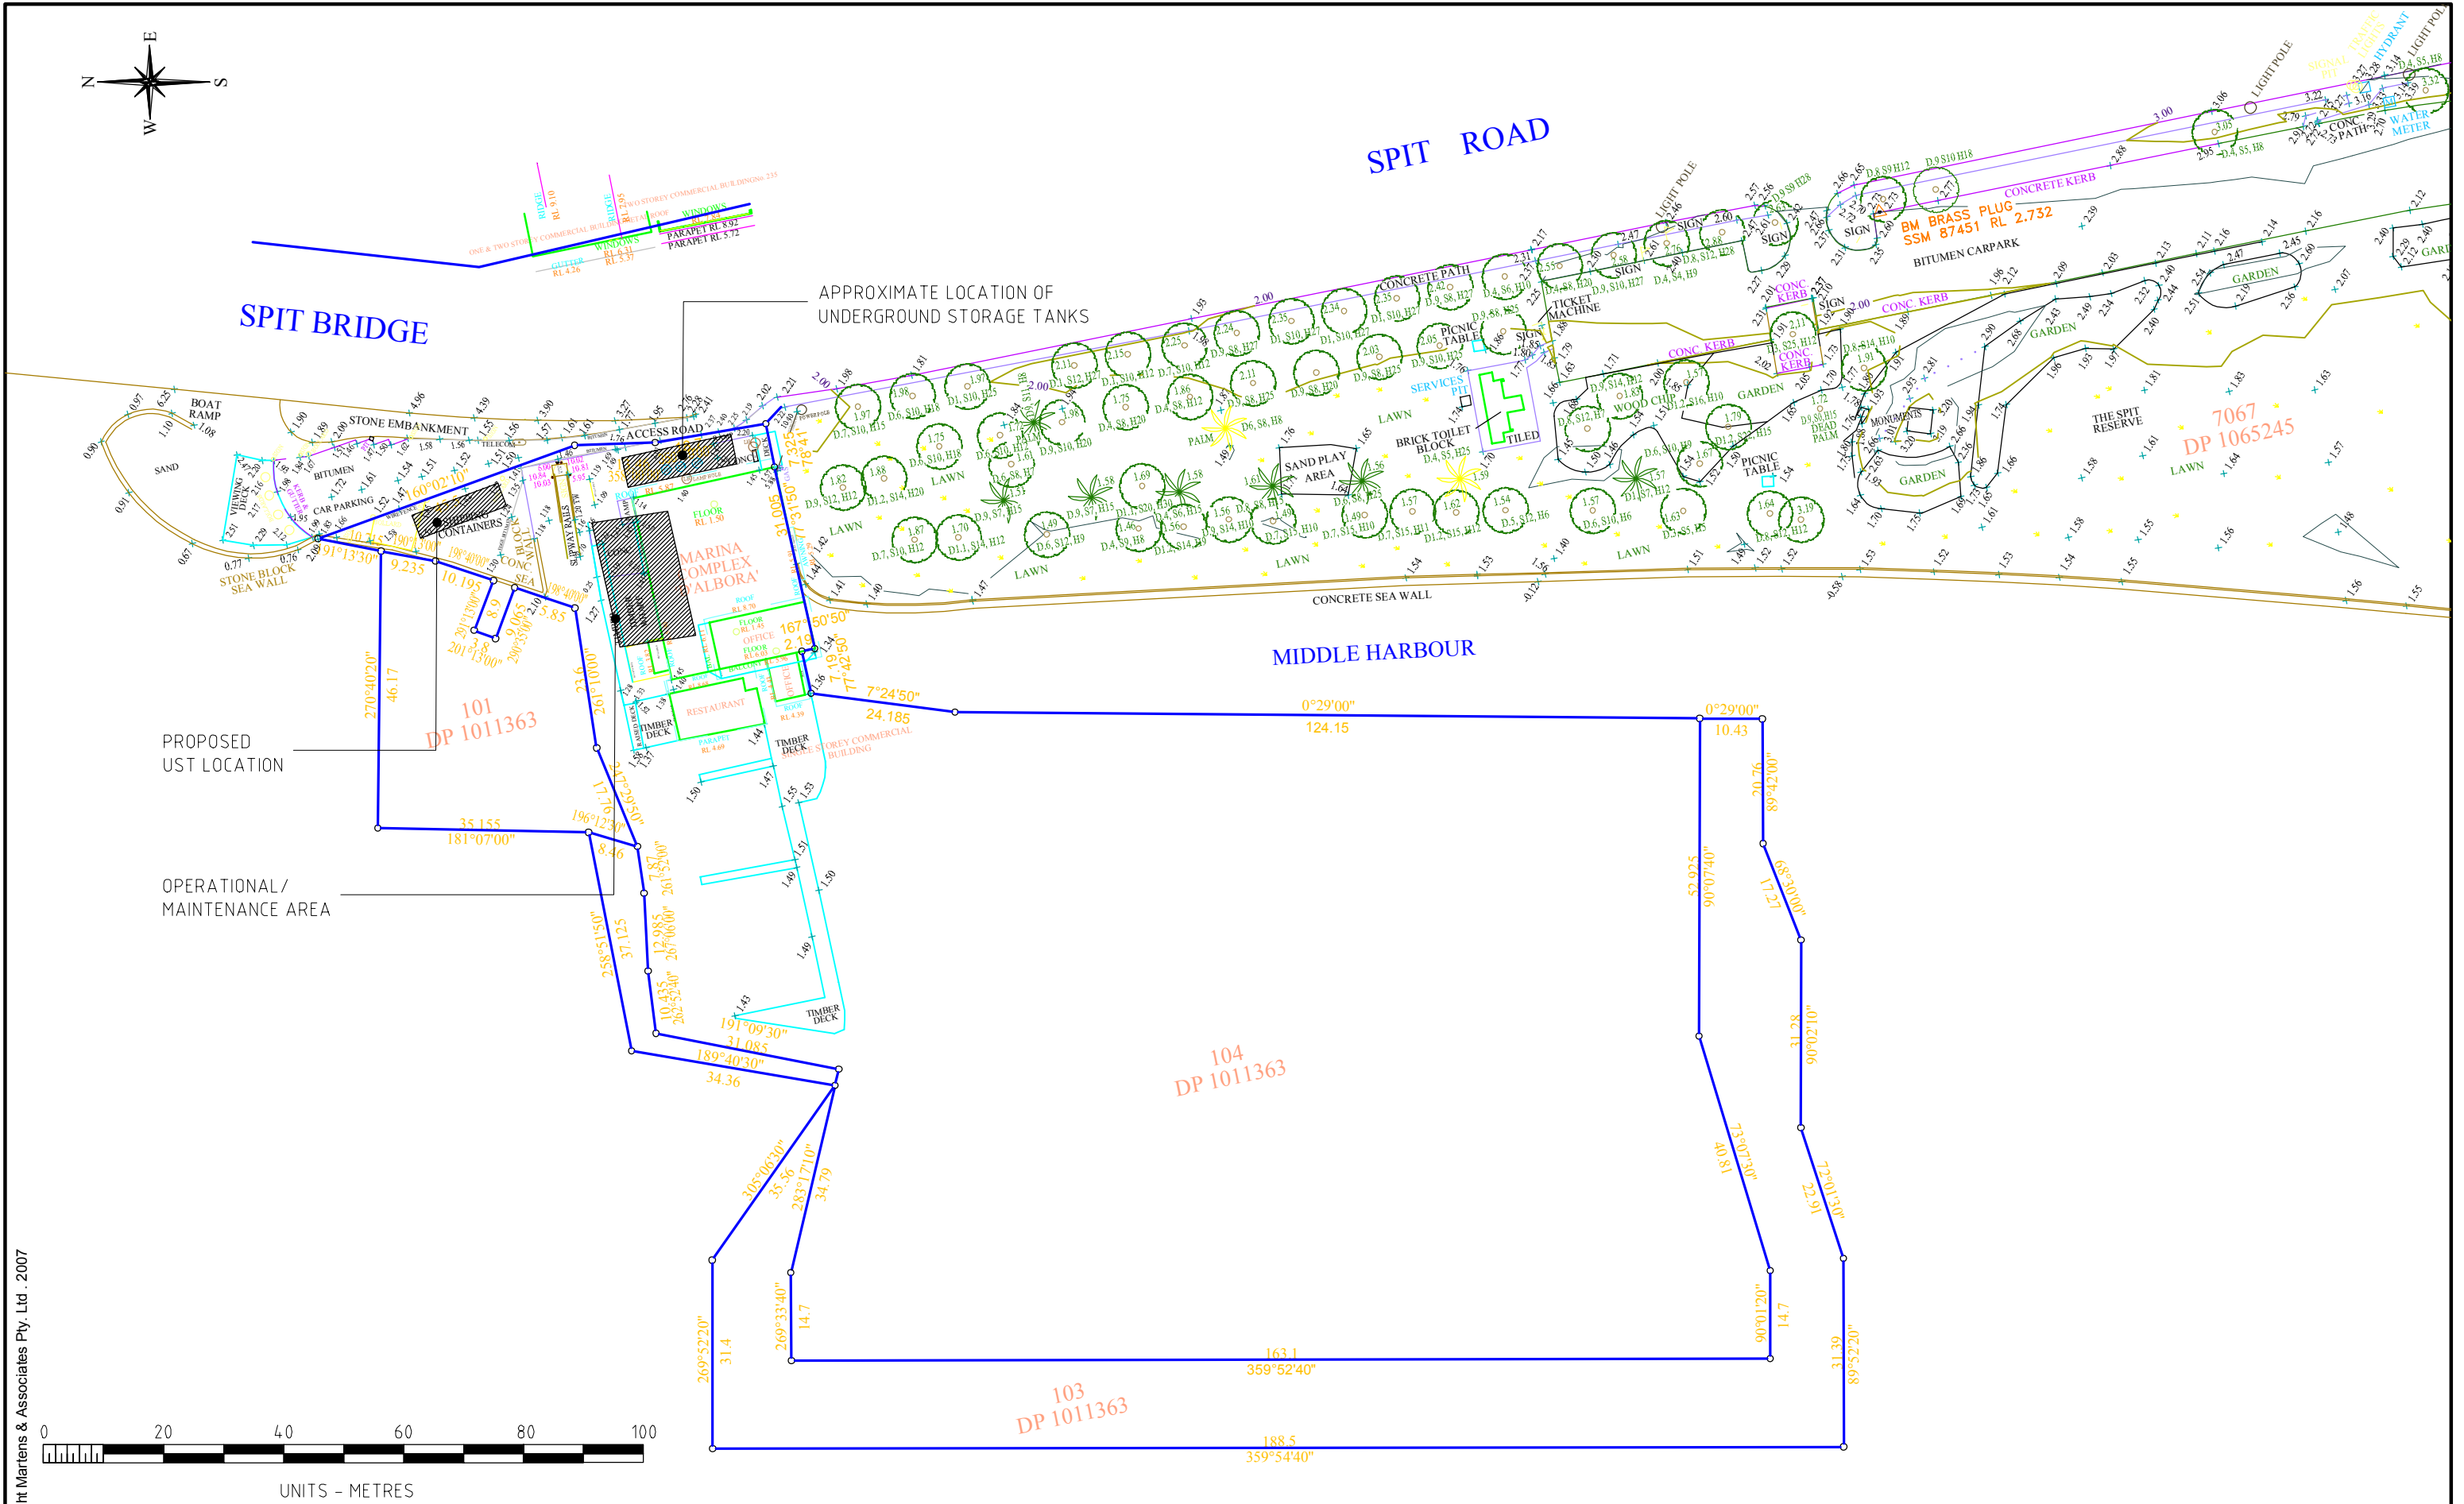
The site is located on the Spit Rd, Mosman and is within the Mosman Municipal Council (MMC) LGA. The site is located on the western side of Spit Rd, and to the north of the Spit Reserve. The marina's jetty and floating pontoons are located on Middle Harbour to the east. Attachment A provides the site plan with pertinent site features. The client leases the land subject to this application from NSW Maritime.

'hotspot' contamination are outlined in Table 1 and indicated on the site plan (Attachment A).

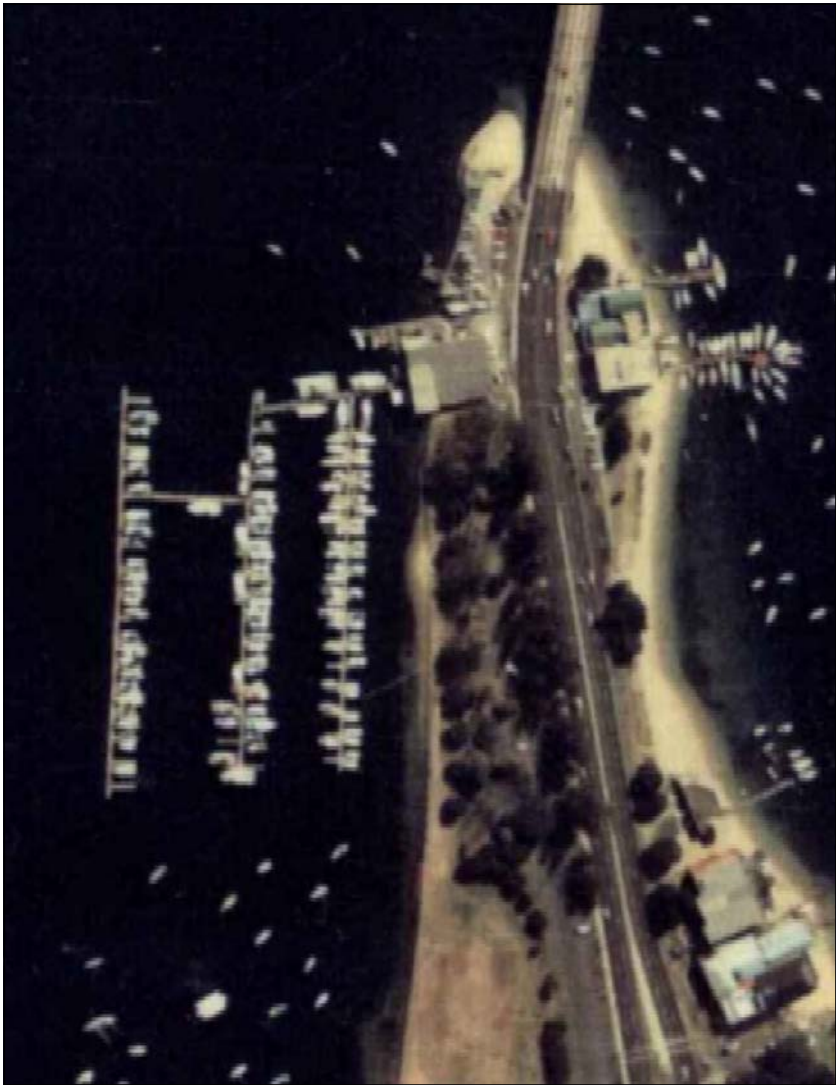
1982	As above, although the small jetty to the north of the marina building has slightly increased in size.
1994	As above, although the small jetty to the north of the marina building has been replaced with one that is offset from the building.
2007	No significant changes from 1994.
