# Visual Impact Assessment

# SUSTAINABLE RESOURCE CENTRE, TERALBA

PREPARED FOR CIVILAKE | 22 JUNE 2010

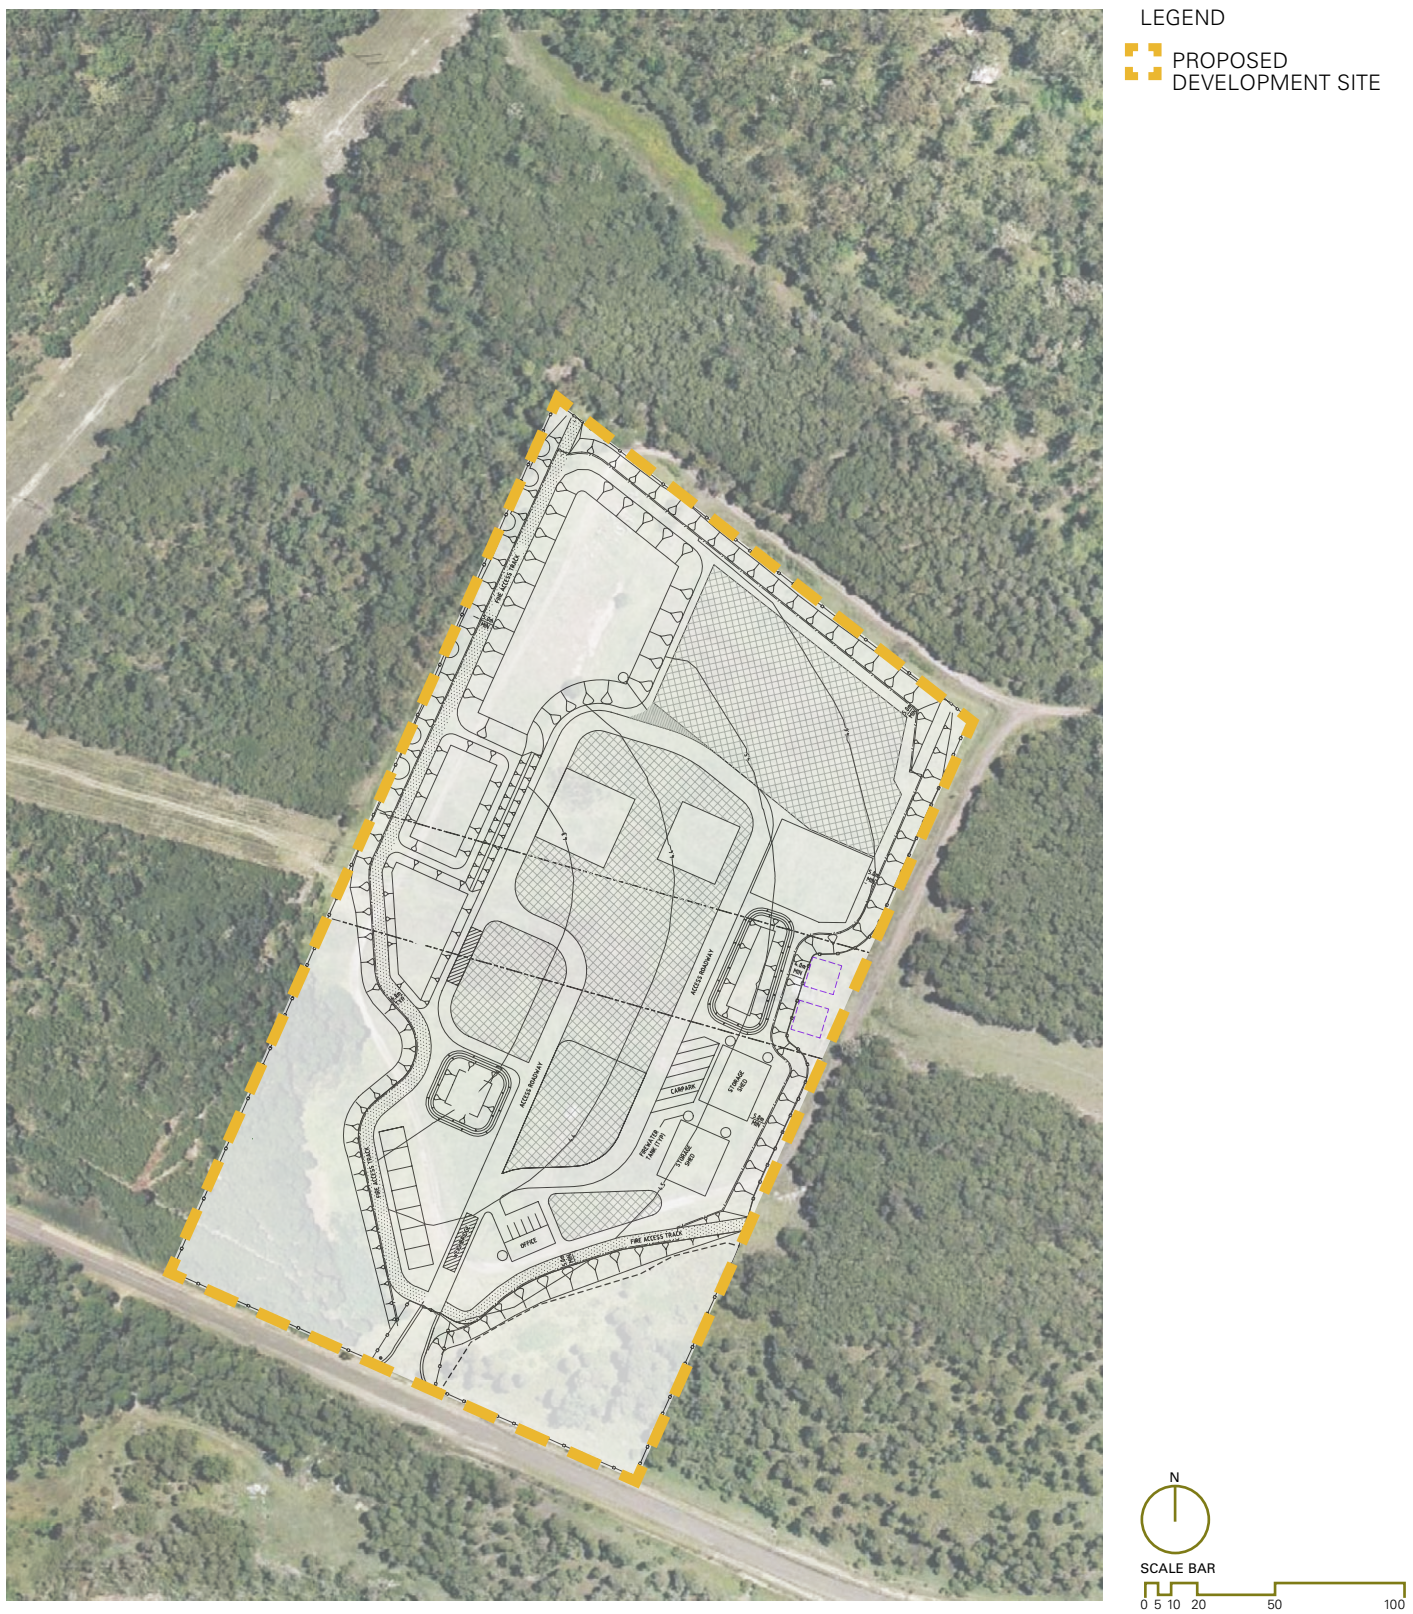
**Figure 1.4.1:** Schematic plan of the proposed development and aerial photograph (aerial photograph from Google Earth)

The proposal is for the development of a recycling facility for construction waste (Sustainable Resource Centre) on a 7ha. site off The Weir Road, Teralba (DP 16062), refer Figure 1.4.1.

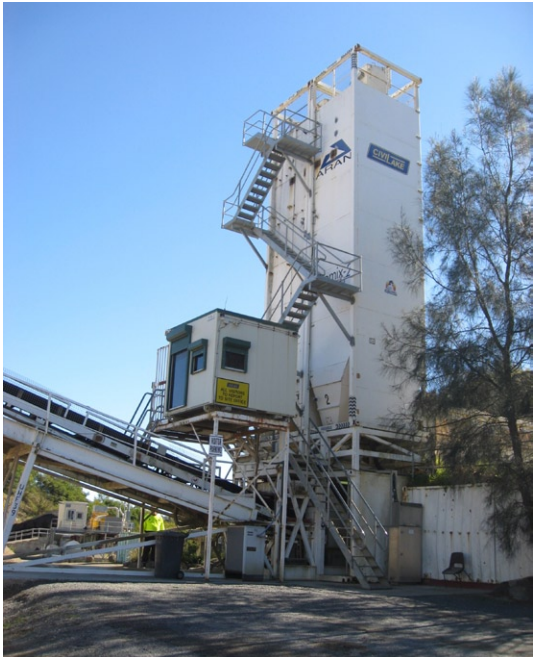
Figure 2.2.1: Existing Pug Mill to be relocated to the site

The proposed development will consist of an administration building and gate office, a pug mill, asphalt recycler, concrete batching plant, two storage sheds, water tanks, parking facilities, access roads and a number of stockpiles for process feed materials and the end products for reuse. A number of product bins will also be built for storage. There will also be a number of surface water storage areas (ponds) and site grading to prevent site runoff into the surrounding areas. Figures 2.2.1, 2.2.2, 2.2.3 and 2.2.4 and 2.2.5 show machinery, infrastructure and typical stockpile types proposed for this site.

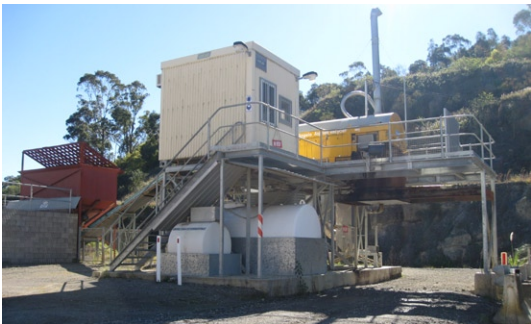
Figure 2.2.2: Existing asphalt recycling machine to be relocated to the site

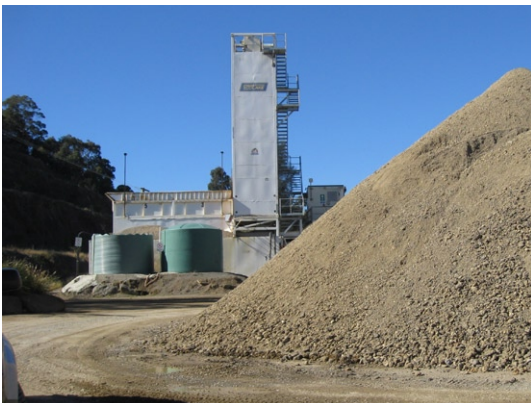
Figure 2.2.3: Typical detail of processed and graded product stockpile

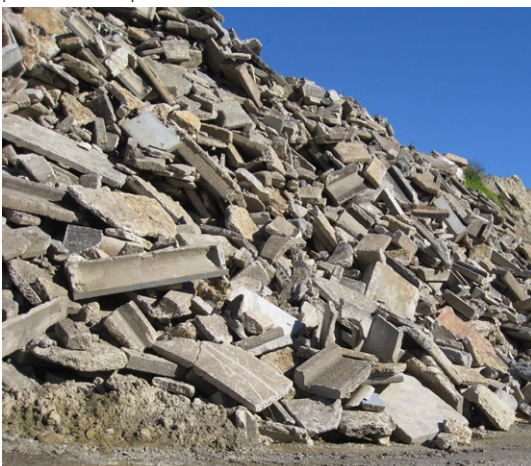
Figure 2.2.4: Typical detail of stockpiled concrete for processing

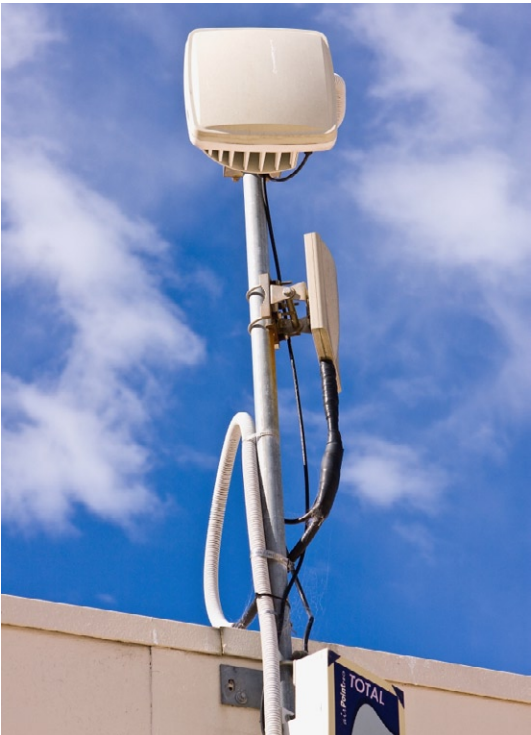
Figure 2.2.5: Communications receiver similar to that proposed to be mounted in the amenities building

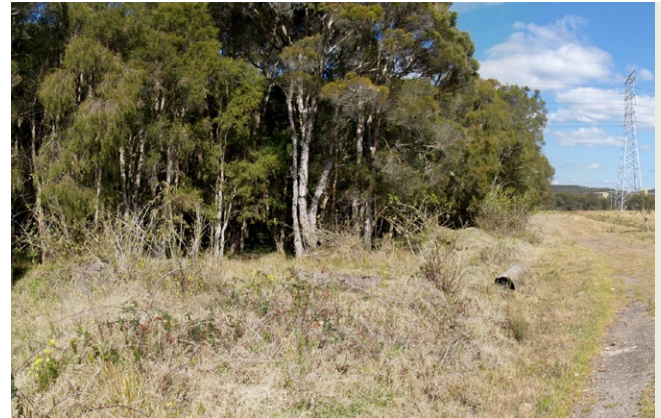
The proposed development on the site is to be situated on the inner edge of the drainage swale (refer Panorama 2.5.1 and Detail Photo 2.5.2).

**Panorama 2.5.1:** View from north-eastern corner of The site.

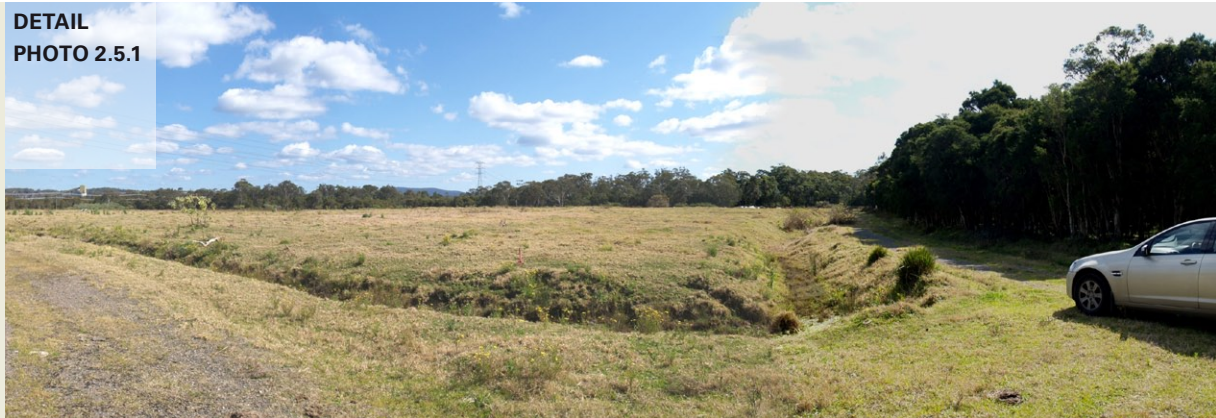
The proposed development boundary lies just beyond the existing drainage channel.

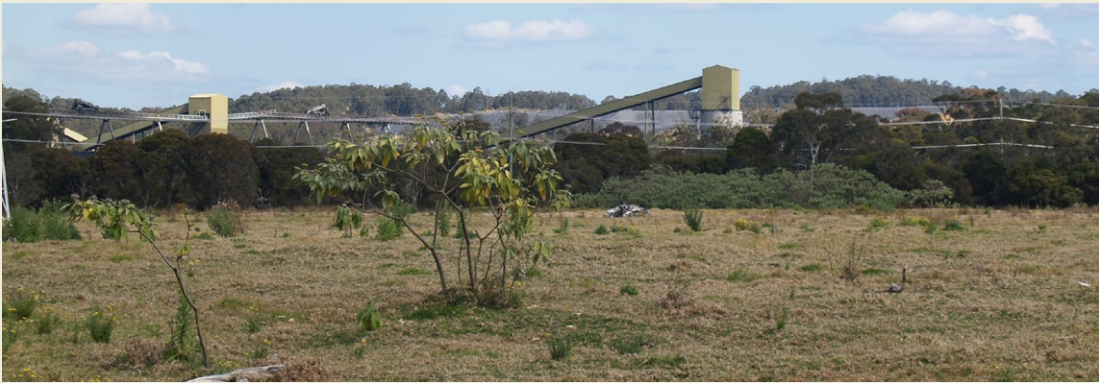
From this location, the only vantage point overlooking the property was what appears to be coal processing equipment and the hillside beyond, which appeared to be heavily vegetated (refer Detail Photo 2.5.1).

**Detail Photo 2.5.1:** Coal processing plant on the southern horizon line of the site

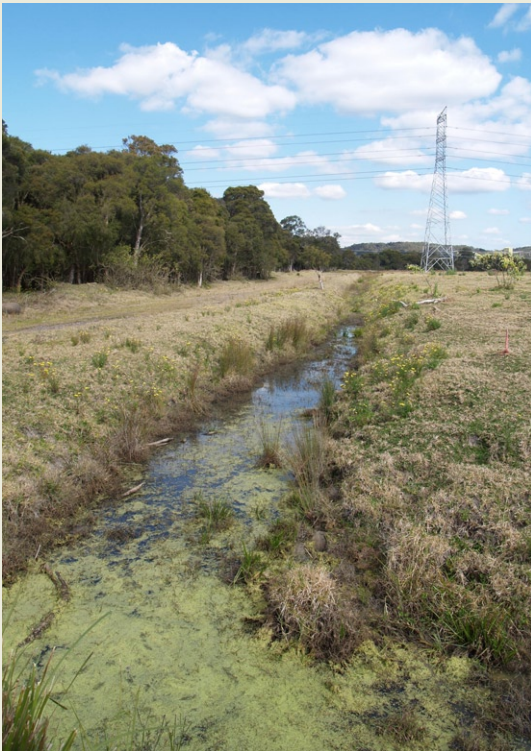
**Detail Photo 2.5.2:** Drainage Channel

**Opposite photograph:** Existing drainage swale, photo taken from the north-eastern corner of The site, looking south. The drainage swale is proposed to be retained, with the development boundary located to right of the frame at the top of the swale batter.

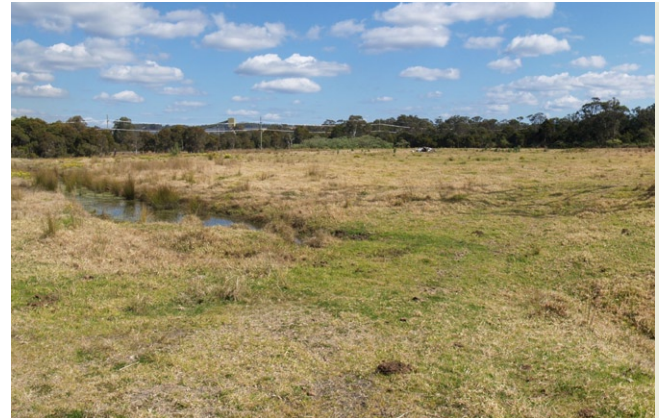
The thick vegetation that surrounds the site has been cleared in a strip along the electrical easement that runs east-west through it. Potential glimpse views could be obtained through this corridor to the site as it is one of the only places that the bushland does not act as a visual screen. Detail Photo 2.6.3 shows the view of the Waratah Golf Club at the end of the electrical easement view corridor, looking east from the site. Panorama 2.6.1 shows the view from the site boundary west across the site.

**Panorama 2.6.1:** Mid-eastern edge of the site

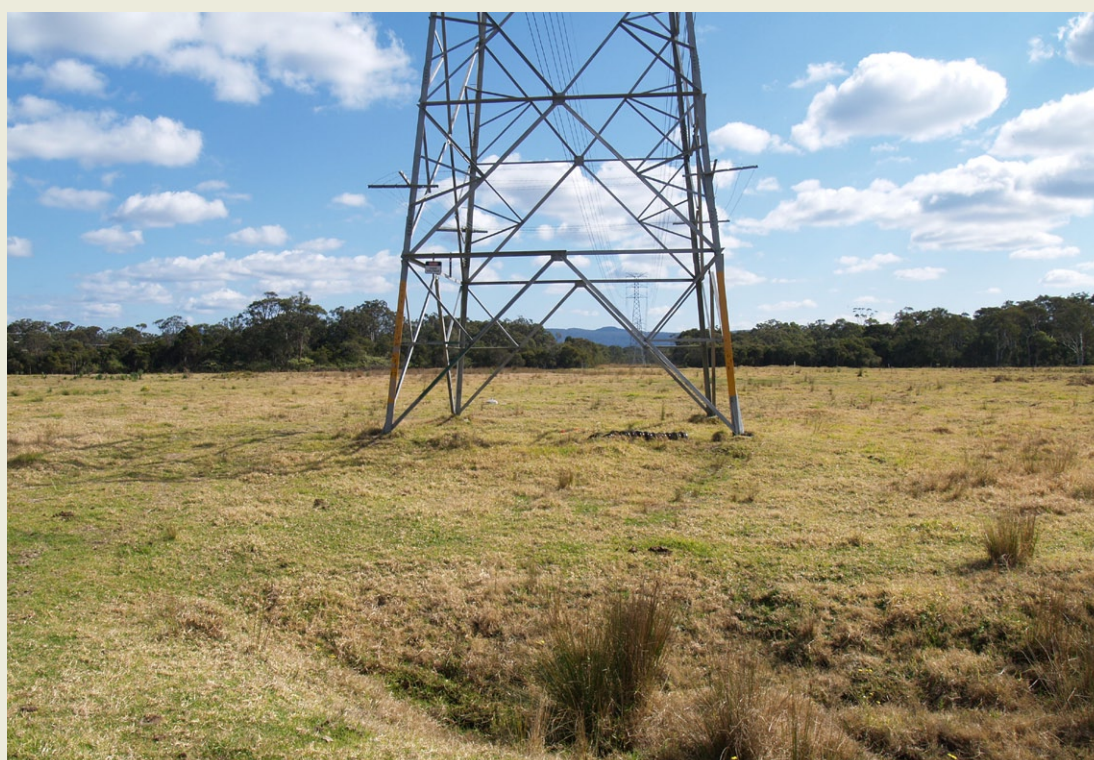
To the west, the only land high enough to possibly have views along this easement is too distant to warrant consideration as a viewer location (refer Detail Photo 2.6.1).

**Detail Photo 2.6.1:** Looking west across the site and down electrical easement

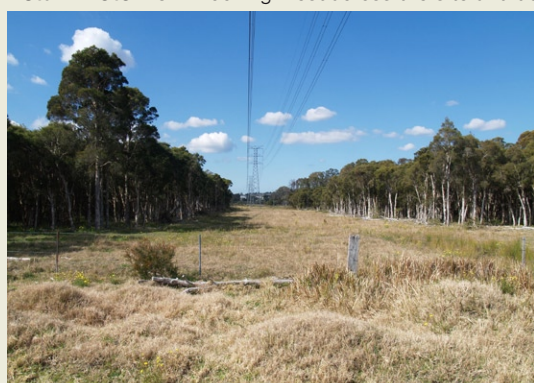
To the east, a number of buildings and a cleared hillside can be observed that may have views down along the easement into the site (refer Detail Photos 2.6.2 and 2.6.3). A further investigation of this area and adjacent hillside locations was undertaken (refer Observer Locations 6 and 7 and Potential Observer Location 8).

**Detail Photo 2.6.2:** View east along electrical easement

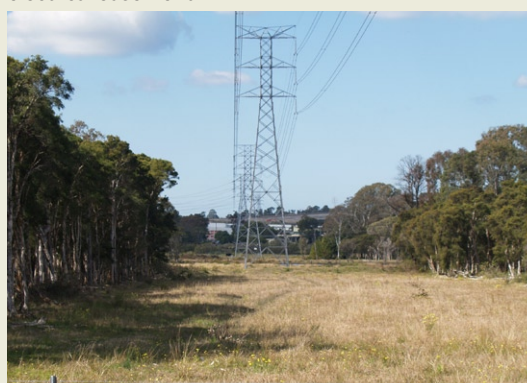
**Detail Photo 2.6.3:** Enlargement of view focus point from Detail Photo 2.6.2

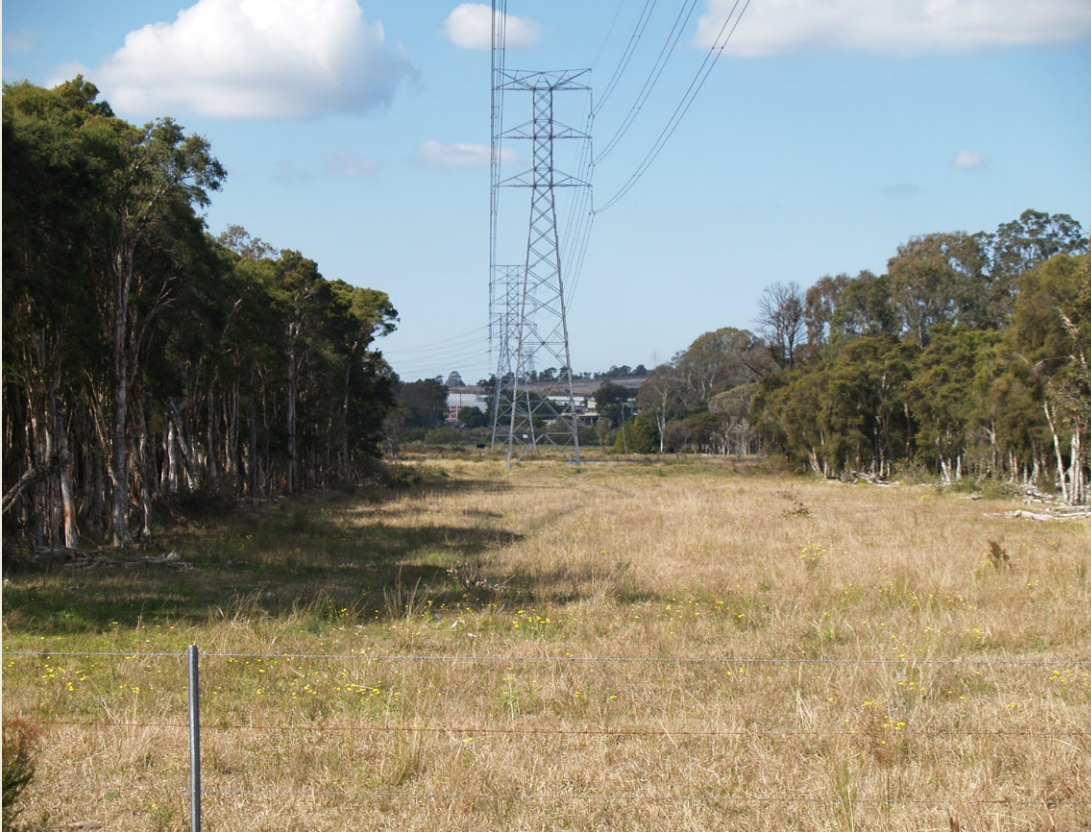
The view east along the electrical easement from the site terminates at a group of buildings and a cleared hillside beyond (refer Detail Photo 2.7.1). These buildings appear to be the Waratah Golf Club (Observer Location 5) and industrial buildings beyond, with some industrial and cleared land on the eastern adjacent hillside.

**Detail Photo 2.7.1:** Photo taken from Point A (the site)

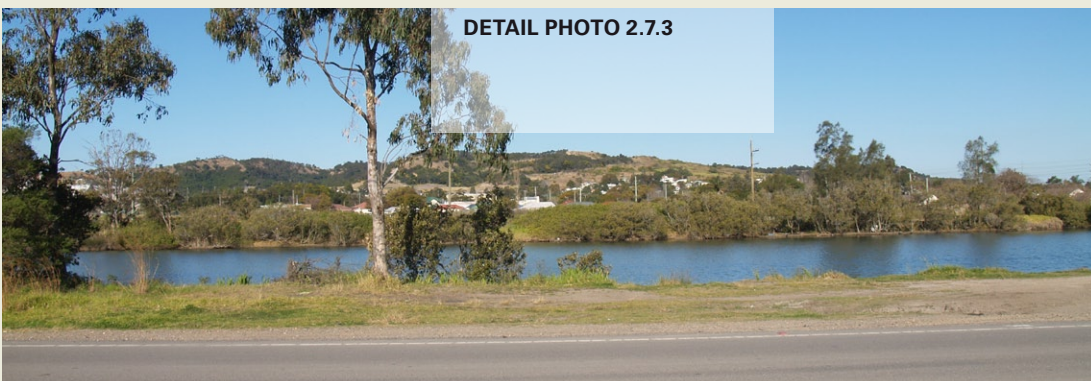
A number of elevated sites in Boolaroo and Argenton were investigated, including the top of First Street (Observer Location 6), Second Street, Third Street and Fourth Street (Observer Location 7), Boolaroo (refer Detail Photos 2.7.2 and 2.7.3).

**Detail Photo 2.7.2:** Photo taken from Point B (Racecourse Road)

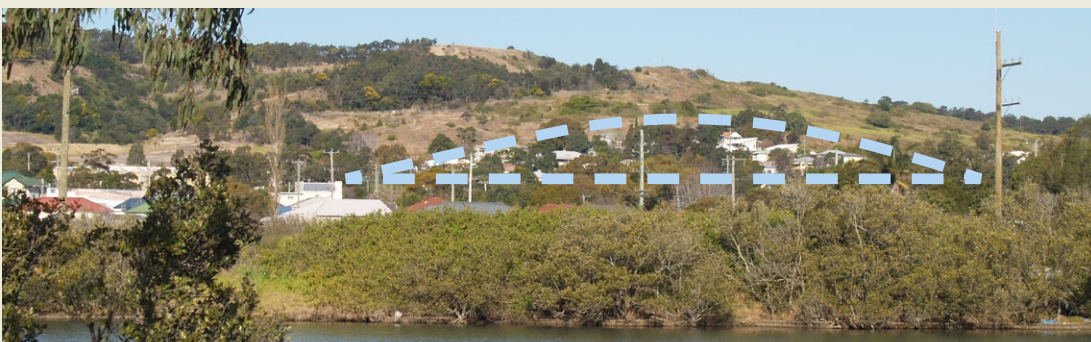
Although there are a number of individual houses near the cul-de-sac ends of these streets that may have views over the site, EDAW/AECOM could not find a position where a clear view of The site could be obtained. It is anticipated that only a small number of people will have views to the site from this location and that the visual prominence of the proposed development within the site will be low given the viewing distance, the relatively small area of the development within the broad extent of the forested floodplain, and the screening effect of the forest immediately adjacent to the site, which is in the order of 6 to 8 metres tall.

**Detail Photo 2.7.3:** Photo taken from Point B (Racecourse Road) showing elevated dwellings with the potential for views to the site

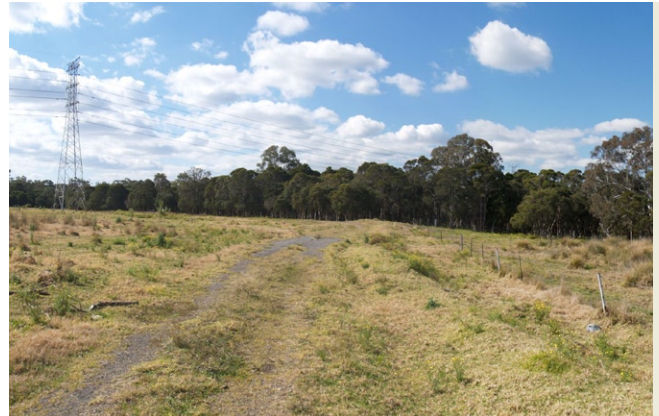
**Panorama 2.9.1:** View south from inside site boundary, towards The Weir Road (refer Keyplan)

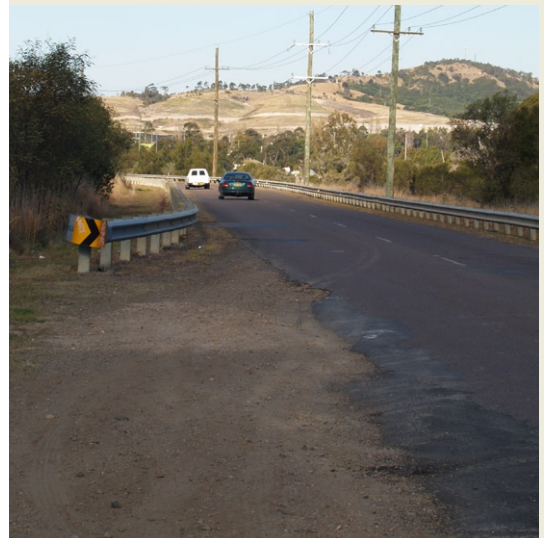
The Weir Road sits around a metre higher than the site (refer Panorama 2.9.2 and Detail Photos 2.9.1 and 2.9.2).

**Detail Photo 2.9.1:** View east from proposed entry

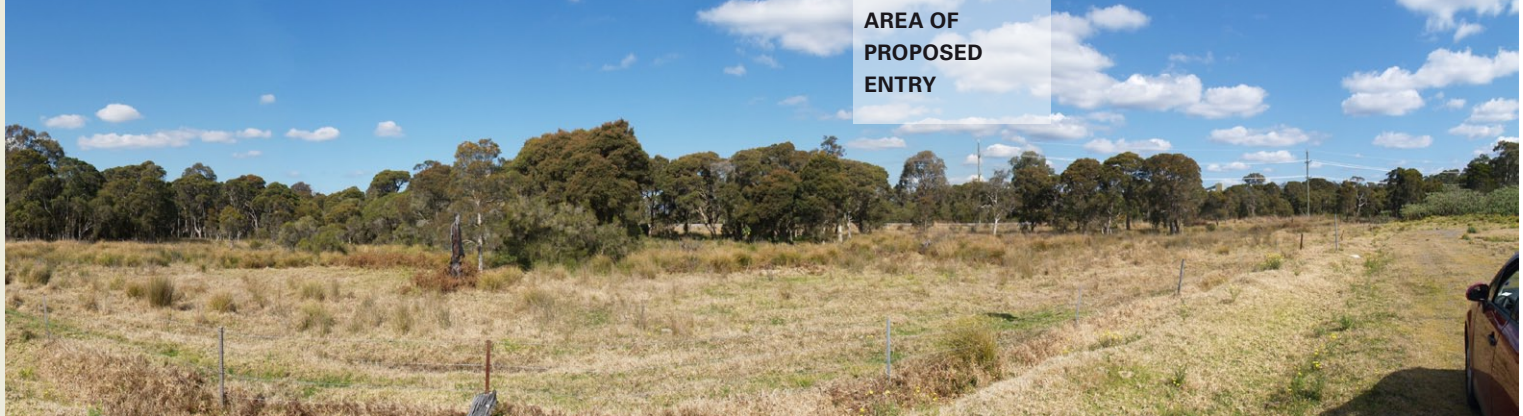
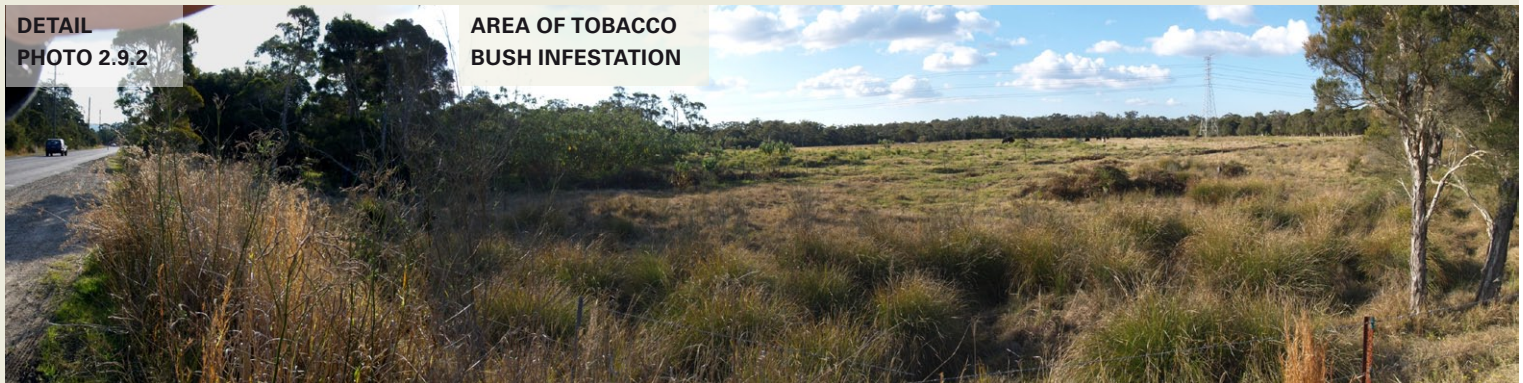
The vegetation on the southern boundary of the site has been identified as Swamp Mahogany / Paperbark / Woollybutt Swamp Forest (an Endangered Ecological Community, refer Detail Photo 2.9.4) which has sporadic weed infestation in areas that have been trampled by cattle. The open areas of this community are dominated by Melaleucas and *Carex appressa* (refer Detail Photo 2.9.3), whereas adjoining higher, filled areas have significant weed growth, mainly Tobacco Bush (refer Panorama 2.9.2).

**Panorama 2.9.2:** View north-west into the site from The Weir Road (refer Keyplan)

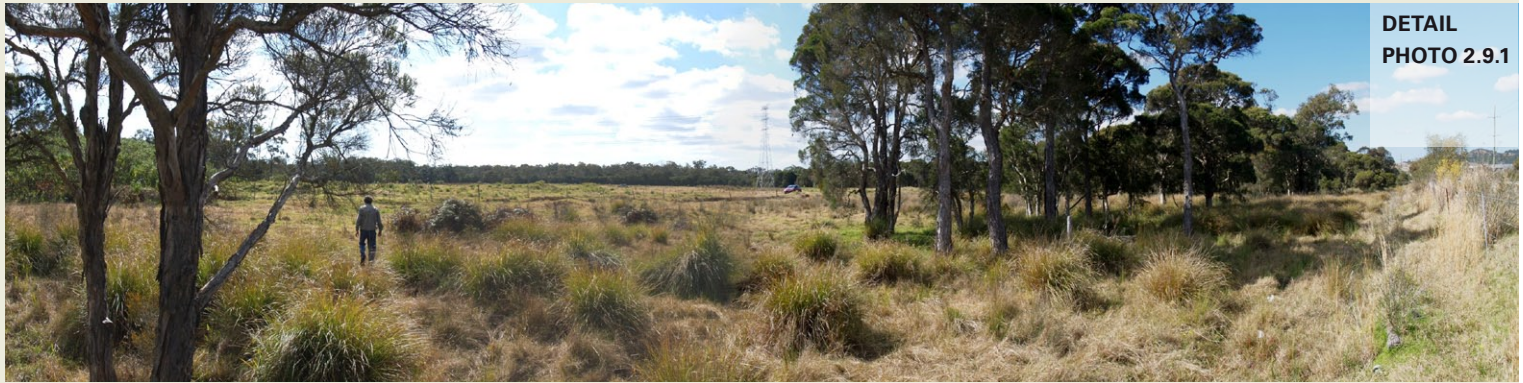
**Panorama 2.9.3:** View north-east into the site from The Weir Road (refer Keyplan)

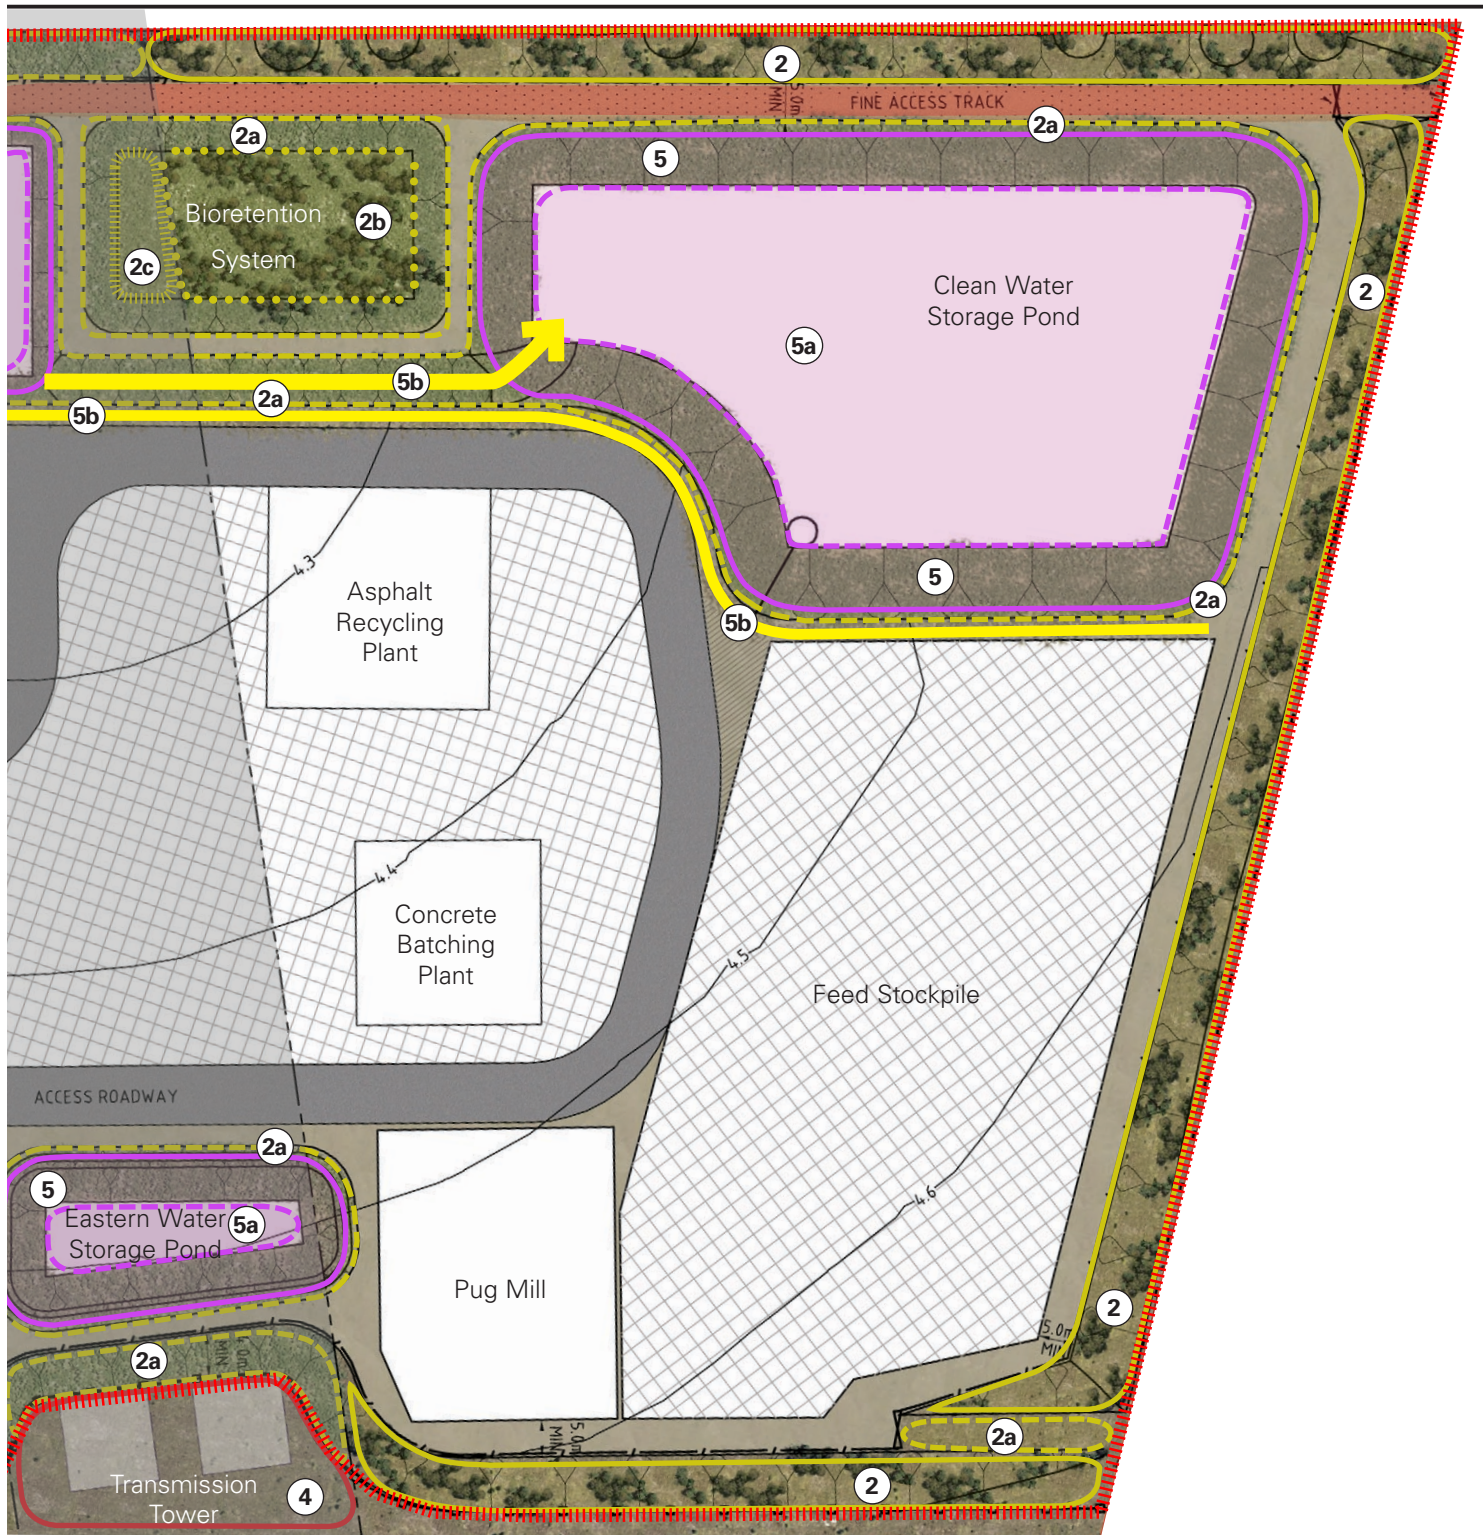
**Community Type 1:** Existing Swamp Mahogany / Paperbark / Woollybutt Swamp Forest
- 1a

**Community Type 2b:**  
Bioretention System planting

**Community Type 2c:**  
Bioretention System planting under electrical easement

**Community Type 4:** Make-up and repair to match existing managed electrical easement beyond site
