## **PHASE 1 ENVIRONMENTAL SITE ASSESSMENT**

Lot 112 DP1073791, Lyons Road, Sawtell NSW

Utila Pty Ltd

GEOTCOFH02467AA-AB  
24 February 2009

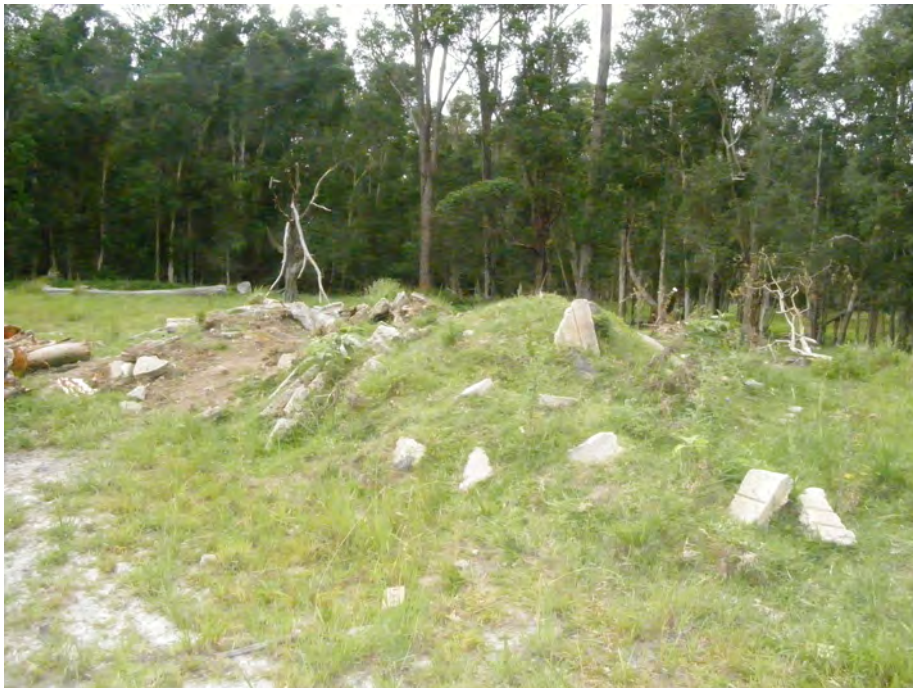
There are no existing buildings located onsite and the site is currently used for cattle grazing purposes. A cattle stockyard was located on the western central boundary of the site. During the site walkover several small piles of fill were observed in the northern portion of the site to the west of the dams, see photo 1 below. The fill material consisted of building waste with bricks, concrete and steel piping observed.

**Photo 1** – Imported fill piles of building waste located in the north east of the site, view is towards the east
