**PRELIMINARY CONTAMINATION ASSESSMENT**

**PROPOSED COMMERCIAL DEVELOPMENT**

**17 O'RIORDAN STREET**

**Project 45586**

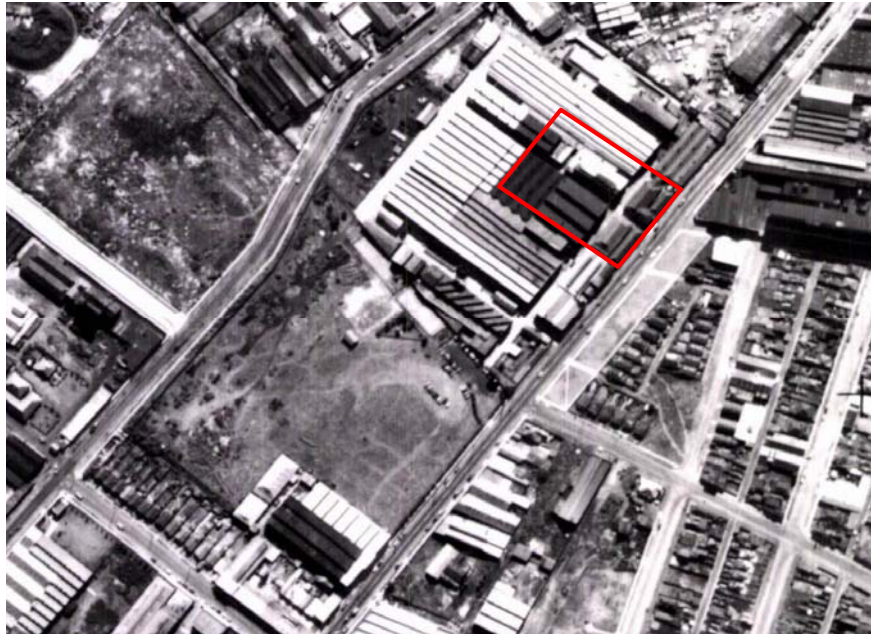
Photo 1: Aerial Photograph 1951

Year	Details
1951	Office-type buildings along the O’Riordan Street boundary. Industrial-type warehouse buildings on the remainder of the site. Internal road between office buildings and warehouse parallel to O’Riordan Street. Industrial-type buildings to the north, west and south of the site. This site layout is different from the current layout.
1965	No discernable changes evident since 1951 photograph.
1970	No discernable changes evident since 1951 photograph.
1978	No discernable changes evident since 1951 photograph.
1986	No discernable changes evident since 1951 photograph.
2004	All buildings seen in earlier photographs on the site and immediately to the north, west and south have been demolished. The current building and carpark are present. The current building to the south is present. The sites to the north and west are vacant as is currently the case.

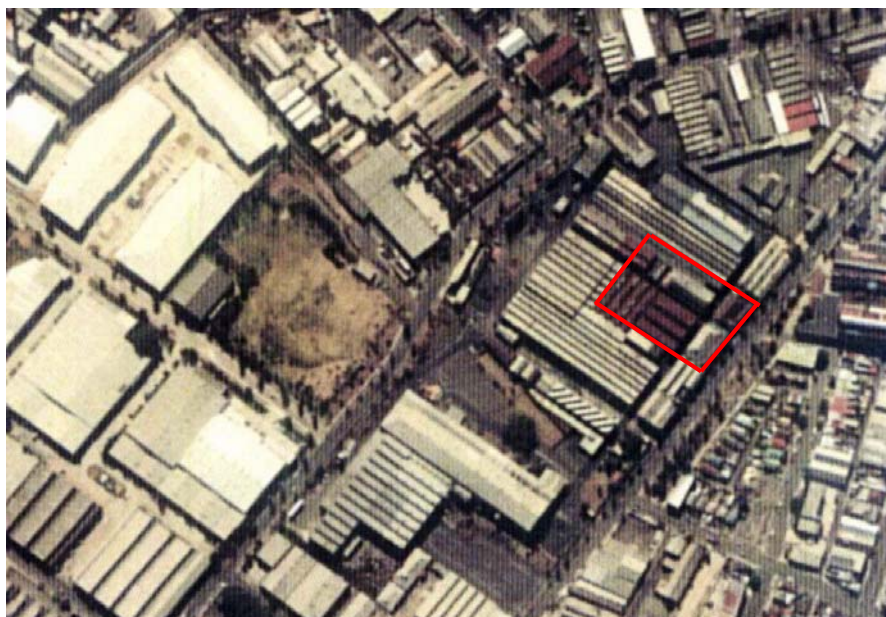
Photo 5: Aerial Photograph 1986

It appears that the metal processing facility was demolished sometime between 1986 and 2004. Scanned images of the aerial photographs are shown in Appendix E.
