Hume Highway Upgrade

Tarcutta bypass

Technical Paper 2

**HUME HIGHWAY TOWN BYPASS: TARCUTTA
ABORIGINAL CULTURAL HERITAGE
Cultural Heritage Assessment Report**

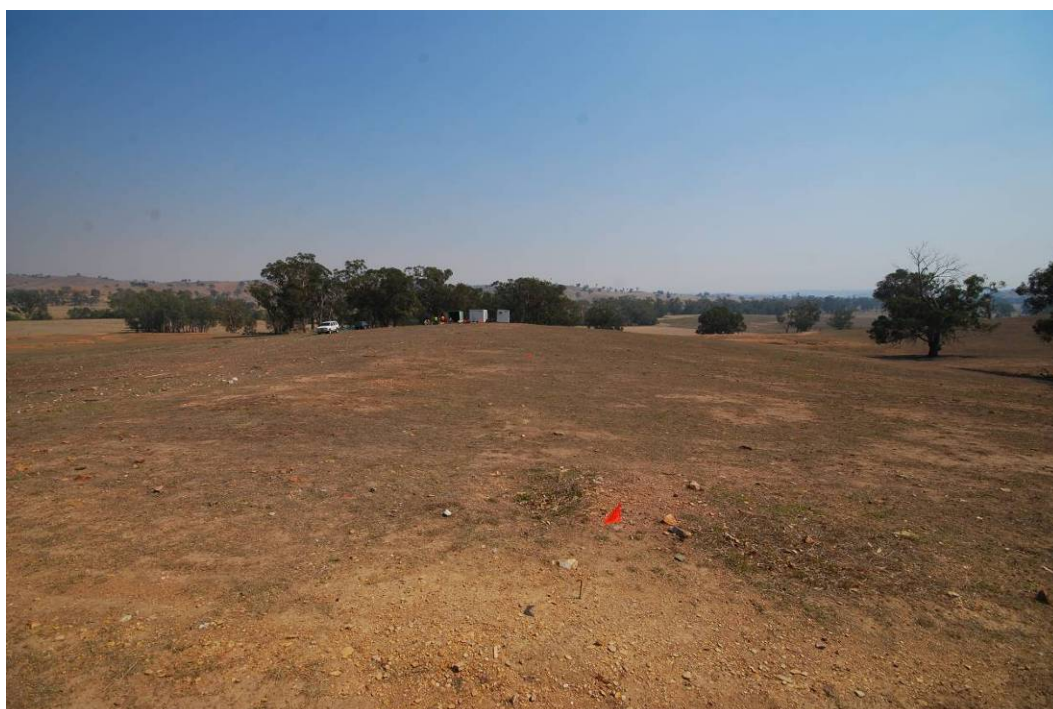
Plate 1. TA14/T9 looking west from the highway with Tarcutta Creek in the distance

Test Area 14 (TA14) was located approximately 2km to the north of Tarcutta along the western side of the Hume Highway on the [REDACTED] pastoral station. TA14 was the test component of site T9. The area was a cleared paddock with testing undertaken on a raised western reaching spur overlooking an alluvial floodplain associated with Tarcutta Creek, located approximately 300m west of the subject area. The spur was bounded on the northern side by a moderate slope running into a drainage gully and excavated dam, the Hume Highway to the east and a moderate slope running into floodplain to the south. The western spur included moderate to steep slopes running directly onto floodplain. Pedestrian surveys undertaken in 2008 identified quartz and metastone artefacts. The landform was heavily eroded, with exposed shale bedrock and large quartz outcrops running down the entire spine of the spur with smaller exposed areas scattered along the slopes. There was little to no vegetation cover, with only occasional remnant dry and desiccated grass patches. Testing aimed to investigate the presence and integrity of subsurface archaeology at the site and to ascertain the spatial extent of the site across the landform.

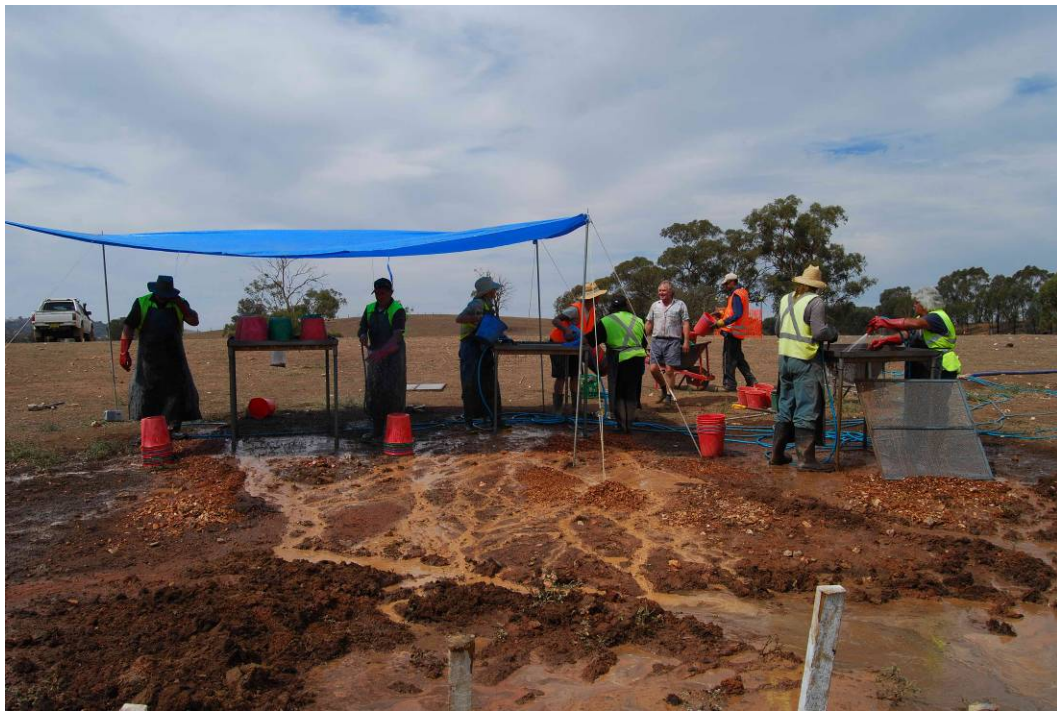
Plate 2. Excavation works at TA14/TT9

All test squares were dug in bulk after it was determined little vertical integrity remained in the subsurface due to long term erosion and colluvial forces. Standard KNC procedure for excavation of test squares is to dig to basal clay, bedrock, or to dig to a determined sterile layer of deposit. The subsurface deposit on TA14 contained no soil horizon apart from 2-3cm of loose sandy dust, only partially humic. In general, excavation was directly onto mixed orange to pale clays and ironstone shales, with occasional large columnar quartz deposits. The shales were interpreted as degrading bedrock deposits, and were found in both horizontal and vertical sheets, with quartz deposits mixed into the shales. The base of the test squares was decomposing shales. Squares were excavated to an average depth of 20cm, with four squares excavated to a depth of between 26cm and 30cm (604E 135N, 604E 180N, 619E 190N and 659E 140N).

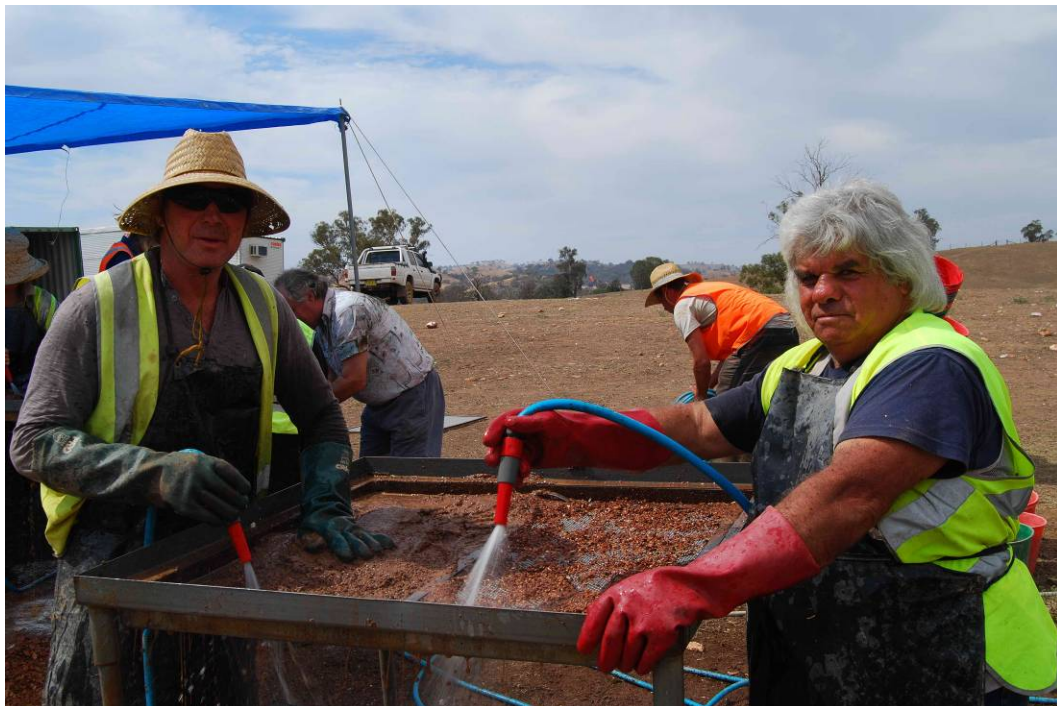
**Plate 3. Sieving the shale deposit from TA14/T9**

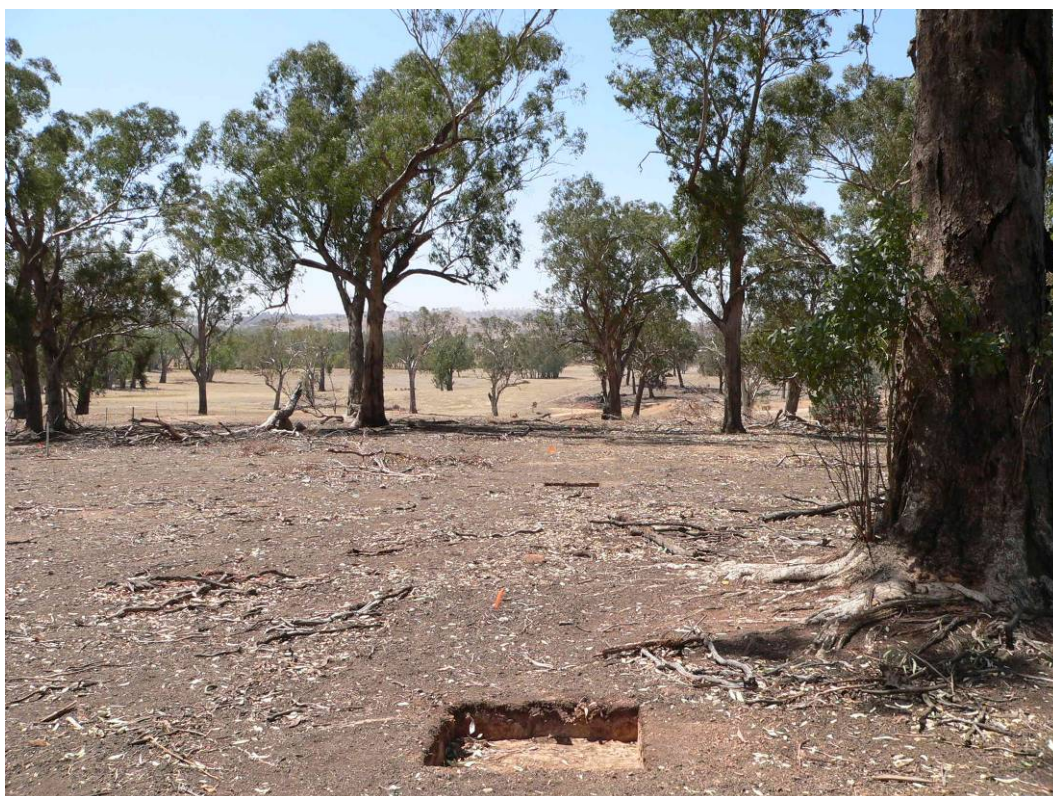
Plate 4. TA15/T12 looking north from the hill top down onto the Tarcutta creek floodplain

Test area 15 (TA15) was located on the [REDACTED] pastoral station, approximately 1km north of Tarcutta, and 200m west of the present Hume Highway. TA15 was the test component of site T12. Quartz artefacts were located on the hilltop here, 500m south of the homestead, during a pedestrian survey in late 2008. Landform comprised a level hillcrest with gentle to moderate side slopes. The test area was bordered to the west by a NNE running fence line. The hilltop featured a grove of mature Grey Box trees. Large Grey Box also grow on lower slopes off the impact corridor, and River Red Gums line Tarcutta Creek 350m to the west. Adjoining paddocks to the south have been cleared for cultivation. During the excavations ground cover comprised leaf litter, low grass stubble, fallen branches from recent storms, sheep scats and locally occurring quartz fragments. Tarcutta Creek was completely dry. The proposed impact corridor is a ramp which will be approximately 30-60 metres wide by c.1000 metres long. Testing aimed to investigate the likelihood of subsurface archaeological deposits on this hilltop landform and assess their nature and intactness.

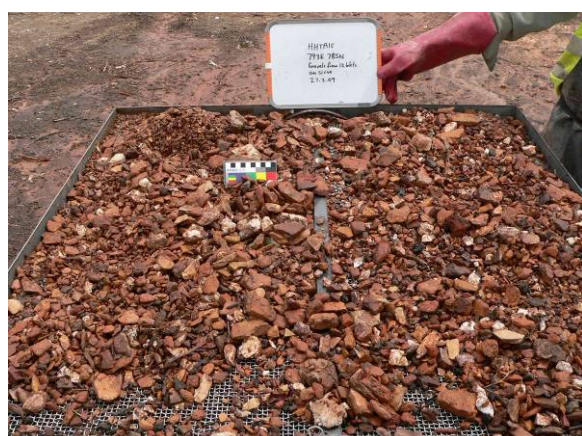
Plate 5. Shale gravels within the deposit at TA15/T12

Testing revealed a shallow, gravelly colluvial deposit at TA15, with an average depth of only 20cm to weathered bedrock or basal clay. Most squares showed evidence of topsoil loss from sheet erosion, and local rock fragments were present on the surface. 296 pieces of artefactual stone was identified in the field, producing an interim low to moderate density of 14 artefacts/m². However, this figure includes a number of angular fragments of good flaking quality quartz that is probably naturally fractured local stone. The large proportion of background quartz made artefact identification difficult, and quartz can often fracture unpredictably. No historical material was found. Stratigraphy varied slightly over the tested area as excavation progressed down the north facing slope (120m x 30m test area). Bedded and folded shale bedrock (Ordovician) was encountered just under the surface on the hill crest (793E 725N), with slightly more soil development occurring lower downslope. Soils typically had thin, loose grey brown recent humus (0-5cm) straight onto compact paler brown to orange brown silty clay loam containing abundant large coarse fragments (quartz and micaceous shale). Decomposing sandstone was also found at the base of pit 793E 740N (at 20cm). Densely packed colluvial gravels were encountered in orange brown silty clay loam further downslope (793E 785N). Soil pH at TA15 ranged from 4.5 to 5.5.

At TA15 there was a high fraction of natural quartz coarse and shale fragments in the soil matrix which made artefact identification difficult. A natural vein of milky quartz outcrops on the northern slopes of the test area. Much of the local quartz is opaque milky white with internal flaws and fracture planes. This material was potentially useable but flakes unpredictably. Initial results suggest that different quartz types of varying

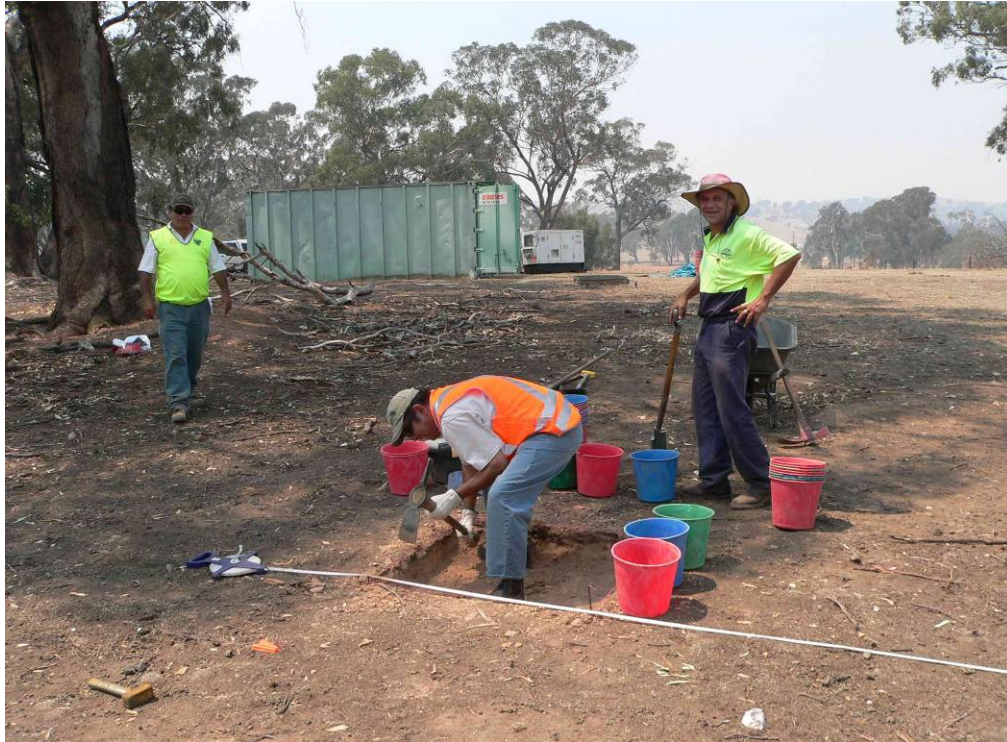
Plate 6. Excavation of test squares on the hill top at TA15/T9

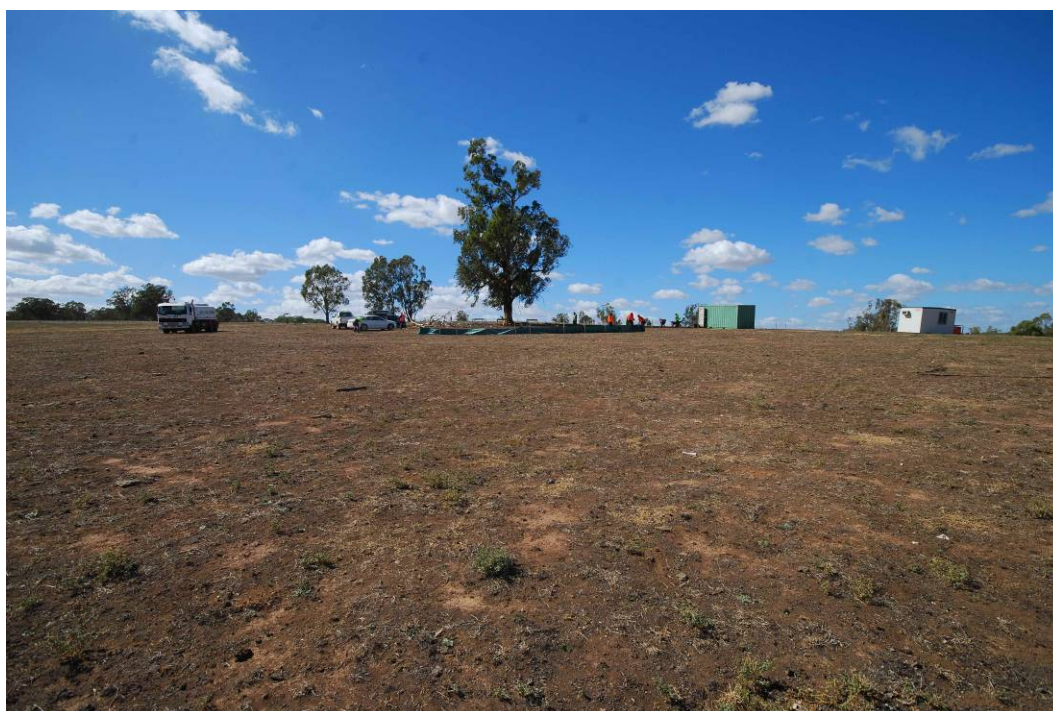
Plate 8. TA16/T20 looking east from the midslope up onto the upper slope and site

Test Area 16 (TA16) was located directly northwest of the town of Tarcutta. TA16 was the test component of site T20 (formerly T-PAD-4). The test area was situated on a raised ridge bearing northeast and overlooking an area of floodplain associated with Tarcutta Creek located between 100 and 150m south and west of the test area. The area under investigation was the southernmost spur line of a series of similar landforms, two of which were tested during this project (TA14 and TA15). The test area consists of the crest of the ridge, a moderate to steep slope to the south, a slight to moderate slope to the west and a series of slight to moderate undulations to the north and east, with the land rising to the east. Pedestrian surveys undertaken in late 2008 identified the area as exhibiting archaeological potential (see section 5.3). The surface of the test area appeared relatively intact with soil and patchy grass cover over most of the ridge, although only one tree remains standing in the paddock. Large craters within the site give evidence to the removal of trees across the area. Natural quartz gravels were apparent, scattered across the area. Testing aimed to investigate the presence and integrity of possible subsurface archaeology and to ascertain the spatial extent of the archaeology.

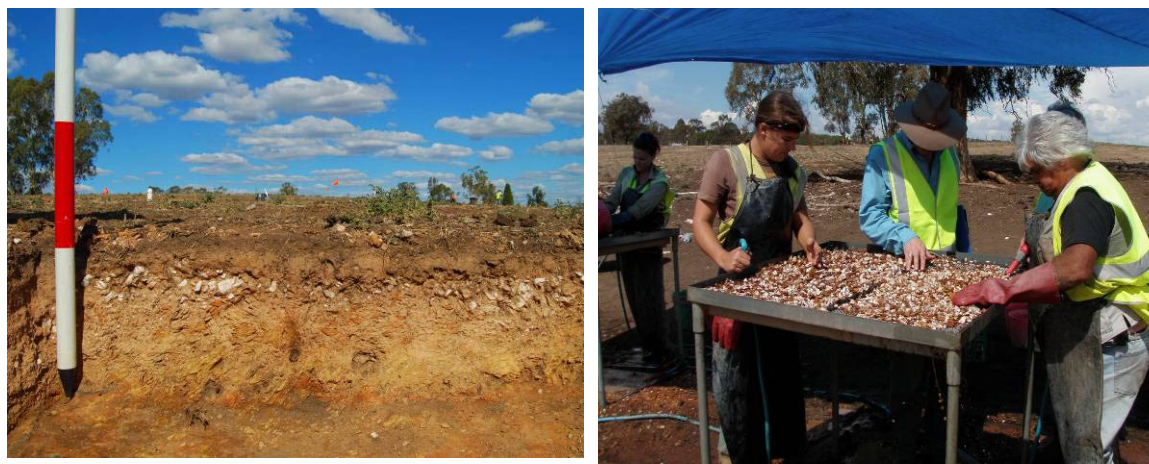
Plate 9. Degrading shales and fractured quartz in the profile resulted in a high gravel content for TA16/T20

minimal soil profile, test squares were then excavated in 10cm spits in an attempt to detect the vertical distribution of artefact discard. The average depth of test squares was between 25-30cm with the deepest being 40cm (899E 440N), although this depth included 10-15cm of introduced landfill (located at the southernmost section of the transects within a mounded area centred around a group of young trees and the fence line). Squares were dug to basal clay where possible, however a majority of squares led onto degrading bedrock, shales and quartz, and in a number of cases, sandstone. All test squares had high concentrations of quartz gravels and shale.

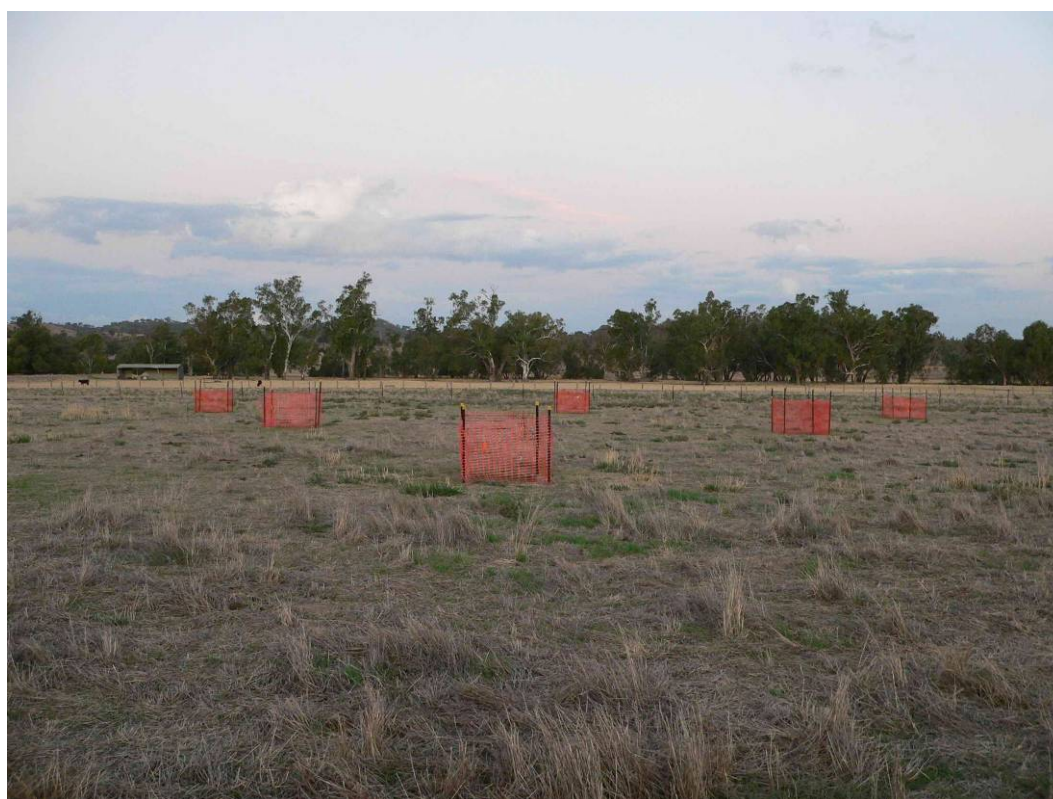
Plate 12. Test squares staggered over TA17/T21 (former Keajura Creek channel in the tree line)

This test area was located on the [REDACTED] property, less than 1km south of Tarcutta and only 100-130 metres east of the present Hume Highway, directly opposite the Mates Gully Road intersection. Test area 17 (TA17) was the test component of site T21 (formerly T-PAD-5). The test area had been identified during a pedestrian survey in 2008 as having moderate potential for subsurface archaeological deposit. The area was given the designation T-PAD-5. This PAD was originally considered to be a possible low lying eastern extension of a hillslope cut through by the present highway. The PAD area was level ground, slightly elevated above the present active floodplain of Tarcutta Creek. A gentle slope drops off in the southern half of the test area. The landform was also adjacent to the modified channel of Keajura Creek, altered during construction of the present highway, to the west. The test area was within a small fenced off paddock (c.250 x 100m). At the northern end of the paddock was a large earthen levee bank, constructed in the 1990s for flood control. Flood waters from Tarcutta Creek are reported to have reached as high as the western half of the paddock, up to the western end of the levee bank [REDACTED]. To the south was a larger paddock cultivated with lucerne, and to the east cleared broad floodplain used for grazing cattle. The study area has been completely cleared and was being used for horse grazing at the start of the excavations. On the western boundary fence was a windmill and 10m deep well. During the excavations ground cover was low, dry pasture grass stubble. Both creek channels were dry. The only trees in the vicinity, mostly large River Red Gums, occur along Keajura Creek and Tarcutta Creek. Two proposed impact corridors are to run through the study area. One is a new main highway route through the NW corner of the paddock, 60 metres wide by 1000 metres long. The other, is a smaller off ramp, 30m wide by 1500m long, which is to run from the NE to the SW corners of the paddock. Testing aimed to investigate the likelihood of subsurface archaeological deposits on this landform and if found, to assess their nature and intactness.

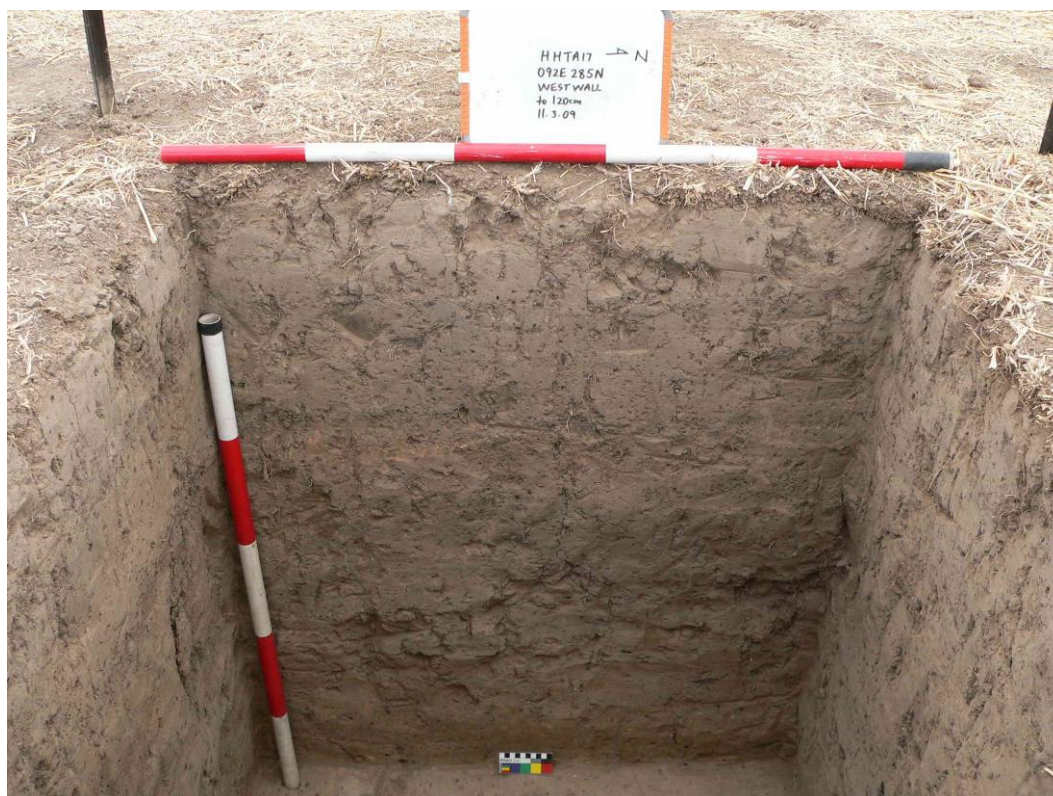
Plate 13. Test square at TA17/T21 showing the many alluvial layers covering the archaeological deposit near the base of the square

Testing at TA17 revealed homogeneous deep deposits of grey silty clay alluvium with minor soil inclusions. Gravels were mostly small (<2cm diameter) and well rounded. Occasional lenses of redeposited charcoal, orange clay and rounded burnt clay nodules were encountered. Bioturbation was found throughout the deposit. A large animal burrow was encountered in 122E 295N at 20-40cm depth. Earthworm burrows continued into the floor of all squares (>120cm depth). Spit 1 (0-20cm) of some squares contained recent historical material, including glass, blue metal, quartz pebbles, angular fragile quartz pieces and other redeposited material clearly associated with the nearby Hume Highway construction and moved by flooding.

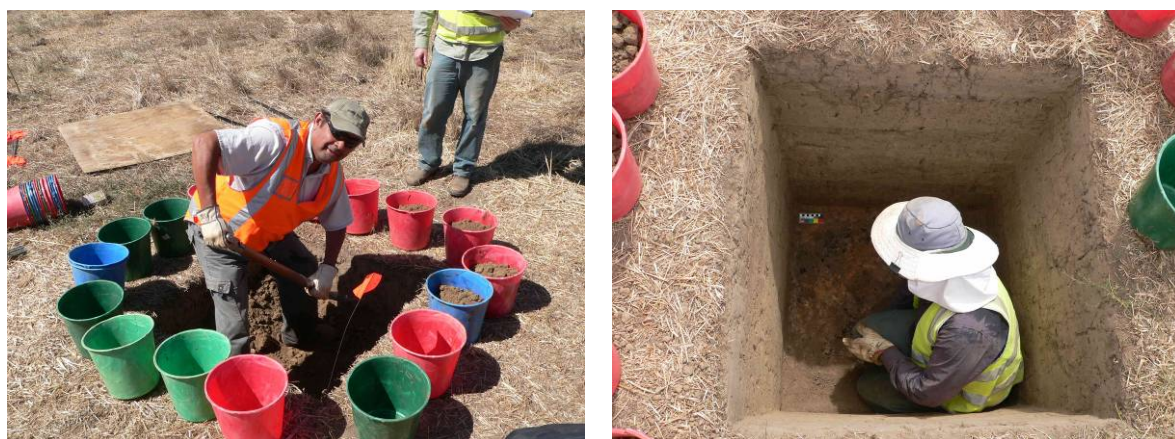
Plate 14. Excavation works at TA17/T21

A total of 18 test squares 1 m² were hand excavated at TA17, over a 45m x 75m area. All pits were dug in 20cm spit intervals, to an average depth of 120cm. Two exploratory pits were dug to 140cm, to test for buried soils that may contain artefacts.

Wet sieving was carried out adjacent to a flood control levee bank at the northern end of the paddock, using nested 2.5mm and 5mm sieves and utilising a water truck. All stone at the sieves was bagged for further examination. This was achievable due to the low proportion of coarse fragments in the deposit. Section drawings were completed for all squares.

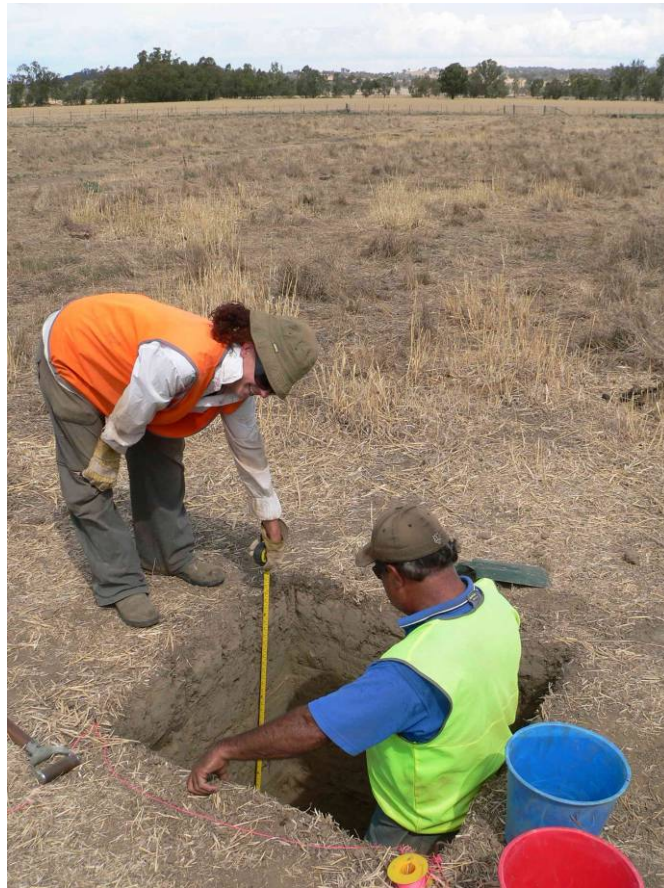
Plate 15. Recording the deep deposit at TA17/T21
