Building 19
Royal North Shore Hospital

Heritage Impact Statement

July 2009

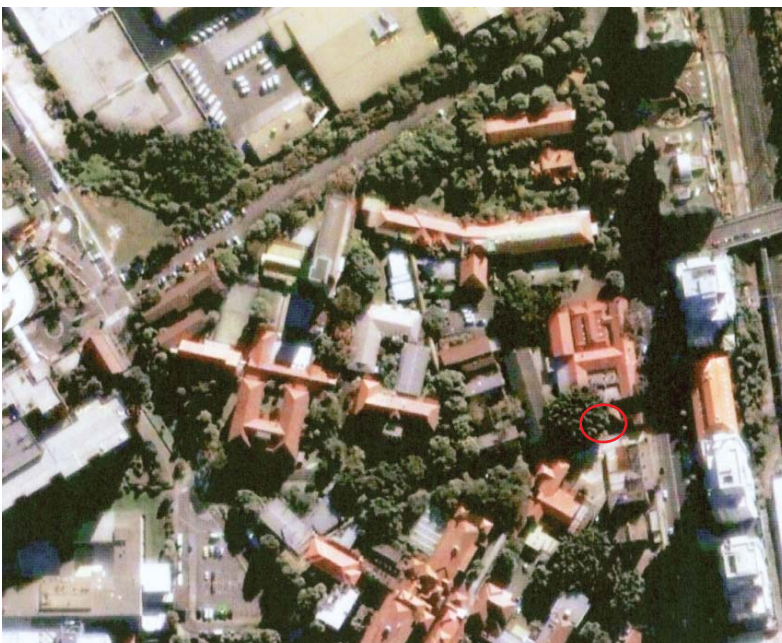
Figure 1-2

Aerial photograph, taken prior to the demolition of the Laundry, showing the location of Building 19 on the Royal North Shore Hospital site

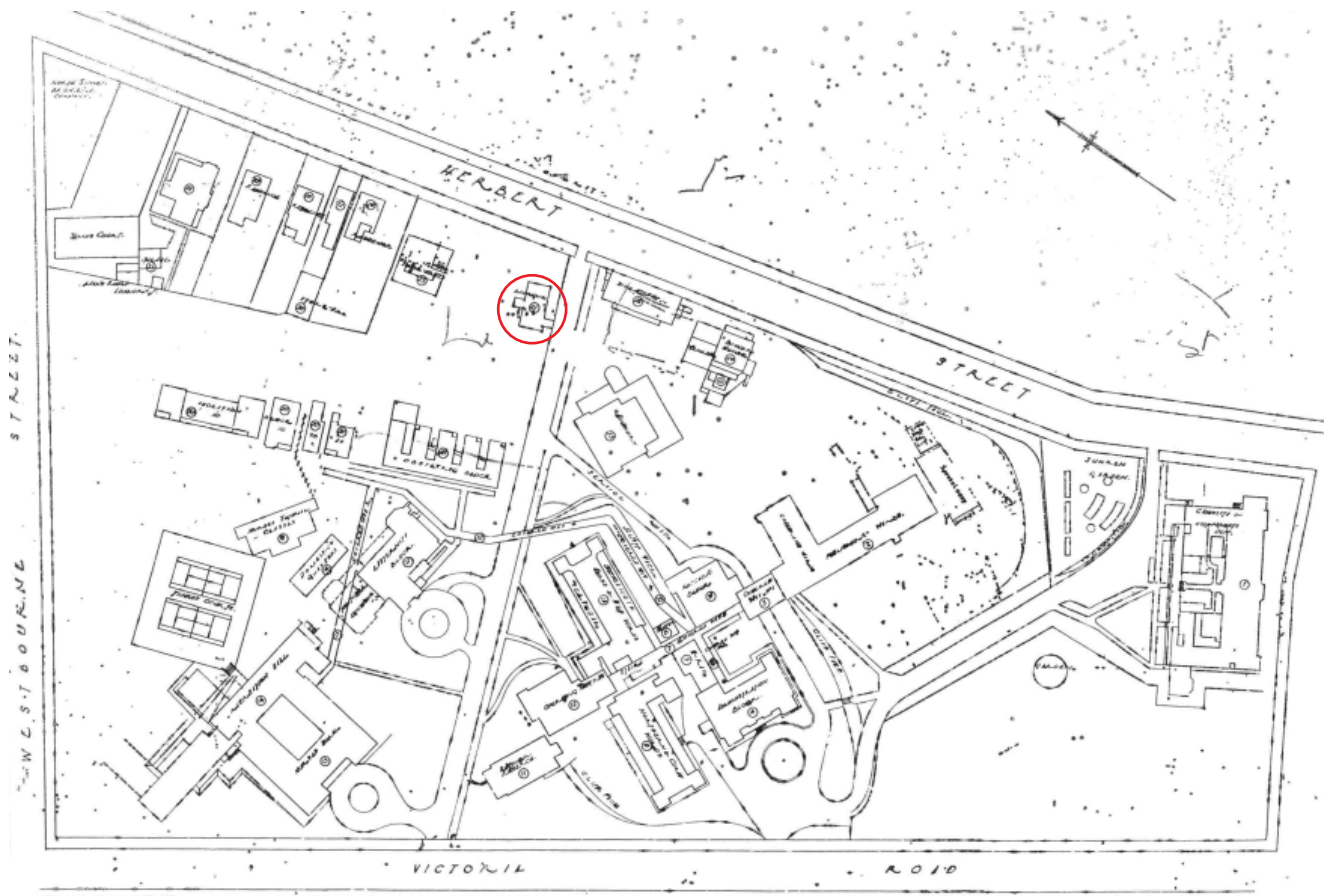
Figure 2-4
1943 site plan showing the location of the Morgue

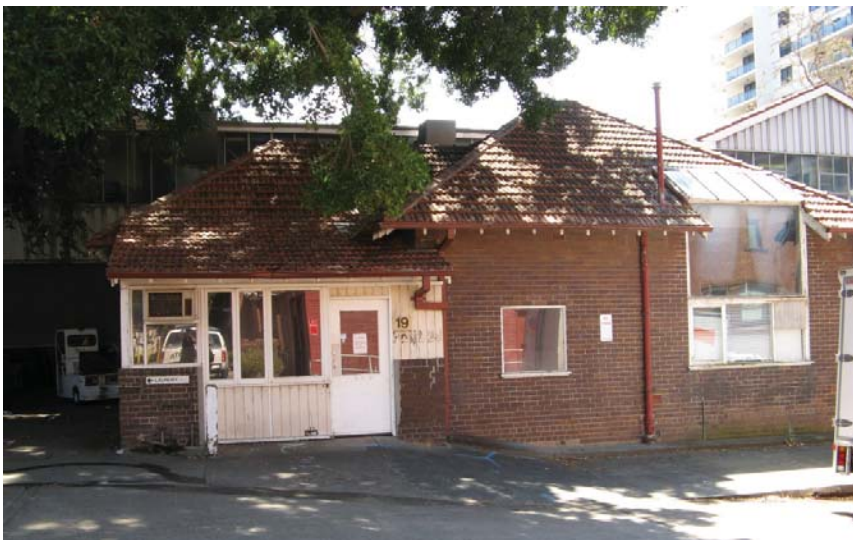
Figure 3-1

View of the south elevation of the former Mortuary, showing the closed in verandah and the enlarged skylight in the former post mortem room

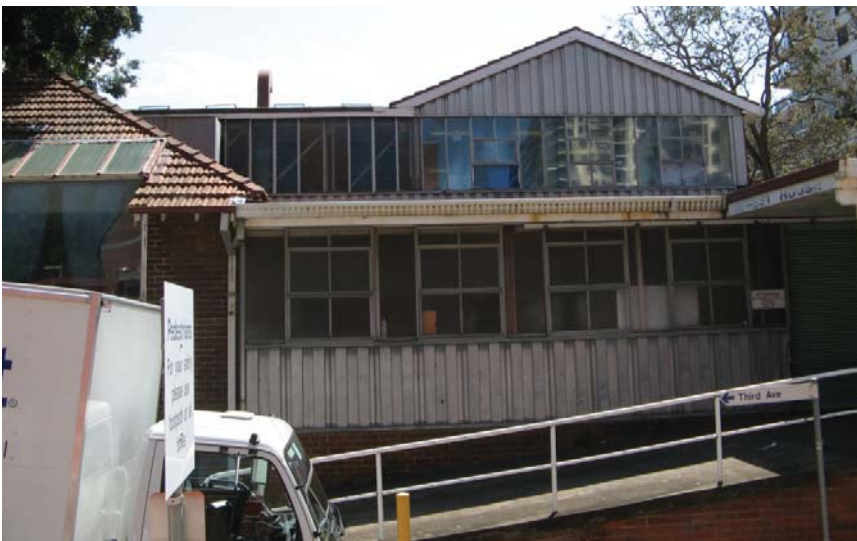
Figure 3-3
South elevation of the eastern addition to the former Mortuary with the top floor of the Laundry (since demolished) visible at the rear

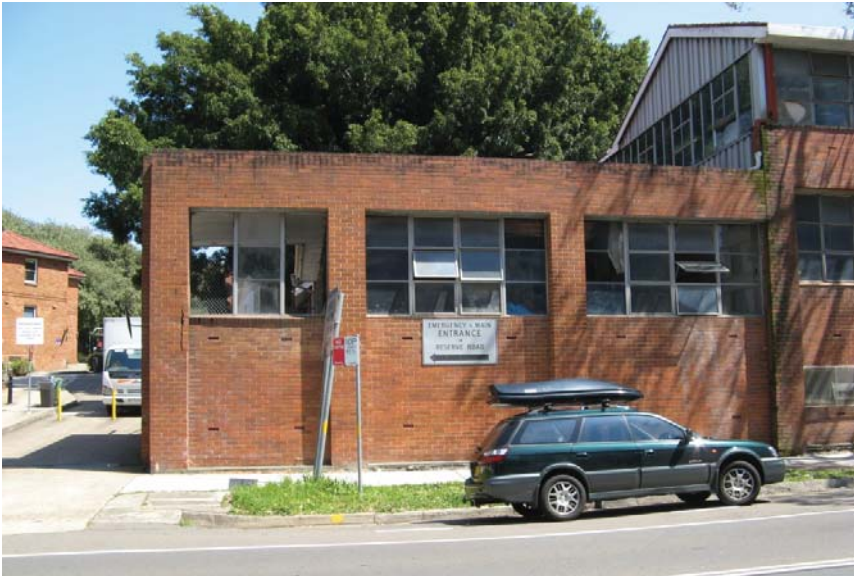
Figure 3-4
Herbert Street elevation of the eastern addition to the former Mortuary and the adjoining Laundry, prior to its demolition

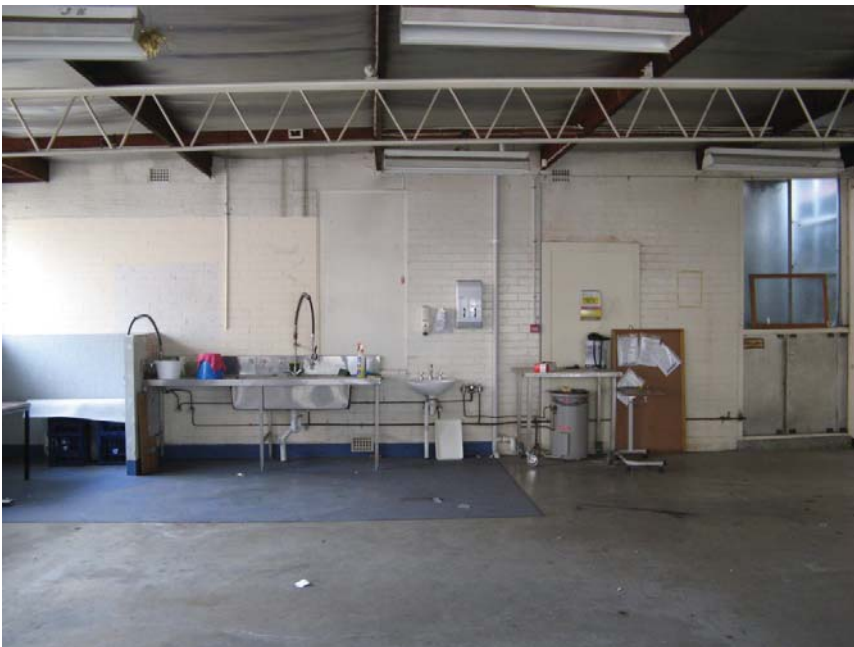
Figure 3-5
Shows the western wall of the extension to the former Mortuary which was the original exterior eastern wall of the Mortuary

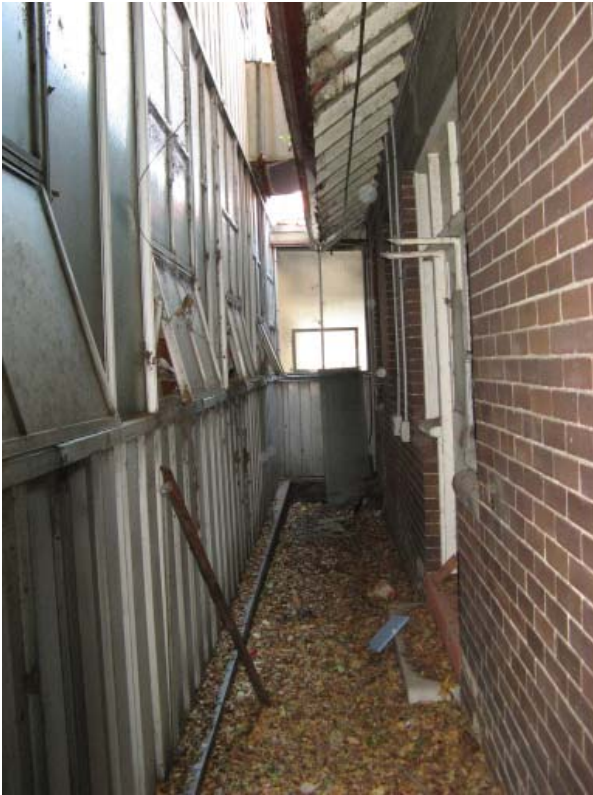
Figure 3-6
North elevation of the former Mortuary (on the right) and the south elevation of the Laundry before its demolition (on the left)

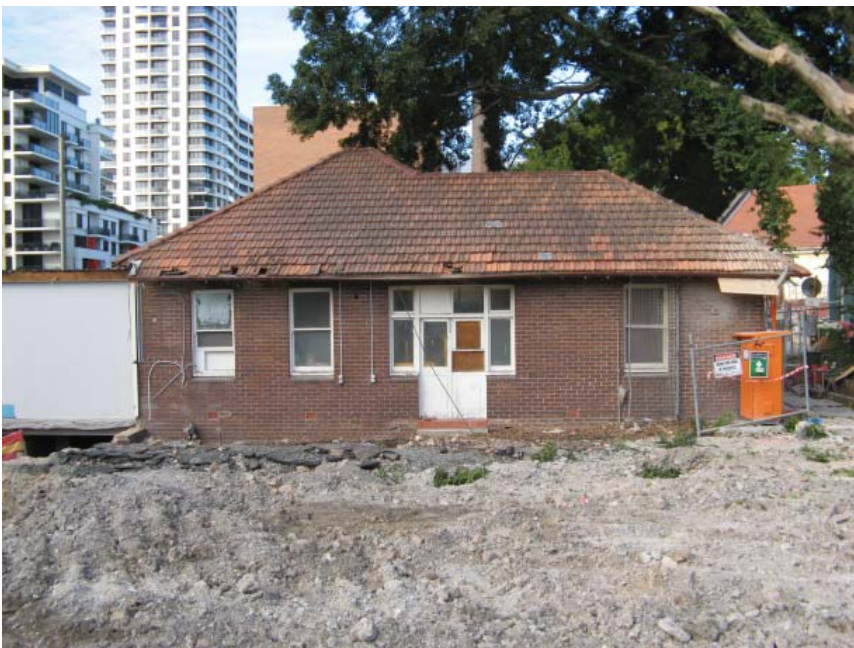
Figure 3-7
North elevation of the former Mortuary

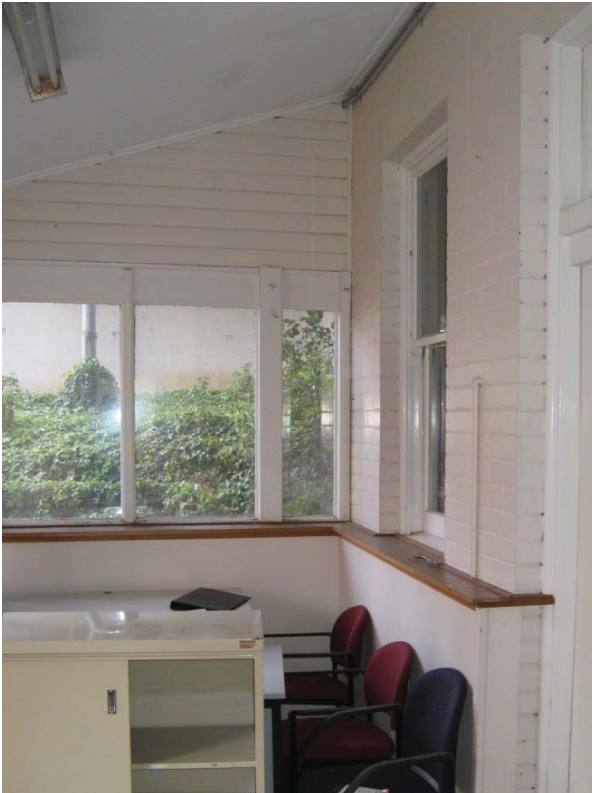
Figure 3-8
Office fitout of the enclosed space of the former Mortuary verandah

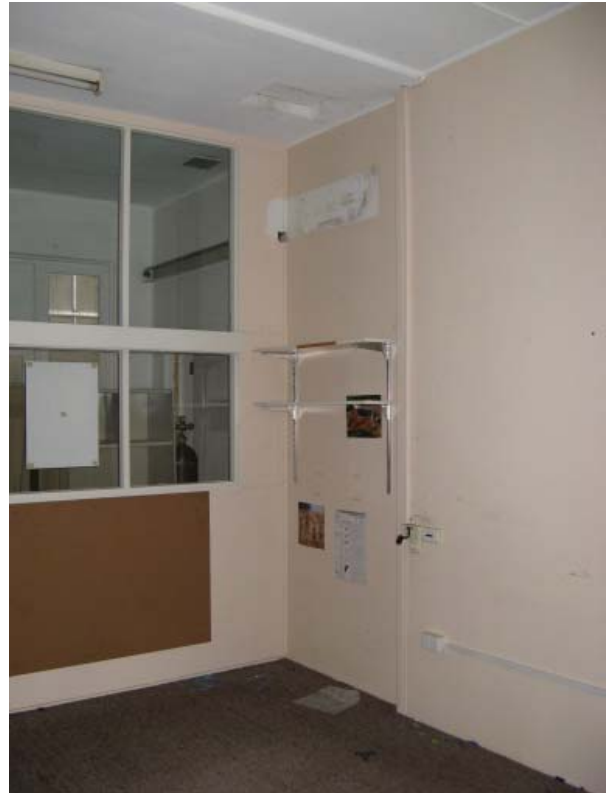
Figure 3-9
The former mortuary chamber has been renovated for office use

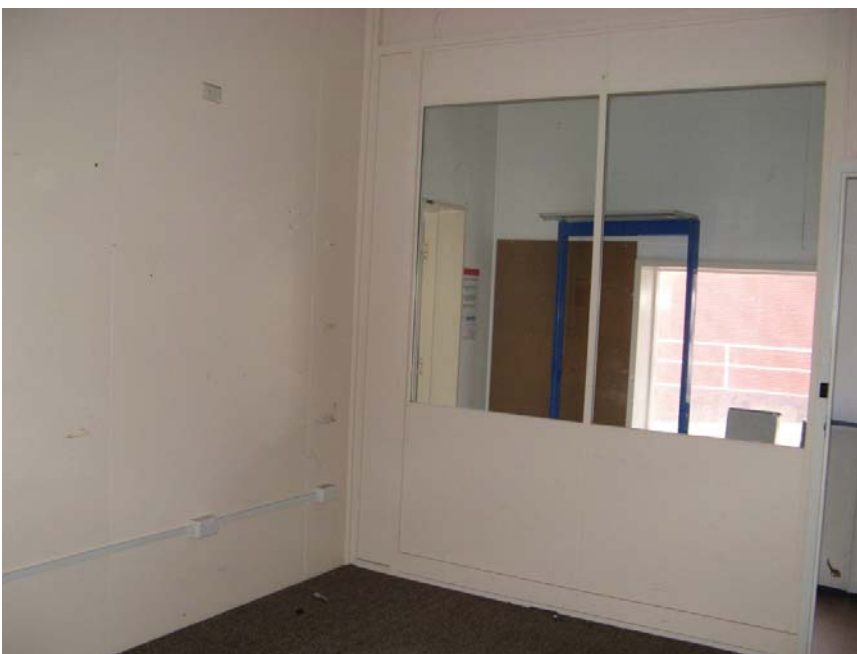
Figure 3-10
View from the former mortuary chamber through to the former Cool Room space of the Mortuary, adapted for office accommodation

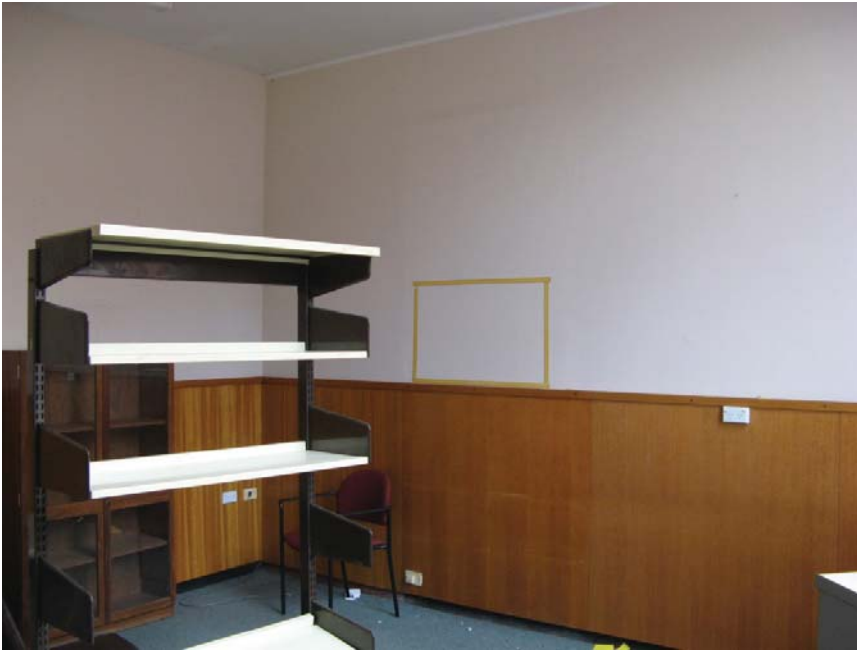
Figure 3-11
Office fitout of the former post mortem room

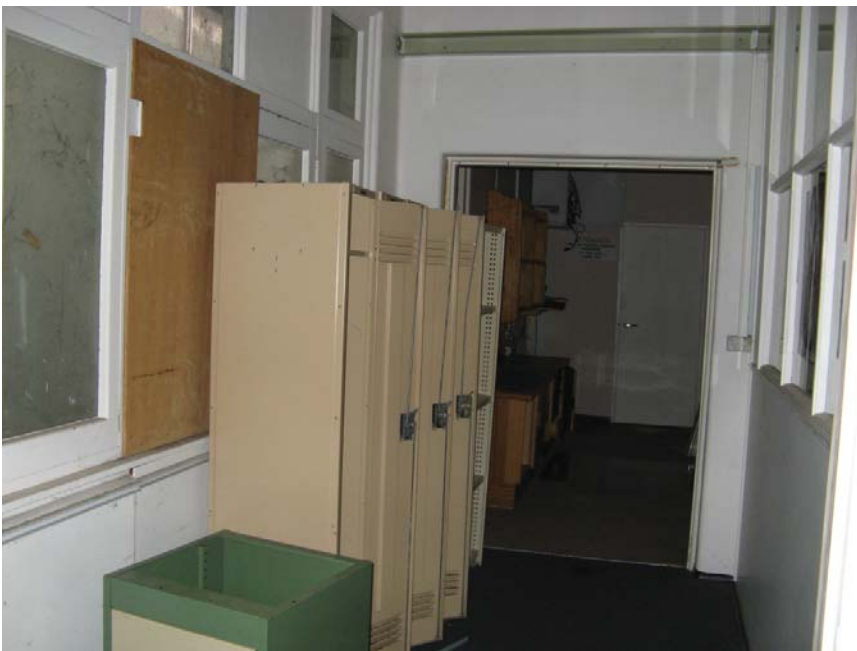
Figure 3-12
Shows the modifications to the northern side of the building which include the insertion of a partition wall (on the right) and the blocking in of the northern entrance doors (on the left)
