Dewatering Management Plan

Lot 7 DP 875447
Tweed Coast Road
Kings Forest

LEDA Group Project 28 Pty Ltd

HMC 2015.046

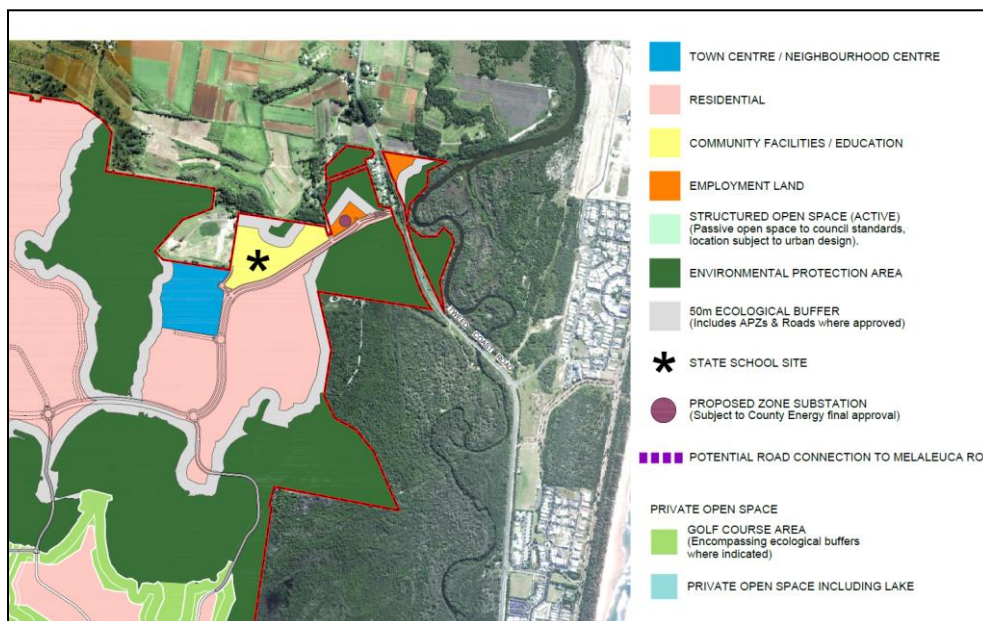
Figure 2 Kings Forest Precinct Plan (Source: Planit)

That part of the allotment which is to house the Service Station is identified in **Figure 2 – Kings Forest Precinct Plan**.

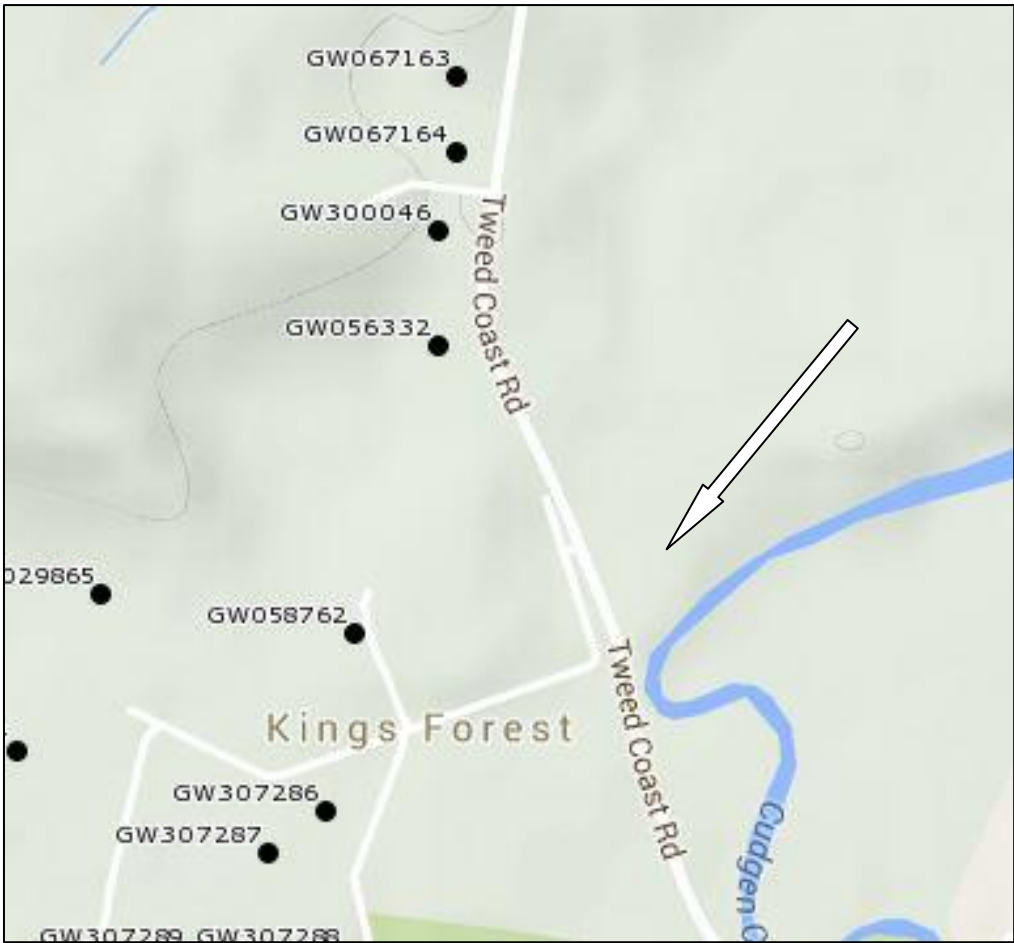
Figure 6 - Groundwater (Source: <http://allwaterdata.water.nsw.gov.au/water.stm>)

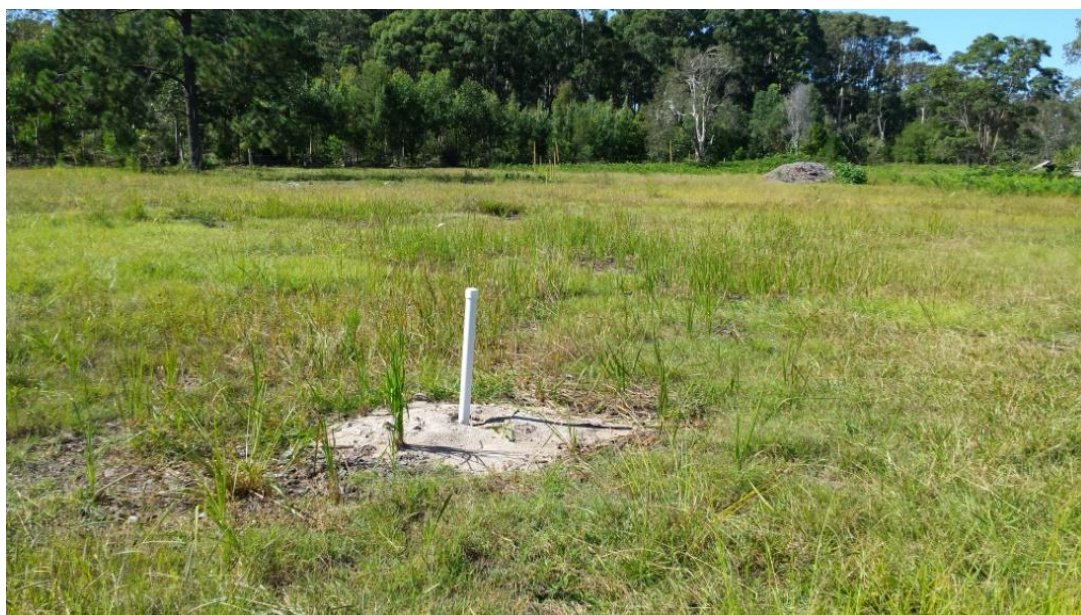
Photo 1 – View NE across excavation site

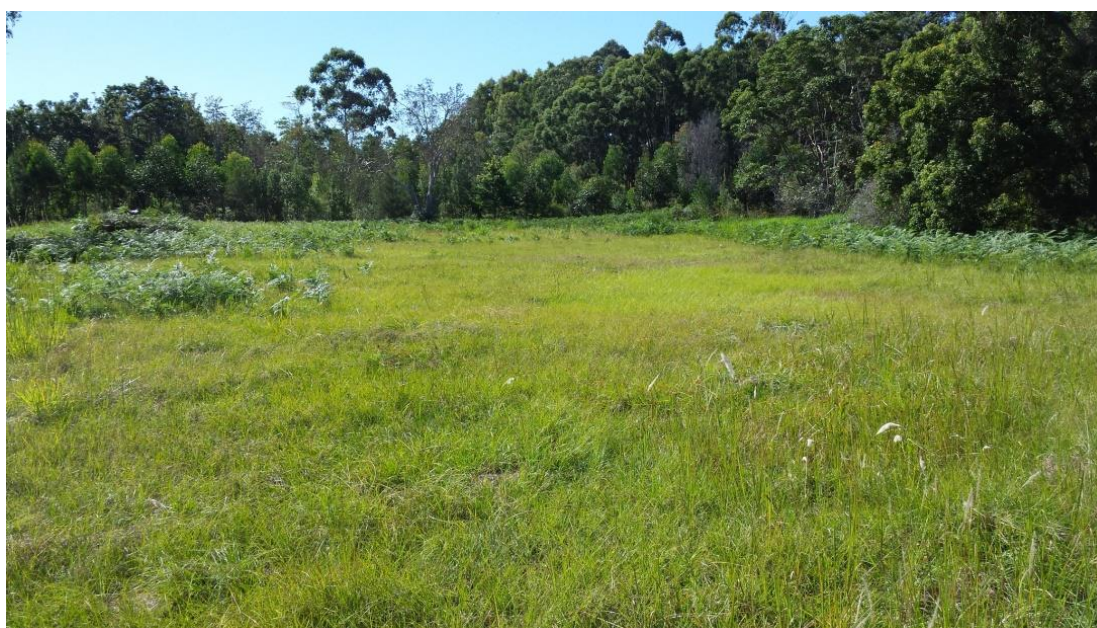
Photo 2 – Potential irrigation site
