**Goodman International Ltd**  
Huntingwood West - Bungaribee Estate  
Huntingwood  
Report on Geotechnical Assessment

October 2009

**Huntingwood West - Bungaribee Estate Huntingwood  
Report on Geotechnical Assessment**

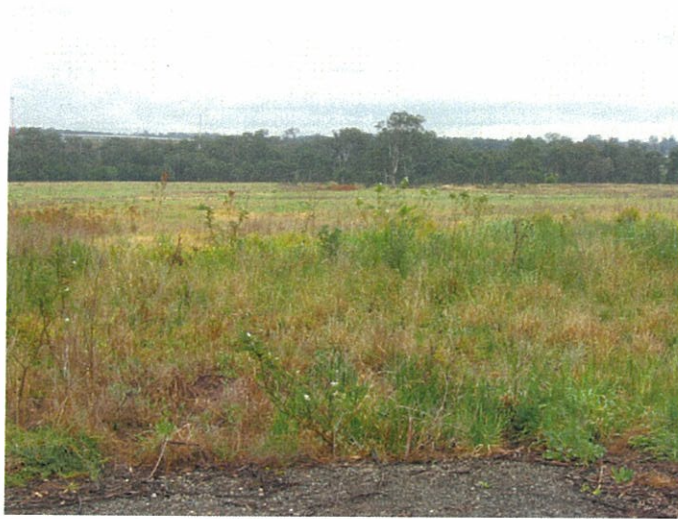
**Plate 1 – View from upland section of site to the flatter section in the west**

Topographically, the site comprises a gently undulating 'upland' region for the most part, with a narrow region along the western boundary, which is relatively flat where it joins the 'floodplain' of Eastern Creek.

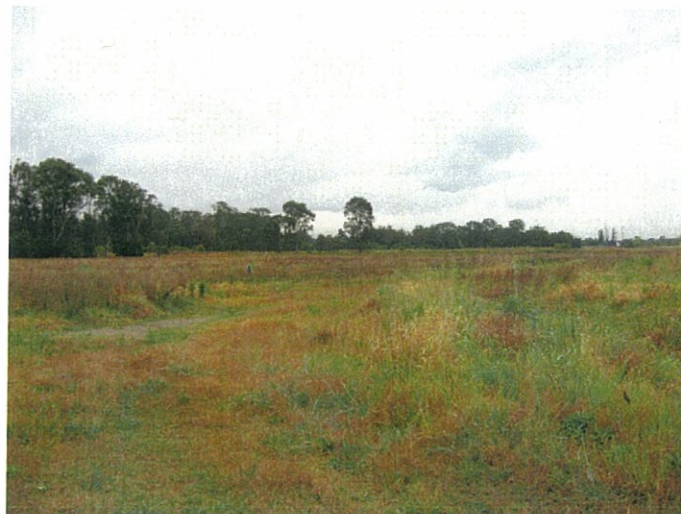
**Plate 2 – View of flatter, 'floodplain' area in western part of site**

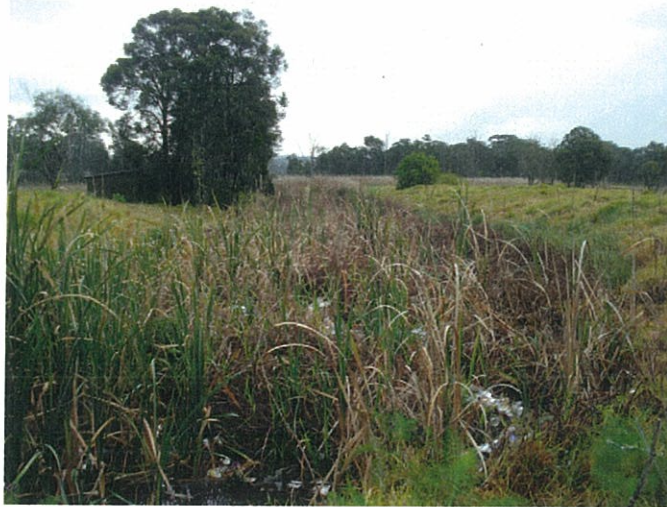
**Plate 3 – View of reed-filled drainage channel on eastern boundary**

The site generally slopes and drains toward the west. Drainage lines were observed in the areas of the 'gullies' indicated by topographic information. The northeastern part of the site contains a drainage channel, which begins as a stormwater culvert from Brabham Drive and drains to the west. We understand that this drainage line then turns toward the north, which is supported by topographical survey information.

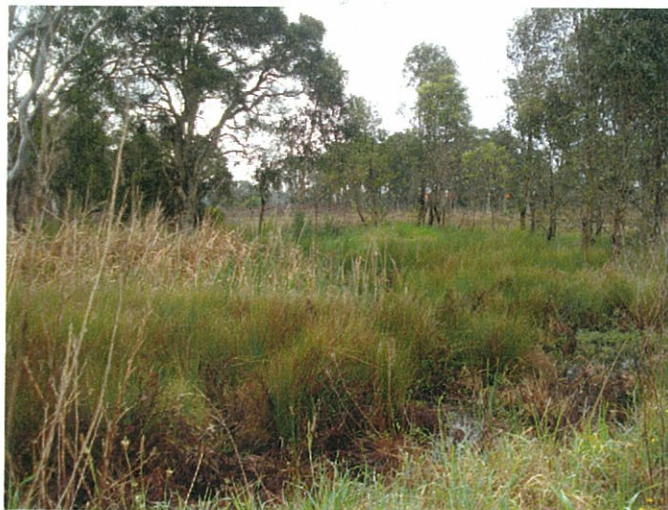
**Plate 4 – View of marshy area in north east of site**

The northeastern part of the site was observed to be marshy and contains standing water in places. Vehicular access to these areas, even with a backhoe, was not possible.

The northeastern part of the site, in the vicinity of proposed test pits TP30 and TP31, was unable to be accessed due to boggy ground conditions at the time of investigation. There are also a number of farm dams/channels in the centre of the site that contain water, vegetation and (potentially) saturated soft soils. Organic and soft soils are unsuitable as foundation materials and should be removed from fill areas. Organic materials are also unsuitable for reuse as general fill. Saturated, soft soils may be suitable for reuse as fill, subject to being allowed to dry out.

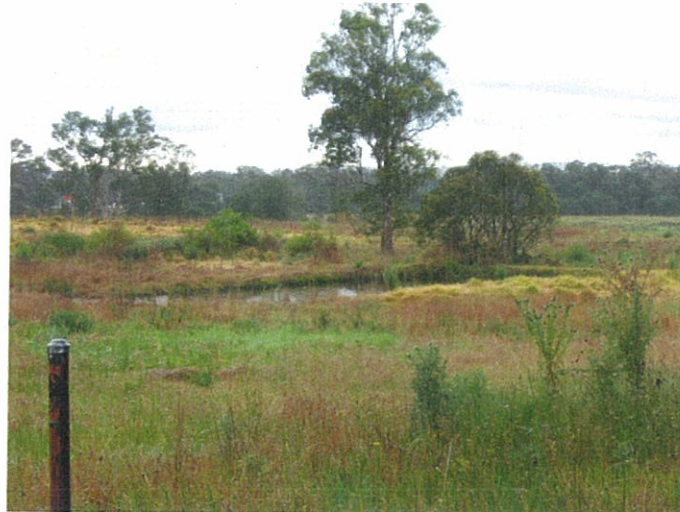
**Plate 5 – View of farm dam in centre of site**

Some paddocks showed minor excavations (furrow and/or drainage lines) and there were several small dams, used for livestock watering, located towards the centre of the site.

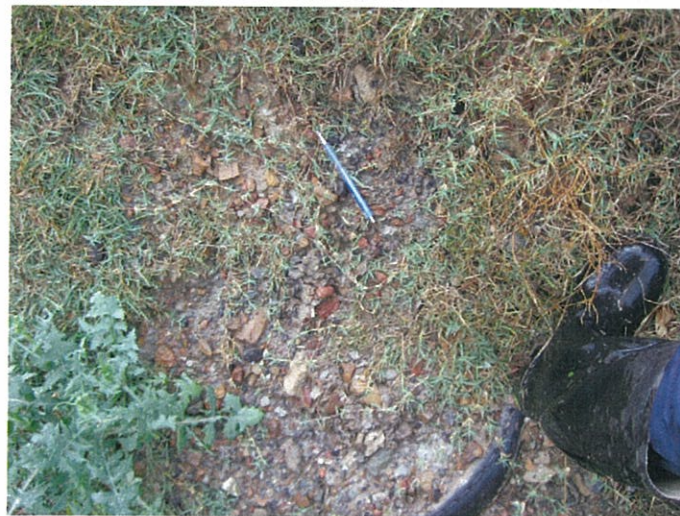
**Plate 6 – Example of fill material**

Fill and dumped material were found to exist in several localised areas throughout the site. Some of these materials were visually observed to comprise clay, gravels, and demolition rubble. There were also some tyres present. It should be noted that, during the period of the fieldworks, illegal dumping was observed being undertaken.

The uncontrolled fill materials and uncontrolled fill stockpiles present on site generally comprise clay, gravels, sands, demolition rubble and foreign objects (ie. tyres). Fill materials are unsuitable as foundation materials and should be removed from fill areas. The uncontrolled fill materials may be suitable for reuse as fill, subject to separate stockpiling, removal of foreign objects, remediation (if required) and assessment for suitability.

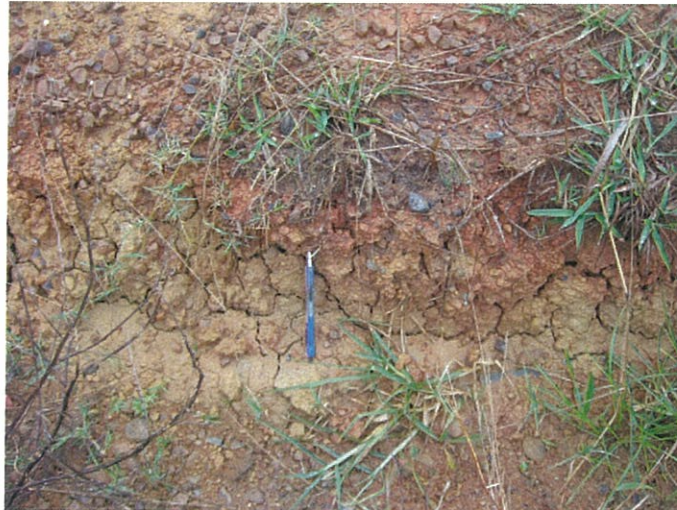
**Plate 7 – Cutting exposure of clay soils indicating shrinkage cracking**

Clay soils were observed to be exposed in a small cutting on the site and showed evidence of shrinkage cracking (refer to Plate 7).

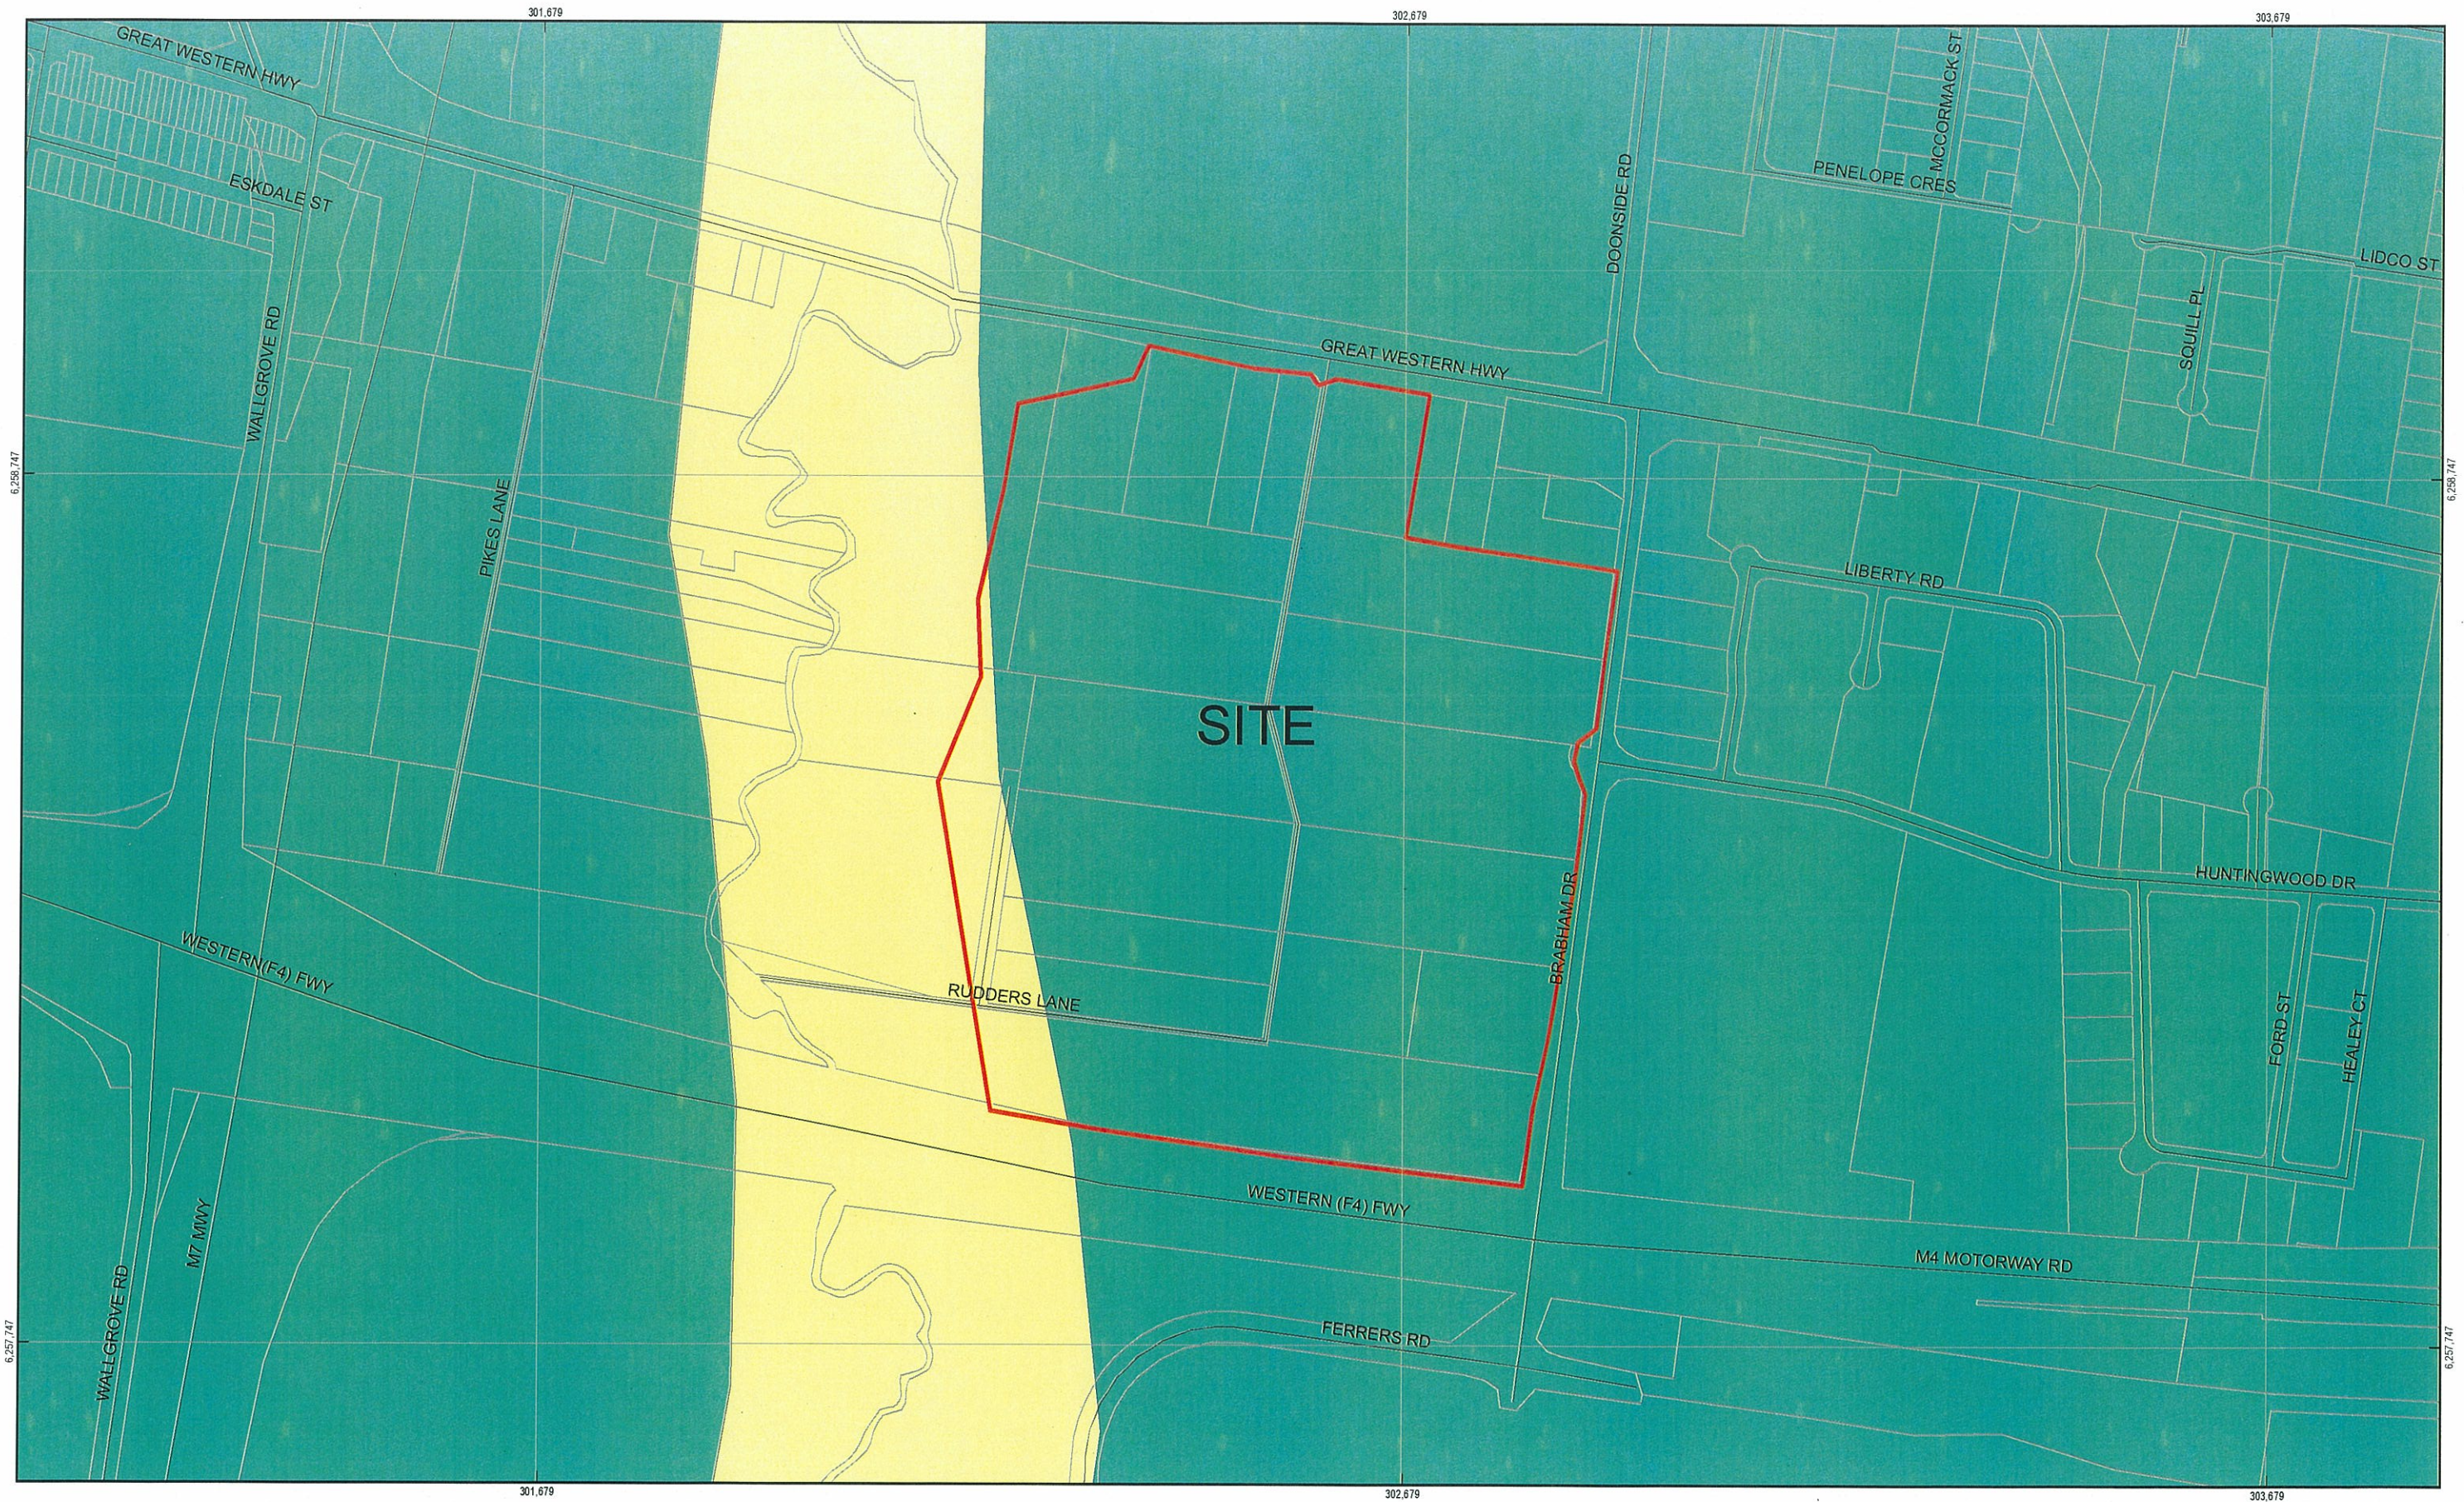
Figure 2

## Geology Map

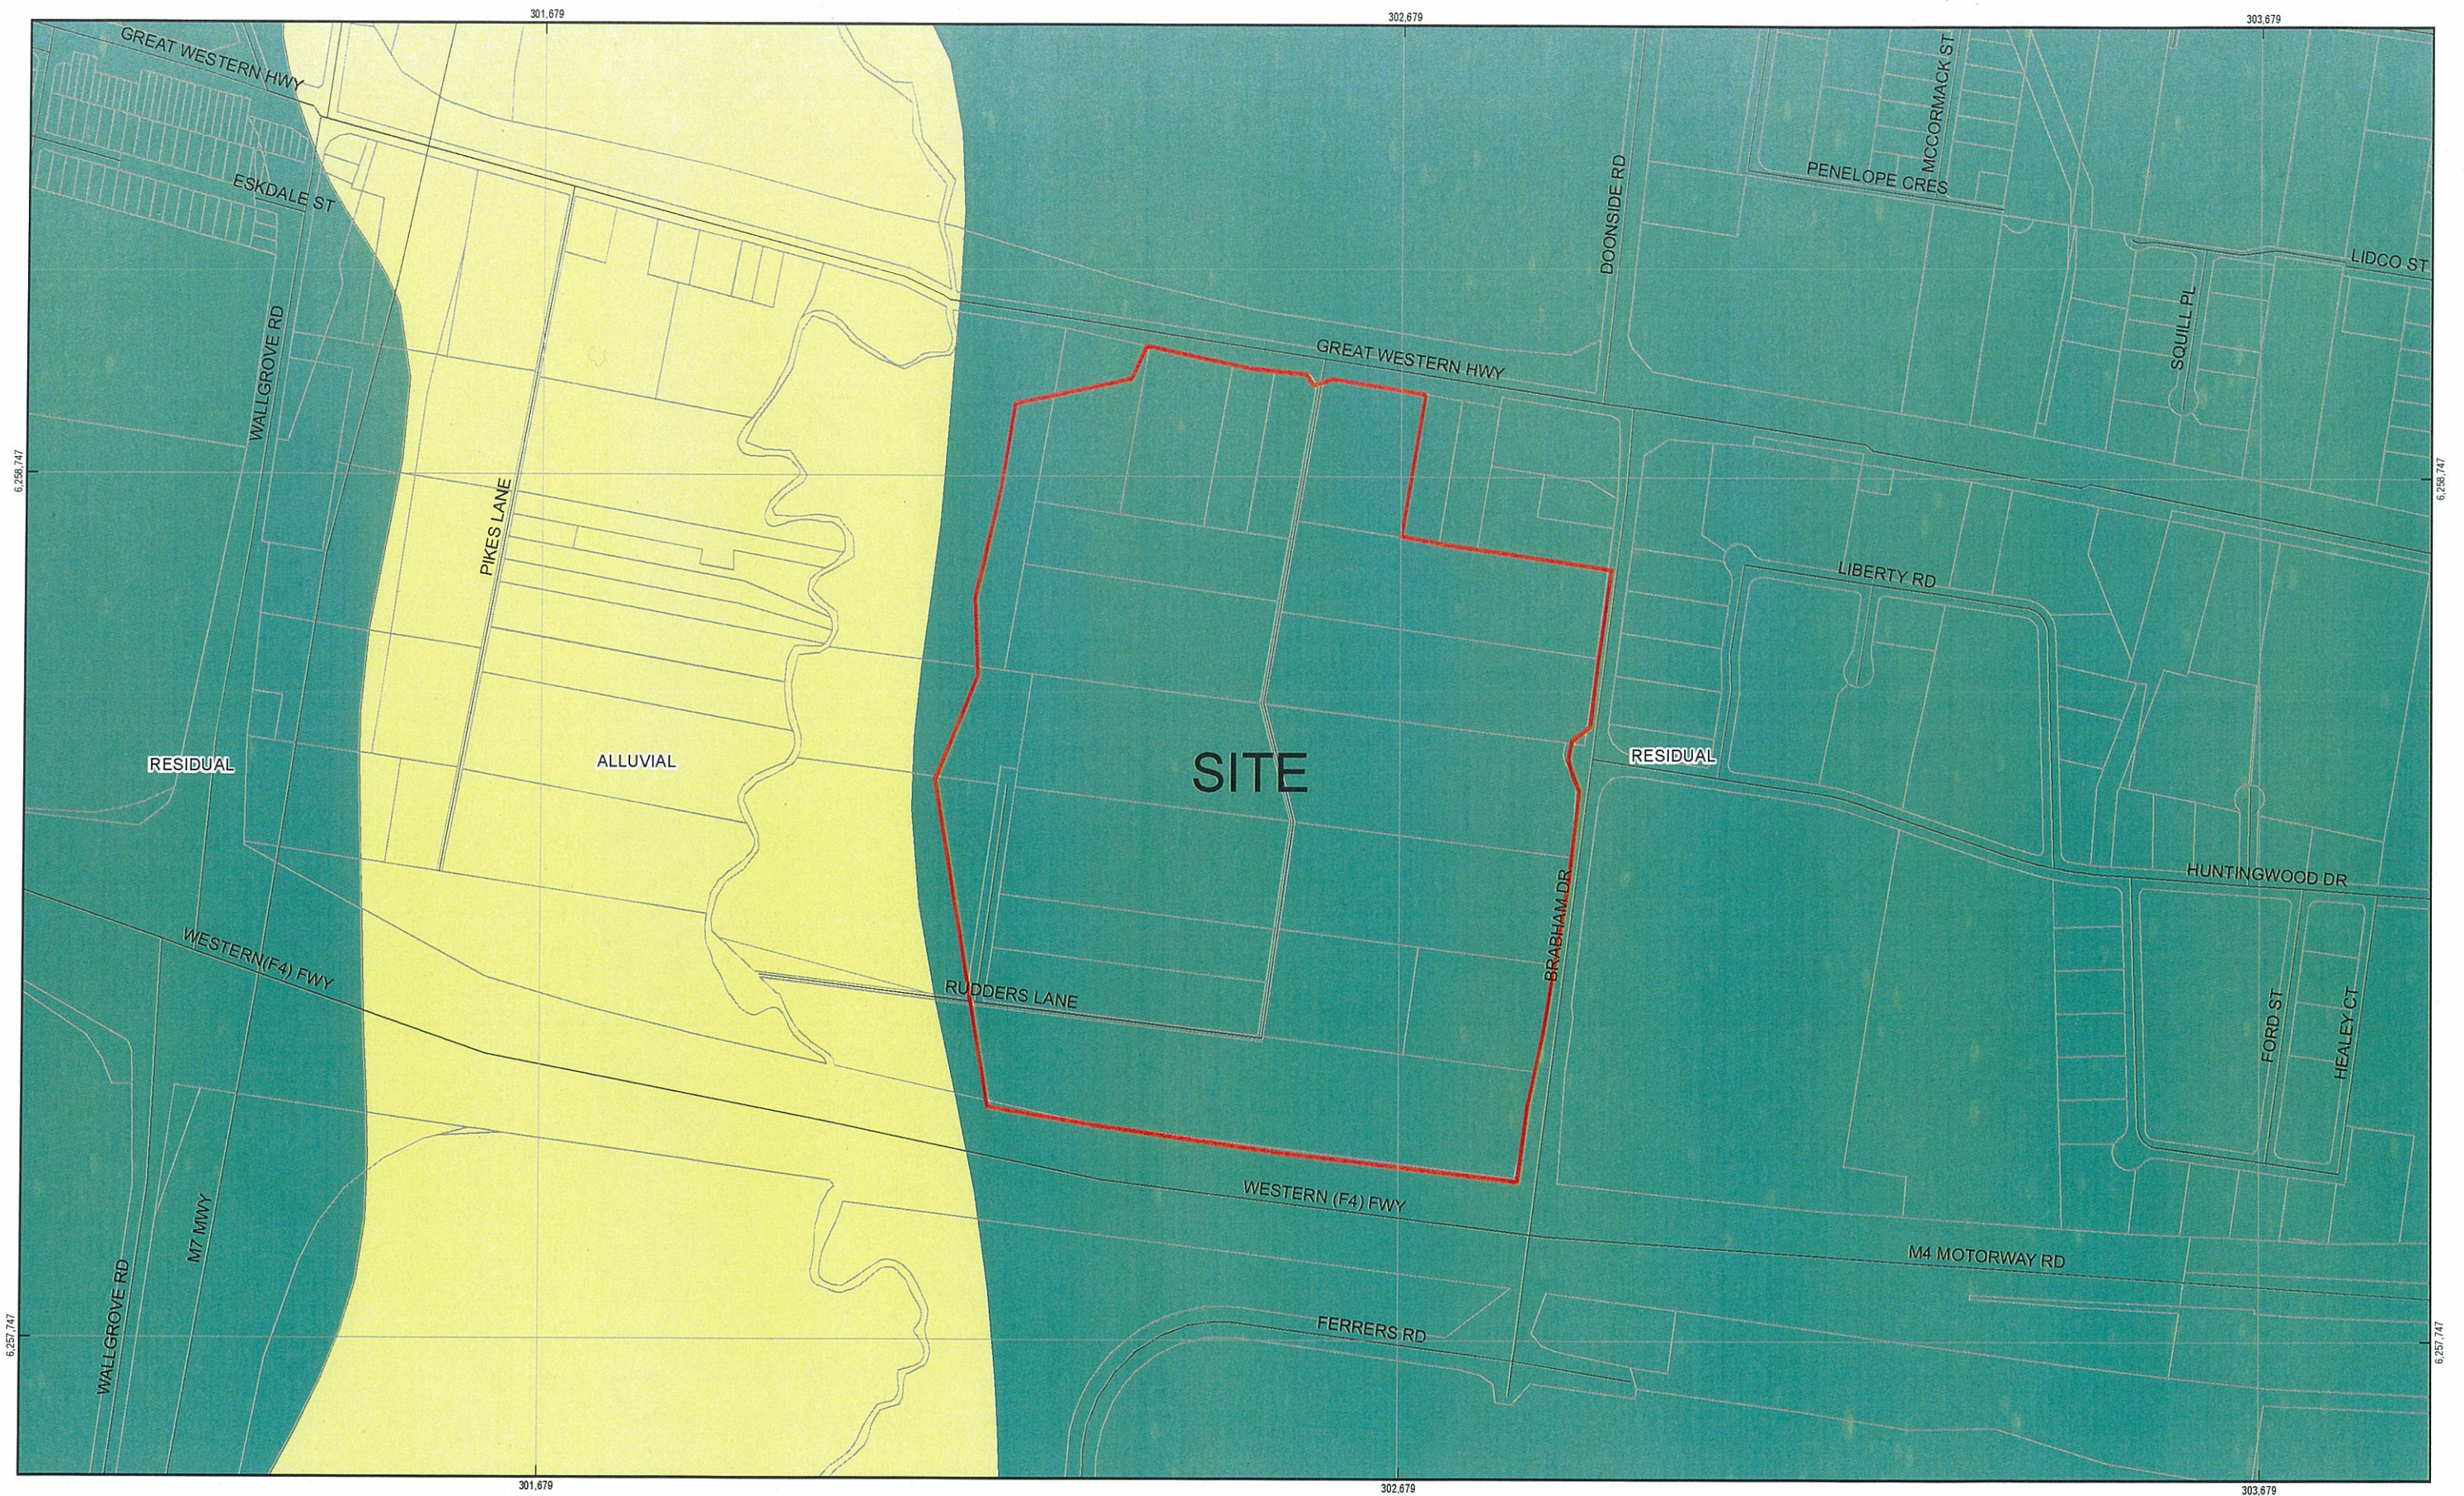
shale, carbonaceous claystone, claystone, laminate, fine to medium grained lithic sandstone, rare coal and tuff. The western boundary of the site is underlain by quaternary alluvium comprising fine-grained sands, silts and clays (refer to Figure 2).
