Goodman International Pty Ltd
Bungaribee Industrial Estate - Huntingwood
Salinity Assessment & Management Plan

February 2009

Bungaribee Industrial Estate - Huntingwood Salinity Assessment & Management Plan

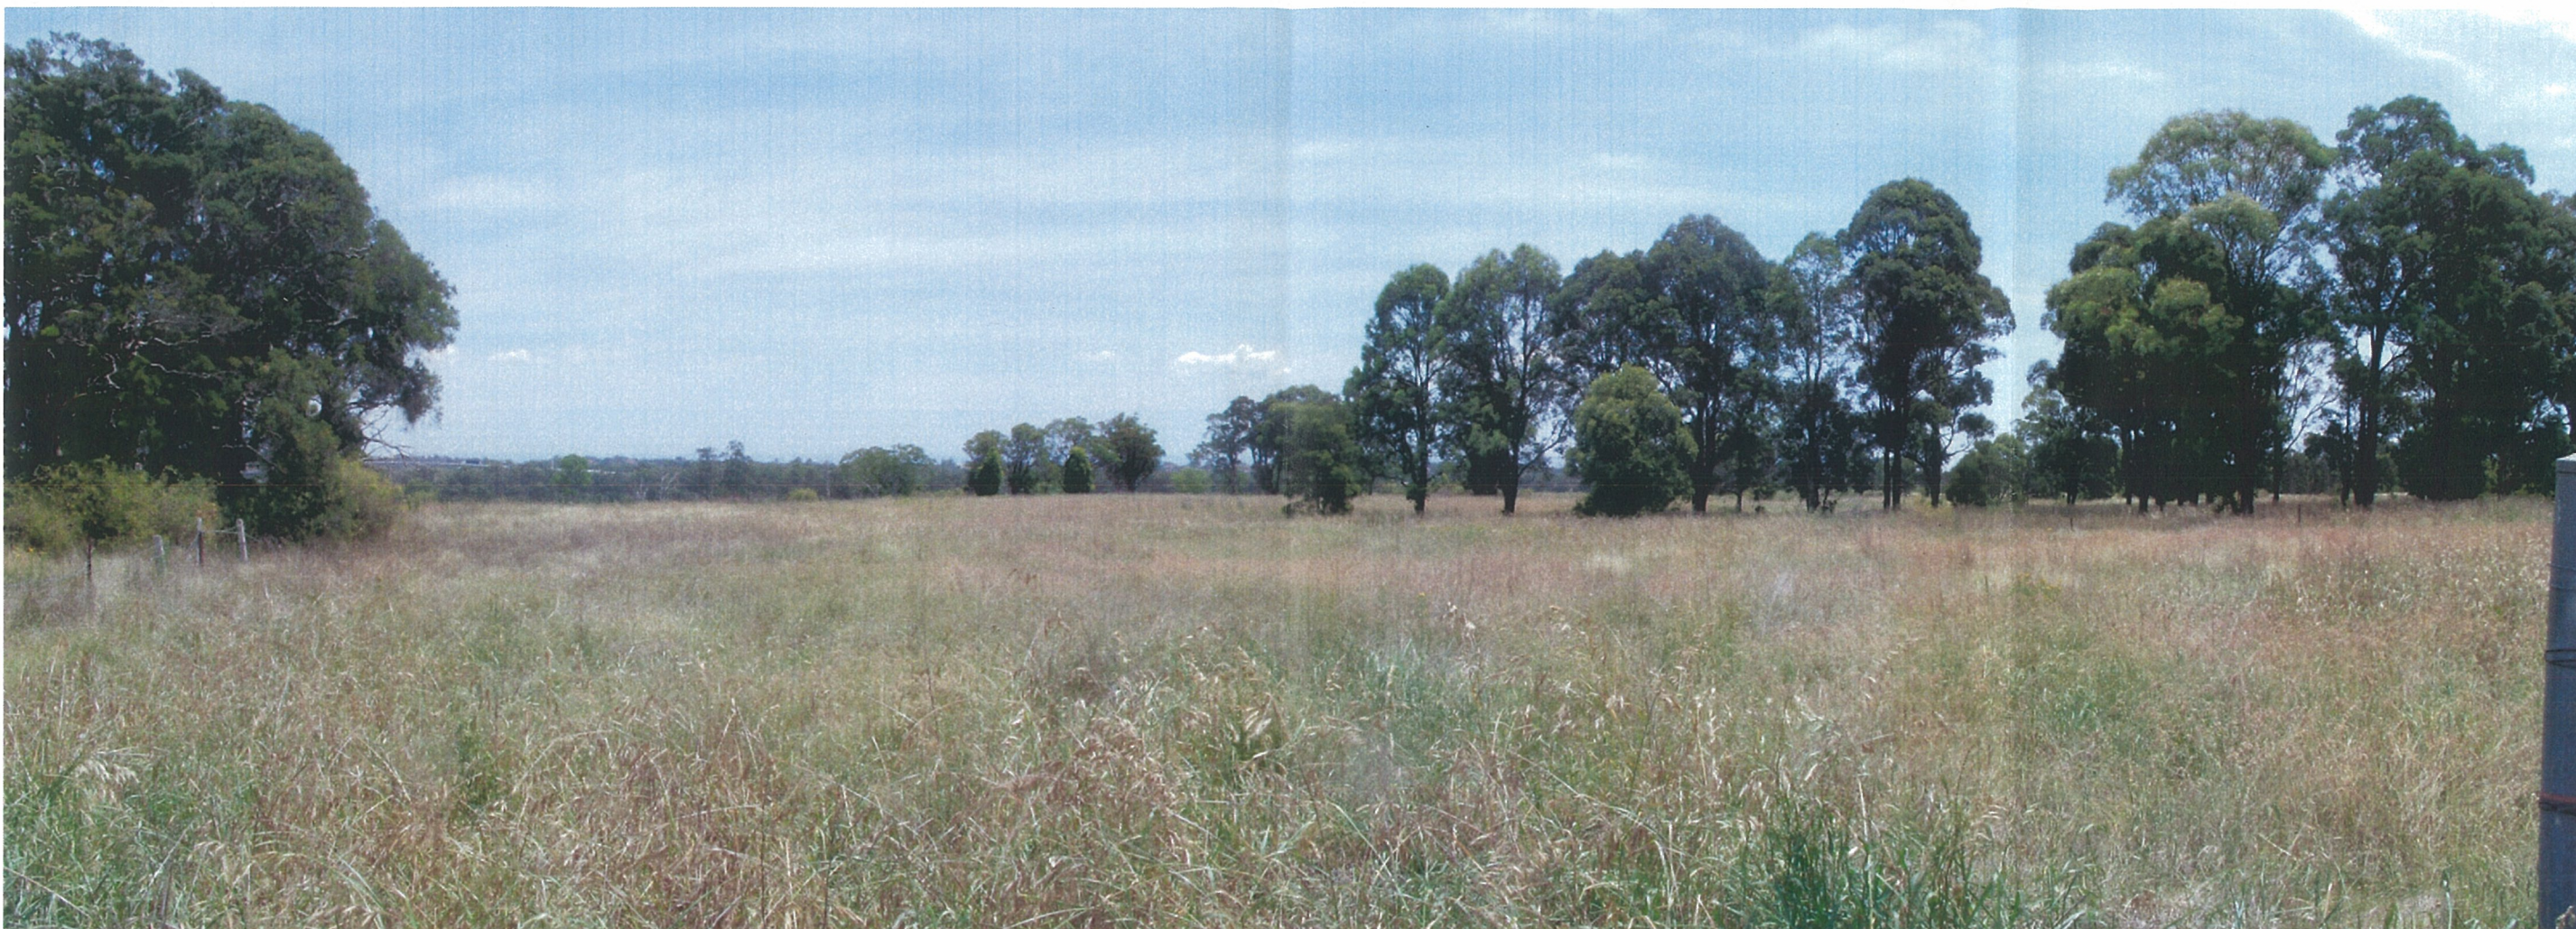
Pano 1 View West from the SE Corner of the site. Gum trees, Paperbark and grasses

- ▶ Saline indicator plants, including Swamp Sheoak (*Casuarina Glauca*) and Couch grass, were observed within the lower landscape and near Eastern Creek. Moreover, waterlogging and saline tolerant paper bark trees were observed across most of the upper landscape. Reed overgrown swamps were also observed in the north-east, waterlogged upper landscape zone. Refer to photographs Pano 1 – Pano 2 and P1 – P5.

- ▶ Saline scalding was observed in the lower landscape of the site, on an abandoned track leading to a former trotting track. Refer to photograph P2.
- ▶ Dead trees, possibly resulting from saline die-back, were observed in the lower south-west and in the waterlogged north-east of the site. Refer to Pano 1 and P3.

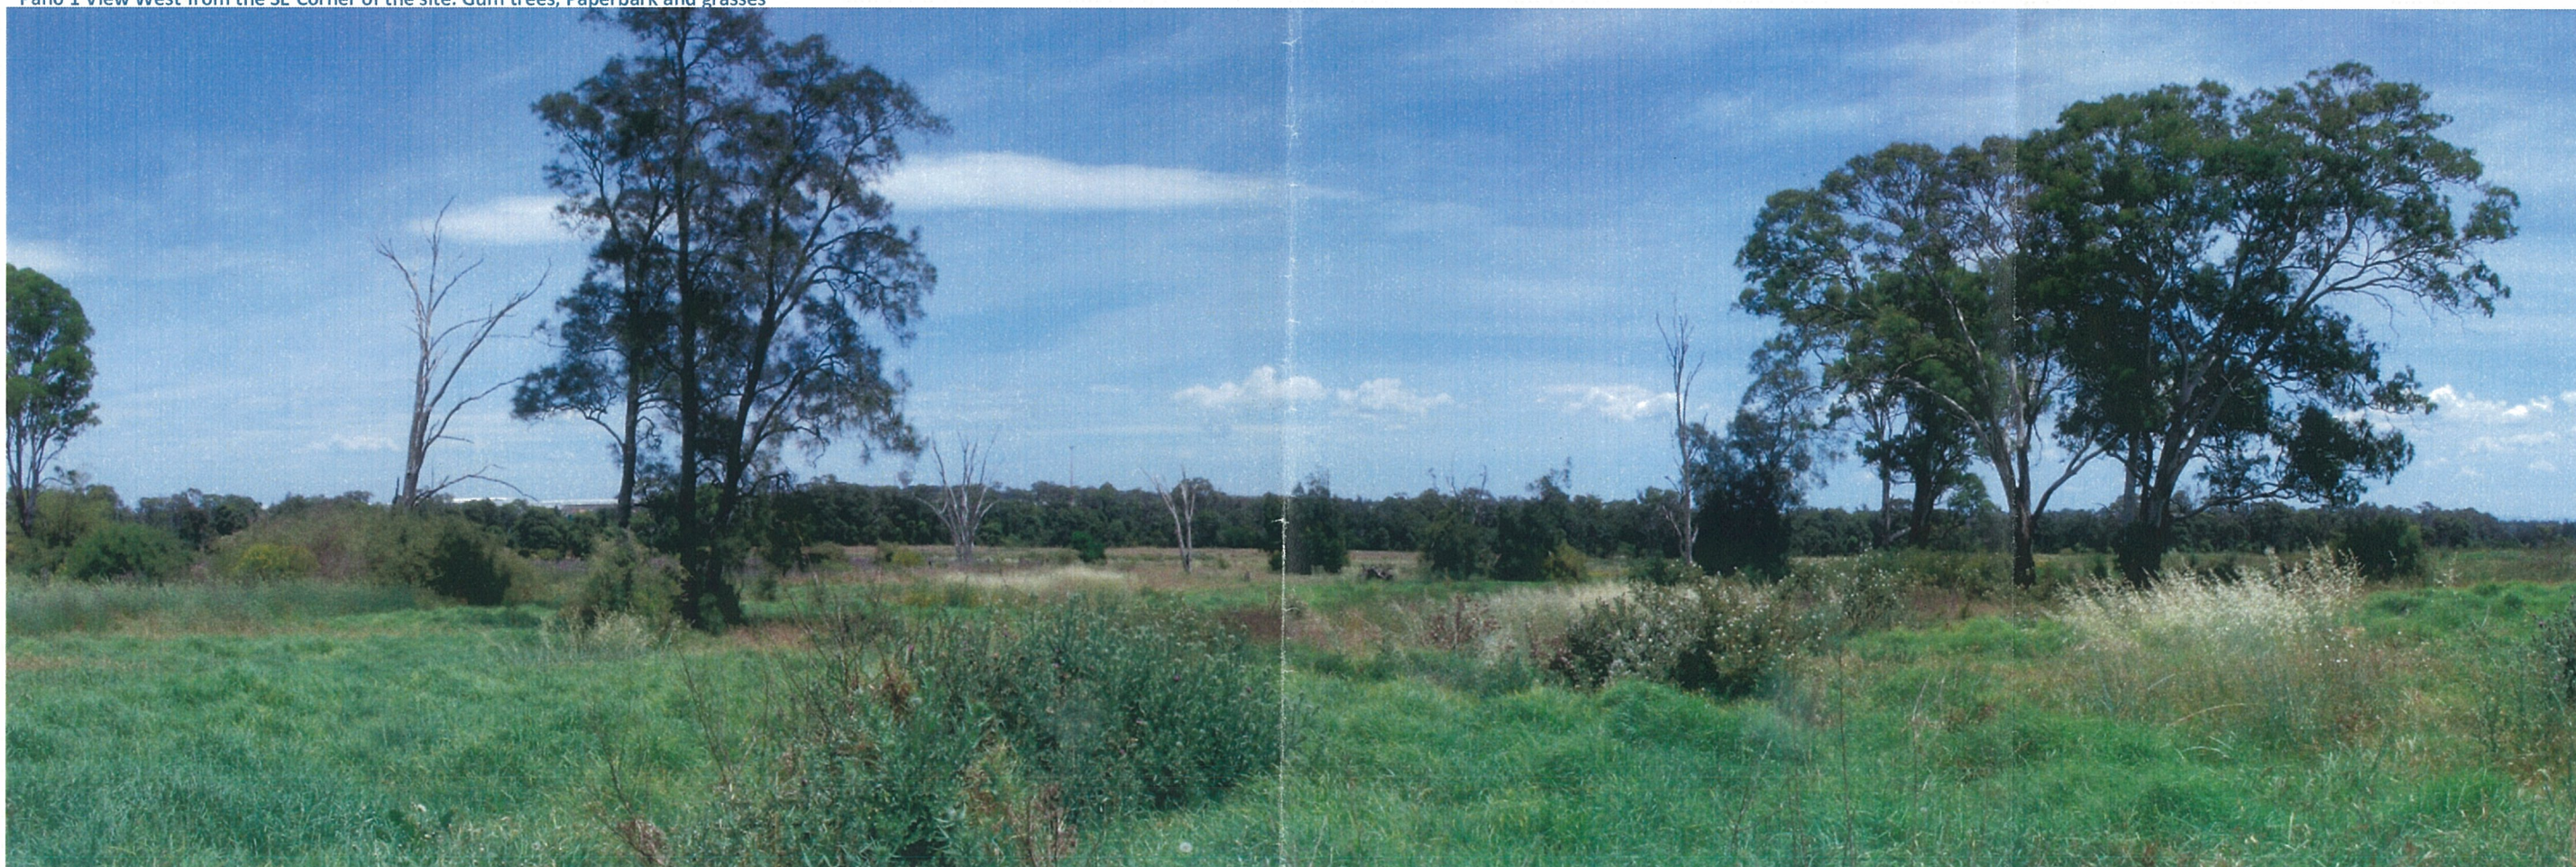
Pano 2 View West in a lower 'gully' on the South-West of the site. Casuarina Glauca on LHS and along Eastern Creek in the background (saline indicator species). Dead trees (saline die-back?).

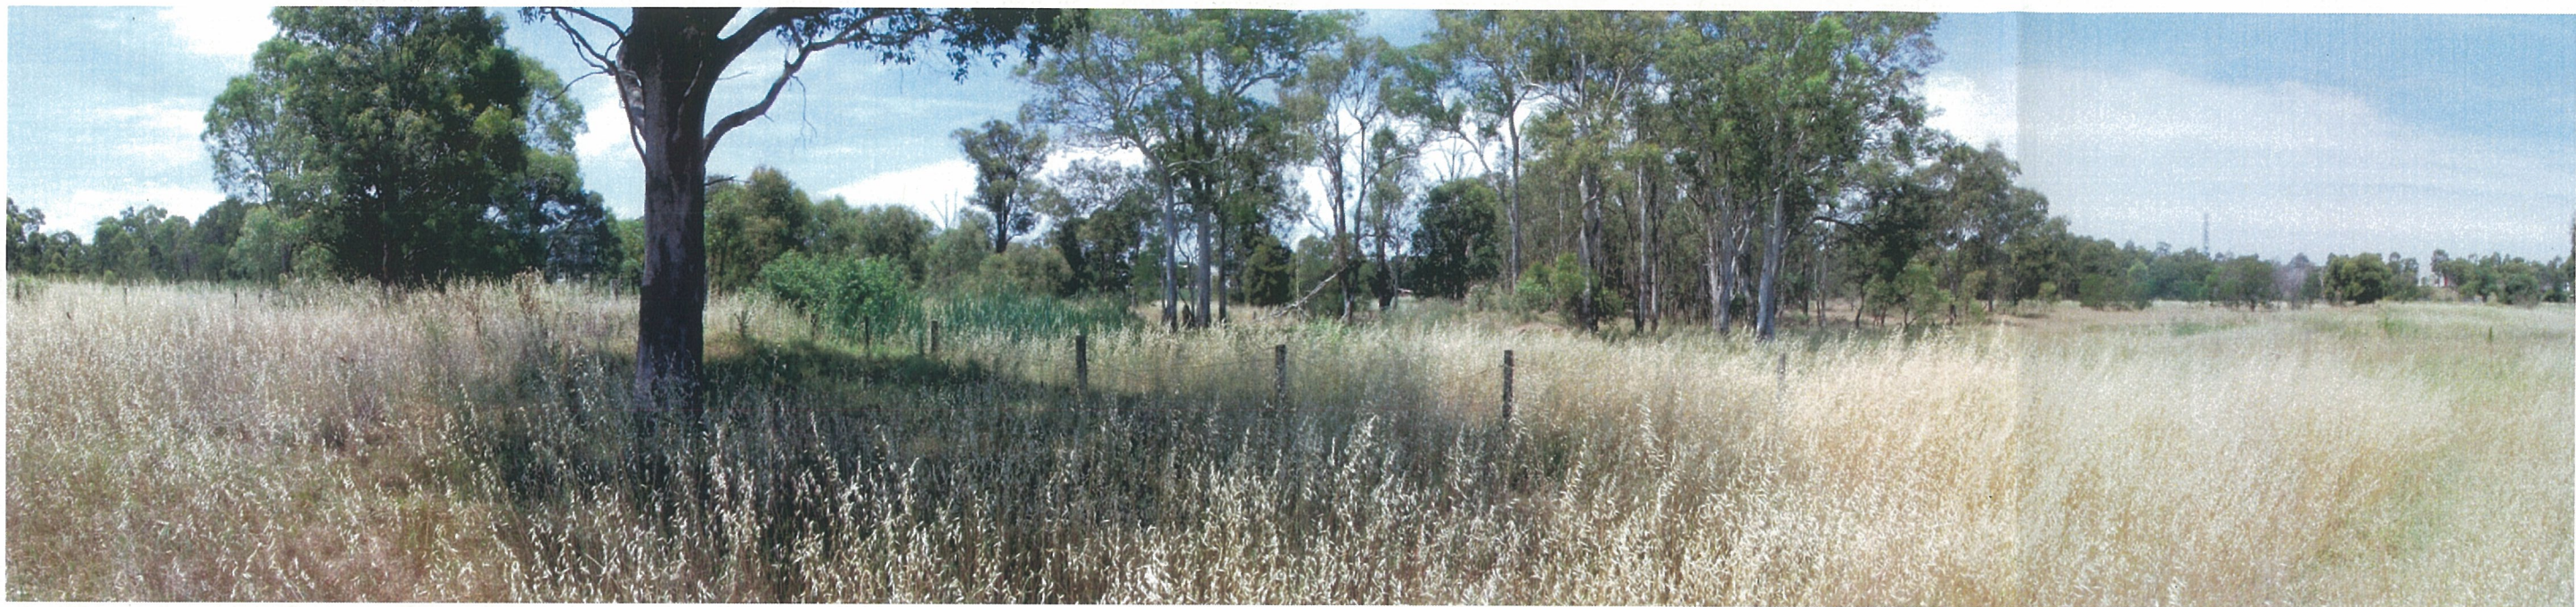
Pano 3 View north along drainage depression leading to the North East of the site. Reeds (salt tolerant) in pond in centre of photo, and paperbarks (waterlogging/salt tolerant) around, but no *Casuarina Glauca* or *Juncus Acutus* (typical saline indicator species).

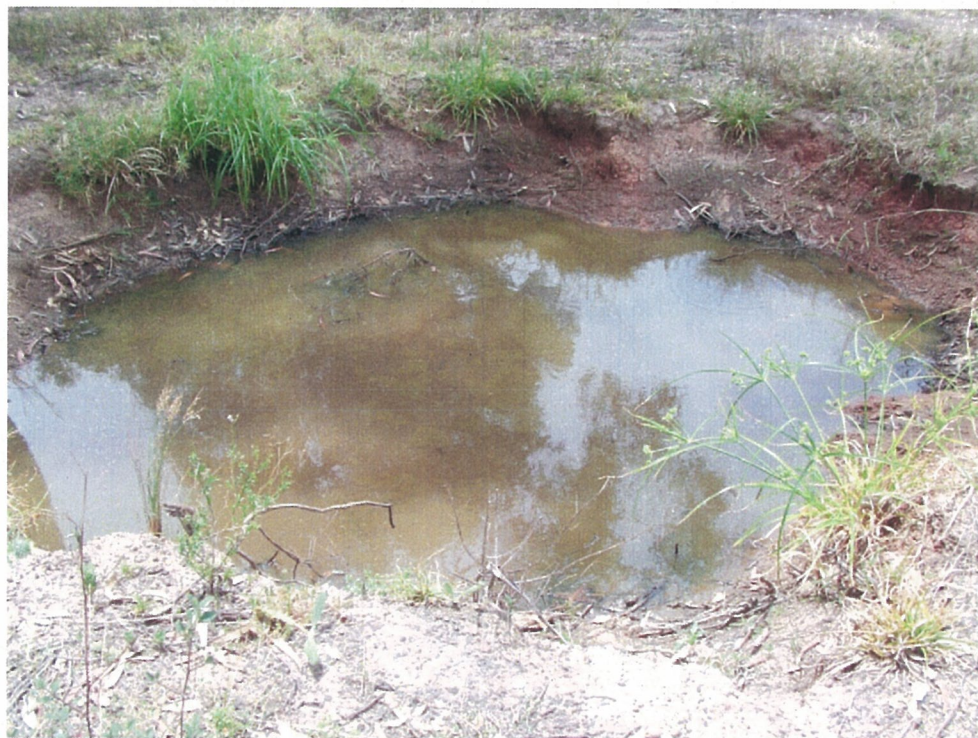
P 1 Higher landscape. 'Perched' water in an excavation adjacent to a stand of gum and paperbark trees. Couch grass. Dispersive erosion

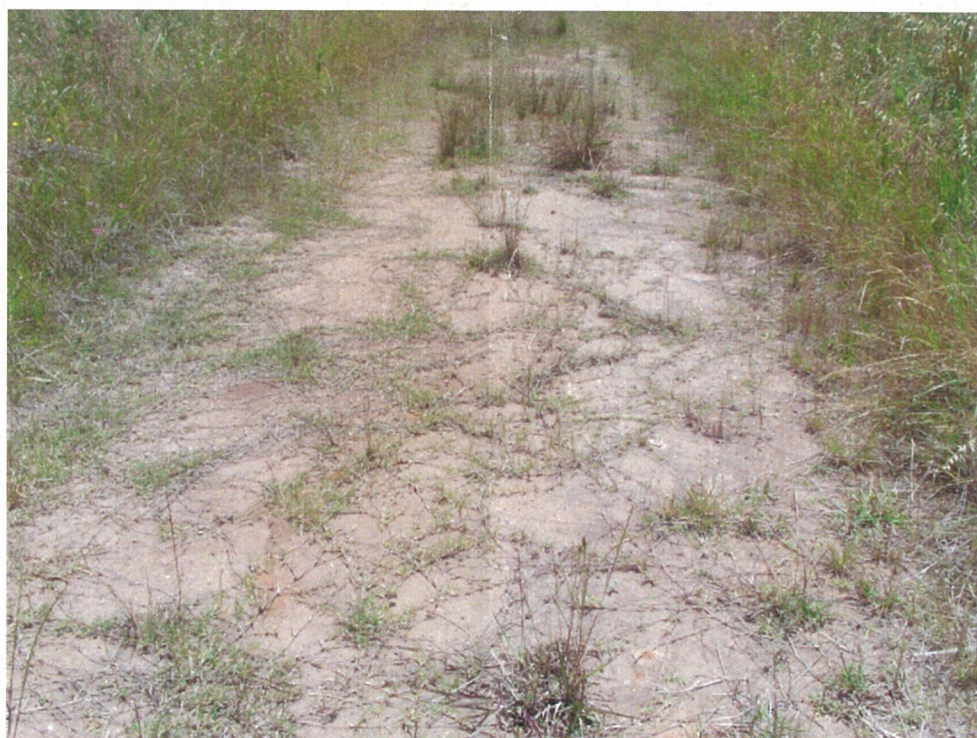
P 2 Lower landscape. Track to old trotting course. Bare (saline scald?) zone. Couch (saline indicator species). Soil sample SS5 (Very Saline).

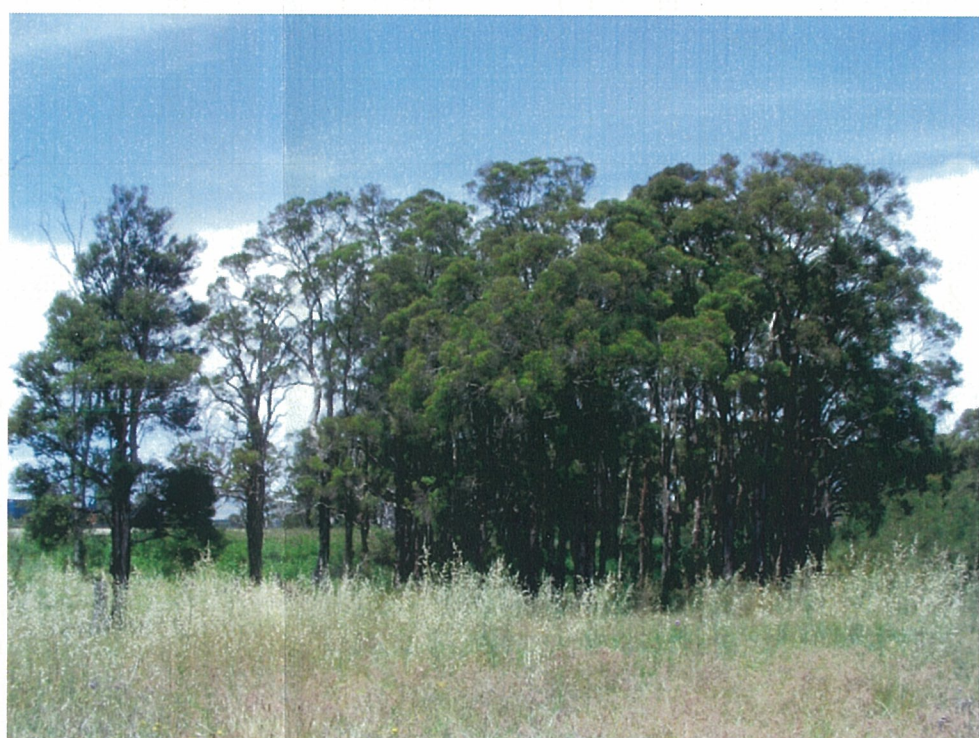
P 3 Mix of gum trees and paperbark in drainage depression (waterlogging zone). Drainage is impeded by the road embankment to the north (in background). SS6 (Very Saline). Dead tree in background is possibly saline die-back.

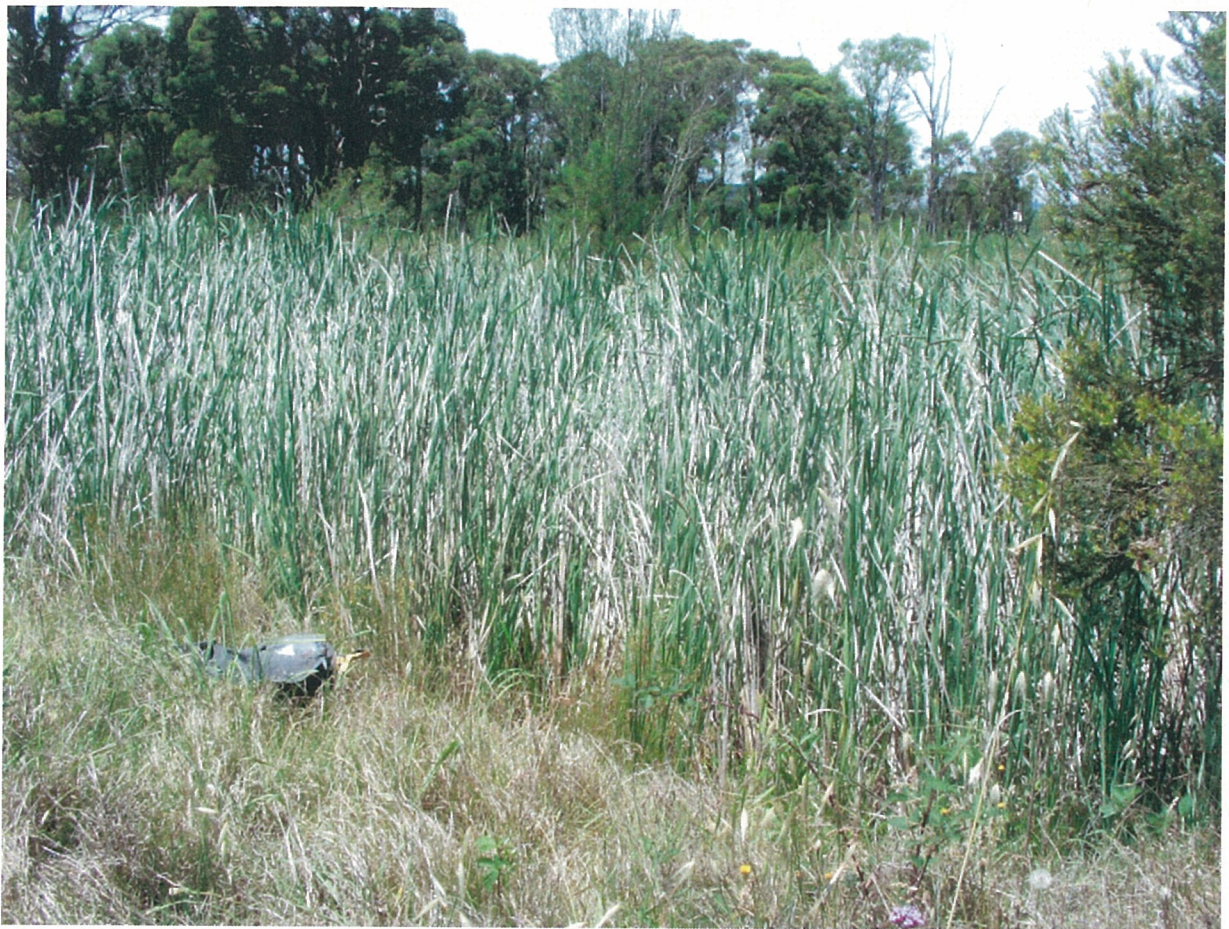
- ▶ The potentially dispersive nature of the site soils was evident from an observed sink hole in the north-eastern area of the site. Refer to P4.
- ▶ Groundwater was recorded at 3.2m depth (approx. RL53.5m) in BH06, approximately 0.6m above the bedrock top. Examination of the core photos for this borehole reveals two iron-stained joints, which may indicate the source of the seepage into this borehole. The rise in the groundwater level since the geotechnical investigations completed a month previous is inferred to be due, at least partially, to significant rainfall, which occurred shortly before the salinity walkover. This rainfall will also have temporarily suppressed surface soil/water salinity at the site, as recorded at the time of the walkover.

P 4 Edge of Swamp, NE Section of the Site. Couch, Reeds. No Standing Water. SS7 (Non-Saline)

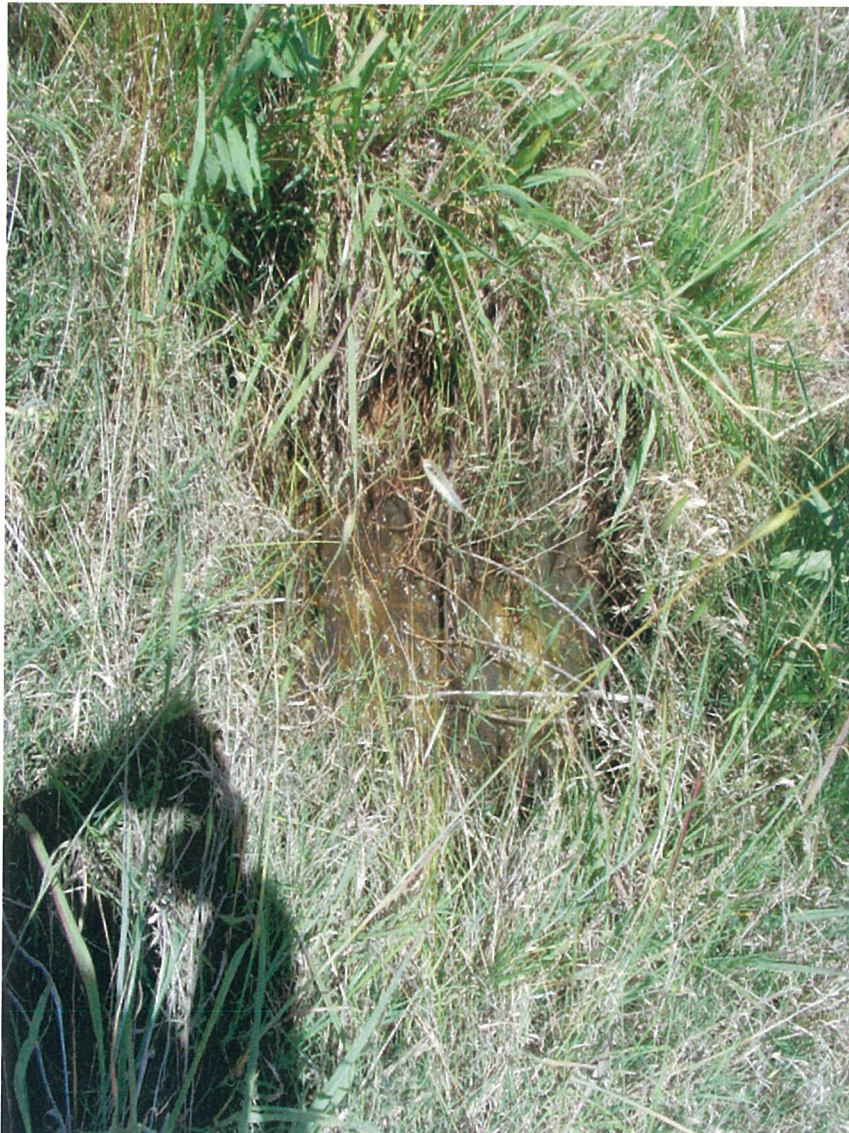
P 5 Sink Hole Near Swamp. Dispersive Soil Indicator. Couch grass. SW2 (Non-Saline)
