Report on
Geotechnical Investigation

Proposed Mixed Use Development
23 – 41 Lindfield Avenue & 9 – 11 Havilah Lane
Lindfield

Prepared for
Aqualand Projects Pty Ltd

Project 73174.02
January 2015

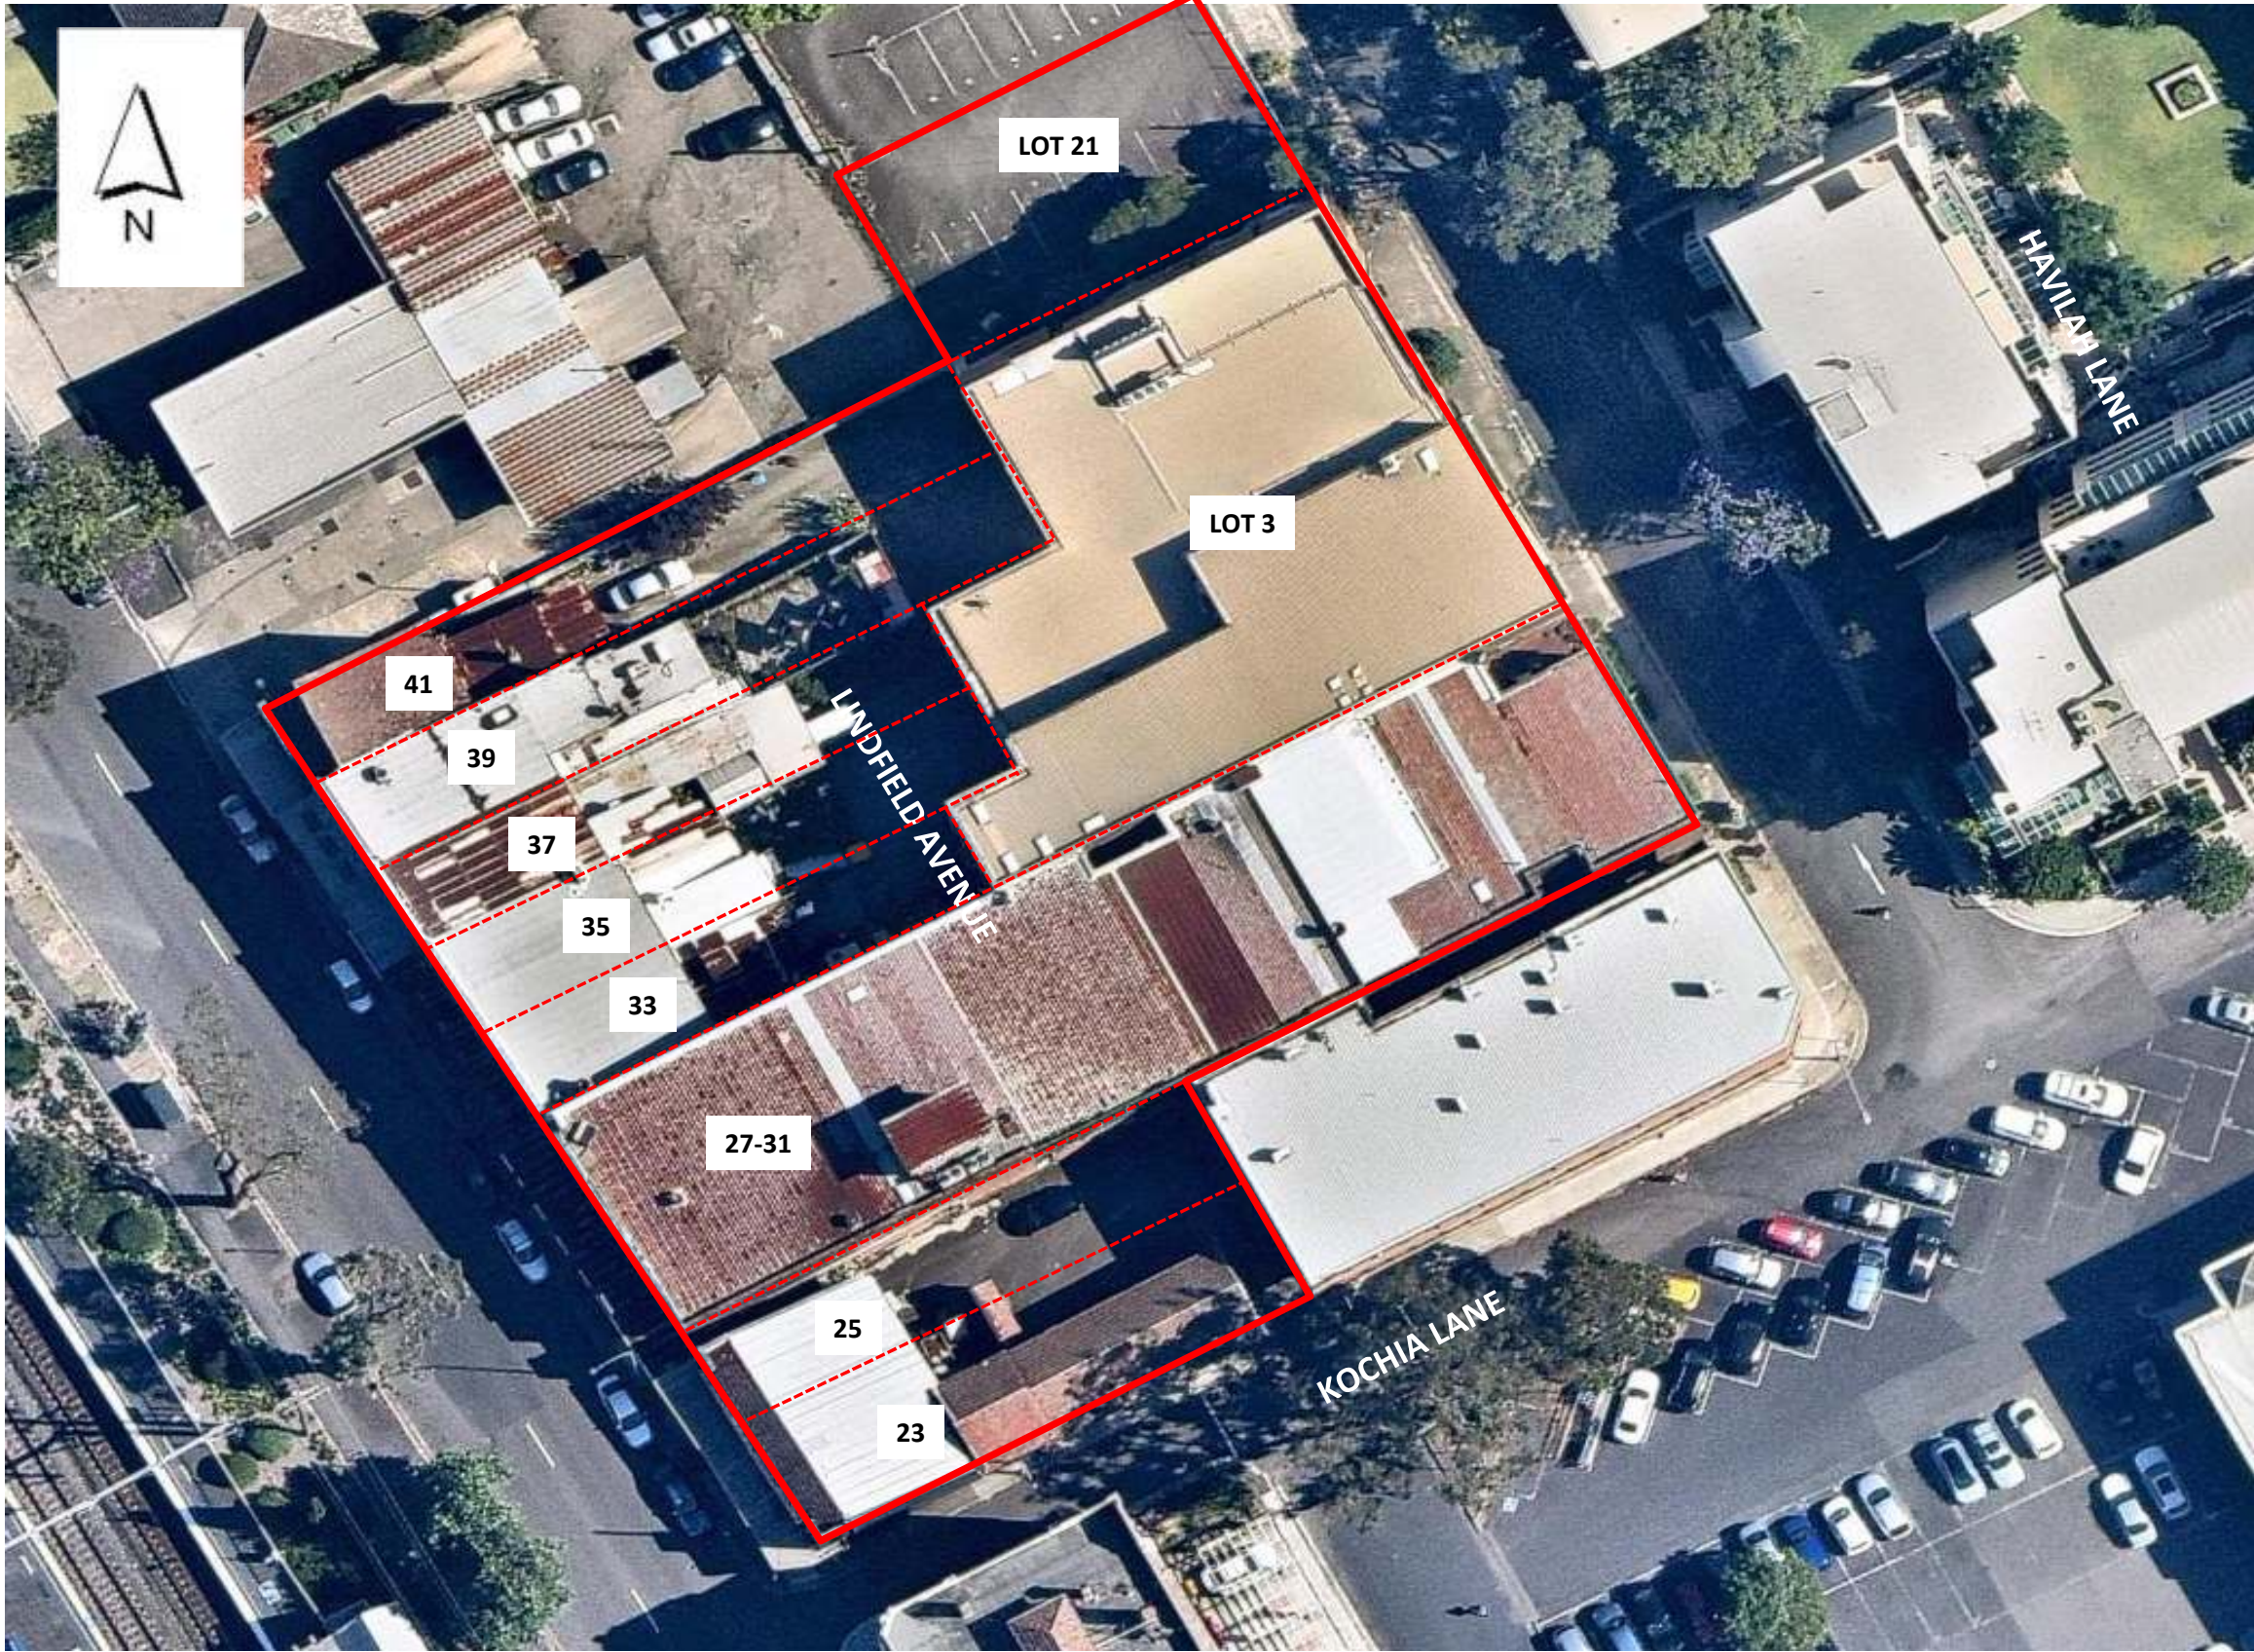
Drawing 3 – Section A-A'

Based on the investigation results, current site conditions can be characterised as including between 2.5 m and 4.5 m of overburden soils (pavements, filling and residual soil) overlying weathered and slightly fractured shale and siltstone bedrock, overlying sandstone bedrock.

Ground conditions prior to development most likely comprised a thin topsoil and vegetation cover over an approximate 2.5 m to 4.5 m depth of residual clay and shaly clay, underlain by shale and siltstone and then sandstone bedrock. Ground surface levels would have been close to current ground surface levels at the perimeter of the site and probably fell gently towards the north to north east, as is typical of the surrounding area.

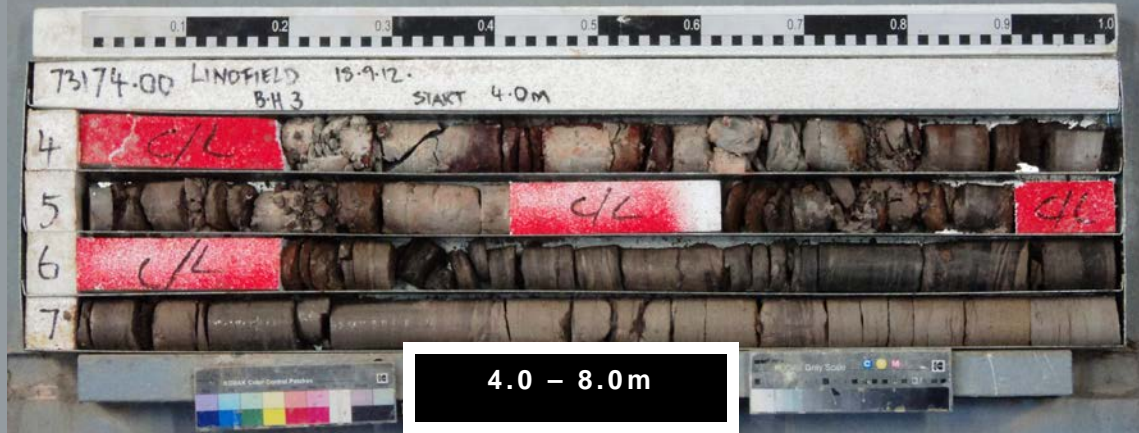
DOUGLAS PARTNERS PTY LTD
PROPOSED MIXED-USE DEVELOPMENT - LINDFIELD
BORE 3 PROJECT 73174 SEP 2012

4.0	SHALE - low to medium and medium strength, highly weathered, highly fractured to fractured and slightly fractured, light grey to grey brown, shale. Some very low strength bands

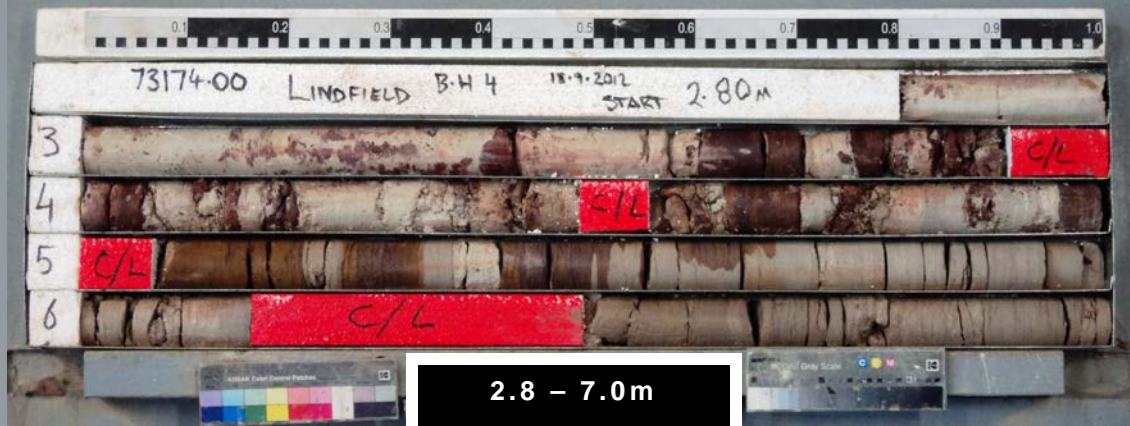
DOUGLAS PARTNERS PTY LTD
PROPOSED MIXED-USE DEVELOPMENT - LINDFIELD
BORE 4 PROJECT 73174 SEP 2012

Although the rock core is typically slightly fractured, some core samples indicate a slightly higher degree of fracturing, which is generally represented by short lengths of core loss in the borehole logs. Core samples also show some inclined joints, most dipping at 40 to 70 degrees in shale and siltstone and 30 to 55 degrees in sandstone. These joints may result in the development of wedge failures in perimeter excavation faces unless excavations are battered at flatter slope angles. For vertical or near-vertical excavations, these joints will require special consideration when designing temporary and permanent retention systems, and again during construction.
