Contextual Analysis

2.3 Topography

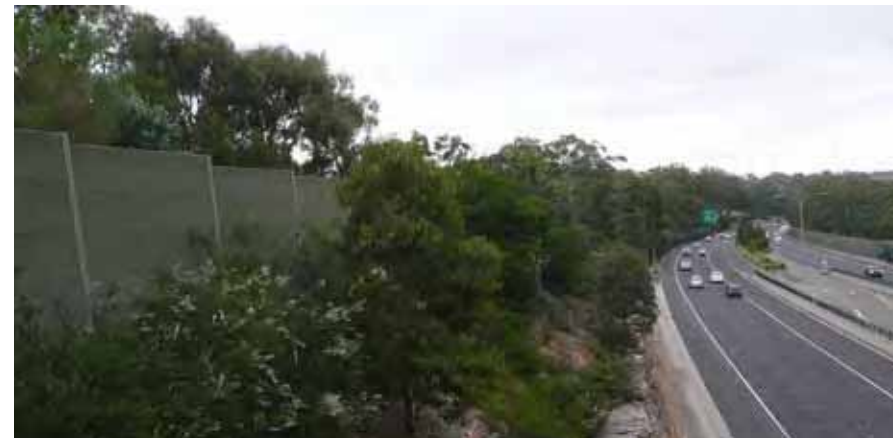
Photo 2.4 The ridgeline prior to Darling Mills Creek valley

Windsor Road straddles the main ridge line of the Hornsby Plateau and is marked by a distinct change in topography as the Motorway heads east. The Motorway crosses the deeply incised Darling Mills Creek as it drains to the south and the Parramatta River system. North of this crossing Darling Mills Creek and the Stevensons Creek system converge. At this point Darling Mills Creek runs east where it joins the Blue Gum Creek system which has its source near Pennant Hills Road. This drainage corridor runs parallel to the M2 corridor, the character of which is defined by the remnant vegetation cover of the Bidjigal Reserve. The Pennant Hills Road Interchange marks the highest point along the corridor, defines the two key drainage catchments of the Parramatta and Lane Cove River systems, and is the edge between two character precincts.

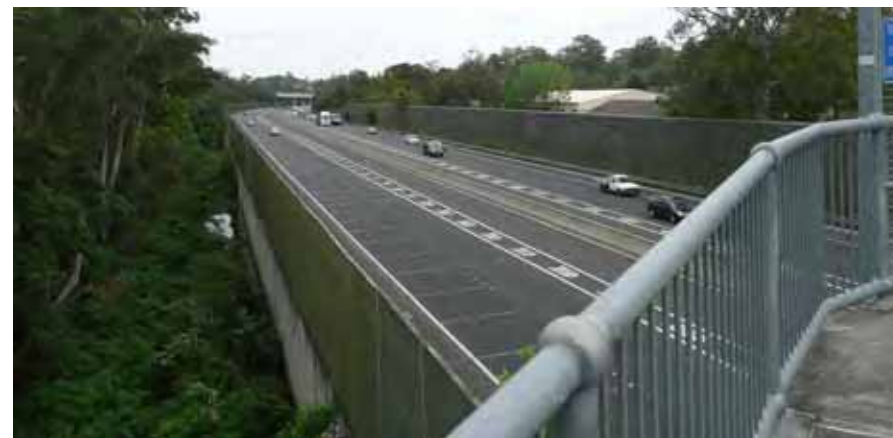
Photo 2.5 Devlins Creek runs parallel to the M2 which is constructed on a retaining wall

Travelling east, the motorway traverses the Devlins Creek Valley running parallel to the creek line until its approach to Beecroft Road (refer Photos 2.5 and 2.6). The motorway descends from 100 metres at Burns Road, Beecroft, to a low of 60 metres at Beecroft Road. The corridor here is lined both by public open space/reserves and housing.

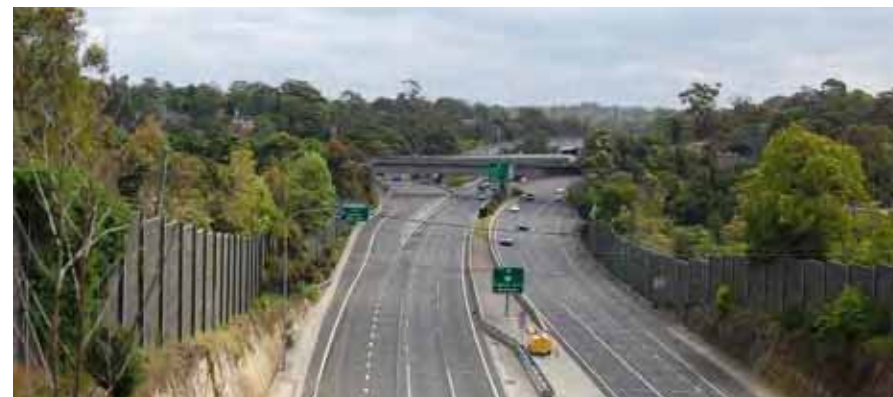
Photo 2.6 View west over Devlins Creek valley

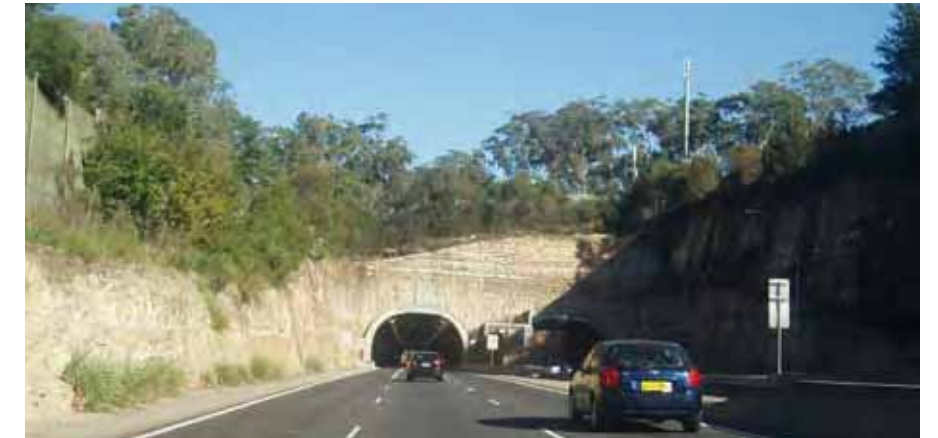
Photo 2.7 Eastern portal of Norfolk Road Tunnel

From Beecroft Road, the motorway cuts deeply into the topography at the edge of the Hornsby Plateau. The motorway alignment avoids traversing this steeper landform by tunnelling beneath Norfolk Road, as illustrated in Photo 2.7. East of Norfolk Tunnel the landform descends towards Terrys Creek.

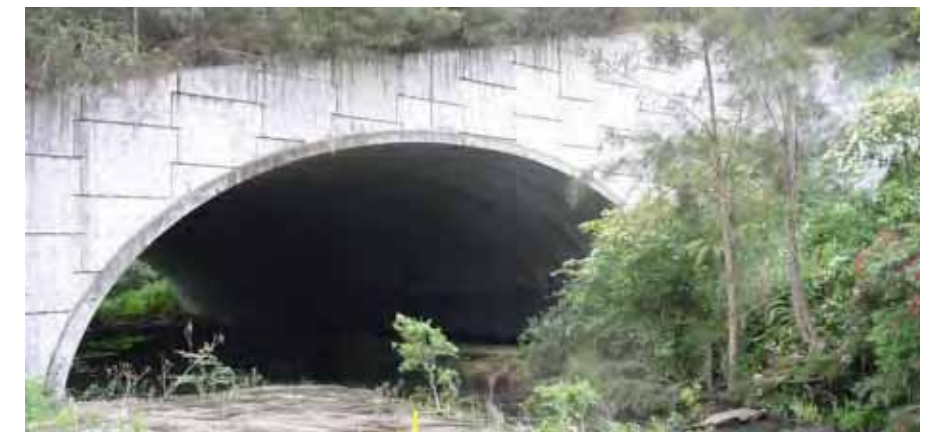
Photo 2.8 Bridge over Shrimptons Creek

Between Terrys Creek and Delhi Road the motorway crosses five creek lines including Shrimptons Creek near Alma Road (refer to Photo 2.8), Mars Creek between Culloden Road and Christie Road and three unnamed creeks. The valley of Terrys Creek marks the edge of this first precinct with its incised channel some 30 metres below the adjoining ridge.

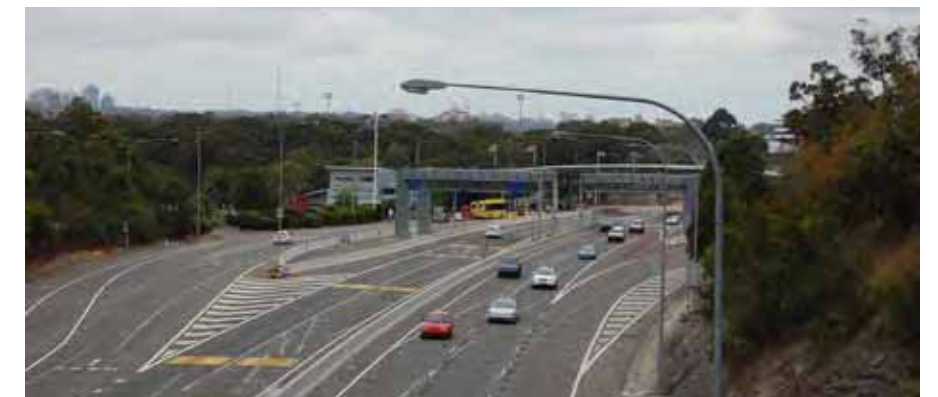
Photo 2.9 Toll plaza located on the broad flat ridge

In the eastern half of the corridor the motorway is generally located at the edge of a broad flat ridge, as depicted at the toll plaza in Photo 2.9, with an elevation of approximately 50 metres. This ridge line is cut by the natural cross drainage which typically flows to the northeast before entering the adjacent Lane Cove River. The Lane Cove River, runs parallel to the motorway and flows to the south east.
