## **Preliminary Contaminated Land Assessment - Site History**

Lots 1, 2 and 3 Section 1 DP 29748  
Lot 4 Section 1 DP 31209

**Proposed Mixed Use Residential and  
Tourist Accommodation  
(Major Project Application No. 09\_0016)**

HMC 2009.073

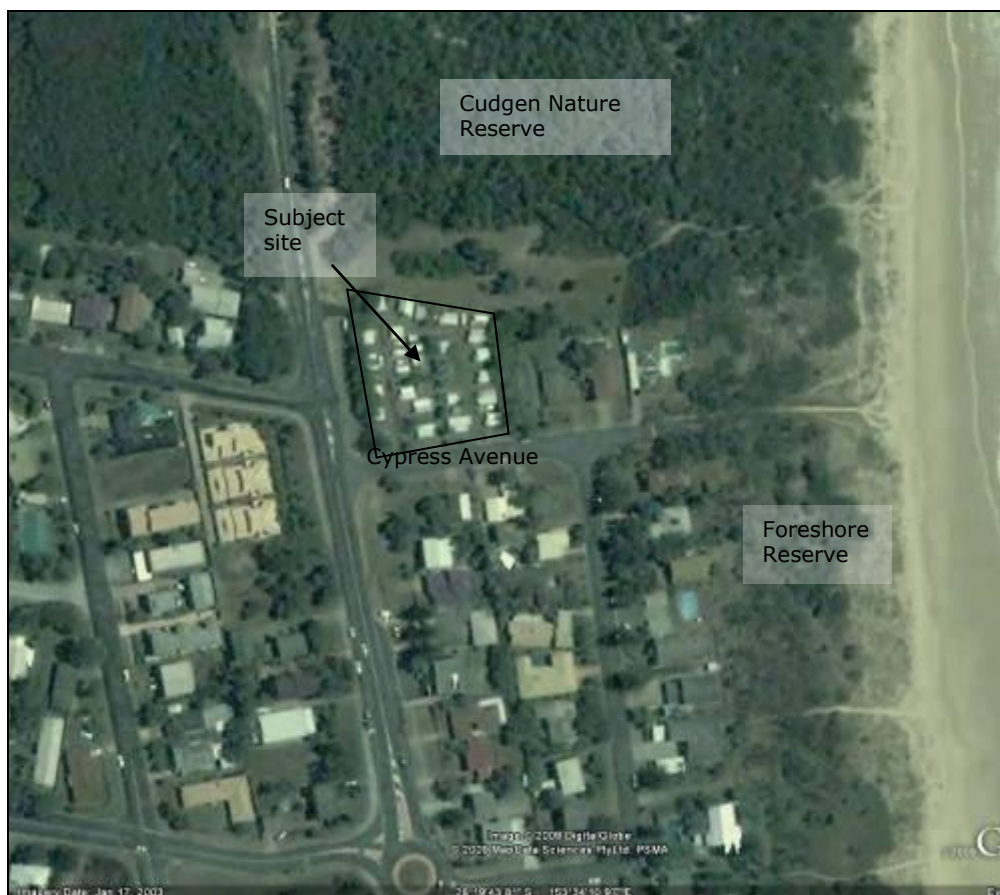
**Figure 1 Aerial photo of the subject site**

The site is located within 100m of the Cudgen Nature Reserve and is therefore within a sensitive coastal location (see **Figure 1**).

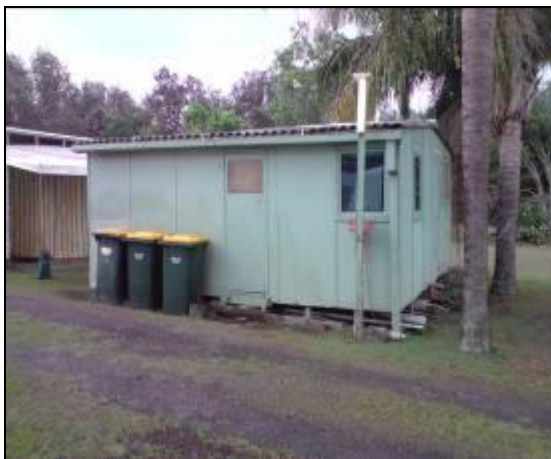
Photo 1 Existing storage building

- A smaller utility/storage building is present and is constructed of fibre-cement cladding and a timber floor on bearers and joists (see Photo 1 below).

- Due to the time of construction, the existing storage shed and amenity block are likely to be constructed of some asbestos containing materials and lead paint. If such hazardous materials are present, demolition is required to be carried out in compliance with the NSW Workplace Health & Safety Act and relevant NSW Workcover requirements.

The existing storage shed and amenity block are likely to be constructed of asbestos containing materials and demolition is required to be carried out in compliance with NSW Workplace Health & Safety Act and relevant NSW Workcover requirements.

Due to the age of the buildings, the existing storage shed and amenity block may contain lead painted materials and demolition is required to be carried out in compliance with NSW Workcover recommendations.

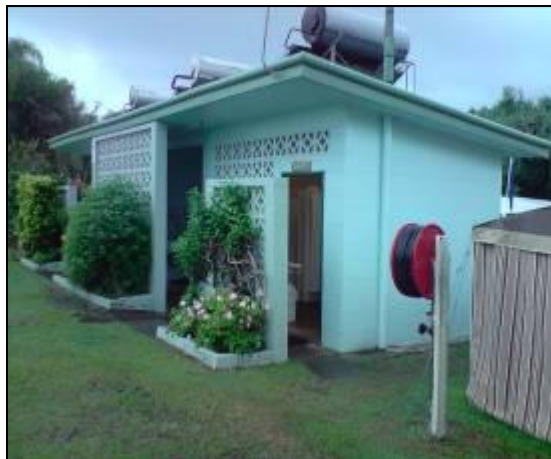
Photo 2 Existing amenities building

- An amenities building is present and is of masonry block construction on concrete slab. No timber framing expected or visible within structure. The eaves were observed to be fibre-cement sheeting (see Photo 2 below).

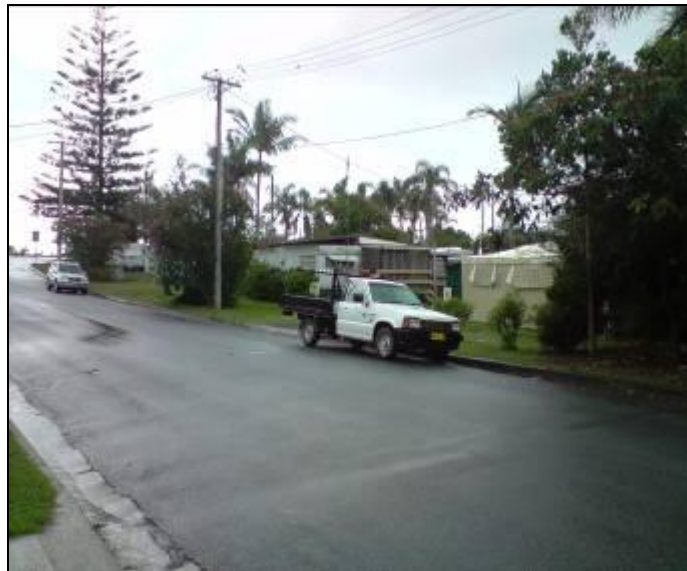
**Photo 4 Looking west along site frontage to Cypress Avenue.**

- The site appears well drained, with land sloping towards Cypress Crescent.
- Adjacent and nearby properties appear to have been used for residential purposes only.
