## Appendix H Non-indigenous Heritage Study

Non-indigenous Heritage Study:  
Maitland to Minimbah  
Third Track Project

Australian Rail Track Corporation

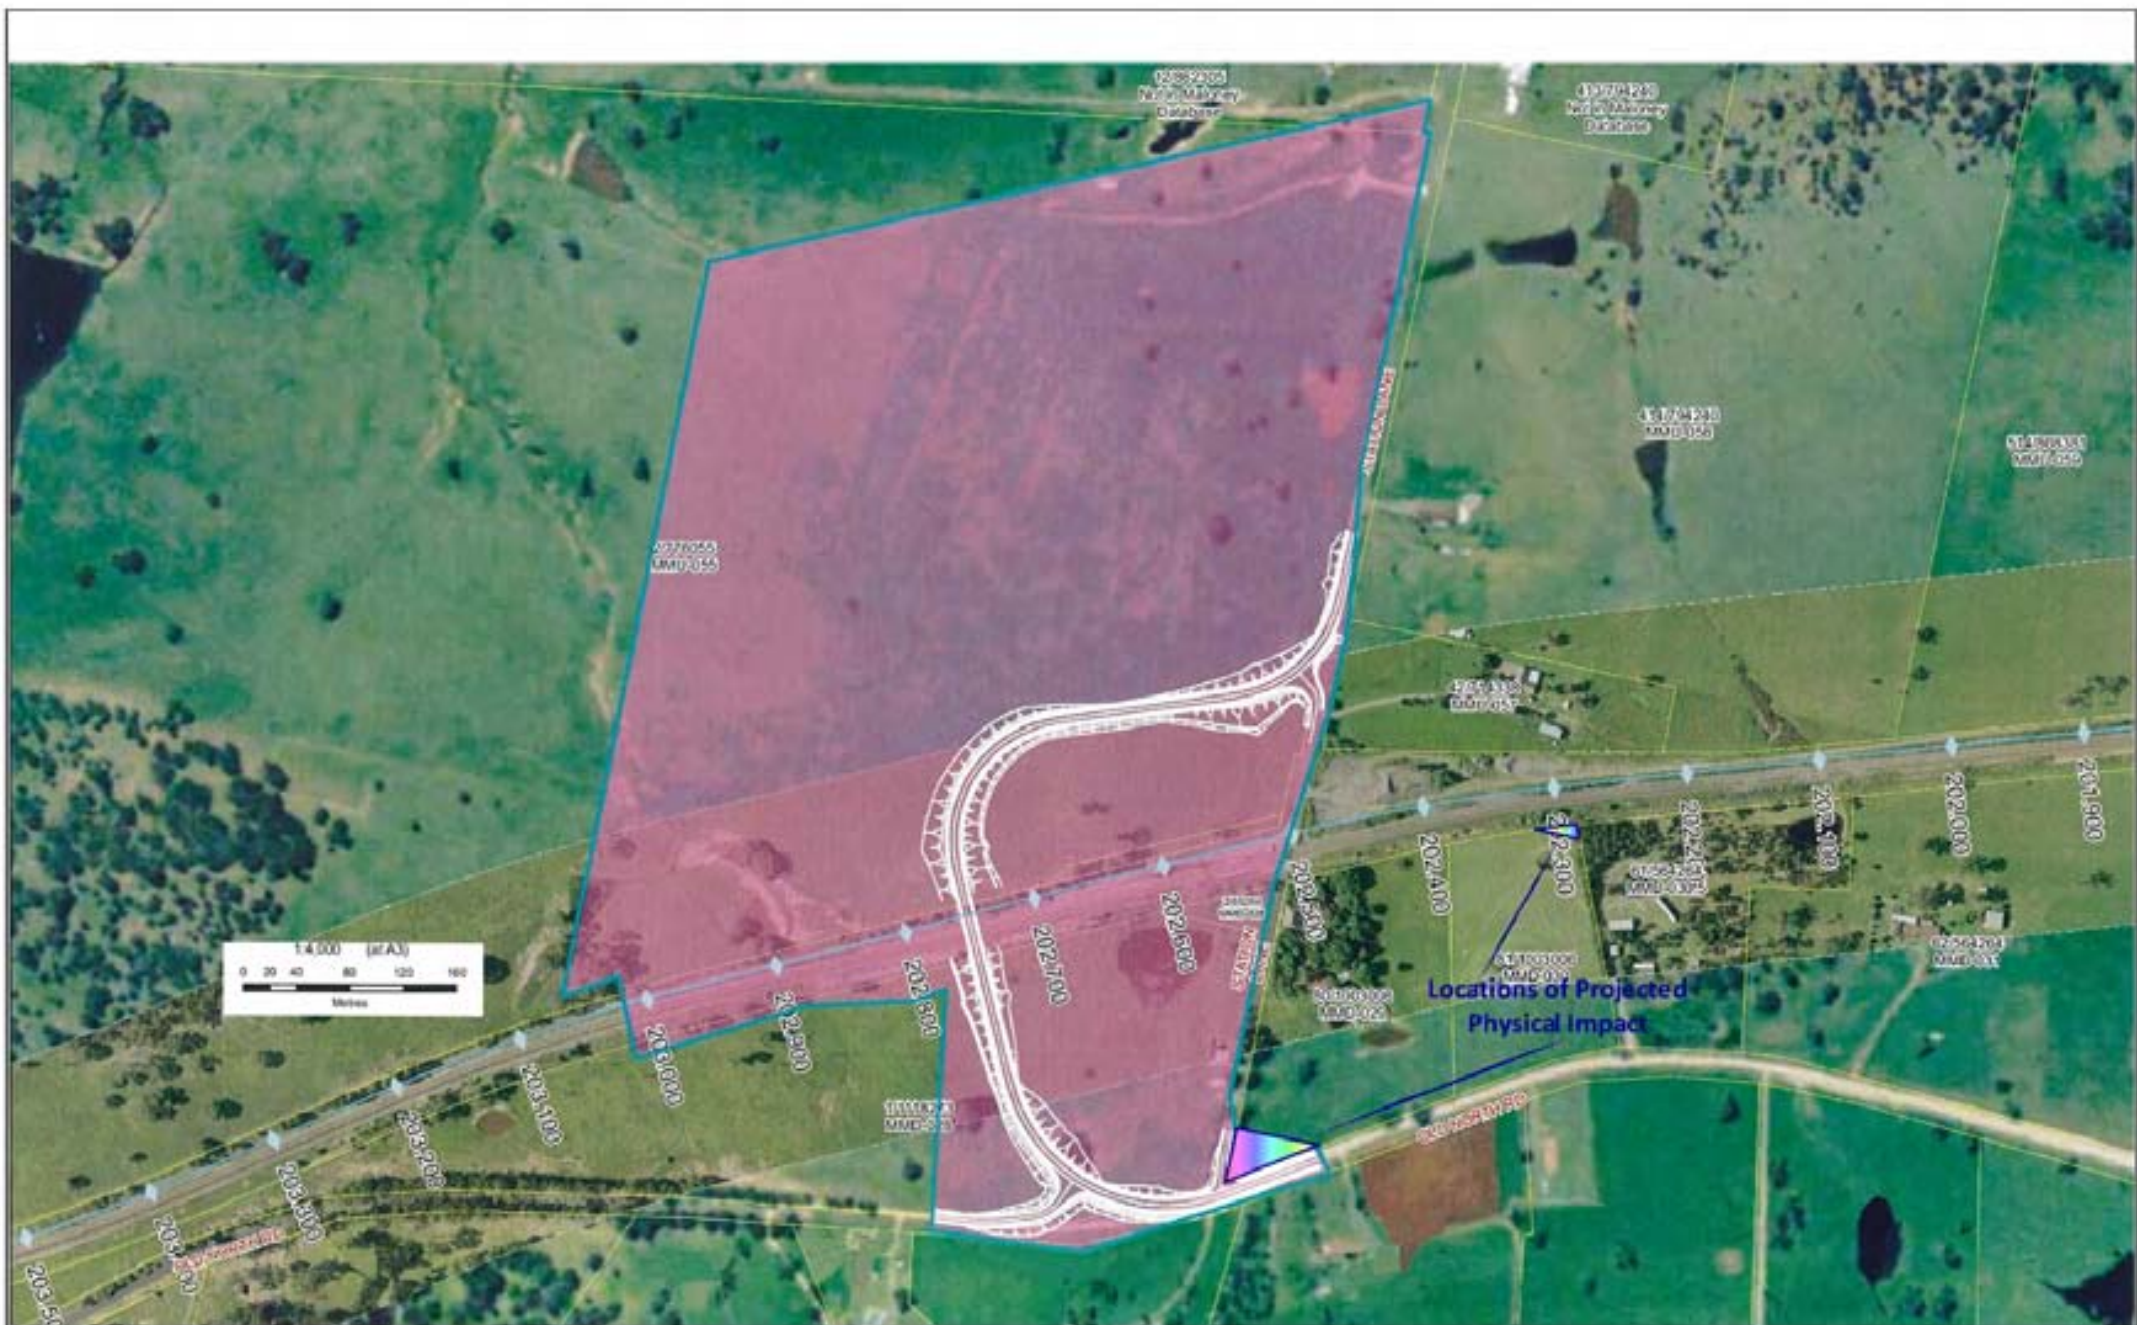
Scale: See Bar Scale	Client: Hunter 8 for ARTC Reference: 90601	Source: GHD	Title: Clifton House Precinct: Location of Physical Impact	Figure 2.1
---	-------------------------	--	----------------	--	------------

The project plan used in connection with the surface survey of the Clifton property is copied as Figure 2.1.

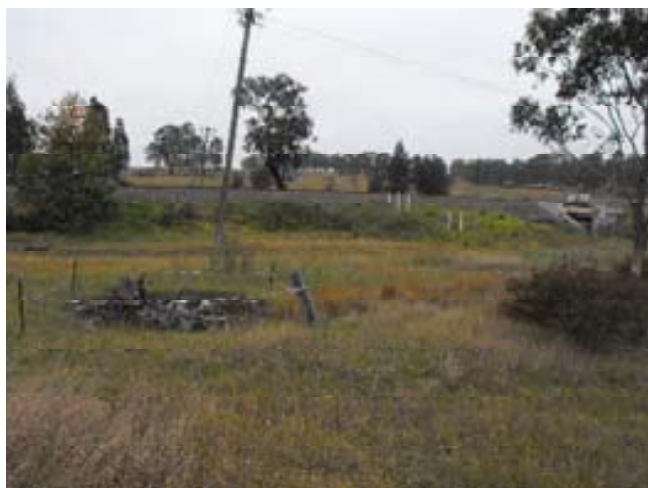
Figure 2.5

In this general view of the Allandale Vineyard/Penfold Winery site, the Allandale Road Underbridge can be seen at right middle ground. In the left foreground, the assemblage of timber marks the position of one of the filled sub-surface water tanks while in far left middle ground can be seen the footing remains of the worker's cottage double fireplace.

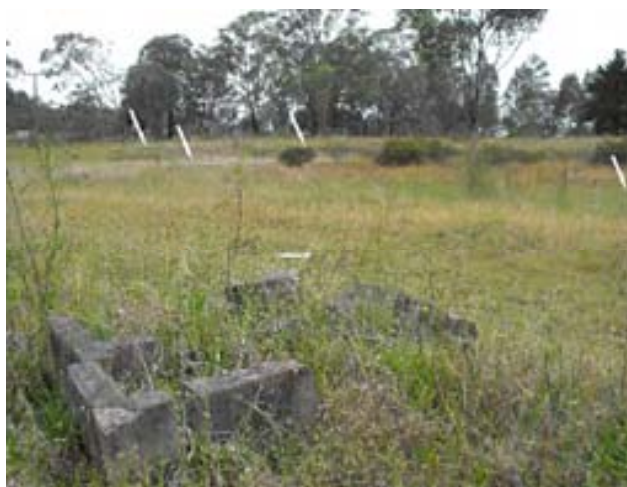
Figure 2.6

In this south-easterly view, virtually from the railway embankment, the footing remains of the worker's cottage double fireplace is in the immediate foreground while the white arrows indicate the approximate centre of the four sub-surface water tanks.

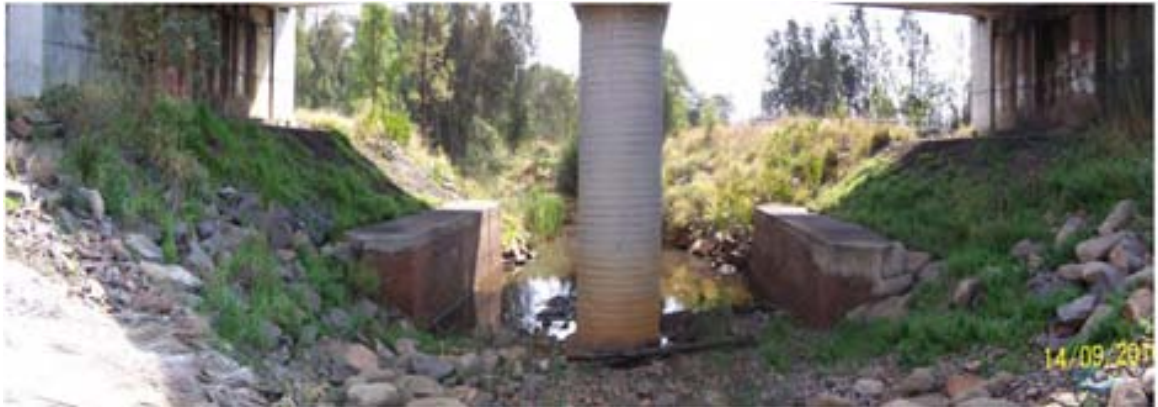
Figure 2.7 (above)

A composite view of the Jump Up Creek Underbridge precinct showing the stumps of an earlier bridge framed by the modern concrete structure

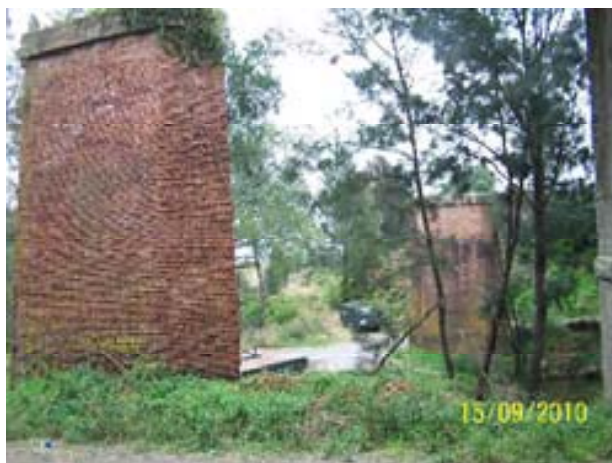
Figure 2.8

The two residual piers of the original Black Creek Underbridge, viewed from north-easterly

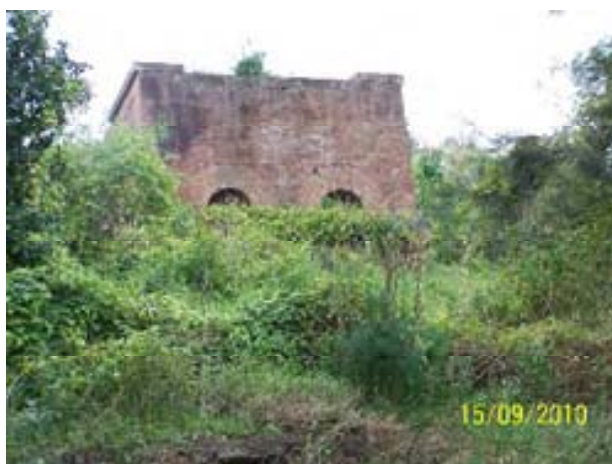
Figure 2.9

The complex brick eastern abutment of the original Black Creek Underbridge. The function of the two arches has not been investigated at this stage

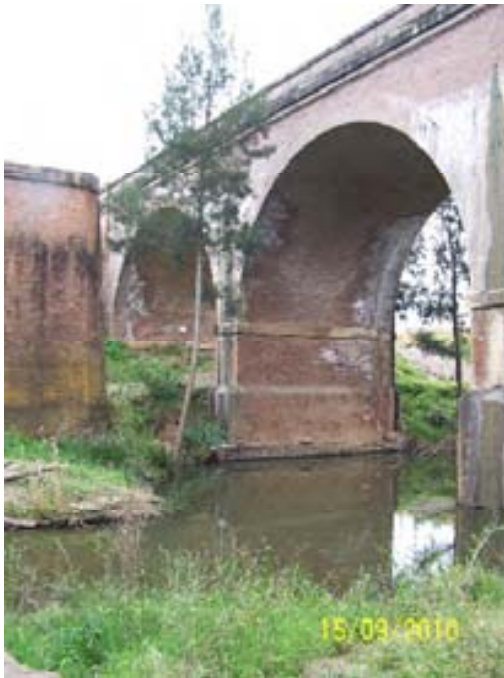
Figure 2.10

The graceful second and third arches of the present Black Creek Bridge contrast in height and mass with the first pier of the original bridge. Where the original bridge piers and abutments were solely of brick, the composite sandstone and brick of the present bridge can be seen at footing, the branch of the arch and as string courses at foot and capping course above the parapet wall.

The remaining Black Creek underbridge has been well described in heritage documentation and presents as an elegant as well as massive masonry construction. In general terms, the structure was founded on a sandstone footing, and sandstone was also coursed as a footing at the branch of the three arches. Sandstone was also used in three courses (including two string courses) as a footing for the parapet wall and as a single course for parapet wall capping. The bulk of the structure was of solid brick: using the second pier as an example, the structure comprised 57 courses between footing and the sandstone course at the arch branch; 92 courses between the arch branch and sandstone string courses at the foot of the parapet wall (including a sawtooth string course). The arch was comprised of 8 soldier courses (see Figure 2.10). An unusual feature of the structure was the use of engaged columns in the abutments, splayed at the base in the nature of a buttress. The description of the internal structure of the piers was borne out by the obvious continued function of the drains, from weep holes in the centre line of piers 20 courses below the sawtooth string course (see Figures 2.11 and 2.12).

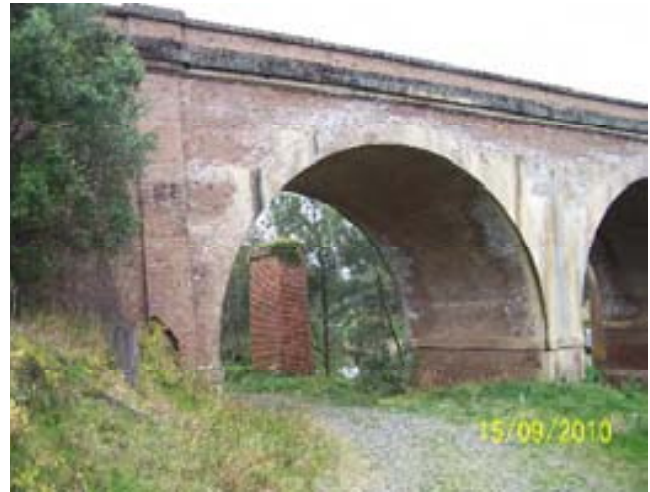
Figure 2.11

Detail of the first arch of the present Black Creek Bridge, incidentally framing the first pier of the original bridge. Note the buttress/engaged column just east (left) of the first arch.

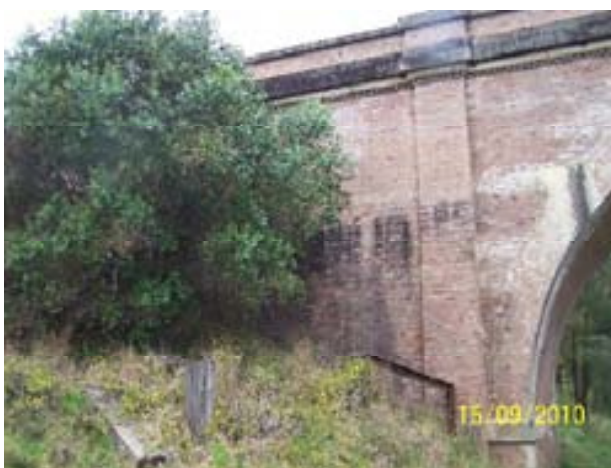
Figure 2.12

Detail of the southern abutment of the bridge and branch of the third arch. Note the massive soldier coursing of the arch, the sawtooth string course below the sandstone string courses, the capping course and the buttress/engaged column.

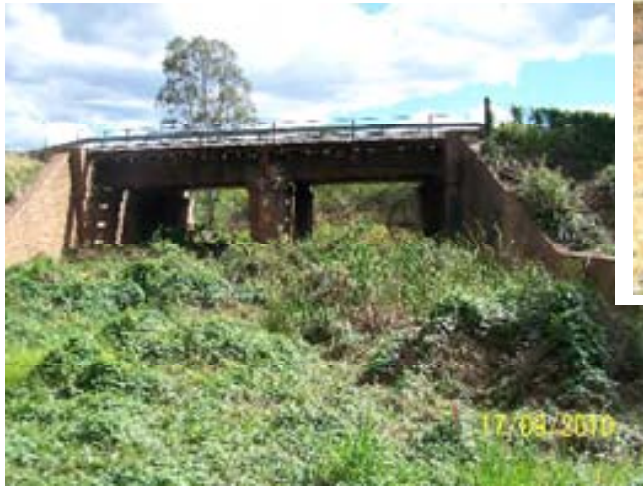
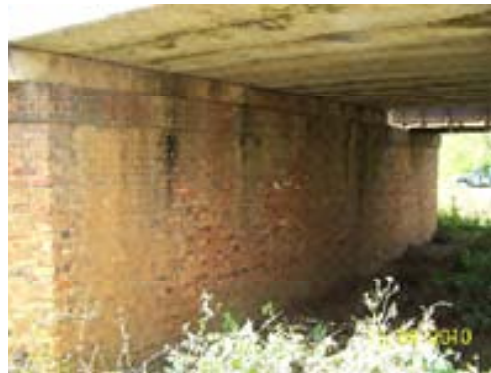
Figure 2.13(above/above left)

Looking south under/through the original Sawyers Creek Underbridge. The original single track bridge remained: brick abutments and central, chamfered brick pier under iron/steel beams. The duplication extension of the bridge continued the style but the decking had been replaced with reinforced concrete (see inset

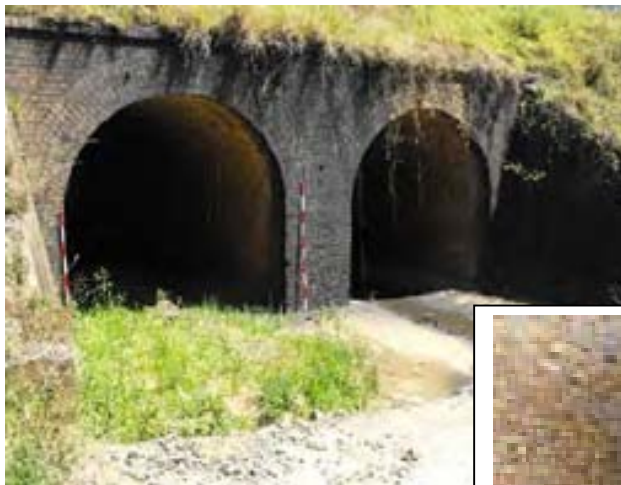
Figure 2.14

The appearance of the Anvil Creek underbridge on the northern side, inset showing the interface of original and duplication arch brickwork, cg stele extension in background, looking south...

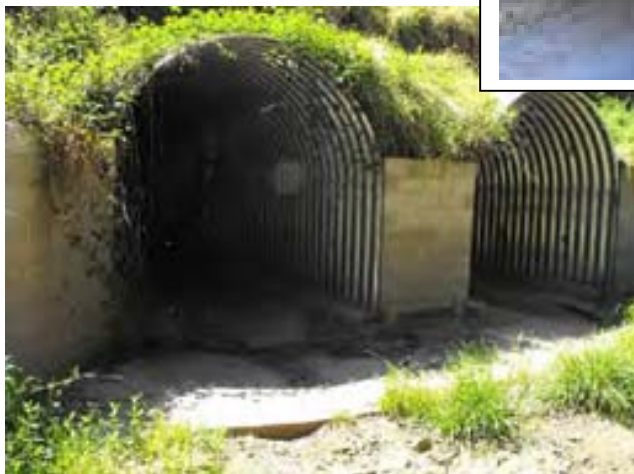
Figure 2.15

...on the southern side, the corrugated galvanised steel extensions carried ou, according to a date scratched in the concrete, in November 2002.

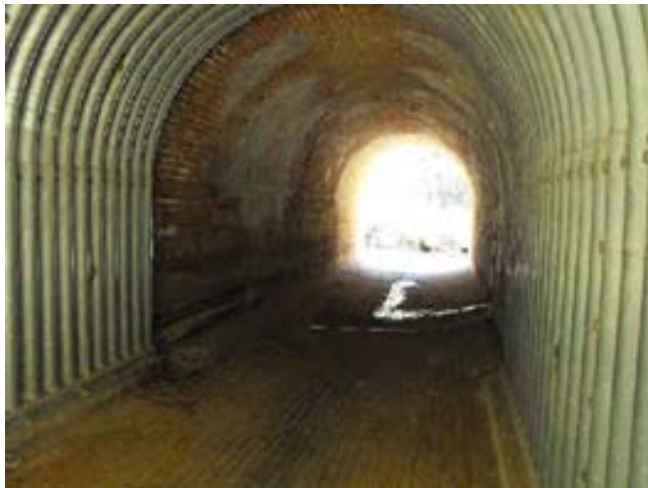
Figure 2.16

Looking south through one of the cells of the Anvil Creek Bridge, emphasizing the corrugated iron extension and the brickwork of the internal arch, including the floor.

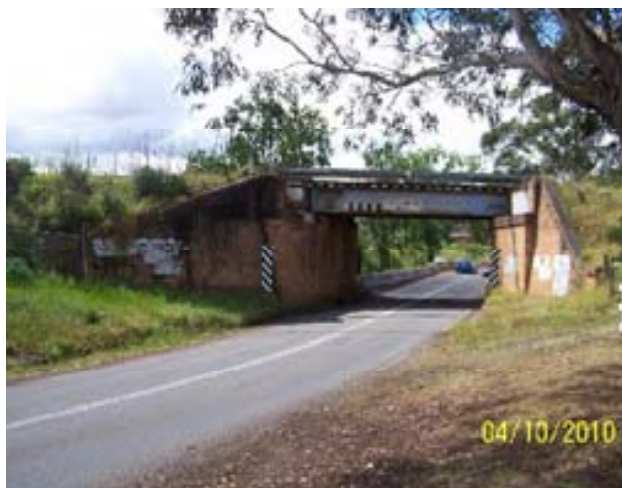
Looking north to the Wollombi Road underbridge from the eastern side of Wollombi Road.

from many of the same style in the general locality and the State. The bridge is shown in Figure 2.17 and comprised abutments of yellow brick in English bond rising 46 courses to four string courses and a single chamfer course above which were platforms rebated to support the ends of steel beams. Above the platforms, secondary abutments were offset to a height of 14 courses. An unusual feature of the abutments was the vacant provision for a third track on the southern side. Wing walls splayed from the northern and southern ends of the abutments.

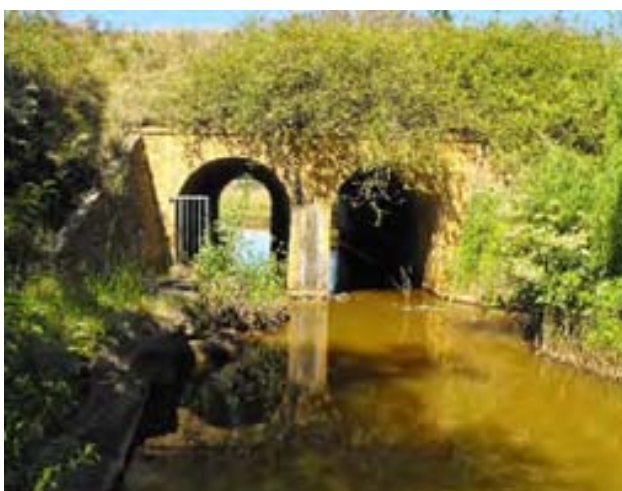
Figure 2.18

The elegant twin-cell brick arch underbridge at chainage 195.555, Stony Creek, emphasizing the extent of standing water and the gated entrance to the pedestrian way

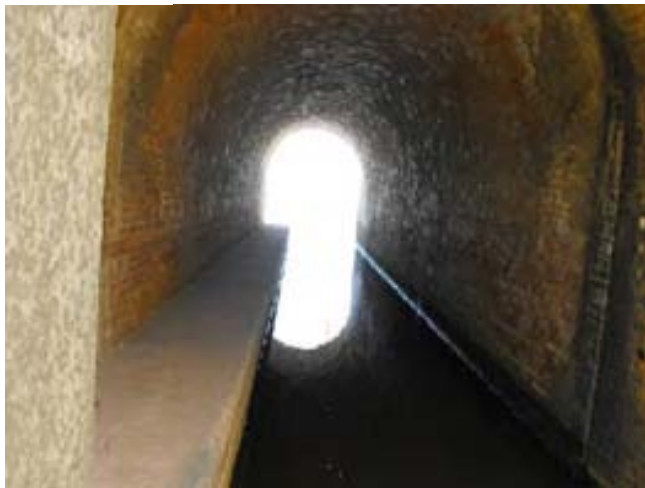
Figure 2.19

Inside the easterly of the twin-cells of the Stony Creek Underbridge, staining of the brickwork of the arch emphasizes the line at which it appears that an original bridge was extended at duplication in the original style.

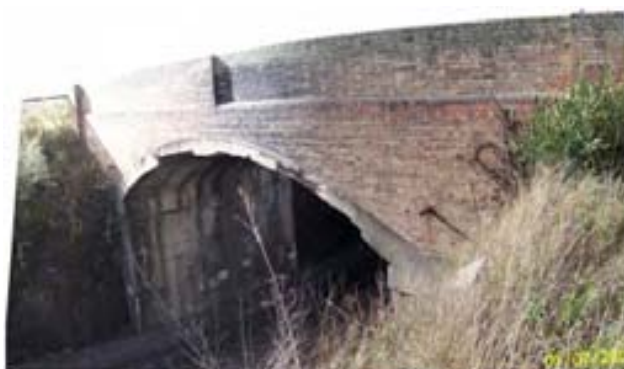
Figure 2.20 (below left)

Composite view of the westerly side of the Old North Road Overbridge at Allandale, noting in particular the deteriorated condition of concrete work.

The Old North Road crosses the GNR at Allandale on a high arch bridge, mostly brick, at a high point of a railway cutting (see Figure 2.20). The vertical walls below the branch of the arch comprised 58 courses of English bond below a string course of cement that may have been faced reinforced concrete or render over four additional courses of brickwork. Above the string course, the arch was framed by a facing of reinforced concrete, which showed signs of deterioration on the western side (note in figure). Above the arch, brickwork varied between 31 and nine courses below the parapet wall which comprised 13 courses of (mainly) stretcher bond in two leaves, with an occasional header as a ty-in mechanism. The parapet was surmounted by a single soldier course. The parapet walls were finished at each end with a tied column. The bridge parapet showed the signs of having suffered from motor vehicle impact on the south-eastern sector, which had been repaired in stretcher bond.

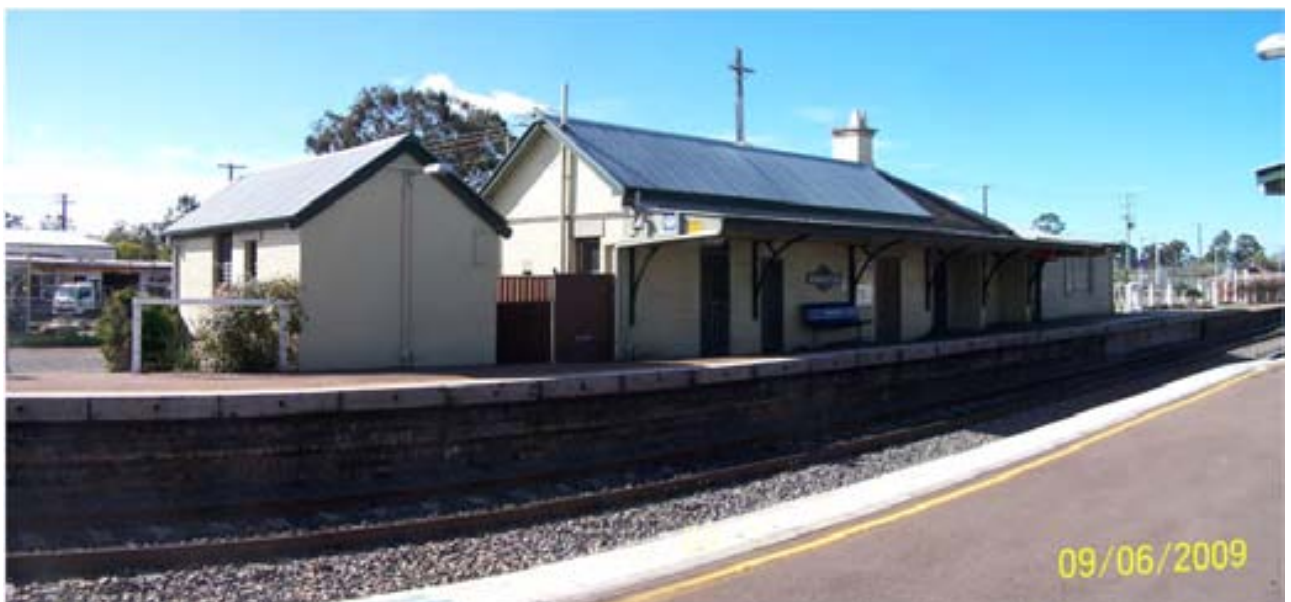
Figure 2.21

Looking north-east, view of the buildings of the up platform of Branxton Railway Station.

Surface survey of the Branxton Railway Station Precinct validated the descriptions of the resources of the precinct contained in the State Heritage Register and the ARTC s170 Register. Upon inspection the Up platform contained a series of buildings in keeping with the age and style of the historic station, and is depicted in Figure 2.21. Of particular note were the parcels office at the western end of the group, the main station building of offices and waiting room, while the signal box remained as a later addition. The platform facing had been modified in front of the signal room in concrete, while the surface of the platform had been raised by approximately 300 mm and bitumen sealed from east of the signal room to the western end of the platform to facilitate passenger access to modern carriages. The eastern end of the platform retained its original antbed surface behind the platform facing of brick, and was notable for the survival intact of the original dock siding, with platform access on both sides.

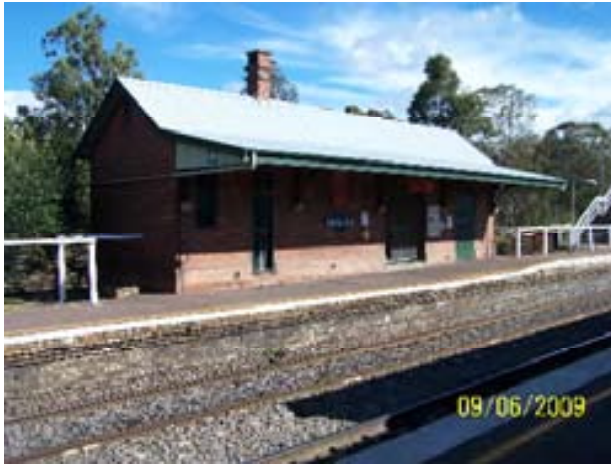
Figure 2.22

Detail of the building on the Branxton down platform, looking south-westerly.

The same style of modification had been carried out, with the same resultant effect, on the Down platform shown in Figure 2.22. The only building on the down platform was the office/waiting room dating from the duplication of the line. Both platforms retained fencing in an original style. Figure 2.23 provides a view looking westerly along the precinct and detailing the dock siding, the Up and Down platforms with buildings and the footbridge at the western end of the precinct. Access between platforms was provided by the footbridge, supported on steel framed columns outside the fence line of both platforms. The access staircase and footbridge adjacent to the Up platform is shown in Figure 2.24

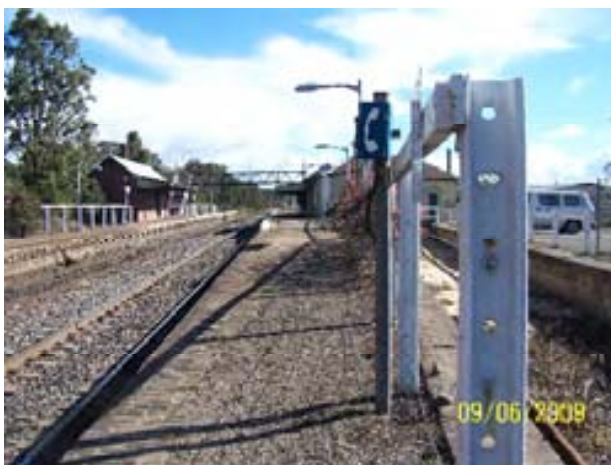
Figure 2.23

Looking westerly along the Branxton Railway Station precinct, this figure also highlights the platform dock on the up platform and the position of the footbridge in the westerly sector of platforms.

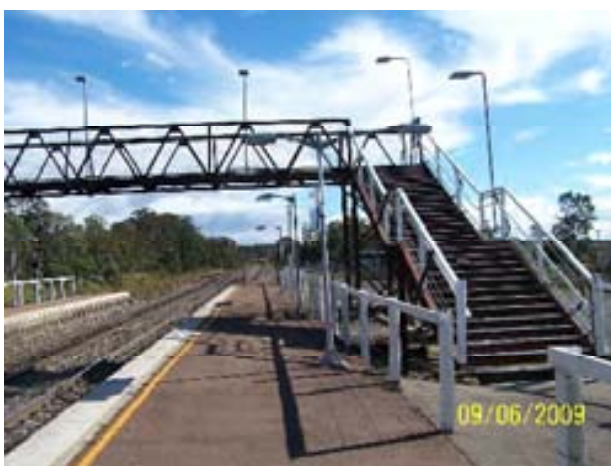
Figure 2.24

Northern stairway and deck of the footbridge at Branxton. Note that the entrance to the footbridge at this side is from the car park, not directly from the platform.

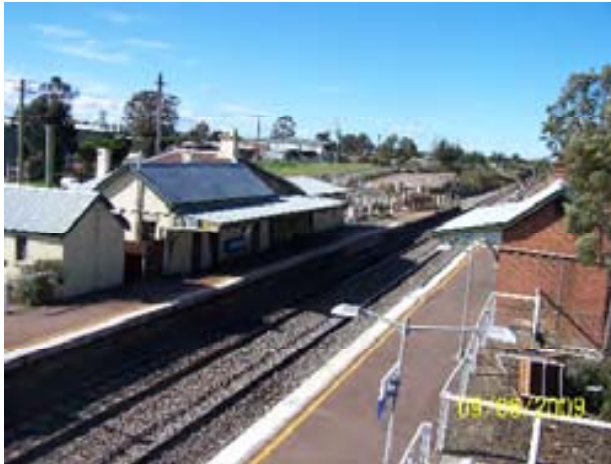
Figure 2.25

From the footbridge, an elevated panorama of the Branxton Railway Station precinct looking easterly.

The footbridge provided a platform for elevated overviews of the precinct, provided at Figures 2.25 and 2.26. The latter shows the alignment of the Down platform and, to its south, the loop siding which also provided the offtake to the siding for the former Rothbury/Branxton/Ayrfield No 3 Collieries. Off the north-westerly end of the Up platform, lay the residue of a siding that served both the Branxton Goods Shed and yard and, while originally looping back to the main, also branched northerly away from the main line. The purpose of this branch was not clear. Suffice it to say that a stop had been imposed on the siding, beyond which lay lengths of lifted track including part of a points system. The various sidings switching were controlled by manual lever blocks at the eastern entry to the southerly loop siding, and at the western re-entry to main/Rothbury branch. A third block controlled access to the northerly siding. At the southern side of this siding remained a large c-i-p concrete block that had formerly supported the goods yard crane, while at the eastern end of the goods yard, north of the platform, lay the remains of a siding that had once served an Oak Milk Factory fronting Railway Street near its intersection with Short Street.

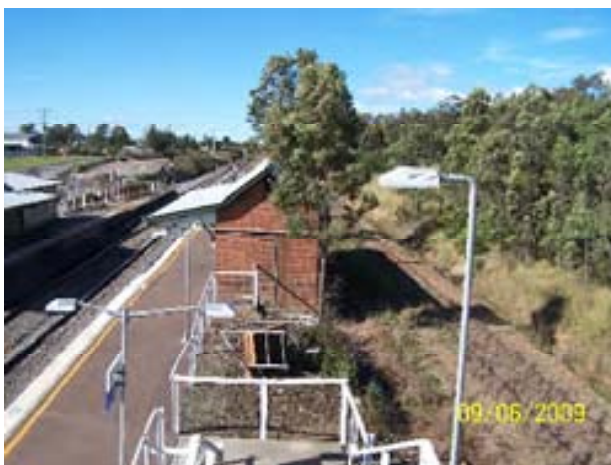
Figure 2.26

Southerly of the previous figure, this figure presents detail of the Branxton down platform and the loop siding from the deck of the footbridge.

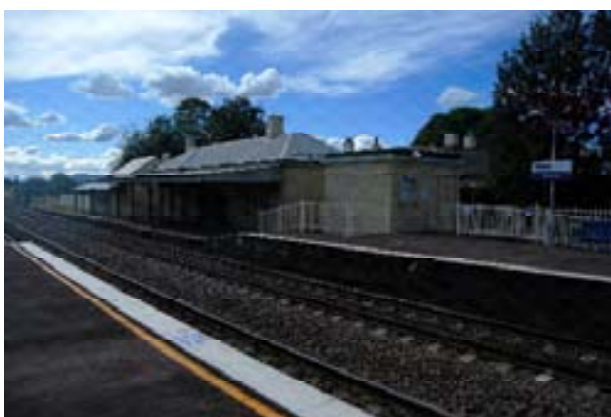
Figure 2.27

Buildings of the up platform at Greta Railway Station. Note the addition of a concrete riser on the easterly end of the platform to facilitate boarding modern passenger cars.

Survey of the Greta Railway Station Precinct reflected the descriptions of the precinct's properties contained in the State Heritage Register and the ARTC s170 Register. Upon inspection the Up platform contained a series of buildings in keeping with the age and style of this historic station, and is depicted in Figure 2.27. From east to west, these buildings comprised a flat roofed brick building, possibly a convenience block, the brick main station offices and waiting room building, the brick parcels office and a weatherboard signal box.

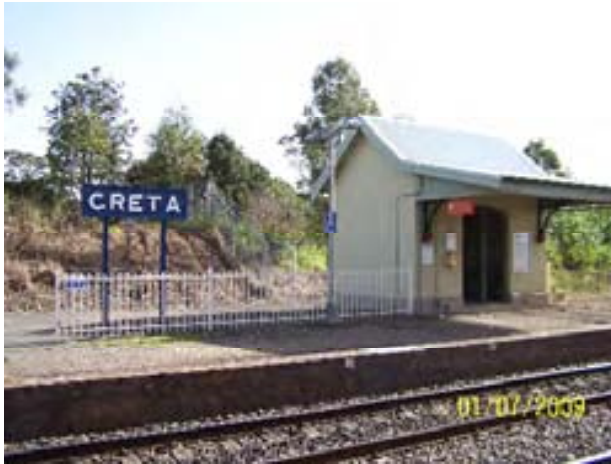
Figure 2.28

Detail of the building on the down platform at Greta, also highlighting the historical nameboard (although now white on blue, not in the former standard white on black).

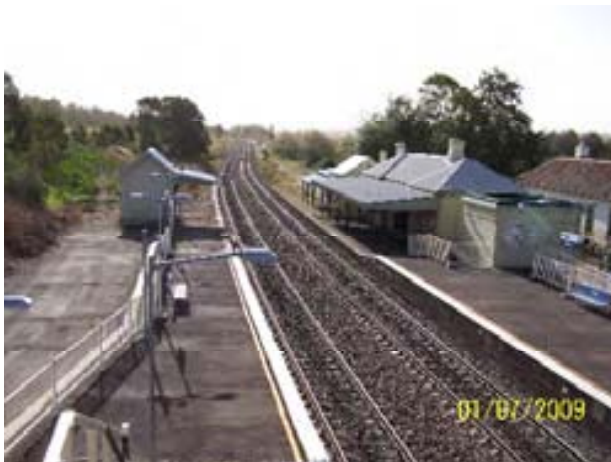
Figure 2.29 (below left)

Elevated panorama of the Greta Railway Station precinct, looking westerly from the deck of the station footbridge.

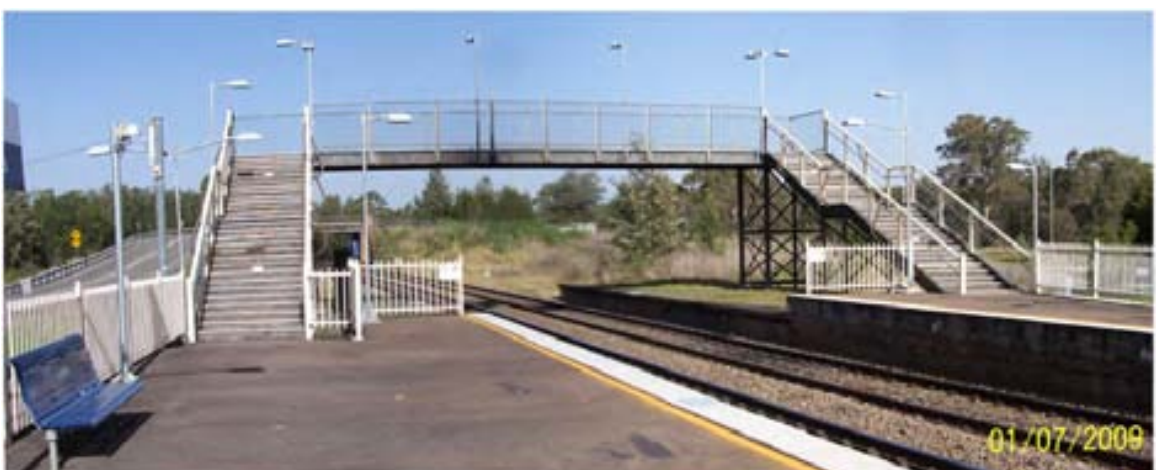
Figure 2.30 (below)

Looking east from the up platform, composite view of the footbridge at Greta Railway Station, noting that both staircases lead from the platforms. This photograph also emphasizes the height of the riser on the down platform to accommodate the boarding height of two-car modern passenger trains.

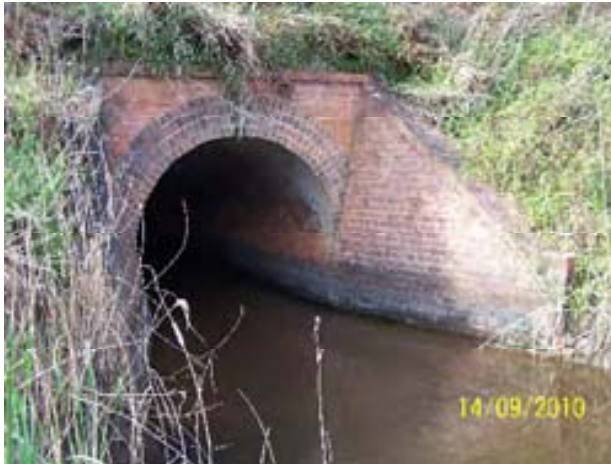
Figure 2.31

The culvert at 219.615 was a good example of a large culvert in operation. The brickwork of headwall, arch portal and drain arch appeared to be in good condition. Note the four soldier course of the arch...

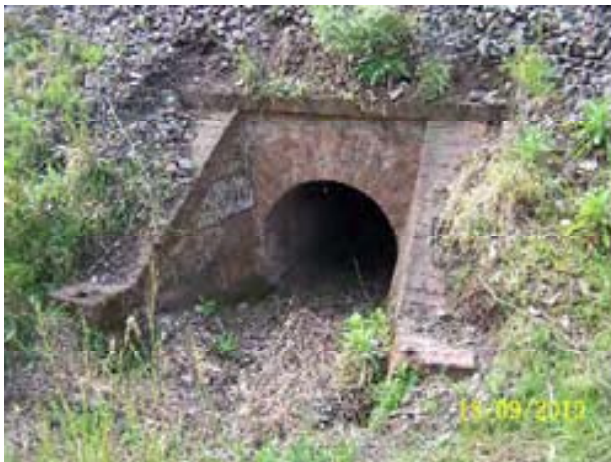
Figure 2.32

..when by contrast the culvert at 213.892 was a working example of a smaller culvert, in similar pattern but significantly scaled down. Note that here the arch was formed in three soldier courses.

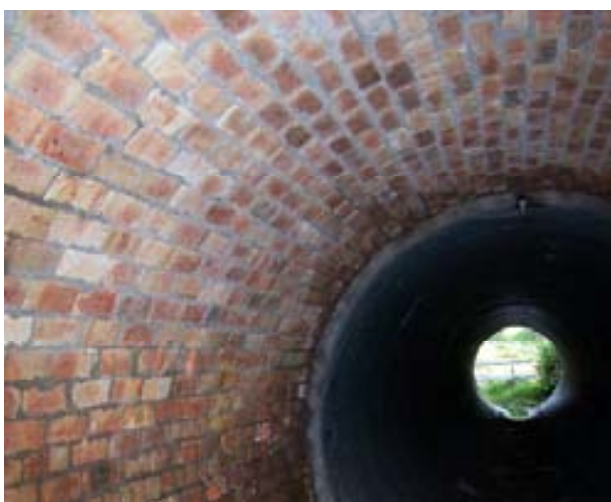
Figure 2.33

In the culvert at 214.566, evolution as the consequence of maintenance showed in a culvert in which the drain arch had been formed in stretcher bond – possibly itself a modern development, which in turn had been reinforced by concrete (probably pumped) above corrugated galvanised steel cylindrical formwork...

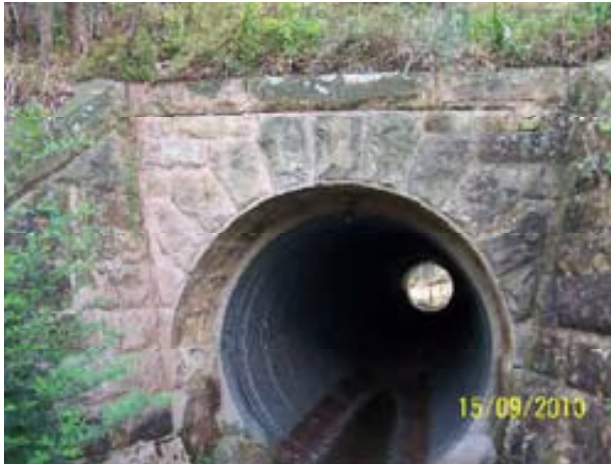
Figure 2.34

...while on the southern side the headwall and wing walls appeared to be in the original sandstone arch and the drain arch appeared to also be of sandstone before the commencement of re-lining.

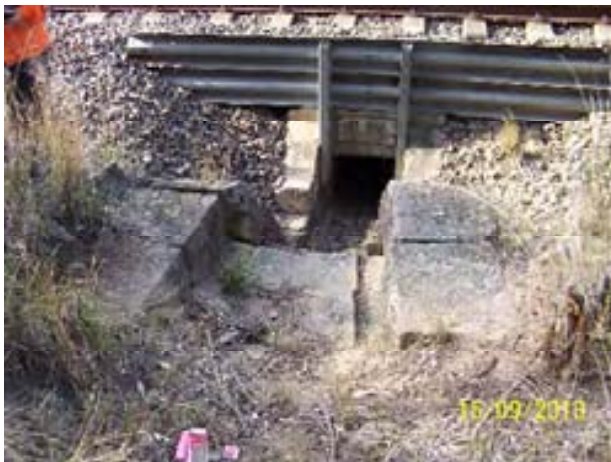
Figure 2.35

In a total contrast (and unique in the study area), the small culvert at 213.690 was formed from dressed sandstone that collected water from a small splay on a bank at about the same height as present tracks and channeled the collected water down a steep slope then shallow slope by way of a stone sluice to a sandstone box culvert, the drain of which was walled and floored in dressed sandstone, the latter formed into a dish formation. The roof had been replaced by cip concrete.

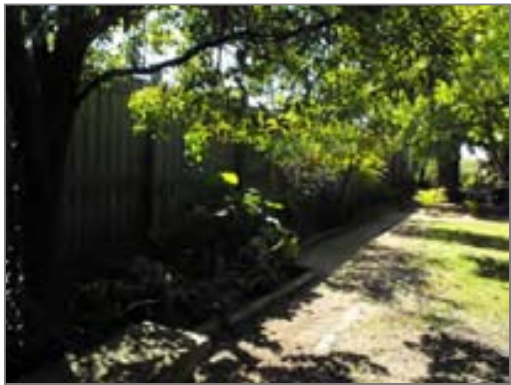
View of northern fence line - Clifton property boundary. The rail corridor is immediately adjacent to fence.

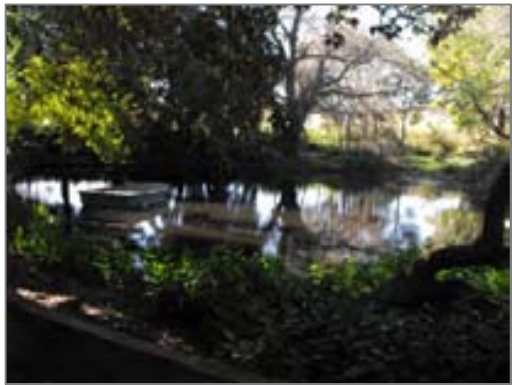
Ornamental lake in northern precinct of restored garden, approximately 20 metres south of rail corridor.

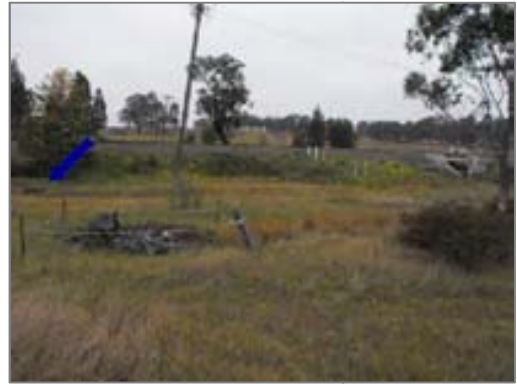
Four of the six underground water tanks were located without difficulty due to the presence of substantial structural remains. The tanks were circular in form and constructed of two leaf brickwork with internal render. Three of the four tanks had been filled with general rubbish including corrugated iron, fencing timbers and wire among other things. The fourth tank was full of water. The location of the remaining two underground tanks was not positively identified although landform evidence indicated the potential for locations to exist in alignment with the found tanks.

View showing rail corridor, Allandale Road underbridge at right, underground water tank in fenced area and fireplace base at blue arrow.

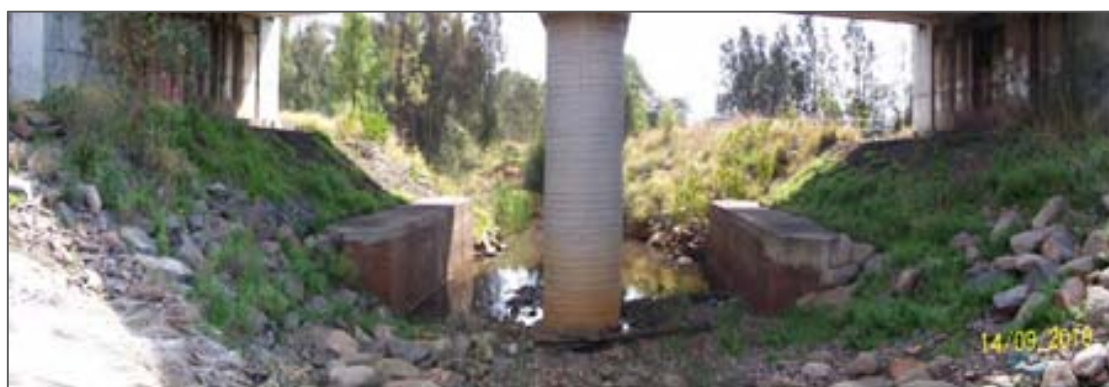
A composite view of the Jump Up Creek Underbridge precinct showing the stumps of an earlier bridge framed by the modern concrete structure.

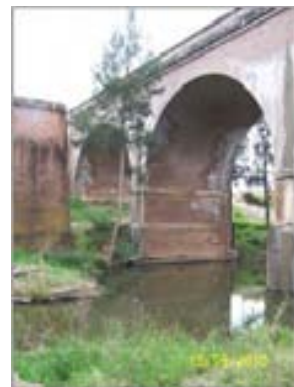
The remaining Black Creek underbridge has been well described in heritage documentation and presents as an elegant as well as massive masonry construction. In general terms, the structure was founded on a sandstone footing, and sandstone was also coursed as a footing at the branch of the three arches. Sandstone was also used in three courses (including two string courses) as a footing for the parapet wall and as a single course for parapet wall capping. The bulk of the structure was of solid brick: using the second pier as an example, the structure comprised 57 courses between footing and the sandstone course at the arch branch; 92 courses between the arch branch and sandstone string courses at the foot of the parapet wall (including a sawtooth string course). The arch was comprised of 8 soldier courses. An unusual feature of the structure was the use of engaged columns in the abutments, splayed at the base in the nature of a buttress. The description of the internal structure of the piers was borne out by the obvious continued function of the drains, from weep holes in the centre line of piers 20 courses below the sawtooth string course.

Second and third arches of the present Black Creek Bridge contrast in height and mass with the first pier of the original bridge.

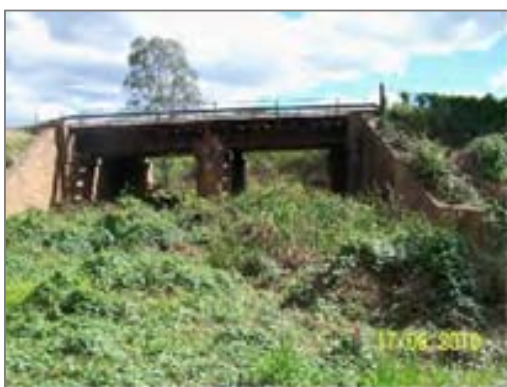
Evolving styles of bridge technology were evident at the crossing of Sawyers Creek. In an earlier (perhaps original) form, the bridge had been constructed as a single line structure with brick abutments and a single central brick pier supporting iron/steel beams. The leading and trailing edges of the pier had been chamfered. The structure closely resembled the style of the single line structure at Black Creek. On this bridge, timber sleepers were still in evidence. With the duplication of the line, the style was maintained with brick abutments and central pier, however in a later modification, metal beams had been replaced by precast concrete sections.

The original Sawyers Creek Underbridge.

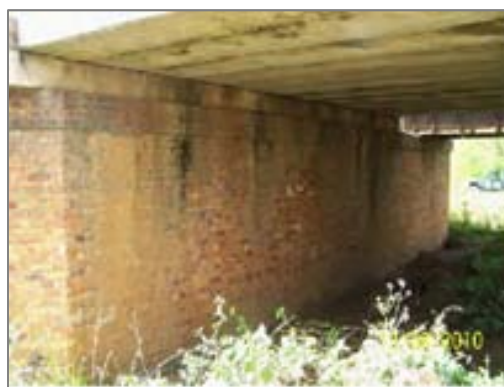
Metal beams had been replaced by precast concrete sections.

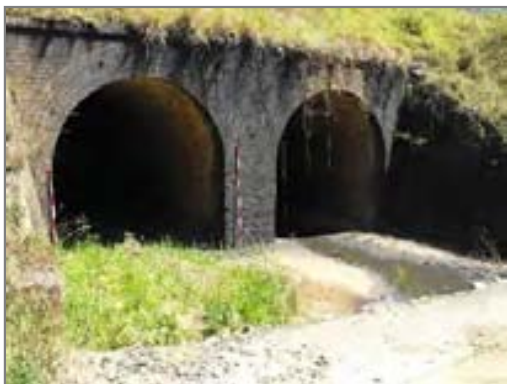
On the upside, headwall height for each arch was 4100 mm, arch height 3430 mm, drain width 3220 mm and the dishing of the drain was 2775 mm deep. Total length of wing walls was 4280 mm, while the wing walls declined over 3350 mm. The height of wingwalls proximal to the headwall was 3980 mm and distal, 1940 mm.

Northern elevation showing face of brick extension c1915-1916.

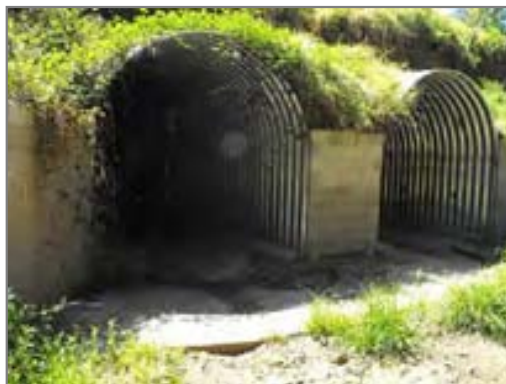
Southern elevation showing 2002 extension.

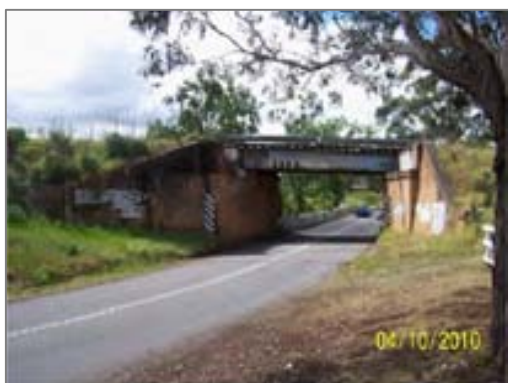
The Wollombi Road Underbridge was observed as a simple structure of east and west solid brick abutments over which the duplicated track was carried on steel beams. In this context, the bridge was not distinguished from many of the same style in the general locality and the State. The bridge comprised abutments of yellow brick in English bond rising 46 courses to four string courses and a single chamfer course above which were platforms rebated to support the ends of steel beams. Above the platforms, secondary abutments were offset to a height of 14 courses. An unusual feature of the abutments was the vacant provision for a third track on the southern side. Wing walls splayed from the northern and southern ends of the abutments.

View of Wollombi Road underbridge, Down side.

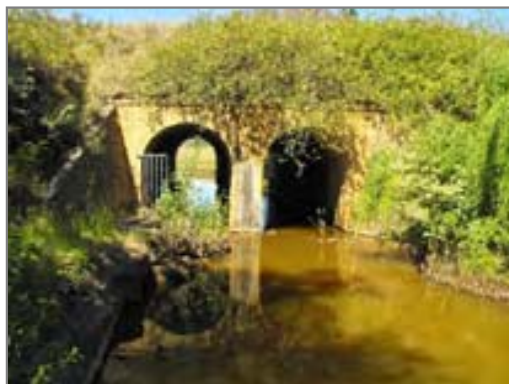
Due to access difficulties, only the northern side of the bridge could be conveniently inspected and accurate measurements were unable to be made because of standing water in the arches and approaches. However, by scaling, it appeared that on the northern brick arches, headwall height above water level was 5750 mm, arch height 4750 mm, drain width 3330 mm while any dishing of the drain obviously could not be estimated. Total length of wing walls was 7400 mm, while the wing walls declined over 6600 mm. The height of wingwalls proximal to the headwall was 5330 mm and distal, 1100 mm.

View of northern elevation, from south.

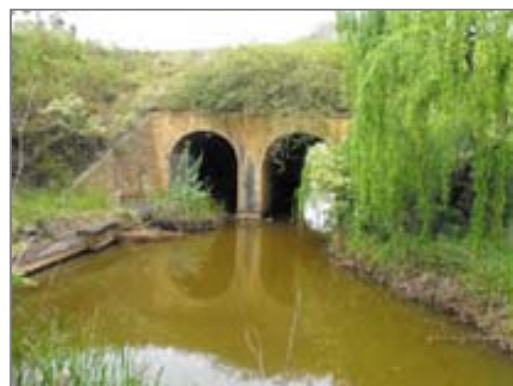
View of northern elevation, from south-east.

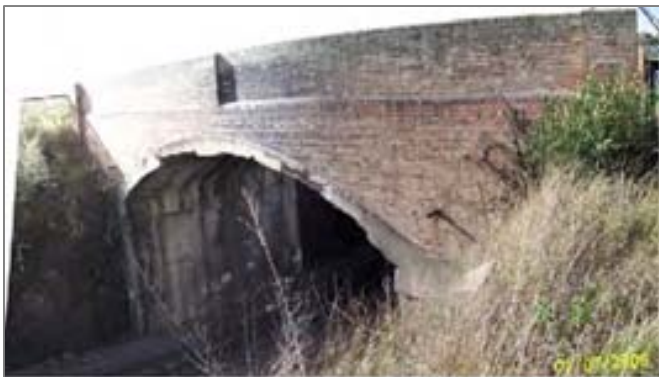
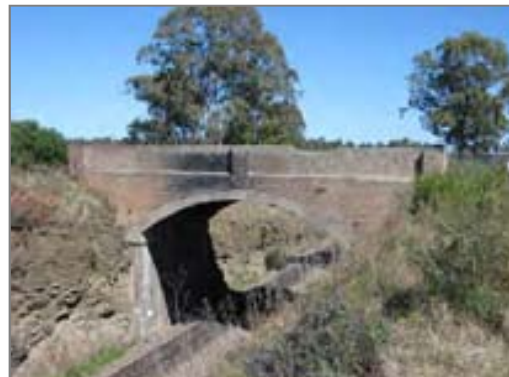
Two views of the westerly side of the Old North Road Overbridge at Allandale, noting in particular the deteriorated condition of concrete work.

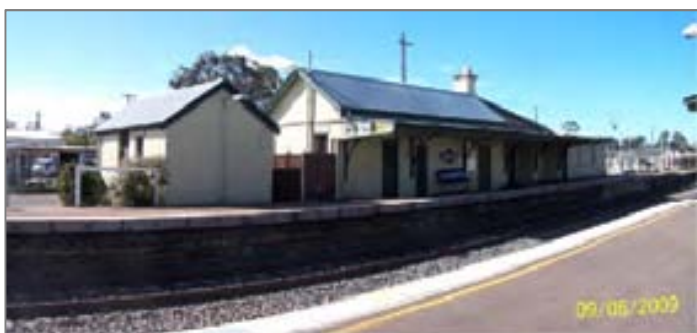
Looking north-east, view of the buildings of the up platform of Branxton Railway Station.

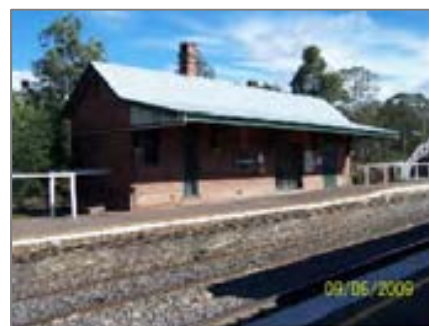
Detail of the building on the Branxton down platform, looking south-westerly.

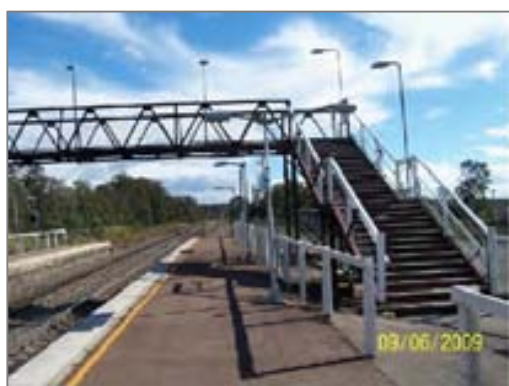
Northern stairway and deck of the footbridge at Branxton. Note that the entrance to the footbridge at this side is from the car park, not directly from the platform.

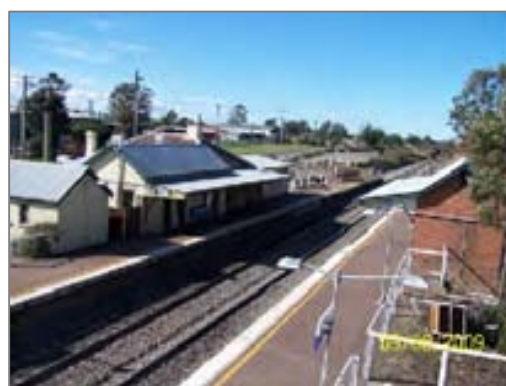
The footbridge provided a platform for elevated overviews of the precinct. To the south of the down platform there was a loop siding which also provided the offtake to the siding for the former Rothbury/Branxton/Ayrfield No 3 Colliery/ies. Off the north-westerly end of the up platform, lay the residue of a siding that served both the Branxton Goods Shed and yard and, while originally looping back to the main, also branched northerly away from the main line. The purpose of this branch was not clear. Suffice it to say that a stop had been imposed on the siding, beyond which lay lengths of lifted track including part of a points system. The various sidings switching were controlled by manual lever blocks at the eastern entry to the southerly loop siding, and at the western re-entry to main/Rothbury branch. A third block controlled access to the northerly siding. At the southern side of this siding remained a large c-i-p concrete block that had formerly supported the goods yard crane, while at the eastern end of the goods yard, north of the platform, lay the remains of a siding that had once served an Oak Milk Factory fronting Railway Street near its intersection with Short Street.

From the footbridge, an elevated panorama of the Branxton Railway Station precinct looking easterly.

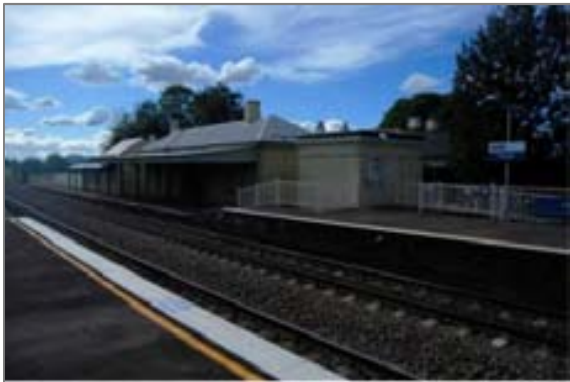
Buildings of the up platform at Greta Railway Station. Note the addition of a concrete riser on the easterly end of the platform to facilitate boarding modern passenger cars.
