## Appendix H Non-indigenous Heritage Study

Non-indigenous Heritage Study:  
Maitland to Minimbah  
Third Track Project

Australian Rail Track Corporation

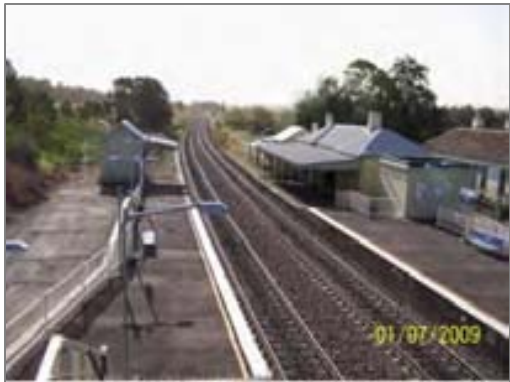
Elevated panorama of the Greta Railway Station precinct, looking westerly from the deck of the station footbridge.

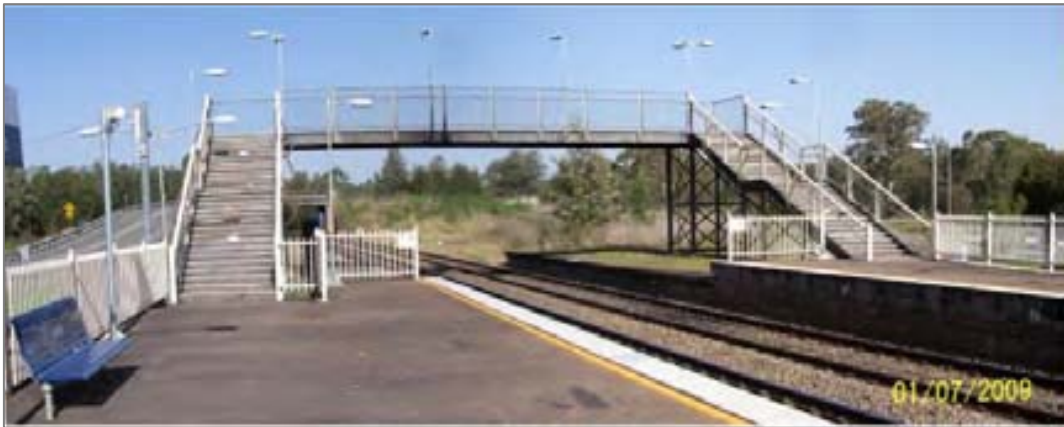
Looking east from the up platform, composite view of the footbridge at Greta Railway Station, noting that both staircases lead from the platforms.

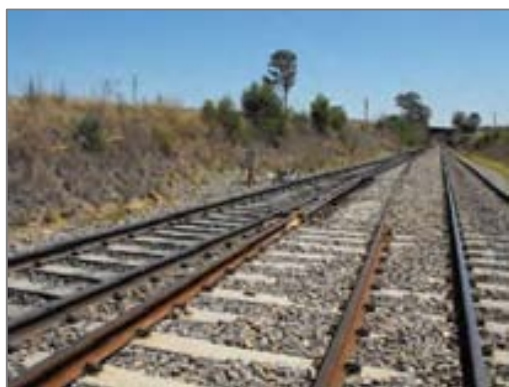
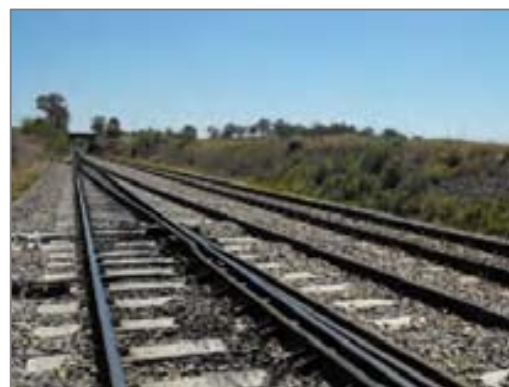
Close investigation of the area (chainage 204.900 ± 200) revealed no positive surface sign of the location or material evidence of this station platform. Some plantings of exotic succulents in the wall of the cutting in the area perhaps indicated general area of a former platform. Given the relatively recent earthworks within the former station precinct, it is unlikely that sub-surface evidence remains.

Downside (left) and upside (right) embankment in the vicinity of the former Allandale Railway Station. The Old North Road overbridge can be seen in the distance.

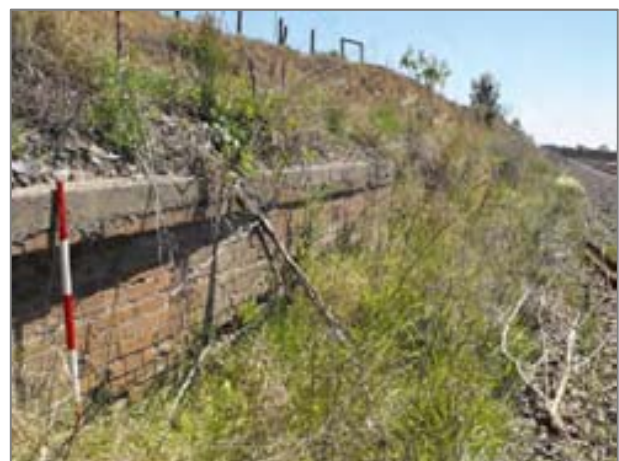
Located on the downside, Farley Railway Station remains were represented by the platform structure, although partly overgrown and degraded by its having been integrated into the service road corridor. The buildings of the station were demolished about 20 years ago, although footings would almost certainly be retained sub-surface. The residual platform was located about 150 metres west of the Wollombi Road Underbridge and was approximately 200 metres long and faced by a brick and concrete wall. Vestigial remains of the original 'antbed' surface of the platform could be seen.

Remaining platform face of the former Farley Railway station looking west.

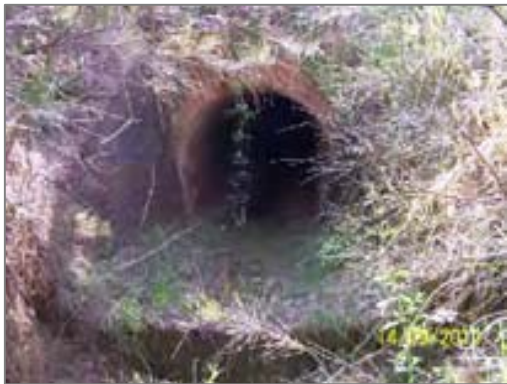
Downside intact brick arch culvert with brick floor and external dish drain.

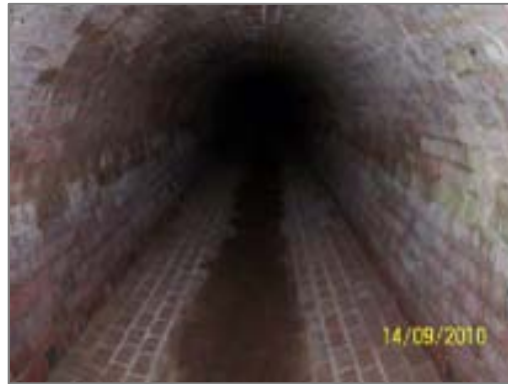
This culvert presented as a brick arch structure, notably on the Down side. A concrete pipe extension had been applied on the Up side. The Down side brickwork was in excellent condition: the red bricks indicated this as an element of original GNR construction c.1860.

Internal view of culvert showing intact dish brick floor.

...the headwall and wingwalls on the Up side will, of necessity, be demolished and relatively modern extension materials will be removed. Any earthwork formation can be undertaken in such a way as to avoid damage to, and consequent loss of heritage values by, the drainage structure(s) and Down side headwall(s), wingwalls and surviving aprons.

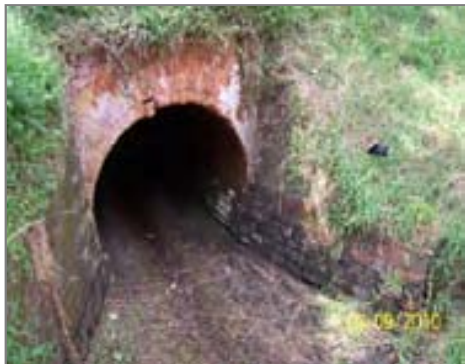
Downside of culvert 214.685 showing intact brick arch and brick apron/floor.

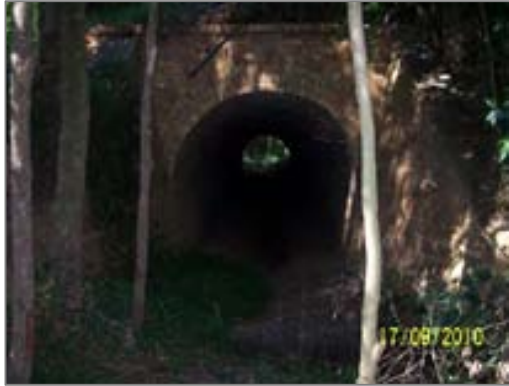
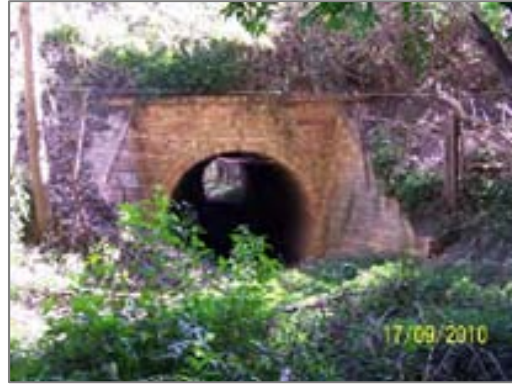
This culvert presented as a brick arch structure, with complete headwalls, wingwalls and aprons in brick on both Up and Down sides. The intact drainage arch reflected the evolution of the original red brick arch of the 1860s and the yellow brick extension of the duplication period.

View of Down side (L) and Up side (R)  
aspects of the culvert at 210.522km.

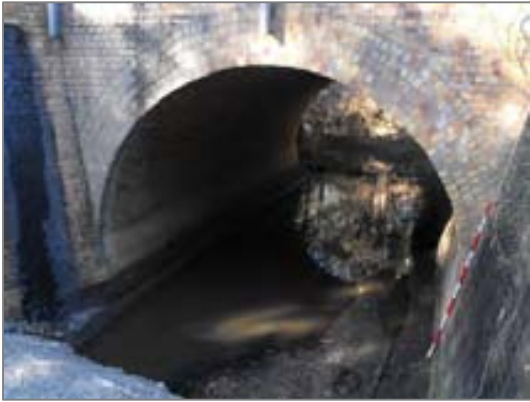
Up side view of the single cell culvert at 209.174km.

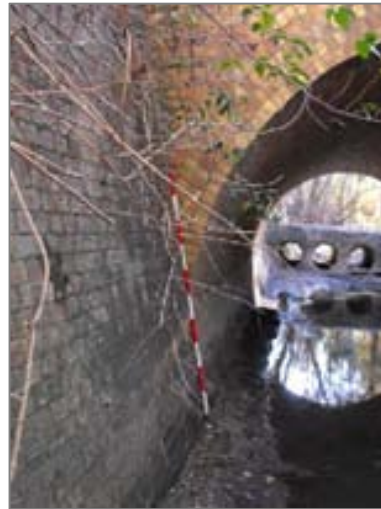
Down side view showing the country side, flat-angled wing walls and brick floor/apron. culvert.

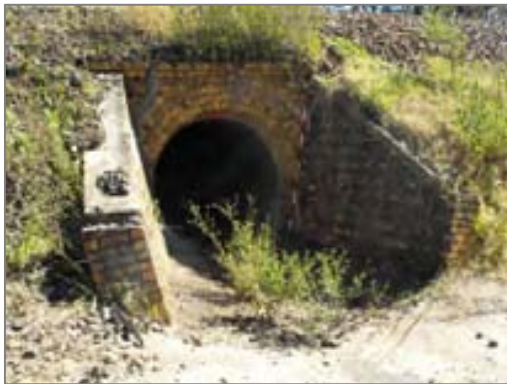
Upside of culvert showing intact brick arch with concrete pipe liner.

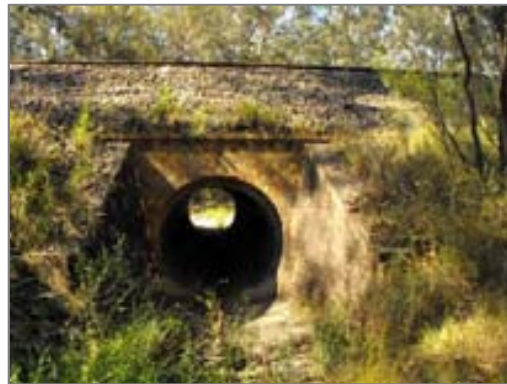
Downside of culvert showing intact brick arch with concrete pipe liner.

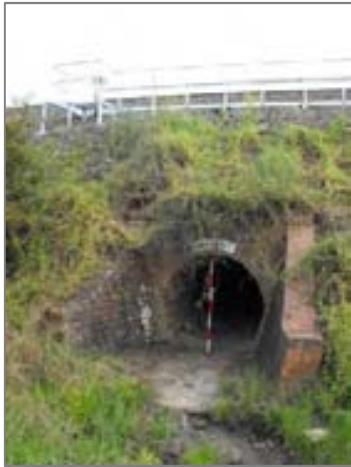
This culvert presented as a brick arch structure, with complete headwalls, wingwalls and aprons in brick on both Up and Down sides. The intact drainage arch reflected the evolution of the original red brick arch of the 1860s and the yellow brick extension of the duplication period.

Down side of culvert 196.561 showing intact red brickwork of arch and brick floor (above and below).

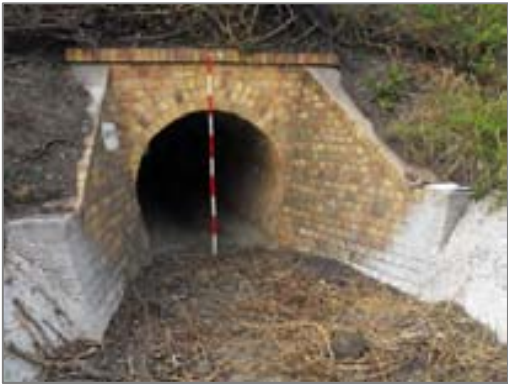
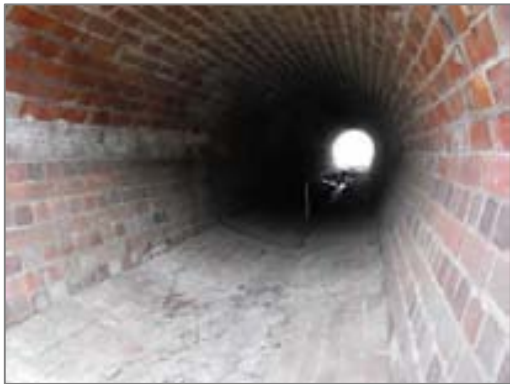
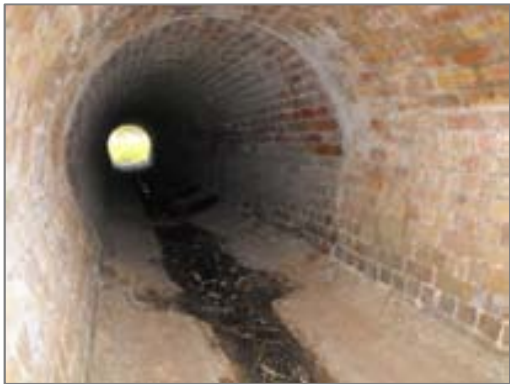
Up side of culvert 196.561 showing yellow brickwork of extension structure c1915-16 (above). The interface of the extension to the original c 1860 brick arch structure can be clearly seen (below).

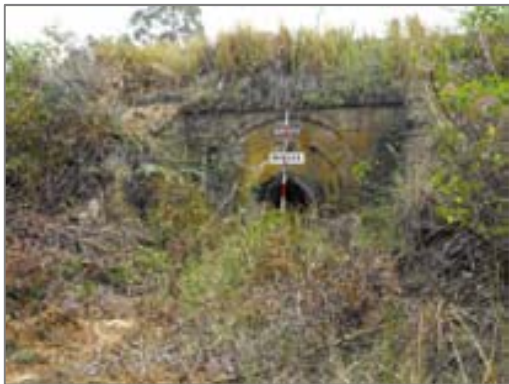
Downside of culvert 196.481 showing very early concrete pipe insert and concrete infill.

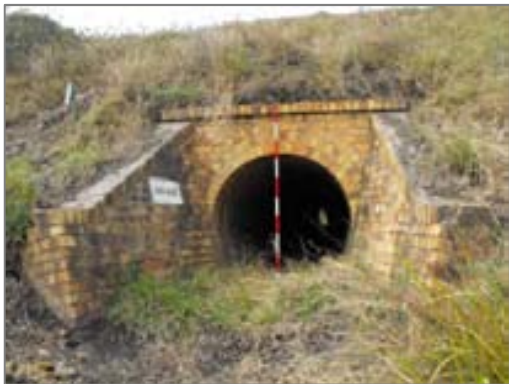
Another feature of this culvert was a survey marker placed on the Up side wingwall brickwork (see photograph below).

Upside of culvert 196.481 showing intact brick arch and brick floor.

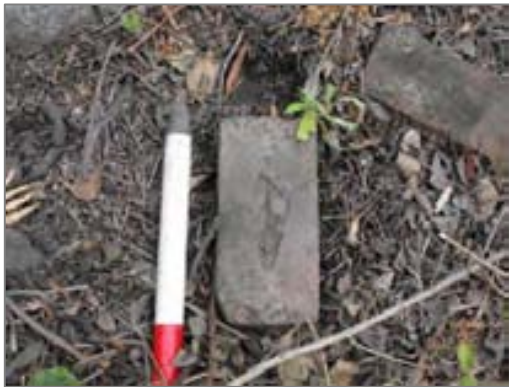
Red brick with diamond frog found on site precinct, probably made by Maitland brickmaker.

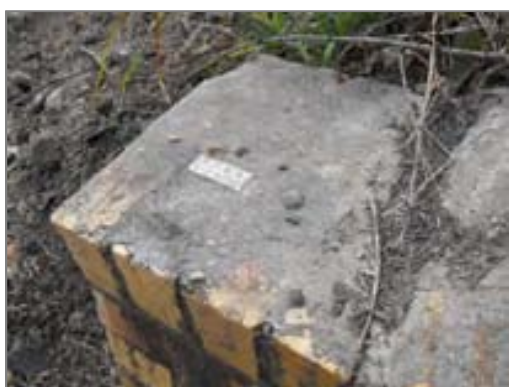
Survey mark on the upper surface of Up side wingwall.

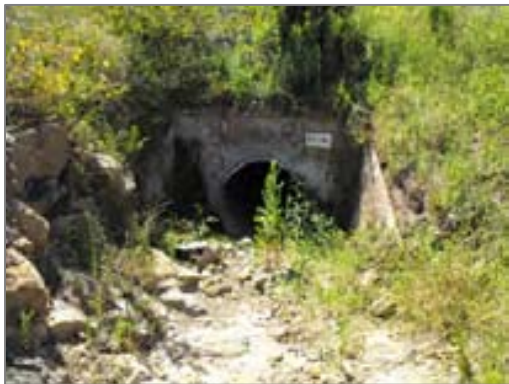
This culvert presented as a brick arch structure, notably on the Down side, where the red bricks indicated this as an element of original construction of circa 1860. On both sides, it appeared that both the headwalls and drainage arch had previously been assessed as needing support: on the Down side, where red brickwork indicated this as an element of original GNR construction c.1860, the brickwork had been bagged around the portal, on the Up side (yellow brickwork dating to the duplication period) a new portal and lintel had been placed in concrete while the arch had been reinforced with galvanised steel liner and backfilled with pumped concrete.

Downside of culvert 196.280 showing intact brickwork (above) and corrugated iron liner with concrete infill (below).

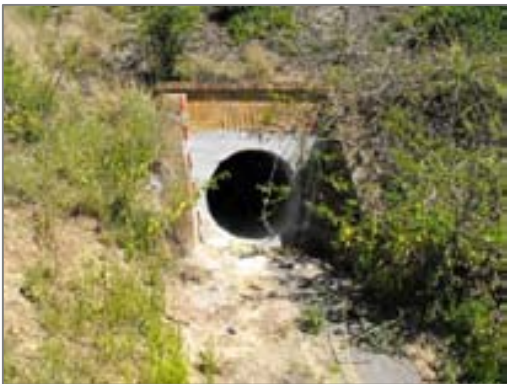
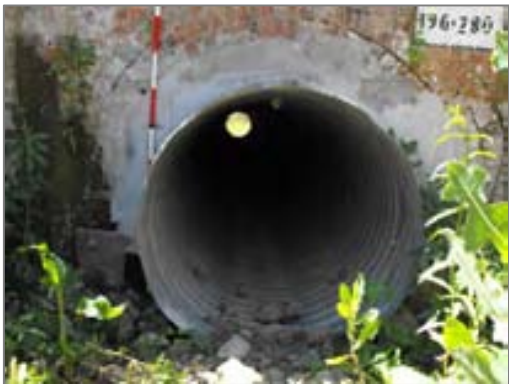
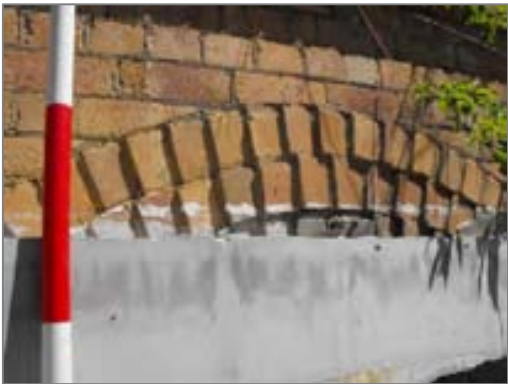
Up side of culvert 196.280 showing residual intact brickwork (above) and corrugated iron liner with concrete lintel with concrete infill (below).

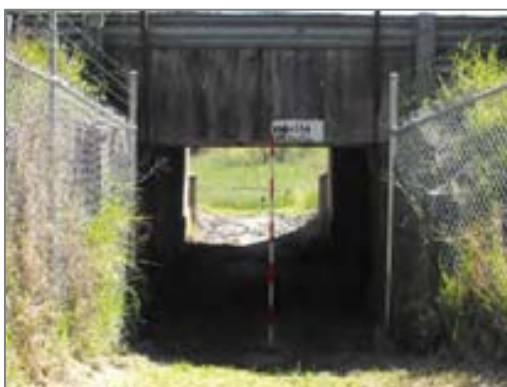
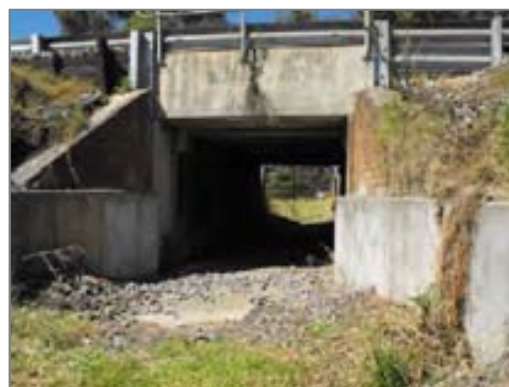
This culvert presented as a box culvert underpass, possibly designed as a pedestrian underpass for connection between the Up and Down sides at Farley Railway Station. Brickwork was laid in English Bond and this part of the structure probably dates from the duplication of the railway. The structure had undergone modifications for reinforcement and the floor was of recent concrete, likely replacing an original brick floor. There was no obvious interface between different types of bricks or brickwork and the need for a pedestrian underpass was unlikely to have arisen for a single track, and was nor a common feature of 19<sup>th</sup> Century station design, suggesting that the brick structure had been constructed originally under the duplicated tracks.

Downside of culvert 195.666 (above) and upside (above right). (see also overleaf)

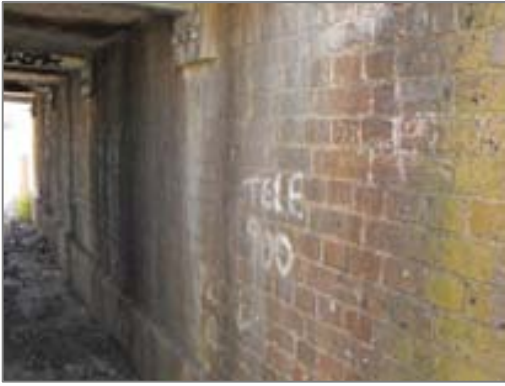
Detail of culvert 195.666: English Bond brickwork.

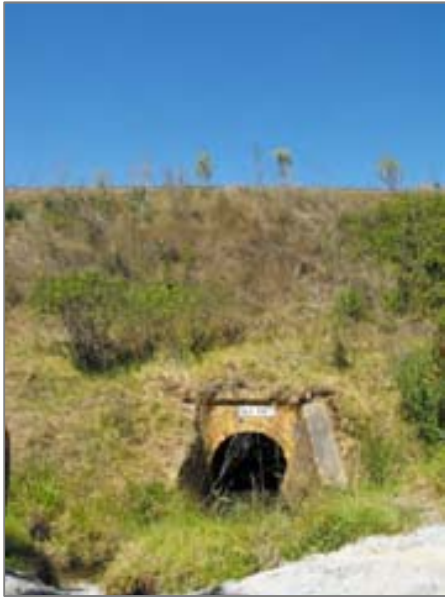
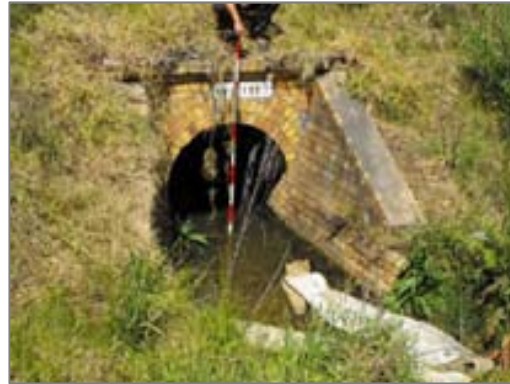
This culvert presented as a brick arch structure on the Up side, where yellow brickwork indicated this as a modification of the original culvert in the duplication period. Access to the Down side was not possible due to the treacherous terrain, however there is little doubt that this side, the culvert, Headwall, wingwalls and apron will have been original GNR construction. There were no indications of modification on either side and the culvert appeared complete.

Up side of culvert 195.133 showing the elevated rail corridor (left) and unmodified brick arch of the 1915-16 extension (above).

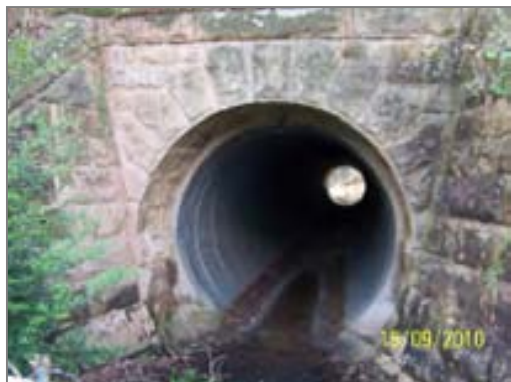
Downside showing original stone culvert with fine gauge corrugated iron sleeve insert (left) and wing wall (below).

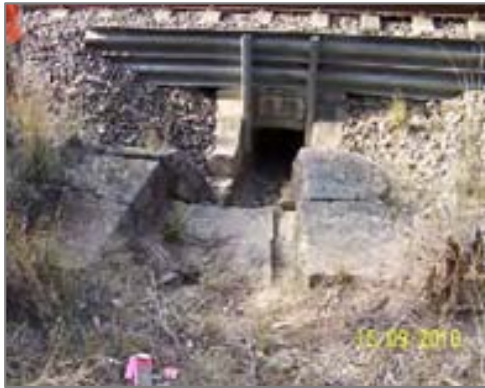
General view showing downside box culvert.

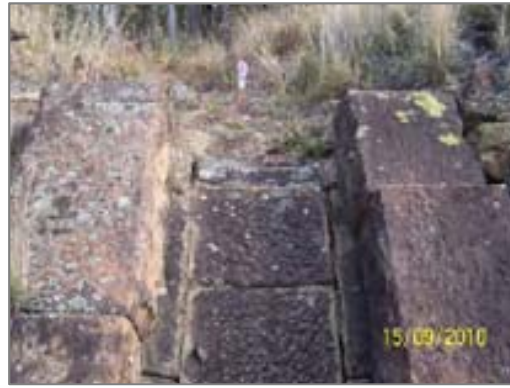
Detailed view of sluice stone work.

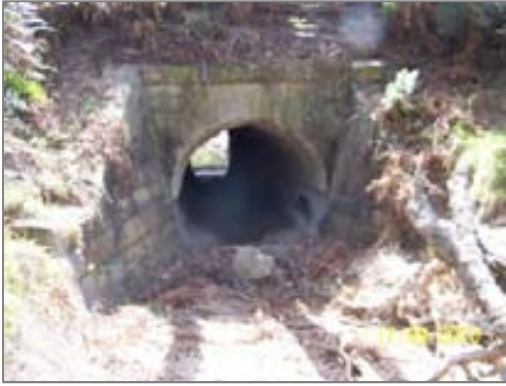
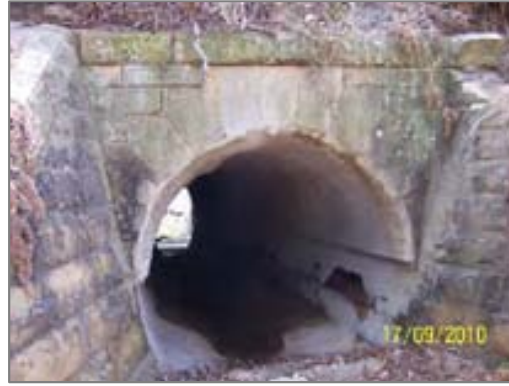
## Photograph

This culvert presented as a stone structure on the Down side, designed site specifically in form and material – the proximity of other stone culverts of the group suggests a local source. The concrete render in the drainage arch appeared to be an early placement and possibly pre-dates the track duplication period: 1914-16. The Up side had been modified during track duplication works c1915-16 by demolition of the former stone headwall, wingwalls and apron and extension by brick arch, brick headwall, wingwalls and apron (see Inventory: Site 24).

Wide view of the Down side elevation of the stone culvert (left) and detailed view of headwall, portal and insert (right).

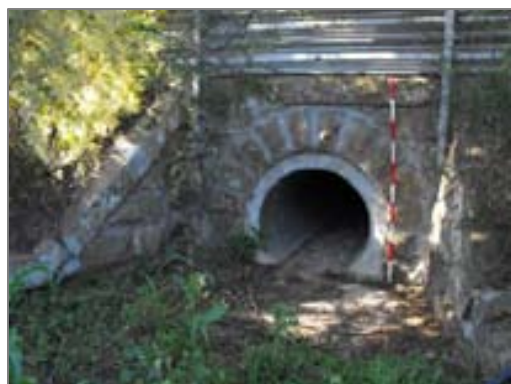
This culvert presented as a unique style of stone box culvert on the Down side, designed specifically for this site and comparatively small in dimensions. The upside had been modified during track duplication works c.1915-16 presumably by brick arch and head and wing walls, but after further modification, now presented as a concrete pipe extension and concrete head and wing walls (of no abiding heritage interest).

View of downside stone culvert showing concrete sleeve insert.

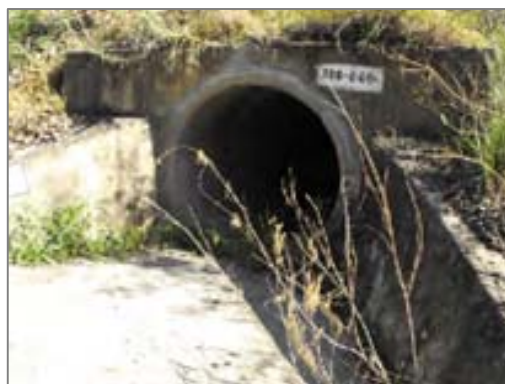
Upside view of concrete pipe culvert extension and cast in place concrete wing walls.
