Report on
Stage 1 – Investigation
and Contamination Assessment

Bundwalls at
Lot 40, Deposited Plan 738126 Patons Lane
Orchard Hills

Project 71102.05
February 2012

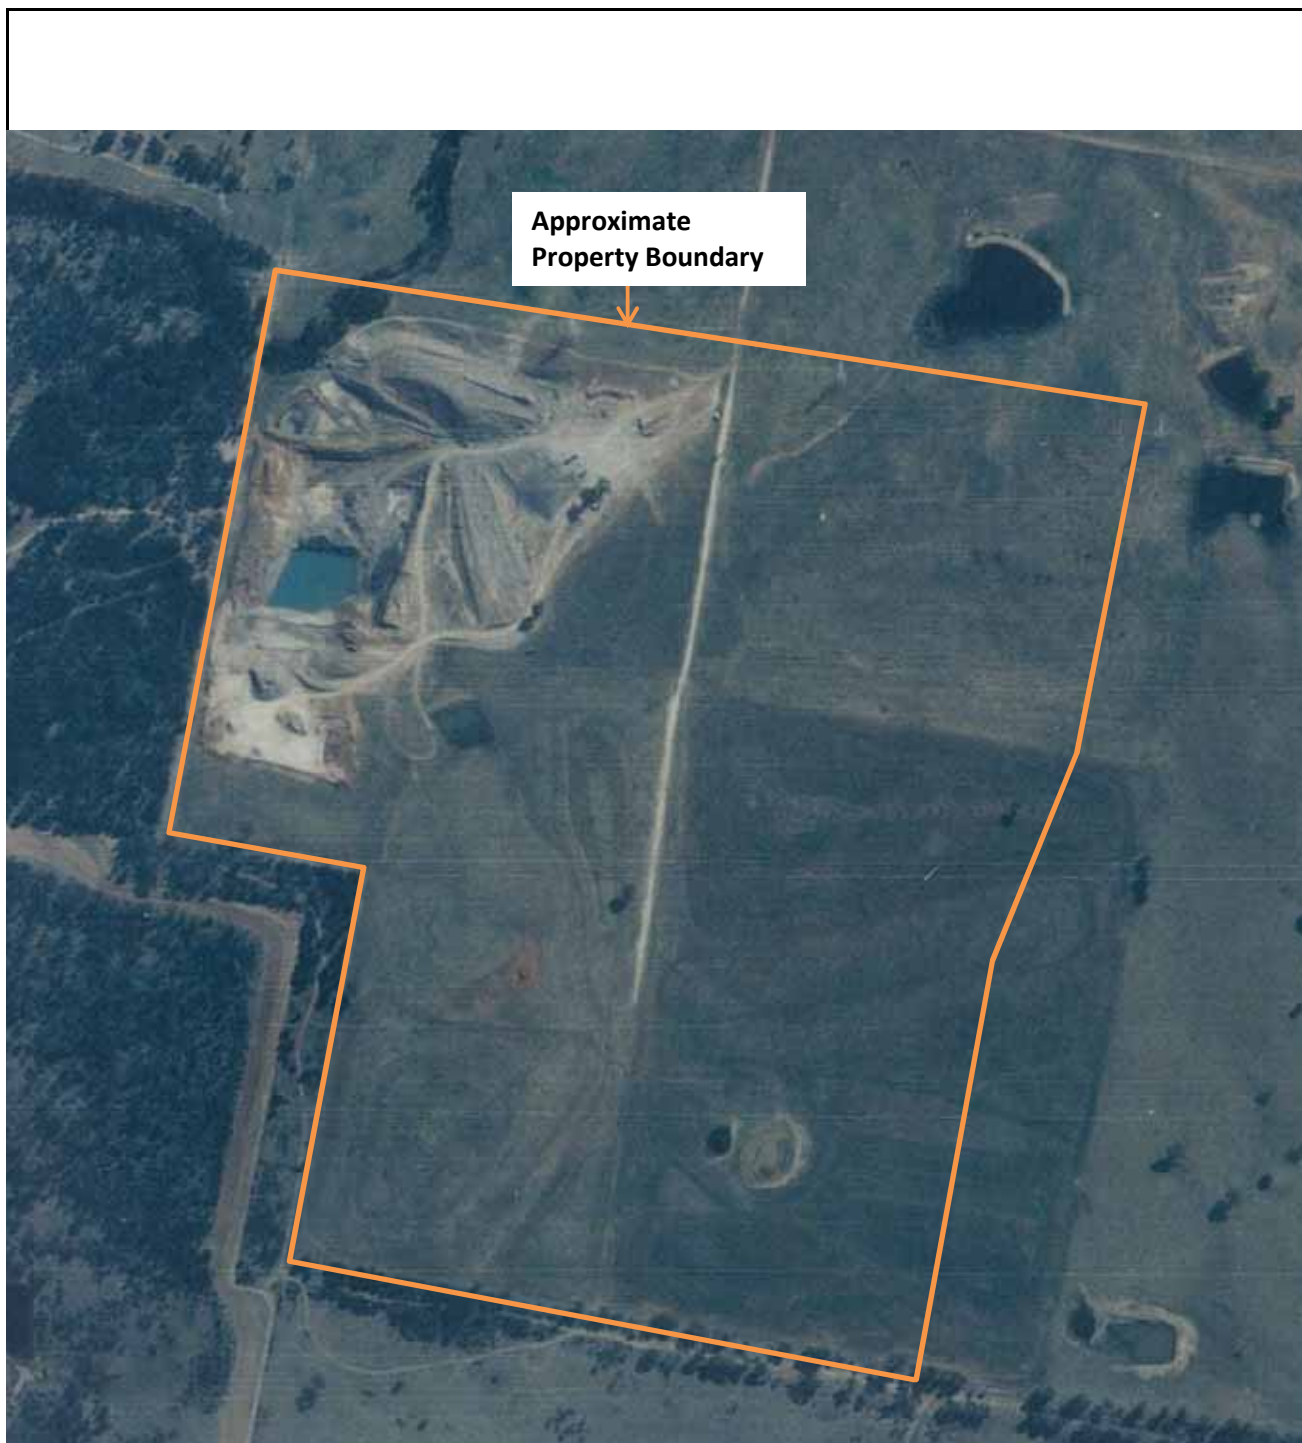
1991 Aerial Photograph Phase 1 Contamination Assess. Patons Lane, Orchard Hills	PROJECT: 71102.05
		PLATE No: C5
		REV: A
	CLIENT: Dellara Pty Ltd	DATE: Jan 2012

1991 – The quarry had expanded by 1991, but was still limited to the north-western portion of the Property. Surface water can be observed in an excavation pit, internal access roads were evident and

some vehicles were present. The remainder of the Property is grassed other than an access road in the centre of the Property which enters from the northern boundary, but did not extend to the southern boundary. Some concentric markings can be observed on the grass, and may relate to lawn mowing or reflect some form of ground disturbance.

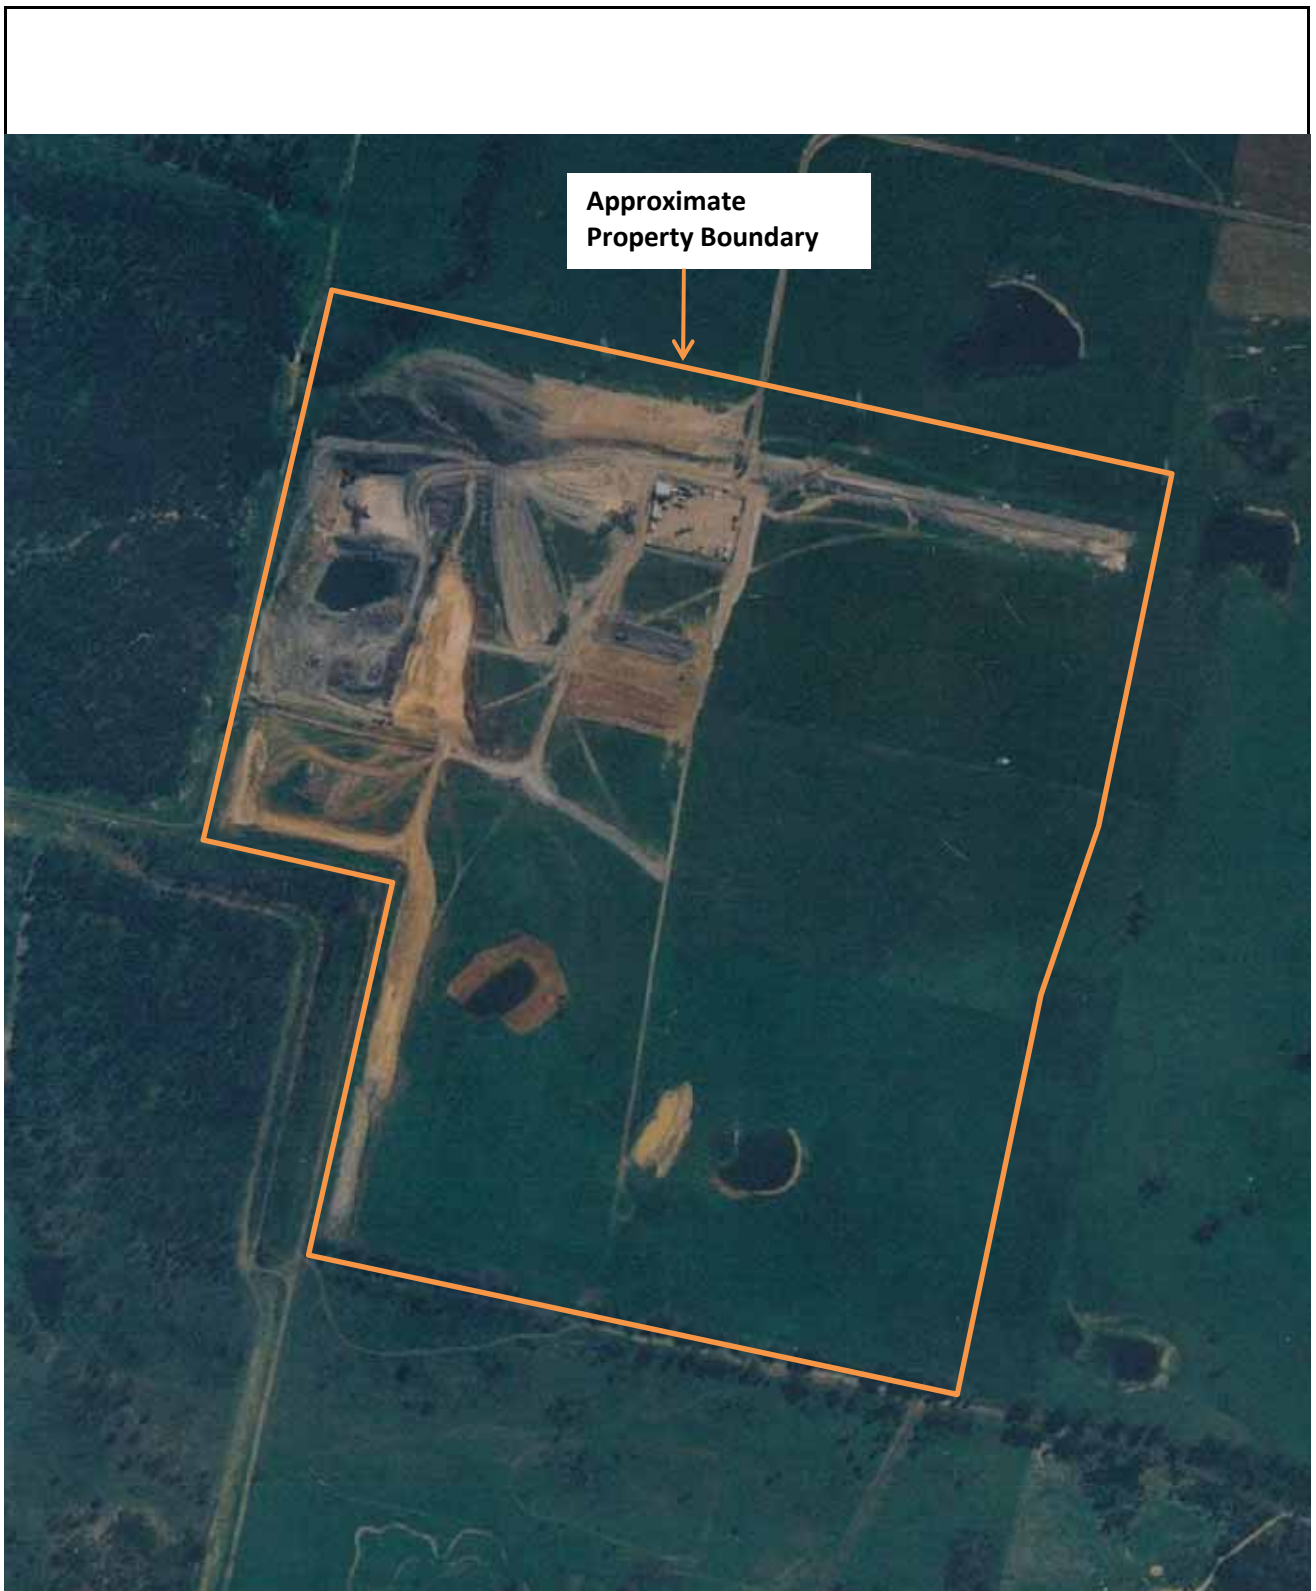
Douglas Partners <small>Geotechnics Environment Groundwater</small>	2002 Aerial Photograph (March) Phase 1 Contamination Assess. Patons Lane, Orchard Hills	PROJECT: 71102.05
		PLATE No: C6
		REV: A
	CLIENT: Dellara Pty Ltd	DATE: Jan 2012

2002 (March) – The quarry had expanded, but was still limited to the north western portion of the Property. Some disturbance (possibly clearing/ excavation/ filling) had occurred along the southern portion of the western boundary and the eastern portion of the northern boundary. Two additional dams had been constructed in the south of the Property. Various buildings and a compound or vehicle parking area were located near the central portion of the northern boundary. A recent housing development can be observed approximately 500 m north of the Property (i.e. The Vines).

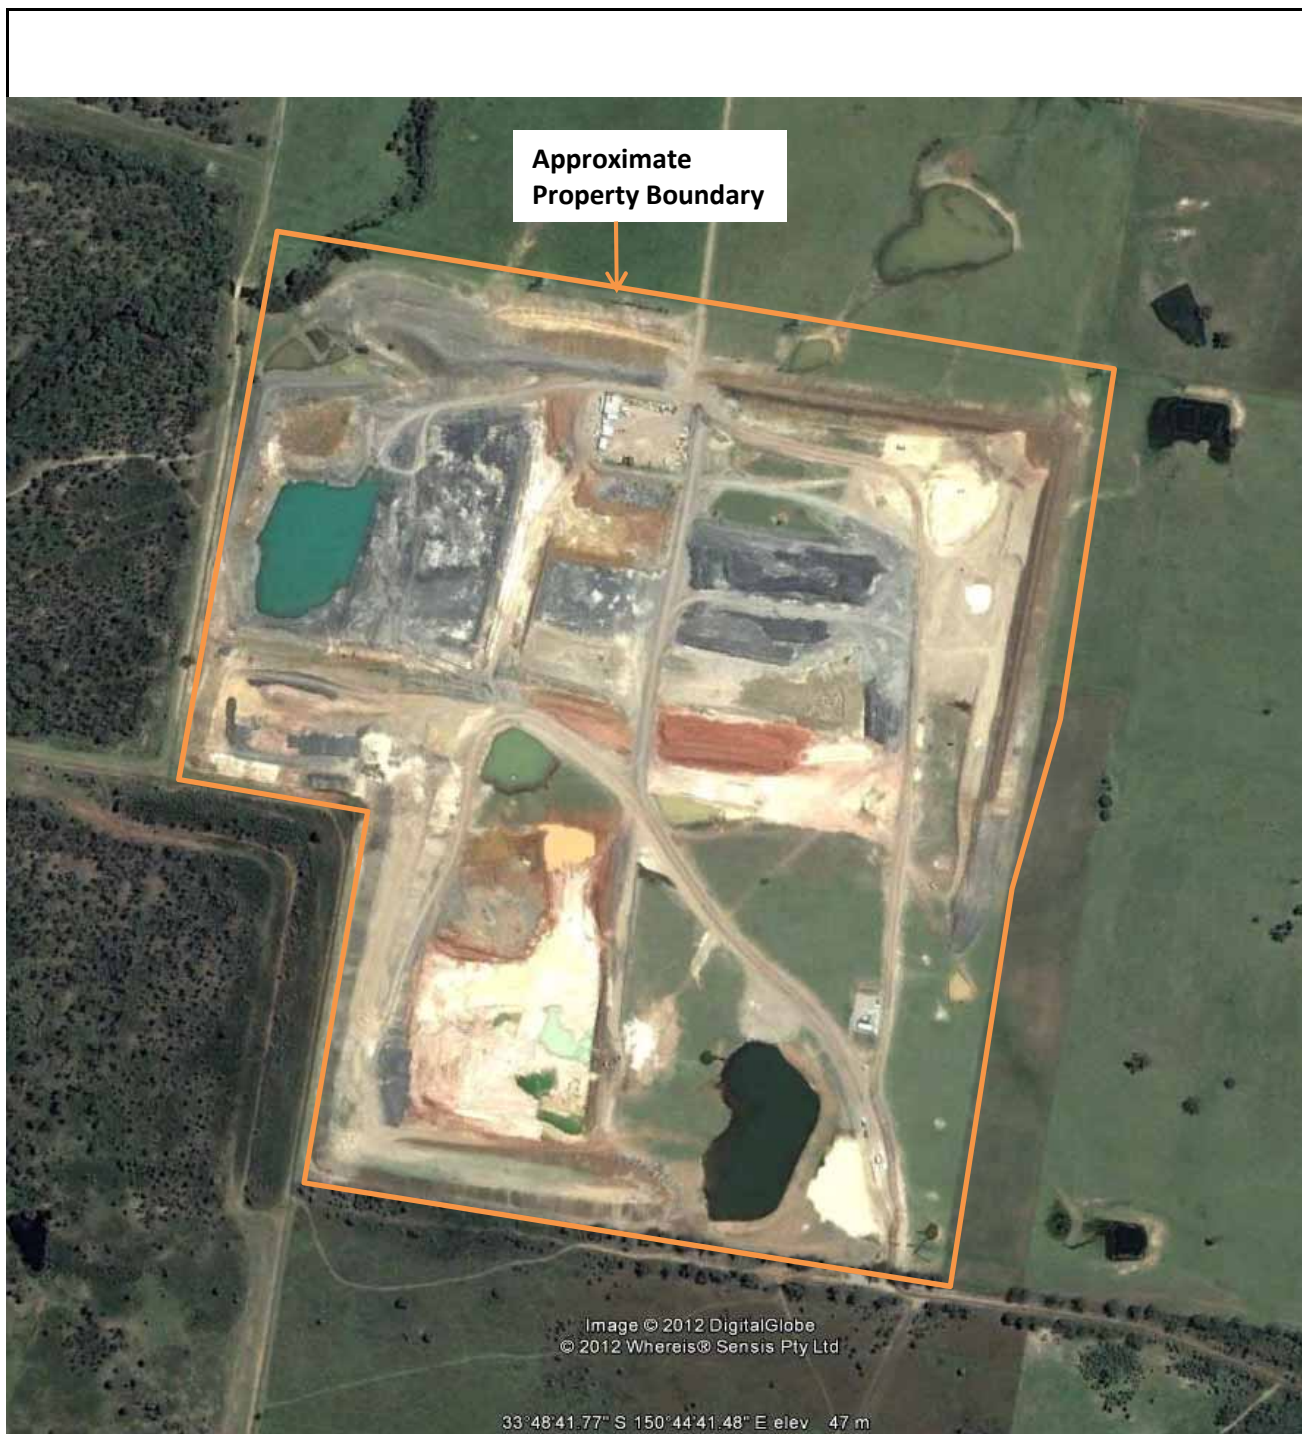
2004 Aerial Photograph	PROJECT: 71102.05
	Phase 1 Contamination Assess.	PLATE No: C8
	Patons Lane, Orchard Hills	REV: A
	CLIENT: Dellara Pty Ltd	DATE: Jan 2012

2004 – The quarry had expanded over the majority of the Property, although development in the south east appeared to be limited to roads, a large dam, a smaller dam and buildings and a vehicle compound or parking area. A structure had been constructed on the internal road in the south eastern corner, and is considered to be consistent with a weighbridge. No significant changes had occurred on surrounding lands. Bundwall 1 appears to have been constructed and Bundwall 4 has been expanded. The dam/ ponded water previously observed in the north west of the Property had expanded by 2004 and appeared to be a large dam. Two further dams, one in the central portion of the property and one in the north had been constructed. No significant changes had occurred on surrounding lands.
