CHULLORA

HERITAGE ASSESSMENT, 1990

NAME OF ITEM: Iron Rack													
No. B63	Map Ref:												
Location: Per Way No. 1 beside Electricians' Room. Precinct G													
Condition: Fair													
Associated Items:													
<p>Description: The iron rack was used to store iron, the iron being part of the stores department. A small 10 ton crane moved the iron. It was brought in on the rail line and was available for workshop use. The racks are made from heavy steel members and the rack may once have been covered by a skillion roof although this could not be verified.</p>													
<p>SIGNIFICANCE ASSESSMENT</p>

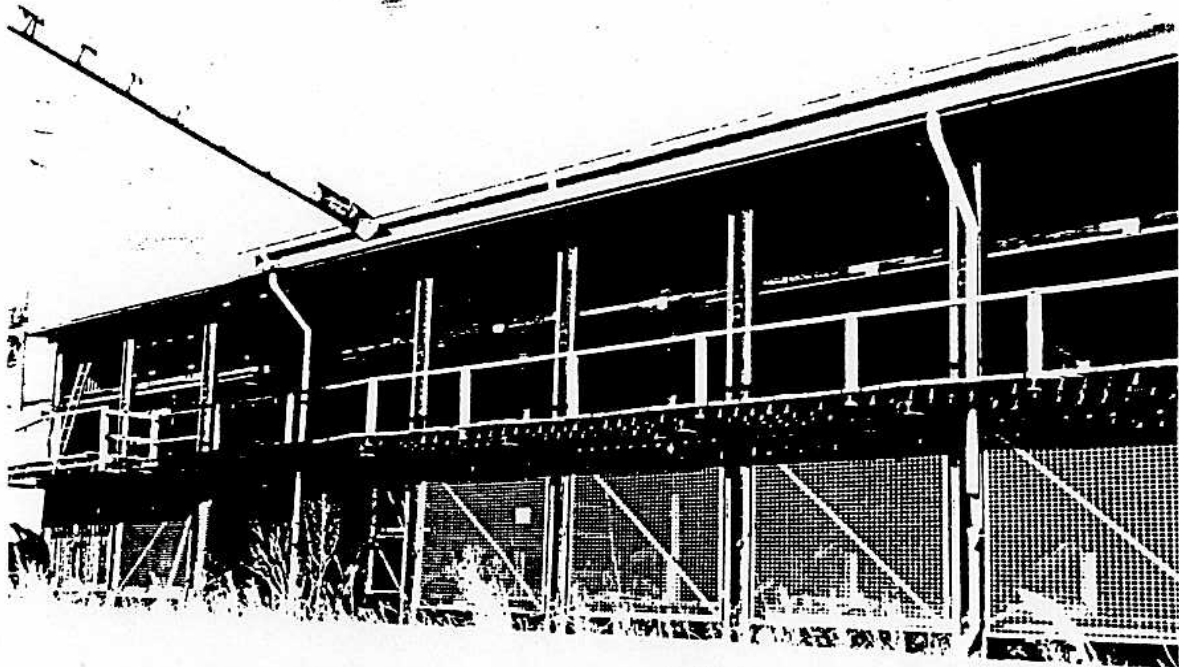
NAME OF ITEM: Timber Rack		
No. B64	Map Ref:	
Location: Western elevation of carpenters/sawmill shed	Precinct G	
Condition: Good		
Associated Items: Furnace Room M27A, OH Crane in shed M26, Sawdust Hopper M34, Carpenters/Sawmill shop B26, Original Furnace Chimney M27.		
<p>Description: The timber racks were used to store timber of various species and sizes prior to distribution among the workshops. The rack is a timber and steel framed lean to with a skillion roof sheathed in corrugated iron butted against the saw mill. Because of the weight supported by the individual racks the building is composed of steel stayed substantial framing members. The upper level has a timber deck about 1.5m wide running its full length with access stairs at the eastern end. The skillion roof is carried forward of the main posts by about 1.5m to provide shelter for the men on the deck.</p>		
SIGNIFICANCE ASSESSMENT Aesthetic Value Historic Association Technological Importance Structural Integrity Interpretive Ability Social Significance	2/5 2/5 3/5 2/5 2/5 2/5 1/5	INFORMANTS: REFERENCES:

RECOMMENDATION: Record	PHOTOGRAPHS: B & W: 90-038-3-12 Slides:

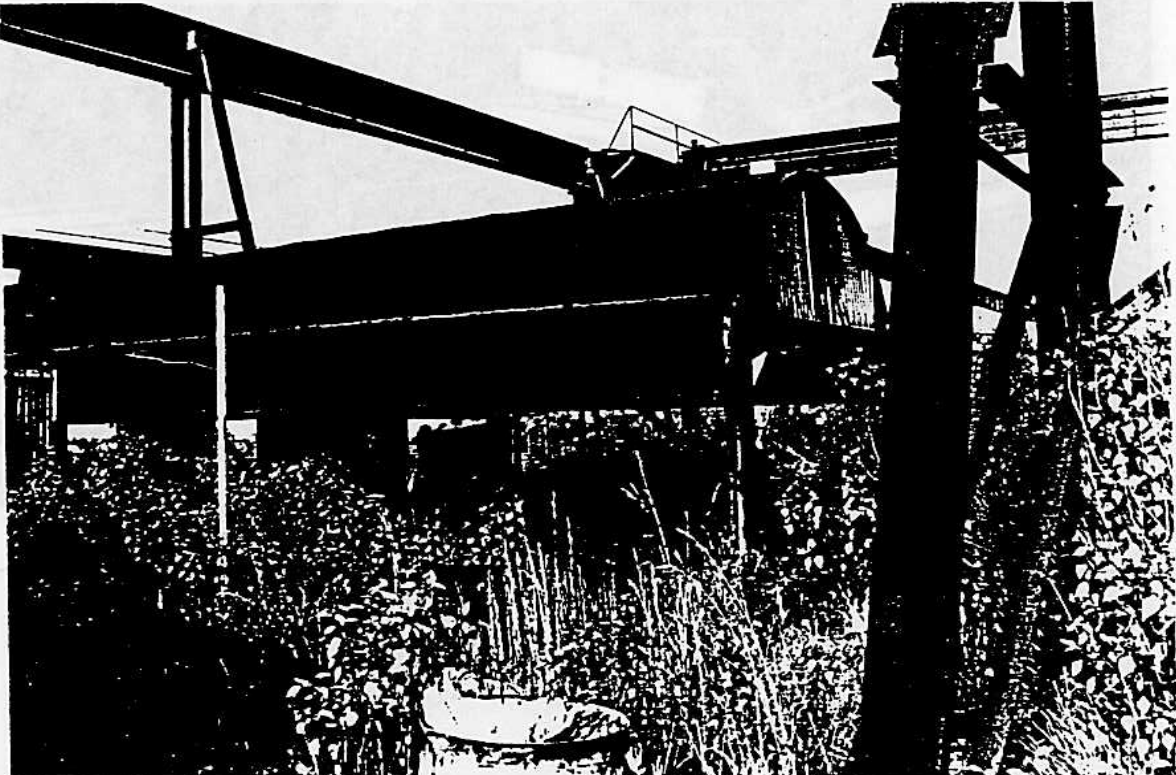
NAME OF ITEM: Saw Bench Shed		
No. B64A	Map Ref:	
Location: Per way No. 1 Beside the main O/H crane	Precinct G	
Condition: Poor		
Associated Items: Timber Trolley M67, Sawdust cyclone M24.		
<p>Description: A steel framed camber roofed building which housed a bench saw beside the Per Way No.1 timber crane. The small corrugated iron structure to the East of the shed probably housed the bench saw motor.</p>		
SIGNIFICANCE ASSESSMENT Aesthetic Value 2/5 Historic Association 4/5 Technological Importance 1/5 Structural Integrity 2/5 Interpretive Ability 1/5 Social Significance 1/5		INFORMANTS: REFERENCES:
RECOMMENDATION: Record		PHOTOGRAPHS: -12 B & W: 90-038-4 Slides:

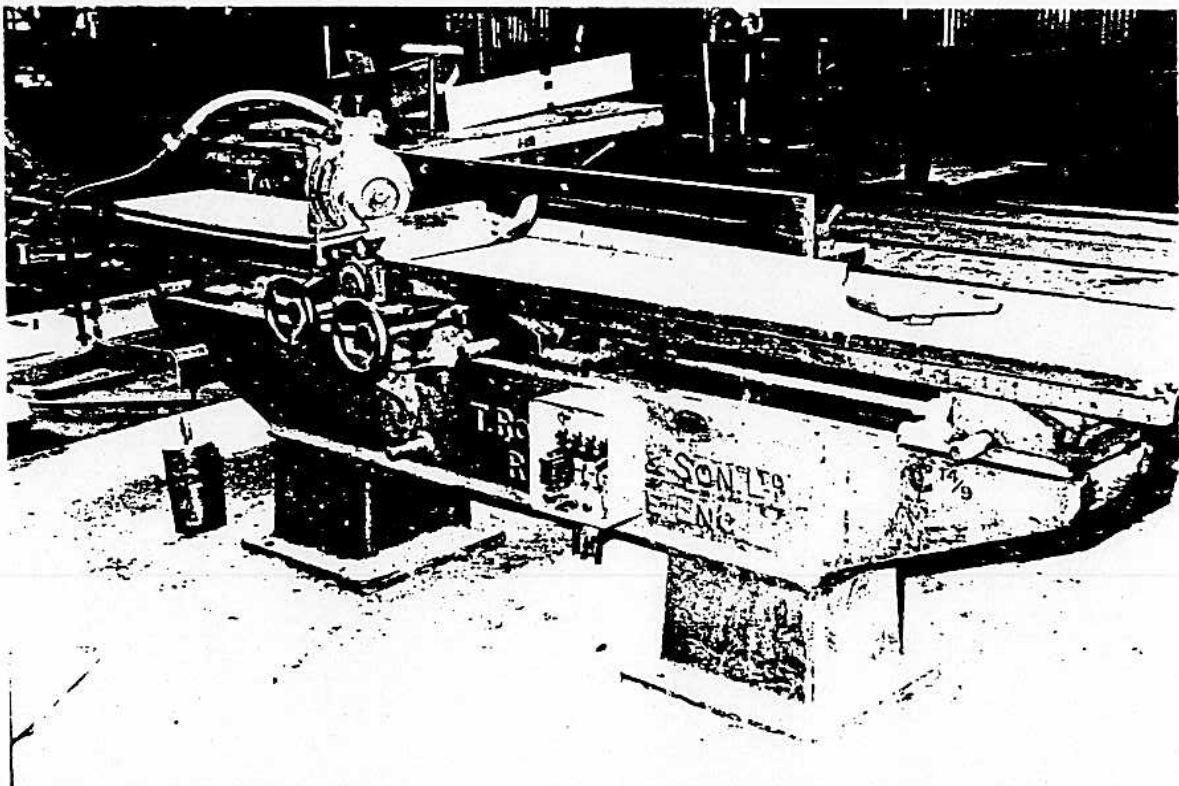
NAME OF ITEM: Robinson Jointer		
No. M65	Map Ref:	
Location: Carpenters/sawmill - Relocated	Precinct G	
Condition: Good		
Associated Items:		
Description: A heavy jointer with a massive twin pedestal cast iron bed. The design is typical of those produced between the wars. (This bench is no longer in situ, it has been moved for sale purposes).		
SIGNIFICANCE ASSESSMENT Historic Association 3/5 Technological Importance 2/5 Structural Integrity 2/5 Relative Rarity 3/5 Operational Ability 2/5	INFORMANTS: REFERENCES:	
RECOMMENDATION: Consider for Conservation.	PHOTOGRAPHS: B & W: 90-038-3-3

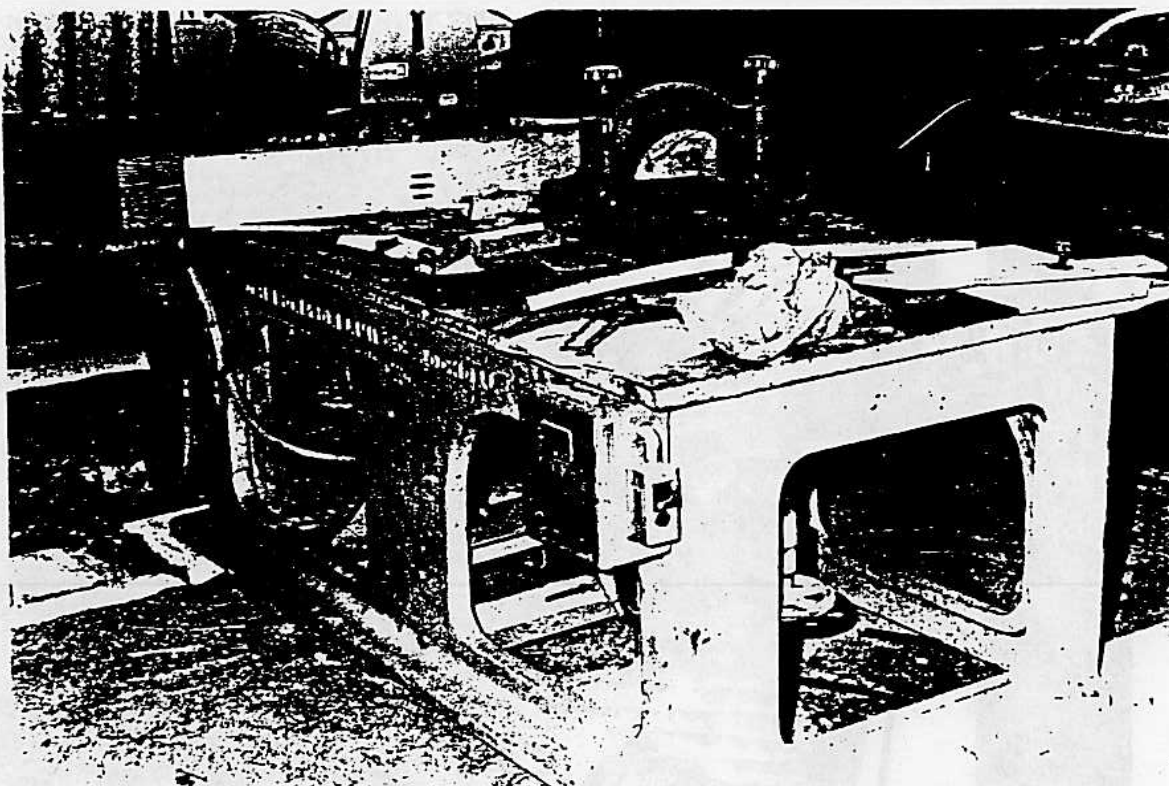
NAME OF ITEM: Robinson Spindle Router	
No. M66	Map Ref:
Location: Carpenters/Sawmill shed - Relocated	Precinct G
Condition: Good	
Associated Items:	
Description: Robinson Spindle Router with massive single piece cast iron frame. The router has been modified and new electric motor attached.	
SIGNIFICANCE ASSESSMENT Historic Association 3/5 Technological Importance 2/5 Structural Integrity 2/5 Interpretive Ability 4/5 Relative Rarity 3/5 Operational Ability 2/5	INFORMANTS: Col Barclay REFERENCES:
RECOMMENDATION: Consider for conservation	PHOTOGRAPHS: B & W: 90-038-3/2 Slides:

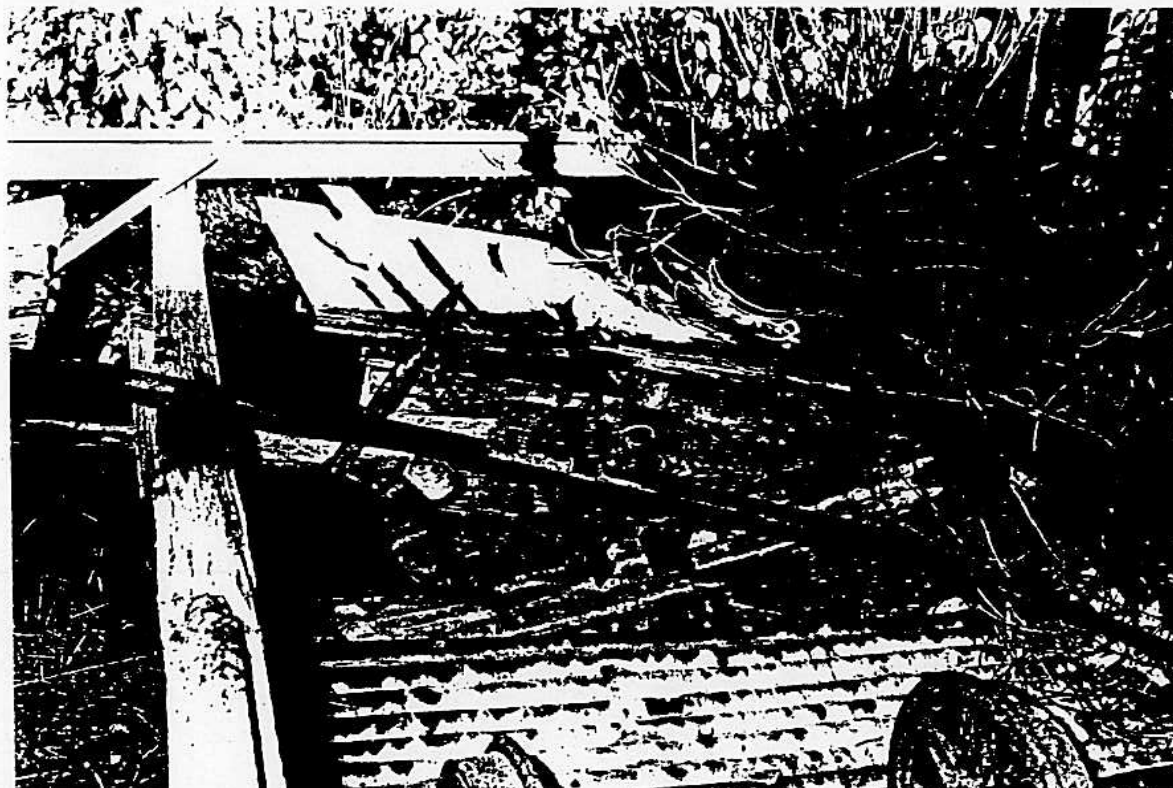
NAME OF ITEM: Timber Trolley	
No. M67	Map Ref:
Location: East of Bandsaw sheds	Precinct G
Condition: Dilapidated and deteriorating	
Associated Items: Sawbench Shed B64A, Sawdust Cyclone M24	
Description: Wooden timber trolleys on a timber chassis which operates on rail tracks. These trolleys were used to transport timber from carriages to storage racks or to the band saw sheds.	
SIGNIFICANCE ASSESSMENT Historic Association 4/5 Technological Importance -/5 Structural Integrity 4/5 Interpretive Ability 3/5 Relative Rarity 4/5 Operational Ability 3/5 -/5	INFORMANTS: REFERENCES:
RECOMMENDATION: Conserve one example	PHOTOGRAPHS: B & W: 90-038-3/20 Slides:

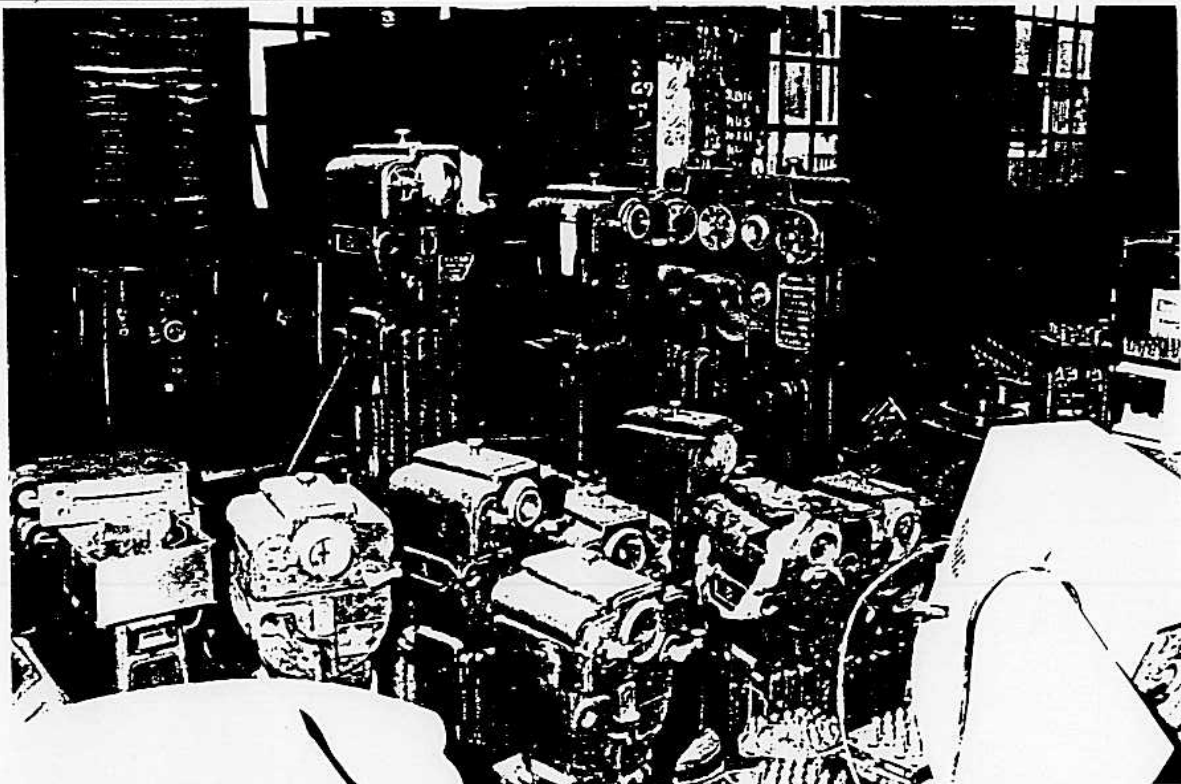
NAME OF ITEM: Redundant Signalling Equipment																
No. M75	Map Ref:															
Location: Opposite Returned Materials Depot	Precinct G															
Condition:																
Associated Items:																
<p>Description: A large collection of redundant single and double line safe working equipment is housed in the Ingot Shop. The equipment consists of staff ports, relays, indicators, levers and control panels. This equipment is significant in that it has been removed from most operational lines.</p>																
<p>SIGNIFICANCE ASSESSMENT</p>

4/5	Historic Association	-/5	Technological Importance	4/5	Structural Integrity	3/5	Relative Rarity	4/5	Operational Ability	2/5	Interpretive Ability	4/5	<p>INFORMANTS:</p> <p>REFERENCES:</p>	
	4/5															
Historic Association	-/5															
Technological Importance	4/5															
Structural Integrity	3/5															
Relative Rarity	4/5															
Operational Ability	2/5															
Interpretive Ability	4/5															
<p>RECOMMENDATION: Conserve</p>	<p>PHOTOGRAPHS:</p> <p>B & W: 90-038-5/26</p>
