RE: UNSW ENERGY TECHNOLOGIES BUILDING, KENSINGTON
GEOTECHNICAL AND ENVIRONMENTAL INVESTIGATION

**UNSW ENERGY TECHNOLOGIES BUILDING, KENSINGTON
GEOTECHNICAL AND ENVIRONMENTAL INVESTIGATION**

PSM1397.R1

OCTOBER 2009

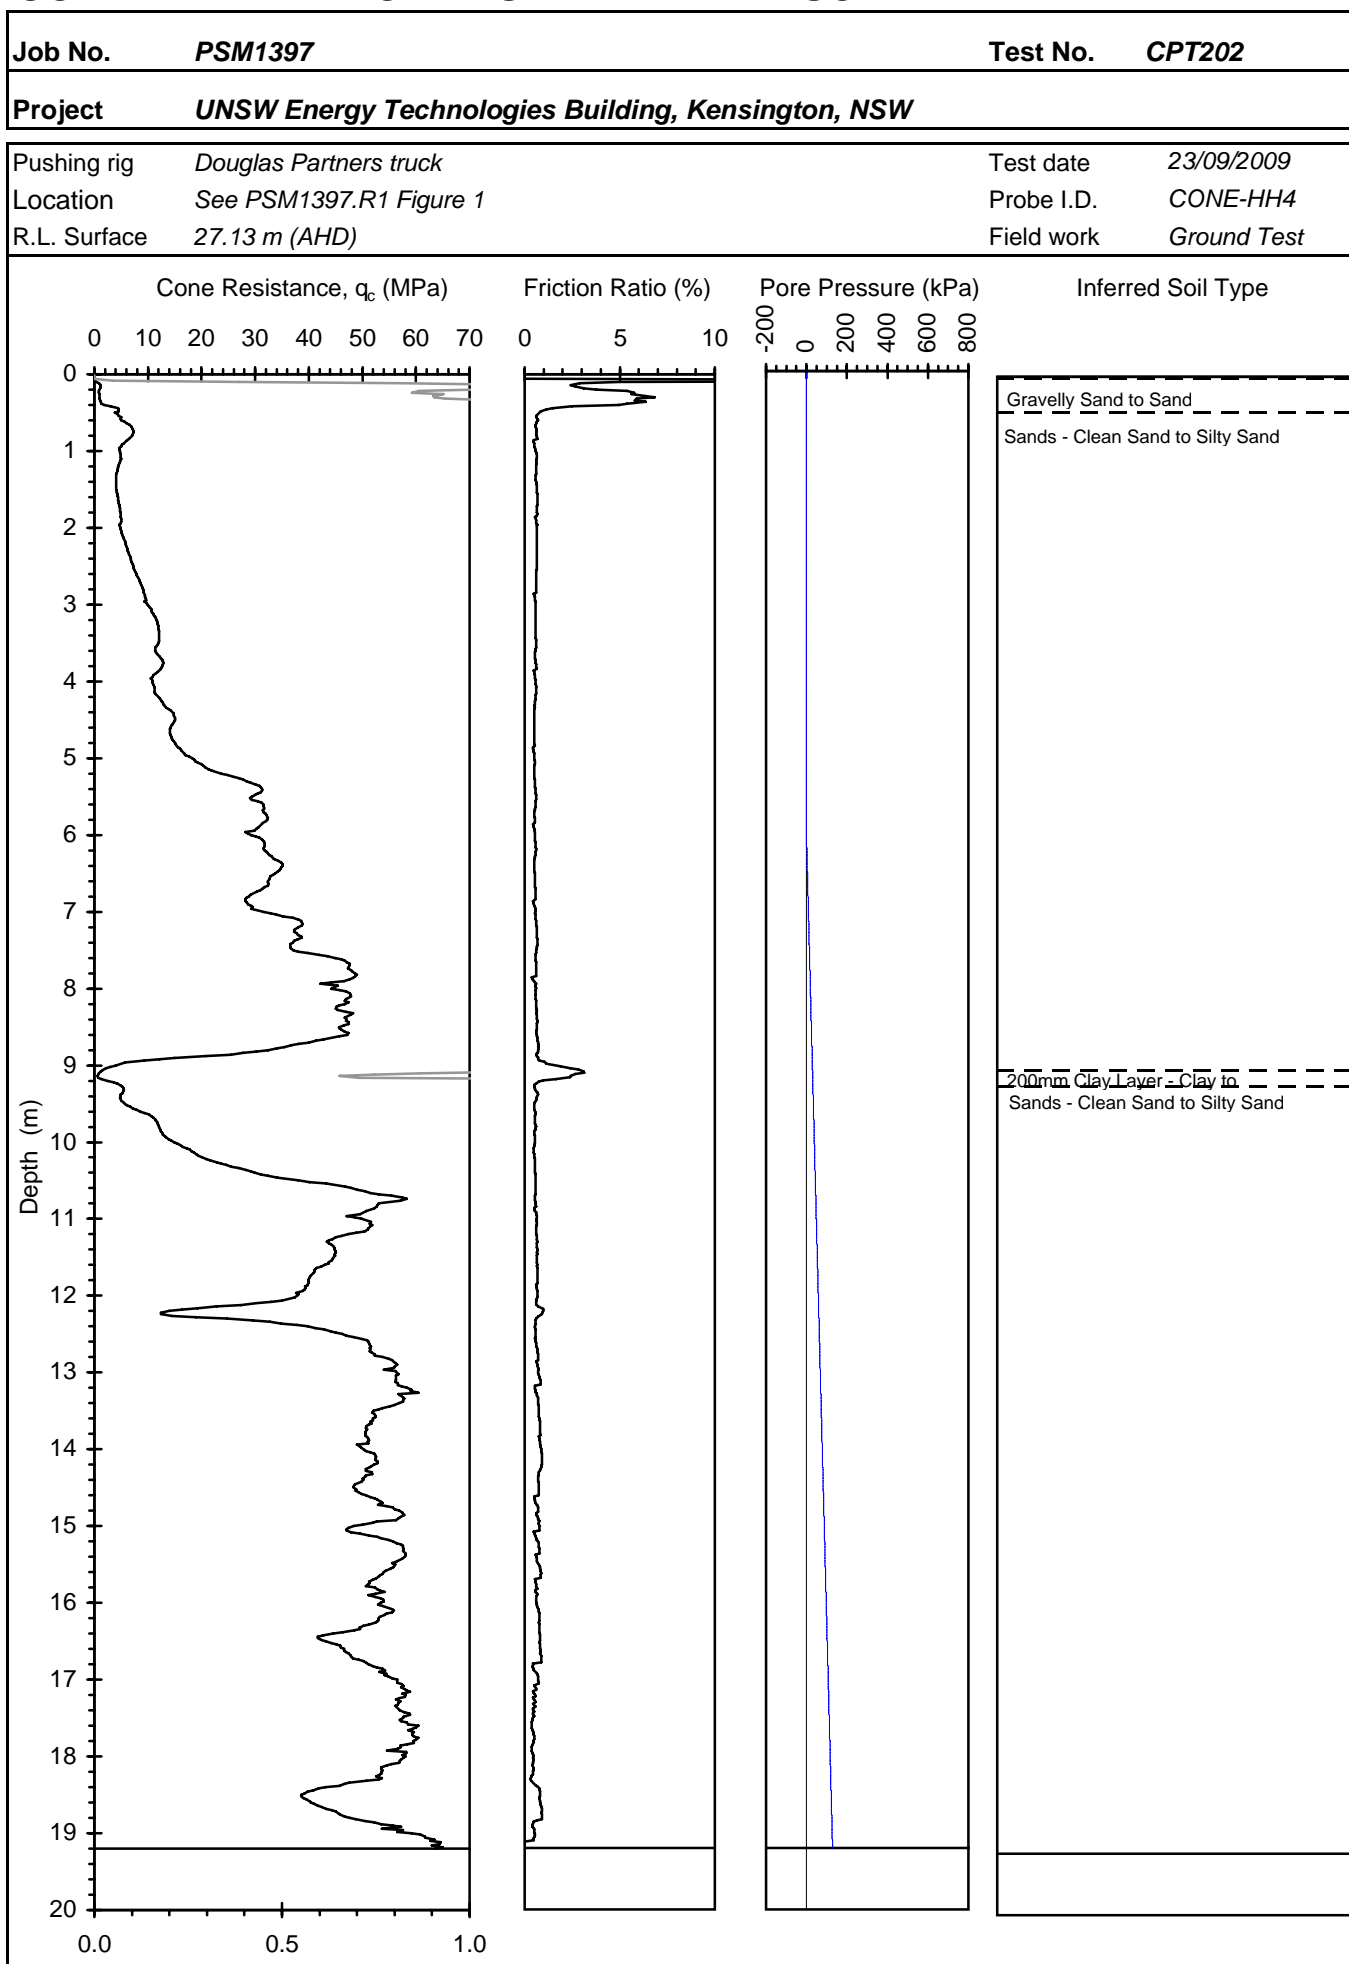
CONE PENETRATION TEST - INFERRED SOIL TYPE
