## **Auburn Hospital Re-Development**

### **Archaeological Monitoring of Area 1b.**

**Auburn, NSW**

**November 2009**

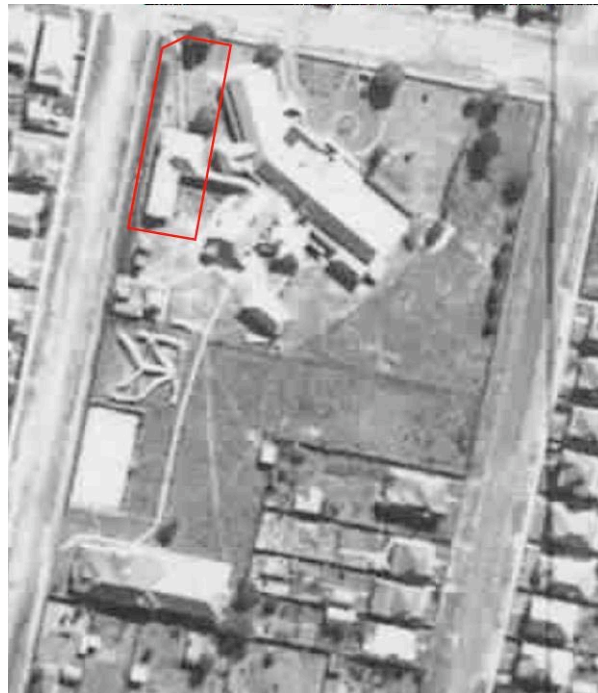
hospital grounds, and the soil remediation works had the potential to removal any remaining *in situ* structure or archaeological deposits relating to the first 1907 to 1961 hospital (Figure 2).

**Figure 2: Aerial photograph of the study area (Red) in 1943.**

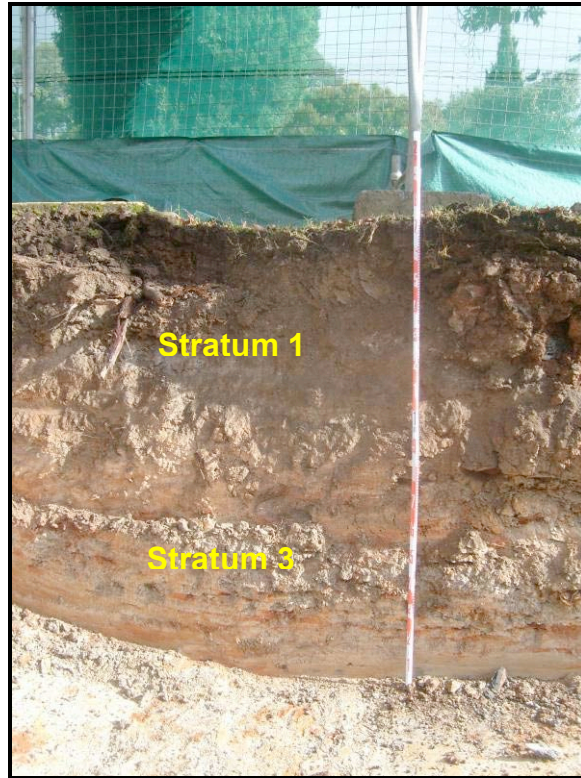
*Stratigraphy:* The stratigraphic profile on the site appeared to be level across the site. There were three defined strata present in this area. The first, topsoil, stratum was a dark brown sandy loam, that is present uniformly across the site between a depth of 0.4 m to 0.5 m (Figure 3).

Approximately 0.20 m below the top of mottled clay stratum formed the base of the excavation that was required for the remediation works (Figure 3). A small deep section cut was made at the start of the excavation in the southwest corner of the site that showed that the mottled clay continued to a depth of 1.3 m below the thin demolition lens (Figure 3).

**Figure 3: Photograph showing Stratigraphy within the site (Photograph Cosmos Archaeology).**

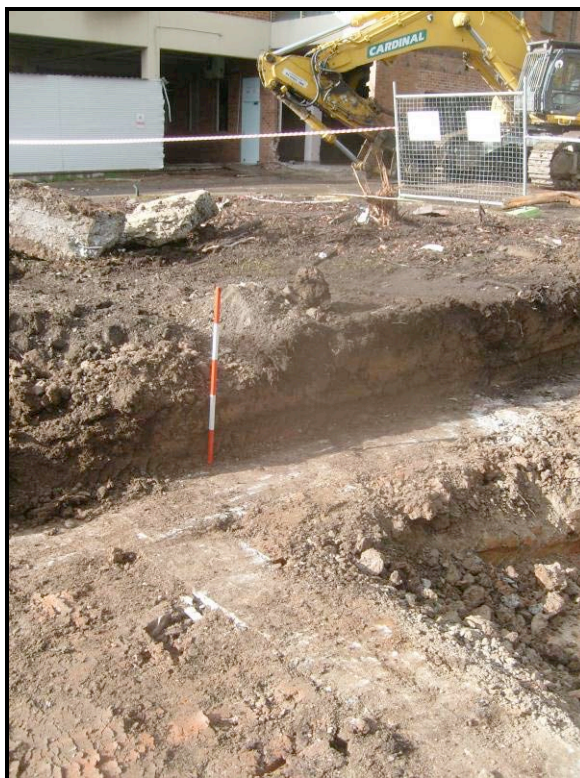
**Finds:** The excavation uncovered the remains of concrete strip footings in the southern half of the remediation area. The footings were orientated north - south and east - west and were found at a depth of 0.4 m below the ground level (Figure 5). The strip footings were 0.5 m wide and 0.65 m deep, and were cut into the natural mottled clay stratum. The strip footing at the southern end of the excavation area was orientated east - west and was 7.0 m long (Figure 6). The footing had a small section of remaining *in situ* bricks cemented into it, however, much of the remaining strip footings uncovered in the area did not have any remains of brickwork or other building material.

**Figure 5: Depth of footings located within soil remediation area (Photograph Cosmos Archaeology).**

From the excavation that took place limited remains of the first Cottage Hospital were present in the form of large concrete strip footings. The building was constructed on large concrete strip footings that were cut into the natural mottled clay. Limited remains of brickwork on the footings indicate that the building – at least the lower portion - had brick walls. The demolition of this building in the early 1960s had not only removed most of the remains of the building down to its foundation, but also cut down the soil profile in the immediate area. This was evident by the presence of the sandy loam immediately above the mottled clay stratum, which was likely imported during the landscaping of the area after the building was demolished.

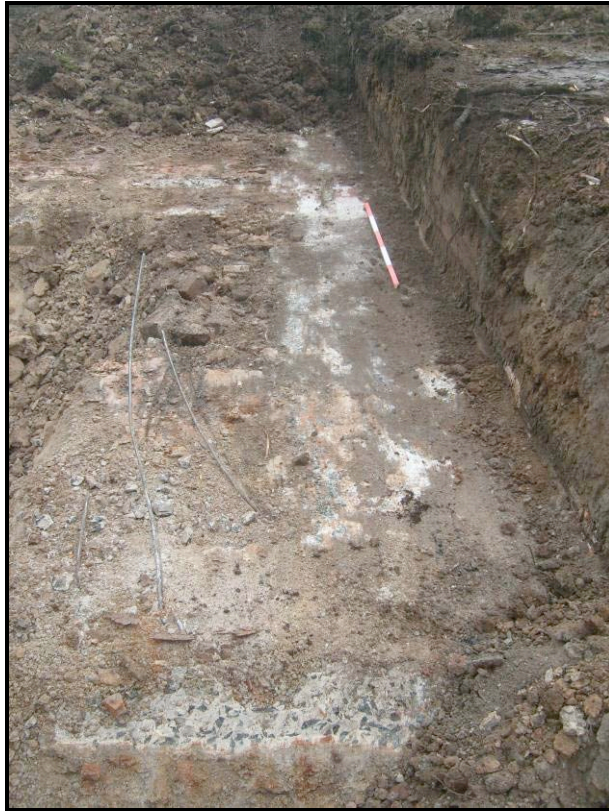
**Figure 6: A portion of the southern, east - west orientated, strip footing (Photograph Cosmos Archaeology)**

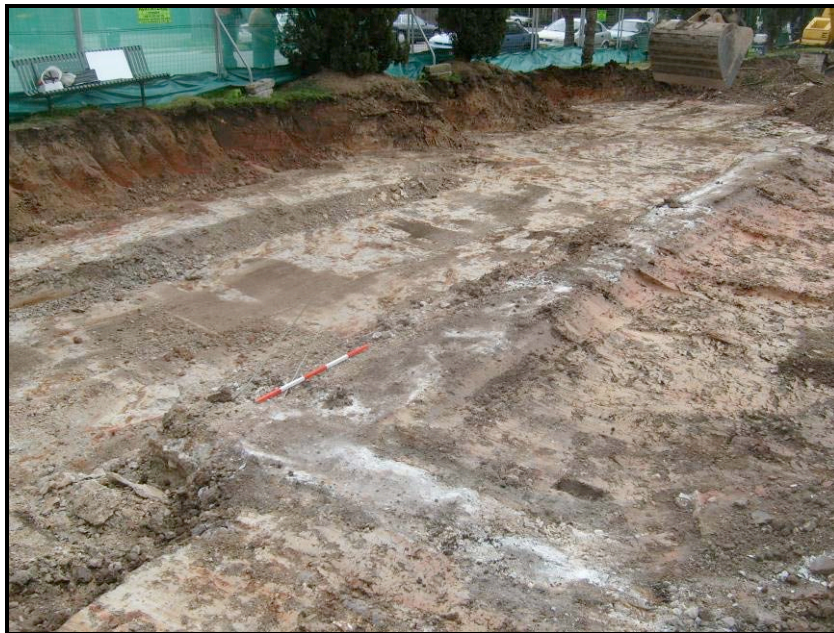
Two individual strip footings were also observed orientated north - south from the southern most, east - west, strip footing. The western most footing was only 9 m long and was located 4 m inside the property boundary. The second longitudinal footing was located 3.3 m to the east of the first and was 20 m long (Figure 7). The southern, east - west, strip footing continued eastwards past the location of the second longitudinal footing, however, no additional footings were located in this area. All footings were removed as part of the remediation works.

**Figure 7: One of the two north - south longitudinal strip footings. (Photograph Cosmos Archaeology)**

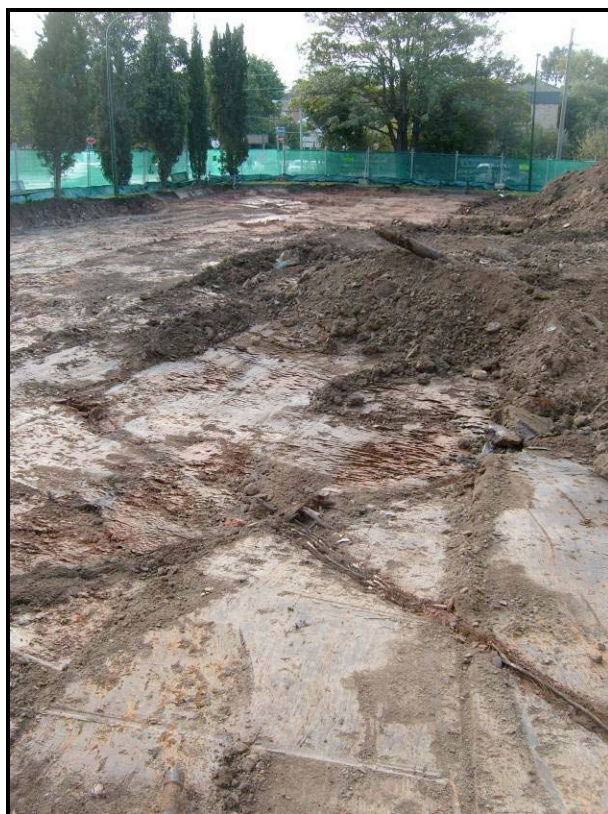
Three ceramic service pipes were also uncovered during the excavation. Two of the services were located to the east of the strip footings, and a third was located running along north - south on the western boundary of the property (Figure 8).

**Figure 8: Two ceramic services located in the south eastern corner of the remediation area.  
(Photograph Cosmos Archaeology)**

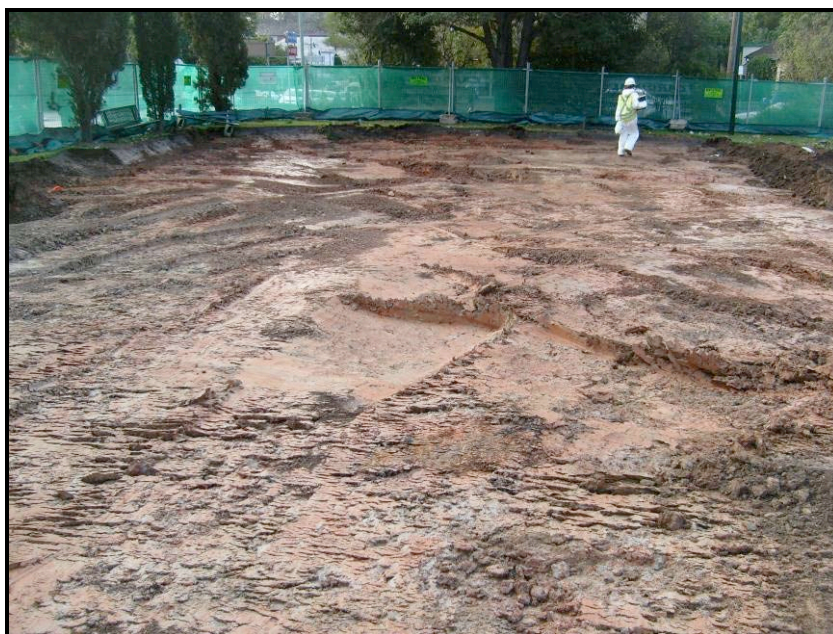
No other features or artefact remains were recorded around or to the north of the strip footings (Figure 9).

**Figure 9: View of the completed northern half of the remediation area (Photograph Cosmos  
Archaeology)**
