Goulburn Mulwaree Council
Highlands Source Project

Waterway crossings
Sector: Weral - Glenquarry

Appendix C

Description of Major and Moderate Waterways

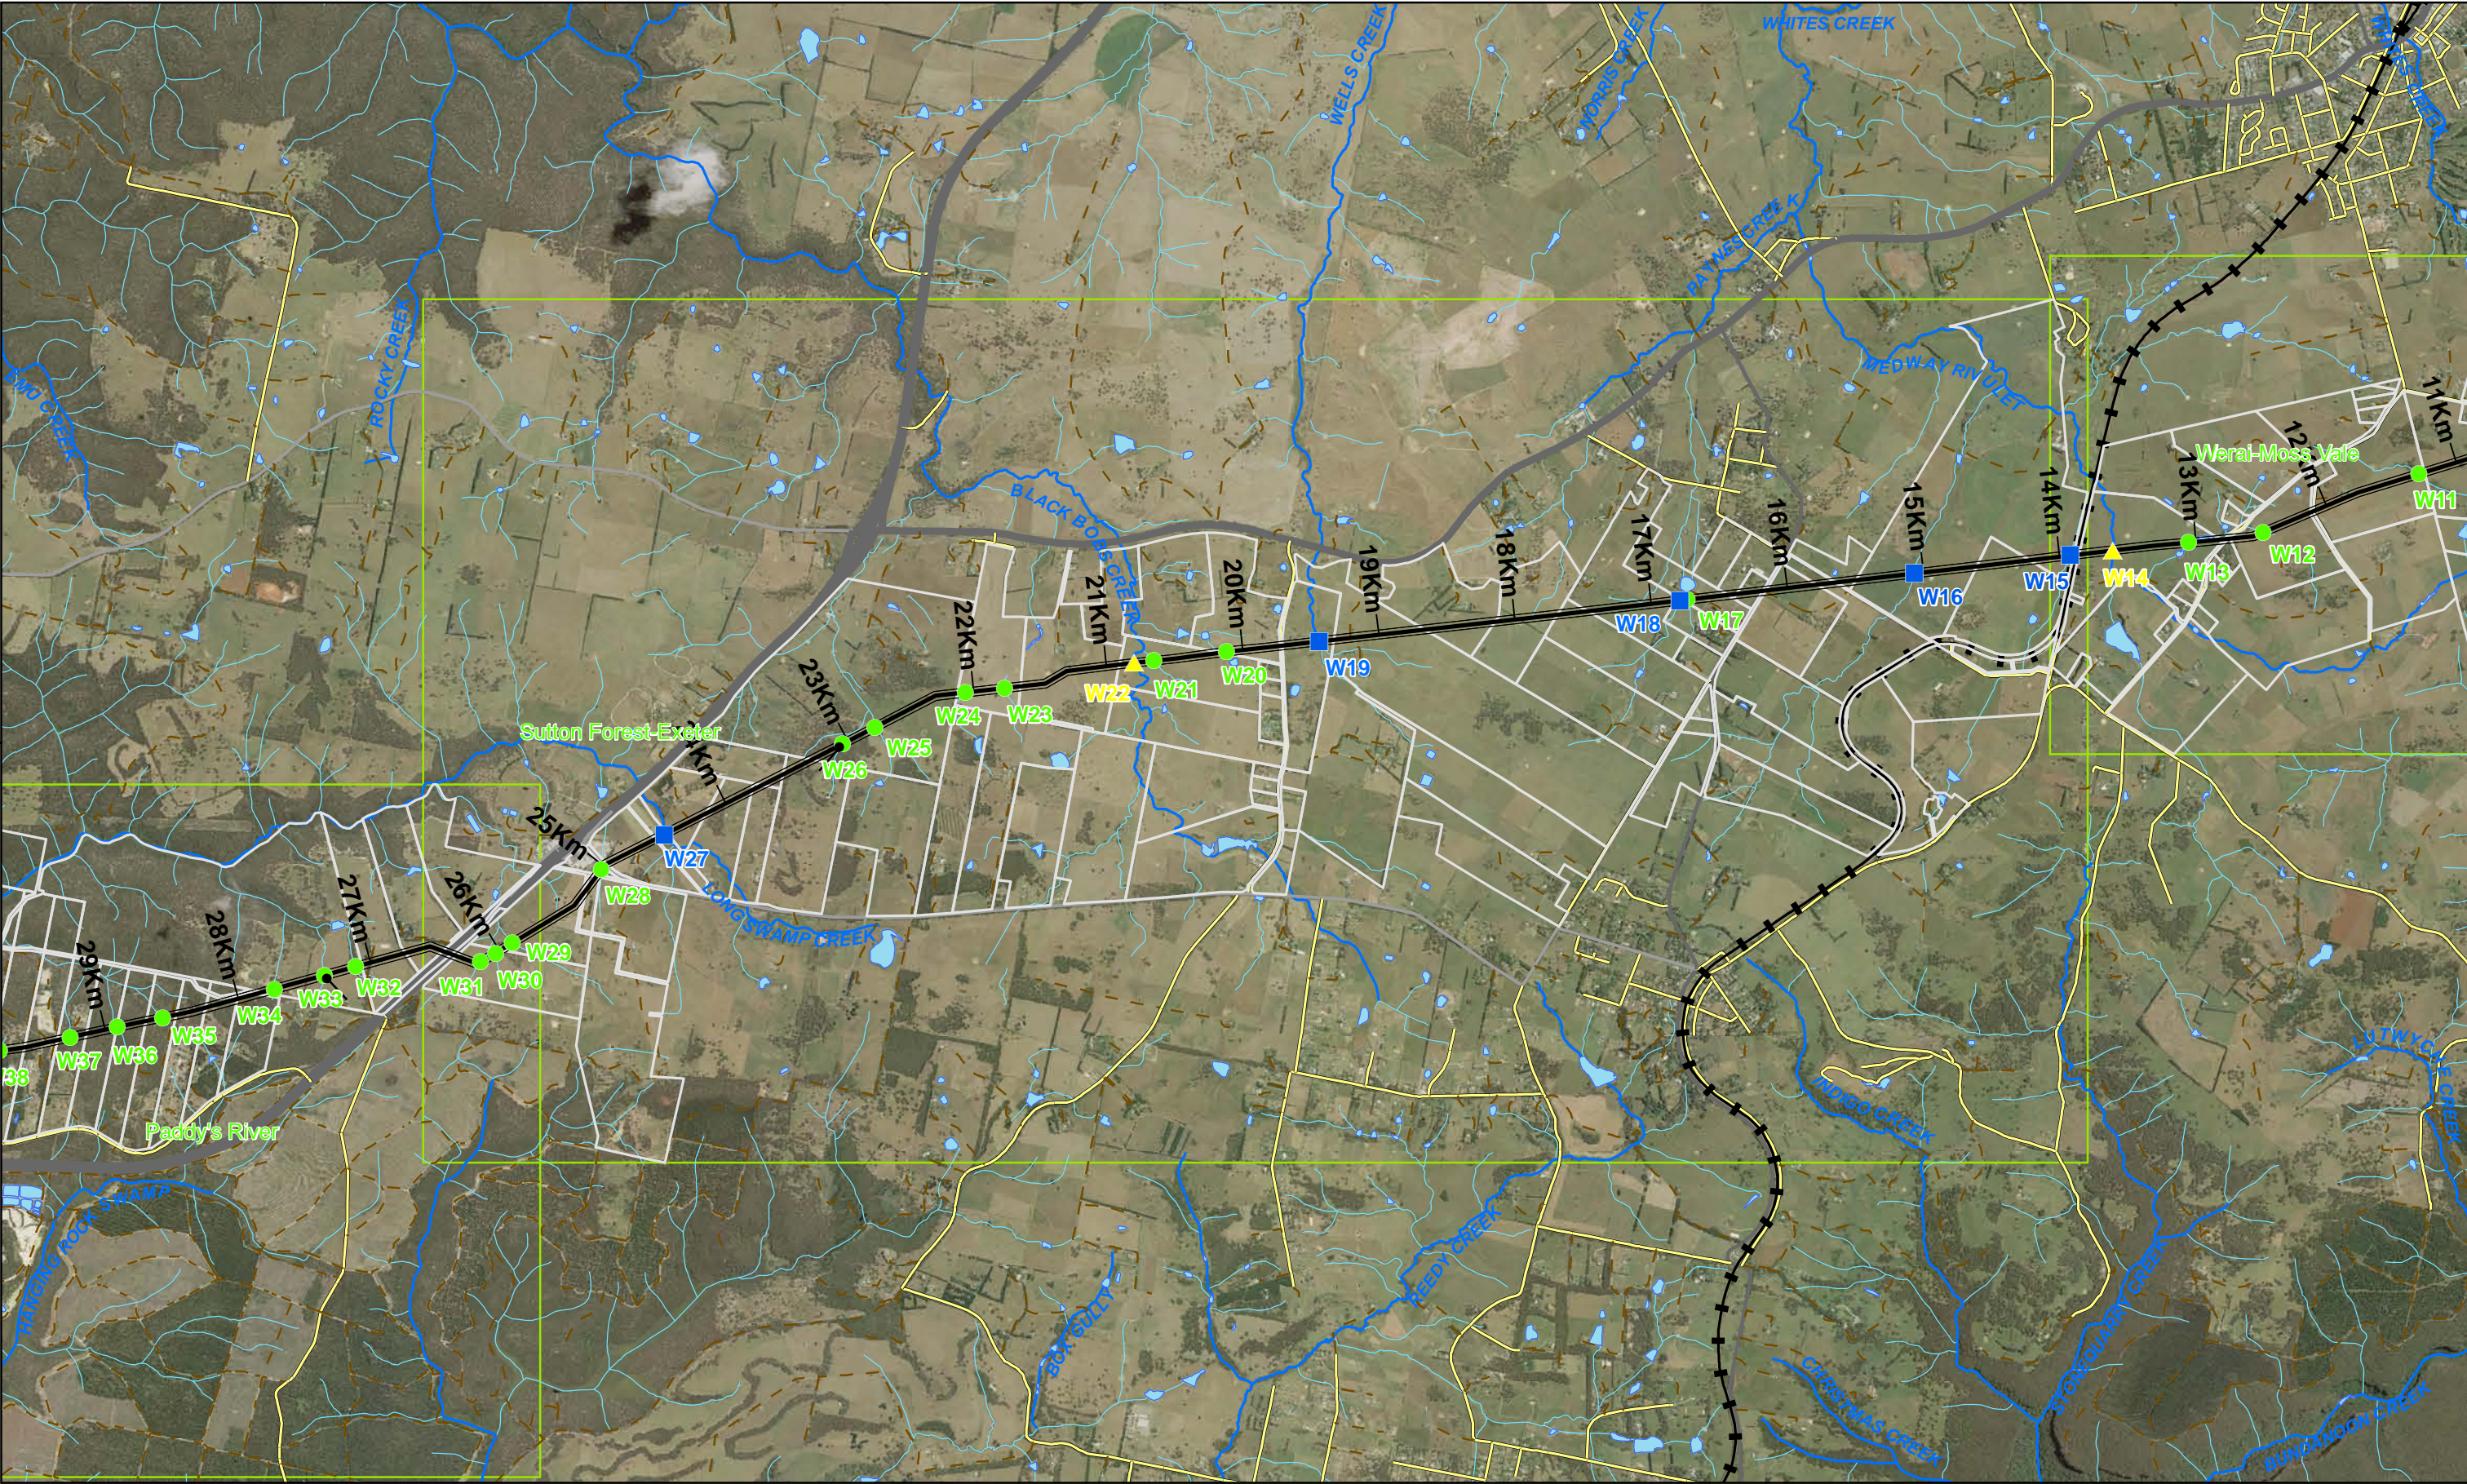
Figure A2

Waterway crossings
Sector: Sutton Forest-Exeter

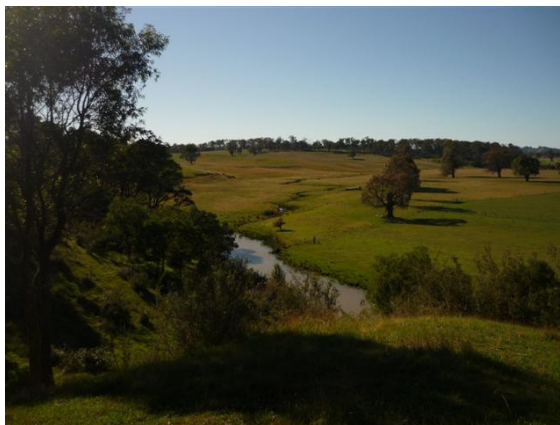
Upstream View

Waterway Crossing – W3

Waterway	Kellys Creek
Waterway Classification	Major Waterway
Stream Type	Low Sinuosity Fine Grained
Land Use	Grazing
Catchment Area	Approx 2255 ha
Stream Order	Third
Flow Frequency	Perennial
Site Inspection	
Date	19/01/10
Valley Confinement	Unconfined
Valley Width	100 – 150 m
Channel Dimensions	3 – 5 m width, 1 m depth
Channel Sinuosity	Low
Channel Stability	Stable channel, limited potential to adjust laterally due to cohesive banks
Banks	Grassed, stable
Instream Features	Pools and runs
Floodplain	Modified pasture land with abandoned channel
Contextual Notes	Juncus and pasture grasses exist in creek

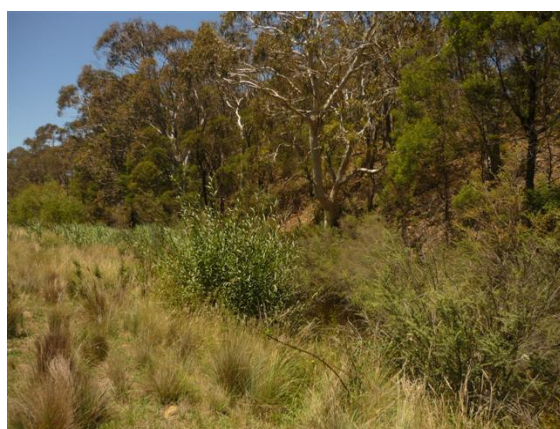
Upstream View

Waterway Crossing – W52

Channel Stability	Channel is stable. Limited potential to adjust due to cohesive banks and bedrock base.
-------------------	--

Banks	Vegetated banks composed of silt.
-------	-----------------------------------

Instream Features	Pools, riffles and small bars.
-------------------	--------------------------------

Contextual Notes	Willows within riparian zone.
------------------	-------------------------------

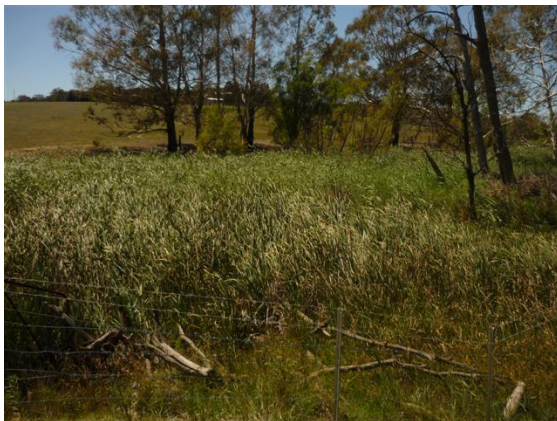
Upstream View

Waterway Crossing – W56

Date	20/01/10
Valley Confinement	Unconfined
Valley Width	80 – 100 m
Channel Dimensions	10 – 15 m width, 1 - 2 m depth
Channel Sinuosity	Low
Channel Stability	Channel is stable with cohesive soils and flow dissipation through reeds area provides adequate resistance to erosion.
Banks	Stable, graded banks colonised by grasses.
Instream Features	Small pools.
Floodplain	Modified grazing land/cropping.
Contextual Notes	Crossing located at confluence of Uringalla and Back Creek.

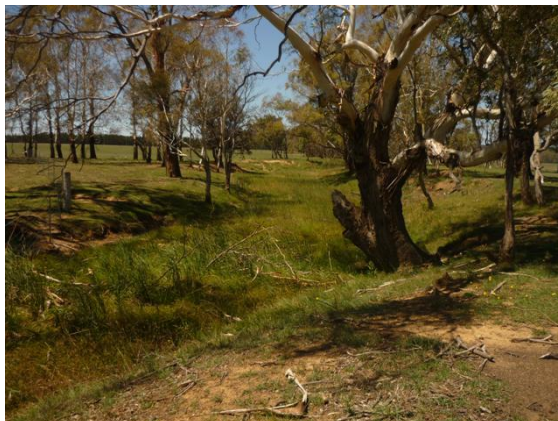
Upstream View

Waterway Crossing – W57

Date	20/01/10
Valley Confinement	Unconfined
Valley Width	80 – 100 m
Channel Dimensions	10 m width, 1 m depth
Channel Sinuosity	Low
Channel Stability	Channel is stable with cohesive soils and flow dissipation through reeds area provides adequate resistance to erosion.
Banks	Stable, graded banks colonised by grasses.
Instream Features	Featureless trapezoidal channel.
Floodplain	Modified grazing land/cropping.
Contextual Notes	Crossing located at confluence of Uringalla and Back Creek.

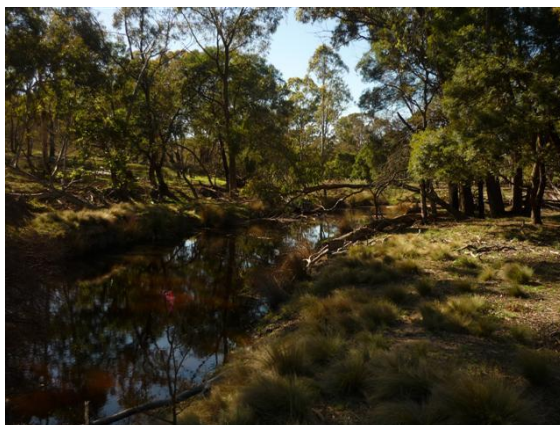
Upstream View

Waterway Crossing – W69

Date	20/01/10
Valley Confinement	Partly Confined
Valley Width	30 – 50 m
Channel Dimensions	< 5 m width, 0.5 m depth
Channel Sinuosity	Low
Channel Stability	Channel is in good condition and currently stable at crossing point.
Banks	Sandy silts colonised with native grasses.
Instream Features	Shallow pools, sand/gravel riffles.
Floodplain	Disturbed native woodland.
Contextual Notes	Rock crossing downstream of pipeline crossing point maintaining upstream bed levels causing shallow pooling. Channel downstream of ford exhibits eroding banks.

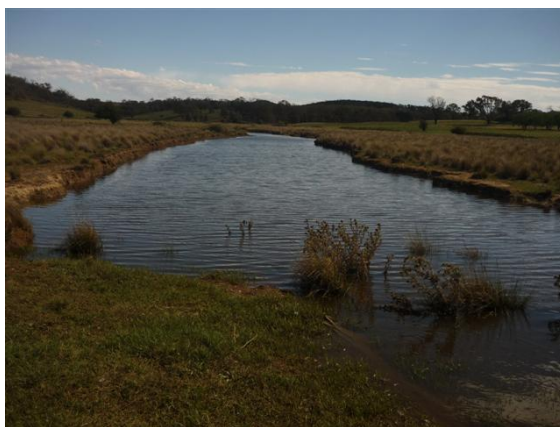
Upstream View

Waterway Crossing – W84

Date	21/01/10
Valley Confinement	Unconfined
Valley Width	150 – 200 m
Channel Dimensions	15 m width, 0.5 m depth
Channel Sinuosity	Low
Channel Stability	Ponds are stable
Banks	Banks are low, vertical in parts and are grassed.
Instream Features	Ponds.
Floodplain	Modified grazing pastures.
Contextual Notes	Ad-hoc ford located at downstream extent of pond.

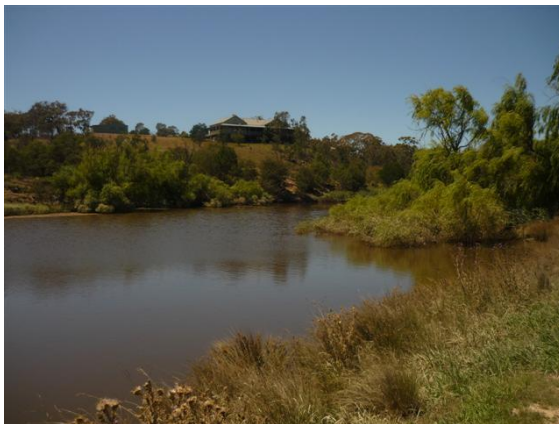
Upstream View

Waterway Crossing – W105

Date	21/01/10
Valley Confinement	Partly Confined
Valley Width	100 - 120 m
Channel Dimensions	70 m width, >5 m depth (at bankfull)
Channel Sinuosity	Low
Channel Stability	Channel is stable.
Banks	Banks are fairly steep and are largely devoid of vegetation at the crossing (except for grass and some Juncus).
Instream Features	Large deep pool at crossing.
Floodplain	Grassed, featureless floodplain.
Contextual Notes	Banks at crossing site exhibit rock protection of existing buried services.

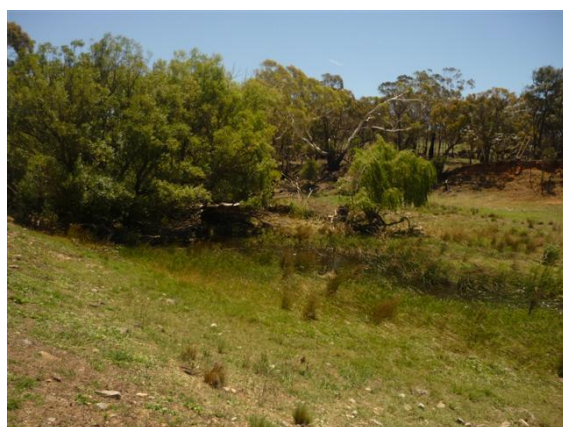
Upstream View

Waterway Crossing – W106

Channel Stability Channel is stable and well vegetated with grasses.

Banks Graded, stable banks.

Instream Features Riffle zones at crossing point with low flow channel up to 5 m wide.

Contextual Notes Banks at crossing site exhibit rock protection of existing buried services.

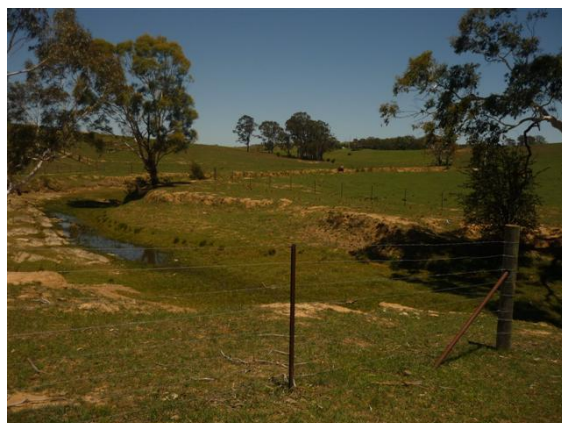
Upstream View

Waterway Crossing – W108	
Waterway	Boxers Creek
Waterway Classification	Major Waterway
Stream Type	Channelised Fill
Land Use	Grazing
Catchment Area	Approx 2921 ha
Stream Order	Fifth
Flow Frequency	Perennial
Site Inspection	
Date	22/01/10
Valley Confinement	Confined
Valley Width	20 – 30 m
Channel Dimensions	20 – 30 m width, 1 – 1.5 m depth
Channel Sinuosity	Low
Channel Stability	Channel is in poor condition with eroding banks.
Banks	Near vertical banks composed of sandy clay. Poorly vegetated and generally unstable.
Instream Features	Featureless channel incised to bedrock.
Floodplain	N/A.
Contextual Notes	Livestock access unrestricted.

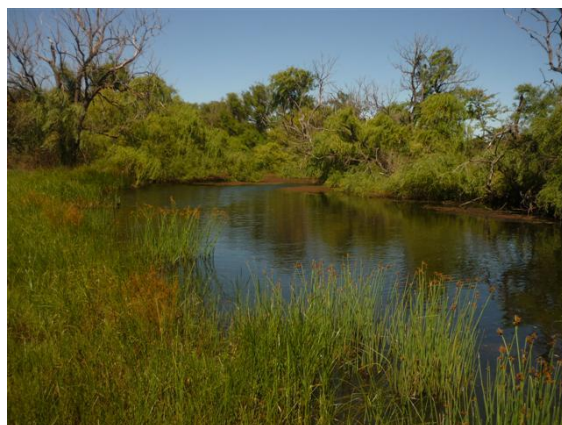
Upstream View

Waterway Crossing – W119	
Waterway	Wollondilly River
Waterway Classification	Major Waterway
Stream Type	Bedrock Controlled Fine Grained
Land Use	Agriculture
Catchment Area	Approx 153469 ha
Stream Order	5+
Flow Frequency	Perennial
Site Inspection	
Date	21/01/10
Valley Confinement	Partly Confined
Valley Width	100 – 130 m
Channel Dimensions	70 m width, 5 m depth (at bankfull)
Channel Sinuosity	Low
Channel Stability	Channel is stable.
Banks	Stable banks are graded and well vegetated.
Instream Features	Crossing point located at downstream extent of pool and upstream of a riffle zone. Pool is 0.5 m deep at crossing point.
Floodplain	Grazing/pasture.
Contextual Notes	Juncus on banks and riffle zone. Rock causeway on riffle zone.

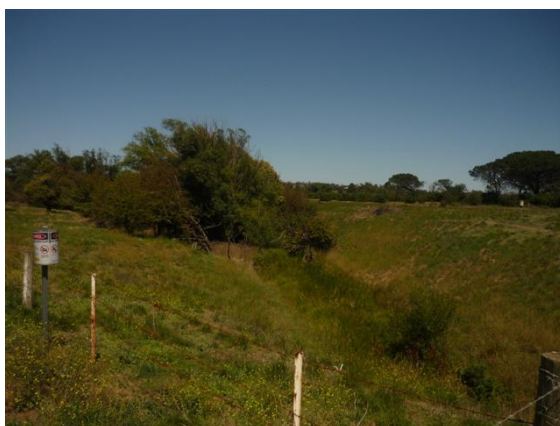
Upstream View

Waterway Crossing – W120

Date	21/01/10
Valley Confinement	Unconfined
Valley Width	30 m
Channel Dimensions	20 m width, 3 - 4 m depth
Channel Sinuosity	Low
Channel Stability	Channel is stable.
Banks	Banks are graded, grassed and stable.
Instream Features	Trapezoidal channel with 3 m wide low flow channel.
Floodplain	Flat, featureless.
Contextual Notes	Entrenched channel within floodplain deposits of Wollondilly River.

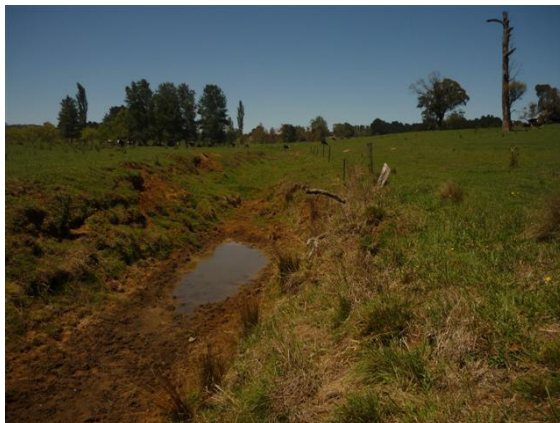
Upstream View

Waterway Crossing – W14

Date	19/01/10
Valley Confinement	Unconfined
Valley Width	40 – 50 m
Channel Dimensions	10 m width, 1 – 2 m depth
Channel Sinuosity	Low
Channel Stability	Channel is moderately unstable due to minimal riparian vegetation and cattle access.
Banks	Banks are steep and moderately unstable.
Instream Features	Trapezoidal channel with small pools.
Floodplain	Highly modified grazing land.
Contextual Notes

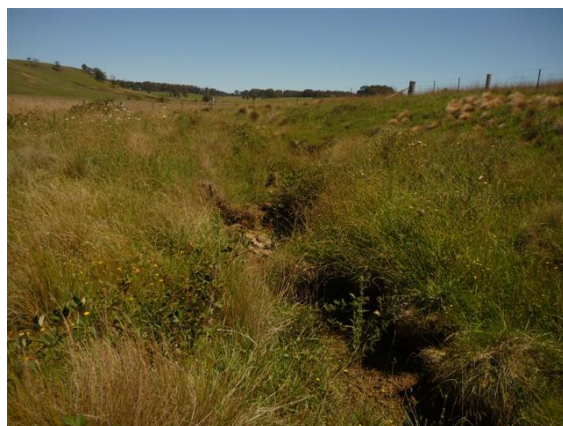
Upstream View

Waterway Crossing – W22

Date	19/01/10
Valley Confinement	Unconfined
Valley Width	30 m
Channel Dimensions	3 – 5 m width, 1 m depth
Channel Sinuosity	Low.
Channel Stability	Channel is stable. Limited potential to adjust due to cohesive grassed banks.
Banks	Sandy clay banks are steep and undercut in locations.
Instream Features	Small pools (dry at time of inspection).
Floodplain	Flat floodplain with pasture grasses.
Contextual Notes

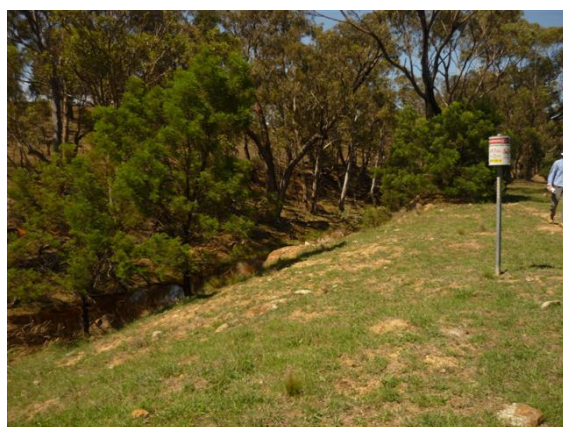
Upstream View

Waterway Crossing – W95

Date	22/01/10
Valley Confinement	Confined
Valley Width	30 m
Channel Dimensions	5 – 10 m wide at channel base.
Channel Sinuosity	Low
Channel Stability	Channel is stable due to high bedrock control.
Banks	Banks are steep, well vegetated and composed of bedrock.
Instream Features	Shallow pools separated by riffles composed of angular cobbles.
Floodplain	N/A.
Contextual Notes	Dense, native vegetation upstream and downstream of crossing point.

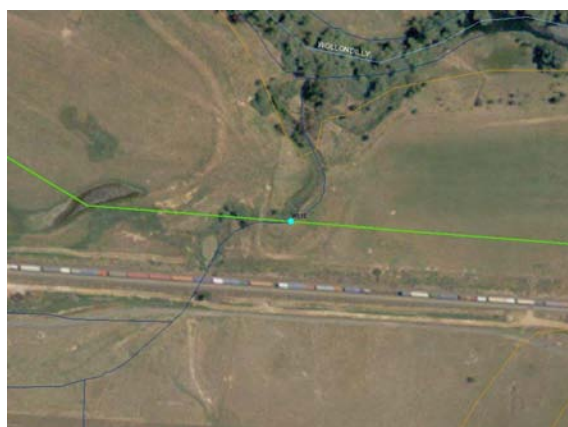
Aerial View (GIS)

Waterway Crossing – W112

Waterway	Unnamed tributary of Wollondilly River
Waterway Classification	Moderate Waterway
Stream Type	Low Sinuosity Fine Grained
Land Use	Agriculture
Catchment Area	Approx 702 ha
Stream Order	Third
Flow Frequency	Ephemeral
Site Inspection	
Date	22/01/10
Valley Confinement	Unconfined
Valley Width	80 – 100 m
Channel Dimensions	10 m width, 1.5 m depth
Channel Sinuosity	Low
Channel Stability	Channel is in poor condition due to railway culvert scour however is relatively stable.
Banks	Banks are well vegetated with grass and reeds at crossing point.
Instream Features	A large scour pool exists downstream of the railway culvert as a result of constraining processes from the culvert.
Floodplain	Agricultural fields.
Contextual Notes	Crossing of the creek is located adjacent to and downstream of the railway.

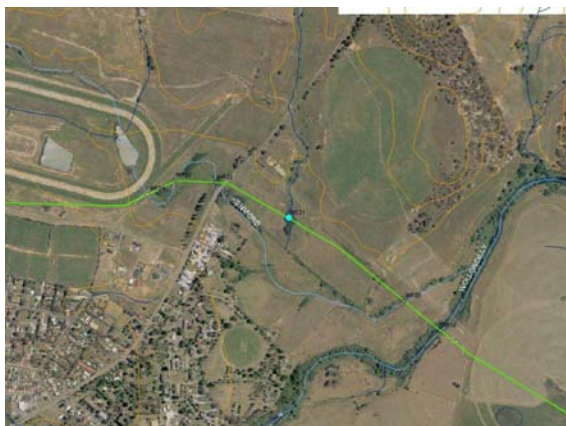
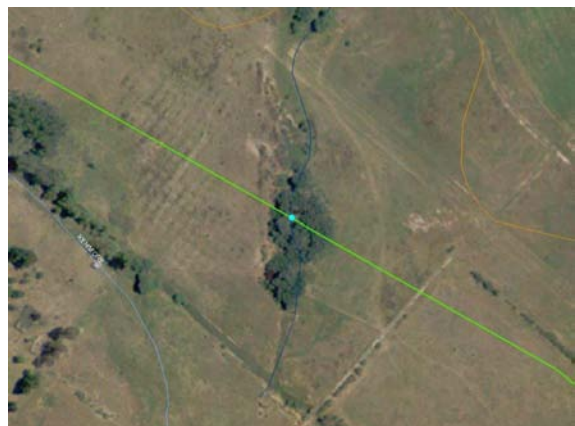
Waterway Crossing – W121

Date	22/01/10
Valley Confinement	Unconfined
Valley Width	60 m
Channel Dimensions	20 – 40 m width, depth (unknown)
Channel Sinuosity	Low
Channel Stability	Well vegetated and apparently stable.
Banks	Not inspected.
Instream Features	Not inspected.
Floodplain	Grazing/Agriculture.
Contextual Notes	Not inspected.

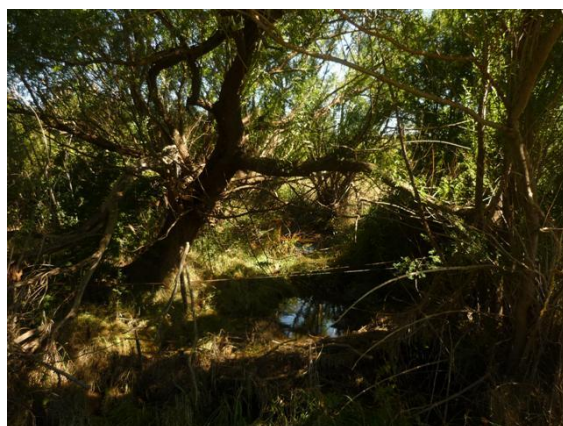
Upstream View

Waterway Crossing – W122

Waterway	Kenmore Creek
Waterway Classification	Moderate Waterway
Stream Type	Low Sinuosity Fine Grained
Land Use	Grazing
Catchment Area	Approx 1388 ha
Stream Order	Third
Flow Frequency	Ephemeral
Site Inspection	
Date	21/01/10
Valley Confinement	Unconfined
Valley Width	50 – 70 m
Channel Dimensions	5 m width, 1 m depth
Channel Sinuosity	Low
Channel Stability	Channel is stable and well vegetated with grasses and non-native Willows and Hawthorn.
Banks	Banks are well vegetated with grass.
Instream Features	Small Pools.
Floodplain	Grazing land adjacent to racecourse track.
Contextual Notes	The pipe crossing of the creek is located adjacent and immediately upstream of a road.

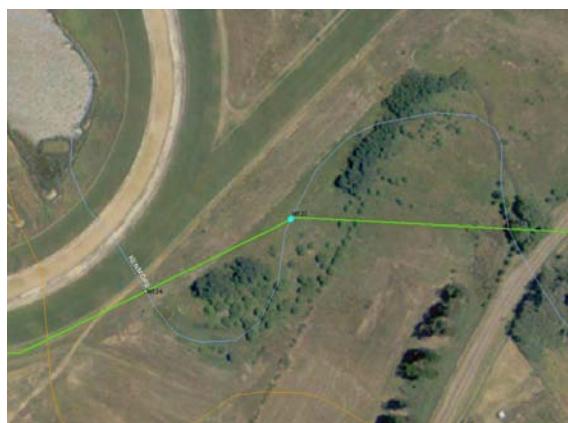
Aerial View (GIS)

Waterway Crossing – W123

Date	22/01/10
Valley Confinement	Unconfined
Valley Width	50 – 70 m
Channel Dimensions	1 m width, 0.5 m depth
Channel Sinuosity	Low
Channel Stability	Channel is stable and well vegetated with grasses and non-native Willows and Hawthorn.
Banks	Banks are composed of clays and well vegetated with grasses.
Instream Features	Featureless box shaped channel.
Floodplain	Pasture land adjacent to racecourse track.
Contextual Notes

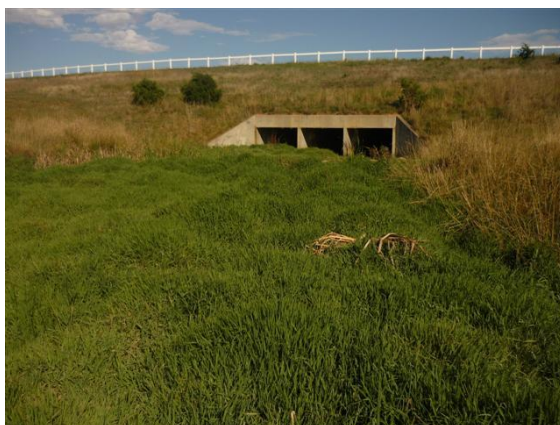
Upstream View

Waterway Crossing – W124	
Waterway	Kenmore Creek
Waterway Classification	Moderate Waterway
Stream Type	Valley Fill
Land Use	Adjacent to racecourse track
Catchment Area	Approx 1385 ha
Stream Order	Third
Flow Frequency	Ephemeral
Site Inspection	
Date	22/01/10
Valley Confinement	Unconfined
Valley Width	40 m
Channel Dimensions	N/A
Channel Sinuosity	N/A
Channel Stability	N/A
Banks	N/A
Instream Features	Flat Valley Fill.
Floodplain	Land adjacent to racecourse track.
Contextual Notes	Location of proposed crossing is immediately downstream of the exit of a large culvert that runs beneath the racecourse track after exiting a dam in the middle of the racecourse. Flow regulation by dam is thought to limit the potential for scour and channel development.
