**PRELIMINARY CONTAMINATION ASSESSMENT**

**VEHICLE AND PEDESTRIAN SAFETY (VAPS)  
PROJECT**

**SYDNEY OPERA HOUSE BENNELONG POINT**

**Project 71529.01**

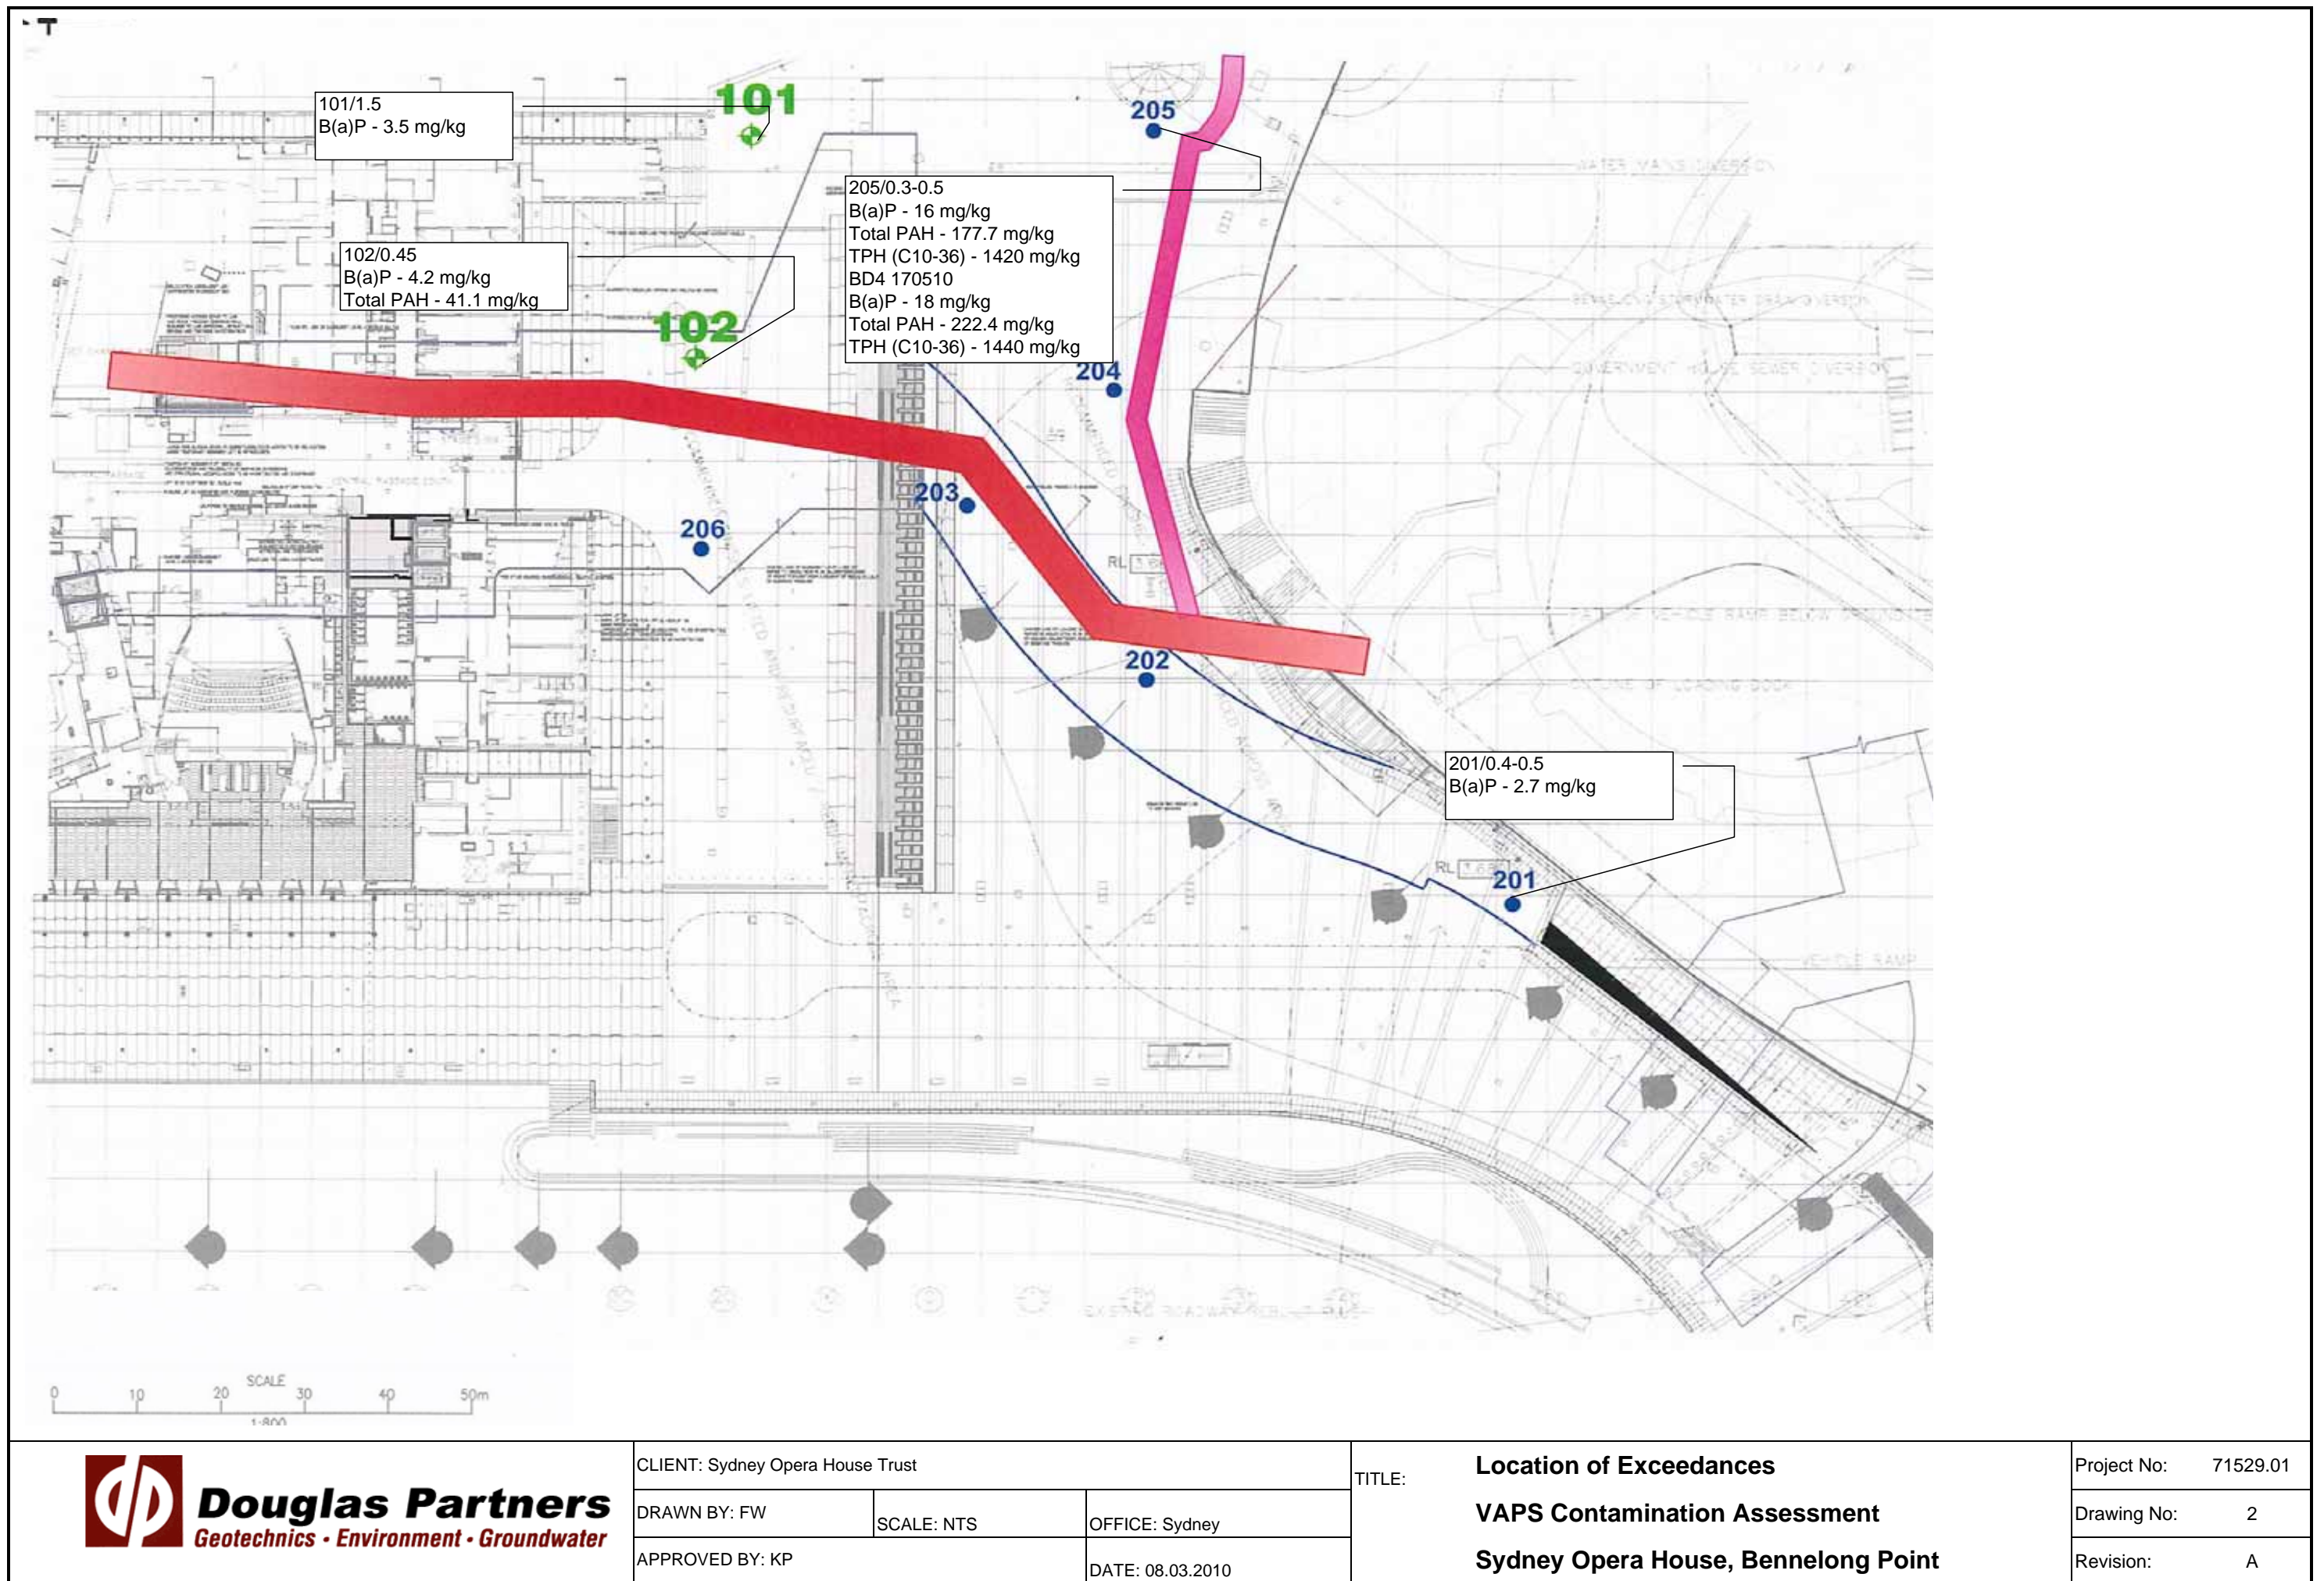
- PREVIOUS DP TEST BORE
- CURRENT DP TEST BORE
- NEW TUNNEL & LOADING DOCK
- EXISTING BENNE LONG DRAIN
- PROPOSED STORMWATER DIVERSION

Details of the sub-surface conditions encountered during the course of the investigation are included in the Test Bore Report Sheets (Appendix D). The bore locations are shown on Drawing 1, Appendix A. The soils were generally free of obvious signs of chemical contamination such as odours or staining. Trace ash was encountered in Test Bores 102, 203 and 205.

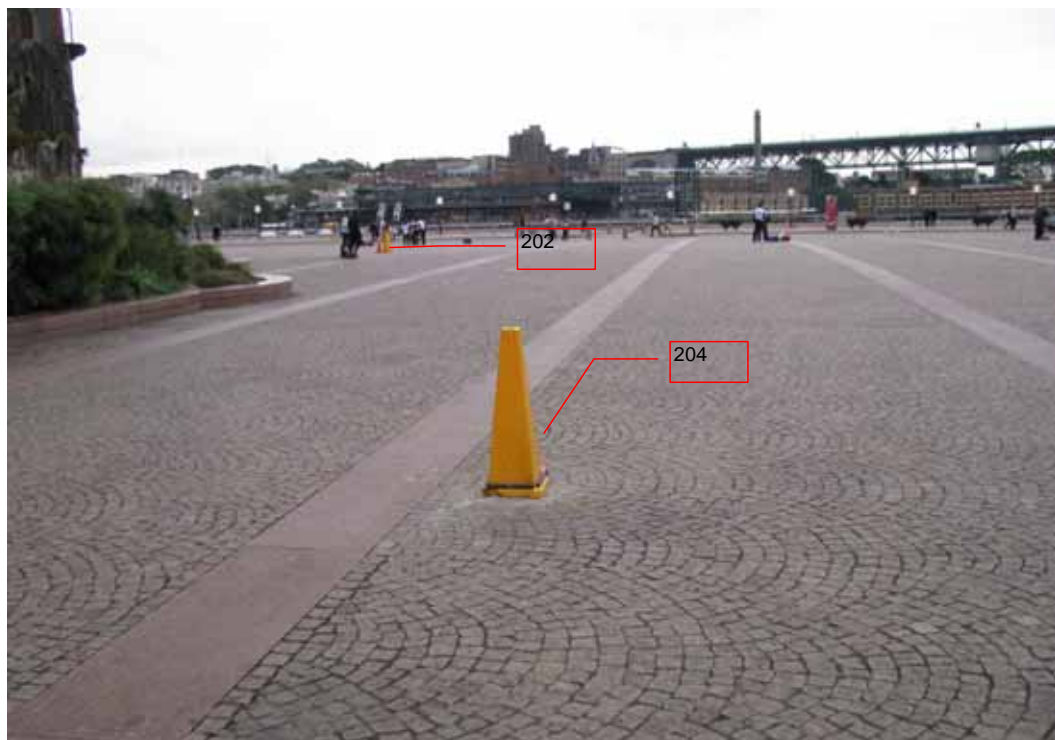
Photo 2: Test Bore 204 and 202 looking west

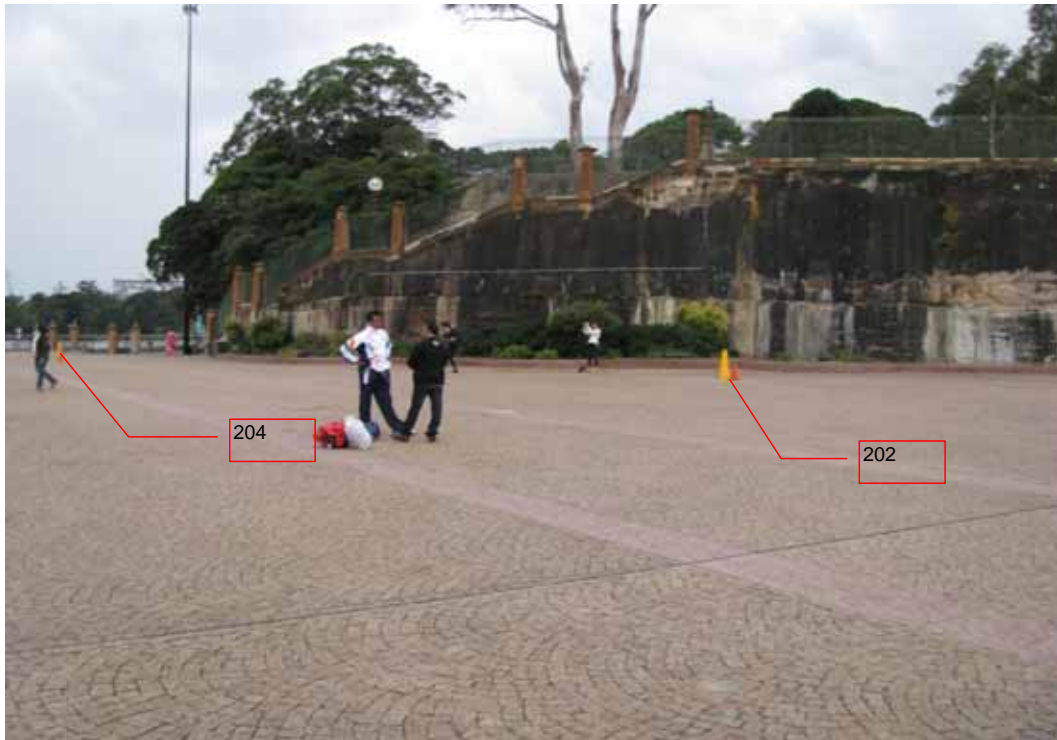
Photo 3: Test Bores 202 and 204 looking south towards Tarpeian Way

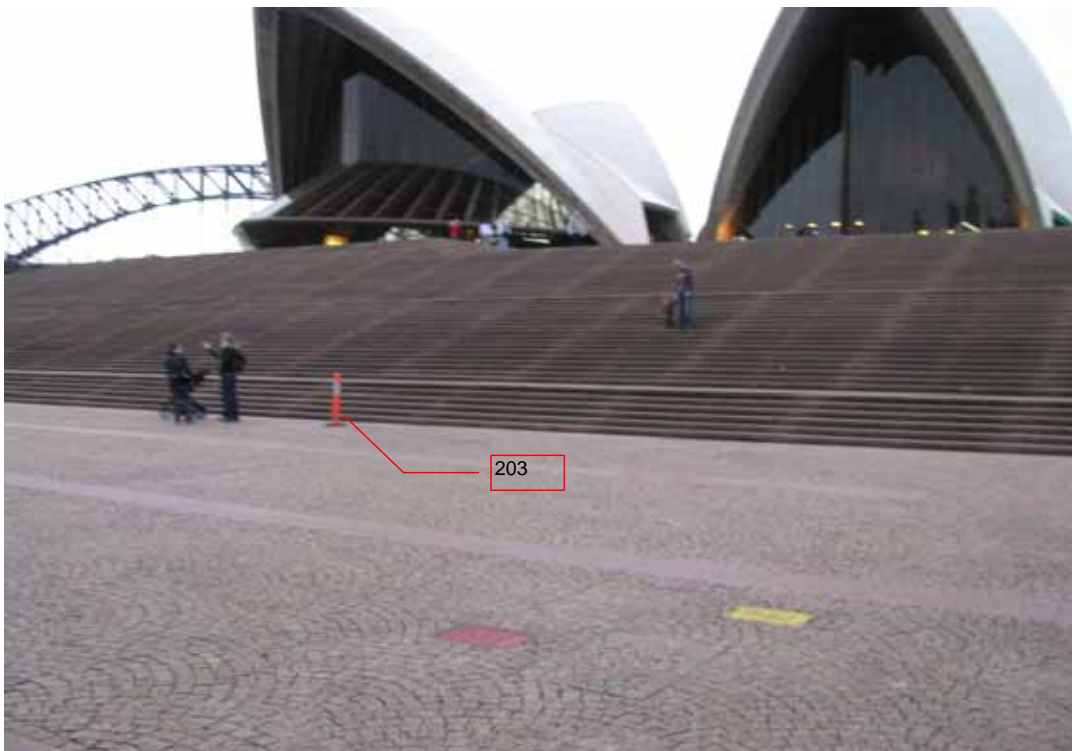
Photo 4: Test Bore 203 looking north west

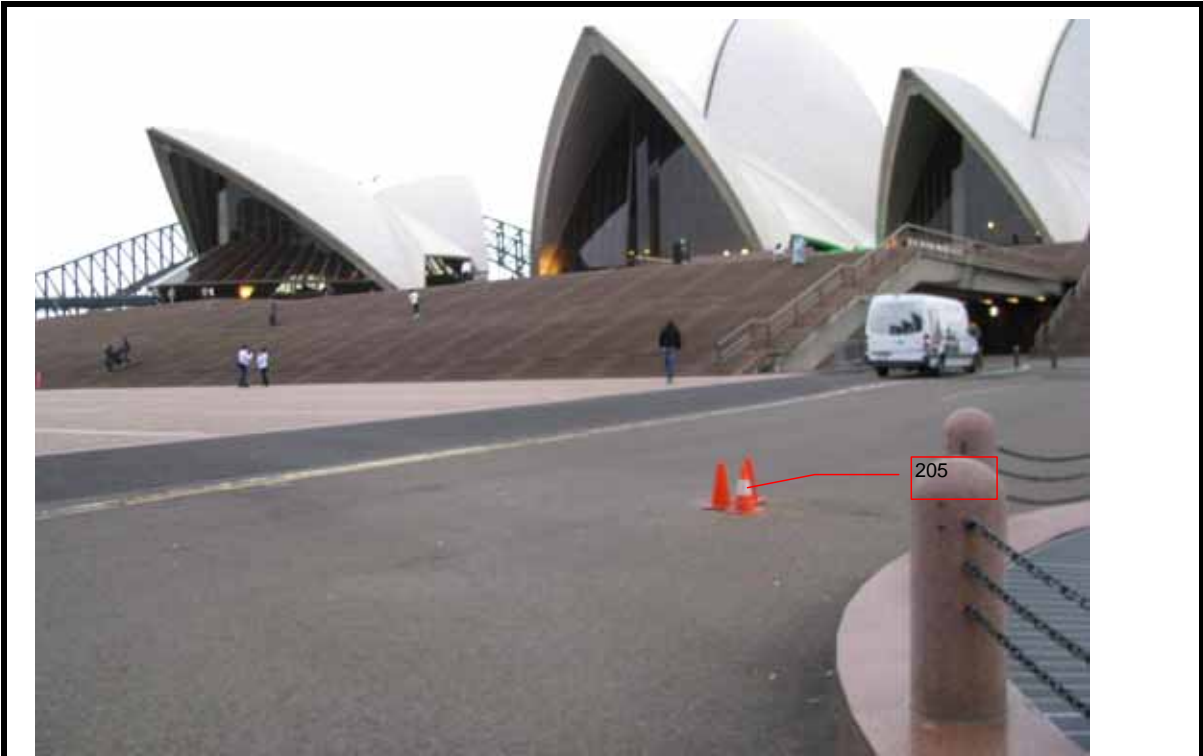
Photo 5: Test Bore 205 looking south west

It is noted that, based on site observations and test bore logs the elevated PAH levels are likely to be associated with trace ash and in the case of sample 205/0.3-0.5 (and its replicate BD4 170510) trace bitumen fragments in the filling. It is therefore considered that there is a limited potential adverse health impact from the elevated levels (i.e. they are generally locked into particulate) and they are therefore not significant unless the particulate is ingested.

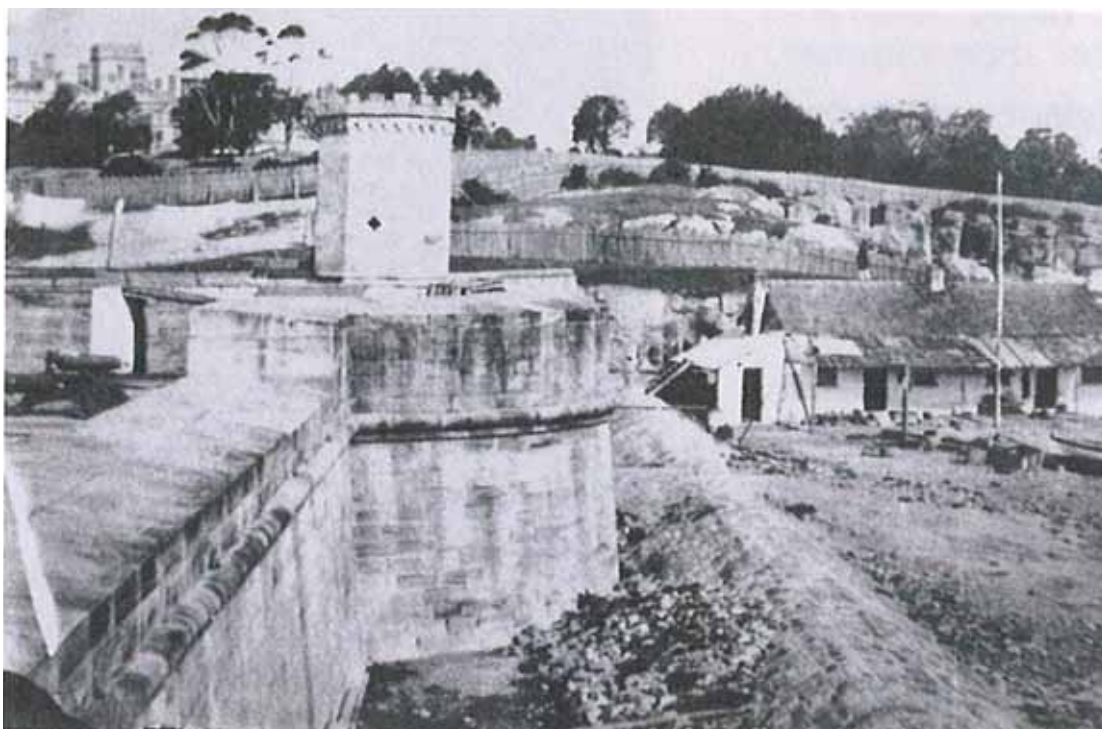
Photo 7: Top of Bennelong Drain adjacent to Fort Macquarie circa 1850s

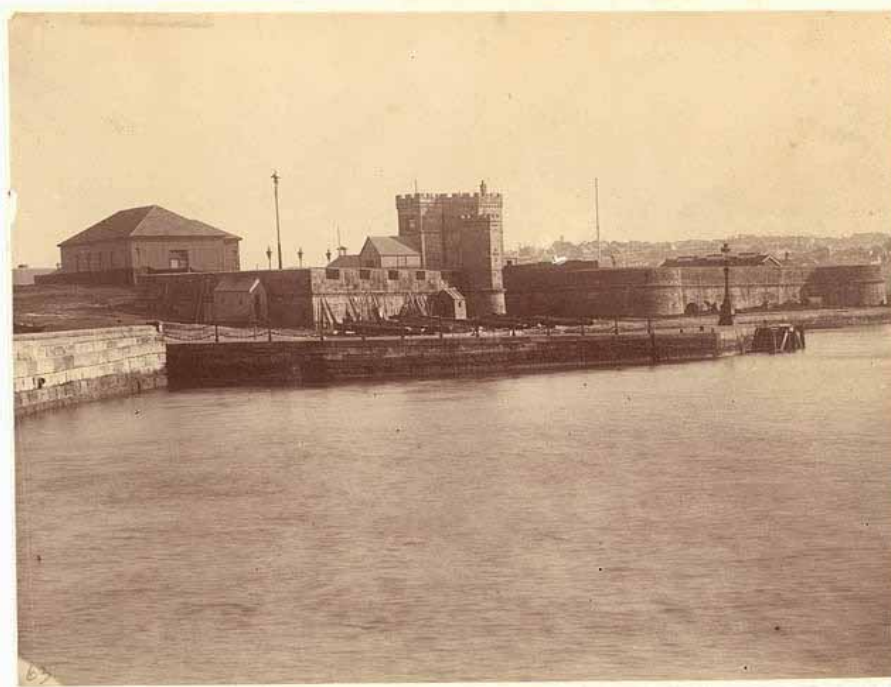
Photo 8: Fort Macquarie, 19th Century Source: <http://www.sydneyarchitecture.com>

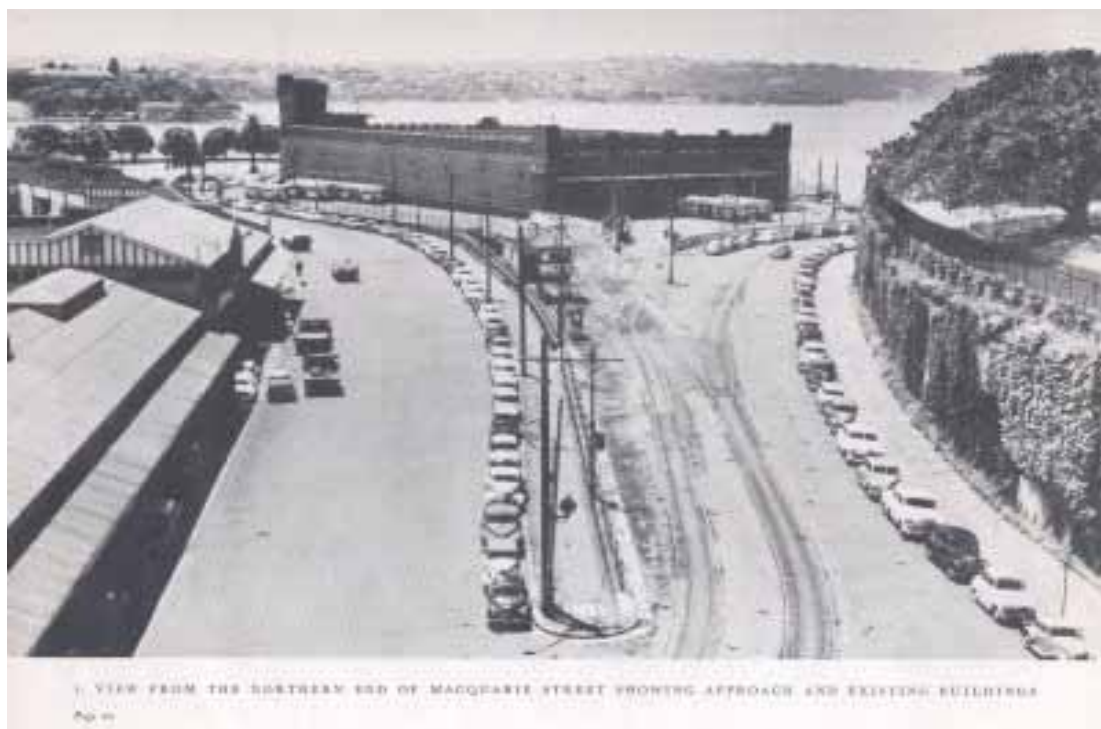
The early 20<sup>th</sup> century photo shows the site after the fort and ancillary structures were demolished and replaced with the tram shed. A number of tram lines are present heading into the tram shed. A number of warehouses are present to the west of the site and the Tarpeian Way is present. The photo is presented in Photo 9, Plate 5, Appendix C.

Photo 9: Early 20th Century. Tramshed that replaced Fort Macquarie  
Source: <http://www.sydneyarchitecture.com>

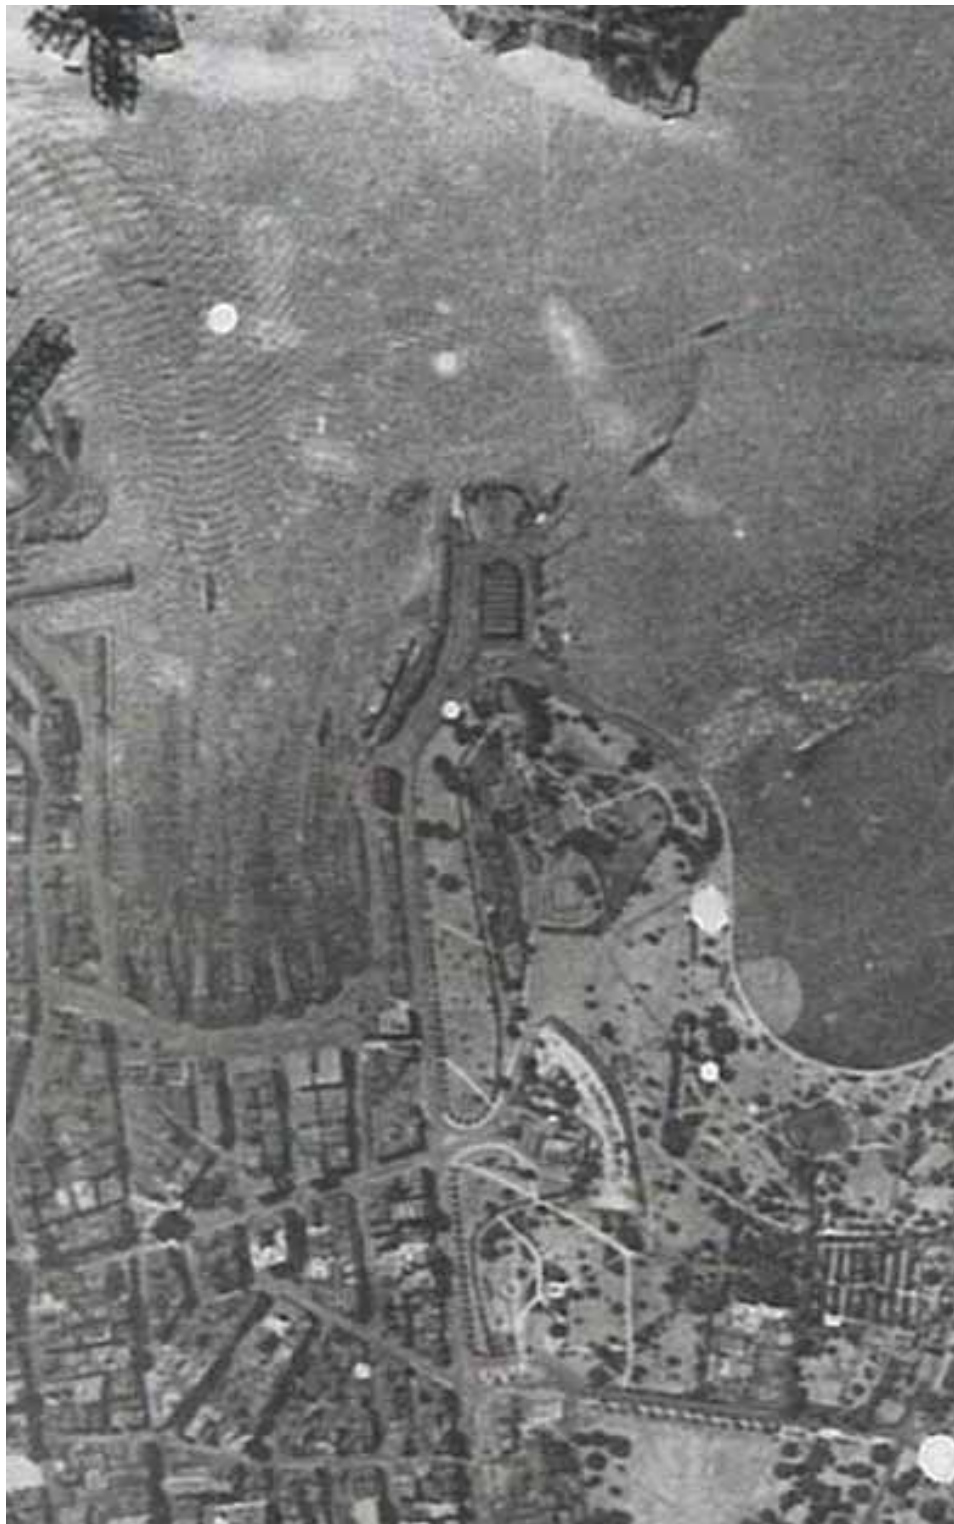
Photo 10: 1930 Aerial Photograph

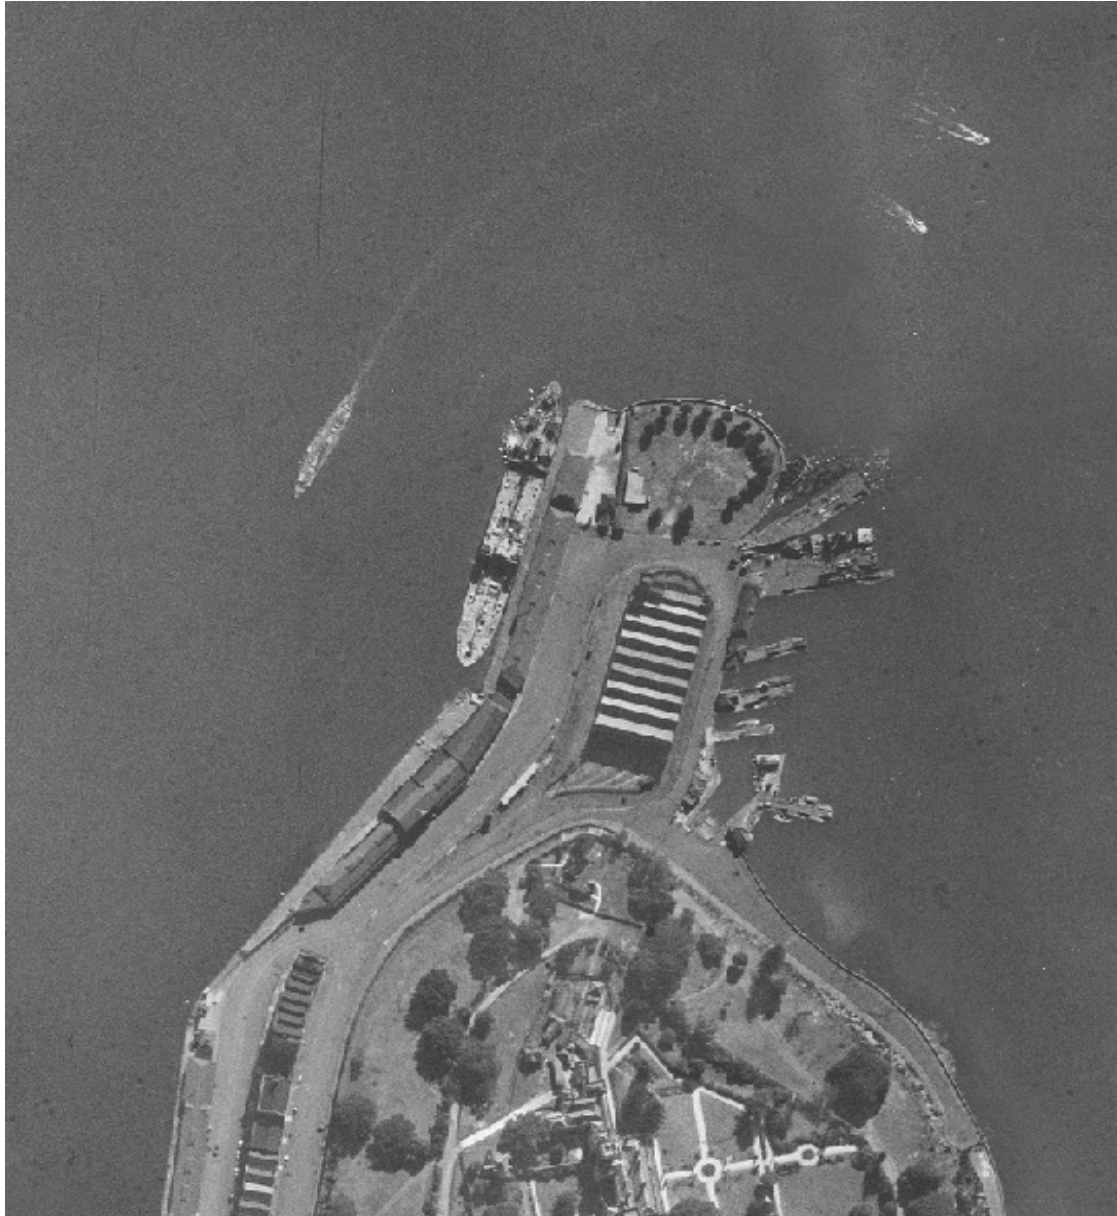
The 1943 aerial photograph is generally similar to the 1930 aerial photograph. It is possible that some minor works have been conducted on the finger wharves, but it is difficult to determine due to the poor quality of the 1930 aerial photograph. The immediate surrounds also appear consistent with the 1930 aerial photograph. A copy of the photo is presented in Photo 11, Plate 7, Appendix C.

Photo 11: 1943 Aerial Photograph

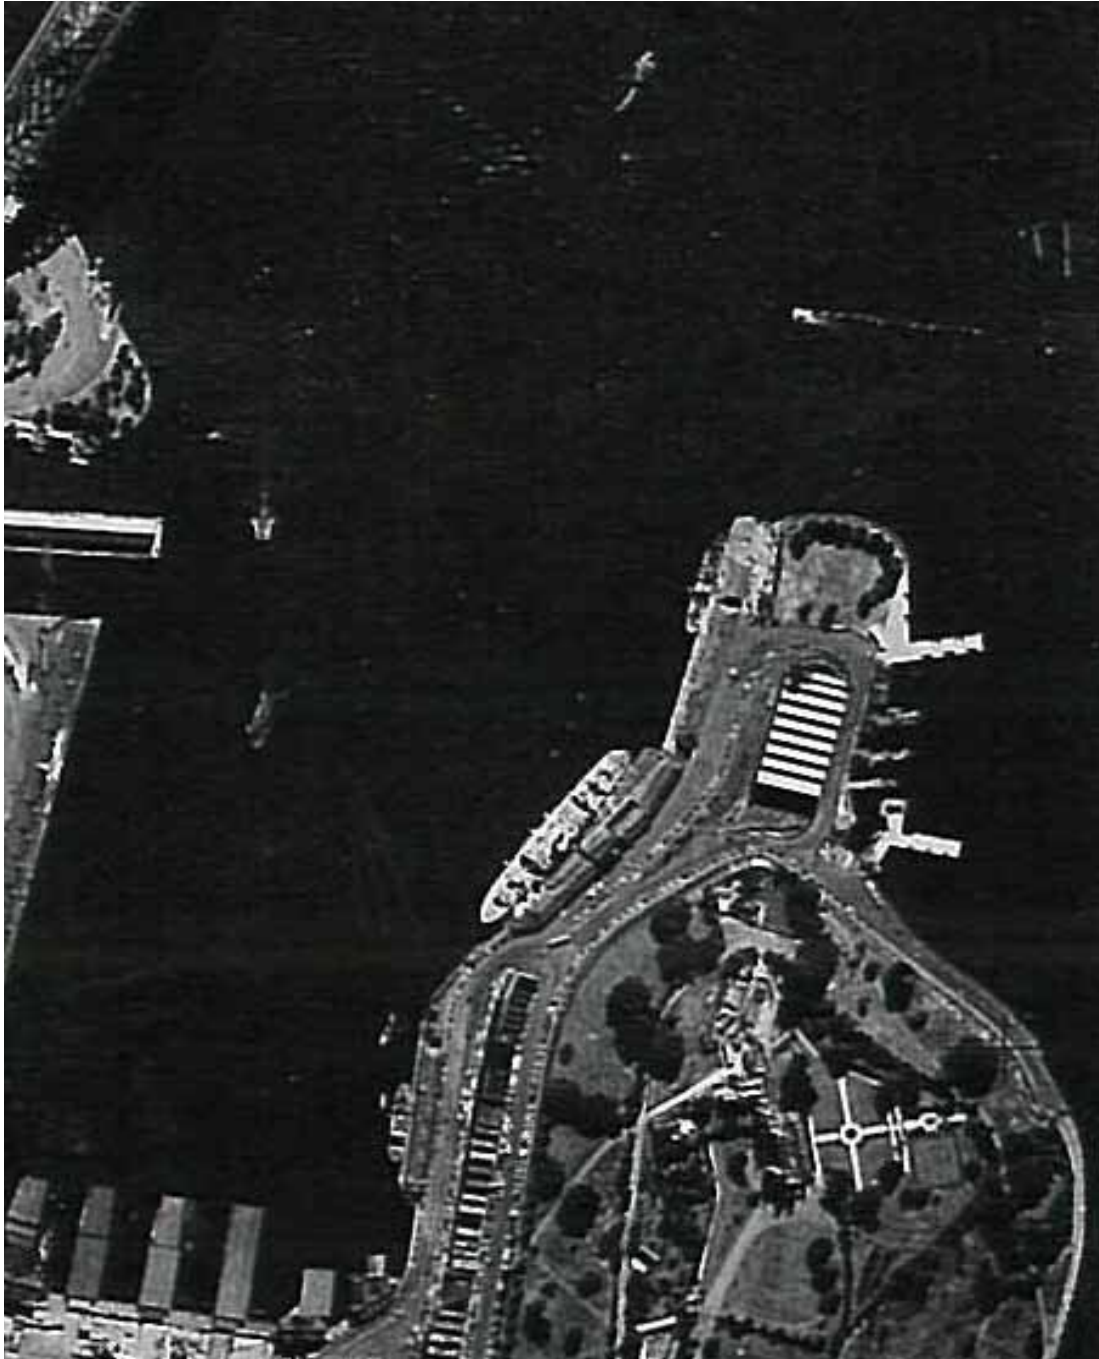
The 1951 aerial photograph is generally similar to the 1943 and 1930 aerial photographs. There have been some changes to the finger wharves on the eastern side on Bennelong Point with the two northern most wharves being removed and replaced with a single finger wharve which is connected to the north eastern corner of the point (although this is outside the VAPS works area). The immediate surrounds also appear consistent with the 1943 and 1930 aerial photograph. A copy of the photo is presented in Photo 12, Plate 8, Appendix C.

Photo 12: 1951 Aerial Photograph

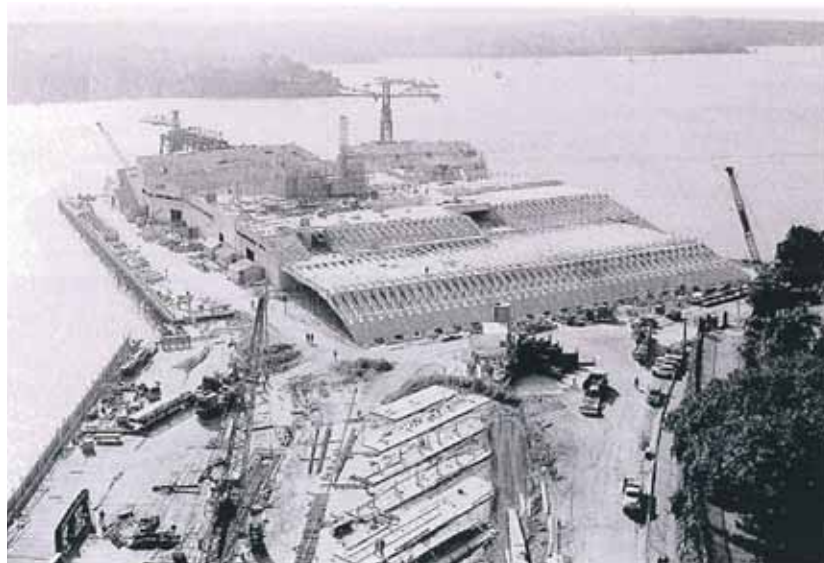
The 1960s historical site photos show the site during the construction of the Sydney Opera House and forecourt. The tram shed and tram lines have been demolished. In addition the Warehouses and docking ports on the western side of Bennelong Point have been removed and the finger wharves along the eastern side of Bennelong Point removed. The only remaining wharf on the eastern side is the Man-O-War Steps. Copies of the photos are presented in Photo 13, 14 and 15, Plate 9, Appendix C.

Photo 13: Opera House During Construction 1960s  
Source: (reproduced in) Godden Mackay Logan 2009)

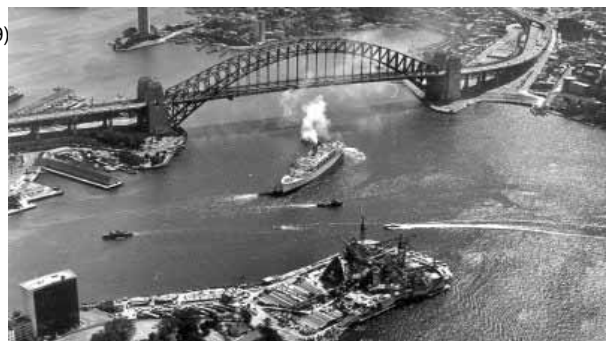
Photo 15: Opera House During Construction  
Source: <http://www.sydneyarchitecture.com>

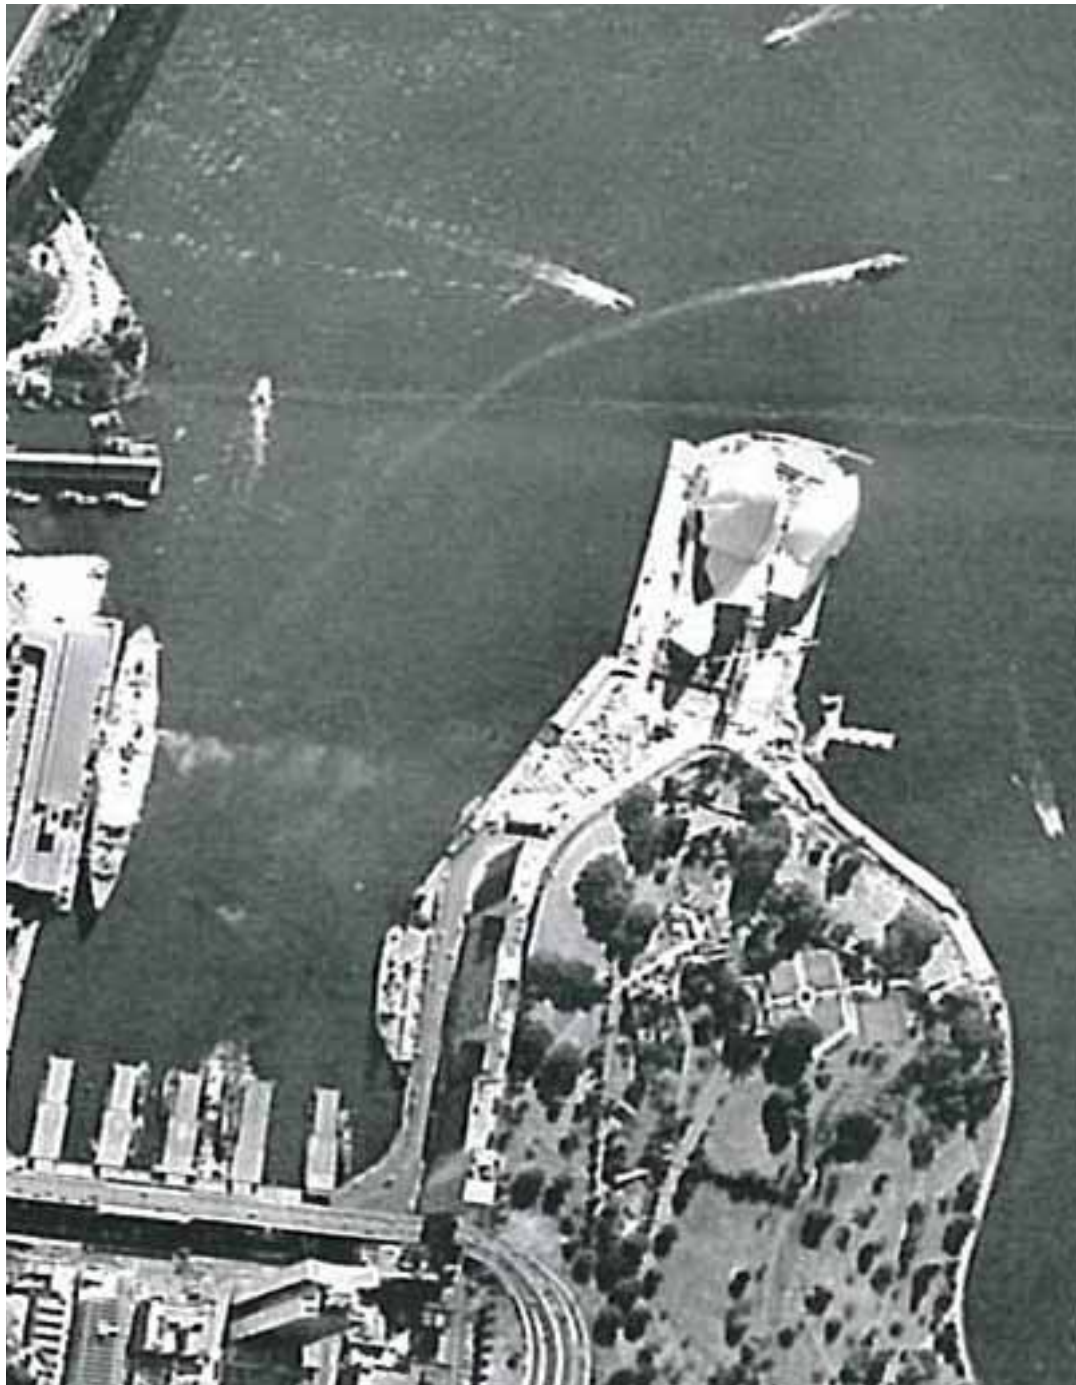
The 1970 aerial photograph shows the site after the completion of the Sydney Opera House. There appears to be some works on-going in the forecourt area. The immediate surrounds do not appear to have undergone significant change with the exception of increasing number of multi-story office buildings to the south east of the site. A copy of the photo is presented in Photo 16, Plate 10, Appendix C.

Photo 16: 1970 Aerial Photograph

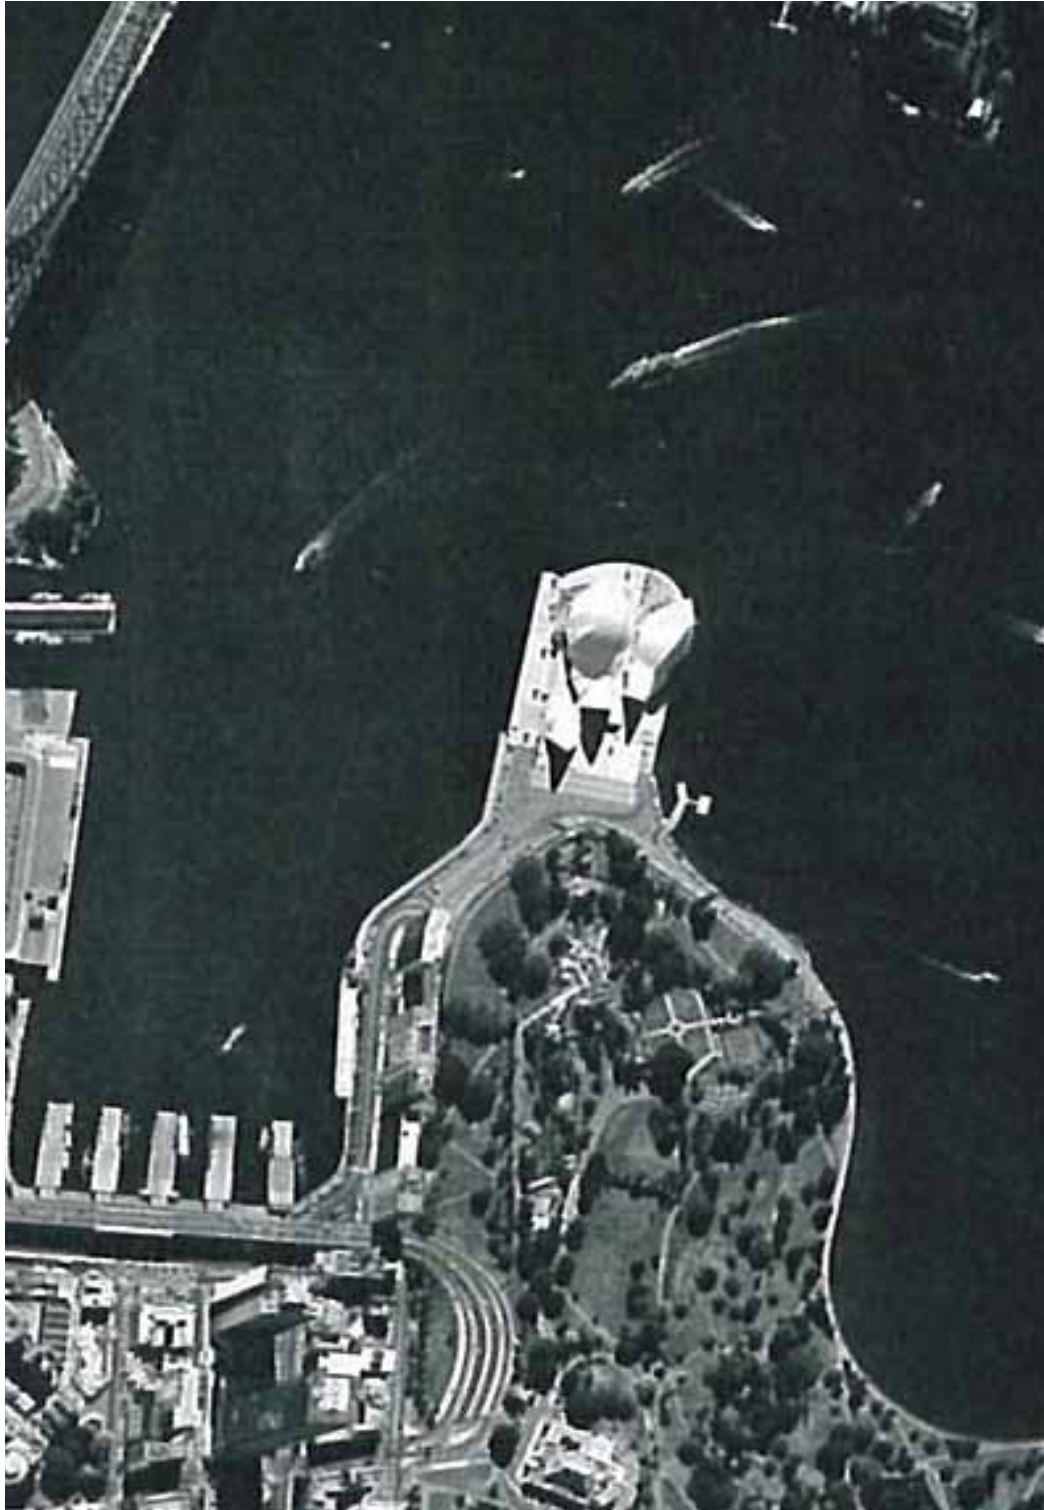
The 1978 aerial photograph shows the site following the completion of works in the forecourt. The western side of Bennelong Point appears to have undergone some minor reshaping and the Ma-O-War Steps appear to have been re-designed and possibly small area along the shoreline at the Man-O-War Steps reclaimed to “smooth out” the shoreline. A copy of the photo is presented in Photo 17, Plate 11, Appendix C.

Photo 17: 1978 Aerial Photograph

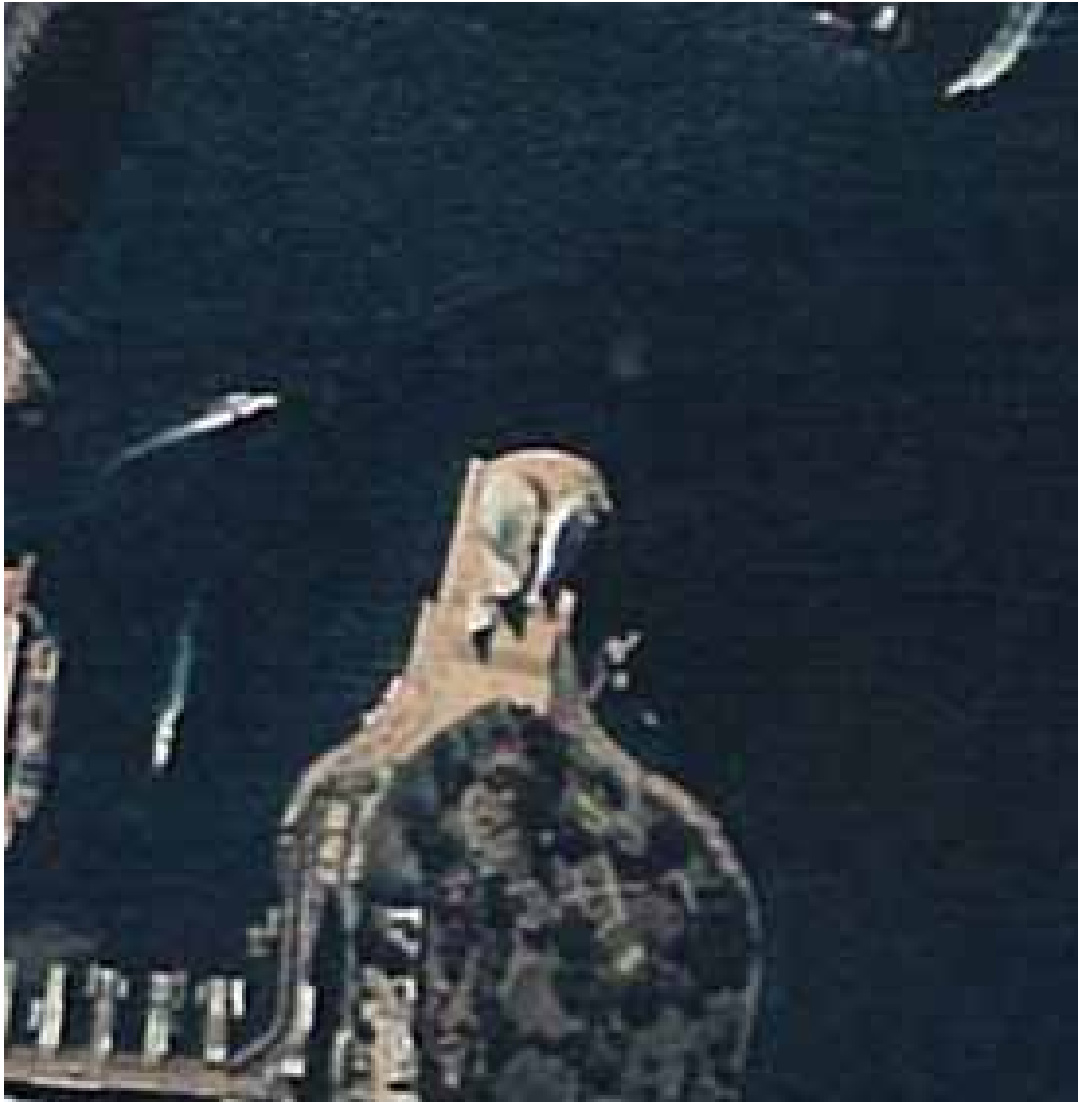
The 1991 aerial photograph does not show any significant change at the site to the 1986 aerial photograph. Similarly there are no significant changes to the surrounding area. A copy of the photo is presented in Photo 19, Plate 13, Appendix C.

Photo 19: 1991 Aerial Photograph

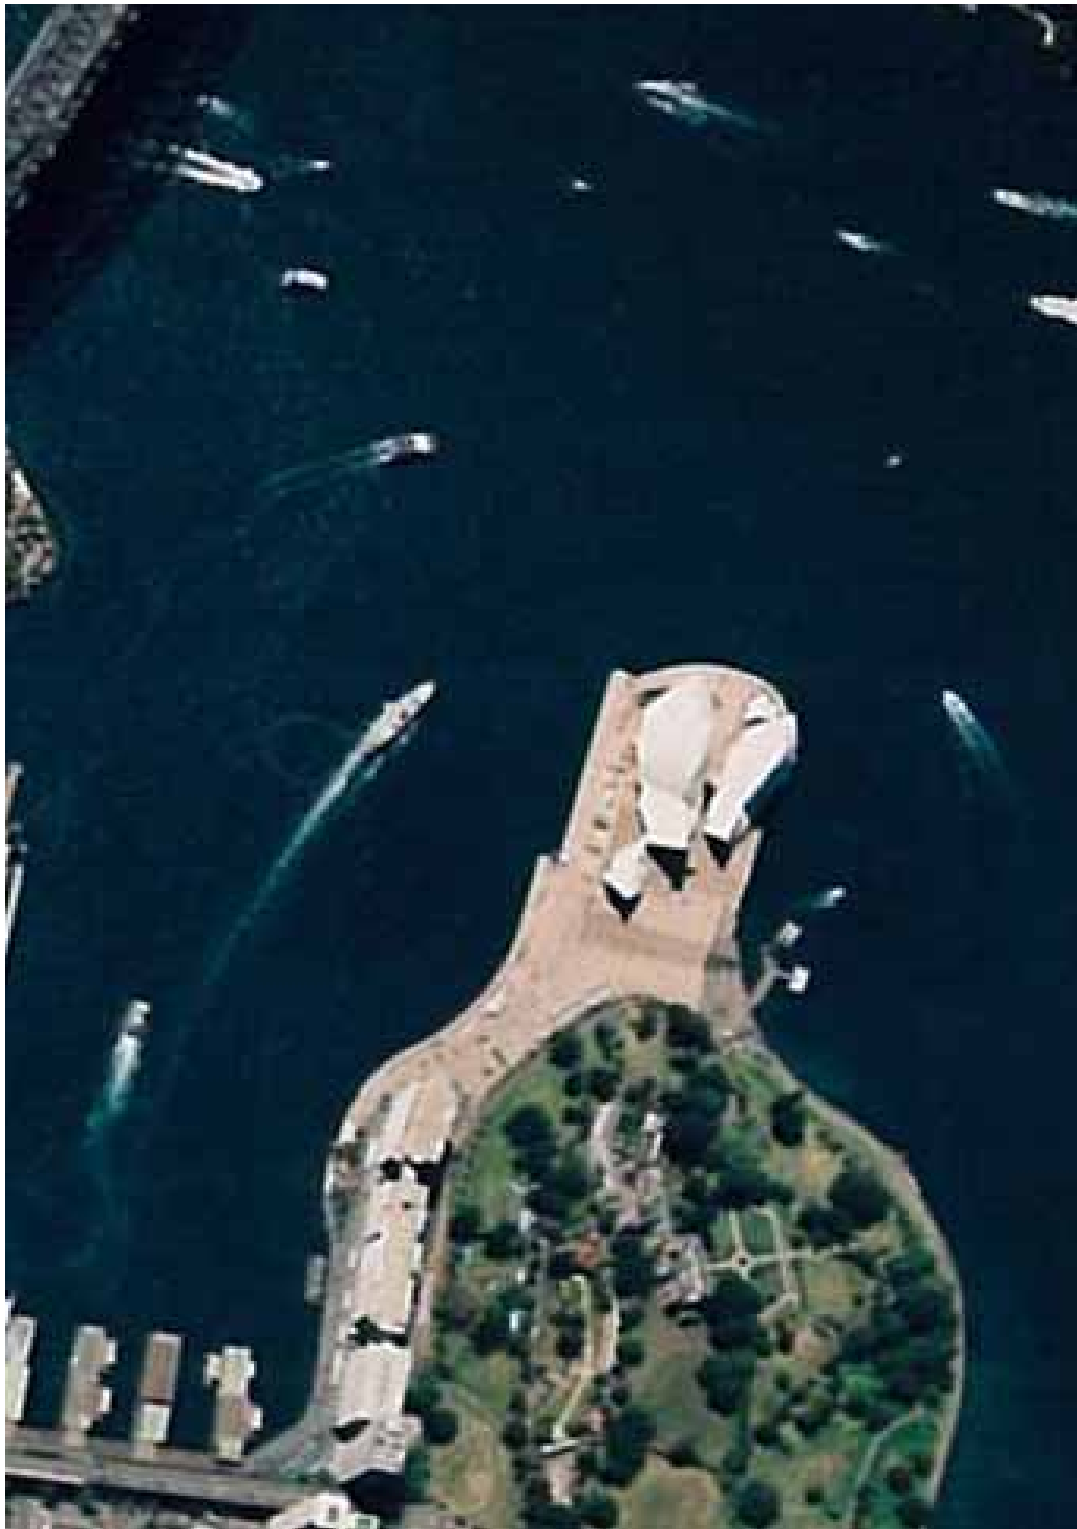
The 2004 aerial photograph does not show any significant change at the site to the 1991 aerial photograph. Similarly there are generally significant changes to the surrounding area with the exception of the construction of a new residential apartment block to the south east (“the toaster”). A copy of the photo is presented in Photo 20, Plate 14, Appendix C.

Photo 20: 2004 Aerial Photograph

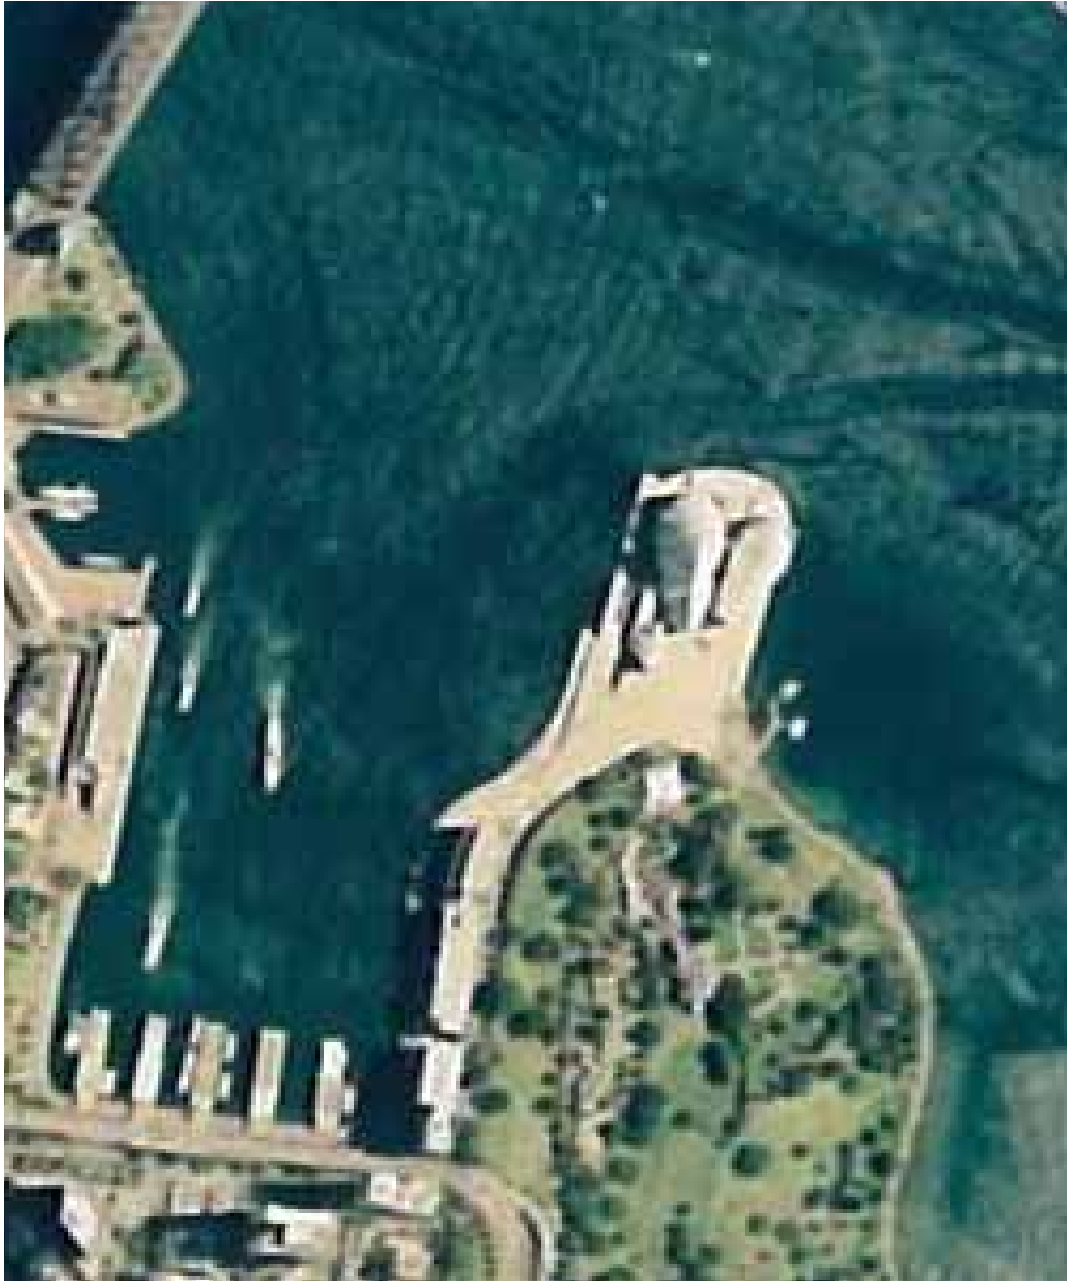
The 2005 aerial photograph does not show any significant change at the site to the 2004 aerial photograph. Similarly there are no significant changes to the surrounding area. A copy of the photo is presented in Photo 21, Plate 15, Appendix C.

Photo 21: 2005 Aerial Photograph
