**PRELIMINARY CONTAMINATION ASSESSMENT**

**VEHICLE AND PEDESTRIAN SAFETY (VAPS)  
PROJECT**

**SYDNEY OPERA HOUSE BENNELONG POINT**

**Project 71529.01**

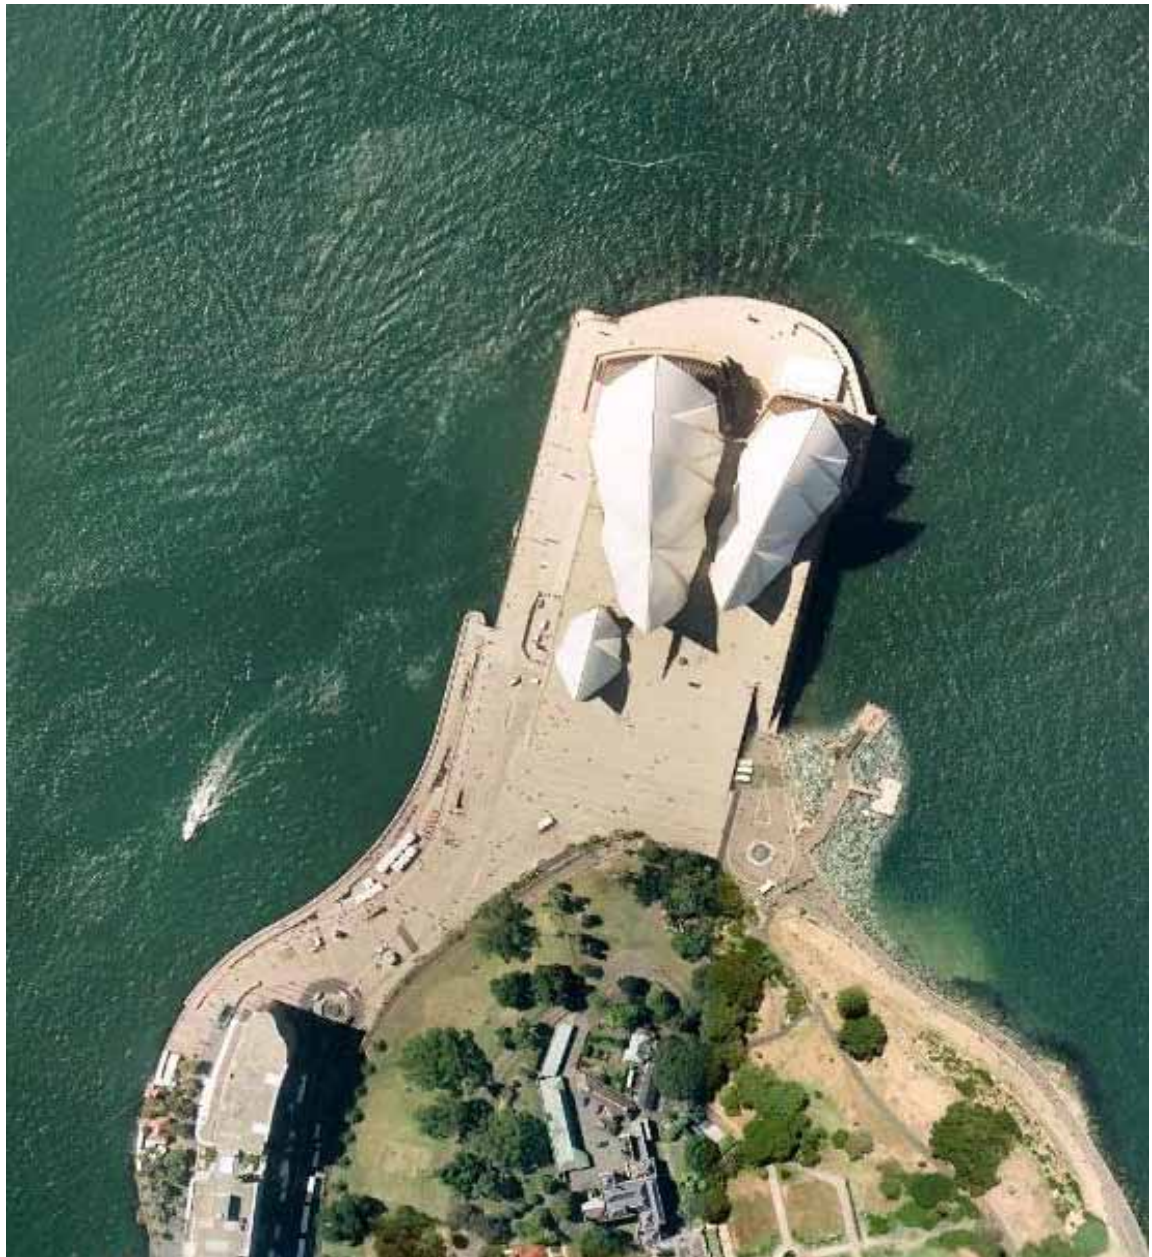
The 2010 aerial photograph shows the current site condition and does not show any significant change at the site to the 1986 to 2005 aerial photographs. Similarly, there are no

Photo 22: 2010 Aerial Photograph
