**PRELIMINARY GEOTECHNICAL INVESTIGATION AND
WASTE CLASSIFICATION ASSESSMENT**

**PROPOSED VEHICLE AND PEDESTRIAN SAFETY
(VAPS) PROJECT
SYDNEY OPERA HOUSE
BENNELONG POINT**

Prepared for
SYDNEY OPERA HOUSE TRUST

Project 71529
February 2010

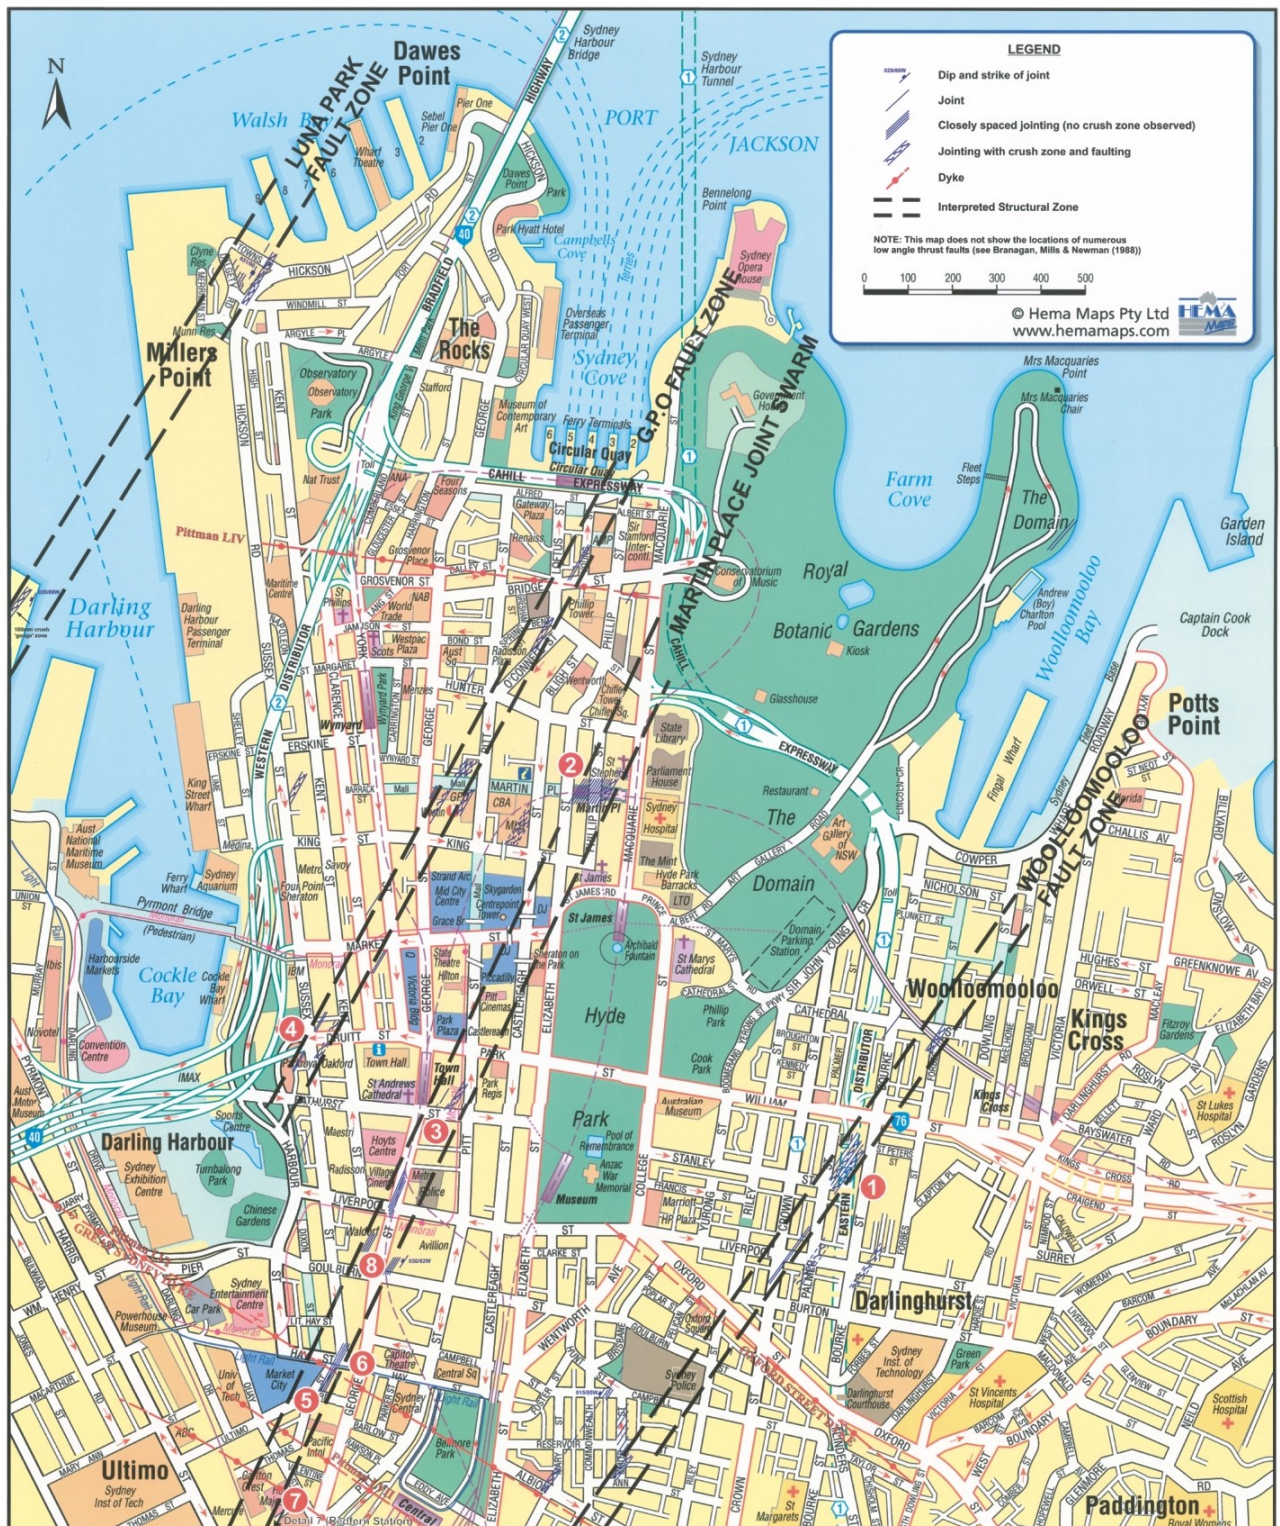
Figure 1 – Vertical Geological Structures in the Sydney CBD

Near vertical geological structural features in the Sydney CBD were described in the paper by Pells, Braybrooke & Och (2004). Figure 1 – Vertical Geological Structures in the Sydney CBD, is reproduced from the paper and shown below:

Apart from near vertical strike-slip faults, there are also numerous low-angle (0° - 25°) thrust faults. These often manifest themselves as crushed or clayey bedding planes between individual sandstone beds or clayey zones ramping-up along cross beds. They generally strike east-west and dip either north or south.

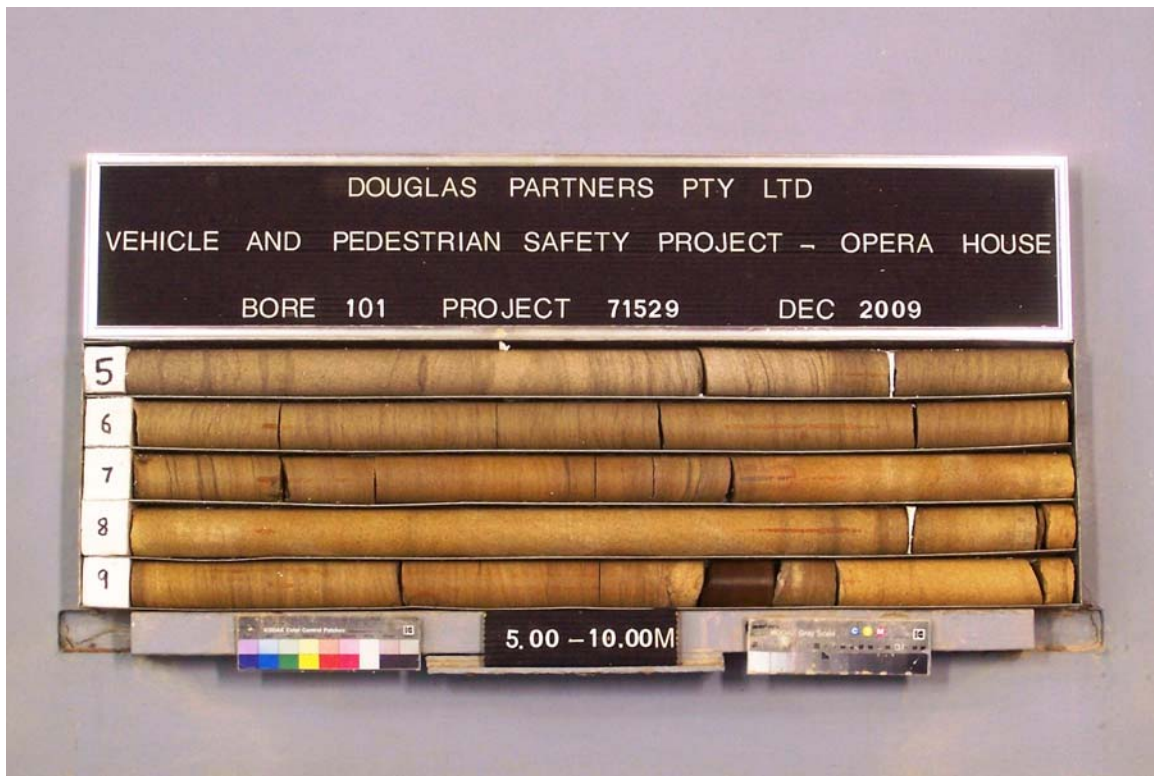
BOREHOLE LOG

Details of the subsurface conditions encountered in the boreholes are given in the borehole logs included in Appendix B, together with notes defining classification methods and descriptive terms. The SPT results are shown on the logs at the appropriate depth. Photographs of the rock cores were taken and are presented opposite the relevant logs in Appendix B.

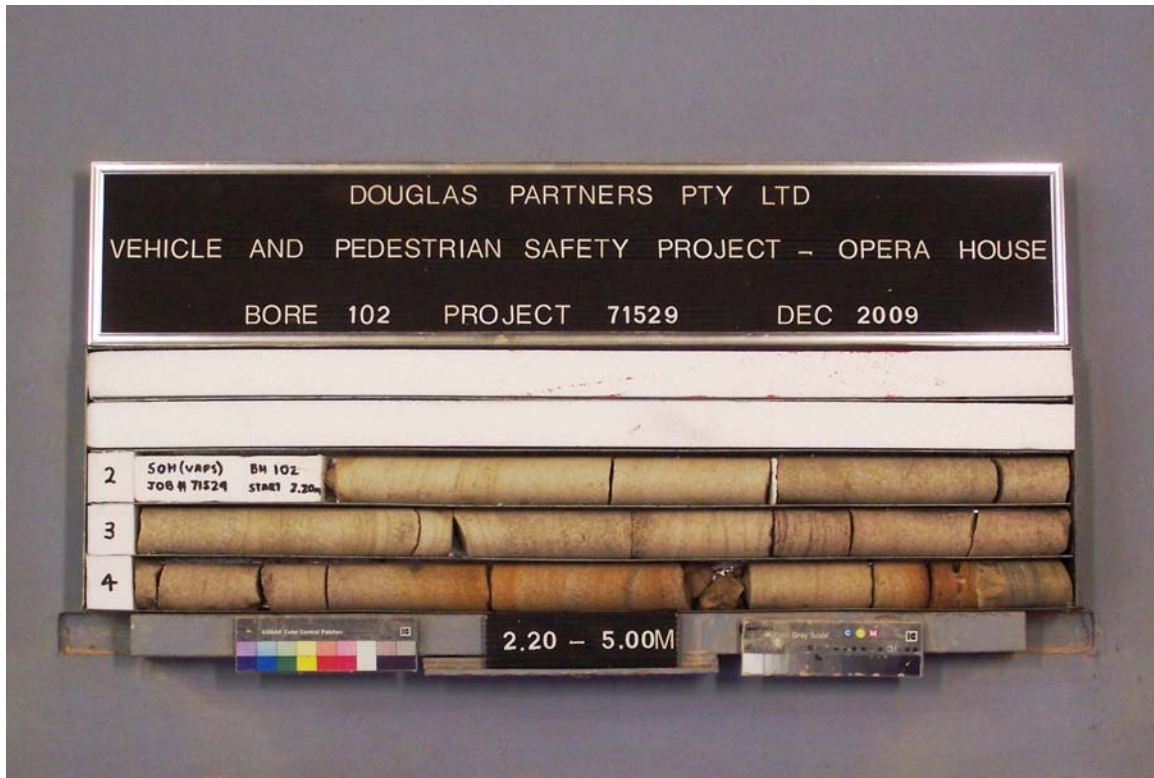
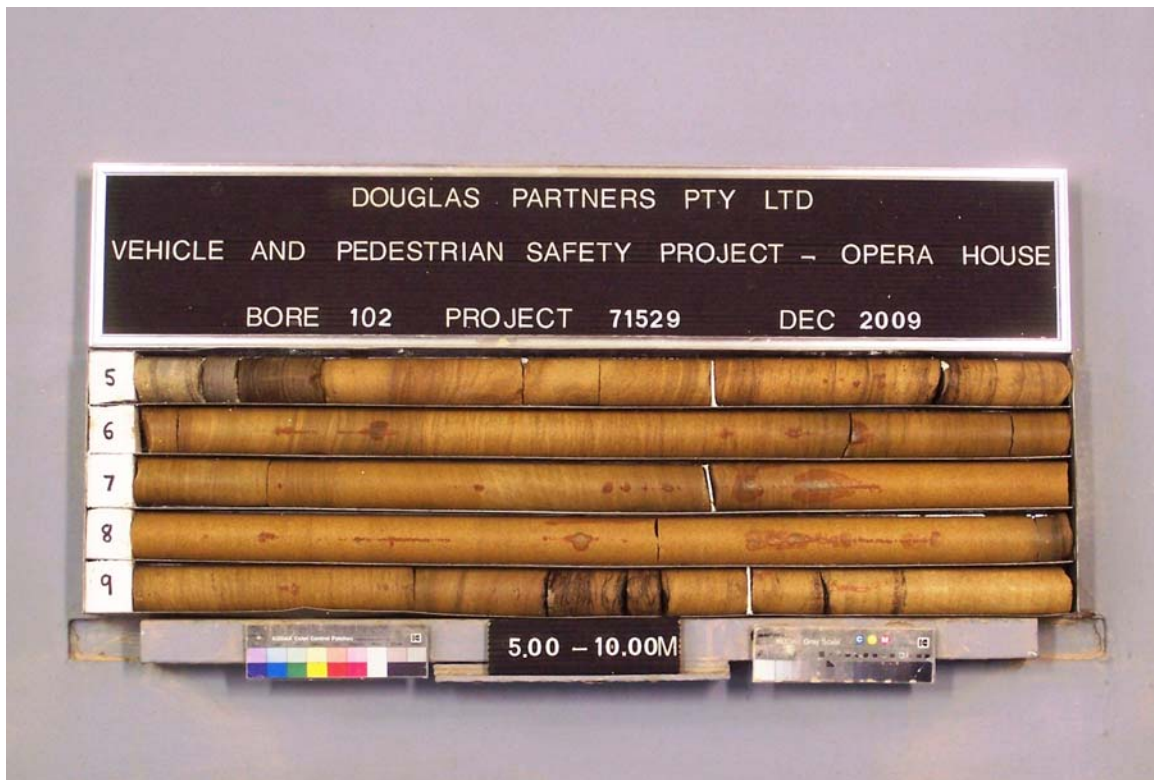
BOREHOLE LOG

2.2	SANDSTONE - high strength, fresh then slightly weathered, slightly fractured and unbroken, light grey, medium to coarse grained sandstone																			
		SANDSTONE - high strength, fresh then slightly weathered, slightly fractured and unbroken, light grey, medium to coarse grained sandstone																C	100	100	PL(A) = 1.7MPa
3																					
4

4.25-4.95m: moderately weathered, fractured zone, 700mm																C	100	91	PL(A) = 2MPa
5	4.95	4.95-5.2m: high strength, laminite band, fresh																			PL(A) = 1.2MPa

5.2	SANDSTONE - high strength, fresh, slightly fractured and unbroken, light grey with yellow coating, medium grained sandstone, medium bedded																			PL(A) = 1.1MPa
6																					
7		7.0-9.1m: possible 'yellow block' sandstone																C	100	100	PL(A) = 1.9MPa
																					PL(A) = 1.5MPa
8																					
9																		C	100	96	PL(A) = 1.6MPa

WATER OBSERVATIONS: No free groundwater observed whilst augering

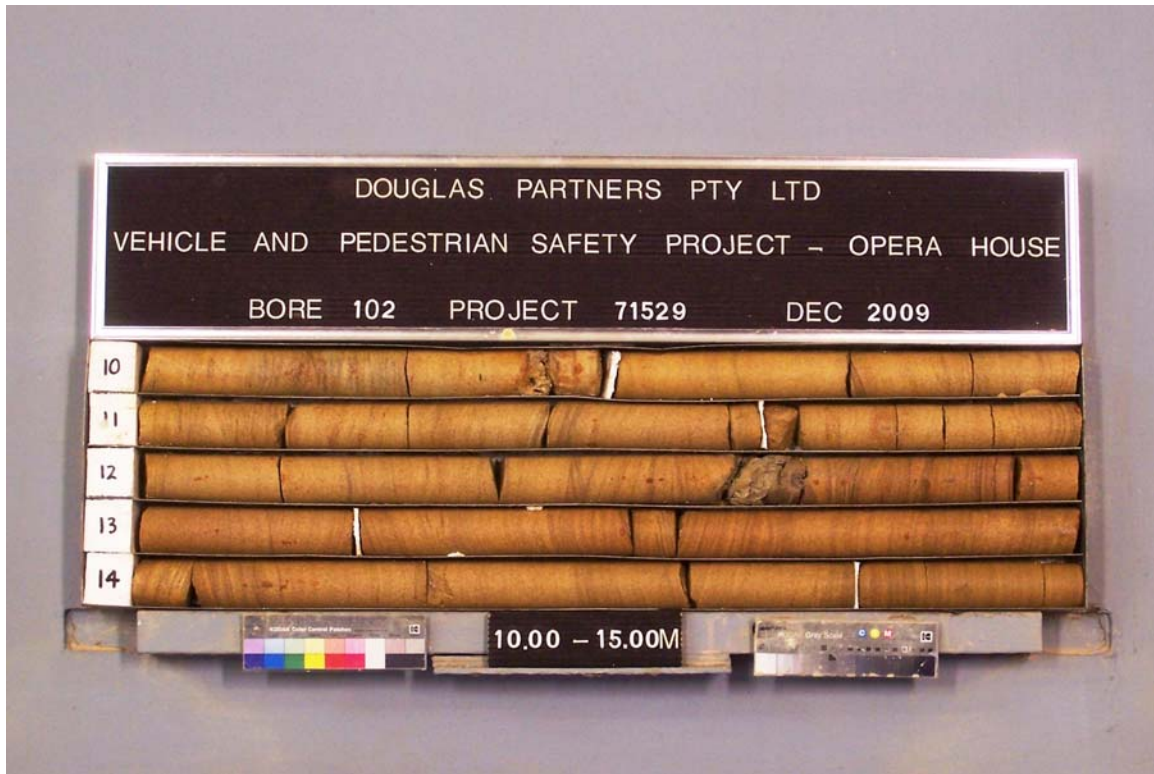
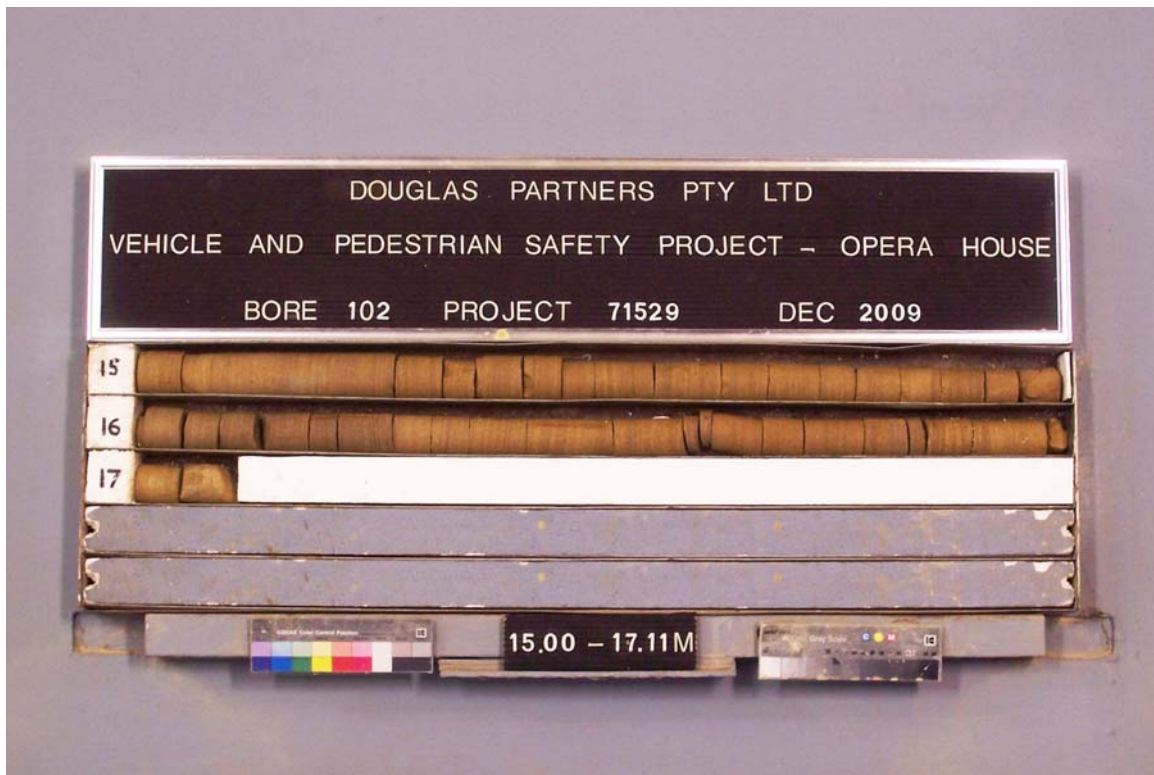
BOREHOLE LOG

-7		SANDSTONE - high strength, fresh, slightly fractured and unbroken, light grey with yellow coating, medium grained sandstone, medium bedded (continued)

WATER OBSERVATIONS: No free groundwater observed whilst augering
