## **6.7      BLAST AND VIBRATION IMPACT ASSESSMENT**

**Blast and Vibration  
Impact Assessment  
Train Support Facility**

Filename: 10634 Blast and Vibration Assessment Rev1.doc  
Job #: J0090227-01 Folder #: F10634  
Revision: 1 (Final)  
Date: 28 September 2010

# Sub-surface Testing of the Archaeology of Part Lot 1, DP1129191, at Greta, NSW, for Pacific National

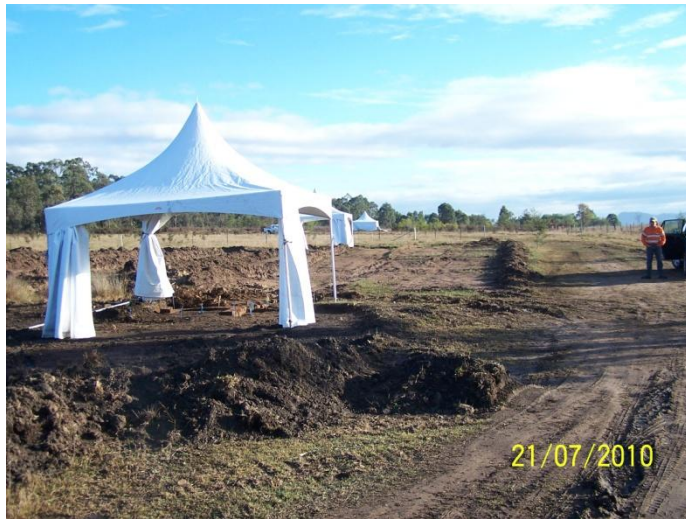
**Figure 2.3**

View from south of site MH11-E, looking along the line of shelters over that site, the location of discarded MH10-E and MH5-E

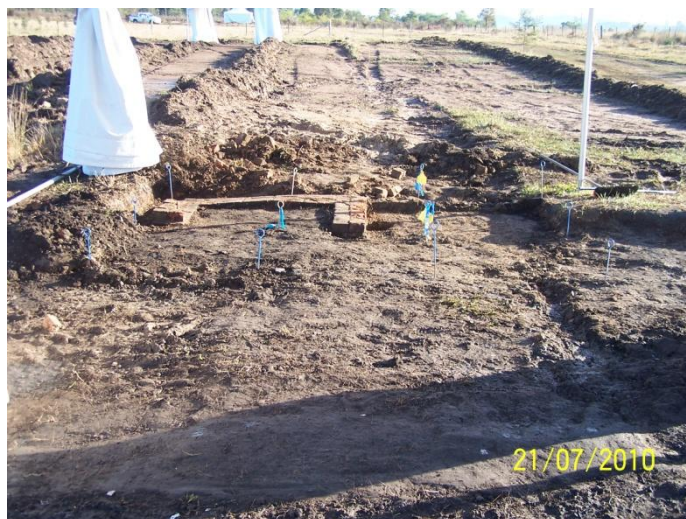
**Figure 2.4**

Overview of the grid at MH11-E.

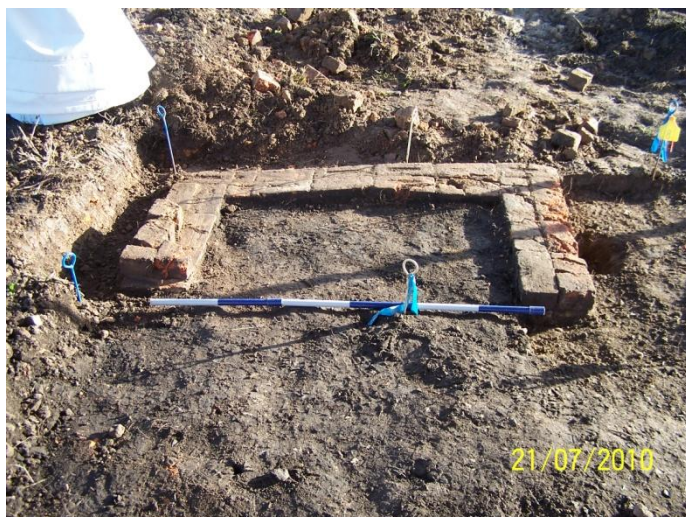
**Figure 2.5**

Detail of the fireplace footing and part first fireplace course, MH11-E, from south.

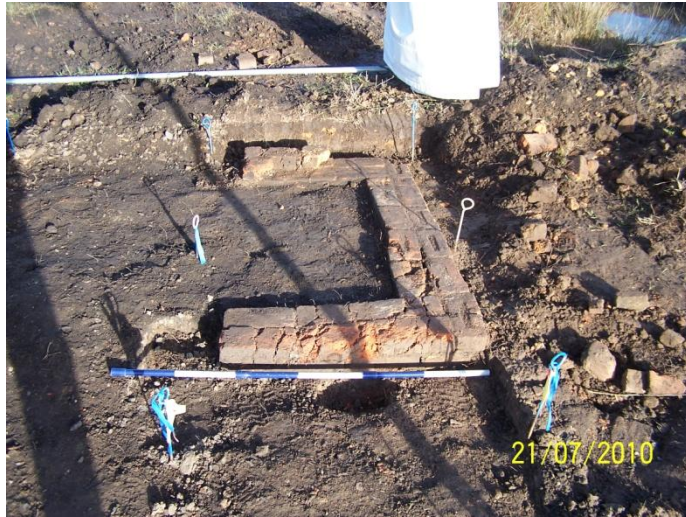
**Figure 2.6**

Detail of the fireplace footing and part first fireplace course, MH11-E, from east

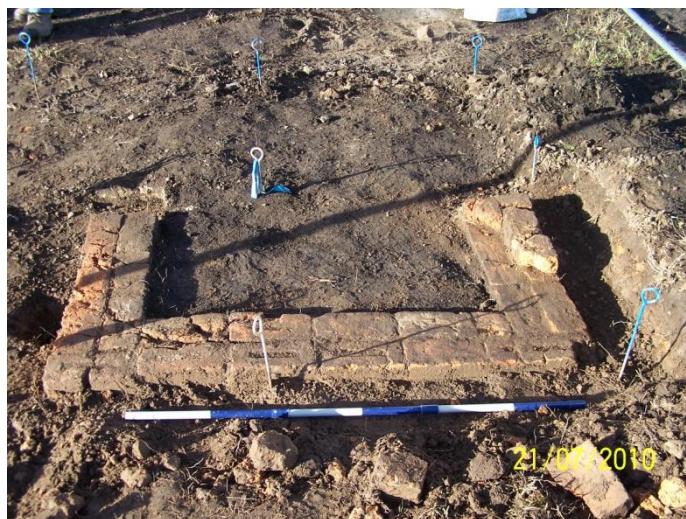
**Figure 2.7**

Detail of the fireplace footing and part first fireplace course, MH11-E, from north.

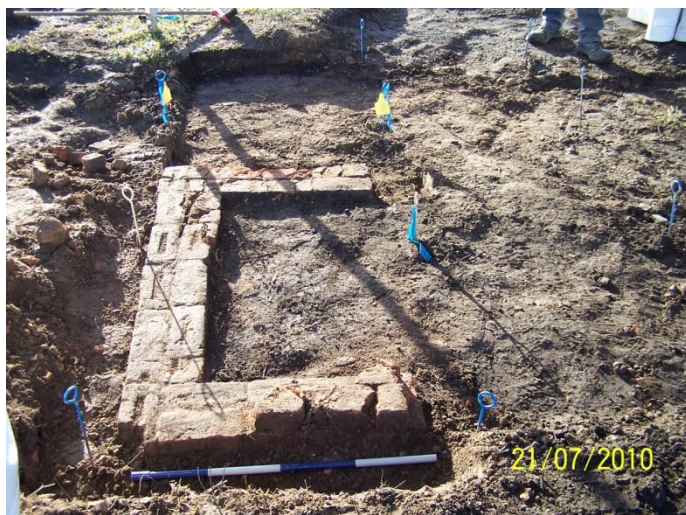
**Figure 2.8**

Detail of the fireplace footing and part first fireplace course, MH11-E, from west

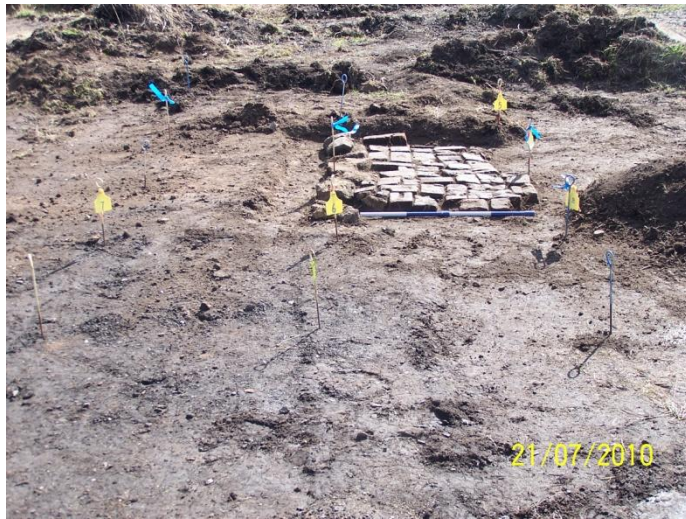
**Figure 2.10**

View of the material part of the grid including the door sill and brick and brickbat apron, MH5-E, from south.

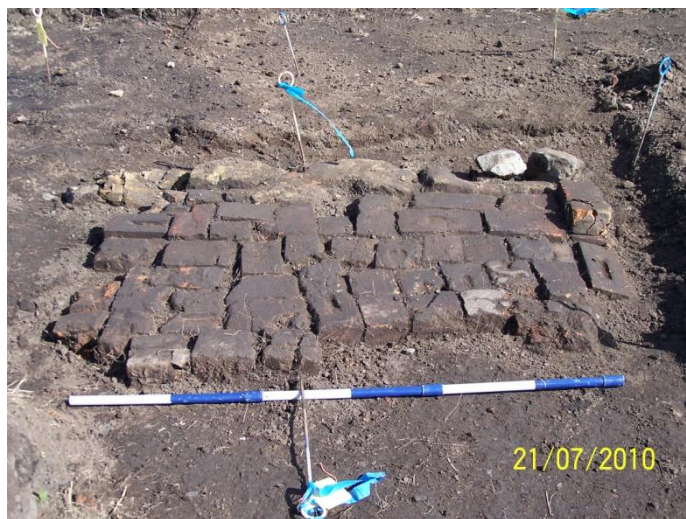
**Figure 2.11**

Detail of the door sill and brick and brickbat apron, MH5-E, from east.

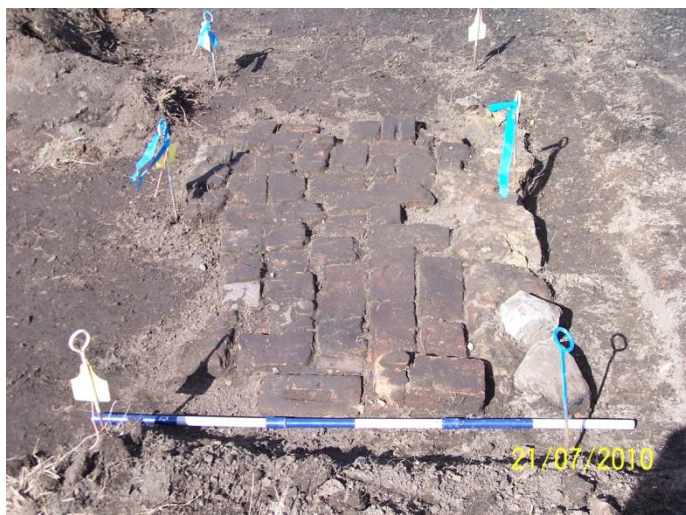
**Figure 2.12**

Detail of the door sill and brick and brickbat apron, MH5-E, from north.

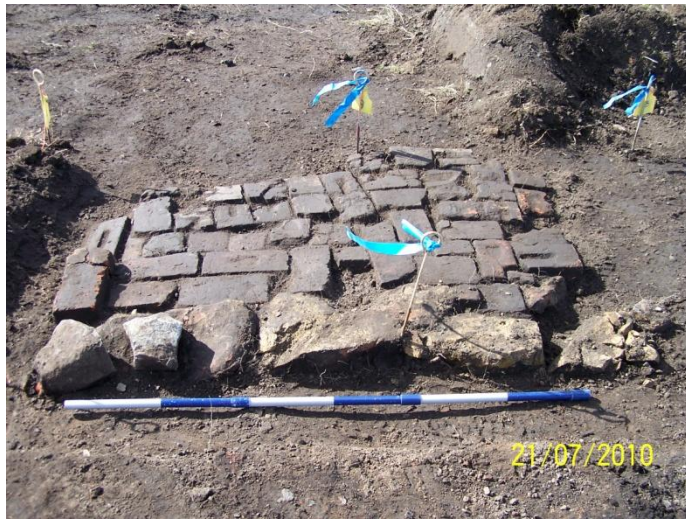
**Figure 2.13**

Detail of the door sill and brick and brickbat apron, MH5-E, from west.

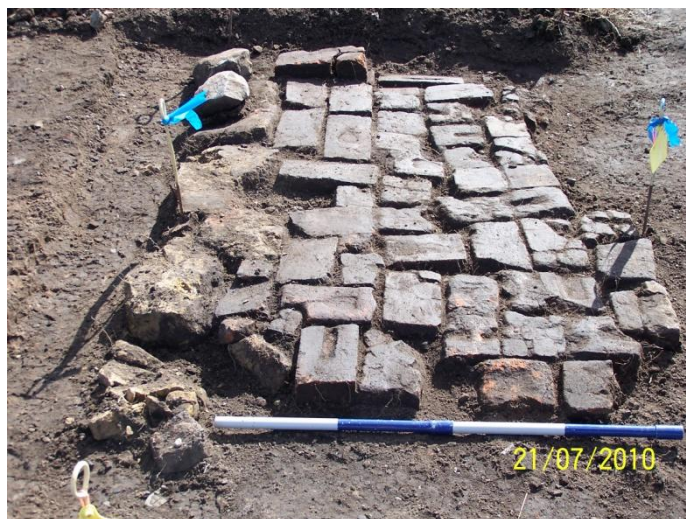
**Figure 2.14**

Detail of the door sill and brick and brickbat apron, MH5-E, from south.

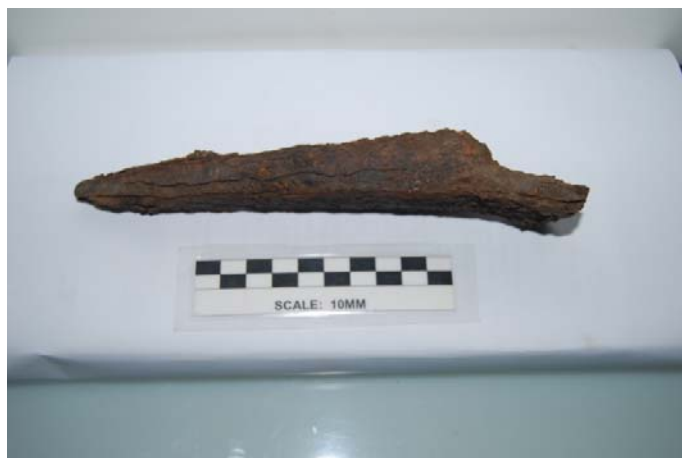
**Figure A10**

The broken head of miner's pick recovered from MH11E, Artefact #95.

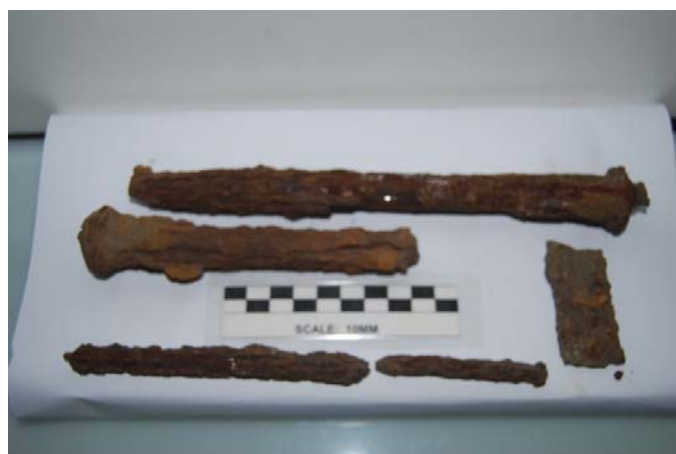
**Figure A11**

Selection of iron spikes, strap and nails recovered from MH11E, Artefacts ##93, 94, 96, 97 and 99.

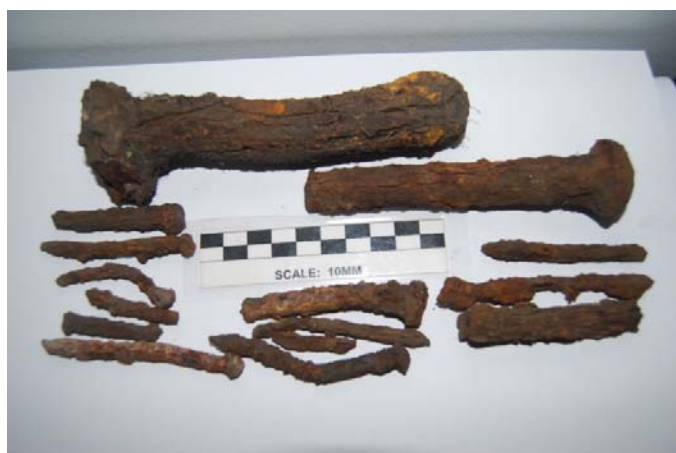
**Figure A12**

Assemblage of iron bolts, nails and fragments recovered from MH5E, Artefacts ##101-107 enc.
