Appendix G

TEM survey

Cobbora Proposed Coal Mine Transient Electromagnetic Groundwater Investigation

for Parsons Brinkerhoff, November 2011

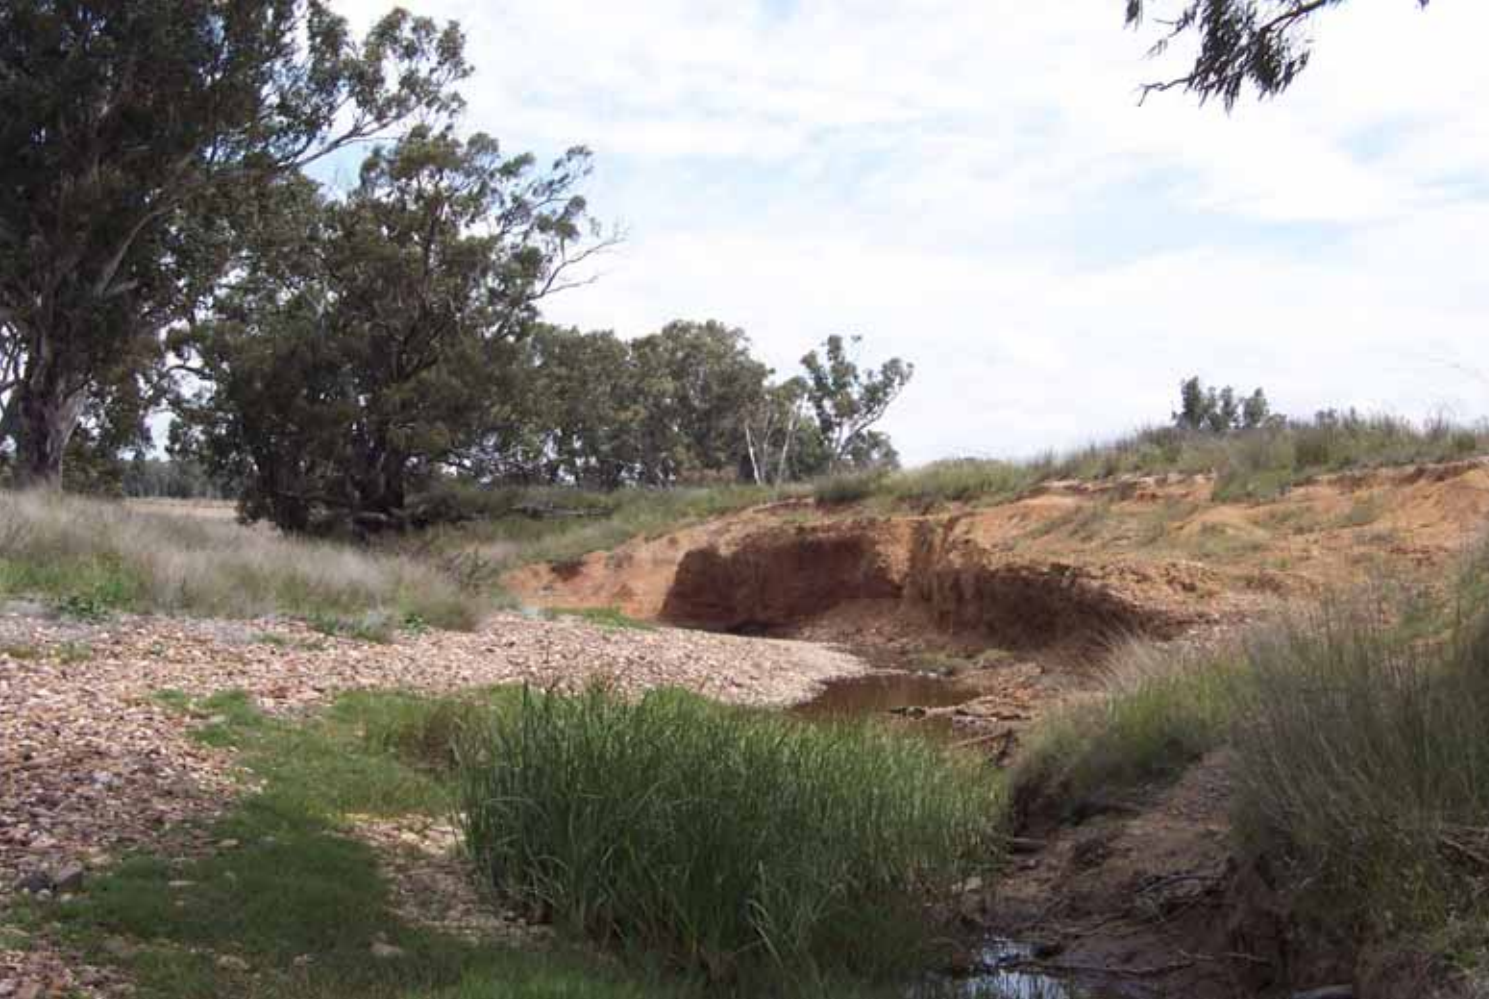
Inferred poorly sorted alluvial sands in the Talbragar River bank. These are only inferred because further comparison is needed to confirm that they are not simply weathered pre-Quaternary sedimentary strata. In this case it is thought that this is extremely unlikely.

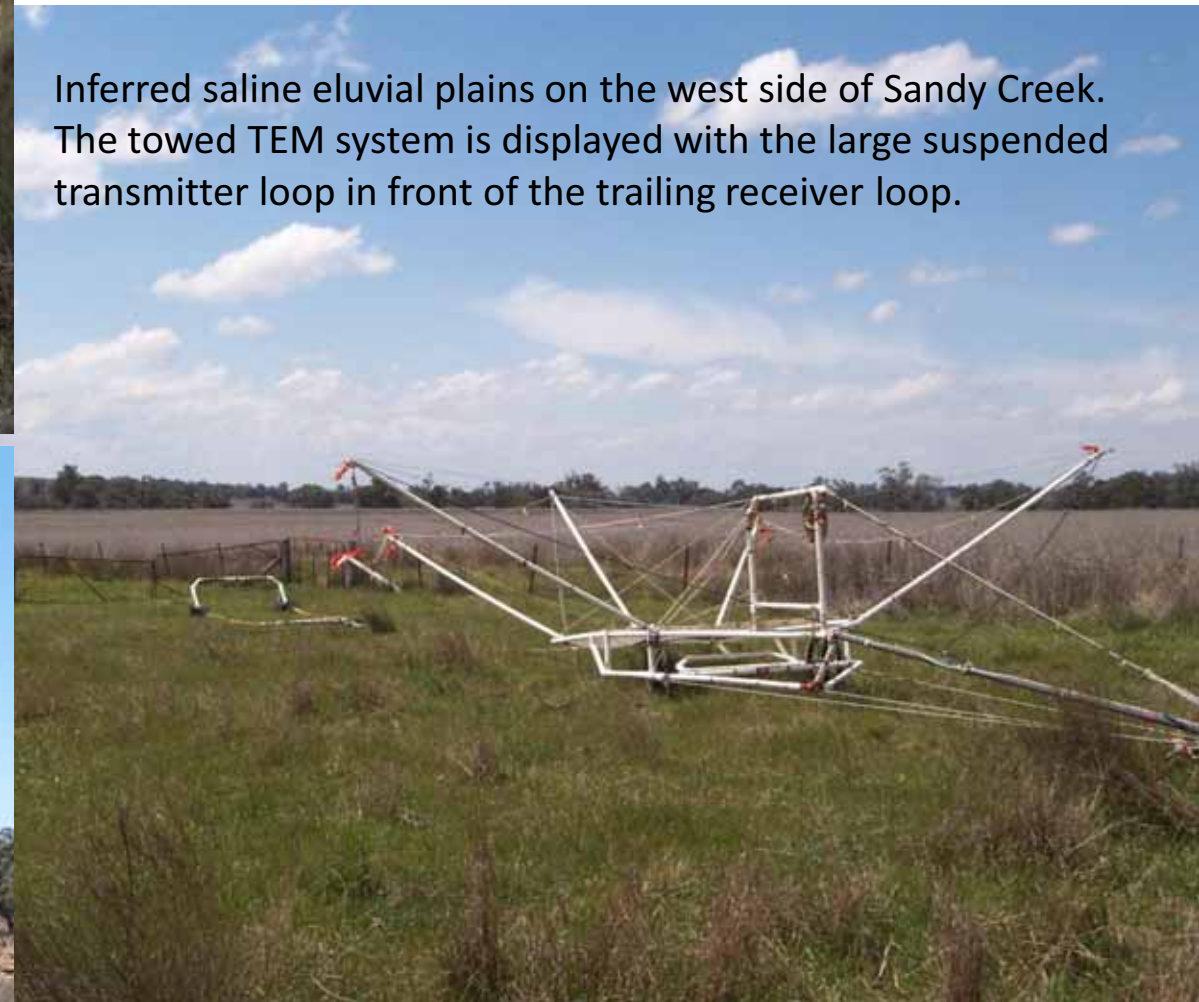
Inferred saline eluvial plains on the west side of Sandy Creek. The towed TEM system is displayed with the large suspended transmitter loop in front of the trailing receiver loop.

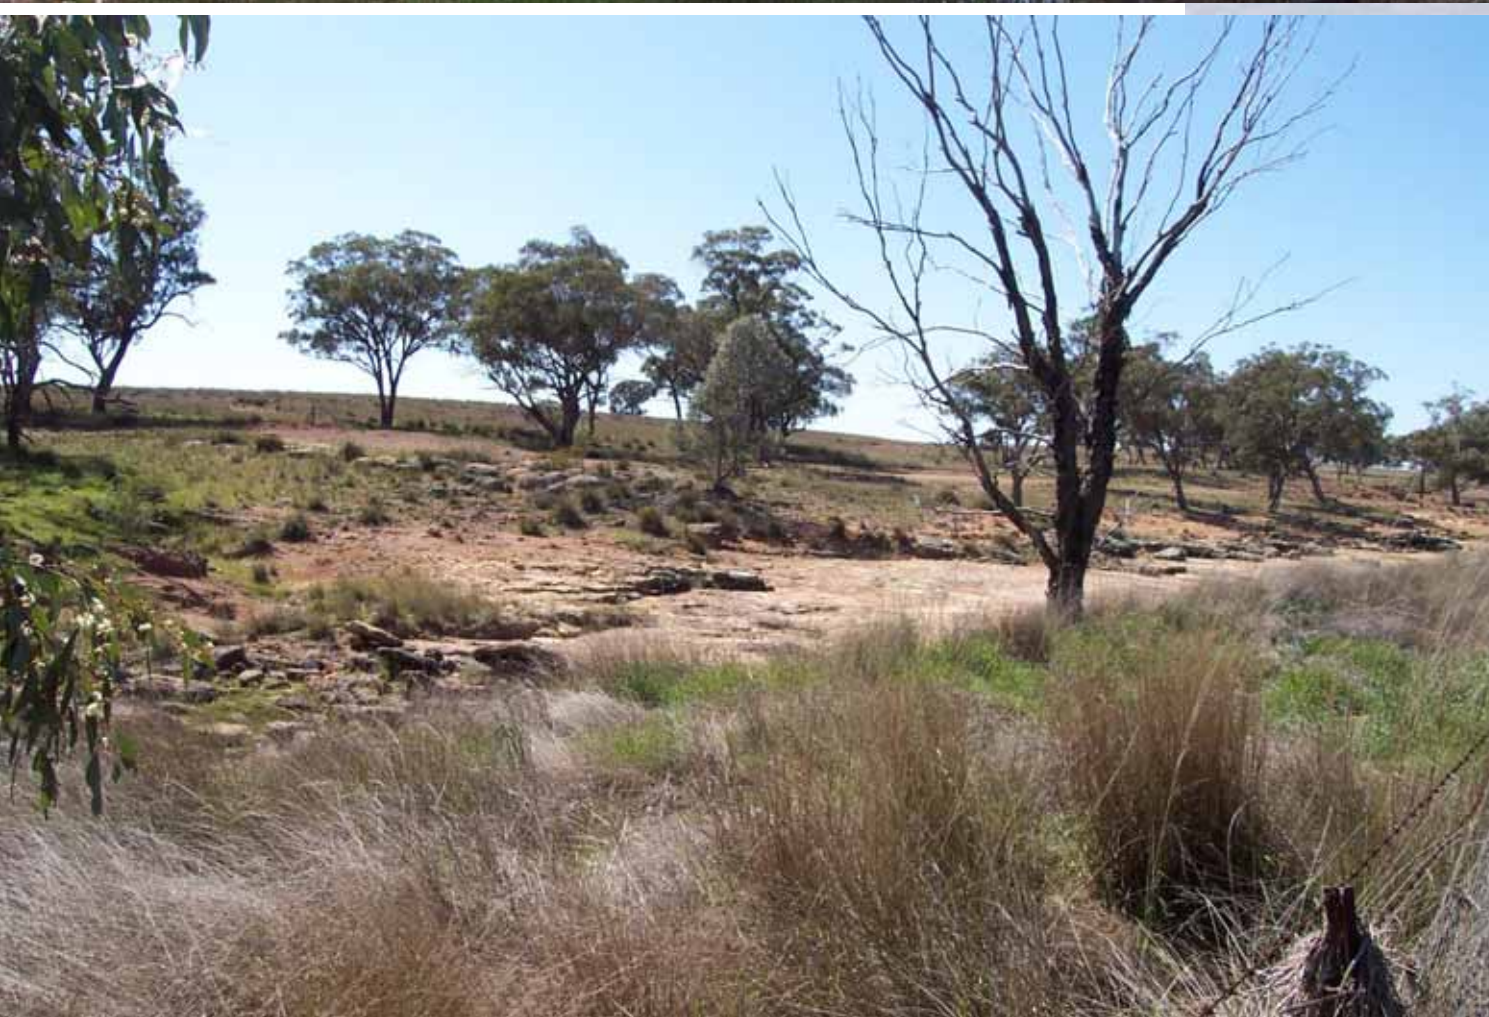
Consolidated rock outcrop in Sandy Creek. There is clearly no alluvium here.

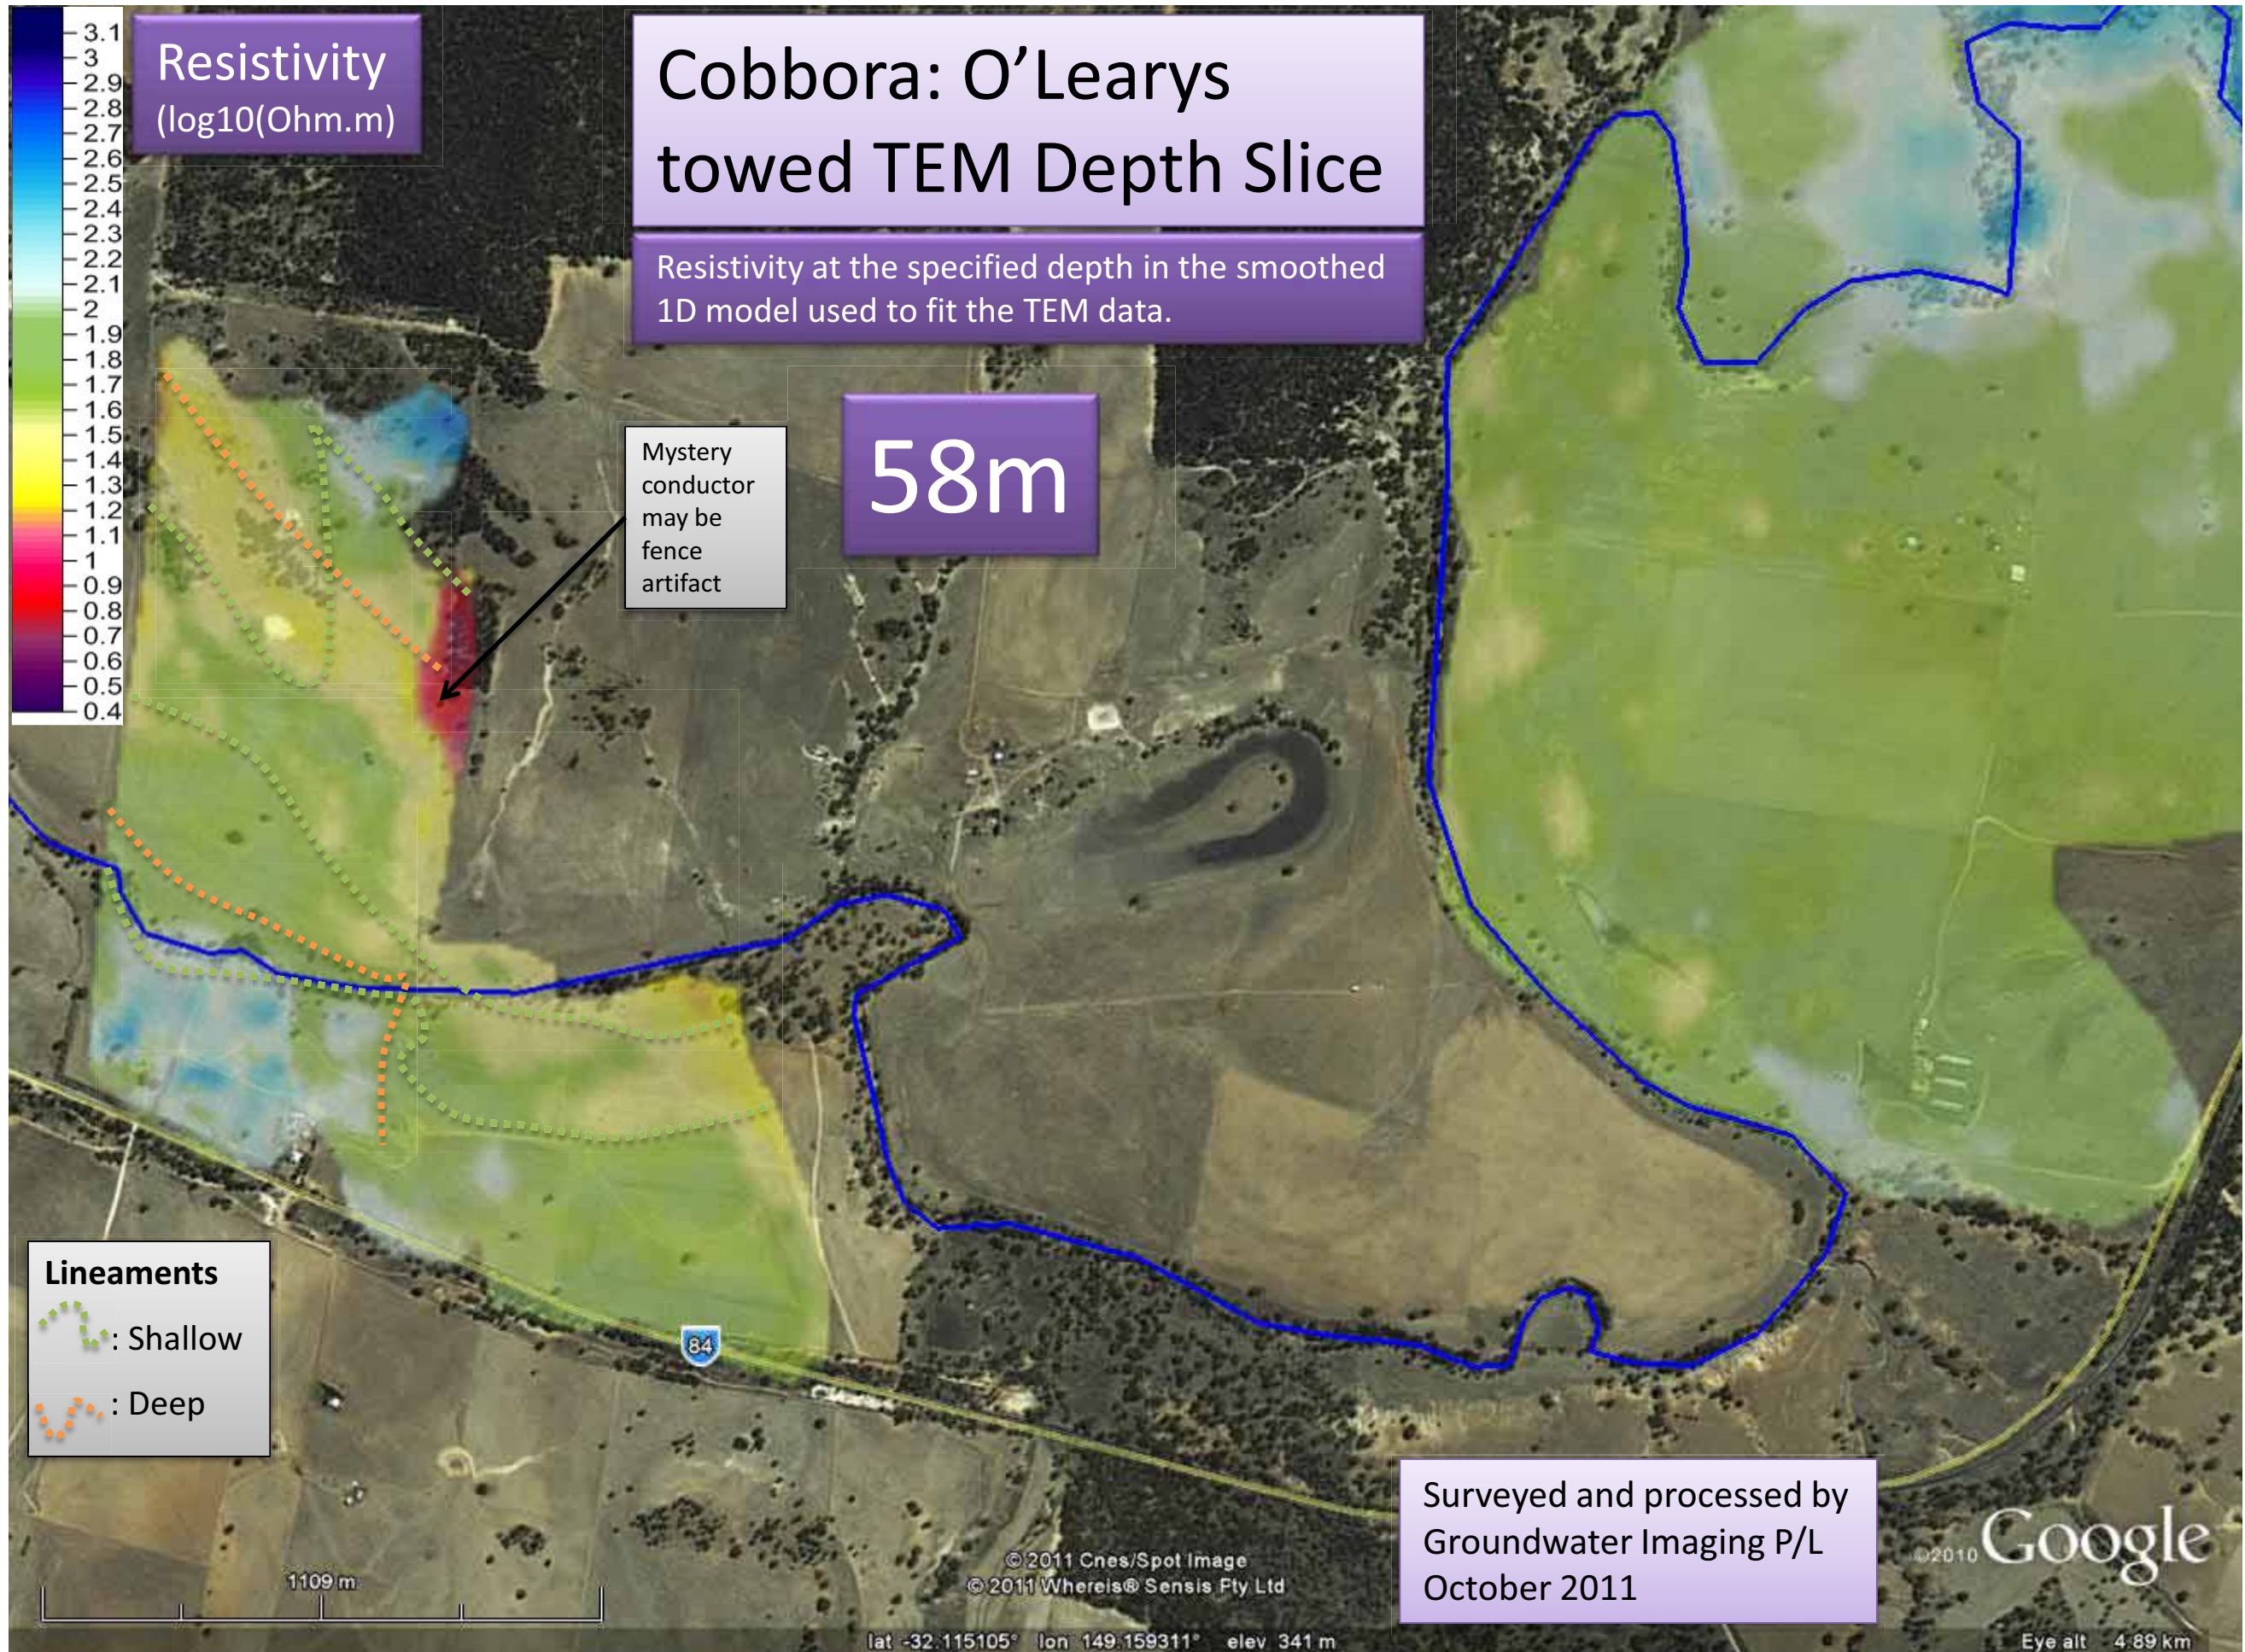
Cobbora: O'Learys towed TEM Depth Slice

Resistivity at the specified depth in the smoothed
1D model used to fit the TEM data.

Mystery
conductor
may be
fence
artifact

- Some fences create bogus conductive anomalies however these are usually identified by approaching the fence repeatedly to identify its effect and then removing clearly affected data. Particularly in the deeper data, some fence effects remain and are evident as anomalies centered on fences. The worst is on the NE part of the O'Learys' property.
