CONSERVATION MANAGEMENT PLAN

THE SCOTTISH HOSPITAL
2 COOPER STREET
PADDINGTON NSW 2021

Issued June 2006
Amended and re-issued 10th November 2010

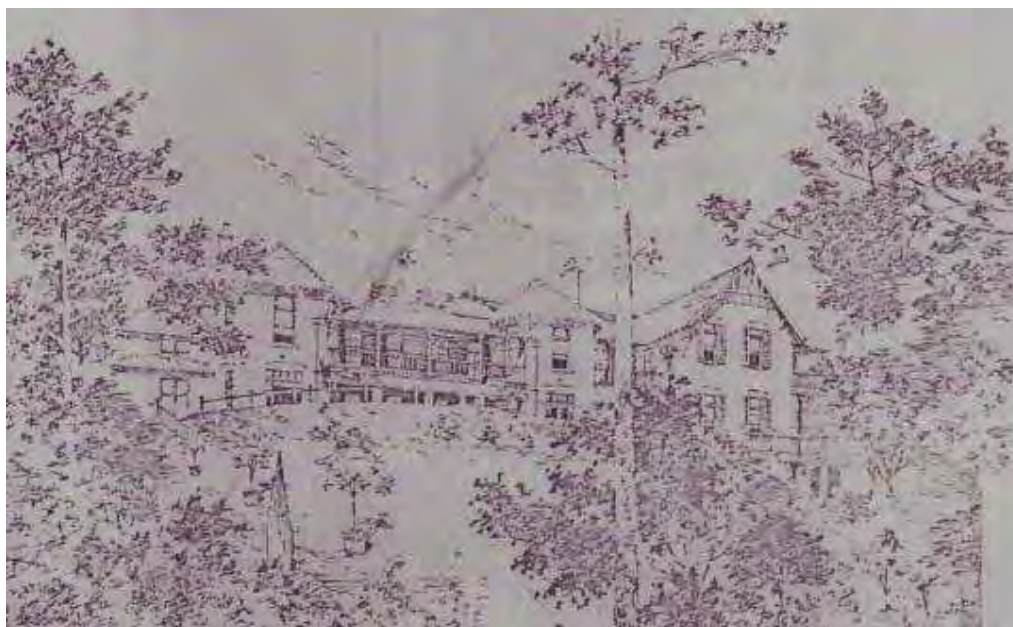
Figure 9 – A perspective of the proposed alterations by the architect, George Sydney Jones, published in 1902.

Jones designed additional spaces including an operating theatre, new wards and administrative support areas. The exterior of the building was finished with pebble-dash render to provide a cohesive appearance to the original building and the new additions, and the first floor balcony was added over the original northern verandah. The building remained roofed in slate tiles, however the hips and ridges were finished with terra cotta capping. The resulting building, renamed The Terraces Private Hospital, was thereby given the appearance of an Arts & Crafts style building (see to Figure 9). The key structural walls and many of the original timber windows dating from c1848 remain in the building today.

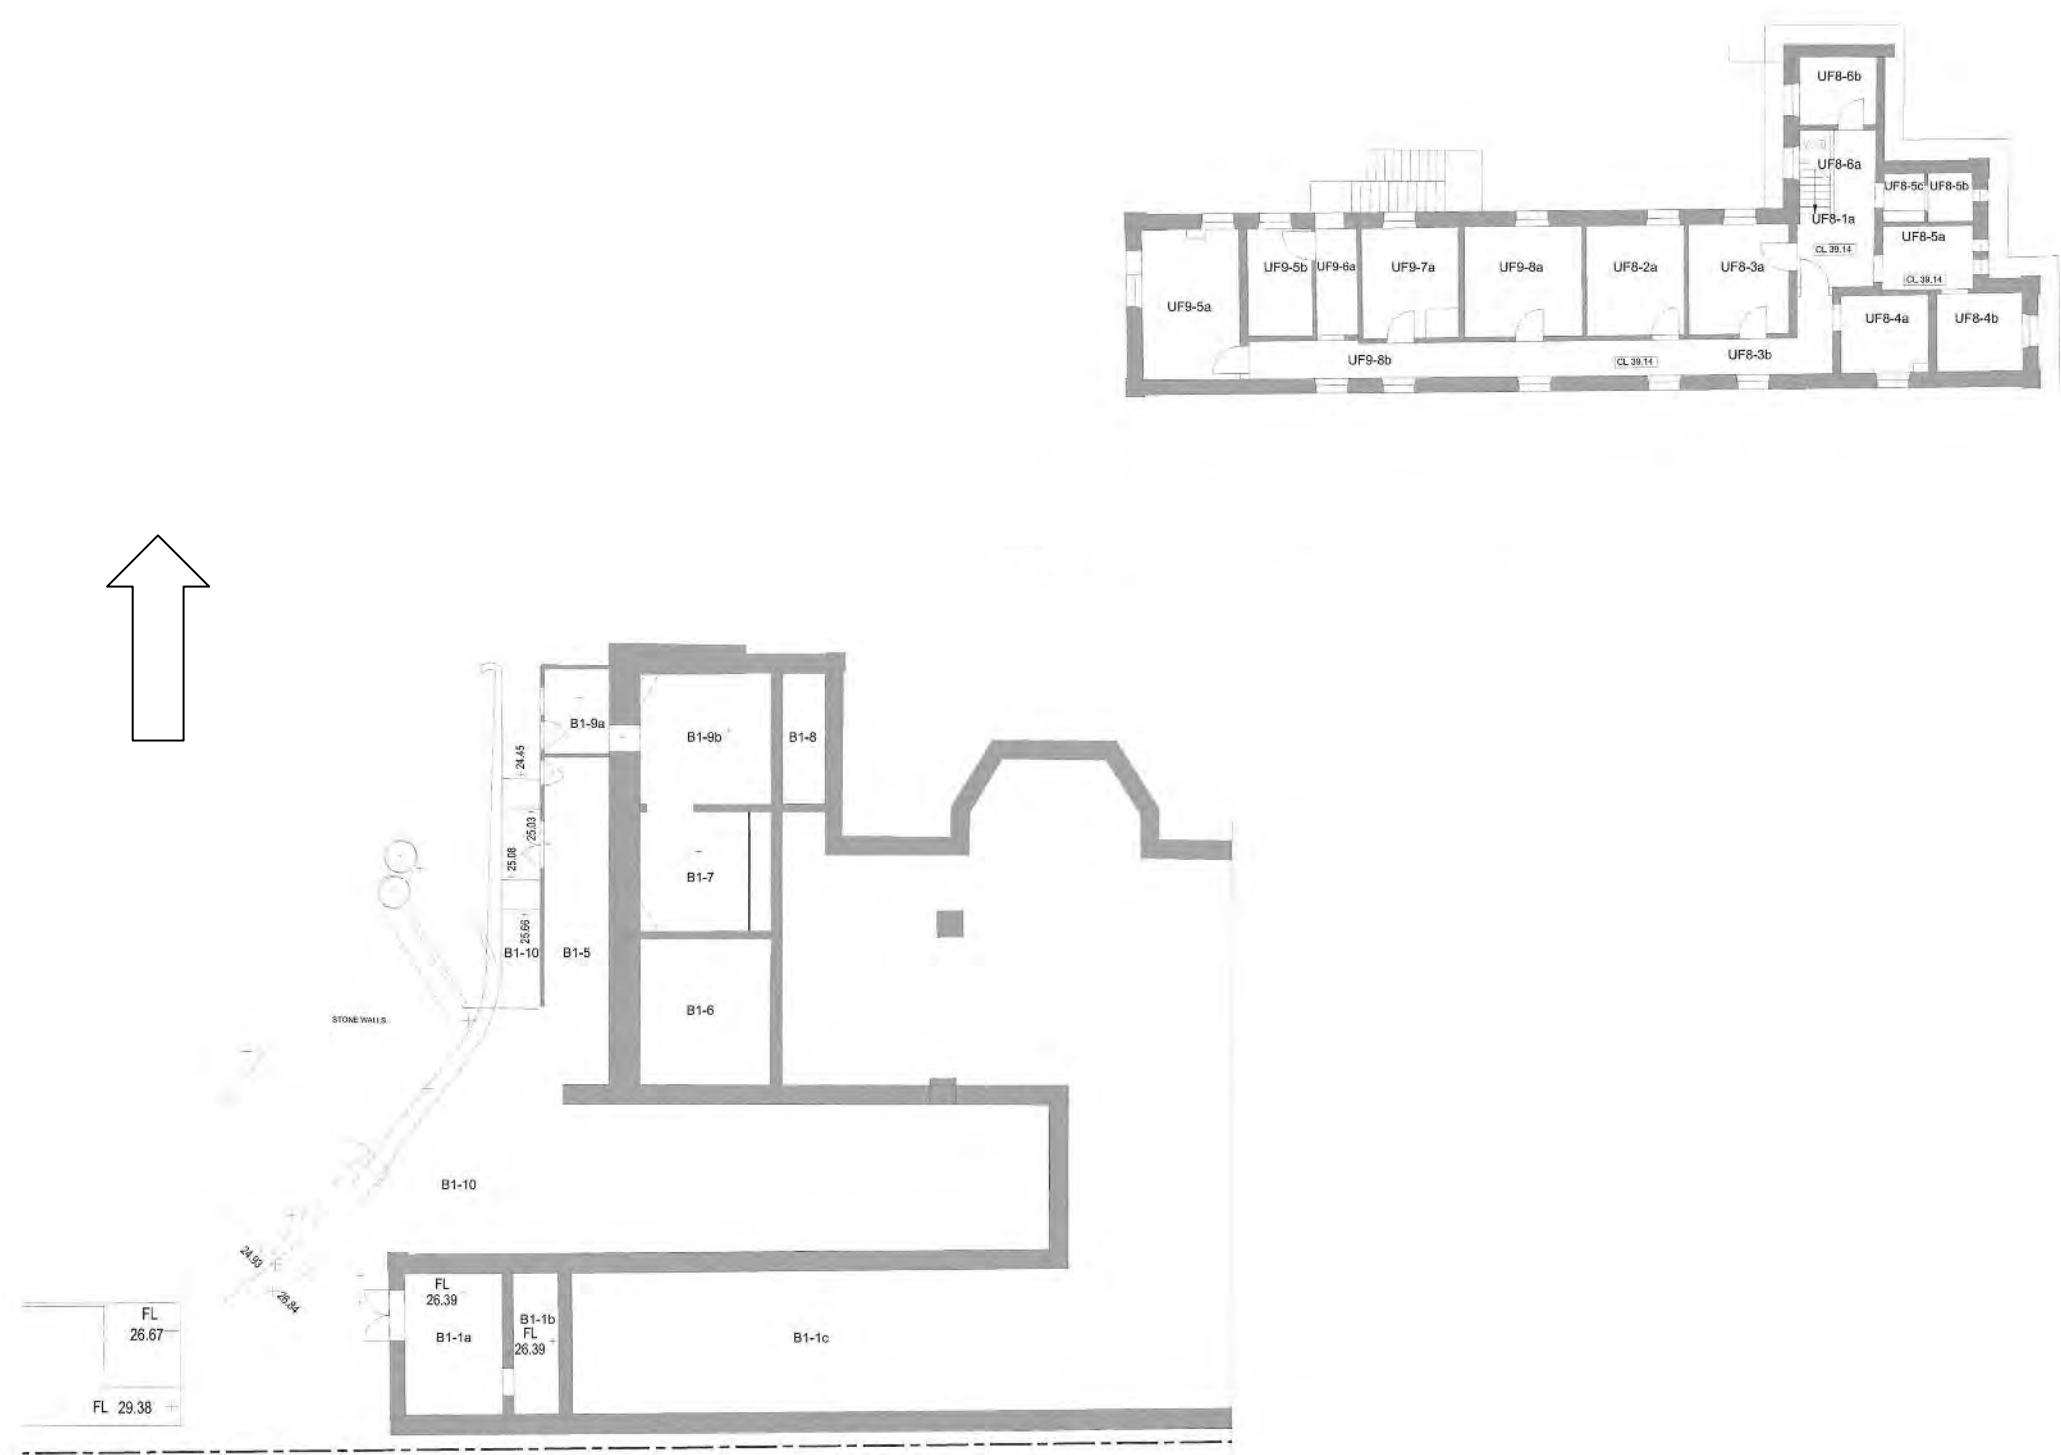
Figure 15 - Plan showing the Basement and Upper Floor layouts and space numbers used throughout this report.
(Source: after Conybeare Morrison International Pty Ltd.)

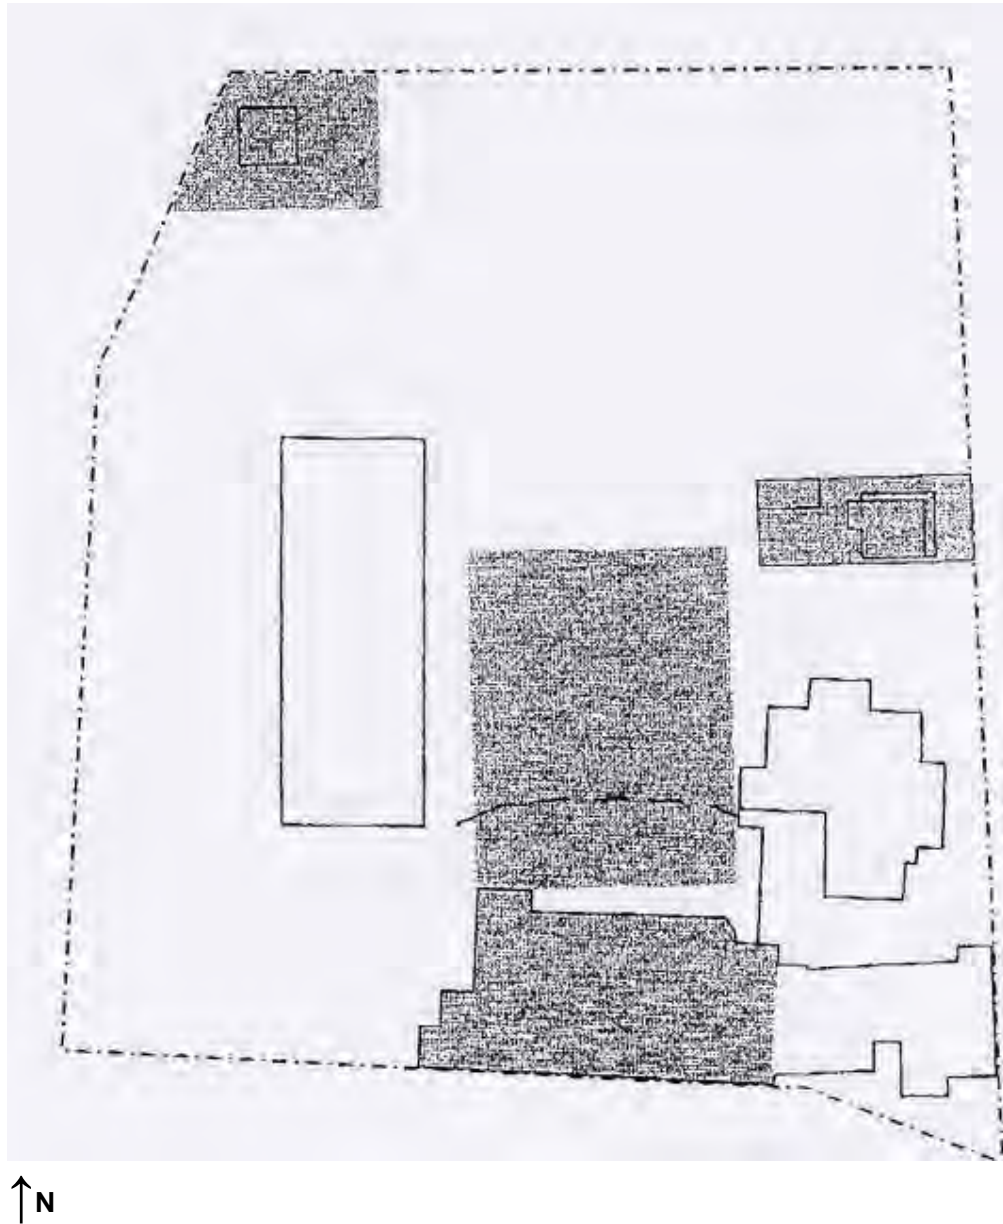
Figure 18. Plan of The Scottish Hospital site showing shaded areas identified as having archaeological potential.

Note any disturbance of identified archaeological areas will require an application to the NSW Heritage Council for excavation permit under Section 140 of the *Heritage Act 1977*.

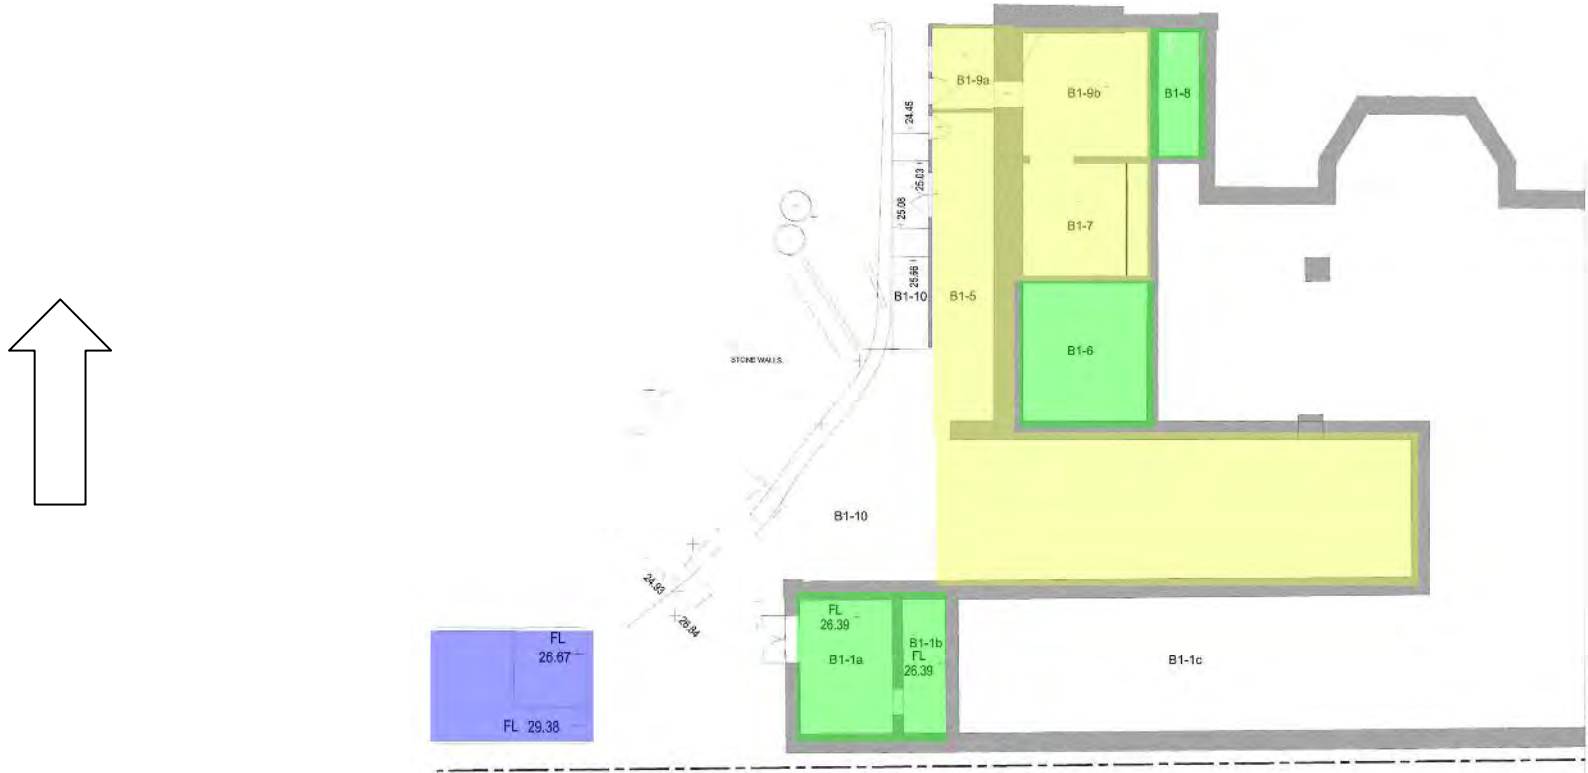
03 EXISTING UPPER FLOOR PLAN 1:100@A1

Figure 19 – Existing basement floor plan and upper floor plan showing the relative levels of significance of spaces within the former Scottish Hospital.
(Source: after Conybeare Morrison International Pty Ltd)

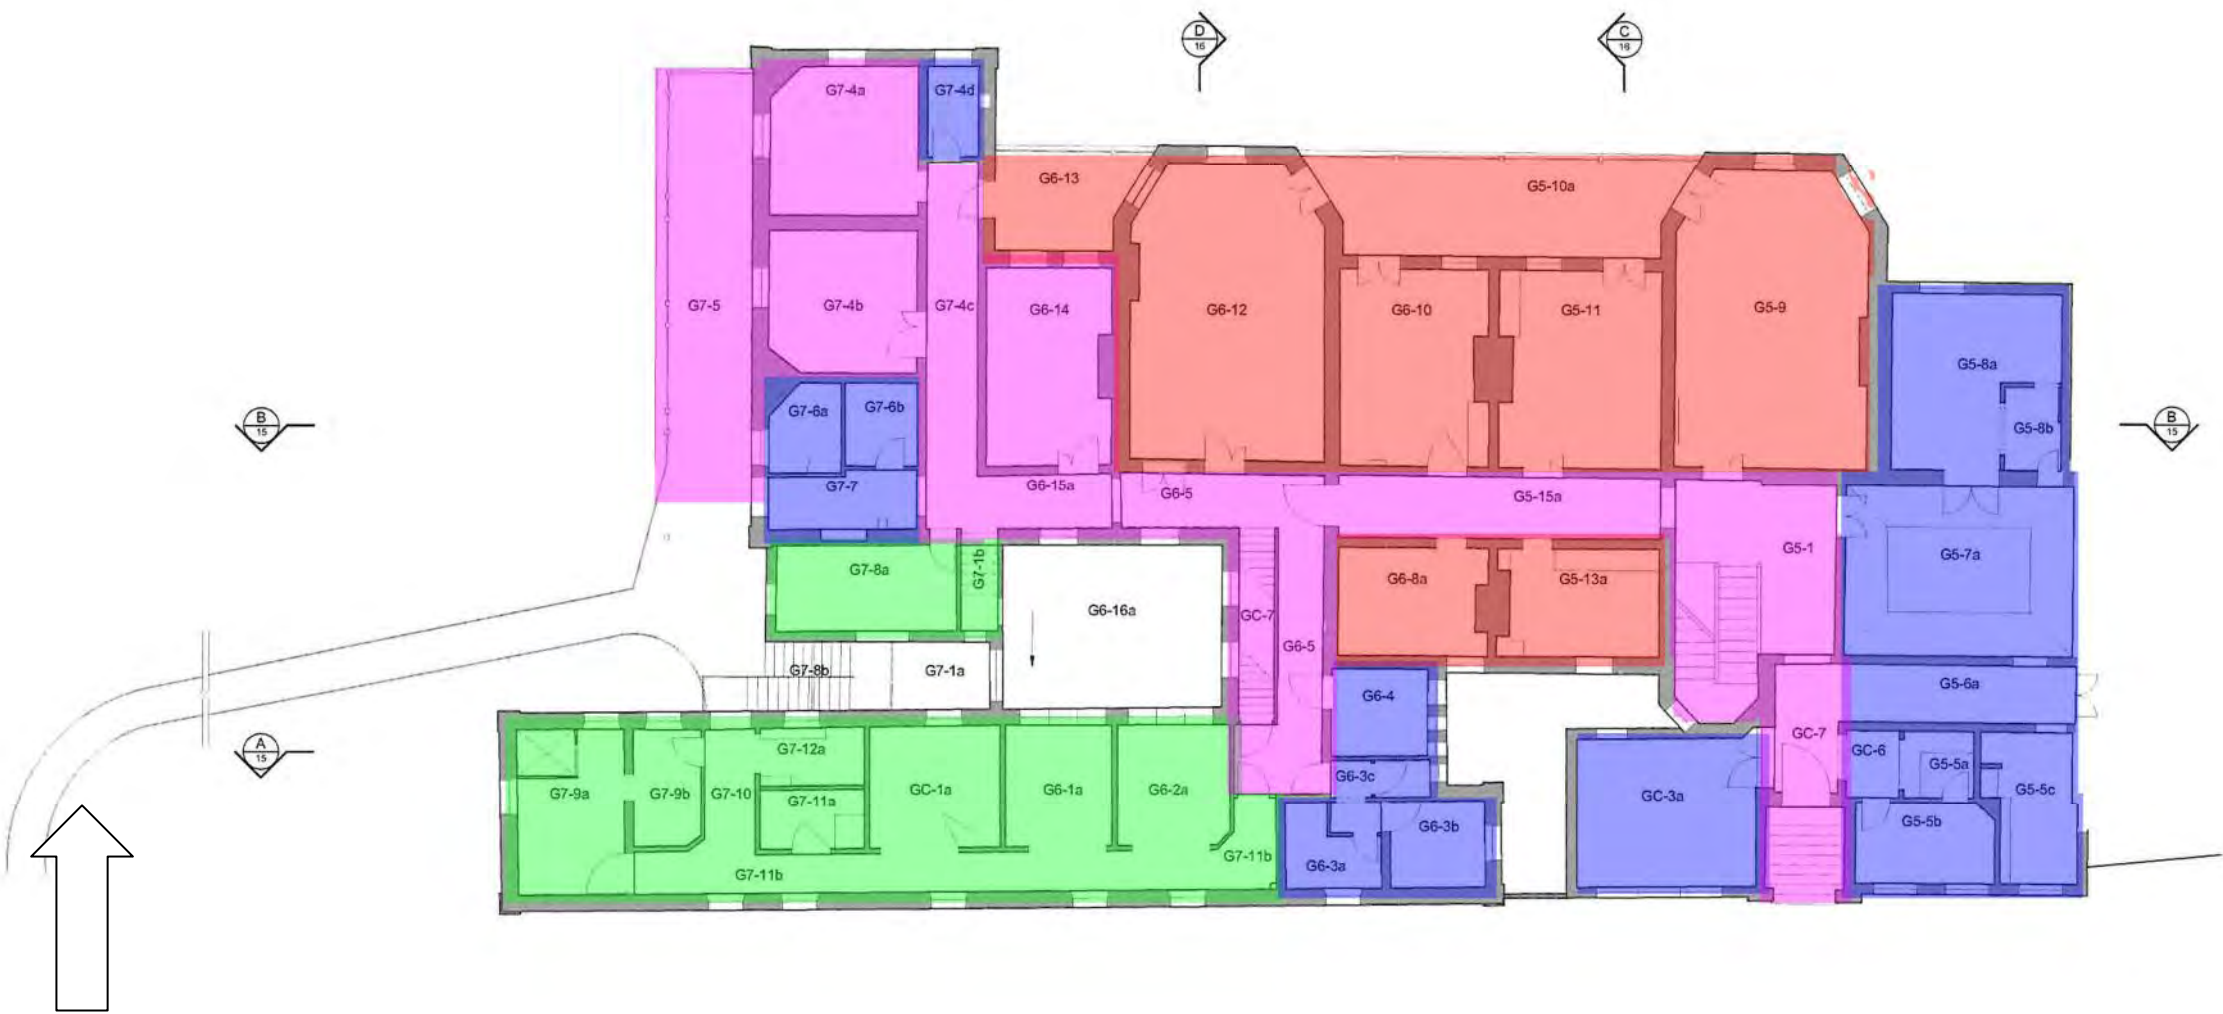
Figure 21 – Ground floor plan showing the relative levels of significance of spaces within the former Scottish Hospital.
(Source: after Conybeare Morrison International Pty Ltd)

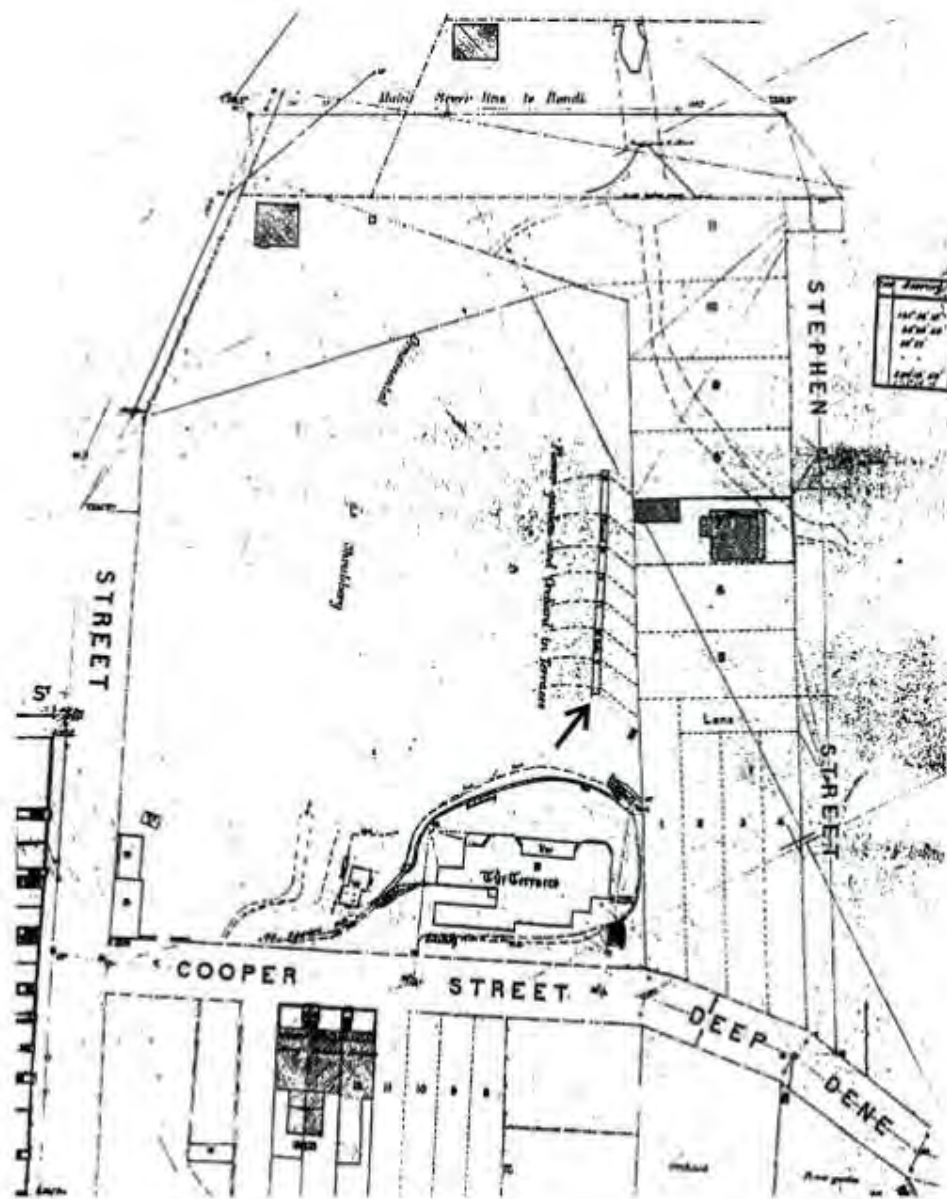
Figure 1 1883/89 plan of site, with stairs arrowed.

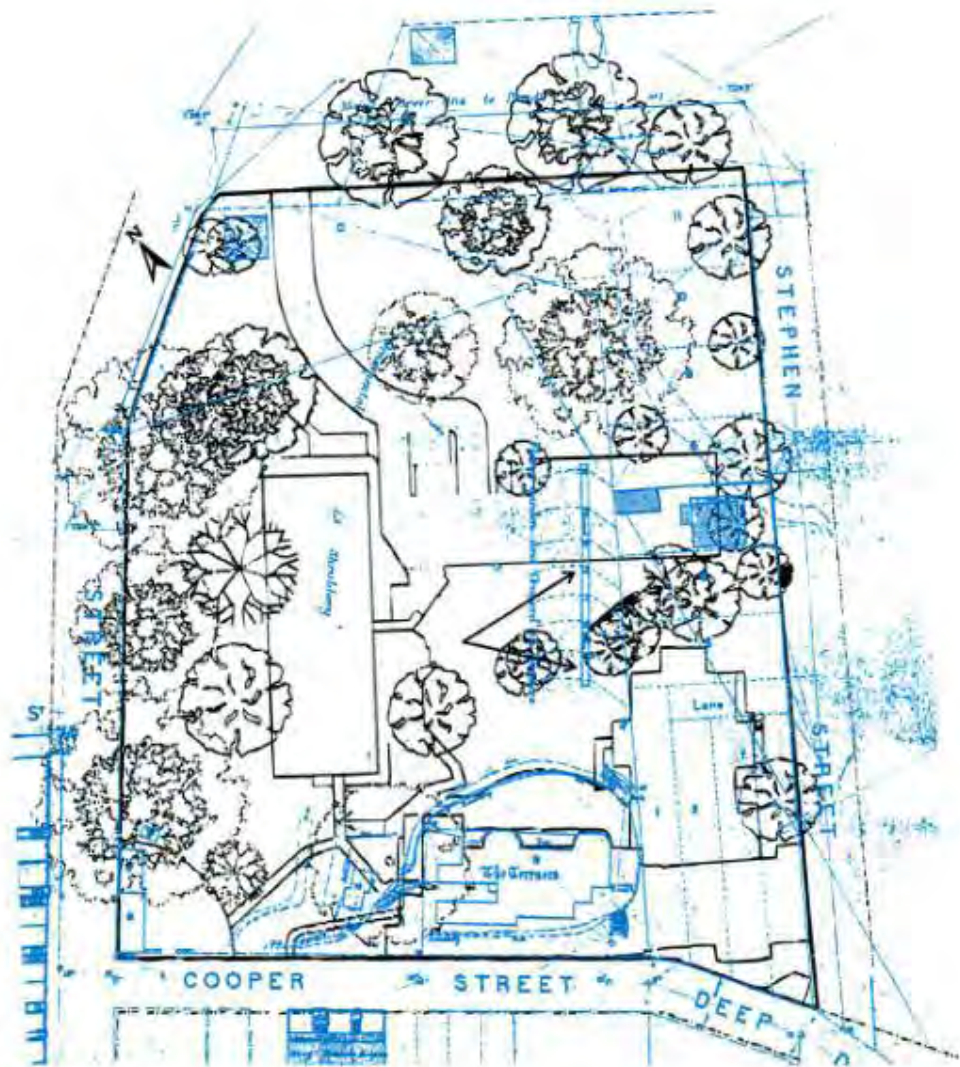
Figure 3. Modern site layout overlaid onto 1883/89 plan, indicating section of stairs uncovered.

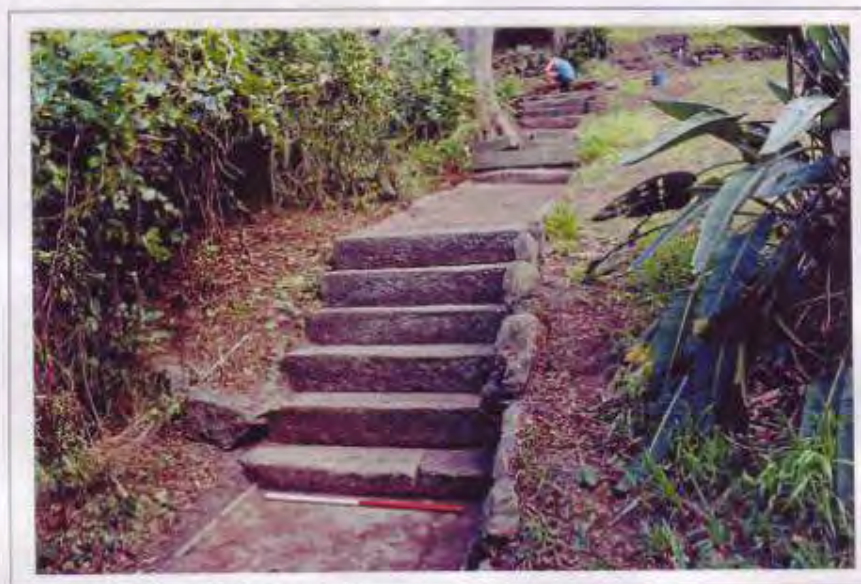
Photo 1: Set of steps looking south. Note terrace wall on eastern side at left.

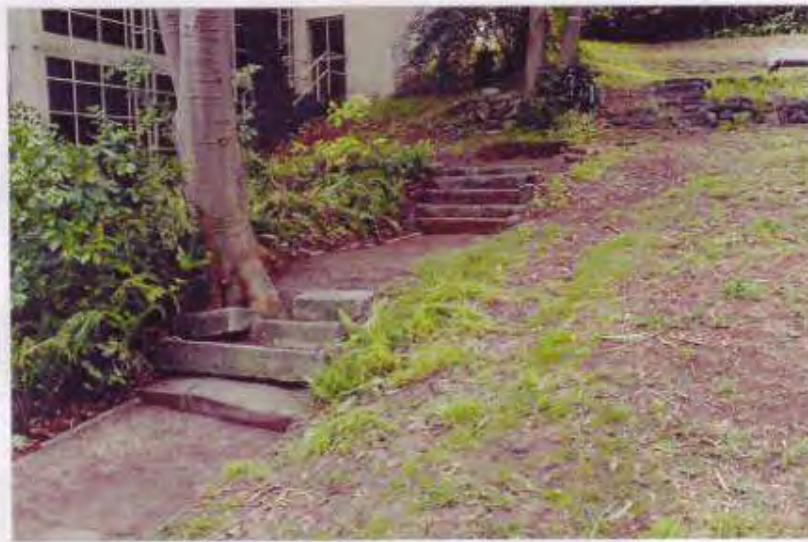
Photo 3: Pathway showing modified terracing to right (west).

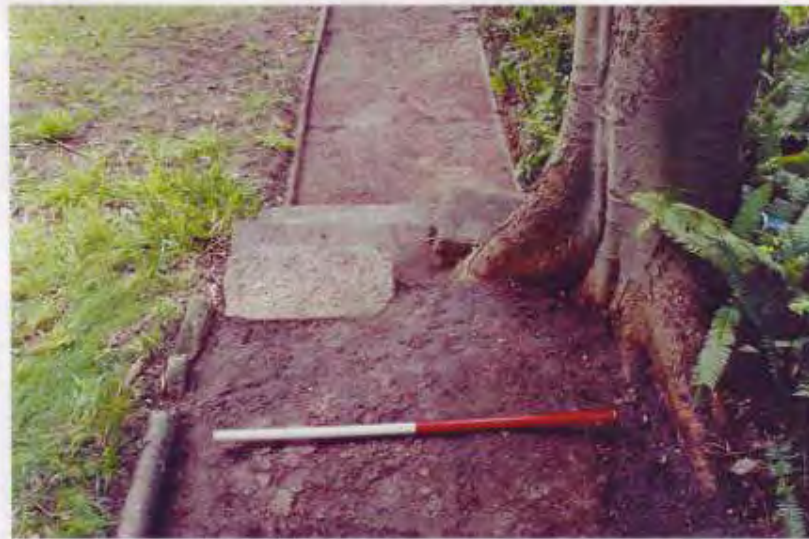
Photo 4: Set of steps damaged by tree but with only minor damage to concrete path.

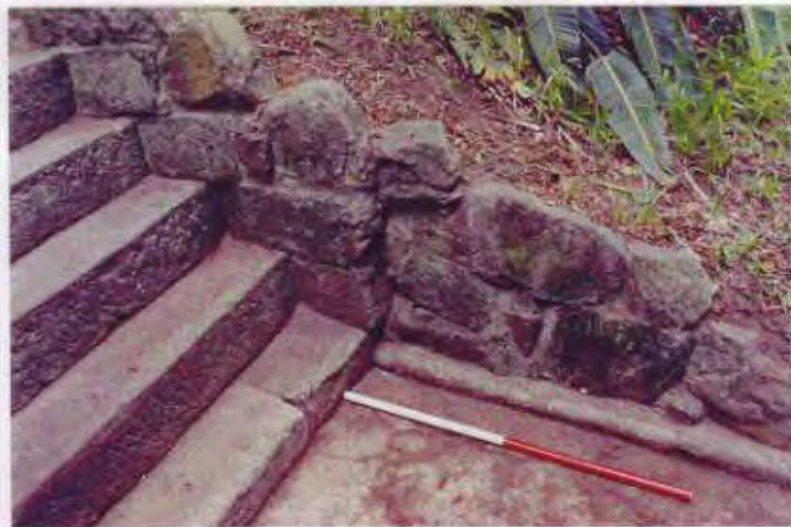
Photo 6: Detail of modified path edging.

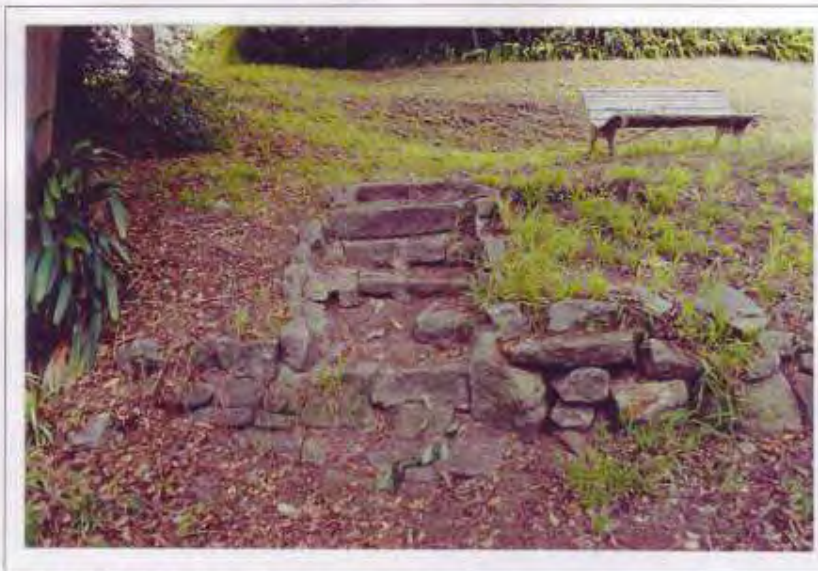
Photo 8: Southernmost rebuilt steps.

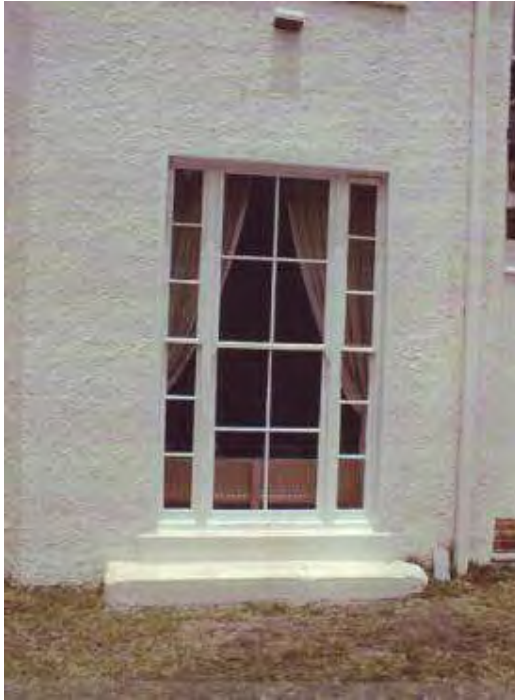
Figure 47 - Main window in north east bay. Note the two main sashes have been replaced with four-pane sashes, instead of six-pane sashes, 8th January 1999, (NBRSPartners)

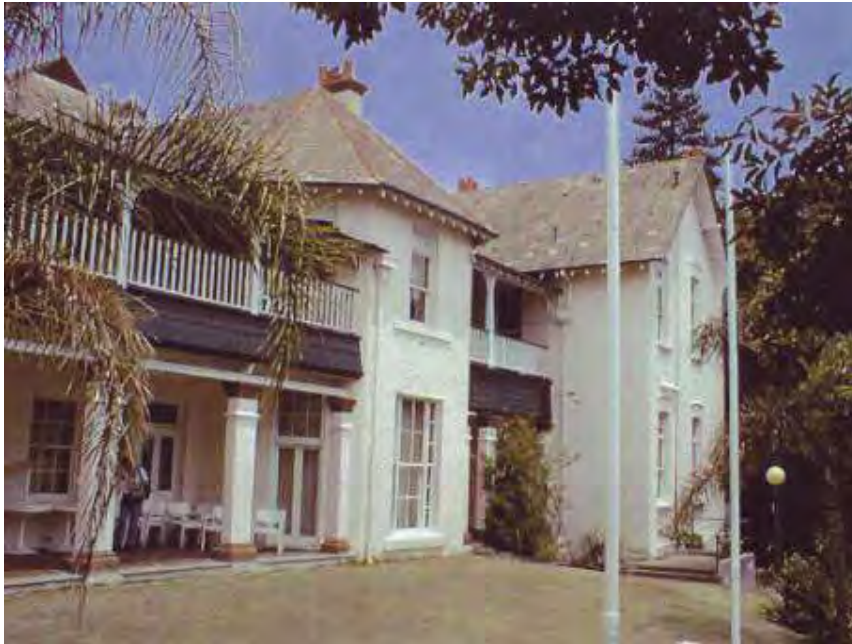
Figure 48 - North elevation of the Scottish Hospital, showing the gable roofed wing added in 1901, 8th January 1999, (NBRSPartners)

The section constructed in 1901 exhibited Arts and Crafts detailing, including external joinery such as the exposed eaves, verandah balustrades, brackets and window awnings on the Cooper Street elevation. The building includes examples of the original 1848 fenestration including window details with six-paned sashes, bay windows with side lights and external sandstone sills remain. French doors were installed in 1901, and new windows and doors can be recognised by arched heads, rather than the flat arches dating from 1848.

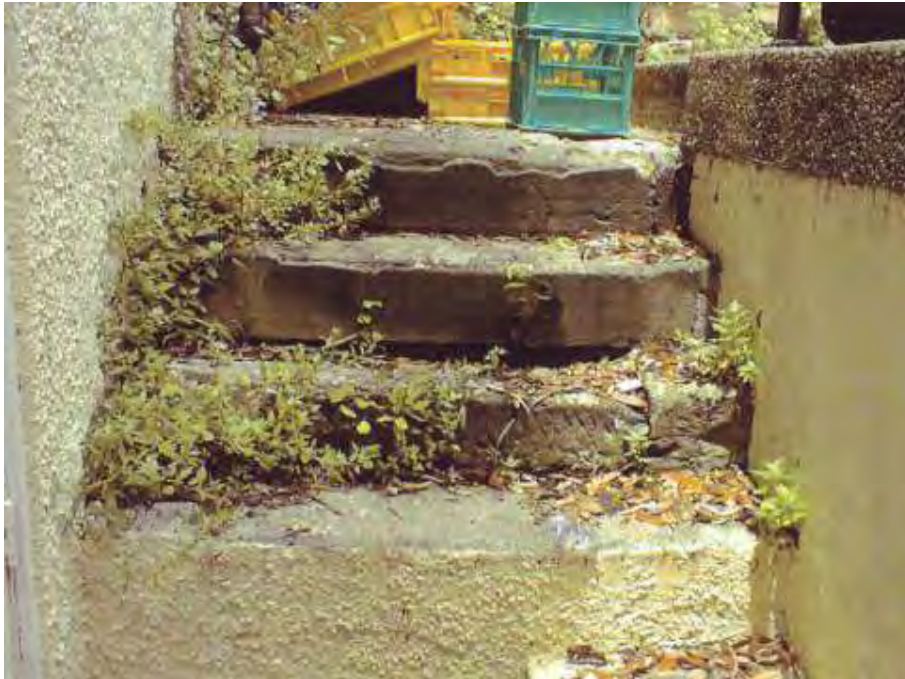
Figure 50 - View of original stone steps leading to a cellar area, 8th January 1999, (NBRSPartners)

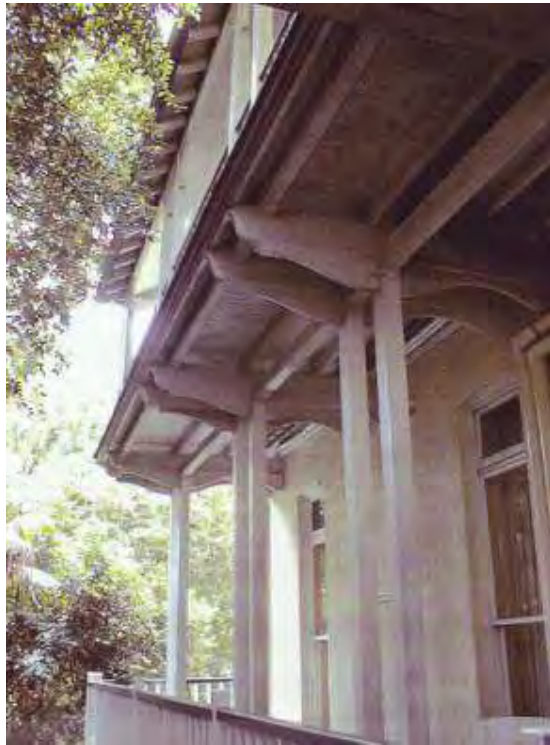
Figure 51 - View of timber verandah columns and joists on the 1901 western wing, 8th January 1999, (NBRSPartners)

The ground floor verandah was originally constructed as a single storey, and was substantially altered in 1901 when an upper level was constructed. The timber columns were replaced with masonry columns finished with roughcast render and moulded face brick details. The western elevation was altered and the annex featuring a two-storey verandah was built.

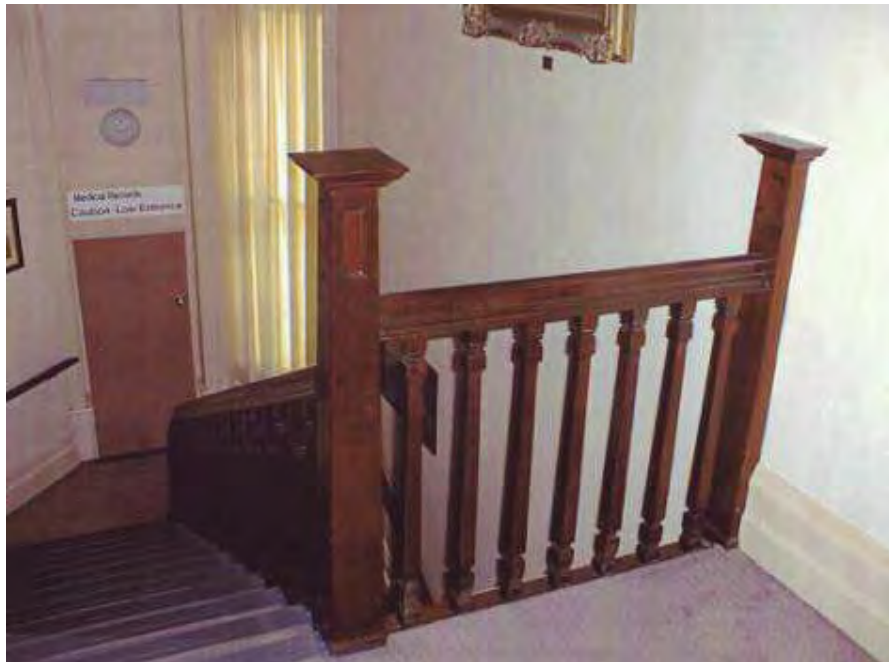
Figure 52 - Detail of internal stair joinery dating from 1901, 8th January 1999, (NBRSPartners)

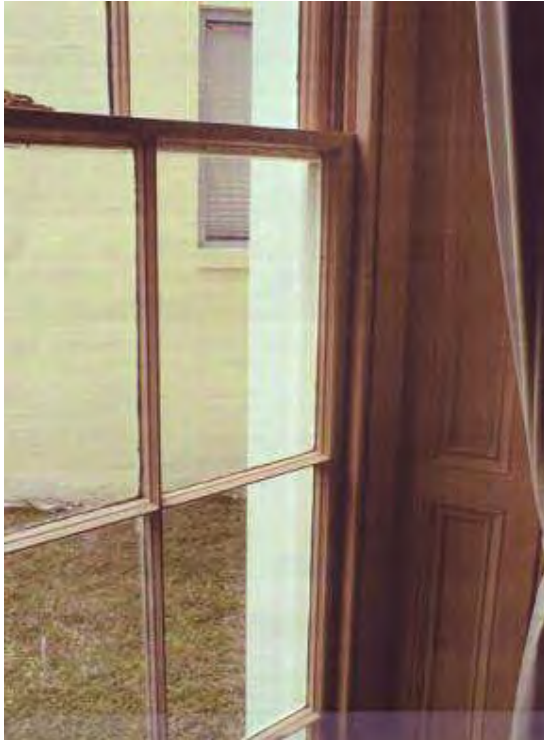
Figure 59 - Detail of original glazing bar and reveal lining on north east bay, 8th January 1999, (NBRS+Partners)

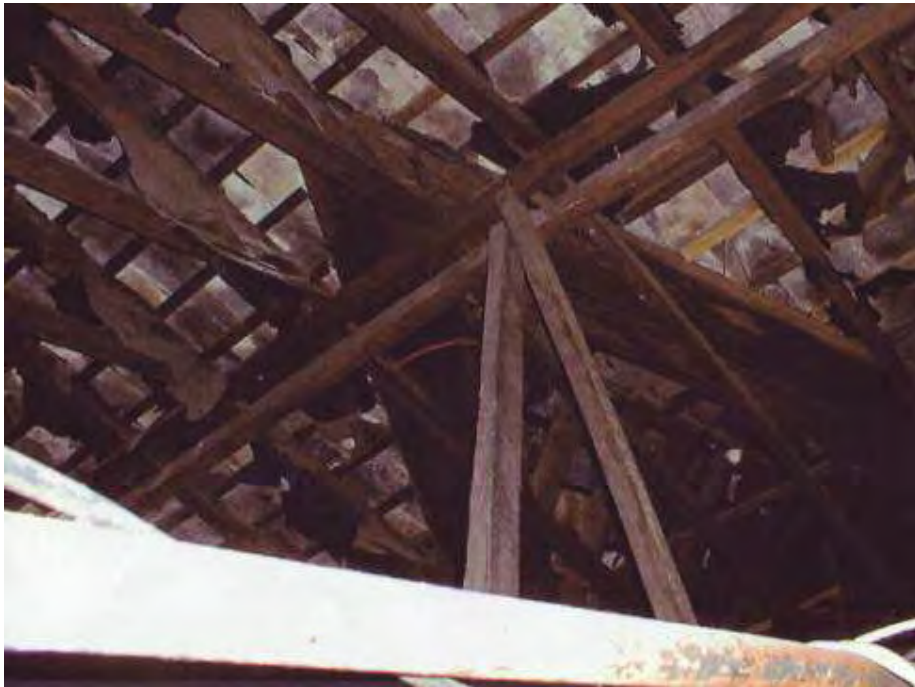
Figure 61 - Underside of existing slate roof, 8th January 1999, (NBRS+Partners)

The original terra cotta and slate roof finishes of The Scottish Hospital were replaced following storm damage in April 2000. Much of the original timber roof framing appears to have survived from c1848, although this should be confirmed on site prior to any further removal or adaptation to the roof.

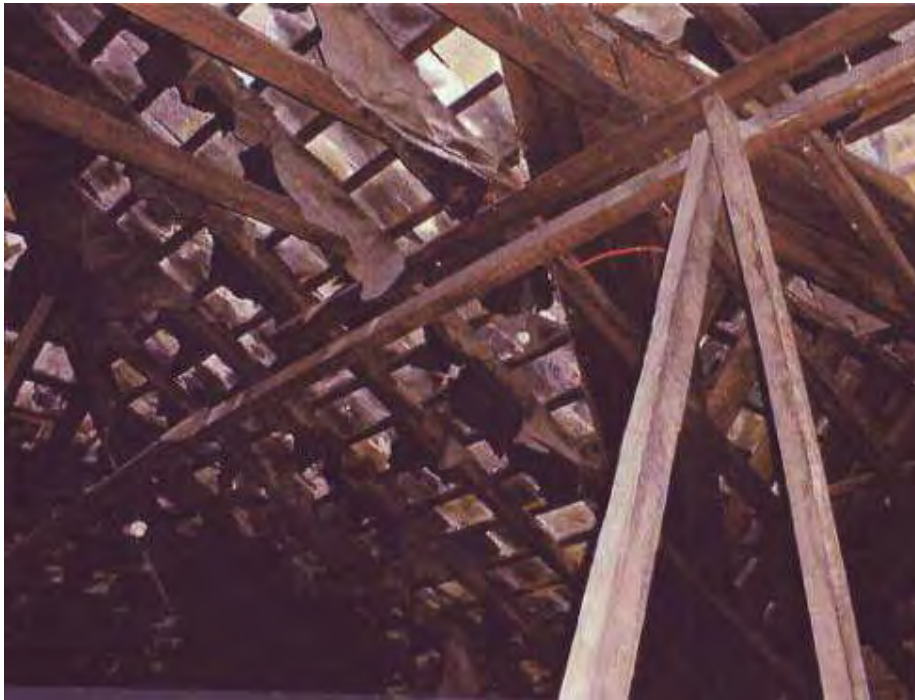
Figure 62 - Underside of existing slate roof, 8th January 1999, (NBRS+Partners)
