**RE: Arboricultural Assessment of Supporting Removal of Tree 130 Sydney Red Gum:  
MP10\_0016 - "The Terraces" 2 Cooper Street, Paddington**

**Ref: 246MonTree130[AR-RE-P-1008]**

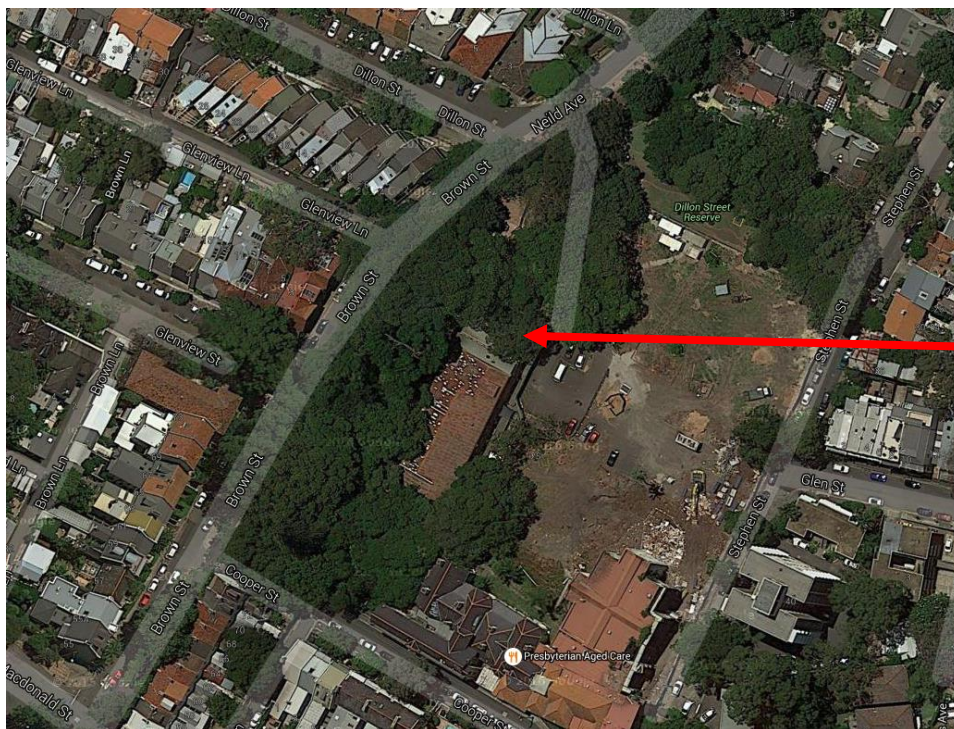
**T130**

Google Maps image 26.11.15 showing Tree 130 following Stage 1 tree removals.

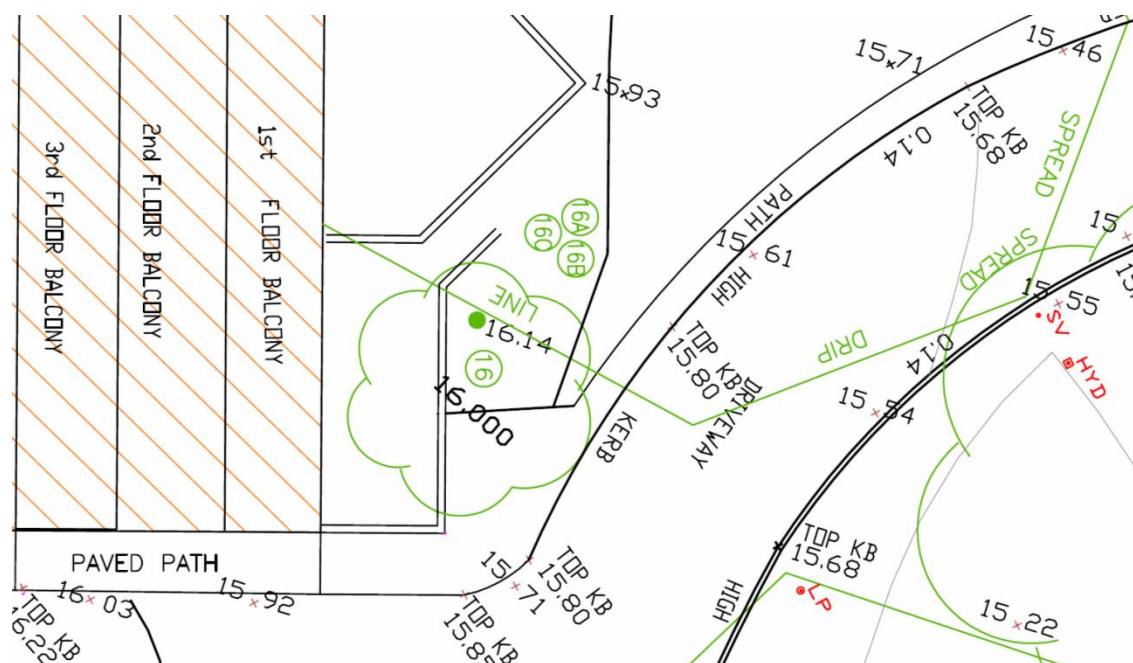
**Excerpt from Survey Ref: 10358, July 2006 by Clement & Reid.**

The assessment of the impact of the proposed building works on the tree in the Arboricultural Impact Assessment report for the DA (Ref: 246DAIA, September 2010) was in error. The close proximity of the trunk of the tree to the proposed Driveway ramp to the basement was not accurately assessed. The earlier tree number (#16) on the Survey was misinterpreted by some as the trunk of the tree. The actual trunk centre is at ERL 16.14 as indicated.

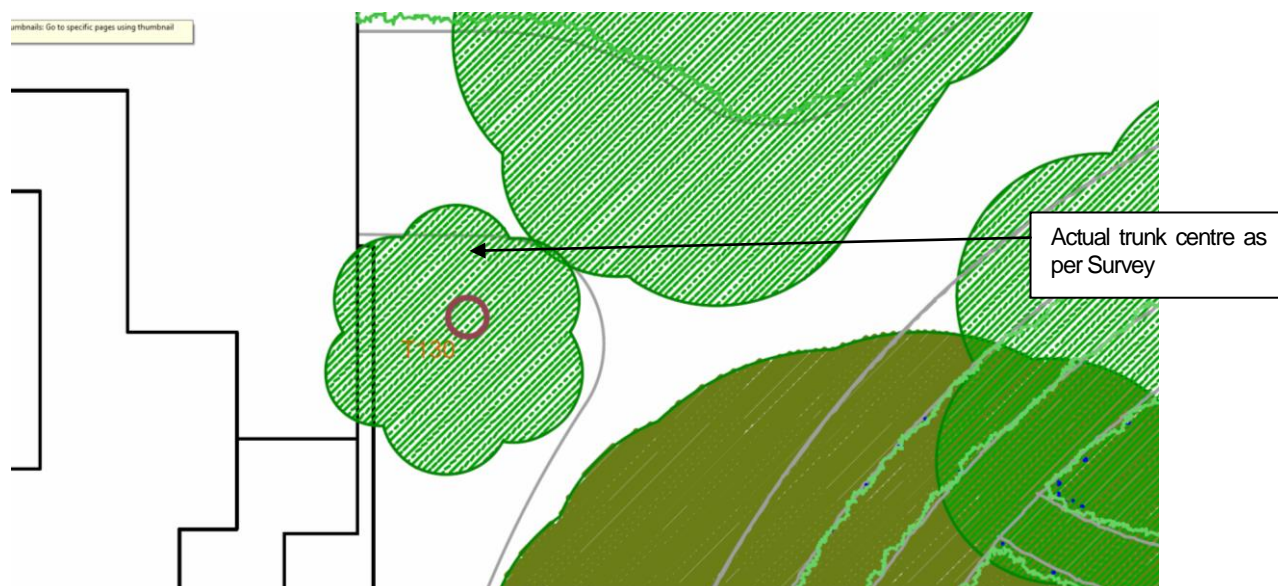
Excerpt from *Site Plan, DA101 Rev. P11* by JPRA.

The JPRA Architectural set, Rev. P11, 7.09.10 reviewed for the AIA, September, 2010 had the trunk shown as the tree number rather than the trunk centre, marginally further from the proposed ramp than shown on the current Drawings.

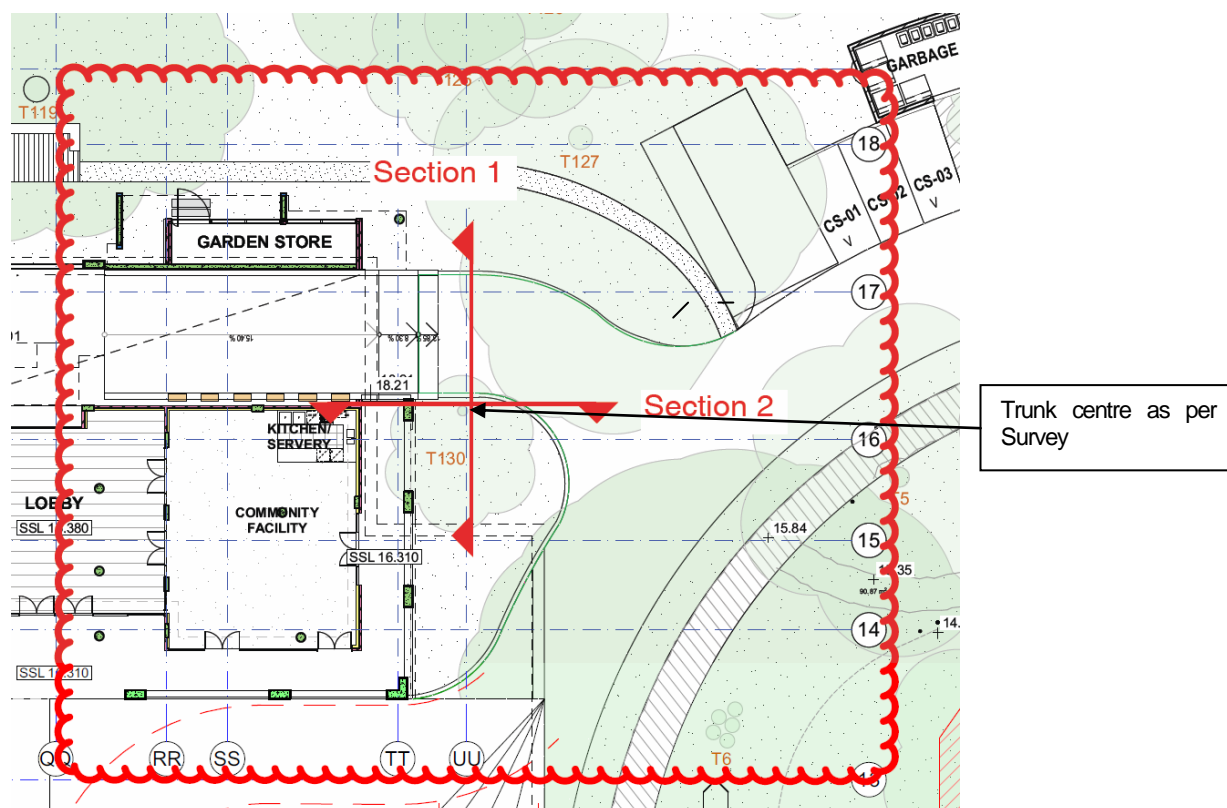
Excerpt from *Level 01 Plan A-P-1103, Rev 10* by JPRA. Refer to Attachment C of detail of Sections 1 and 2.

The current construction drawings show the actual trunk location well within the Structural Root Zone (SRZ) (2.8m) of the tree. In fact the excavation needed for the Driveway ramp down to the Basement is within 1m of the base of the tree and will result in root cutting on the tension side of the tree.

Section 1 shows the existing ground lines and proposed cut required for the Driveway ramp. Substantial cut for the proposed Driveway ramp is required at the base of the trunk to the west well inside the SRZ. Section 2 shows the cut required for the Basement (Grid line 15) within the Tree Protection Zone (TPZ) (7.2m) and excavation for the Basement (Grid line TT) within the SRZ. The tree will be destabilised by these combined excavation works within the SRZ, particularly given the lean of the tree away from Driveway ramp line of cut.

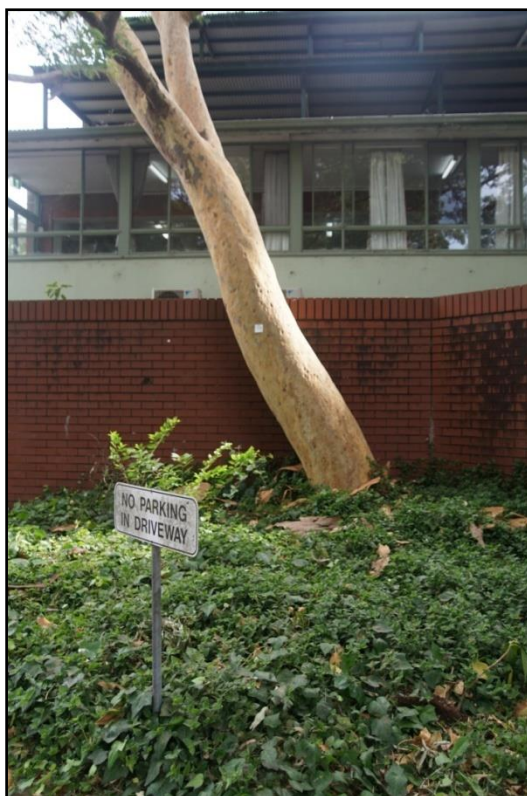
**Photo A:** Tree 130 looking southwest showing significant trunk lean to the south and close proximity to existing walling.

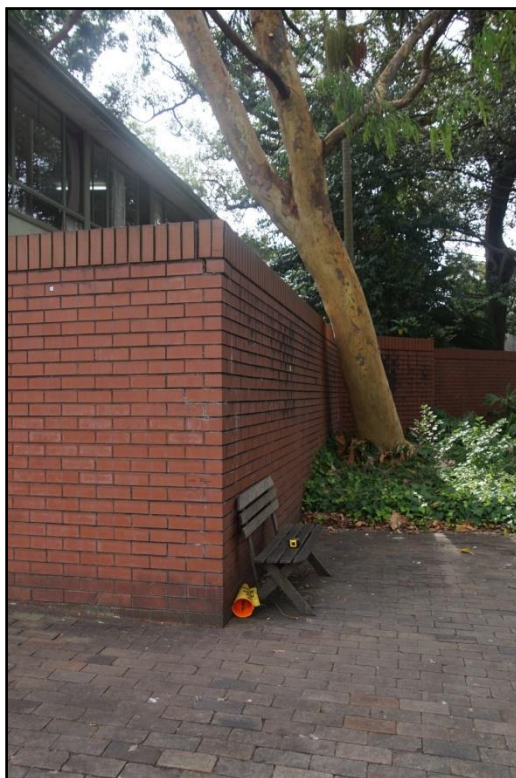
**Photo B:** Tree 130 looking west showing proximity to existing walling and overhang of existing building.

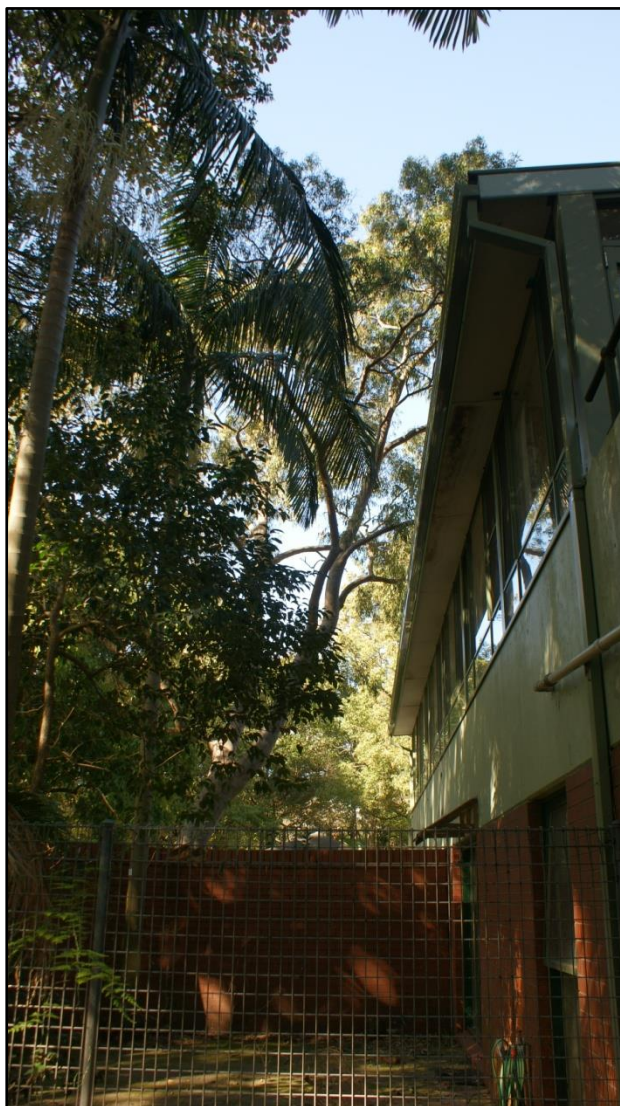
The crown symmetry of Tree 130 has been influenced by the older and larger adjacent trees predominantly Tree 127 (Port Jackson Fig, *Ficus rubiginosa* Photo C).

The crown of the tree is skewed to the south as indicated in Photo C, in the Survey excerpt above and as indicated in the External Works Sections markup (Attachment C). Substantial crown pruning would be required to allow for the proposed building facade and the scaffold required for the construction. As indicated in Section 2 (looking west) scaffolding is required in line with the base of the trunk. Even if the building were to be constructed without external scaffolding, the southern-most leader would need to be pruned to the main junction at approximately 3m above ground level and all the southern branches would need to be pruned to provide reasonable building clearance. This extent of crown pruning would render the tree significantly disfigured such that its ULE would be reduced and the landscape amenity provided by the tree would be lost.

**Photo C:** Tree 130 looking east showing crown skew to south over existing and proposed building.
